Post War Example Residential Building Survey

INTRODUCTION

Firstly, may we thank you for your instructions of xxx we have now undertaken an independent Building Survey (formerly known as a Structural Survey) of the aforementioned property. This Survey was carried out on xxx.

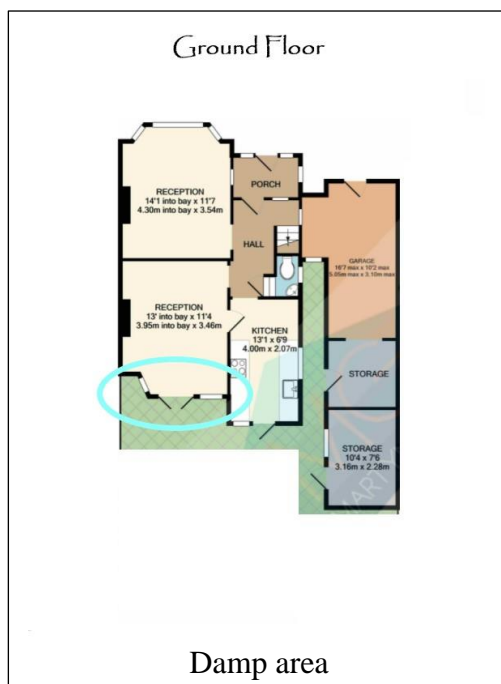
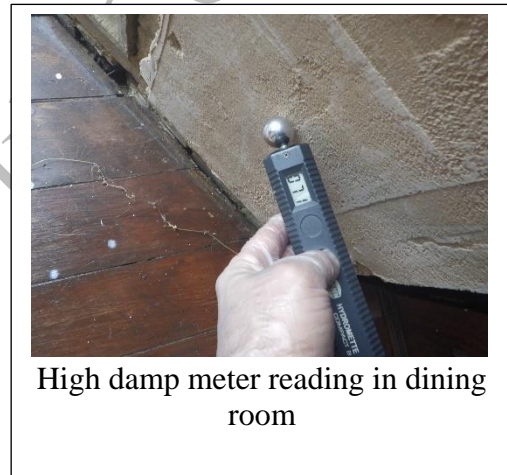
To the rear of the property there is a broken downpipe and also a gully that is allowing dampness into the property. The owner is aware of the problem and has tried to resolve it by adding a gully. Unfortunately, this has then allowed dampness to go under the building.

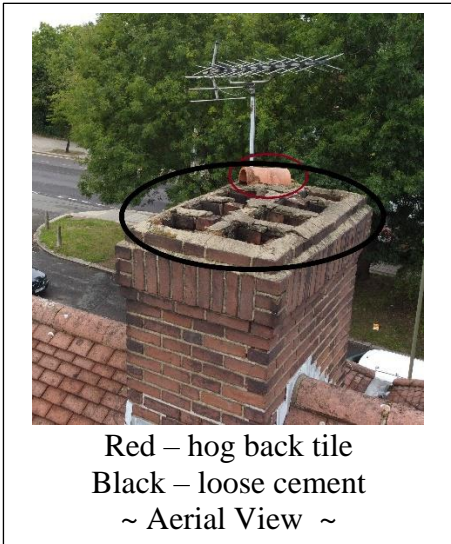
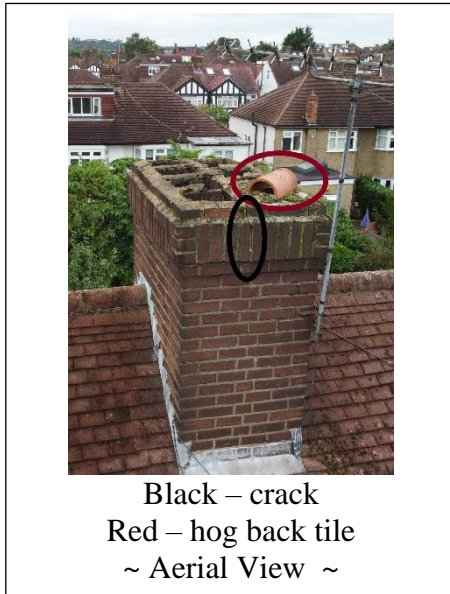
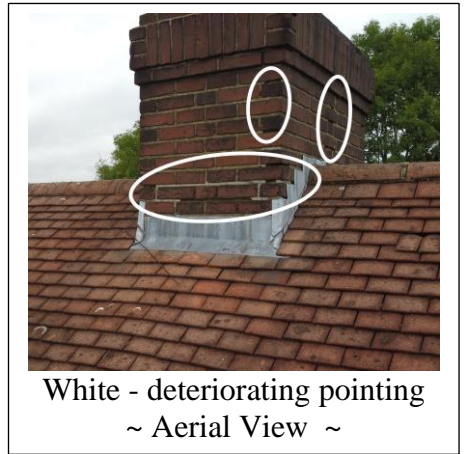
The main chimney looks to be weathered and in need of repointing. From our aerial photographs we would comment the chimney is in slightly below average condition. What surprised us from our aerial photographs is that it was an open pot at the top. We can see one hog backed tile has been used to close one chimney; you may decide to close all of them if you are not going to be using the chimneys to stop dampness getting in.

dampness is getting in through the main chimney, we think it is likely and we would carry out repairs to the rear chimney which will need a tower scaffold or similar (or even scaffolding to the main chimney).

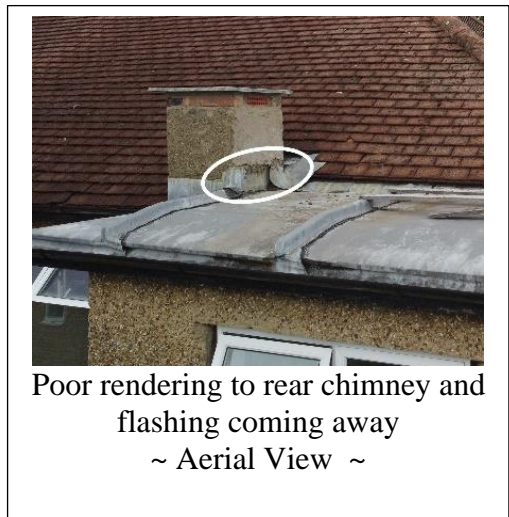
To the rear chimney the render is deteriorating and the flashing is coming away.

ACTION REQUIRED: Replace flashing and make watertight.

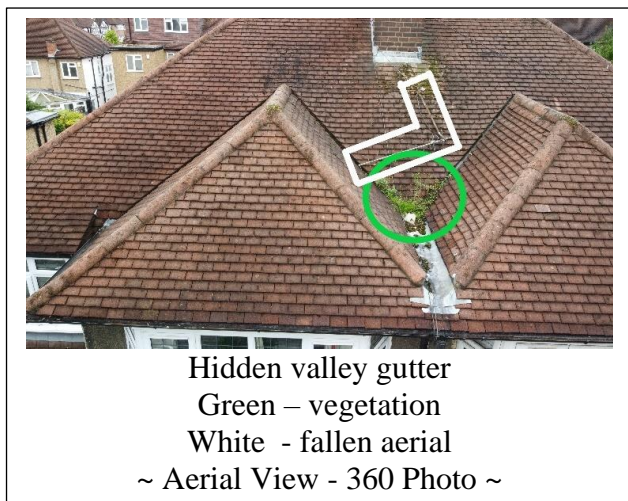
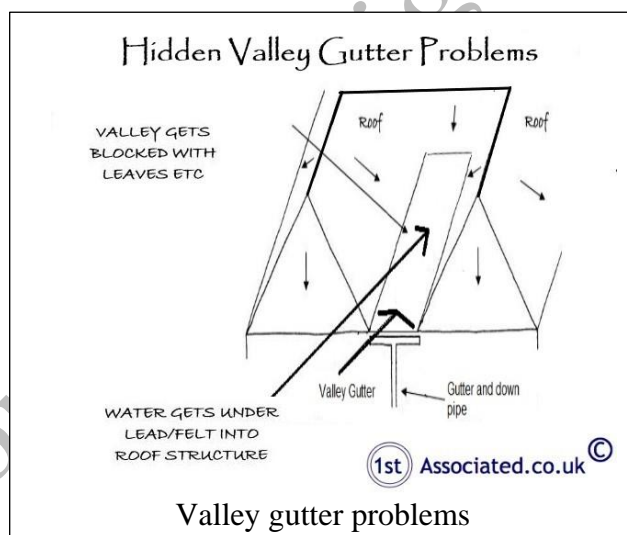
To the front of the property there is a hidden valley gutter. We can see from our aerial photographs that there is moss on this roof and we can also see from within the roof that there is staining where the valley gutter is. This has resulted, we believe, in the staining that is visible in the front right bedroom adjacent to the chimney.

ACTION REQUIRED: Clear the moss and grass and any other debris and have a roofer check the tiles are in place, the tiled valley gutter and also the lead valley gutter. Ask the roofer to take photographs after they have carried out the work which we would be more than happy to comment on.

ANTICIPATED COST: In the region of £750 - £1,500 depending upon what is found and how access is gained; please obtain quotations before you legally commit to purchase the property.

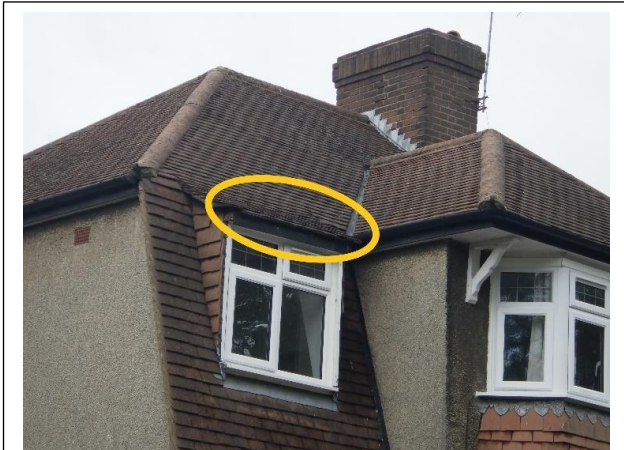
Front tile problems
~ Aerial View ~

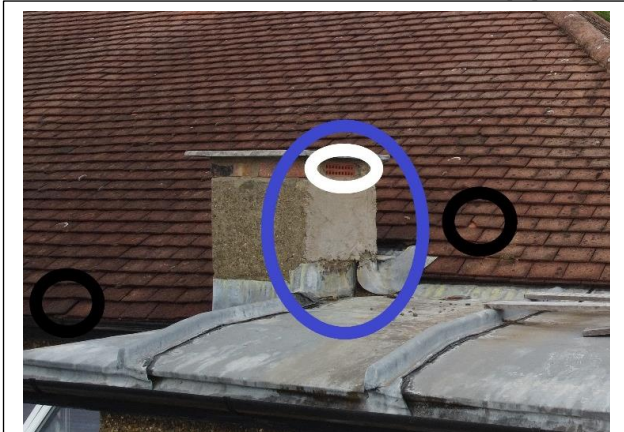
Rear roof
Black – sample of slipped or damaged tiles
Chimney poor rendering and airbrick
~ Aerial View ~

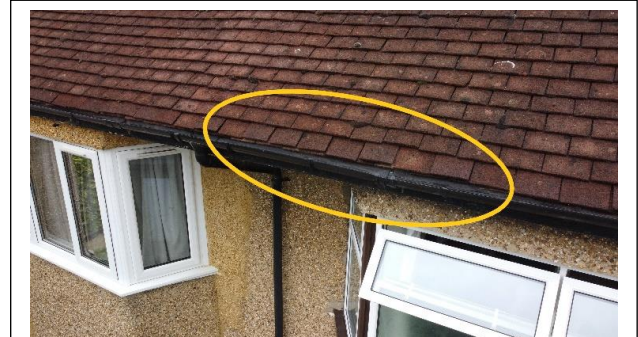
Loose tiles to rear right
~ Aerial View ~

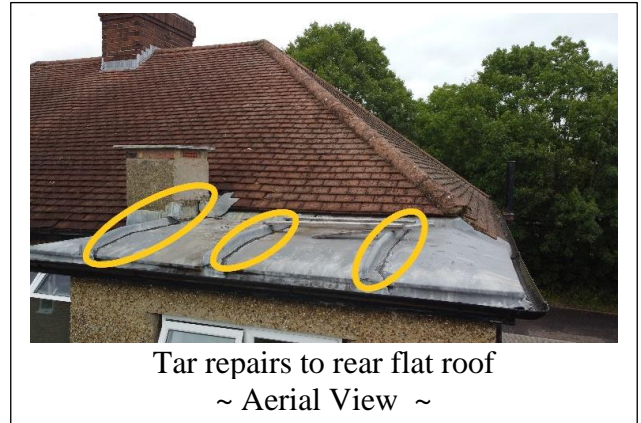
There are tar repairs to the rear flat roof.

ACTION REQUIRED:
Monitor if the roof is still leaking, the tar may have sorted it out. In the long term you need to think about re-roofing and we would also look to add insulation.

ANTICIPATED COST: £2,500 - £5,000; please obtain quotations before you legally commit to purchase the property.

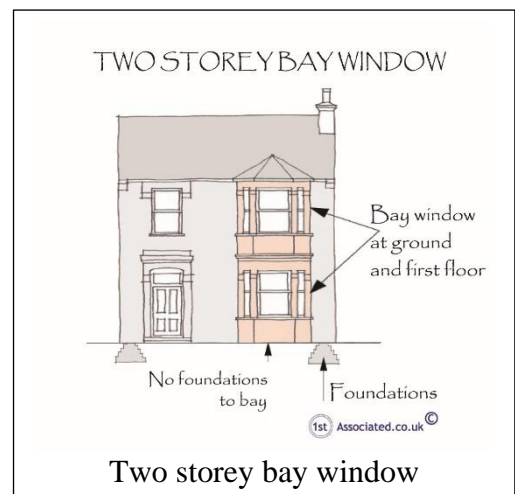
The front bay can be seen to be moving and there is a crack to the left side. The upper bay, we believe, is quite a lightweight construction with a vertical tile. Generally these type of bays did not have a foundation, the movement could be because of this and also the amendments to the roof.

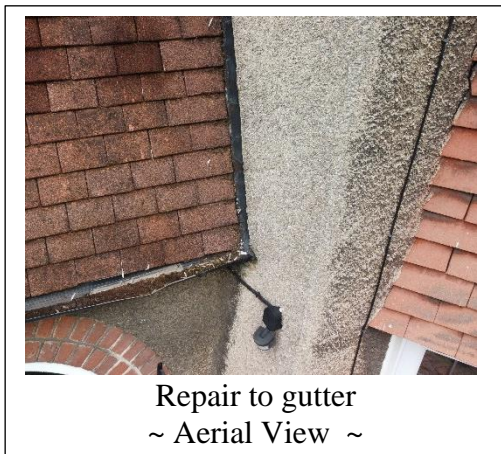
Repair to gutter
~ Aerial View ~

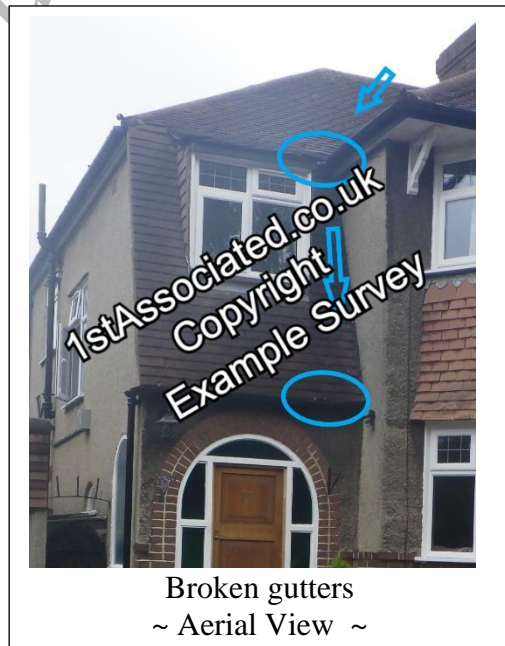
Broken gutters
~ Aerial View ~

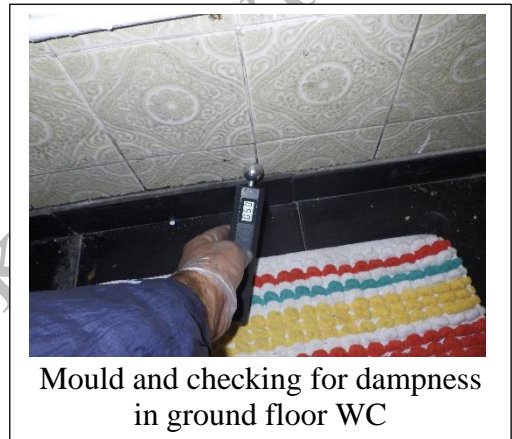
We believe there is an above average possibility of condensation as there is no extract fan in the bathroom or the kitchen. Although there is an air filter in the kitchen and there are vents this is not the same as having a mechanical extract fan.

ACTION REQUIRED: We would recommend large good quality humidity controlled extract fans are added to the kitchen, the bathroom and any areas that are humidity generating for example areas that are used for drying clothes internally during winter months (we would assume that clothes will be dried externally during the warmer months). By large extract fans we mean 150mm.

ANTICIPATED COST: We would anticipate costs between £250 - £500 per extract fan depending upon the wiring required. We always recommend quotes are obtained before work is agreed/commenced.

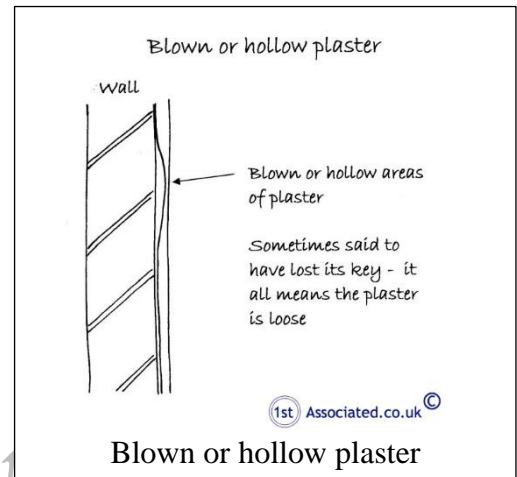
We found more than the average level of blown plaster particularly to the perimeter walls so when redecorating you may find that some of the plaster comes away. A way around this would be to resist taking off the existing wallpaper and add a lining paper or similar. You can of course replaster the areas.

ACTION REQUIRED: Re-plaster where plaster has come away. You need to use an appropriate plaster;

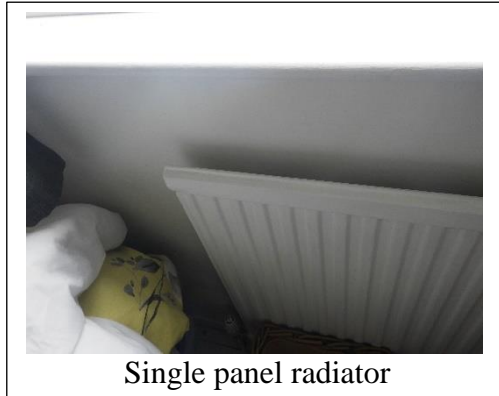
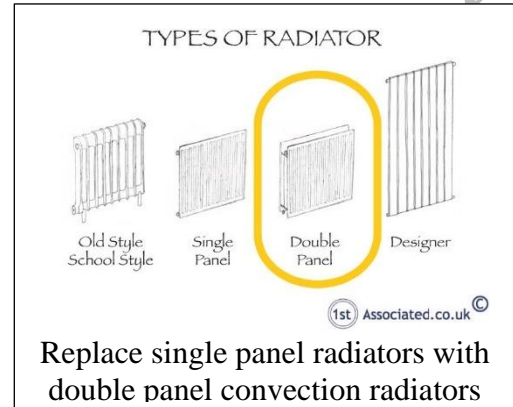
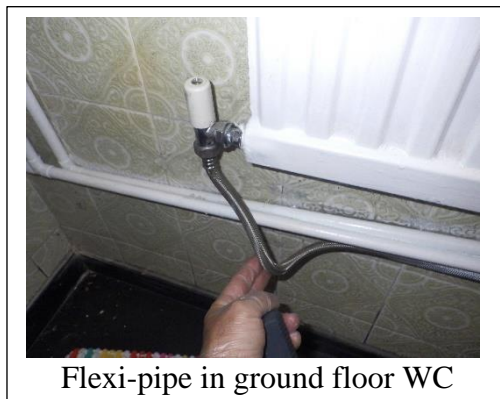
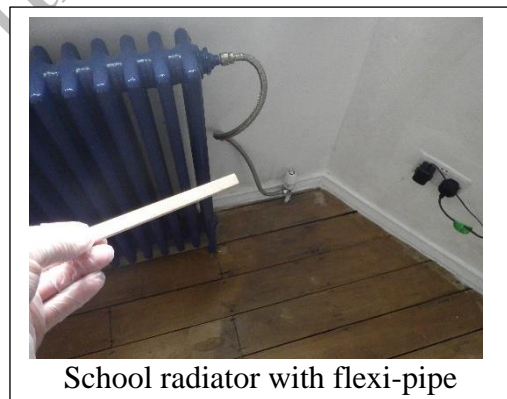
The property has single panel radiators. These may not warm the property to the heat that you desire/modern standards. We much prefer to see double panel convection radiators. The radiators have flexi-piping which is unusual.

ACTION REQUIRED: We recommend you upgrade to double panel convection radiators.

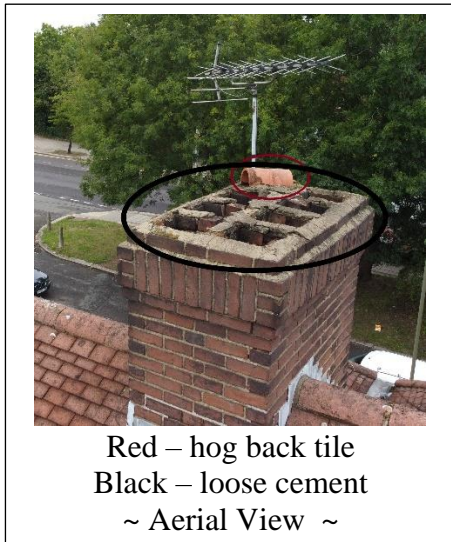
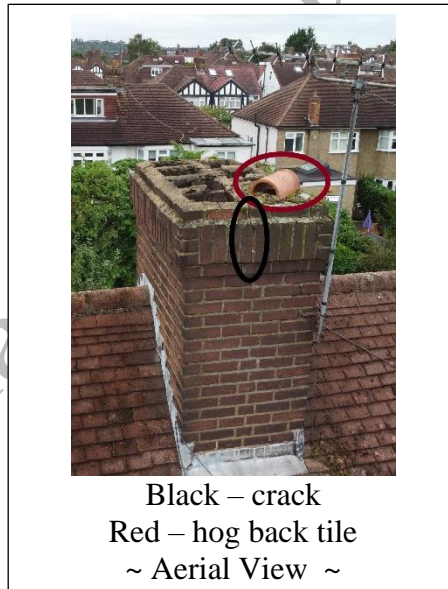
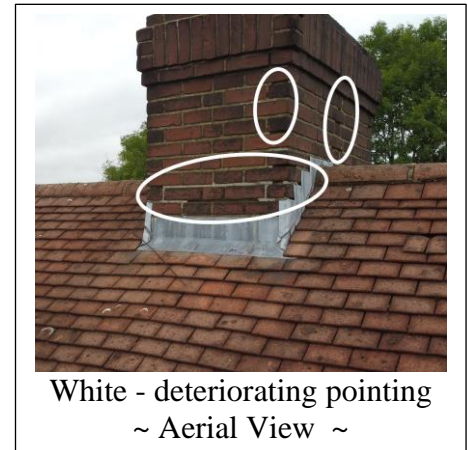
This chimney is brick finished with a lead flashing. From what we could see from ground level it looked in below average condition considering its age, type and style.

ACTION REQUIRED: Please see our comments in the Executive Summary.

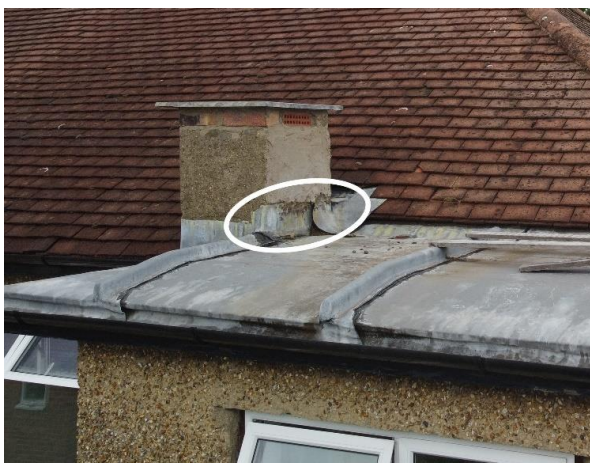
This chimney is rendered finished with a lead flashing. From what we could see from ground level it looked in below average condition considering its age, type and style.

Poor rendering to rear chimney and flashing coming away
~ Aerial View ~

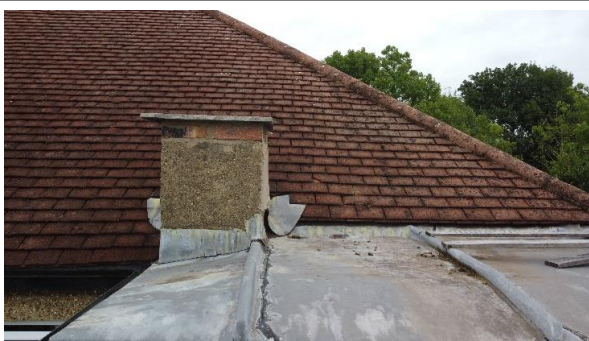
The flat roof is located to the rear left and is covered with metal/lead. We would comment it is in below average condition for its age, type and style and has been tarred on the rolled joints which is often where they leak. This is also an indication that the lead roof may need replacing.

Bitumen repair to flat roof
~ Aerial View ~

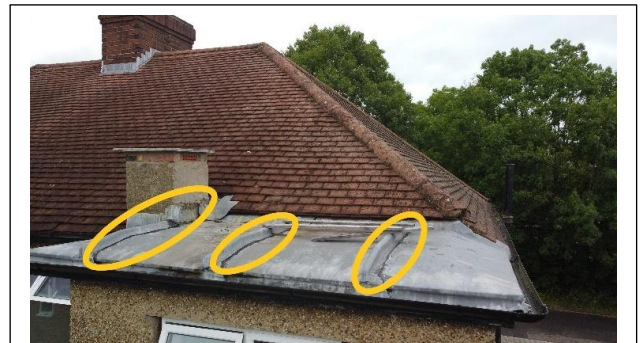
Rear flat roof tarred on rolled joints
~ Aerial View ~

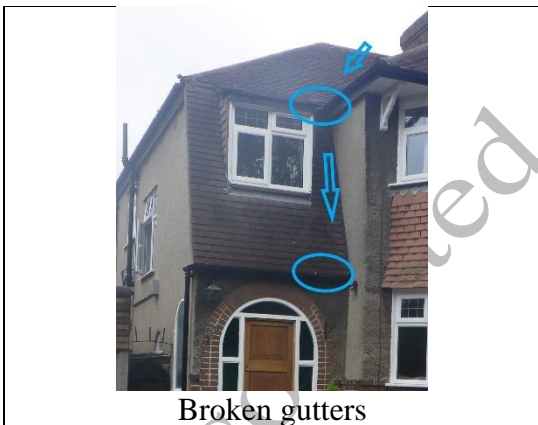
Broken gutters

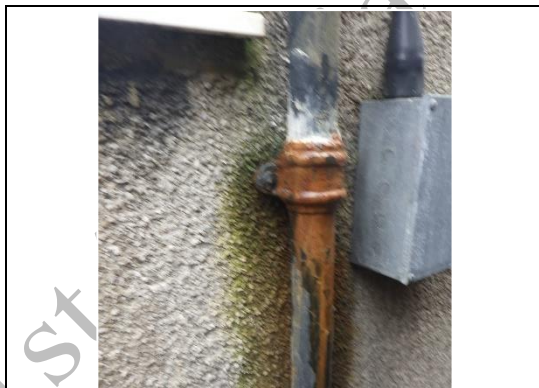
Soil and vent pipe leaking next to electrics

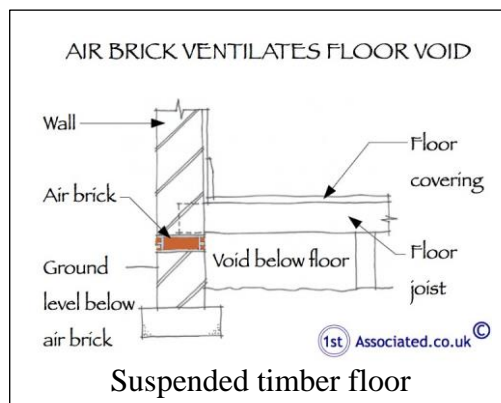
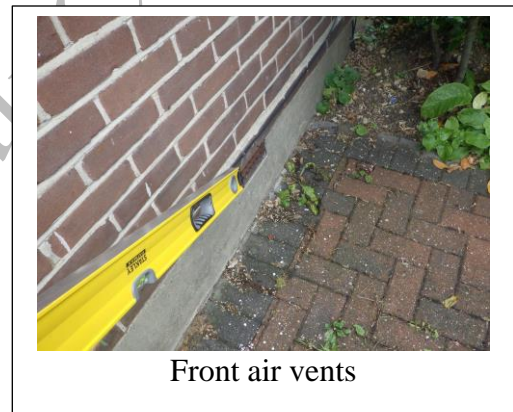
Air vents are essential to have a through flow of air as this helps to reduce the chances of wet rot, dry rot and woodworm. In this case, the property has air vents, some of which are acting as gutters.

ACTION REQUIRED: Please see our comments in the Executive Summary.

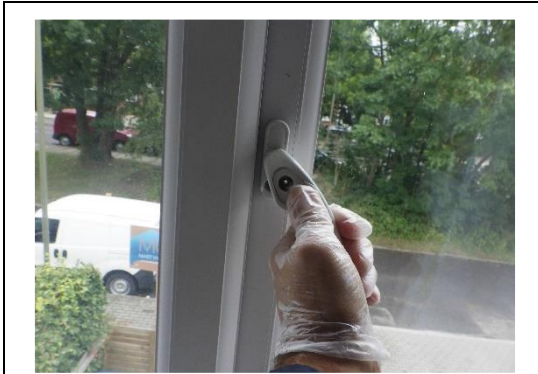
Some of the windows difficult to open

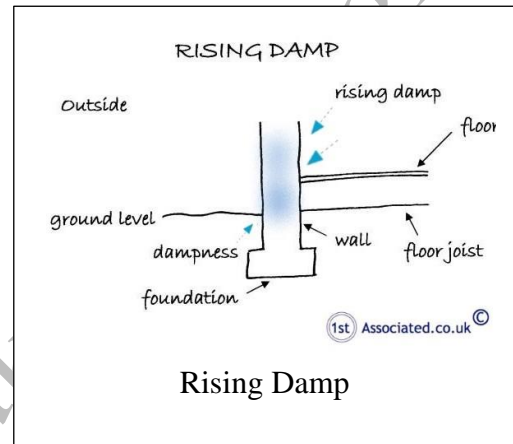
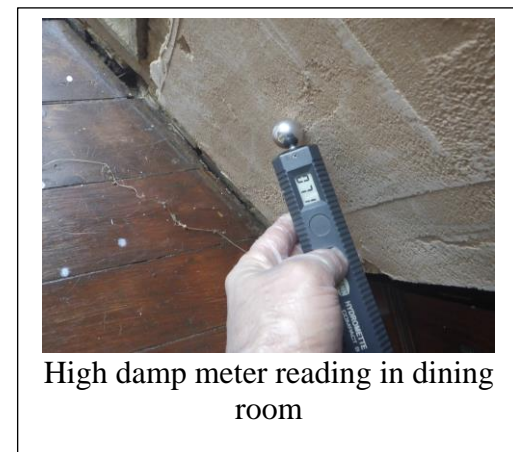
A visual inspection and tests with a moisture meter have been taken to the perimeter walls. In this particular case, we have found significant rising damp to the rear and under the stairs.

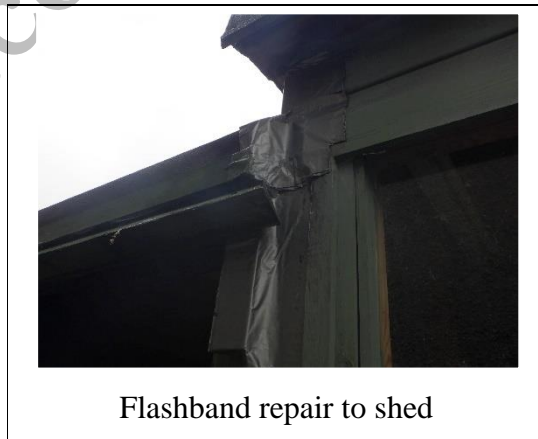
Flashband repair to shed
