# War Years Example Residential Building Survey

## **GENERAL INTRODUCTION**

Firstly, may we thank you for using our services once again and your kind instruction of XXX we have now undertaken an independent Building Survey (formerly known as a Structural Survey) of the aforementioned property. This Survey was carried out on XXX.

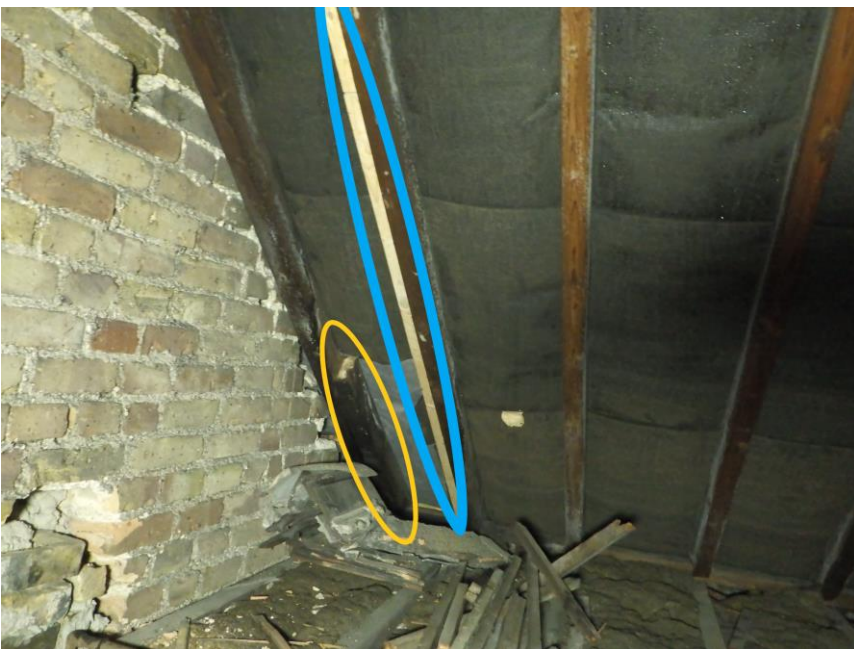
To the rear left of the main roof there looks to be a long term roof leak, which has resulted in re-felting of the area, also a new base of the common rafter. There look to be other leaks to the roof, such as dampness getting into the rear right.

Roof to rear where there have been new tiles on left side (blue) and dampness getting in to rear right (purple) (all directions given as you face the property from the front)

**ACTION REQUIRED:** Information to be obtained from the owners as to when these repairs were carried out.

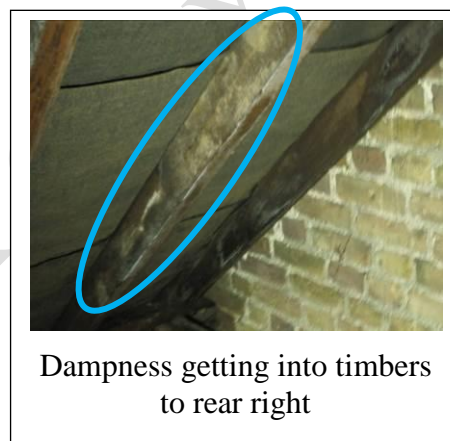
**Roof to rear right - roof still leaking**

We can see signs of other leaks into the roof, such as dampness getting into the timbers to the rear right, which indicates some problems with the roof.

**ACTION REQUIRED:** We would allow for more general repairs to the roof.

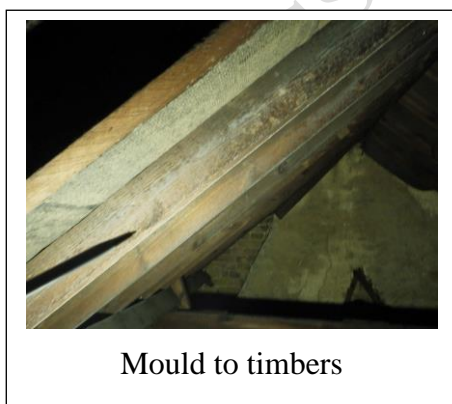
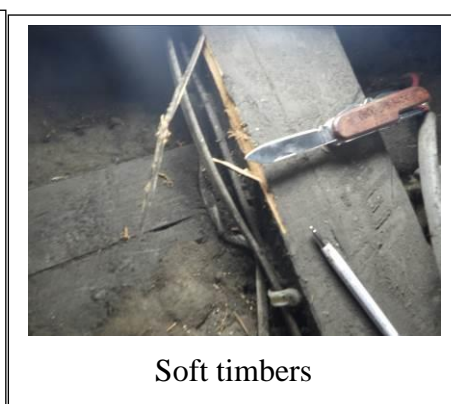
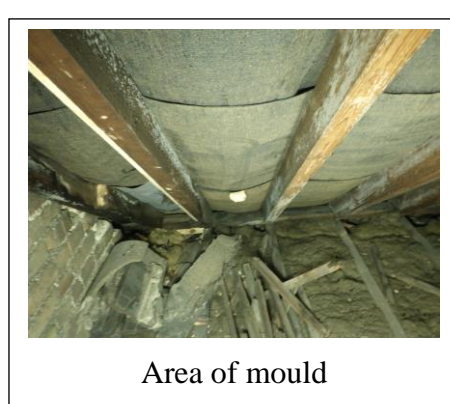
**Soft timbers and mould**

Generally within the roof we found soft timbers and areas of mould, which indicates to us dampness is getting in. We sometimes find mould in roofs where the property has been warmed quite well and there has been a lack of ventilation in the roof space, meaning moisture gets in in the form of a leaking roof and /or condensation occurring; we think probably both in this case.

**ACTION REQUIRED:** We recommend the roof has some general repair work to the tiles as needed, unless the existing owners can provide evidence that they have already carried out roof repairs in the form of receipts and/or specifications.

We would also recommend adding air vents to give a through flow of air to help reduce any problems with condensation, which could be added via the soffit boards.

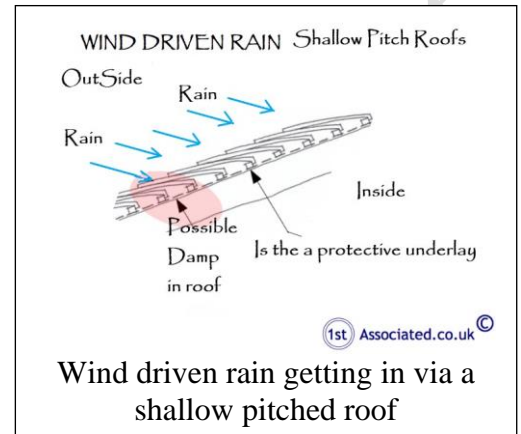
We noted the rear single storey roof has a cement flashing. These tend not to work very well as the cement cracks and cannot move and adjust with the seasonable movement of this type of house. We generally find that lead works much better as it is more flexible.

There also looks to be a slight bow in the rear roof, which may mean that the timber structure forming the roof may have deteriorated as well. Please note, we have not been able to get into the rear roof.

Also please note this rear roof is a relatively shallow pitched roof. Normally we recommend 15 to 22 degrees for a pitched roof, however this looks to be less and as such can be susceptible to wind driven rain.

**ACTION REQUIRED:** We recommend you make the roof watertight and replace the cement flashing with a lead flashing.

We also recommend an access hatch is added to allow you to view within the roof structure.

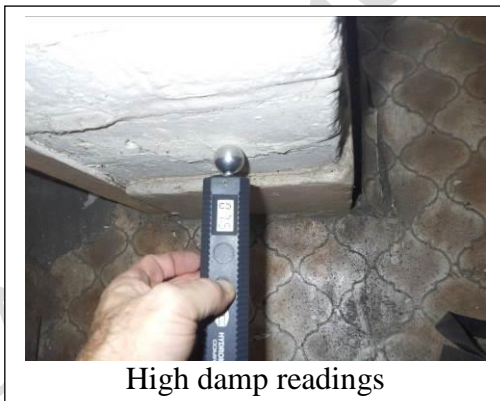
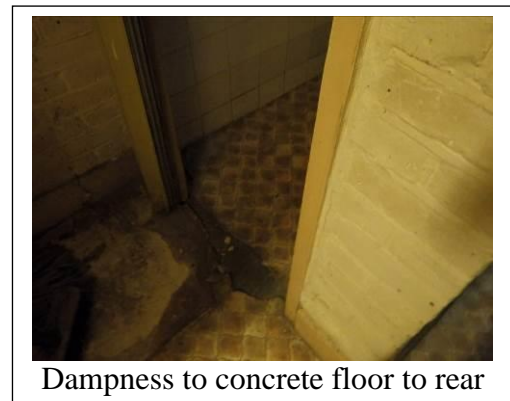
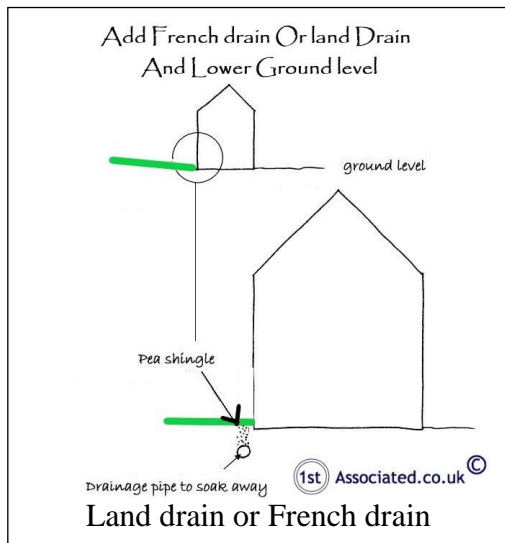
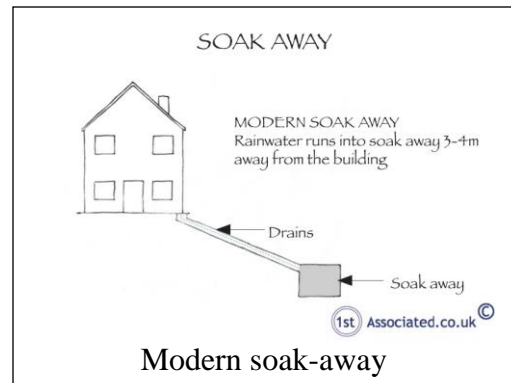
We feel there is some deflection to the floor. The problem is also likely to be exacerbated by the rear lobby area and toilet having a concrete floor where we obtained high damp readings and this we believe is acting like blotting paper and likely to be causing deterioration to the suspended timber floor.

We would also add that there is a concrete element to the rear of the floor which is very damp. We find with this type of arrangement that the dampness held within the concrete can add to the deterioration in the timber floor.

**ACTION REQUIRED:** Ideally open up the floor before you legally commit to purchase the property. We are concerned there could be wet rot, dry rot and/or wood destroying insects under the floor, particularly to the rear where there appears to be more deflection than we typically come across. If you recall, we did an impact test in this area.

We recommend lifting up the paving slabs and adding a Land drain and/or French drain, with a perforated pipe to the base. This is likely to need a soak-away.

**ANTICIPATED COST:** To open up the floor costs in the region of £250 to £500 per opening and to replace. If the present owners will not allow you to open up the floor then we think it is best to assume there are problems. Adding a land drain or French drain in the region of £4,000 to £6,000.

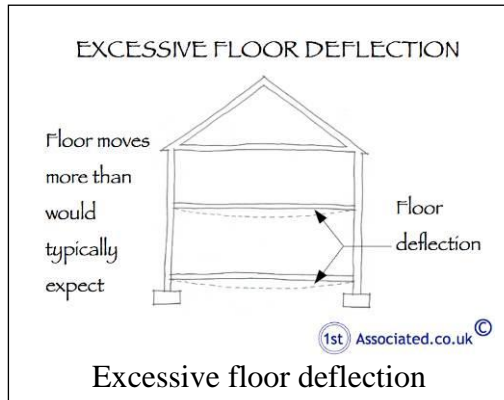
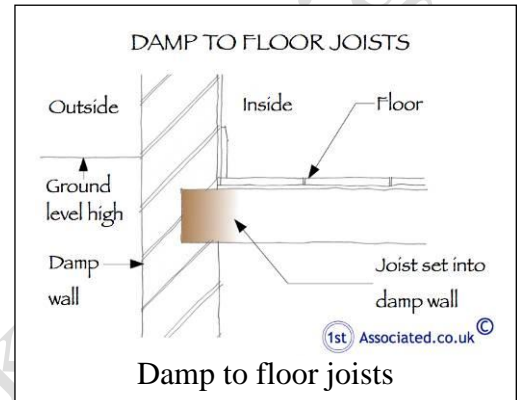
The first floor front bedroom also had above average deflection. Here we would expect the flooring to be embedded into the walls in this era of property. We believe some of the dampness has probably got into the solid walls and affected the timbers and/or the timbers are thinner/wider spaced than we typically come across, causing the deflection.

**ACTION REQUIRED:** Open up the first floor. You may need to add additional timber in the form of back to backing or cross-bracing/herringbone strutting to strengthen the floor.

**ANTICIPATED COST:** Allow the sum of £250 to £500 to open up the first floor. Ideally open up the floor before you legally commit to purchase the property. Expects costs in the region of £2,000 to £4,000 to carry out repairs. It would be best if you could open up before you commit to purchase.

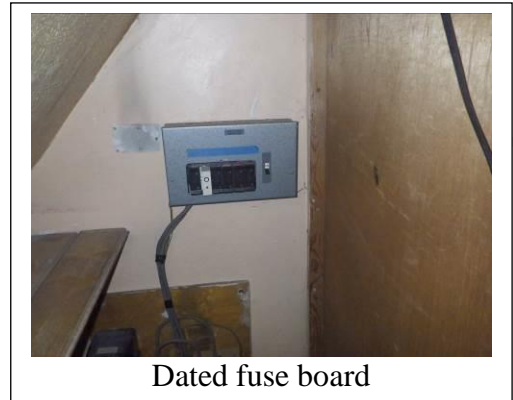
The property will need a partial if not total re-wiring and particularly as you are looking to probably rent this property out you need to have a full electric test and upgrade.

**ACTION REQUIRED:** We recommend a new fuse board as soon as possible with a metal casing; modern standards require half hour to one hour fire resistant casing around a fuse board.

We recommend a test and report and as the property is changing occupancy an Institution of Engineering and Technology (IET) test and report and any recommendations should be carried out by a NICEIC registered, or equivalent, approved electrical contractor or similarly approved.

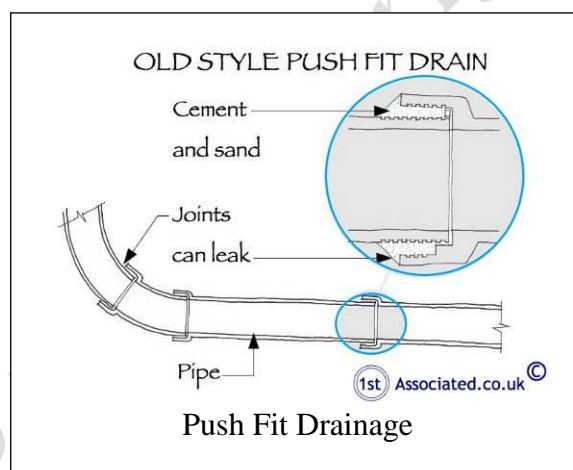
In older properties, such as this, drainage was often push fitted together rather than bonded together which means that they may leak over the years.

We have not located any manholes.

**ACTION REQUIRED:** Whilst we ran the tap for fifteen minutes without any build up or blockages the only way to be one hundred percent certain of the condition of the drains is to have a closed circuit TV camera report.

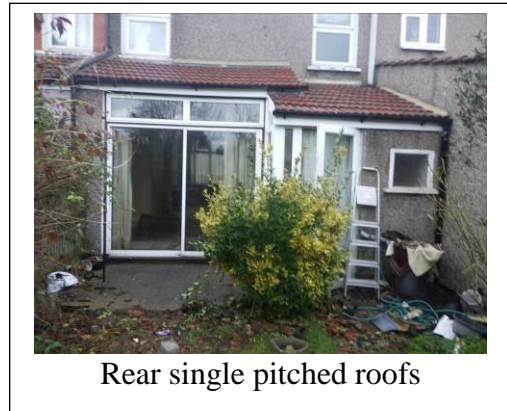
The rear roofs are shallow pitched and clad with concrete tiles. They have a cement flashing where it meets the wall; we much prefer to see a lead flashing. We would comment it is in slightly below average condition and we believe it is bowing slightly and looks to also be allowing water in (either that or it is the downpipe), it is impossible to be certain from a one off inspection when it is not raining.

**ACTION REQUIRED:** Add lead flashings.

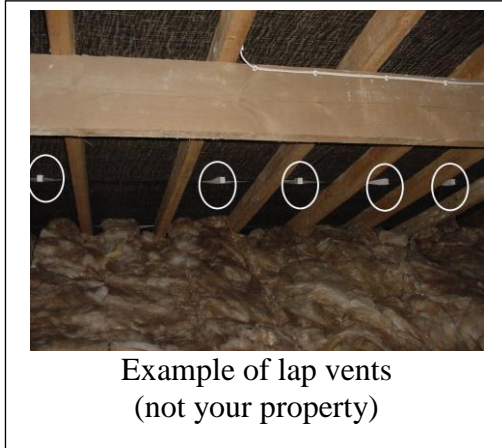
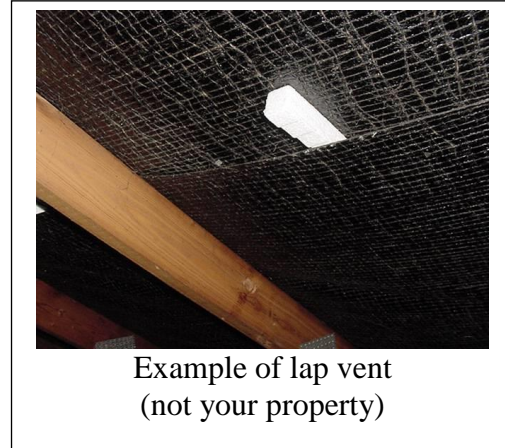
The roof is not vented.

**ACTION REQUIRED:** We recommend vents are added, ideally via the soffit boards.

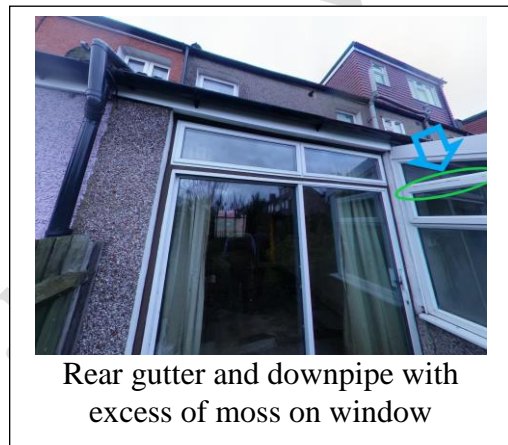
The gutters and downpipes have been replaced with plastic, originally they would have been cast iron and there may still be some remaining. They are in average condition for their age, type and style, bearing in mind it was not raining at the time of the survey. The rear guttering and downpipe looks relatively new.

Rear gutter and downpipe with excess of moss on window

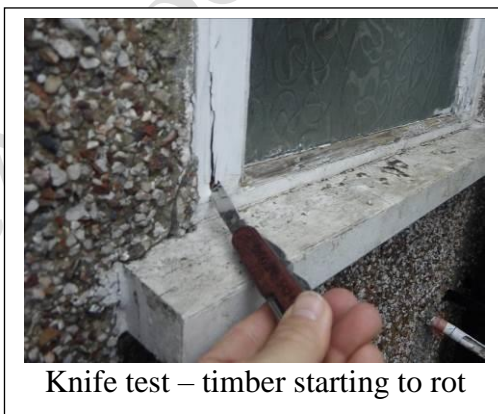
Generally, we would comment the timber windows are in below average quality for their age, type and style, with deterioration and flaking paint and the plastic windows need cleaning.

Knife test – timber starting to rot

**ACTION REQUIRED:** Clean, repair, prepare and redecorate where appropriate. However, we would budget for replacement of the windows; the sooner the better.

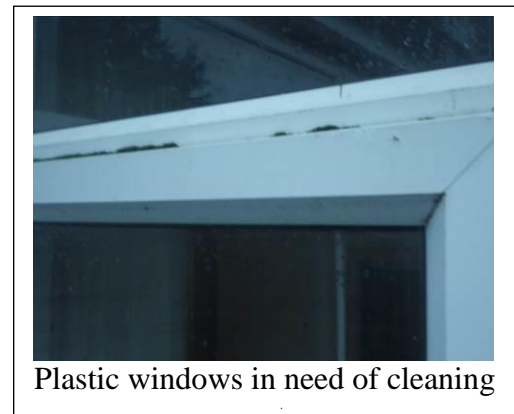
Plastic windows in need of cleaning

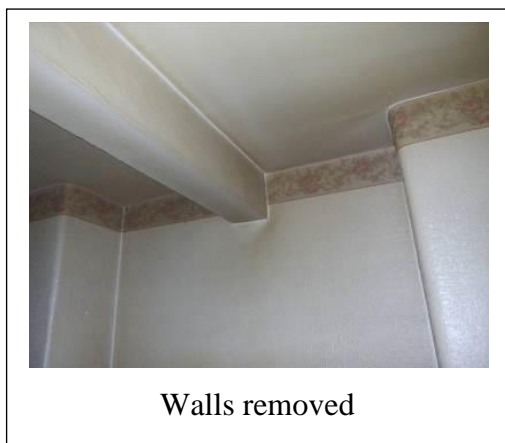
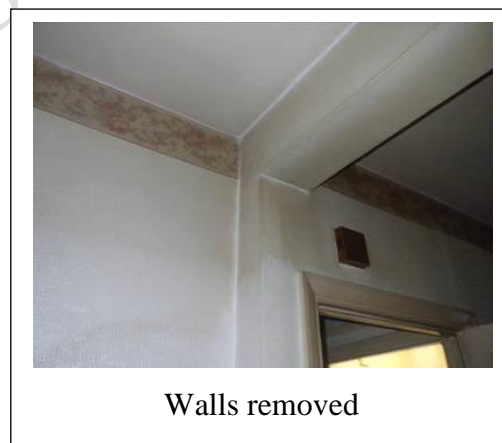
We noted some internal walls have been removed. They have not been removed to what is considered good building practice today and would not meet Building Regulations/best building practice as they require a pier, and as such we believe this has contributed to the deflection in the floor and some of the movement that can be seen in the building.

**ACTION REQUIRED:** Please see the Executive Summary.

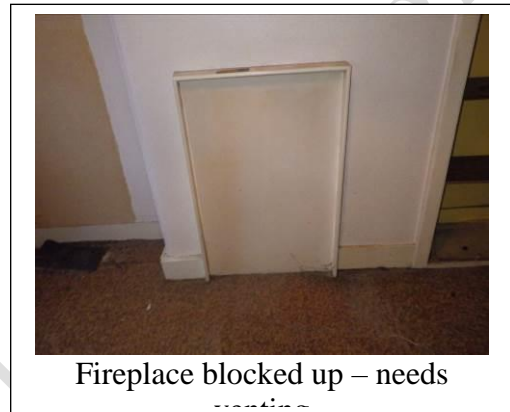
The fireplace has been blocked up and as far as we can see they have not been vented, which will cause dampness.

Fireplace blocked up – needs

If you do intend to use the fireplaces then we recommend a chimneysweep checks the lining and that the chimney/s are clear and open up the chimney pots.

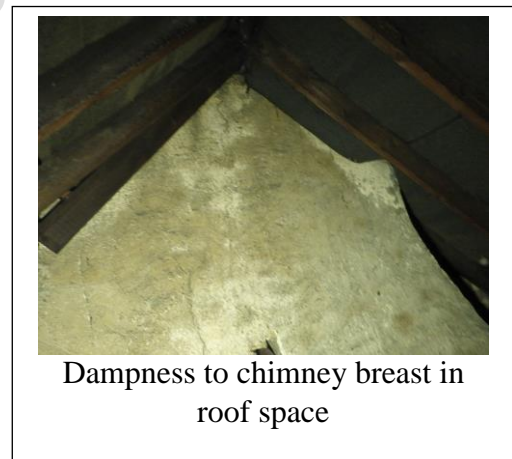
Dampness to chimney breast in roof space

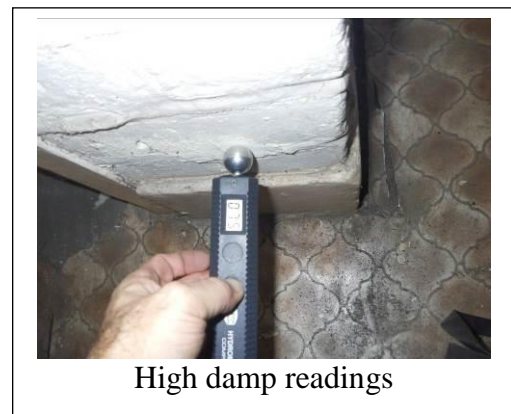
A visual inspection and tests with a moisture meter have been taken to the perimeter walls. In this particular case, we have found significant rising damp to the rear.

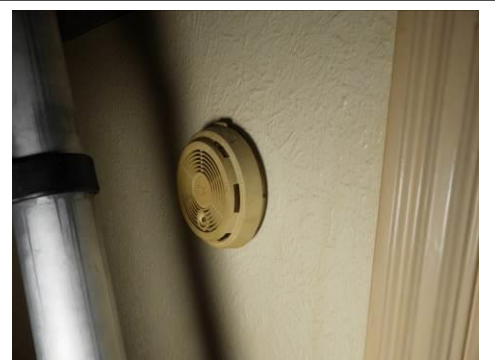
An old battery smoke alarm
