# Timber Frame Example Residential Building Survey

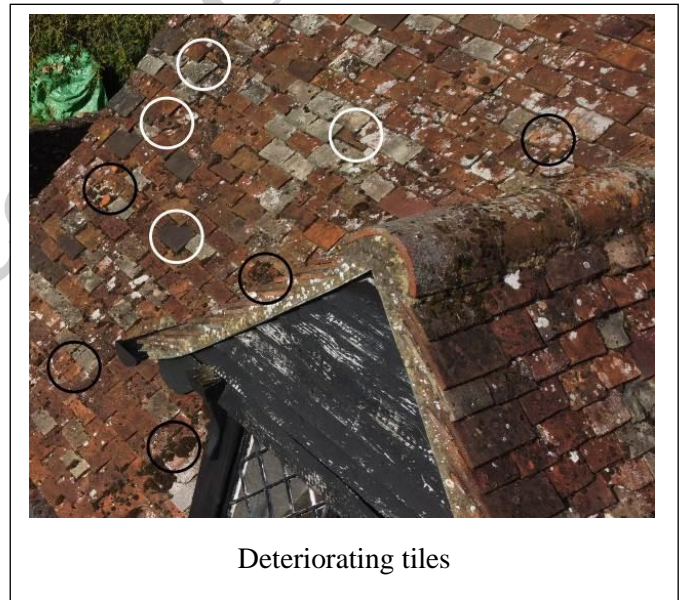
The main roof is clad with clay tiles which looks to be an old peg tile roof. We noted some of the tiles are starting to slip, deteriorate and some are spalling, causing dampness to get into the roof, making the timbers damp, which in turn we noted there has been wood destroying insect activity (see next section).

<b>Key for above photo showing a sample of the problems</b>	
Slipped, displaced or broken tiles	White circles
Spalling starting to occur and/or areas of moss	Black circle

**ACTION REQUIRED:** We recommend a roofer spends about a week to carry out work to the roof and make it as watertight as possible, depending how the roof is once you have started to carry out the repairs. They will need to be very careful when they are carrying out the roofing work, otherwise they can cause probably as much damage as they repair, so ideally you should be at home when the work is being carried out to oversee what is being done.

**ANTICIPATED COST:** In the region of (depending upon how many tiles can be re-used) £15,000 to £20,000. Equally it may be something you can live with for a while carrying out ad-hoc repairs. Please obtain quotations before you legally commit to purchase the property.

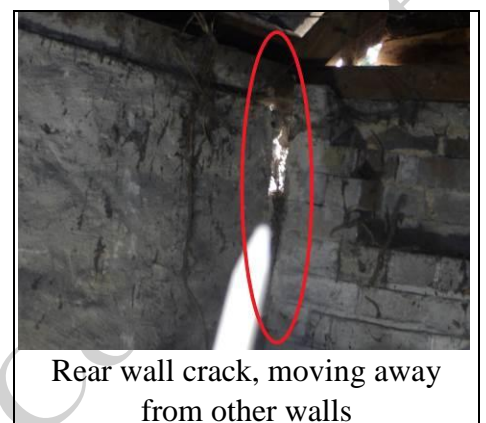
Rear wall crack, moving away from other walls

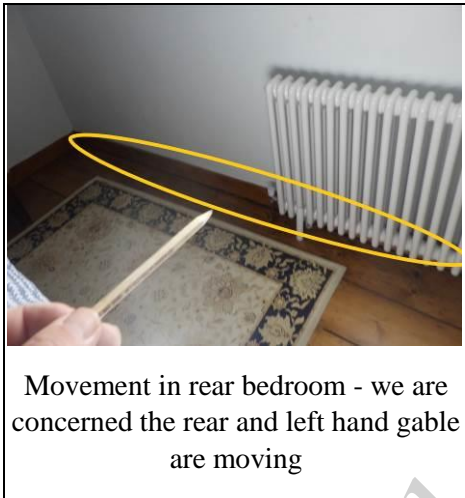
Hairline cracking to gable end

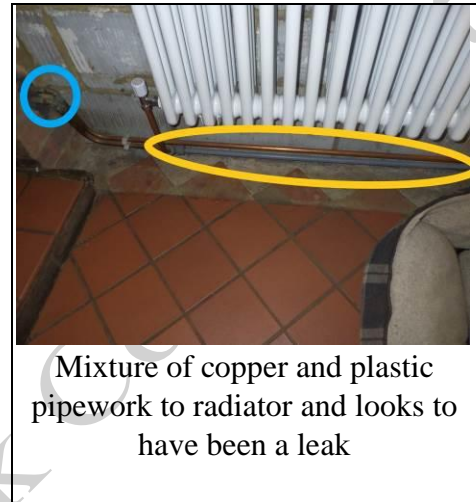
There is a mixture of copper and plastic pipework in the property, which we are not keen on as there can sometimes be leaks where the two joint. We much prefer to see all copper or all plastic. There does look as though there may have been a leak to the pipework.

Key for above photos	Showing sample of problem areas
Mix of copper and plastic pipework	Yellow oval
Possible leak to pipework	Blue circle

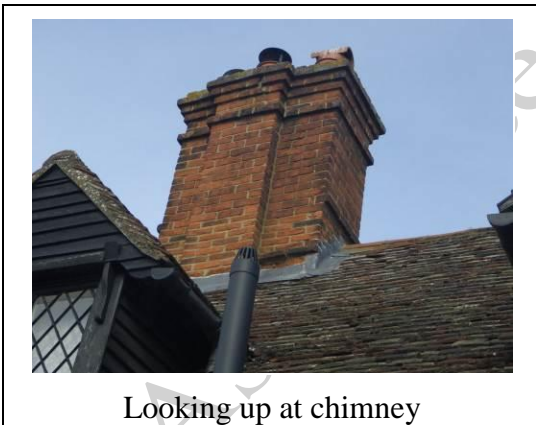
This is a large chimney, brick finished with a lead flashing and three chimney pots. From what we could see from ground level it looked in average condition considering its age, type and style.

Looking up at chimney

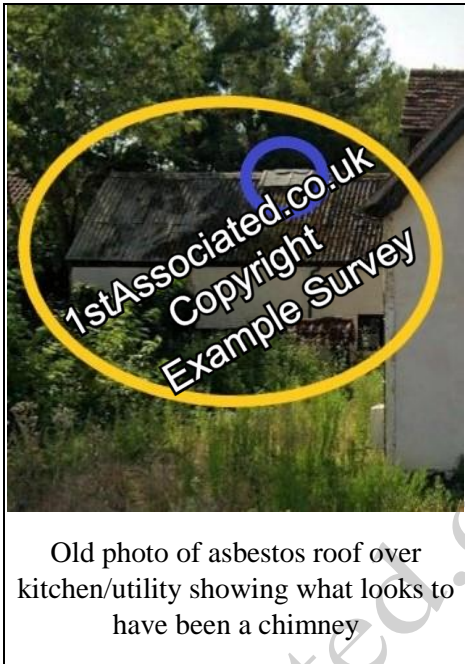
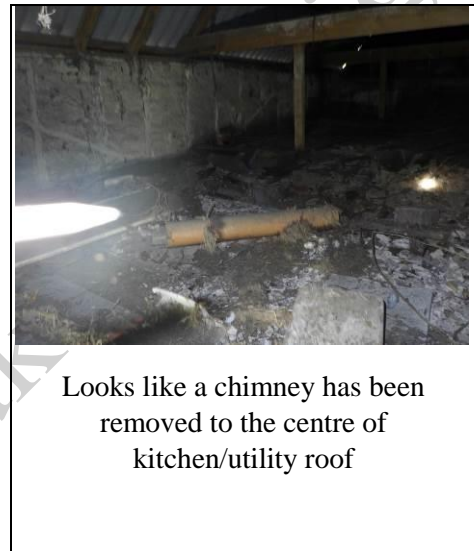
*Between the kitchen and utility we think there may once have been a chimney.*

**ACTION REQUIRED:** Your legal adviser to check and confirm if permission has been obtained by Building Regulations and Listed Building permission to remove the chimneys.

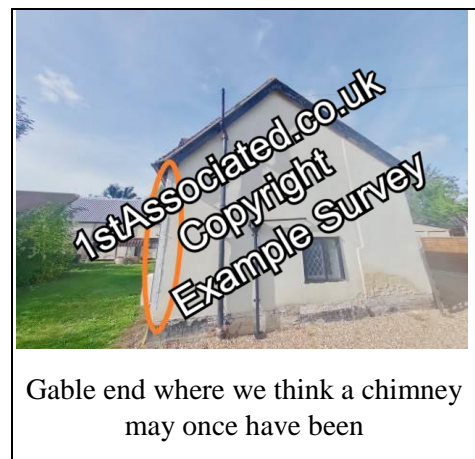
There may also have been a chimney on the roadside gable, further investigation is required on this. In fact, it may have been the removal of this chimney that caused the possible movement in the end gable.

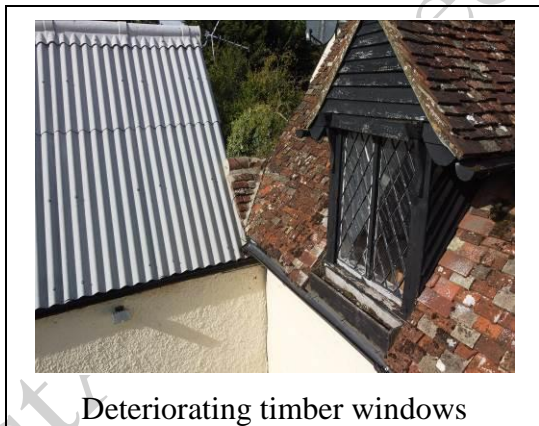
Deteriorating timber windows

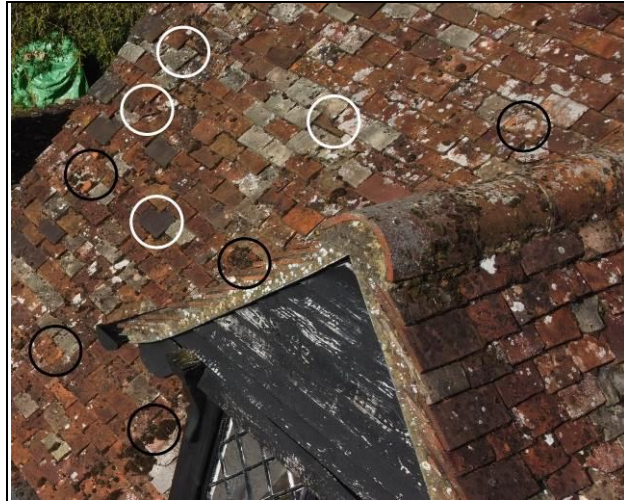
Slipped, displaced, broken and spalling tiles

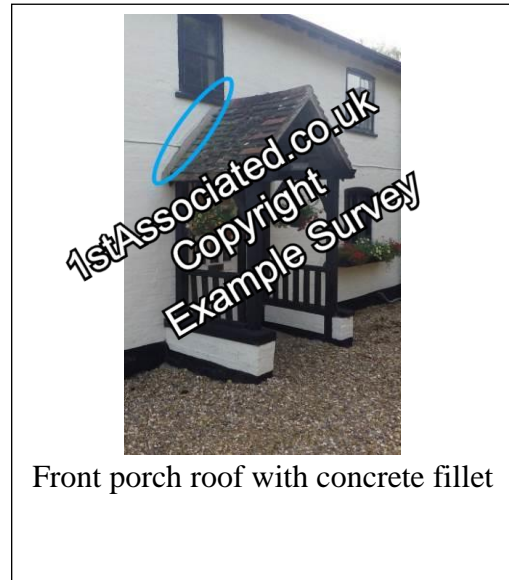
Front porch roof with concrete fillet

**ACTION REQUIRED:** We recommend it is replaced with a lead flashing, subject to Listed Building Consent. Lead flashings tend to work better with older properties as they move and adjust.

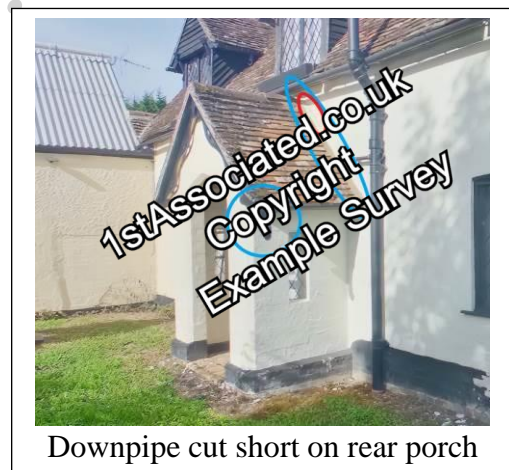
Also, the downpipe on the porch does not go to the ground.

Downpipe cut short on rear porch

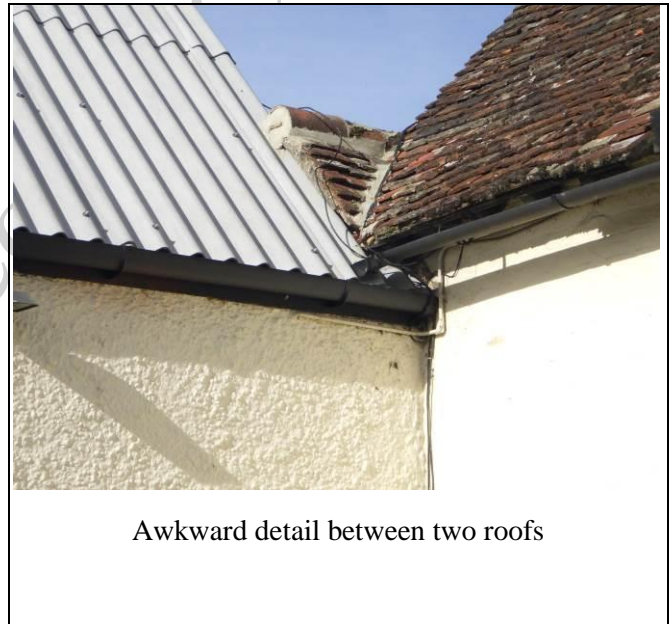
This area may be susceptible to water leaks.

Awkward detail between two roofs

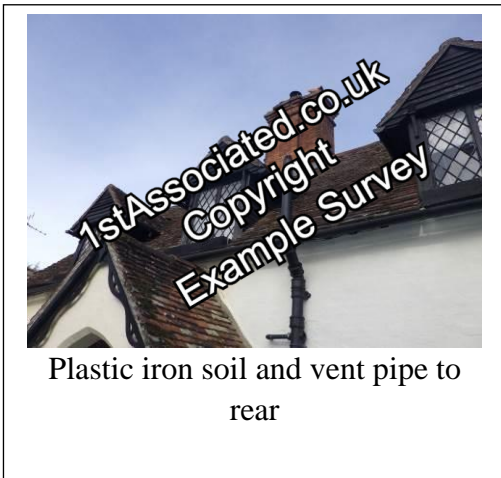
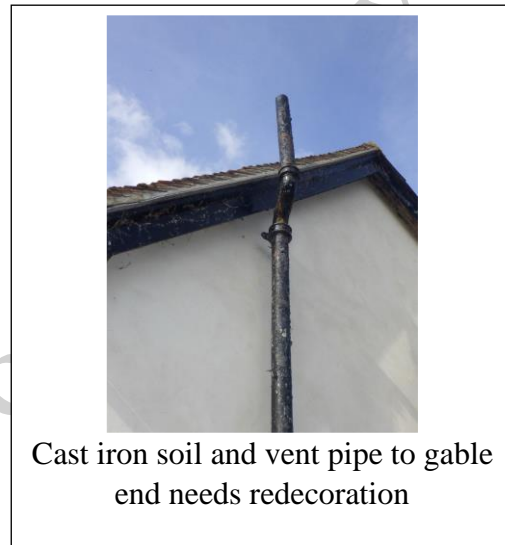
The property has two soil and vent pipes, one plastic to rear and one cast iron to gable end. The soil and vent pipe to the gable end is in below average condition with flaking paint and does not appear to be attached to the render wall.

**ACTION REQUIRED:** Repair, prepare and redecorate gable end soil and vent pipe and secure to wall.

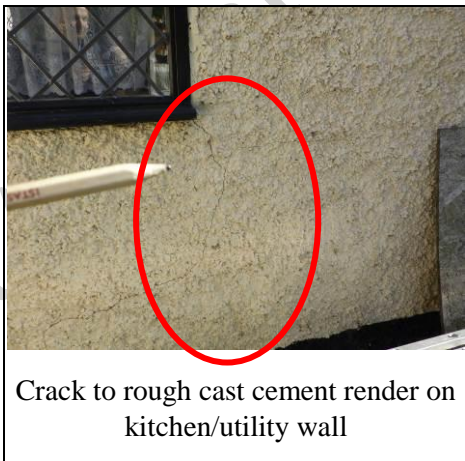
The use of cement render is inappropriate for a property of this age as it prevents it from 'breathing'. We noted numerous cracks to the rough cast cement render cracking on the kitchen/utility building and also some to the smooth render.

Crack to rough cast cement render on kitchen/utility wall

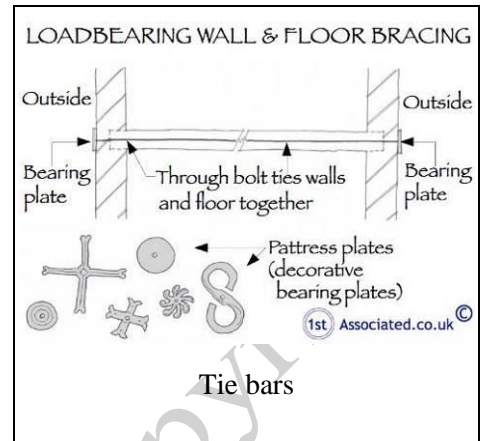
We noted historic movement in the property. We noted tie bars externally and internally to the kitchen/utility building.

S-shaped tie bar

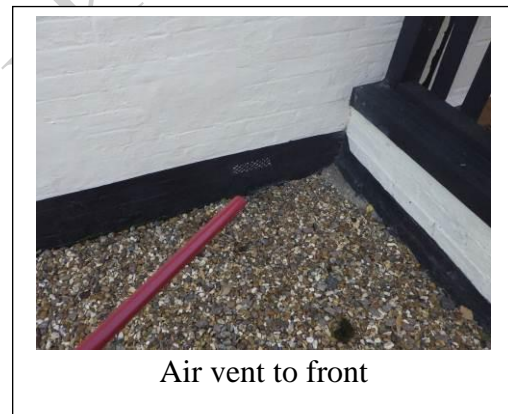
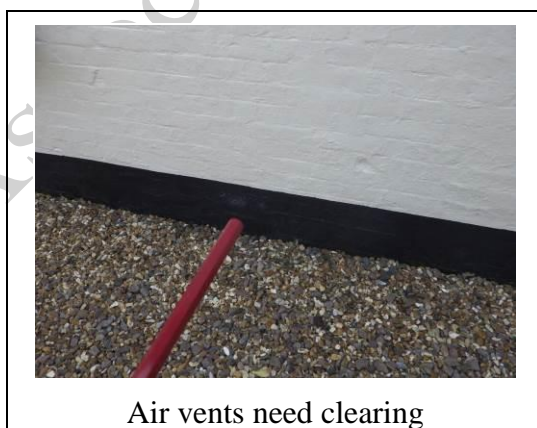
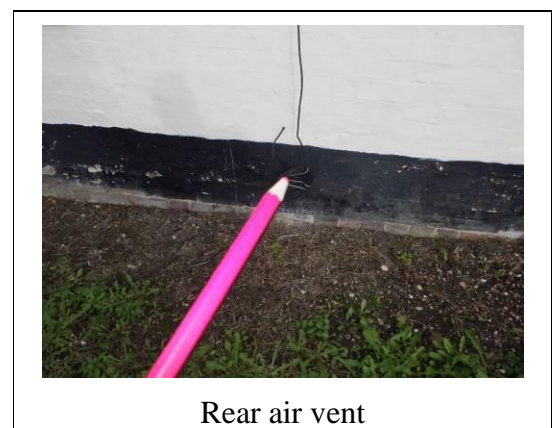
Air vents are essential to have a through flow of air as this helps to reduce the chances of wet rot, dry rot and woodworm. In this case, we noted air vents to the front and rear. Some of the air vents to the front need clearing. We also think water is discharging towards the air vents.

**ACTION REQUIRED:** Ensure air vents are clear.

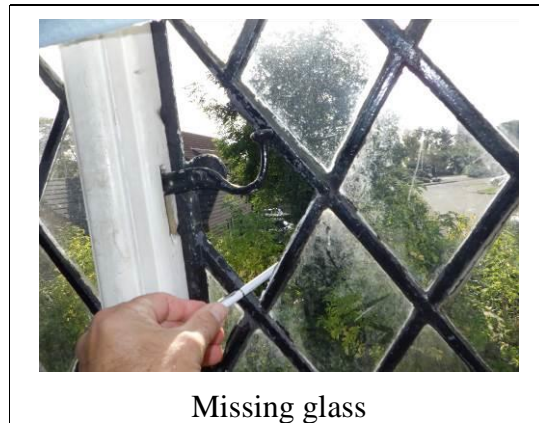
Missing glass

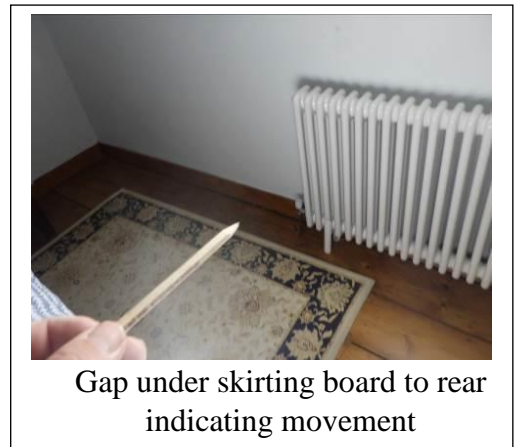
The skirting boards are timber. The most notable fact about the skirtings is where they are coming away from the floor to the rear of the property where there may be movement.
