RESIDENTIAL BUILDING SURVEY

XXXXXXXXXXXXXX

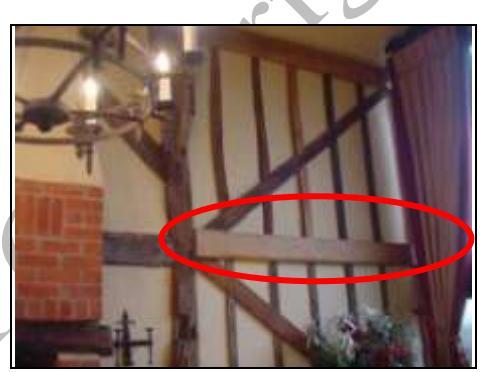
Honest repair – the lighter timbers in reception room/open hall

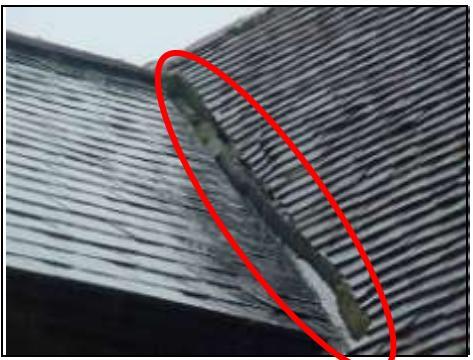
Problems with the valley guter to front left side of property

ACTION REQUIRED: We recommend the mortar is replaced, in part or as a whole.

ANTICIPATED COST: It is high level work so is likely to need a tower scaffold or long ladders and a crawler board. Costs will be in the region of $\pounds 500$ to $\pounds 1,500$ (five hundred pounds to one thousand five hundred pounds) depending upon whether it needs a part repair or if all of it has to be replaced.

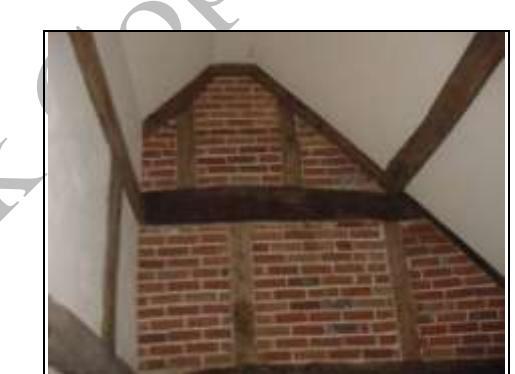
Hidden timber frame (within the walls) visible internally

Where we can see the structural timbers we can see there has been woodworm. We also have concerns with regard to the condition of the roof timbers.

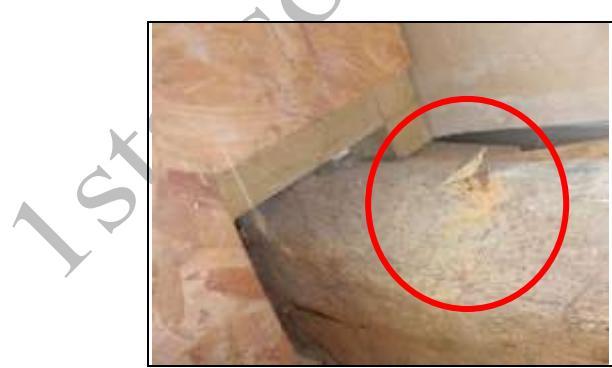
Signs of woodworm to purlin on right side of roof

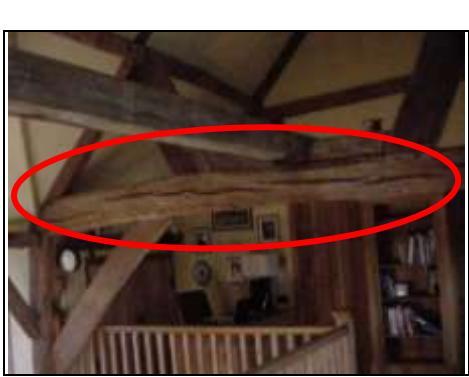
Gallery style landing, cracks in roof timbers

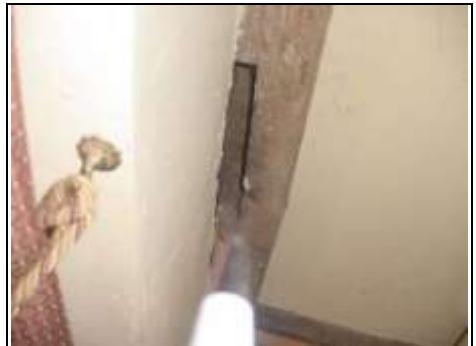
Top of stairs where the brace is missing

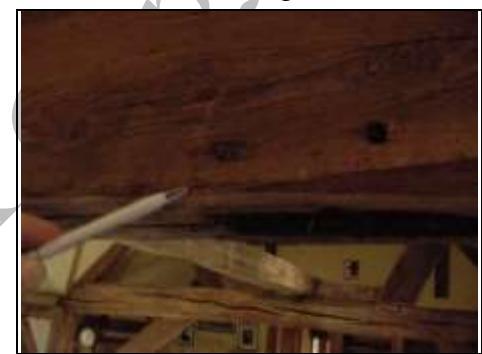
Two peg joints on beam where brace is missing

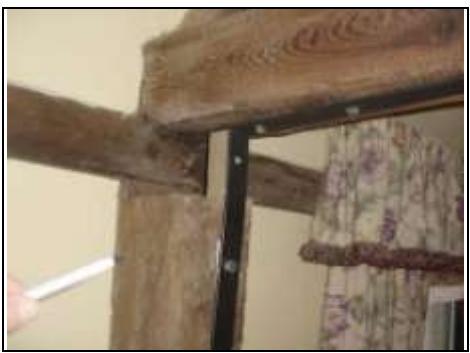
Metal work in master bedroom

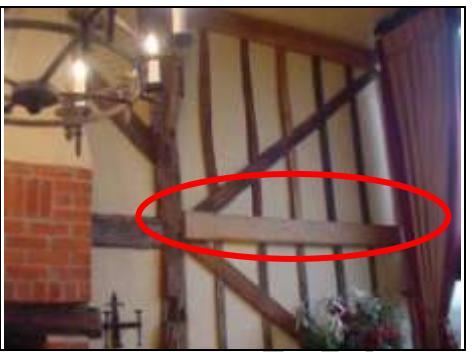
The timber that is marked the year 2000 that you pointed out within the main reception room is what we call an 'honest repair'. This is a repair that shows it has been carried out more recently and tends to be in a style that follows the older/original style yet is obviously newer. This tends to be a style that many Listed Building Conservation Officers require depending upon their thoughts on heritage restoration/thinking.

Honest repair – the lighter timbers in reception room/open hall

> **ACTION REQUIRED:** We would recommend you have a 'cup of tea' meeting and discussion with the Listed Building Conservation Officer before you purchase the property, most definitely before you carry out any work on the property.

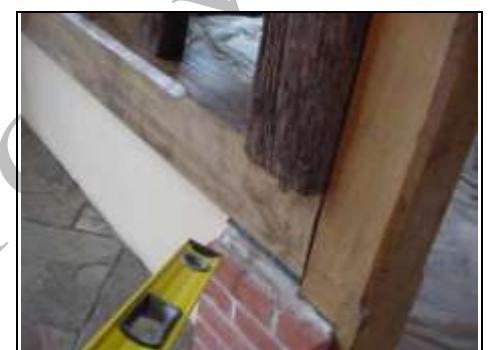
Honest repair in original timbers which stand out and what looks to be newer brickwork

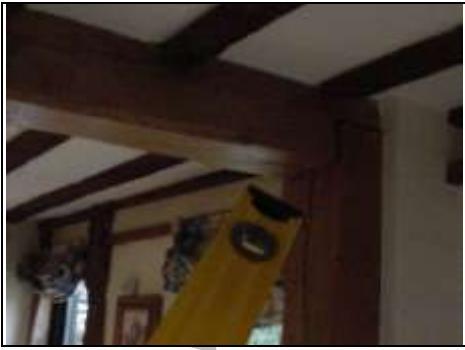
Splits in modern timbers in kitchen/breakfast room – may be an I-beam behind this

If a metal frame has been inserted into the property this would alleviate some of our concerns with regard to timbers that are cracking, deteriorating strength due to woodworm/termites and/or timbers that have been removed completely.

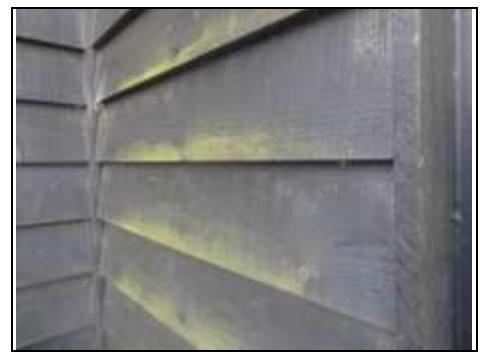
The weather boarding to the rear shows signs of mould and moss. We can also see mastic repairs to sections indicating that you may get wind driven rain to this elevation.

Moss to weather boarding

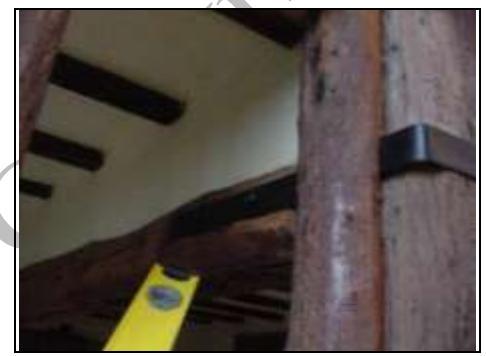
Bare timber visible in some areas

ACTION REQUIRED: Prepare, repair and redecorate the timber.

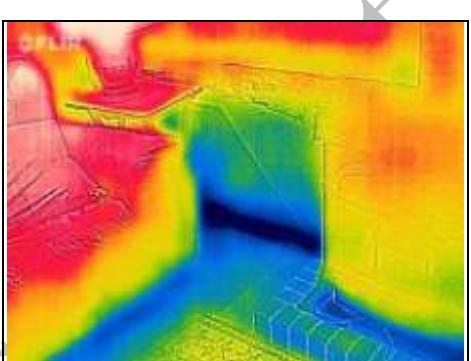
Blue indicates coldness in the snug, which in turn often means there is dampness in the area although there was no visible sign of it

ACTION REQUIRED: We recommend a French drain is added, ideally running along the entirety of the rear of the property.

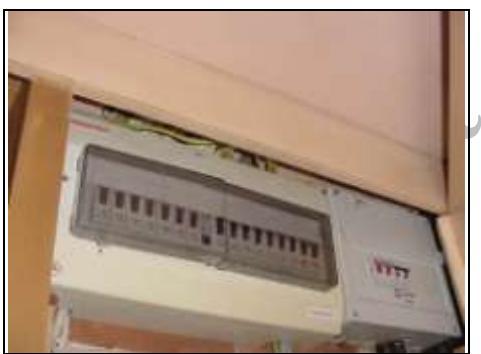
Dated fuseboard

ACTION REQUIRED: The Institution of Engineering and Technology (IET) recommend a test and report when properties change hands, to be carried out by an NICEIC registered and approved electrical contractor or equivalent.

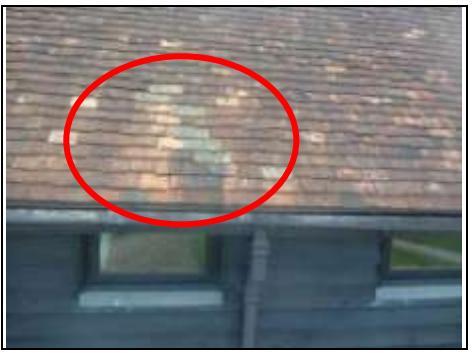
Spalling tiles to front Aerial view – 360 photo

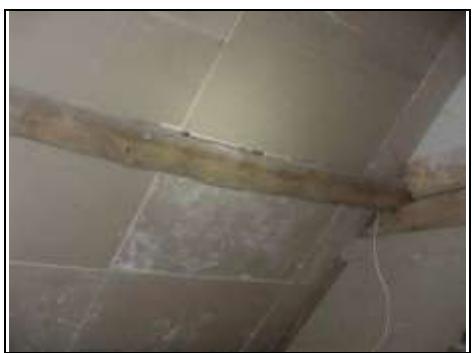
Left side of roof dry lined/ boarded out

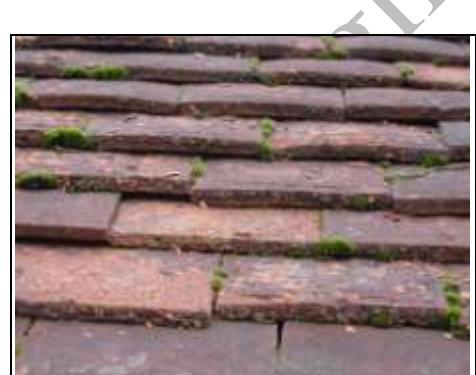
Spalling tiles – the lighter tiles

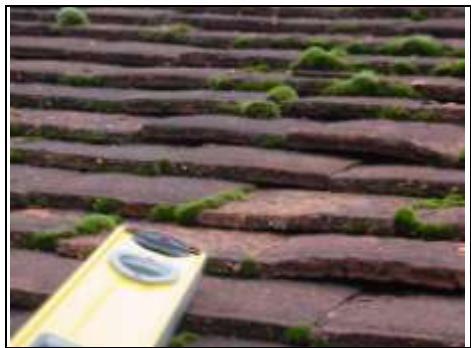
Moss on roof

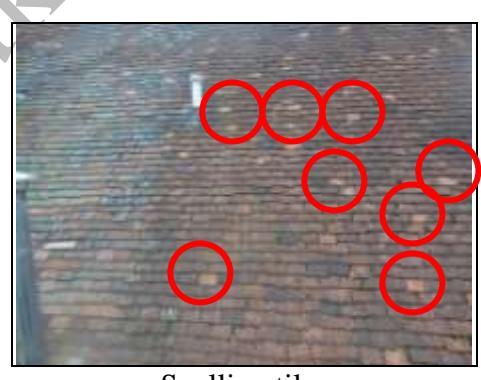
Spalling tiles

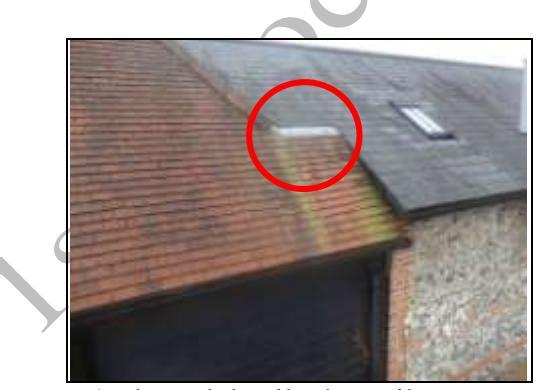
Awkward detail where tiles meet slates

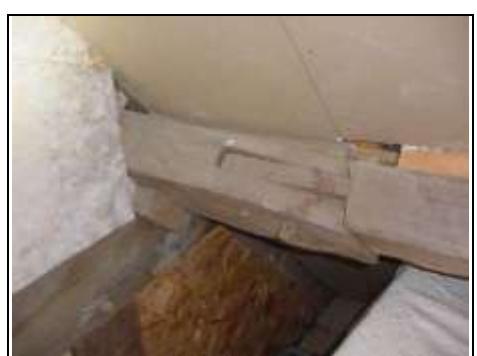
Repairs to purlin in roof void to right side

ACTION REQUIRED: We recommend the roof is opened up, especially also over the internal shower room area.

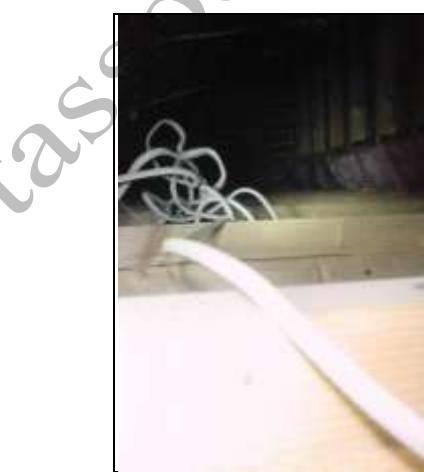
Roof over rear internal shower room – timber should be going left to right

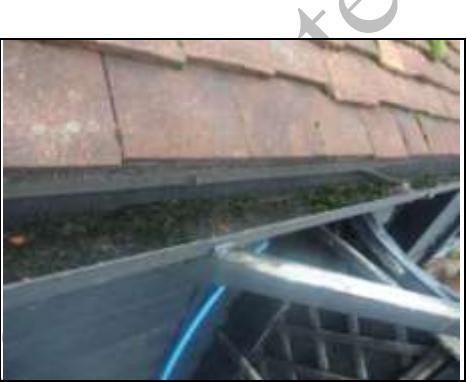
We also noted felt coming down into the guttering.

Large guttering with felt lapping into it Aerial view – 360 photo

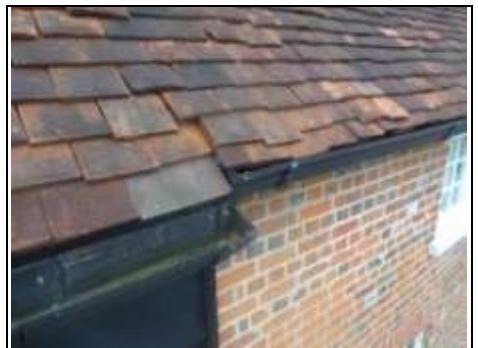
Bolts projecting on the gutters which makes the gutters block up, need to be made flush

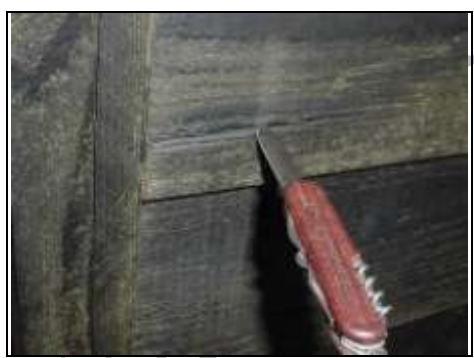
Repairs to weather boarding

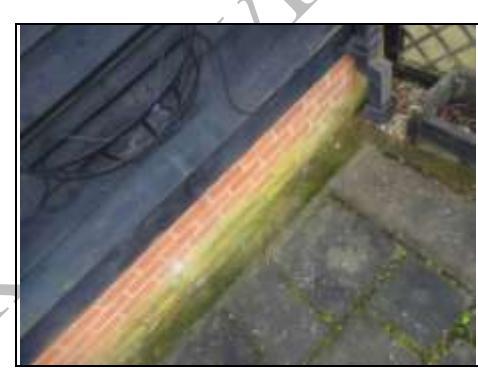
We could see to the rear left side moss is accumulating. This looks to be relatively new brickwork as well.

Moss to rear brickwork

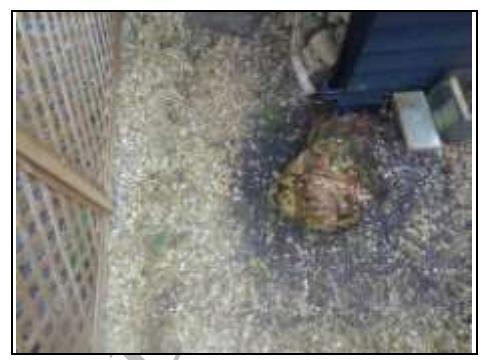
Tree cut down to rear right side of property

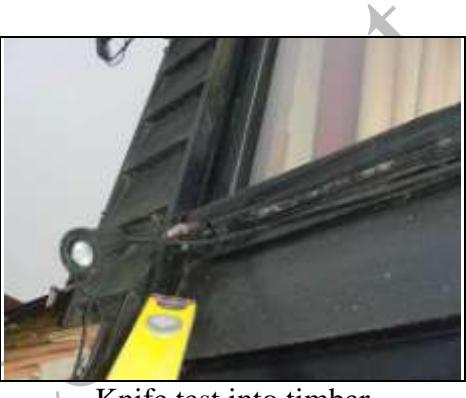
Knife test into timber

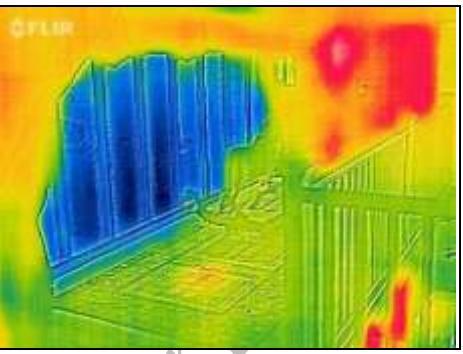
Thermal image of landing, colder to the windows

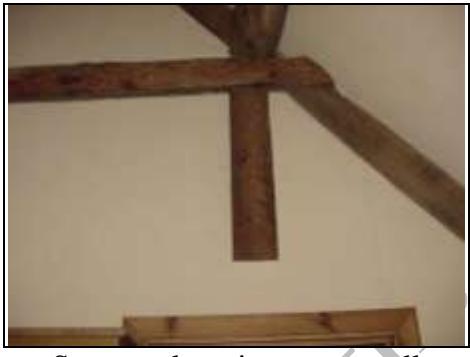
Strange alteration over small bedroom door

ACTION REQUIRED: Ideally a section of the walling should be opened up to check the condition of the timber beneath and/or discussions with the Conservation Officer/Listed Buildings Officer to see if there is a photographic record of this property.

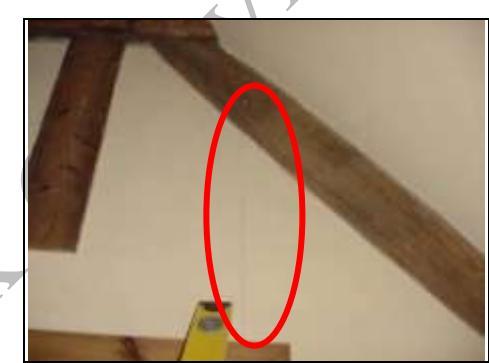
Hairline crack in small room to middle right

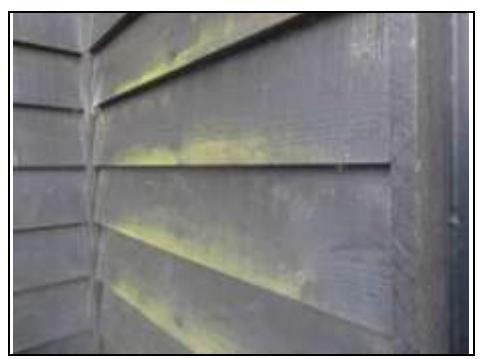
Mould/moss to weather boarding

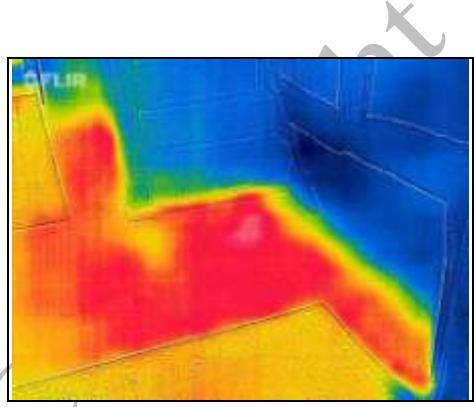
Base of stairs (only place where there was any heat – underfloor heating system) isn't the usual pattern of an under floor heating system

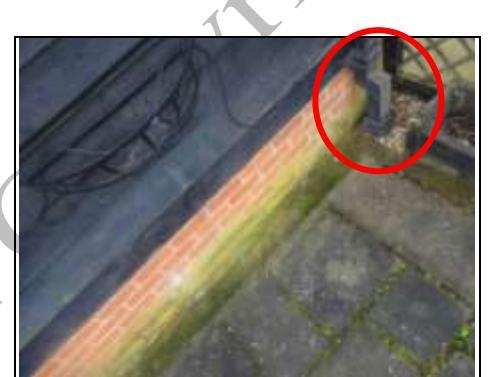
Downpipe discharging into ground, we would expect it to discharge into a soak-away
