COMMERCIAL BUILDING SURVEY

Essex. SS15 XXX

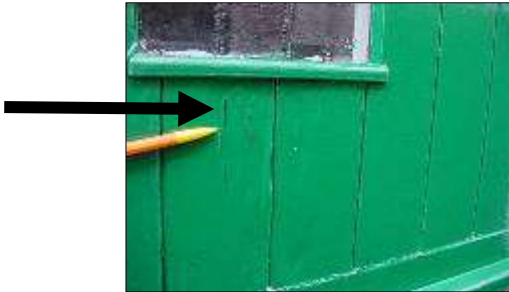
We utilise photographs and sketches to illustrate issues or features. In some photographs a pencil has been used to highlight a specific area.

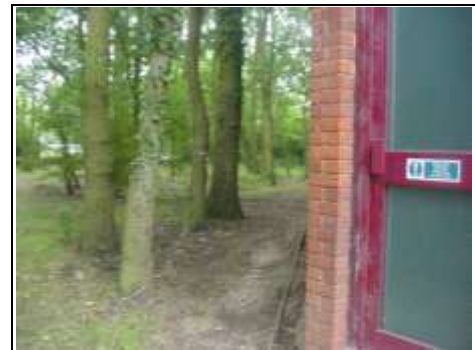
Trees close to property at rear

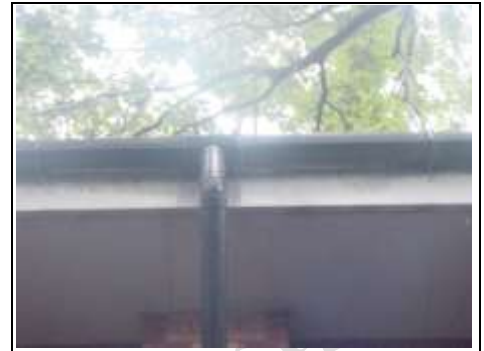
Close up of rear gutter and downpipe, staining to fascia board which indicates leaks. Note the tree hanging directly over this guttering

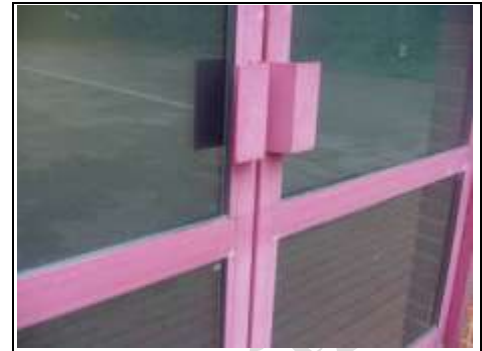
Front door paintwork fading

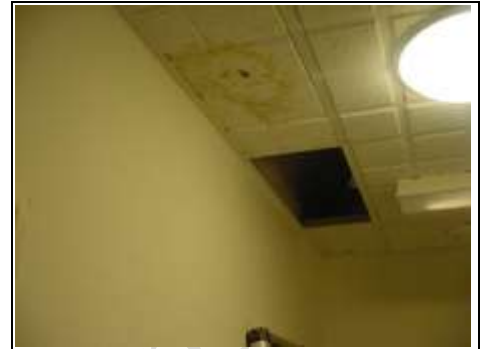
Signs of water leaks in ceiling system

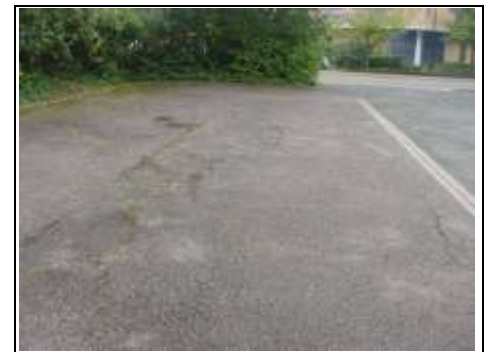
Car park unmarked and deteriorating

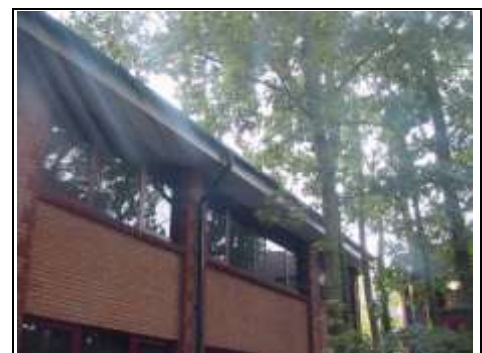
Trees close to building

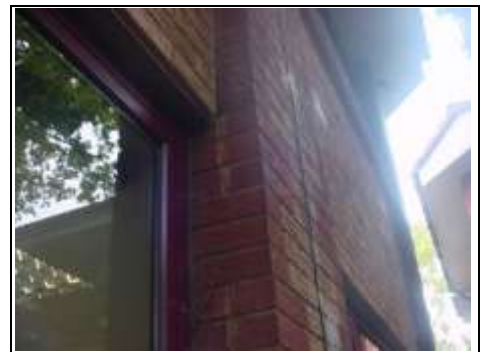
Repairs to perpendicular brickwork

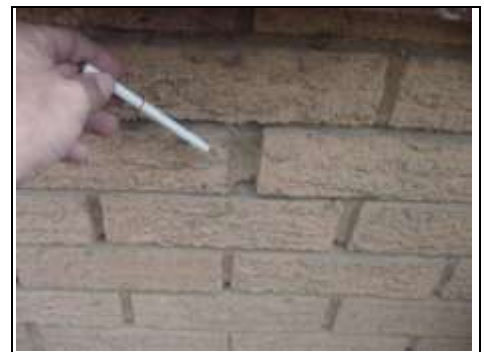
Raking crack to rear brickwork

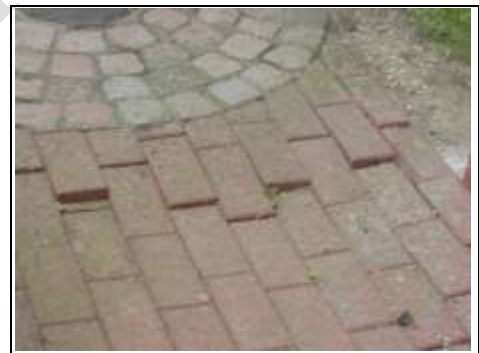
Settlement in brick paves at front of property

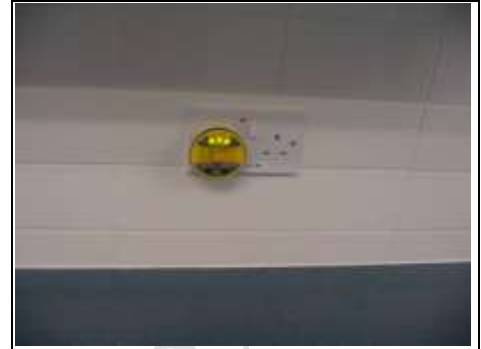
Earth Test ground floor kitchen

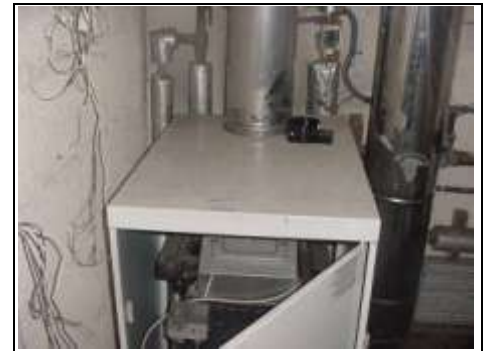
Potterton Kingfisher boiler

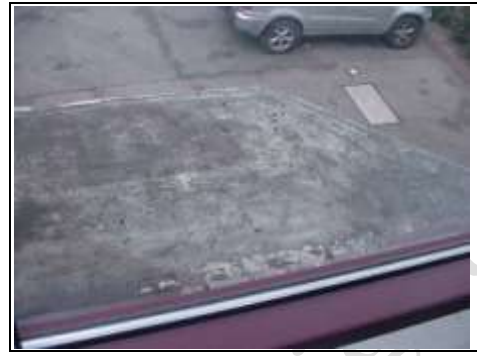
Entrance area roof, we recommend guttering is added

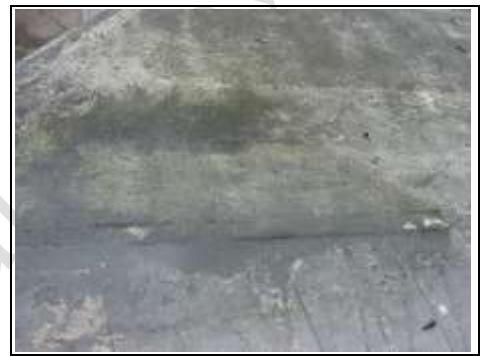
Close up view of entrance area roof

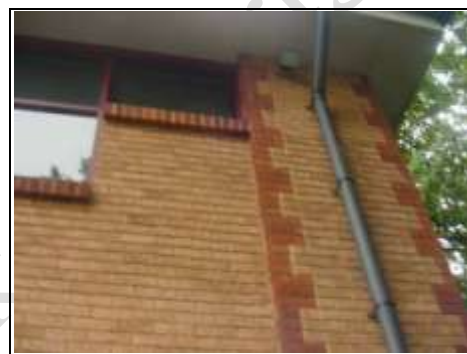
ACTION REQUIRED: You will need a cherry picker to access the gutters, they do need regular cleaning. We would always recommend that the gutters and downpipes are cleaned out, the joints are checked and the alignment checked to ensure that the gutters fall towards the downpipes. Please see our comments in the Executive Summary and speak to the next door neighbour who has experience of actually clearing these.

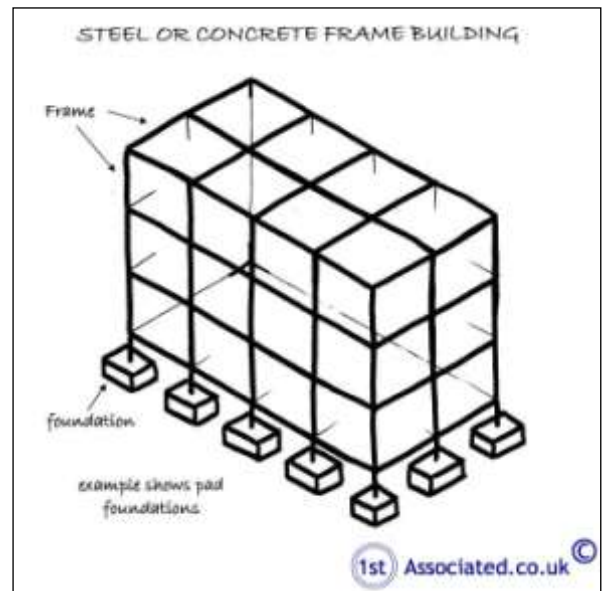
Steel or concrete frame building

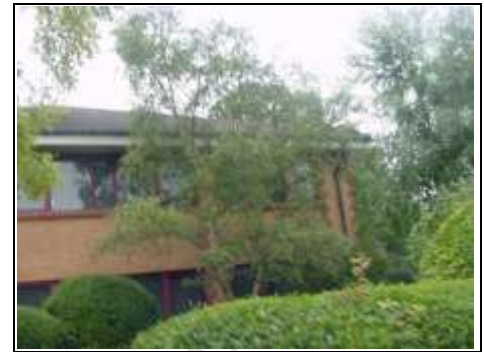
Trees and vegetation close to property

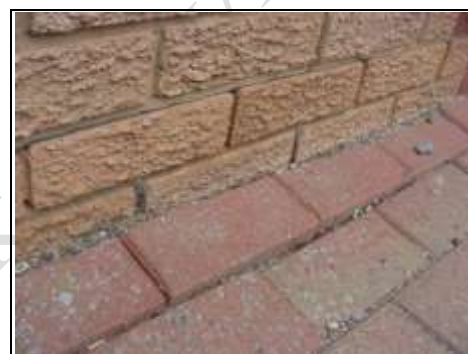
All modern properties should incorporate a damp proof course (DPC) and good building practice dictates that a differential of 150mm (6 inches) should be maintained between the damp proof course and ground levels. In this case, we could see a damp proof course, please see our comments with regard to the brick and mortar deterioration that is being caused by rainwater bouncing up off the brick paves to the front of the property. Your attention is drawn to the section of the report specifically dealing with dampness.

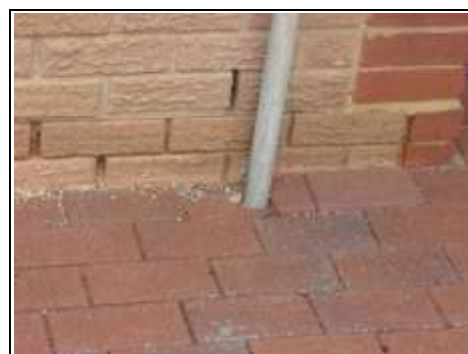
Weathering to the bricks and joints, we would recommend a French drain is added

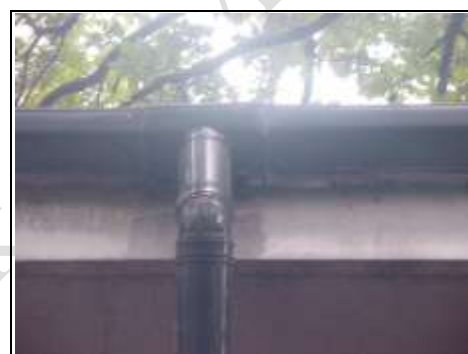
Fascia board stained due to leaking gutter and downpipe

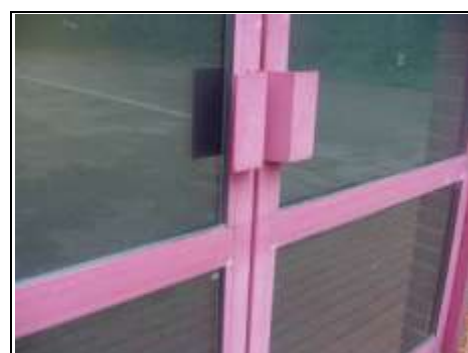
Fading paintwork to metal windows

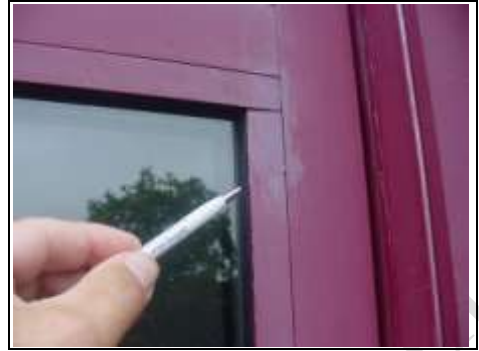
Deteriorating paintwork to metal
window

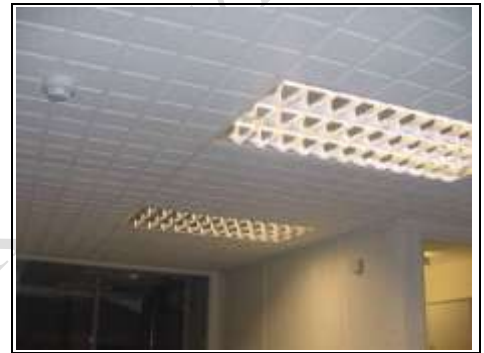
Suspended ceiling system

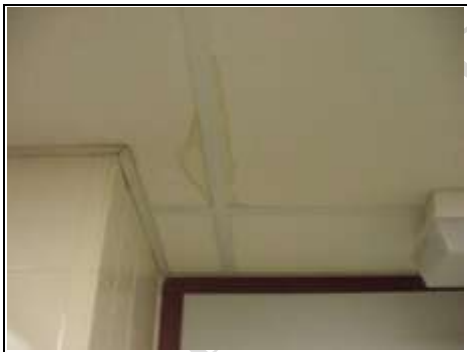
Staining to ceiling leaking from above

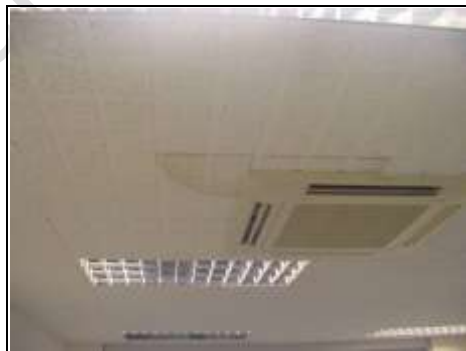
Staining to first floor rectangular ceiling grid system

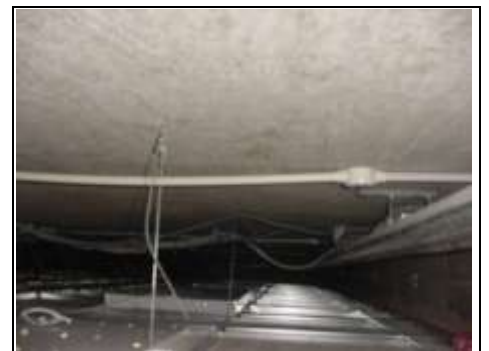
Ceiling ground floor

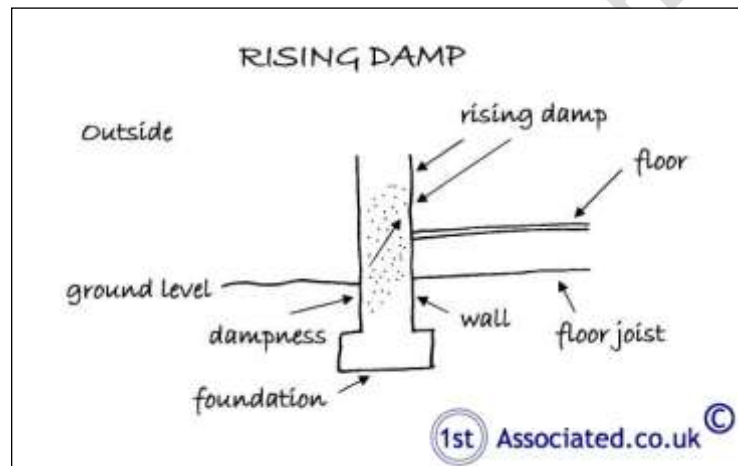
Rising damp depends upon various components including the porosity of the structure, the supply of water and the rate of evaporation of the material, amongst other things. Rising damp can come from the ground, drawn by capillary action, to varying degrees of intensity and height into the materials above.

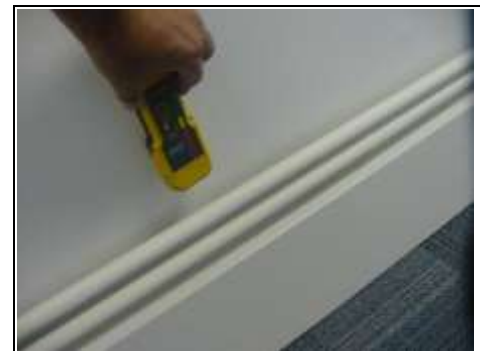
Testing for rising damp

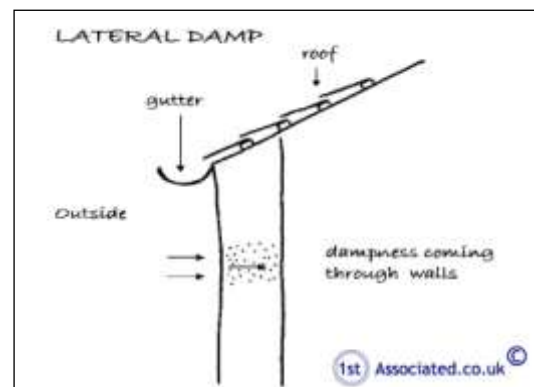
Tests were taken with a moisture meter at random points to internal walls, floors and other surfaces. No evidence of any

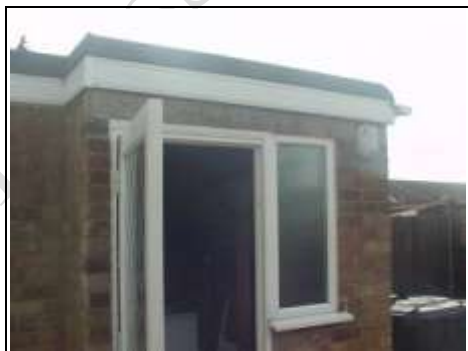
Example of a concrete lintel – can you notice where the cold bridging would be in this photo?

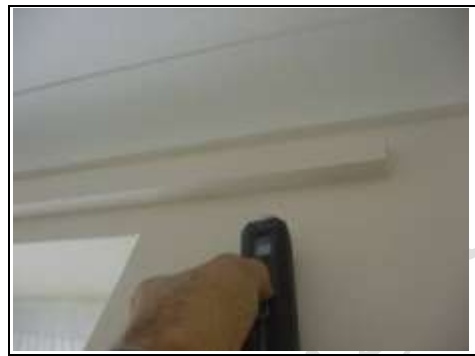
Dampness and condensation around
the concrete window lintel

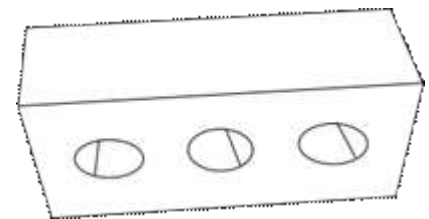
There are several ways of finding out if your property is built on clay soil.
