PROPERTY REPORT

London. N1 XXX

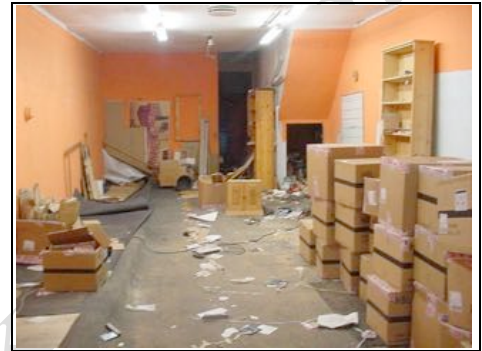
As you are aware a fair amount of money is required to bring this shop unit into good order and indeed what we would term operational standard.

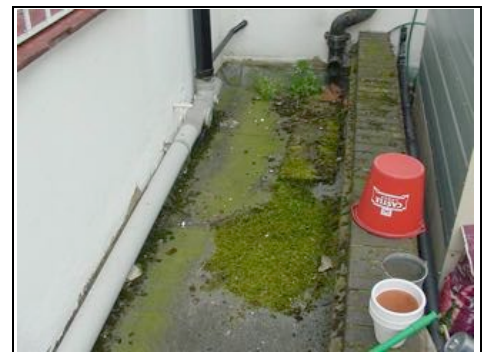
Close up of rear flat roof over the shop with moss and signs of leak below

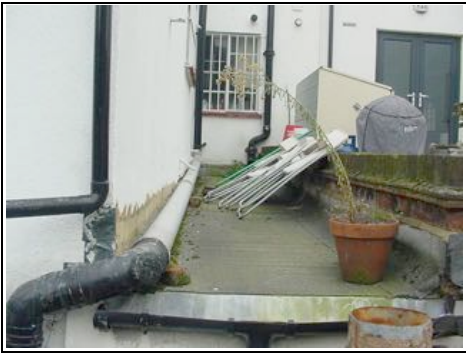
Flat roof over the shop

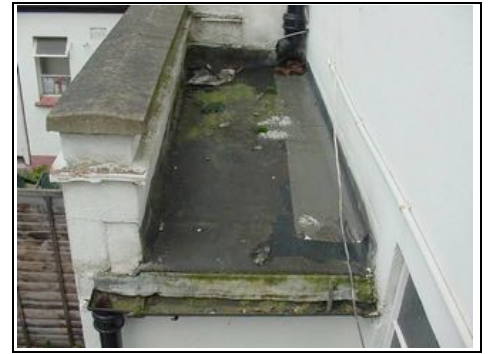
Roof over the entrance, patch repaired in Flashband

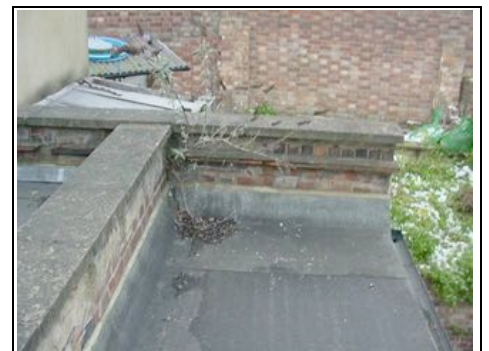
Roof over toilet with tree growing out of parapet wall

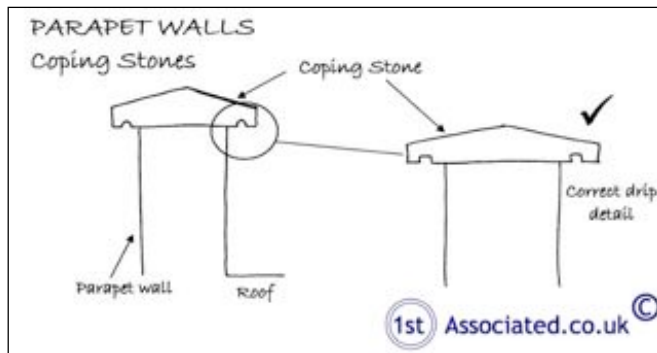
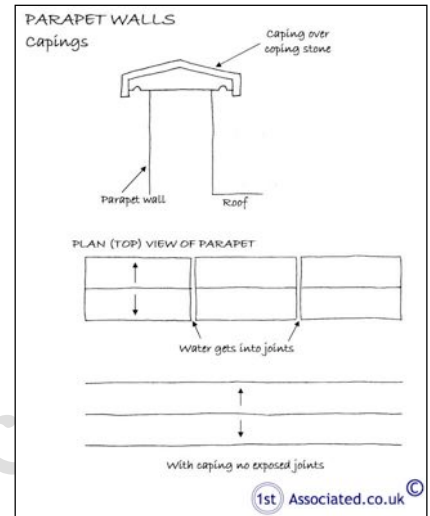
The sketches show typical problems that we find with coping stones where they are not large enough.

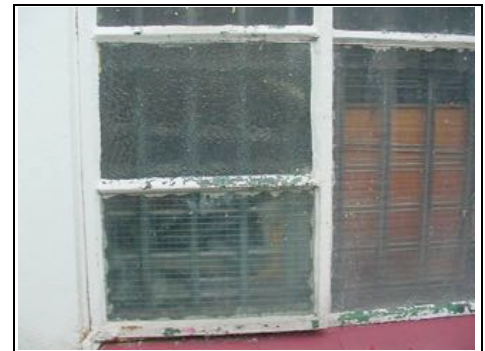
The windows to the rear are metal windows (often referred to by one of the largest manufacturers Crittall windows). Typically these windows warped due to the lack of maintenance and this is what has happened in this case. The warping is so bad that the windows now replacing, repair and secondary glazing or double glazing added.

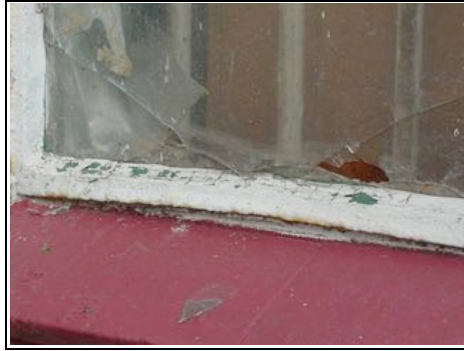
Broken glass in toilet window

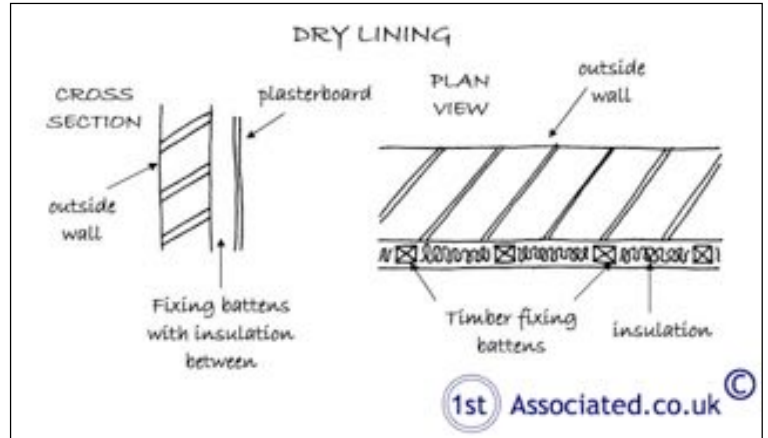
We would always recommend over-cladding the existing walls, you now have insulation board which is also plasterboard which makes an excellent surface to apply the finish. You do need to ensure that the walls are suitably battened if you intend to hang things off the walls of any weight.

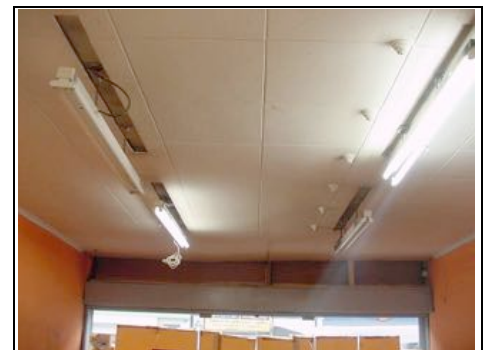
Ceiling is water damaged 15
