PROPERTY REPORT AND NEGOTIATION DOCUMENT

Wandsworth

We have been instructed to inspect and prepare a Property Report and Schedule of Condition for:

Property Report

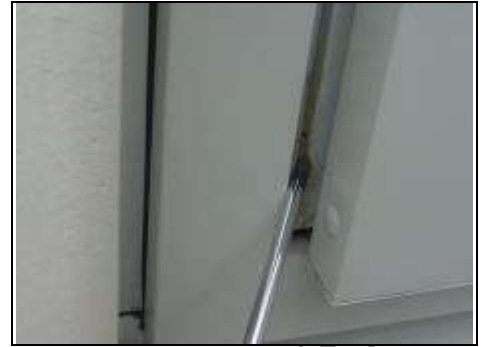
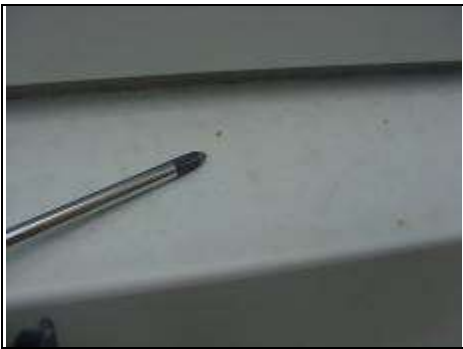
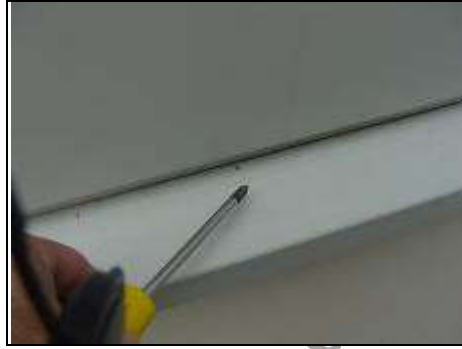
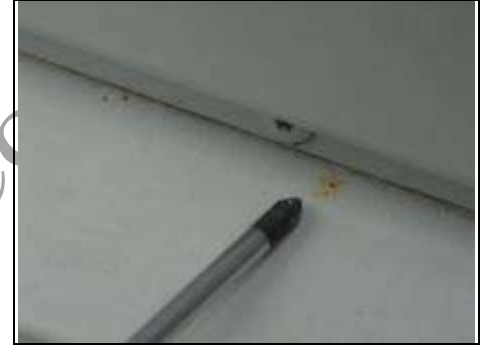
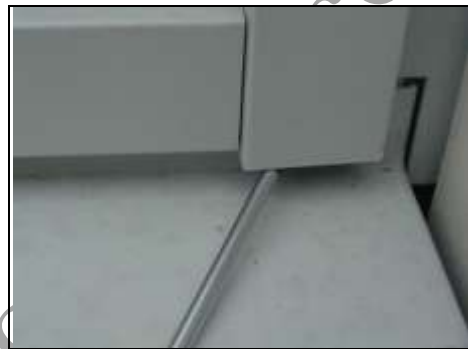
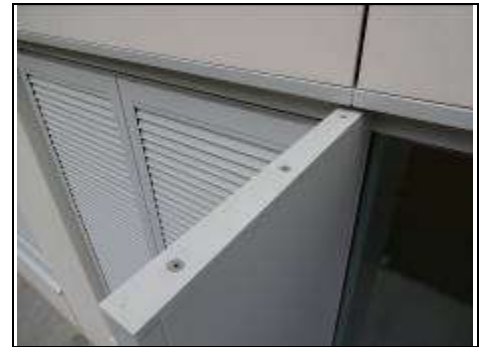
2.0) Rust to windows and surrounds

We can see rust spots appearing to the painted profile metal. This will be very onerous in years to come due to the difficulty of repairing and respraying this type of material and quite concerning that it is rusting already.

Rusting

Rust spots

Rust

Rust spot

Cut metal around windows which will rust

Rust to top of shutters. A flat surface like this will promote rust relatively quickly if not painted properly.

We would classify this as an inherent design defect. It does lead us to question other parts of the construction as a whole.

ACTION REQUIRED: All responsibility for this area should be removed from the lease.

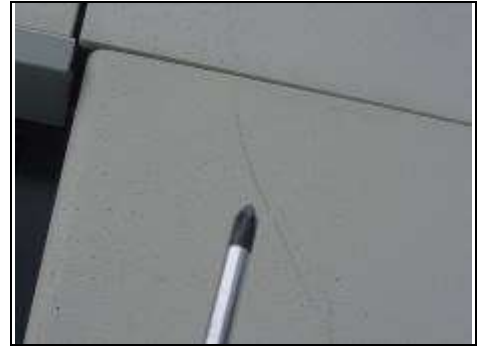
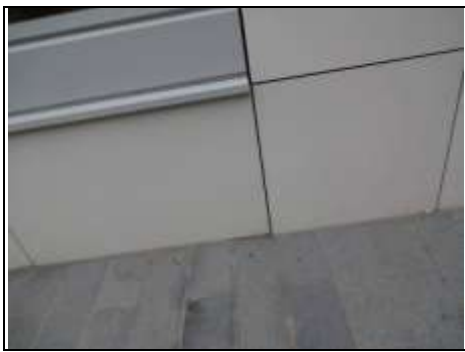
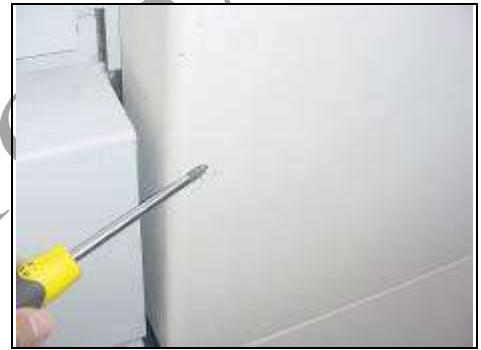
3.0) Rain cladding marked and puckered

We are not sure exactly what the rain cladding is formed from; it is some type of composite material. It has a puckered surface which we feel unfortunately will attract dirt and will be difficult to clean in years to come. Although the textured surface is quite pleasant to look at, it will not be good to repair and keep clean and it is already getting marked.

Mark to rain cladding

Rain cladding not sealed properly to ground in all areas

Marked

ACTION REQUIRED: Consider having excluded from lease.

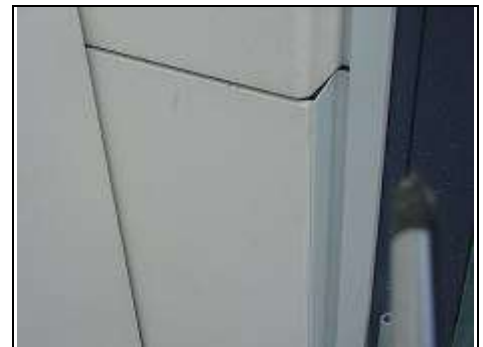
Examining one area closely for example the left double doors into Room One there is poor detailing and patching around the doors.

Poor detail around left double doors

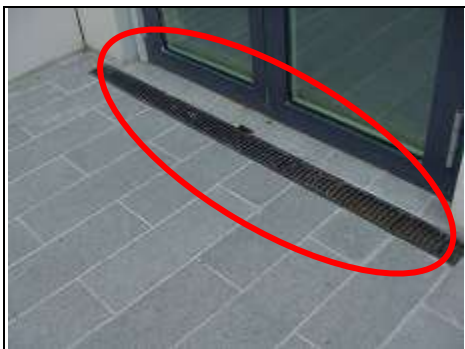
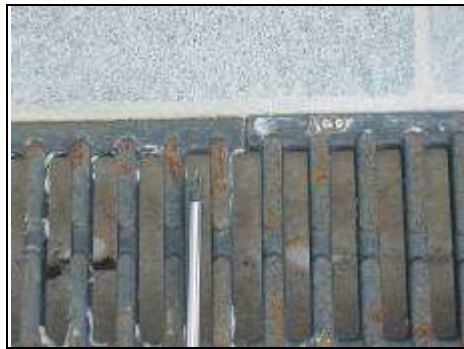
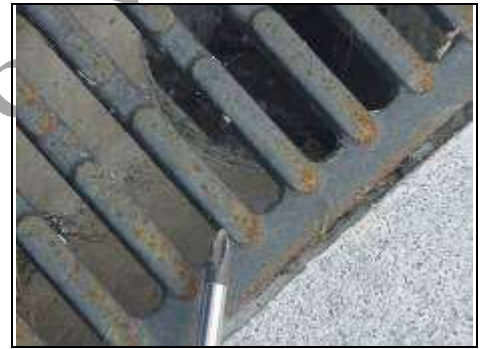
4.0) Rusting running gully and problems of water discharging towards the doors

We can see the running gully is rusting. This is unusual on a development so new however it does highlight a problem that we believe is present in this building, which is that the falls on the paved area have not been considered properly and they may be falling towards the doors, which is why this running gully has rusted already. This can lead to not only dampness coming in through the doors but also dampness in the walls which is very difficult to predict, particularly where rain cladding has been added.

Running gully

Rusting

Close up

ACTION REQUIRED: Replace or remove from lease.

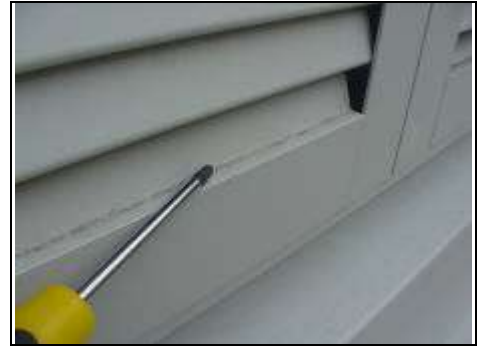
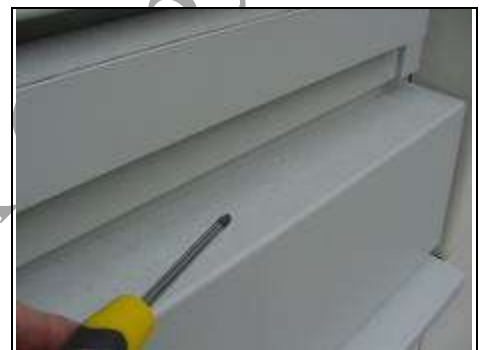
6.0) Weathering of the shutter windows, fixed windows and opening windows

We can see a layer of dirt on the windows at present. You will need to ensure these are kept regularly clean. Whilst there are cleaning systems for this type of painted metal windows, in a twenty year life of a lease we would expect you to have to redecorate it. Most leases will require this every three to five years.

Dirt accumulating

Weathering of windows

ACTION REQUIRED: The windows need cleaning before the handing over of the lease and need regular cleaning.

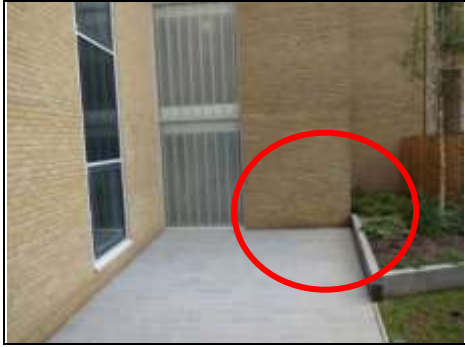
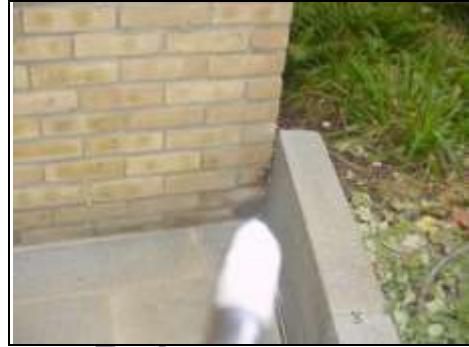
High ground level

There is an area where there is a high ground level which looks like it would cause dampness to the adjoining brick wall area (not part of the crèche).

High ground level against brickwork

Close up of where high ground level starts

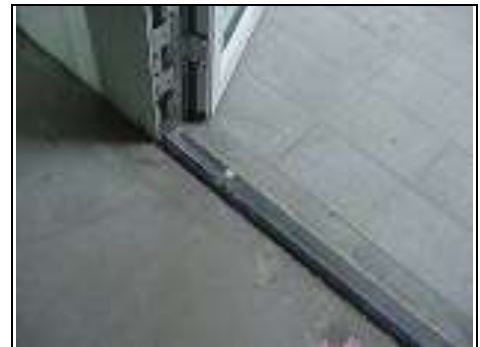
We have already talked about this but look here specifically at the threshold of the right hand door.

The threshold to the left door has a running gully however the door threshold to the right has no running gully and is the same level inside and outside, so there is nothing to stop water getting in as far as we can see unless there are falls on the floor that we cannot see. Sorry to reiterate this point, but we do feel it is important.

Right side has no running gully and is same level inside and outside

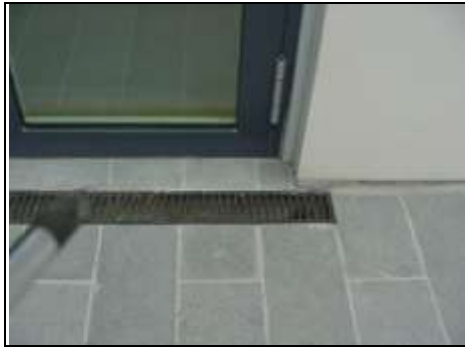
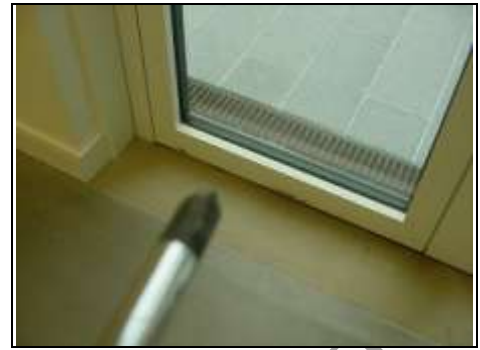
Threshold on left side has running gulley

Running gulley protects left door

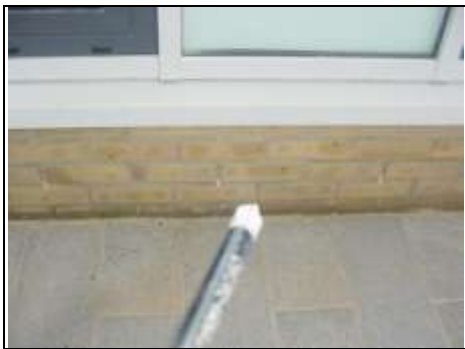
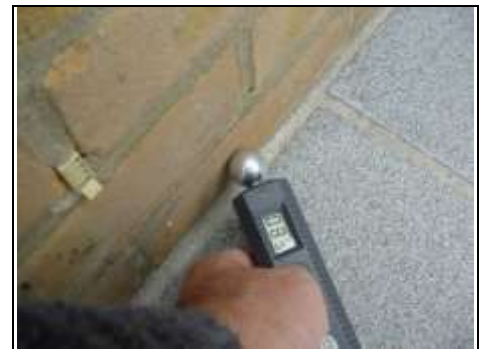
Weep holes

Generally on the wall it is a modern type of construction with weep holes to the base of it where we were obtaining high damp meter readings at the time of our survey.

Weep hole

Dampness present on brick wall

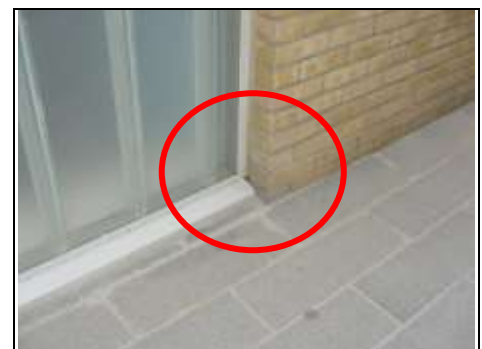
Sill detail

We believe there is a poor sill detail and there are elements hidden that we cannot see that protect dampness from getting in.

Opening in sill detail

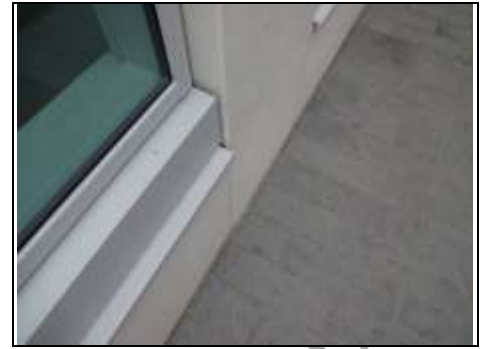
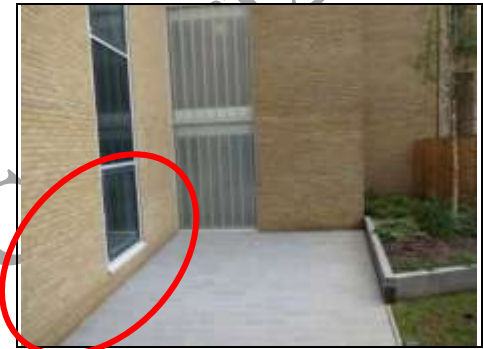
What happens to the rainwater that gets behind the rain cladding and where does it drain to?

Where does water drain to

The drain to the left is a thin drain so will have to be kept regularly maintained to take water away. We would firstly question does the rainwater run towards it as it doesn't look to and secondly does it work?

Drain to left

ACTION REQUIRED: We suggest that you take photographs of the terrace on the first rainy day to establish where it ponds.

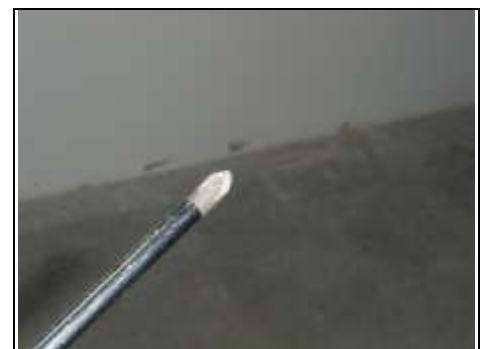
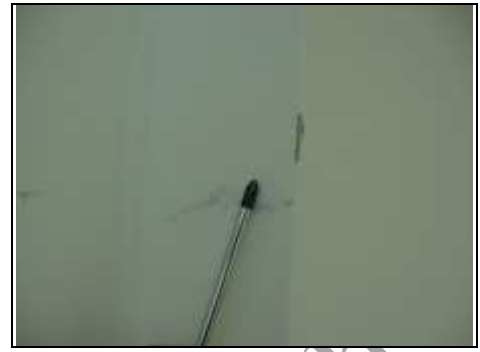
Internally is generally to a standard we would expect on a new build nevertheless we would be arguing strongly that the paintwork has been damaged internally and you are not getting the building freshly painted and will have to paint it. As part of most Full Repairing and Insuring leases you will certainly have to leave it freshly painted.

Wall marked at base in open plan room right

Wall marked in Room One

ACTION REQUIRED: Negotiate with the landlord.

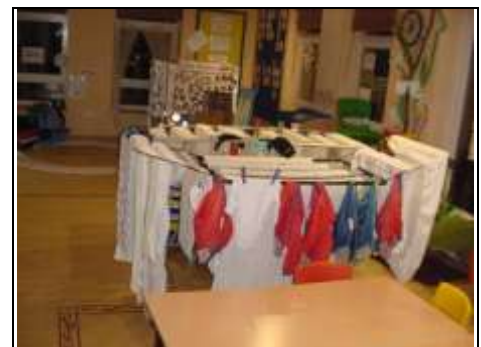
Of course the way you operate will affect the amount of humidity in a crèche/nursery. For example this photograph shows a lot of clothes being dried within a crèche which is difficult to avoid sometimes, but nevertheless needs to be considered.

Drying clothes internally adds to humidity

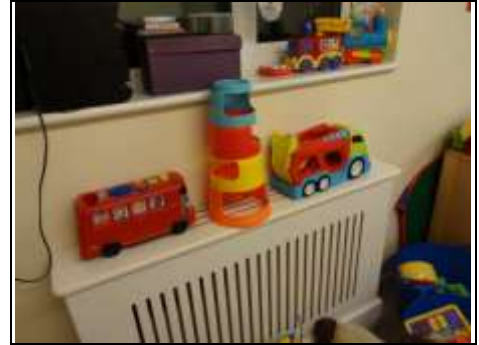
The radiators that you have presently are exposed as are the pipes to them. These need to be covered.

Example of covered radiator

ACTION REQUIRED: Add covers.
