PROPERTY REPORT AND NEGOTIATION DOCUMENT

INDEPENDENT CHARTERED SURVEYORS

We have been instructed to inspect and prepare a Property Report and Schedule of Condition for:

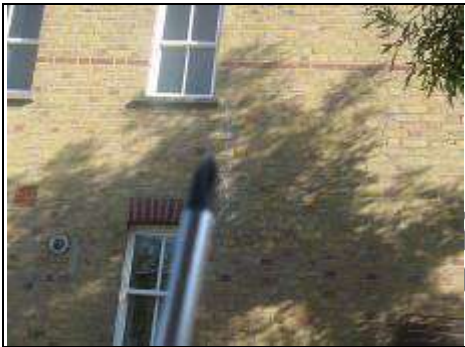
There is vertical cracking both through the brickworks and the joints and there are also signs of historic cracking which has been stitched together.

Vertical cracking through brick and brick joints

ACTION REQUIRED: You need to ensure that anything relating to movement is excluded from your lease.

Ideally we would recommend the existing owners take out an insurance claim, advising that the cracking has been noted by a structural surveyor (this should cost them nothing other than time to write the letter). This usually means that the insurance company will carry out a monitoring exercise (the Building Research Establishment recommends monitoring any cracks for a minimum of one year) to establish if there is any progressive movement. Your future liability will be limited to the cost of the excess on the insurance policy.

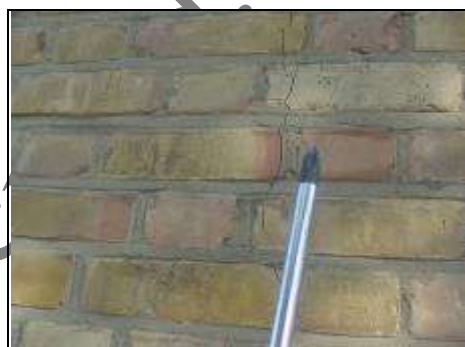
Cracks through bricks

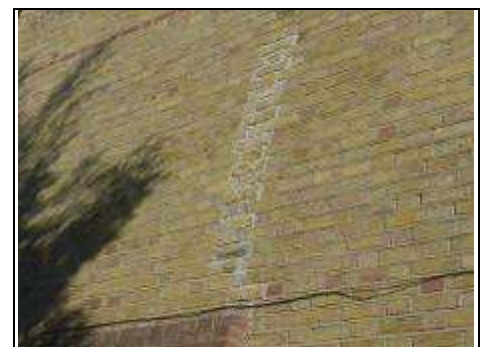
Stitching in of bricks, old repairs

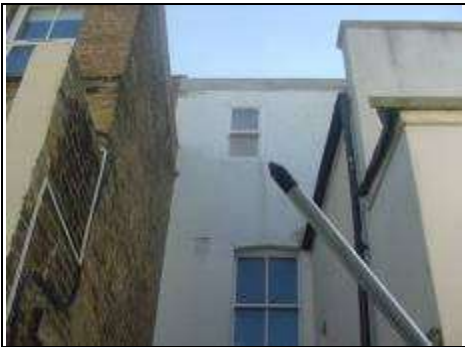
The rear of the property has a brickwork and render area. To the render we can see cracking. Our view of the brickwork was limited. The photographs are a sample of the cracking.

Diagonal and horizontal cracking

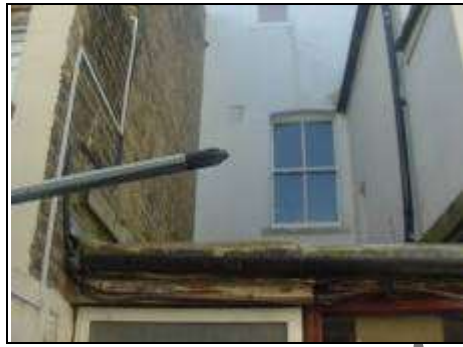
Cracking

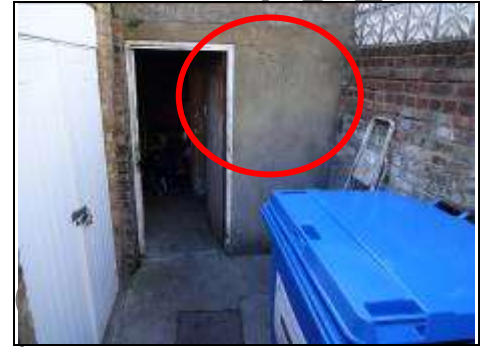
Crack to outbuilding area

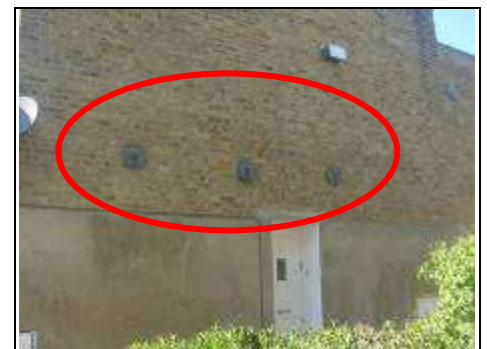
Movement in surrounding buildings also noted (not this property). Structure tied in place

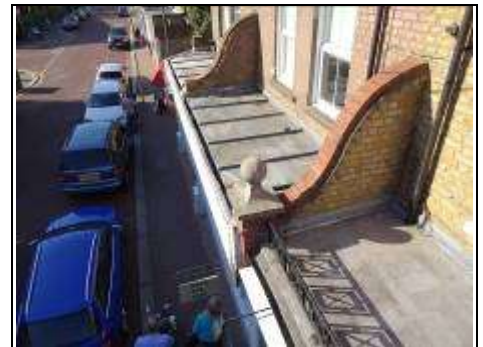
Front roofs

To the front of the property there are two metal flat roofs. There looks to be some leaks particularly to the right hand side. Unfortunately the leaks can affect the trade below so whilst they may be a shared responsibility, it is important for your trade and you may ultimately end up repairing it yourself if agreement is not made.

ACTION REQUIRED: Negotiate with the landlord with regard to repairs to the front roof. We would recommend that you insist that any leaks that affect the trade area can be repaired by you if they are not repaired by the landlord within 24 hours (or time to suit yourself).

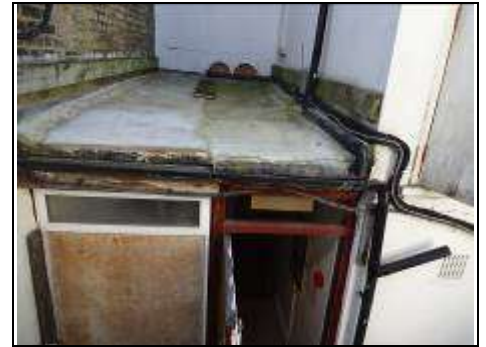
There are two rear roofs at two storey level which we have not been able to view properly. There is a roof at a storey and a half level which has a DIY plastic roof covering which is very poor. There is a single storey roof that has an asphalt covering which is also in poor condition and dampness can be seen getting into the property via this roof.

Dampness can be seen to be getting in through the low level flat roof and flashings have deteriorated

ACTION REQUIRED: Replace the DIY plastic roof, add a flashing and leave watertight and also replace the fascia and soffit boards.

We would expect the low level flat roof to need re-roofing with a lead flashing all the way around it. We would also make good the semi-circular holes to the rear of this roof.

ANTICIPATED COST: £3,000 - £7,000 (three thousand to seven thousand pounds) depending upon whether the roofs are re-roofed as cold roofs or what we would recommend as warm roofs; please obtain quotations.

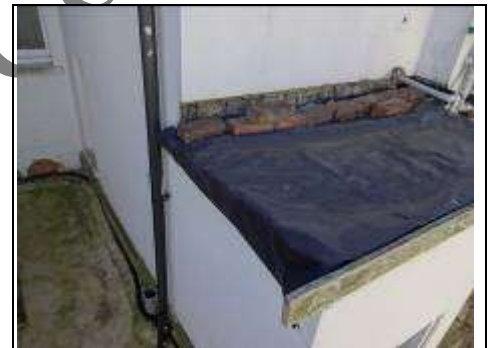
DIY repair to flat roof

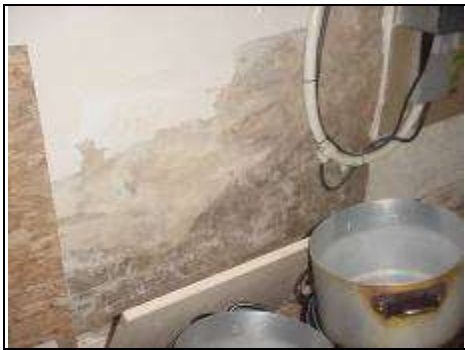
Dampness can visibly be seen in the store and preparation areas of the basement. We believe it is also in the kitchen, the only reason it cannot be seen is due to the metal wall cladding.

Render coming off wall

ACTION REQUIRED: It is very difficult to know what to do with dampness particularly where it is coming into a food environment within a basement.

There are various options available to help keep the basement drier. Some are permanent solutions and some are long term solutions. We would however recommend you speak to the landlord about them carrying out the work or contributing to the cost.

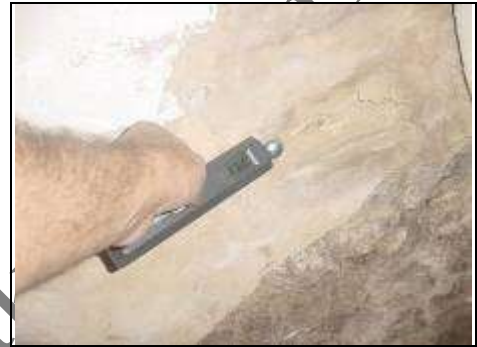
Render coming away due to dampness in front right store

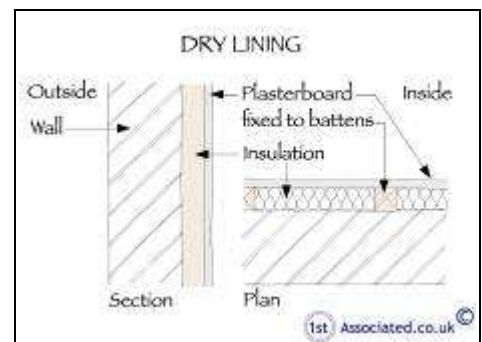
We could also see dampness on the ground floor particularly to the rear of the property to the toilet areas and corridor areas, however we do think it is to the main property as well but it has been hidden by false walls/dry lining.

False wall/dry lining

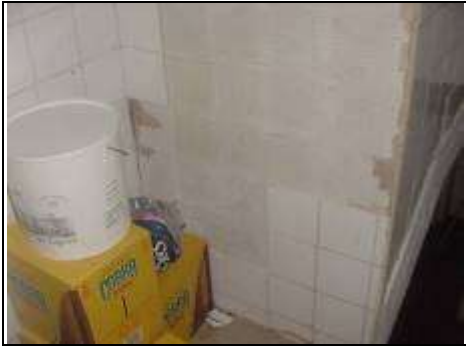
Tiles off wall near stairs

Unfortunately it is very difficult to resolve fully without major work. We believe there is likely to be dampness in the actual restaurant area as well but false walls/dry lining has been added. Unfortunately there is a lack of space in the toilet areas to the rear which is why we believe false walling has probably not been used.

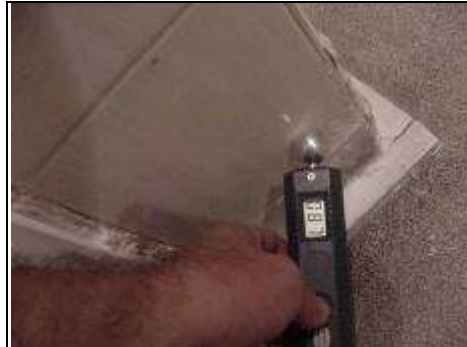
Some of the dampness to the rear looks to have been present for a long time with rot to the timber frame of the door in the ladies toilets and tiles coming off, etc. We were obtaining Gann electronic damp meter readings much higher than we were expecting.

Dampness to base of tiles in ladies toilets

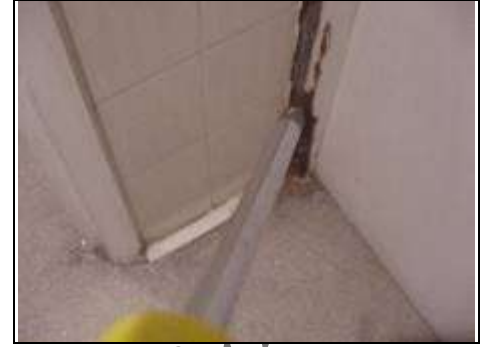
Rot in door frame in ladies toilets

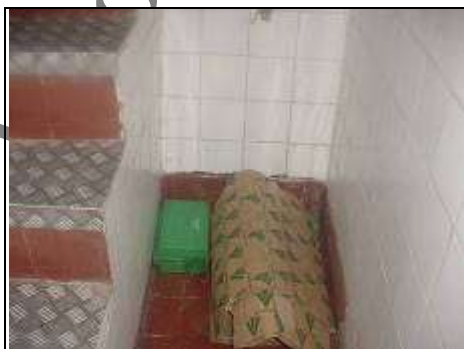
We believe the property does not meet environmental health standards. There is a considerable number of mice and rat traps in the kitchen. We do not believe the damp conditions make it inappropriate to be storing the food in some areas as dampness is considerable.

Rat trap

ACTION REQUIRED: Have a cup of tea meeting with the environmental health officer before you commit to purchase the lease to establish exactly what the problems are and your legal advisor needs to obtain certificates of the previous two years environmental health visits.

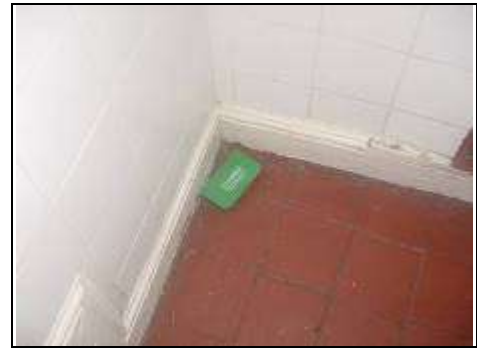
Mice trap

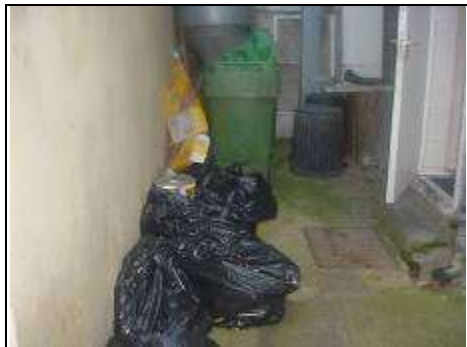
We would comment the tiled floors are marked and damaged; a safety floor is preferred and often recommended. Another example we would give of unacceptable practices is the storage of rubbish to the rear of the property adjacent to food storage.

Bags of rubbish to the rear

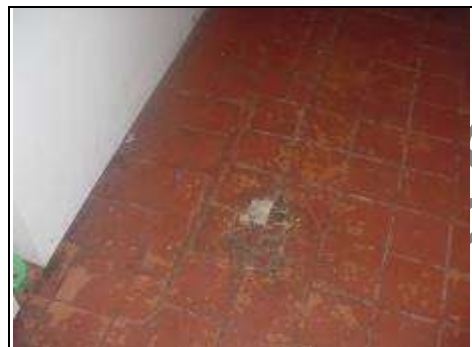
Tiled floors marked and damaged.

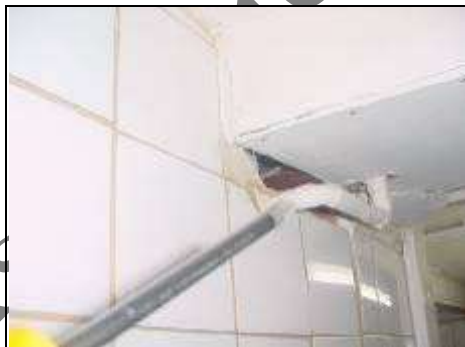
We would draw to your attention there are more holes in the walls and damaged walls than we normally come across. From damaged walls this is everything from the dampness that we can see throughout the property, particularly to the ground floor toilet areas and the basement area, to the holes in the wall in the store under the stairs and also on the corridor to general holes (old fixing points and marks) to the tiles. We feel you would probably be better off re-tiling but we also feel/fear that once the tiles come off you will expose other problems including dampness.

Hole in wall to link corridor

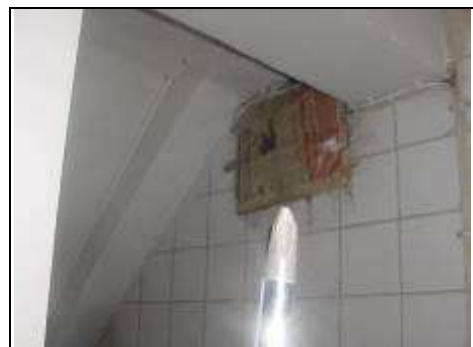
Newspaper covering up hole under stairs

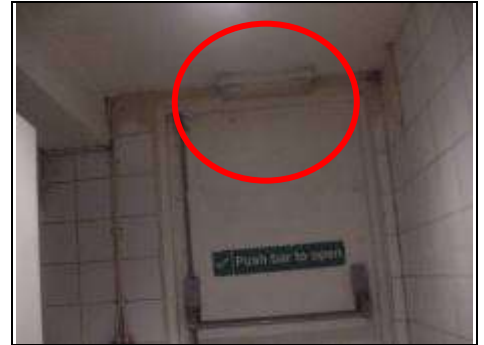
We do not believe the property meets current fire regulations. We could see from a signage point of view that the alternative exit to the rear of the property is not suitably signed and we believe there should be an illuminated sign over the fire exit door and there should also be other illuminated signs guiding you to the exit. We could also see for example that there are a minimal number of fire extinguishers, for example the one near the rear door did not have the appropriate signage advising what it was used for.

Fire exit door – we believe requires illuminated sign

ACTION REQUIRED: Ask to see the fire certificates and have an informal meeting with a fire safety company or the fire brigade.

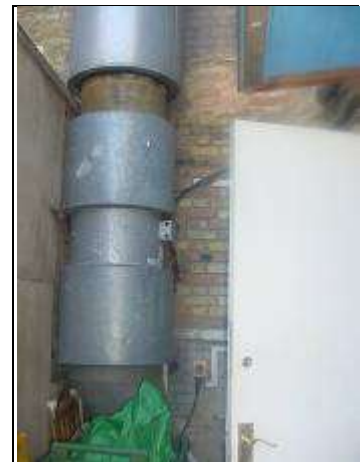
Extract flue – when was it last cleaned

When was flue last cleaned?

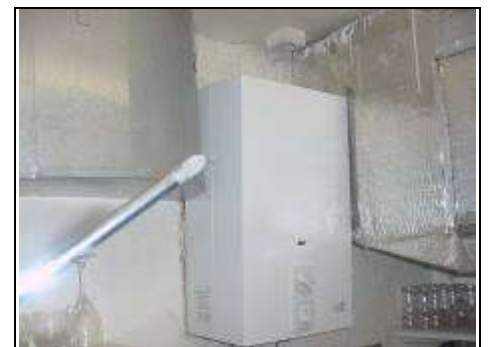
We would also comment that the boiler needs to be vented to outside air.

Boiler in front right store should be vented to outside air

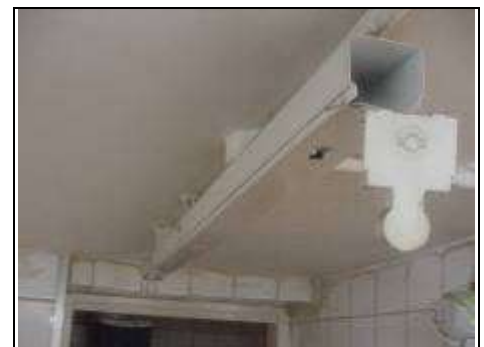
From a functional point of view the lighting within the back of house areas we feel is poor. There are lights missing completely and there are also lights without protective covers. Some lights are simply getting in the way due to the low head height from what we could see.

Damaged light

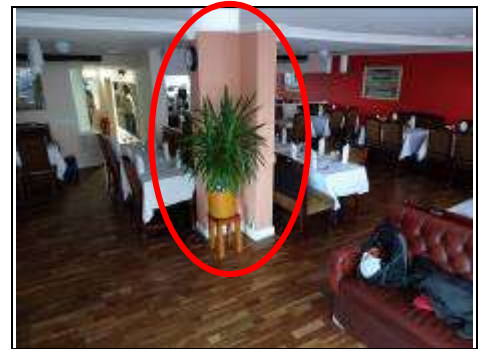
We discussed the possibility of removing the columns. The columns are positioned where the walls would have been that supported the entire building above. Generally you now require them to be 450mm large in each direction they give support which is about the size they are. In buildings you can of course do almost anything, it is just that the cost goes up drastically. Please note there is also a nearby column that has got some movement in it.

Column hiding behind plant
