SCHEDULE OF CONDITION

Apartment X Bathrooms and Bedrooms (no reception rooms, etc), Corridors, Stairs and Lift Lobbies to Apartment X

XXXX XXX London NW8 XXX

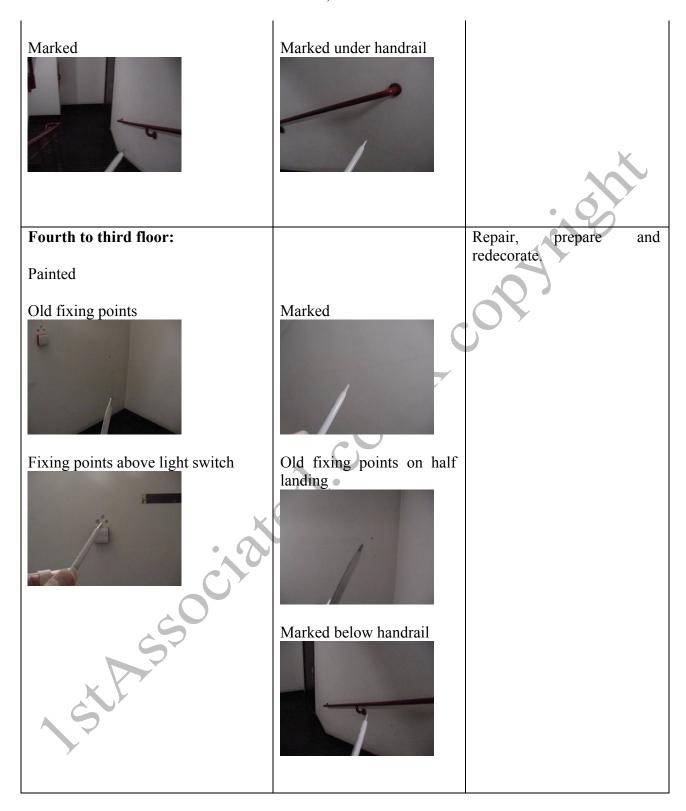
DESCRIPTION	CONDITION	ACTION	REQUIRED
Ceiling:	<u> </u>		
Painted	Average	Repair, redecorate.	prepare and
Walls: Fifth floor to fourth floor:	7.co.	Repair, redecorate.	prepare and
Painted Old fixing points from old fire signs Marked	Old fixing holes on half landing Particularly marked at low level

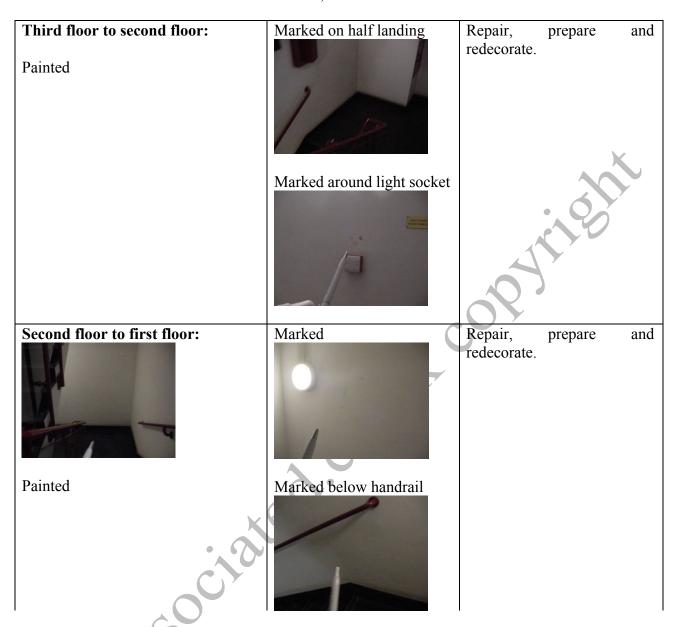
First Floor to Ground Floor:		Repair, redecorate.	prepare a	and
Painted	Marked on landing	1000001000		
				J
Half landing	Marked on wall at half landing	5087		
	Marked underneath handrail			
Ground floor:	Marked near fire exit	Repair, redecorate.	prepare a	and
Floors: Plastic	Marked	Deep clean
