RESIDENTIAL BUILDING SURVEY

**Dagenham,
Essex,
RM10 xxx**

INDEPENDENT CHARTERED SURVEYORS

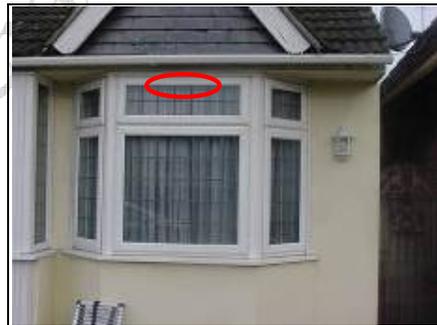
6.1 The lack of air ventilation externally as there are no trickle vents to the windows.

Front bay.
No trickle vent in window

ACTION REQUIRED: Large humidity controlled extract fans to be added to the kitchen, bathroom and possibly the conservatory. If this is not carried out you may find black mould is occurring. We are still in the early days of discovering the health problems associated with this black mould.

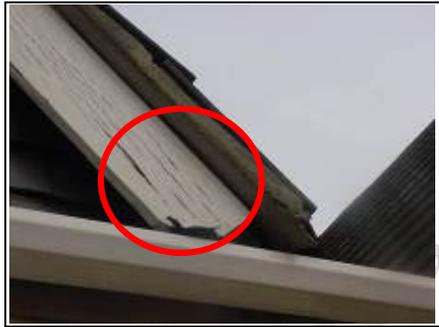
We did notice that the external joinery would benefit from being re-decorated.

Fascias need painting

ACTION REQUIRED: Re-decorate.

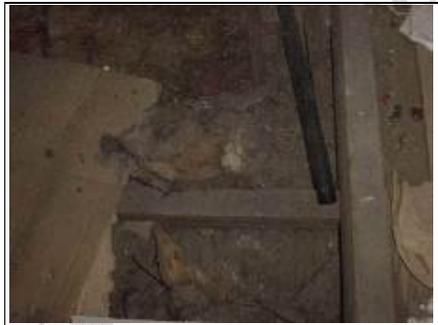
With us moving more and more towards energy efficiency measures in buildings we would note that the roof was not insulated and that the conservatory area was not double glazed. It would be relatively hard to double glaze within the wood units but it is possible although the sealed units may suffer from movement and could break the seals. Secondary glazing may be an option.

No insulation

ACTION REQUIRED: Insulate the roof but ensure it is appropriately ventilated and also consider double glazing to the conservatory.

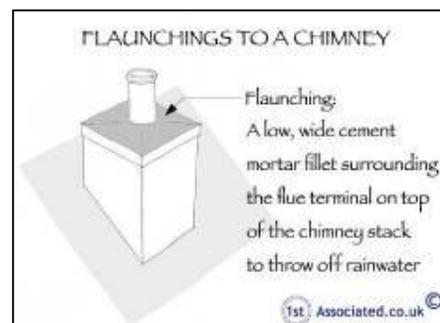
Flaunching

Unfortunately we were unable to see the top of the chimney known as the flaunching, we therefore cannot comment upon them other than to say as dampness is getting in then this is also a possibility.

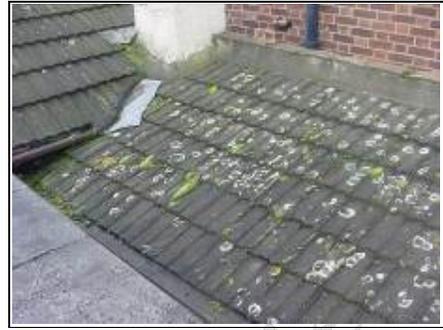
This is clad in concrete tiles and has a fair amount of moss on it. Again this needs cleaning particularly as it goes into the awkward and poorly detailed valley gutter to the rear. Remember you will rarely see these valley gutters so if there is a problem the first time you will notice is because of dampness inside the property.

Rear single pitched roof

ACTION REQUIRED: Please see our comments within the Executive Summary.

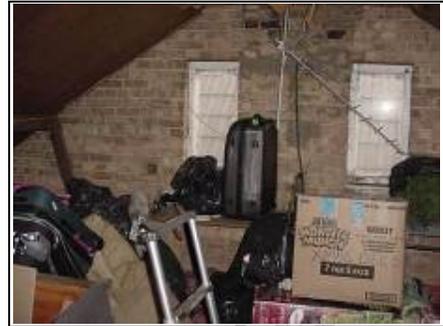
Our examination was limited by the general configuration of the roof and the stored items. Our view was also limited by the building paper so we could not see the common rafters and these are the rafters that form the pitch of the roof. What we could see was generally found to be in average condition for its age, type and style. It is, however, feasible that there are problems in the roof that are hidden.

Stored items limit our view to the ceiling joists and the building paper limited our view to the common rafters..

ACTION REQUIRED: The only way to be 100 per cent certain is to have the roof cleared and checked.

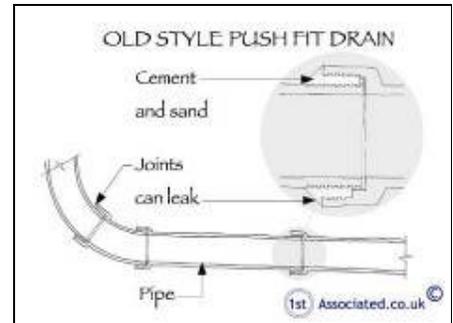
We noted cracking on the right hand neighbours building. This may indicate some leaks to the drainage. Older drains tend to be a push-fit type system that do leak.

Push fit drain

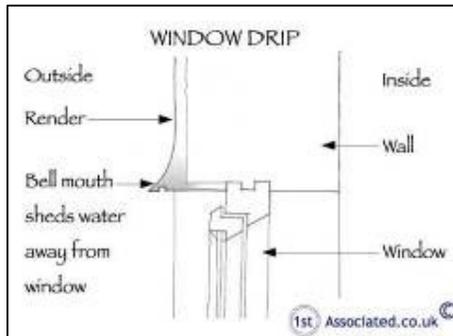
With regard to the window drip detail there are not any windows that should have a drip detail apart from the side windows, which we can see, do not.

Side window

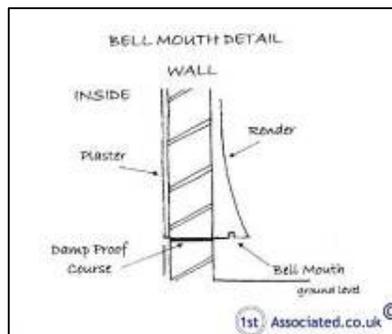
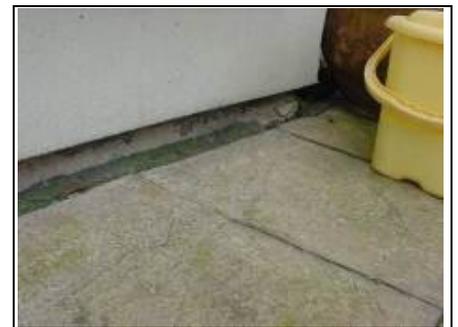
We could only see a bell mouth detail to the base of the property to the very rear of the extension. To both the left and right hand side of the original property there is no bell mouth with the render going all the way down to the ground. This will cause capillary action and allow some dampness in.

Bell mouth to the rear

ACTION REQUIRED: We would recommend that a bell mouth is added.

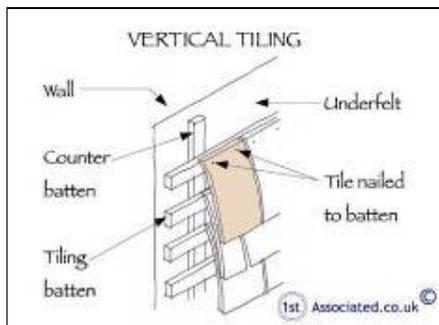
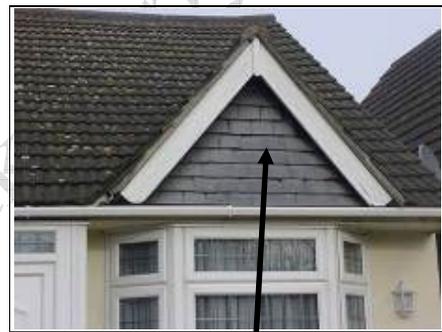
There are small areas of vertical tiling above the splayed bays to the front of the property which look to be in average condition.

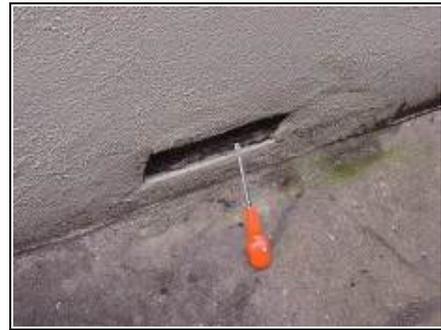
There are air bricks to the front bay at low level and we could also see some to the side of the property. We would however prefer to see some airbricks to the rear of the property to allow a through flow of air. Air bricks are essential to have a through flow of air as this helps to reduce the chances of wet rot, dry rot and woodworm.

Air brick to the front bay at low level

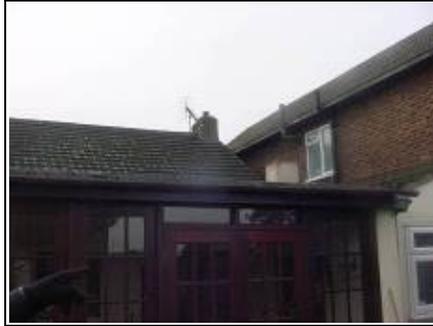
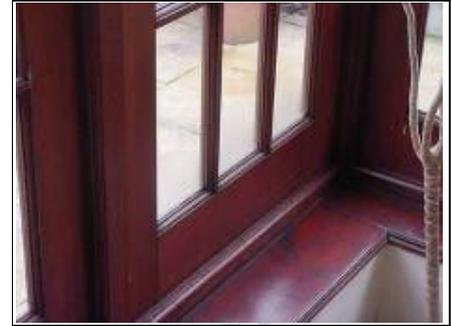
There are also timber single glazed windows to the rear of the property and also in the roof space.

Single glazed windows to the rear

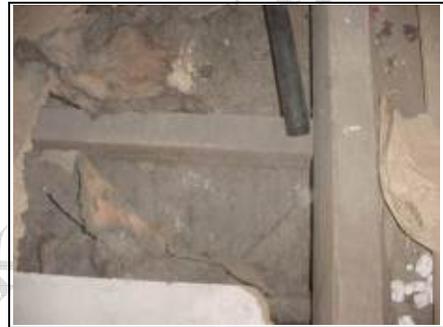
From our visual inspection of the ceilings and our general knowledge of this age and type of construction and where we could see the ceilings from the roof space we could see that they were lath and plaster. We think there is likely to be plasterboard to the newer extension i.e. the kitchen and the conservatory.

Lath and plaster ceiling visible from roof space

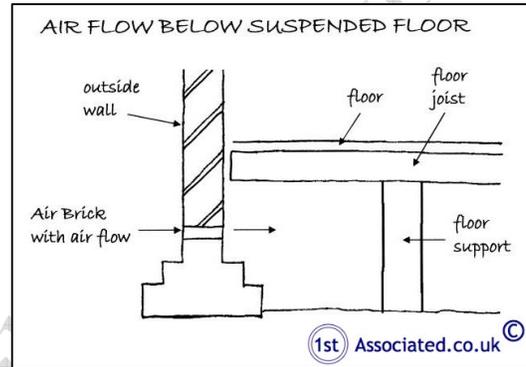
The floors to the front of the property are suspended timber floors which require air movement underneath to minimise wet rot, dry rot and woodworm. However this is blocked by the solid floor.

Suspended timber floor

ACTION REQUIRED: We recommend that air bricks are added in the Utility Room or the cupboards in the kitchen.

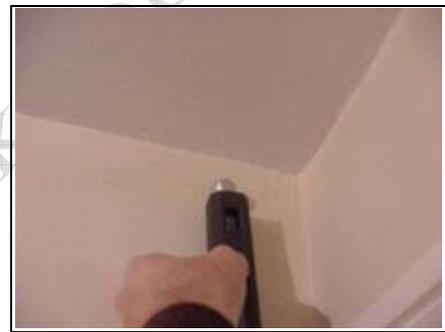
We used a damp meter on the external walls. We have not found dampness.

Testing for lateral dampness

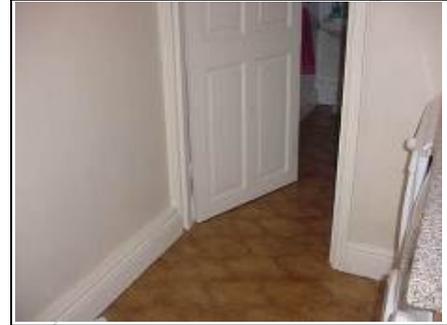
The doors are painted panel doors.

Panel door

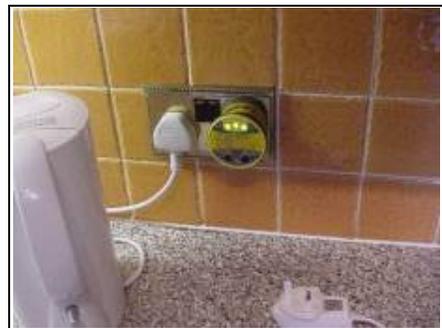
Earth Test

We carried out an earth test in the kitchen area to the socket point that is normally used for the kettle, this proved satisfactory.

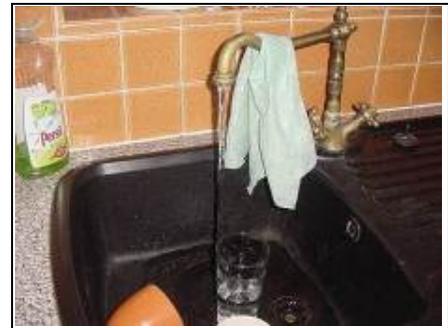
When the taps were run to carry out the drainage test we checked the pressure literally by putting a finger over the tap and this seemed average. The Water Board have to guarantee a certain pressure of water to ensure that things like boilers, particularly the instantaneous ones have a constant supply of pressured water (they would blow up if they didn't!).

Running the tap to carry out drainage test and to check the pressure

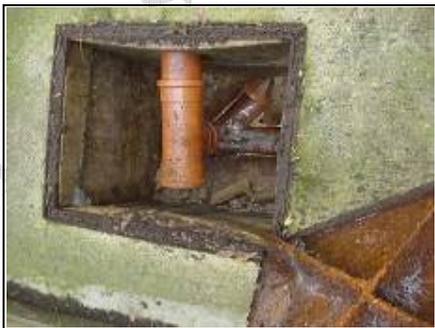
Manhole- rear right

We duly lifted the cover and found it to be free flowing at the time of our inspection.

From what we could see it is brick built. It appears to have had a new plastic pipe added to it which we assume is from the kitchen.

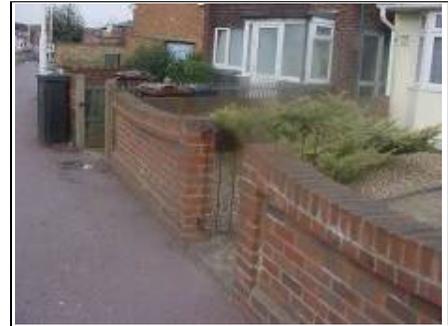
There is an alpine style garden to the front of the property. The brick wall has a stepped crack in it and will need repair.

Front Garden and wall

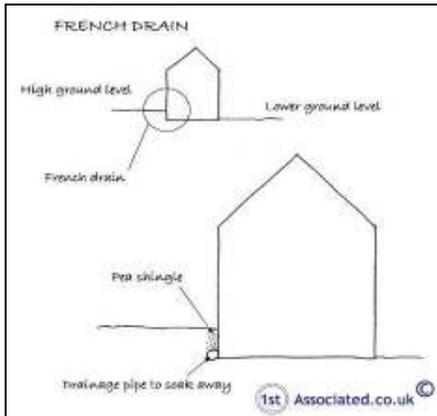
French Drain

French drains would typically have been used where water was getting into a property.
