RESIDENTIAL BUILDING SURVEY

Shooters Hill, London,
SE18 xxxx

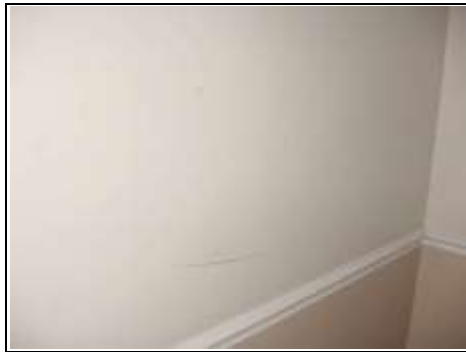
Communal stairwell
These would benefit from
re-decoration

We noted that the communal areas would benefit from a re-decoration. Whilst this does not affect you much, as you do not have to walk up the stairs etc., it does give an indication of the quality of the management company.

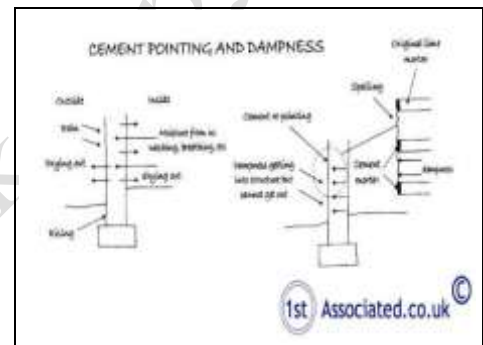
Unfortunately the cement re-pointing, whilst well meaning, is not appropriate for this type of construction. A cement mortar has been used rather than a lime based mortar. We recommend you use lime mortar in any future repairs regardless of what the builders say! Using lime mortar will limit further damage to the brickwork, which is almost impossible to repair successfully. However, we would add that many, if not most, of the properties that are re-pointed are re-pointed wrongly; it is only in recent years that we have discovered the problems that can occur from it.

Cement- re-pointing and dampness

ACTION REQUIRED: The using of cement mortar would seem to be due to a lack of knowledge and next time the building is re-pointed it should be carried out in a lime mortar. This will not be that long as this is a very thin/poor re-pointing and is starting to come away.

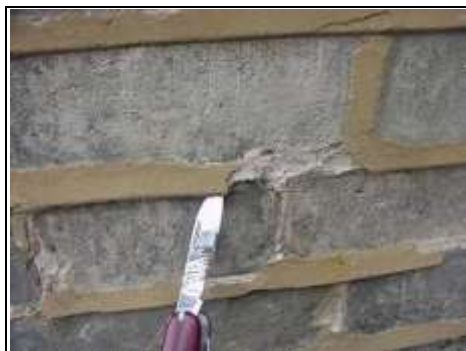
Poor re-pointing.
Just a skim coat we are amazed it has stayed on.

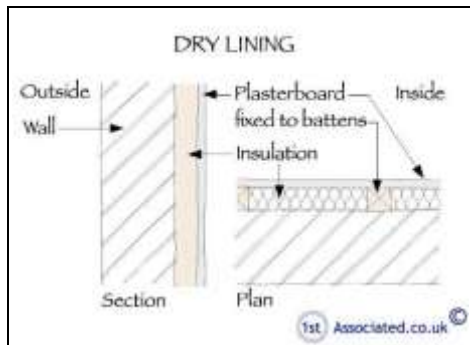
Dry lining

We often find that alterations and conversions such as this one often suffer from the over-use of stud work partitions. This means that you do get some noise transfer between the properties. As mentioned we did speak to one person on the ground floor and we also spoke to a neighbour on the top floor who advised that in their particular location noise transfer was minimal.

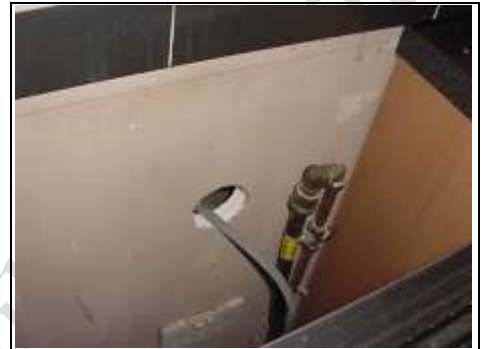
False wall / dry lining in the kitchen

Please see the Internal Walls Section of this Report.

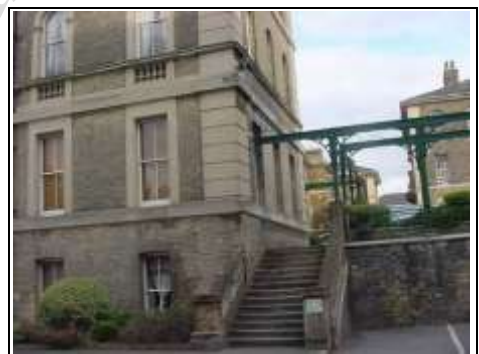
It was noted when we carried out the survey that other occupiers literally walk right past your window to the side of the property and to the rear. The entrance to the block of properties is at the rear. You need to revisit the property and make sure you are happy with this.

This is the main staircase used by a number of people. This passes by the side of your lounge

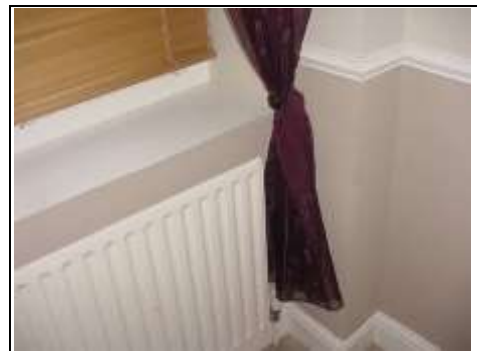
Single panel radiator

The large rooms are heated by single panel radiators which we feel may be undersized especially for rapid heating of the rooms with their large single glazed windows.

ACTION REQUIRED: We would change these to double panel convection radiators.

ANTICIPATED COST: In our experience this is a few hundred pounds per radiator if you are having a few done at once. It can be more expensive to just have a single radiator replaced. However you do need to live in the property for some time before making a decision on this; please obtain quotations.

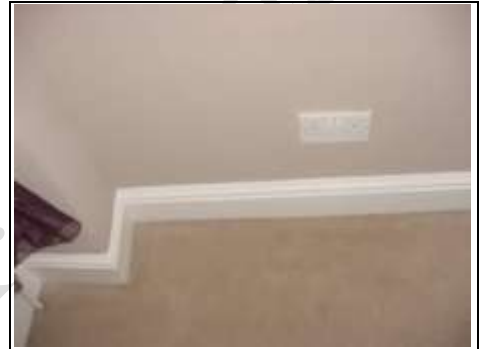
Electric socket point

The number of electric sockets in the property is minimal.

ACTION REQUIRED: You may wish to increase the number of electric sockets before you re-decorate.

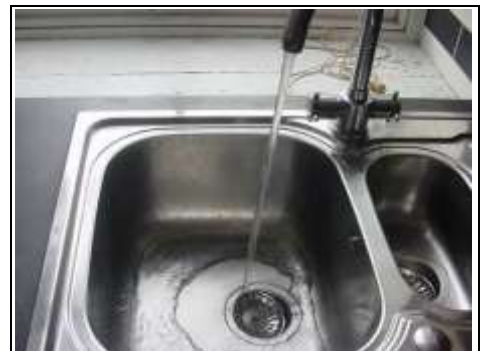
We ran the tap for 15 minutes and found that water leaked onto the floor. This may be due to the disconnection of a washing machine or similar or it may be a leak. Please see our comments in the earlier part of the report.

There was no build up or back up but the only true way to find out the condition of the drains is to have a closed circuit TV camera

Taps run for 15 minutes to check for blockages

ACTION REQUIRED: Your Legal Advisor to check and confirm if there are any drainage repairs due and if there is a closed circuit TV camera report of the drains.

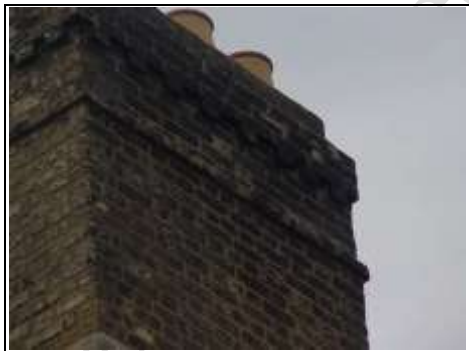
This is the chimney that should in theory lead into your property but we cannot see it so we assume it has been removed. The chimney is brick built with four or more chimney pots. We cannot see the flashing properly. From what we could see from ground level it looks to have weathered over the years

Close up of rear chimney

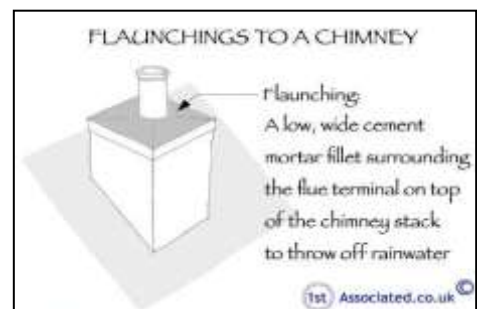
Flaunching

Unfortunately we were unable to see the flaunching, we therefore cannot comment upon them.

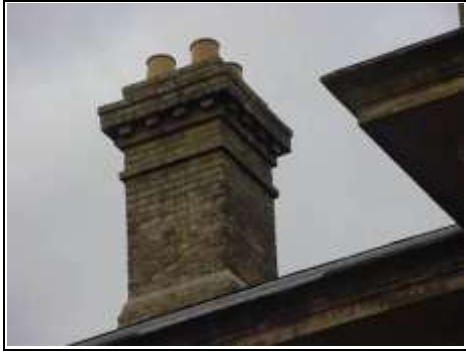
Chimney two

This chimney is also brick built and has four or more chimney pots and again we cannot see the flashing. From what we could see from ground level it looked in average condition considering its age, type and style.

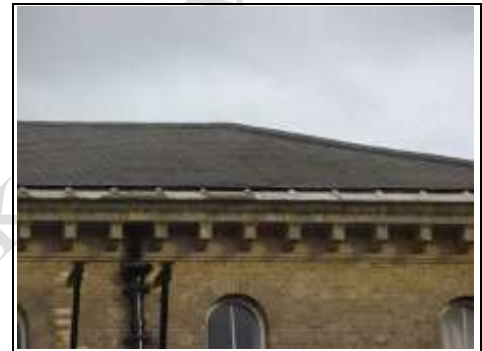
Roof

The main roof is pitched and clad with a quarried slate tile and, from ground level, this looks in average condition considering the roofs age type and style. We assume it was re-roofed in the mid 1990's when the property was refurbished. Unfortunately we have not been able to access the roof.

ACTION REQUIRED: Both you and your Management Company should carry out periodic inspections of the roof with the Management Company carrying out any maintenance that would usually be re-charged to you.

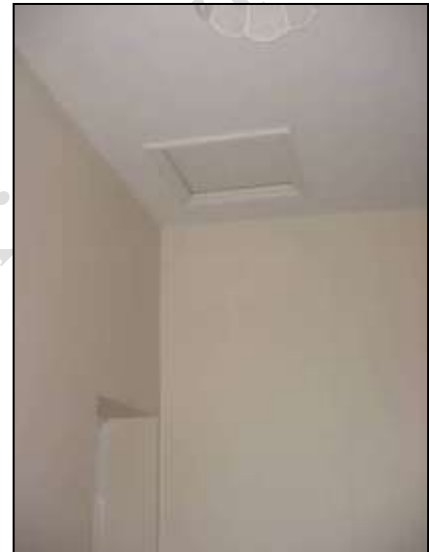
We did not feel we could safely access the roof space with the ladders that we had and more importantly be able to get out of the roof space!

Very high Roof access
Our ladder was not long enough

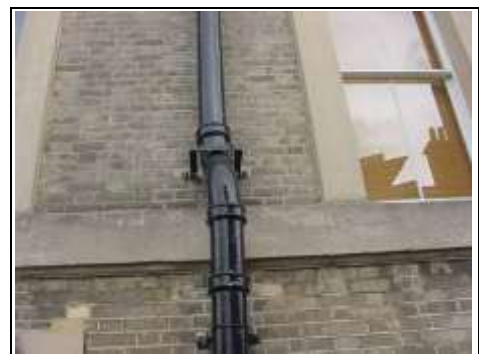
The rainwater is transferred down the downpipes which may be cast iron/ plastic and or painted asbestos. We have made comments on this within the Executive Summary.

Possibly asbestos

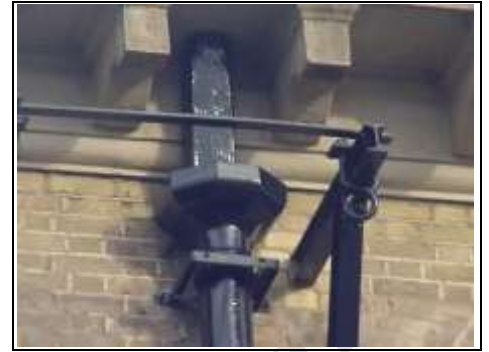
Hopper head

This appears, from its size, to be metal.

We could not see any leaks but it is not unusual to have some minor leaks but most people would be happy to live with this in this age of property.

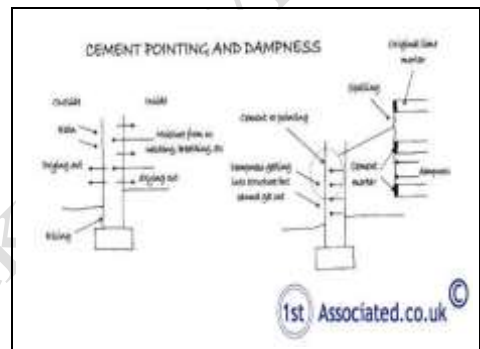
The re-pointing is poor; please see our comments within the Executive Summary as we expect it to come away quite quickly. The colour of it also indicates it is cement rather than a lime mortar. We would personally have recommended that re-pointing was carried out. The clearing out of the joints, which would allow the mortar to bed properly, would have been advisable.

Cement pointing and dampness

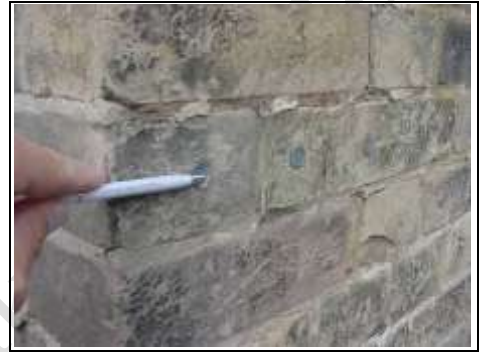
All modern properties should incorporate a damp proof course (DPC) and good building practice dictates that a differential of 150mm (6 inches) should be maintained between the damp proof course and ground levels. In this case, we can see a DPC in places. This building would not originally have had a damp proof course given it was built in 1865 but we can see it has had a damp proof course inserted after. Again this is something we would never recommend on an old Listed building such as this. It really is about allowing the brick work to breathe. Please see the sketch in the brickwork.

ACTION REQUIRED: Please see our comments within the Executive Summary.

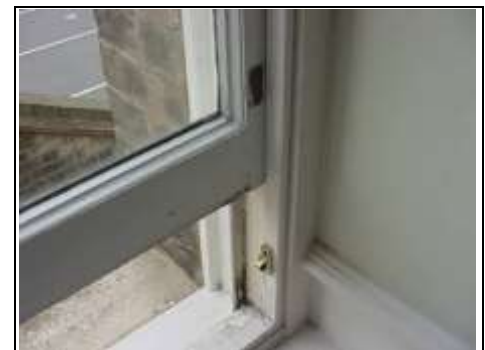
The property has single glazed timber sliding sash windows. We would specifically comment that we opened some of the windows and they opened without problems.

We opened the sash windows

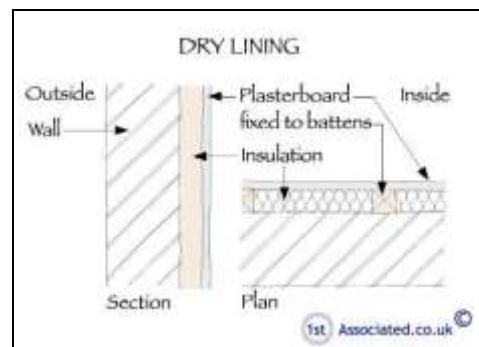
Dry lining

Again we believe dry lining may have been used. This may have been to meet building regulation requirements.

This comment has been based on the visual look of the wall which is relatively “smooth” and normally means a modern finish.

ACTION REQUIRED: Please see our comments within the Executive Summary with regard to the cracking and dry lining.

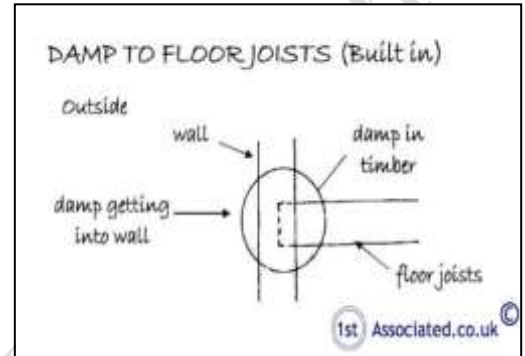
We have assumed that the first floor construction is joist and floorboards with embedded timbers, as this is typical in this age of property.

Damp to floor joists
Embedded timbers

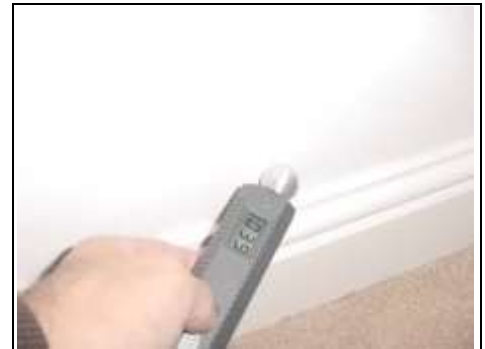
A random visual inspection and tests with a moisture meter have been taken to the perimeter walls. In this particular case we have found slightly higher readings than usual but this is acceptable for an unoccupied property at this time of year.

Testing for rising damp

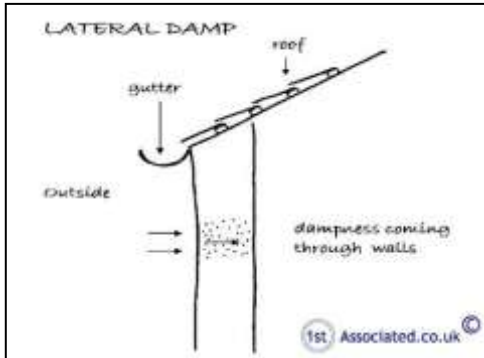
Lateral damp .

We used a damp meter on the external walls. We have not found dampness. We found it to be in line with what we would expect for this age, type and style of property.

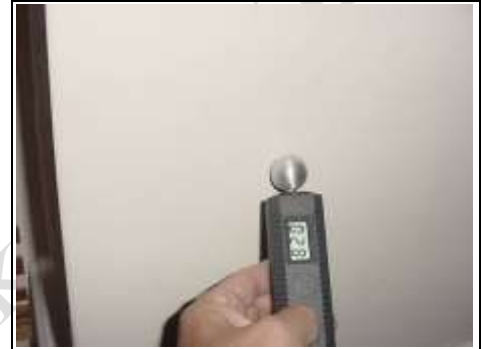
Testing for lateral dampness

Downstairs neighbour

We noted that the downstairs neighbours flat, which is where the damp proof course was inserted, had what looked to be a wet area to the front of the property which may be from a leaking rainwater gutter at high level (check next time it rains heavily). Remember that this flat is partly underground and that it is directly under your property. We knocked on the door to ask about this but did not get an answer. Our concern is that this dampness may affect your property.

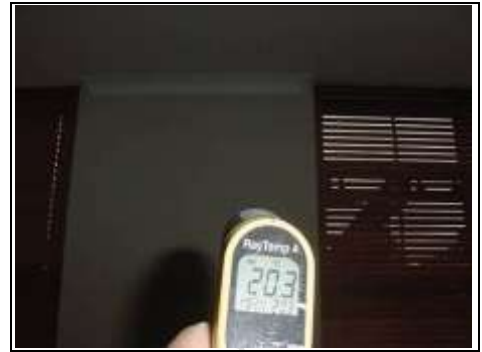
At the time of the inspection there were obvious signs of condensation including the mould in the bathroom and there also looks to be condensation on the window sills throughout the property.

Checking for condensation

ACTION REQUIRED: We would recommend humidity controlled extract fans be added to kitchens and bathrooms. You will need to agree this with your landlord/ the local authority conservation officer as we think an extract fan in the kitchen may be seen from the outside.

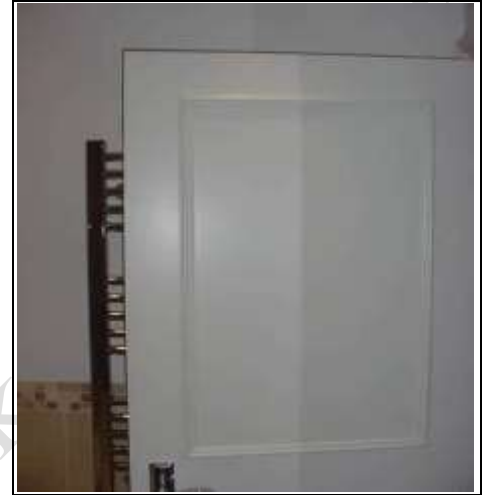
Door

The doors are painted panel doors and are in average condition.

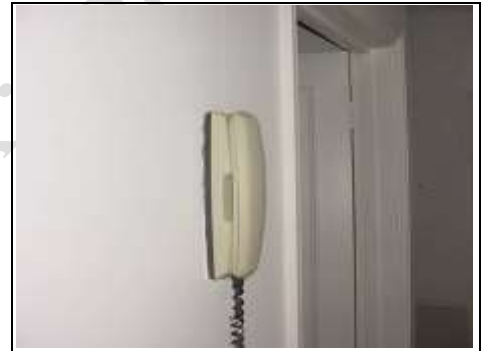
Entry phone system

We would prefer to see a video phone entry system these days and this is the sort of thing that could be budgeted for via the sinking fund.

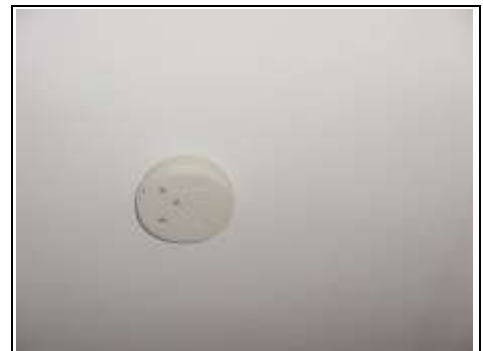
Smoke alarm

We are a strong believer that where properties are multi occupied, i.e. there are more than one resident or tenancy, that the fire alarm system should be interconnected alerting any of the properties if there is a fire anywhere within the building.

In addition to this there should be regular fire alarm drills.

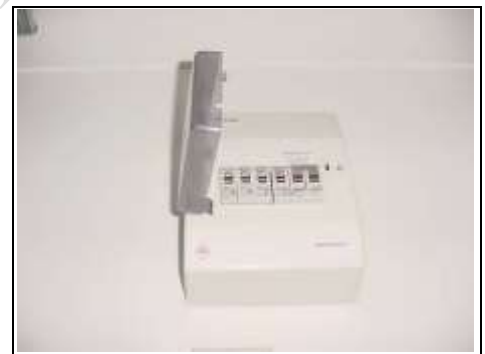
Fuse Board

The electric fuses and consumer units were located in the hallway to the right hand side. The fuse board looked to be dated, circa 1990's, which was when the property was refurbished, better are now available. In multi occupied properties a defective fuse board can be particularly dangerous.

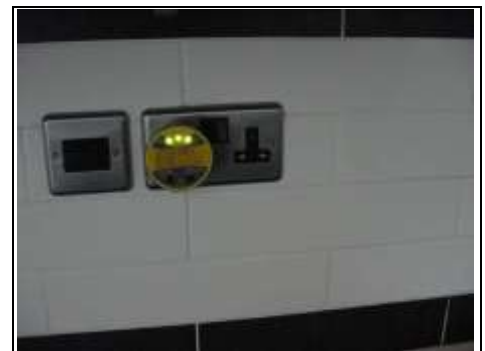
Earth Test

We carried out an earth test in the kitchen area to the socket point that is normally used for the kettle, this proved satisfactory.

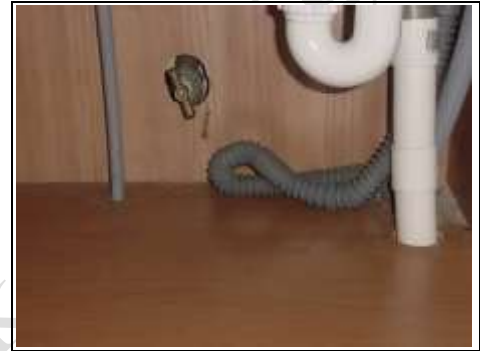
We found what we believe to be the controlling stopcock is located under the sink.

Stopcock under the sink

ACTION REQUIRED: Ask the owners to show you where it is.

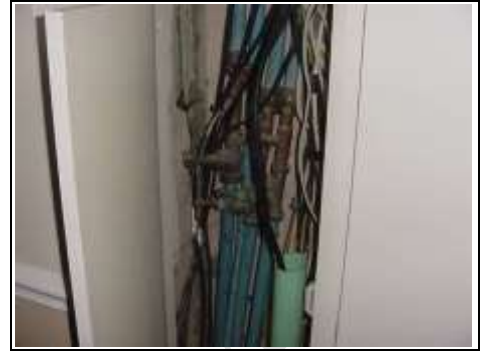
The plumbing, where visible, comprises plastic and copper piping. we are not keen on mixing plastic with copper as we tend to find that the joints suffer but we are aware that this is the way the plumbing industry is heading.

Plastic and copper pipe in communal area

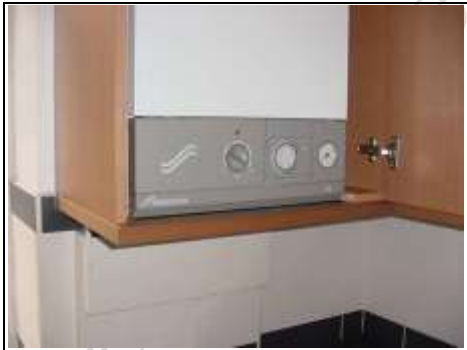
Our limited inspection of the hot water and central heating system revealed no evidence to suggest any serious defects but we would nevertheless recommend that the system be tested and overhauled before exchange of contracts and that a regular maintenance contract be placed with an approved heating engineer.

Wall mounted
Worcester Boiler

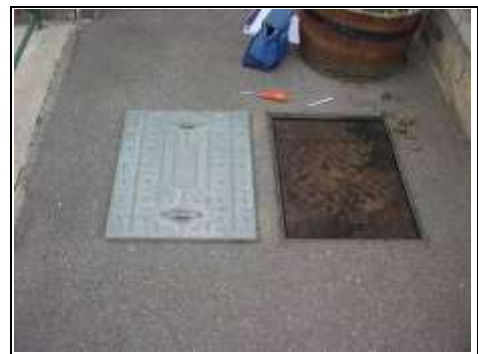
Manhole - right

When we lifted the cover we found another manhole underneath it which is most unusual. We could not lift the second manhole.

The Management Company for the property as a whole should have details of this.

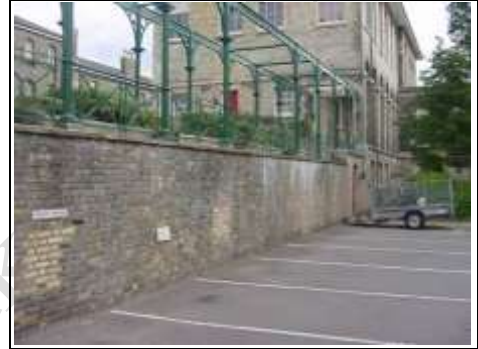
Parking area

It is likely that the property has allocated parking although we did not know where this was. We are also aware from talking to the security guard on the entrance gate that there are visitor spaces as well (one of which we used).

ACTION REQUIRED: Your Legal Advisor to check and confirm.

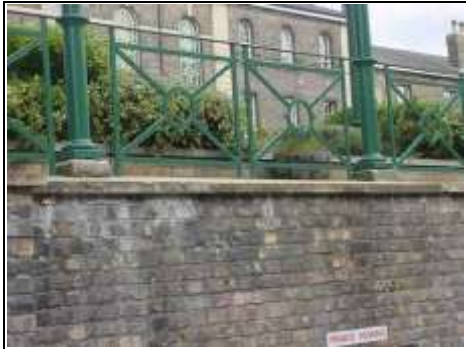
Retaining wall without weep holes

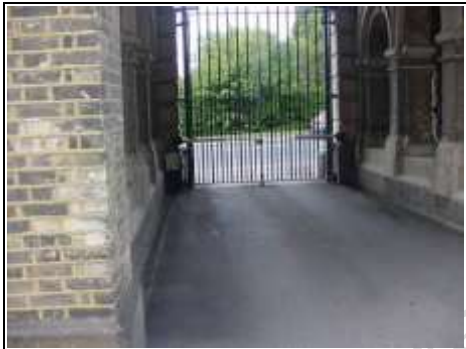
Other gated entrance for cars that we did not see used during the course of our survey. We do not know the arrangements for this.

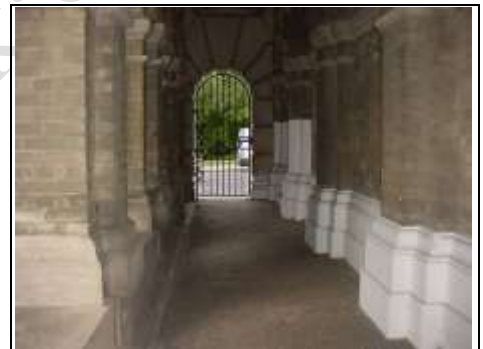
Pedestrian access that we did not see used during the course of our survey.

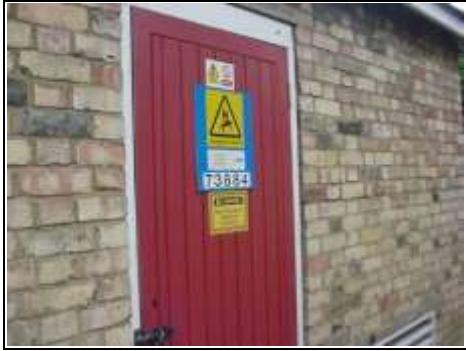
Rubbish store seems to have a generator

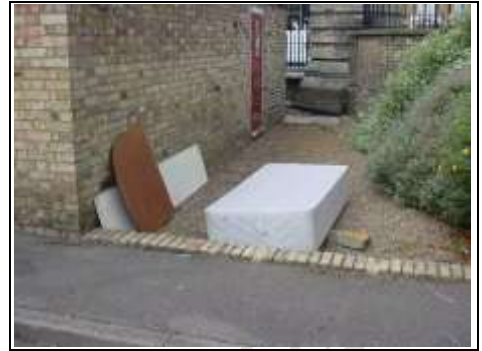
Dumped rubbish
