**RESIDENTIAL BUILDING SURVEY
OF
Warwickshire**

INTRODUCTION

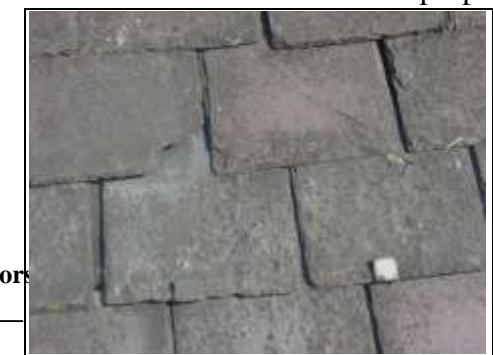
Tingles holding the slates in place

Lead Tingles or Lead Slaps Defined

These are strips of lead usually about 25mm wide which are used to secure slates where they have slipped.

ACTION REQUIRED: It is so easy with the roof to glibly say that it all needs replacing. You need to obtain a selection of the right slates and good tradesmen . A good place for this and a good day out is a building reclaims yard such as Solar Park based near Cambridge (rumoured to be one of the biggest in the country). We propose a section by section repair and replacement of the slate. Whilst it is not the most economic way to carry out work (also the continuation of work that will allow you to get to know the roofer allowing him to understand the property) we feel it is probably the best option providing you have the right roofer carrying out the work. We would also suggest that you speak to the local council before you purchase the property to get a feel for the type of requirements that they will have (ensuring they are not too onerous before you purchase the property) and to ensure that you are happy to liaise with them or whether you wish to employ someone such as ourselves to carry this out for you. We would advise that we haven't been able to see the rear roof at all other than from ground level. It is very often rear roofs that are the bigger problem as they tend to use

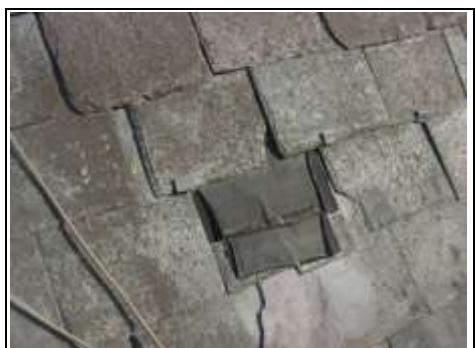
inferior slates and workmanship on roofs that can't be seen as well. It may even be worth you purchasing a tower scaffolding to allow access to this area for viewing before the work commences. We would be more than happy to return and comment on it for you.

As mentioned we would recommend a section by section approach to the repair and replacement of the roof. Whilst this is not the most economical way to carry out the work we feel that it is better to do some work rather than no work at all. This will also ensure that you get to know and understand your building better.

ANTICIPATED COST: We would expect costs to be in the region of £40,000 - £50,000 over several years (no more than three years). We would also add the caveat that as mentioned we have been unable to see the back of the front roof properly so this needs a close examination as soon as possible. You also need to establish a safe way of accessing that rear roof which may in itself be very costly, sometimes the scaffolding can cost as much if not more than the actual work. We would recommend three quotations from companies experienced in this type of work.

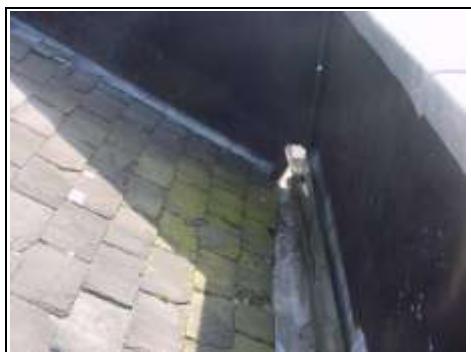
We couldn't see any major problems with these areas which does surprise us! Part of the battle is regular maintenance and for this you need to add good access. We were pleased to see that there was access, many roofs have very limited access.

Box gutter

ACTION REQUIRED: Regular maintenance of these areas needs to take place to ensure that they don't block. Sometimes out of sight out of mind is not good! We would also recommend that another access is added to the rear roof in the form of a roof light so there is another area where you can view the condition of the roof. You would need to obtain Local Authority approval for this.

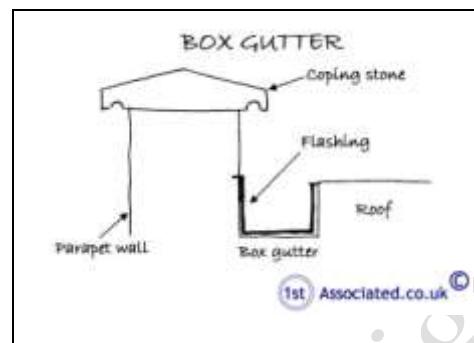
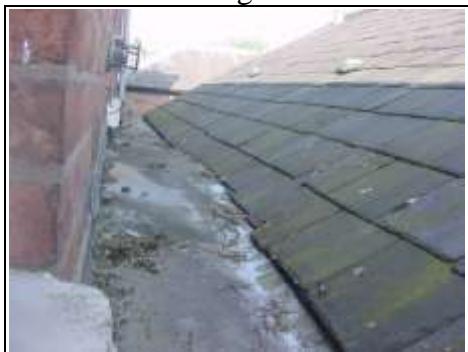
Valley gutter

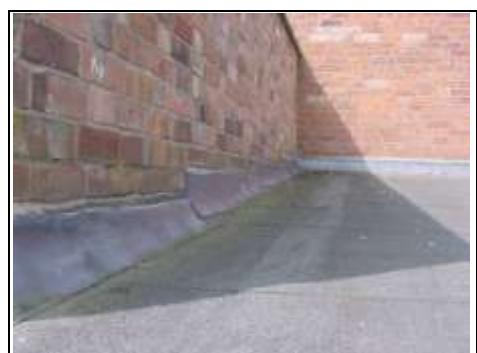
6) Flat Roof to the garage

We noted that the ceiling joists have rotted and new timbers have been put in place and bolted through (sometimes known as back to backing) into the new timber. However the rotting of the timbers is likely to be the effect rather than the cause.

ACTION REQUIRED: You do need to inspect this flat roof next time it rains heavily to see if the rainwater is travelling off it or sitting on it otherwise the original problem will just be recreated.

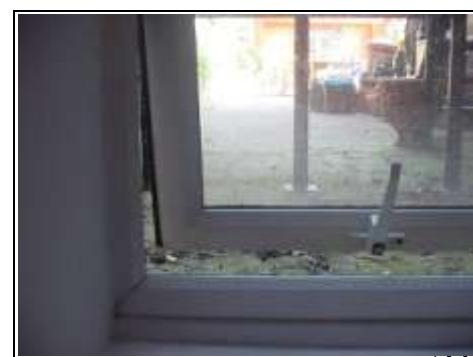
8) Dampness

In an older property you should expect some dampness and you really shouldn't be buying an older property if you are not happy with living with some dampness to some extent as it is part of the character of an older property! In any property of this age there is likely to be some dampness.

We found dampness to the rear of the property. We feel you may well be able to live with this so we suggest that you do live with it for a while. If however you are unhappy with this we would then suggest a French gulley is placed around the property to reduce the dampness.

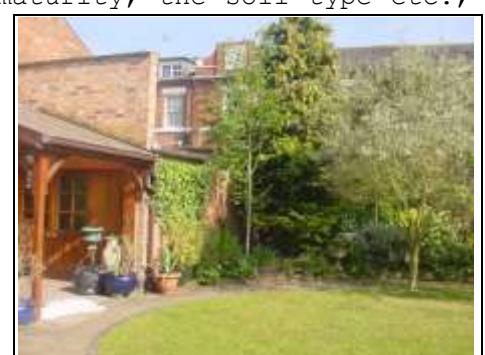
There are some large trees to the front of the property and some reasonably sized trees to the rear of the property which are within influencing distance of the property.

Trees to rear of property

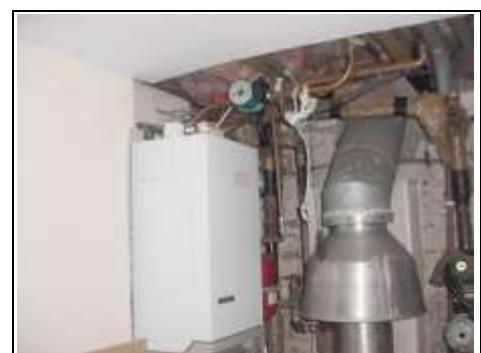
12) Boilers

There are numerous boilers throughout the property. Each one ranges in age and efficiency. We were advised by the owner that they are between ten and twelve years of age. Typically we find they are lasting for fifteen to twenty years. The newer boilers are lasting to the latter of these figures.

ACTION REQUIRED: You need to request service records for all the various boilers and if the present owners have a regular servicing company we would be more than happy to contact them if you forward their phone number particularly as today new boilers are in the thousands of pounds.

ANTICIPATED COST: You do need to set aside a budget of a few thousand pounds for checking and maintaining them; quotations required.

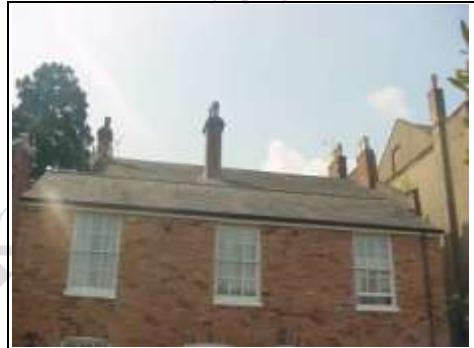
View of rear roof chimneys

We think it is well worth carrying out work to the chimneys to replace the cement fillet flashings with a lead flashing to the rear chimneys. The difficulty is accessing this area. We think it can probably be carried out on crawler boards although you do need to get roofing contractor quotations as soon as possible. Please see our comments in the Executive Summary.

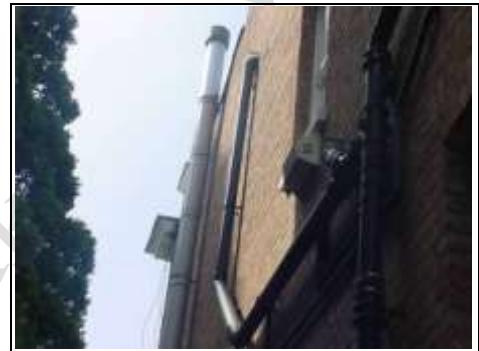
Flue

To the front right hand side a flue is present. Our immediate concern was that it would need planning permission and it may not have been applied for.

ACTION REQUIRED: Your solicitor needs to check and confirm that planning permission has been obtained for the flue on the front right hand side.

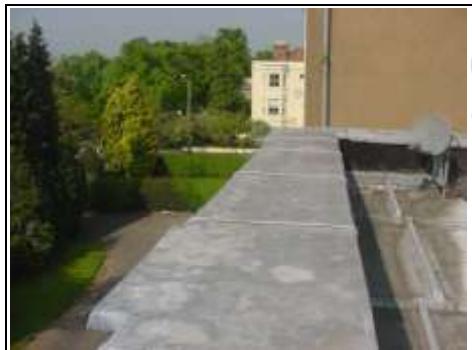
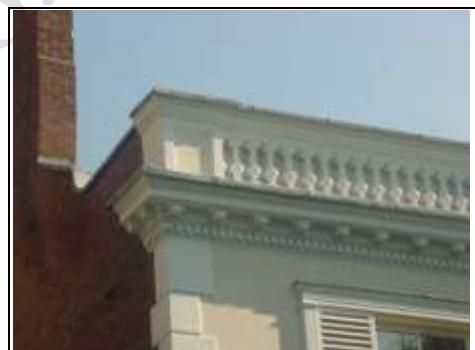
Front parapet wall

There are parapet walls to the front and both sides of the property. The front parapet wall has a lead capping and is in average condition for this age of property.

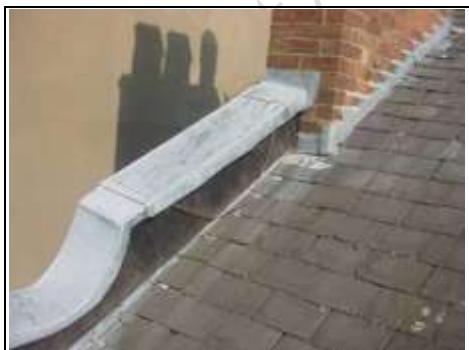
Lead capping to left hand parapet wall

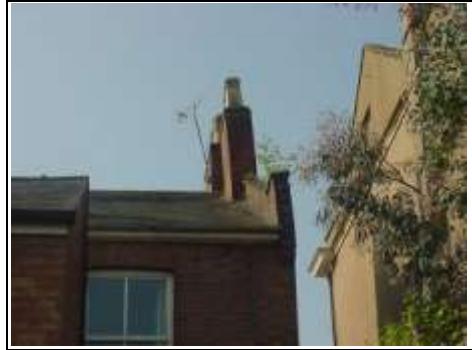
A brick built chimney with chimney pots and a lead flashing in reasonable condition requiring some minor repointing. This is mainly a preventative measure.

Again, a brick built chimney with chimney pots and a lead flashing in reasonable condition requiring some minor repointing.

Chimneys 1 & 2 and parapet wall

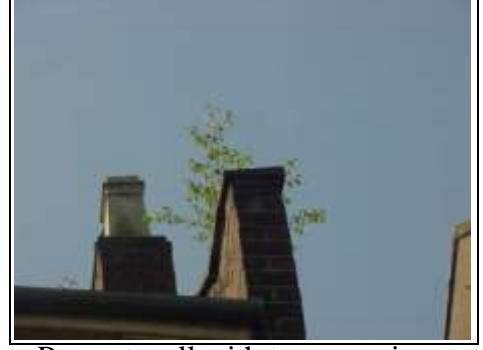
Brick built with a cement flashing which we recommend is replaced with lead as we do on the parapet wall. You can see the tree growing out of the end of the parapet wall.

Parapet wall with tree growing out of it

ACTION REQUIRED: We therefore recommend replacing the cement flashing with a lead flashing and overcladding coping stones. This is likely to need local authority approval for this work.

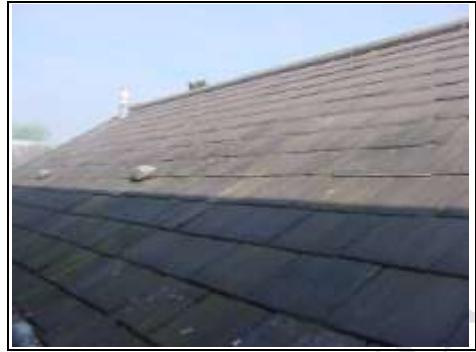
In the close up of the rear roof you can see some vents in it which indicate that it is relatively new (in roofing terms this is less than fifty years) due to the vents we can see.

Box gutters and valley gutters

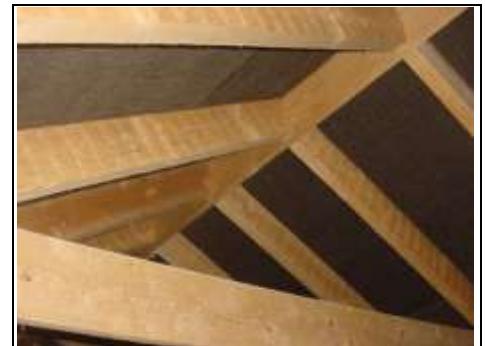
Sacking felt/Underlayer

Both roofs have sarking felt indicating that they have been re-roofed since the 1960's possibly slightly earlier. We generally found the sarking felt to be in average condition where we could see it to the rear roof, we couldn't see it to the front roof due to the insulation.

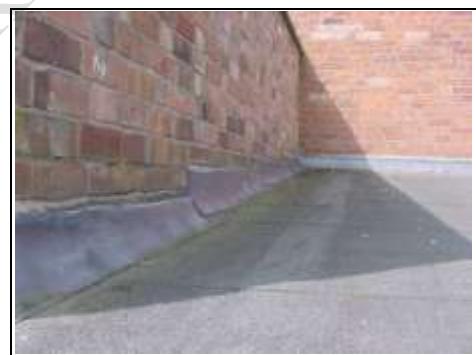
Garage roof

Please see our comments in the Executive Summary where we have identified that previously there has been considerable problems that have meant that the ceiling joists have need replacing. Please see our recommendations in the Executive Summary.

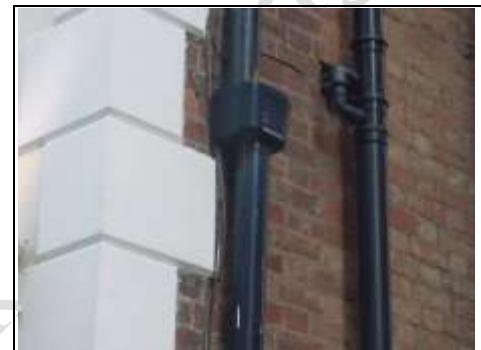
The property has a mixture of the original cast iron gutters, downpipes and hopper heads and the more modern replacement. What we found were in typical condition for this age, type and style where there is a mixture of materials.

We were pleased to see larger downpipes were being used.

ACTION REQUIRED: We would always recommend that the gutters and downpipes are cleaned out, the joints are checked and the alignment checked to ensure that the gutters fall towards the downpipes.

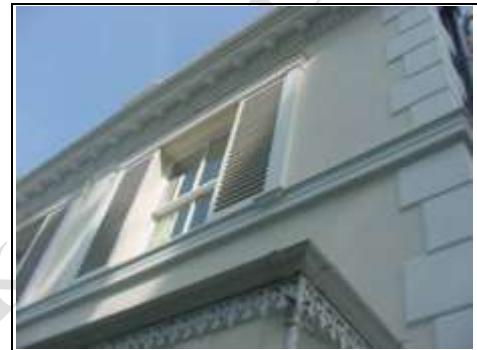
Front render and quins

The front of the property has a classic render/stone look of stucco render with nice detailing. When this property was built it would have been a lime based mortar with lime finish. Over the years this has changed and from the feel of the render it would seem to now be cement at the lower levels. Without taking a sample we cannot one hundred per cent be certain. This does mean that the characteristics of the property have changed and should dampness occur to the front of the property where we can see there has been treatment in the past we would therefore recommend a proper analysis of the render. It is in reasonable condition for its age, type and style.

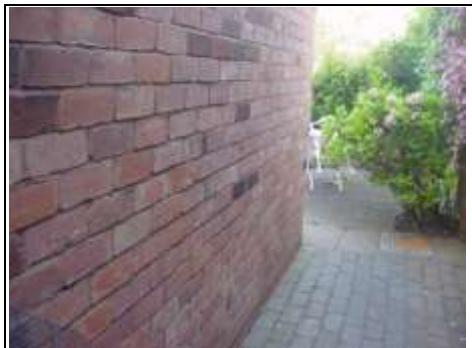
Stretcher bond brickwork to rear

The brickwork to the rear is stretcher bond brickwork as is used in more modern construction.

ACTION REQUIRED: As a general comment we would recommend that all future repointing is carried out in a lime mortar and a gradual repairing and removal of the cement mortar takes place.

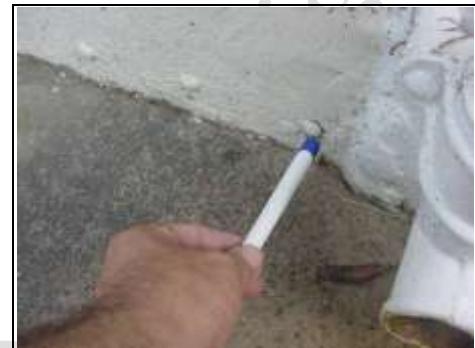
Old inserted damp proof course

All modern properties should incorporate a damp proof course (DPC) and good building practice dictates that a differential of 150mm (6 inches) should be maintained between the damp proof course and ground levels. We believe the older front part of the property would not have had a damp proof course originally and the rear has. In this case, we can see holes to the outside of the front part of the building. This is a typical sign that a chemical injection damp proof course has been inserted.

Our main concern is that the floor construction is damp where the timbers are embedded into the wall. Please see our comments in the Floors Section, the Dampness Section and in the Executive Summary.

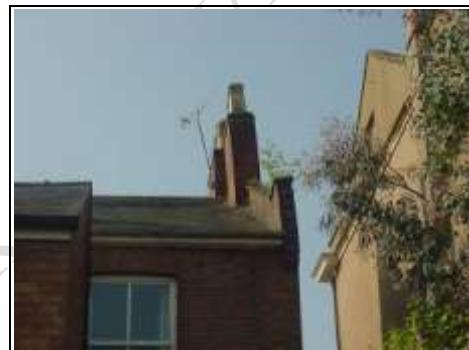
Fascia and soffit

To the front of the property there is a rendered parapet. To the sides there are fascia boards and some soffit boards which are painted timber.

ACTION REQUIRED: Ideally re render parapet and re decorate in the next three years.

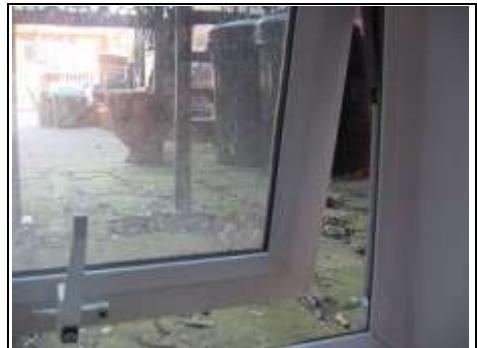
We noted some plastic windows to basement area

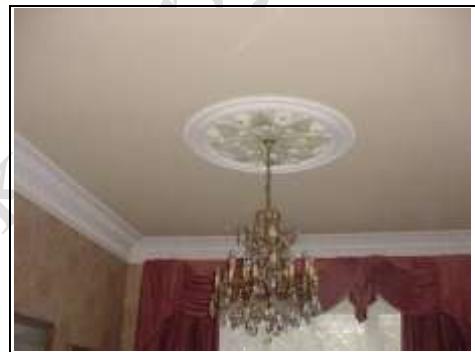
Cornicing and ceiling rose detail

The older lath and plaster has in part lost its key due to its general age, although having said that there is no obvious signs of sagging within the ceilings indicating that there may have been repairs carried out in the not too distant past.

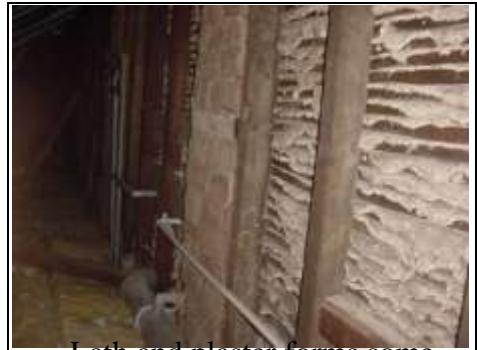
In some of the older parts of the property the inner walls have had lath and plaster as you can see in the adjoining photo.

Lath and plaster forms some internal walls

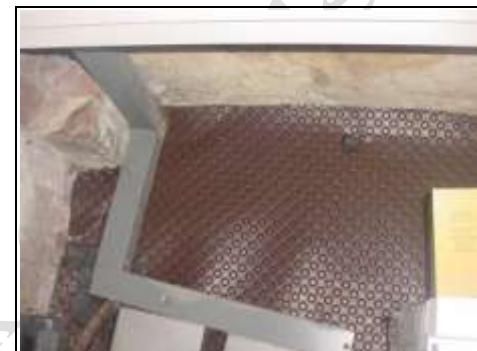
All the walls within this area are dry lined and therefore we believe damp.

Damp proof membrane behind some of the dry lining of both the internal and external perimeter walls in the basement area

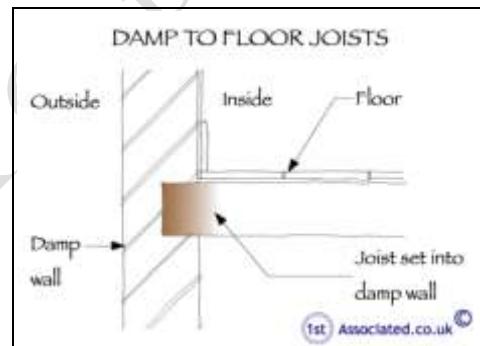
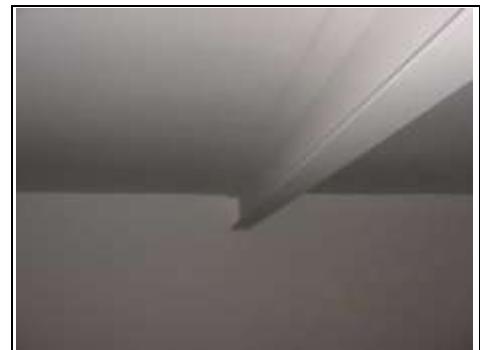
ACTION REQUIRED: Ensure that the floors are vented. We can see in some of the rooms in the basement area that RSJ's have been added indicating that there have been quite a lot of changes within the floor area.

RSJ viewed from basement

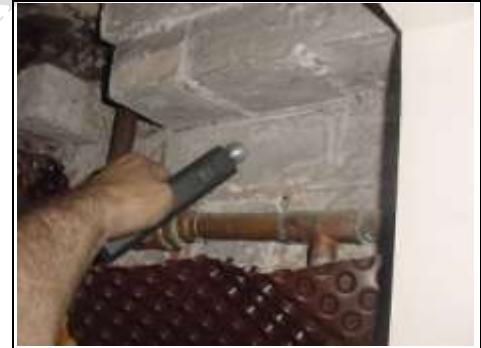
Where we have taken damp readings on the ground floor they were always within acceptable limits although there is some dampness with the exception of the rear right hand side of the property. In the basement area we were unable to take any meter readings (except in the service cupboard) as all walls are dry lined which does indicate to us that there is dampness in the basement which we believe is perfectly normal and the dry lining/false walls have been used to hide this.

Checking for dampness in damp proof membrane area

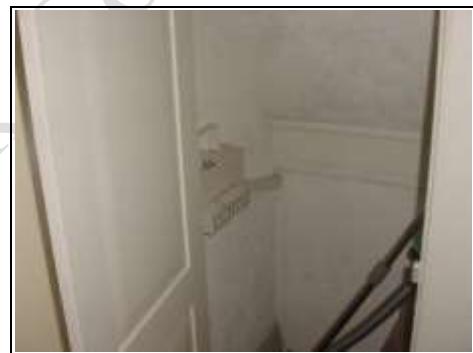
Fuse boards are located in various locations throughout the property. The oldest of these dates we believe from the 1960's. The owner advised that the main switch off for all the electrics was in the cellar. The electrics were last tested in 1999/2000 therefore it is due a test.

Dated electrics

ACTION REQUIRED: We would recommend an upgrade of all fuse boards. If there is no record of an electrical test having been undertaken within the last five years, it is recommended that the installation be tested by a competent electrician (NICEIC registered) and all recommendations implemented. Thereafter, the installation should be re-tested every five years.

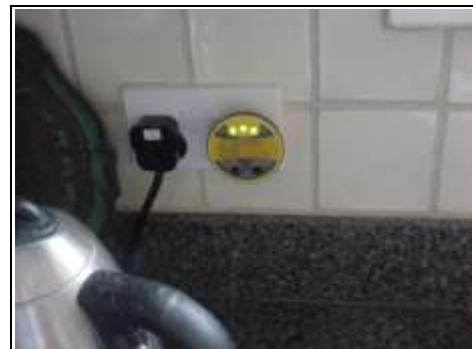
We carried out an earth test in the kitchen area to the socket point that is normally used for the kettle and this proved satisfactory.

Earth test in kitchen

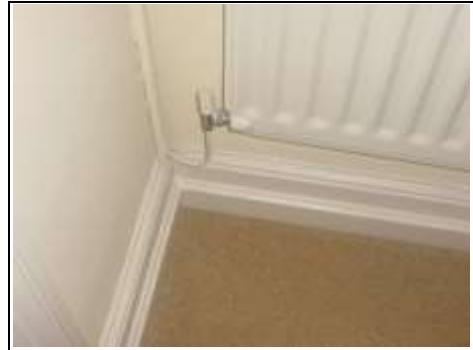
We noticed some areas were in micro ball pipe, a system that we are not keen on as it does tend to block up quicker than a normal sized pipe. The plumbing, where visible, comprises copper pipework. No significant leakage was noted on the surface, although most of the pipework is concealed in ducts and floors.

Heating system micro ball pipes

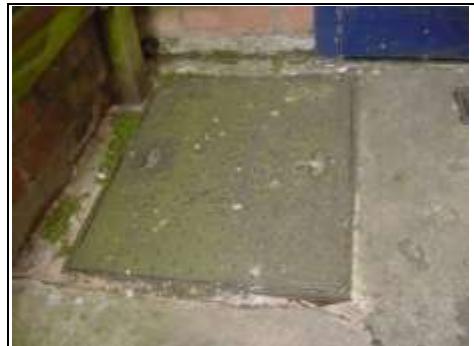
Inspection Chamber / Manhole Two close to the front

We duly lifted the man hole/ inspection chamber cover and found the drain to be free flowing, we noted it was finished in brick

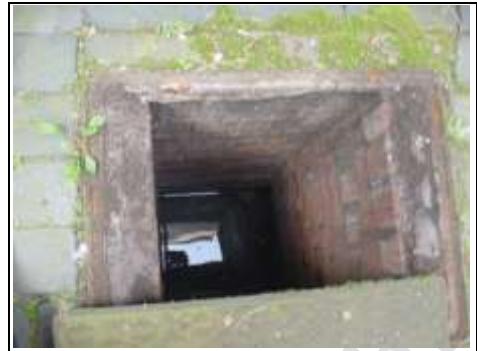
Inspection Chamber / Manhole Three located to the middle right hand side

We duly lifted the man hole/ inspection chamber cover and found the drain to be free flowing, we noted it was finished in a precast concrete ring.

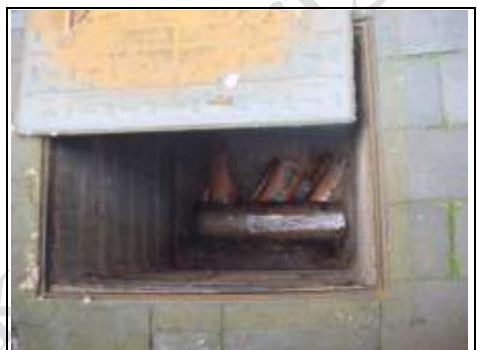
Inspection Chamber / Manhole Four located to the rear right hand side

This man hole was lifted and found to be free flow and built as previously described.

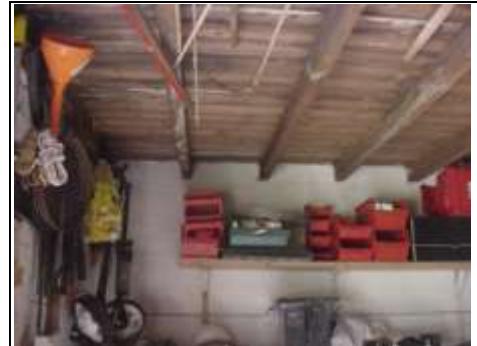
There is a garage to the rear of the property, we have made comments elsewhere with regard to roof timber rot.
