# RESIDENTIAL BUILDING SURVEY

**XXXXX**  
**Radlett**  
**Hertfordshire**  
**WD7 XXX**

**Mr and Mrs M X**

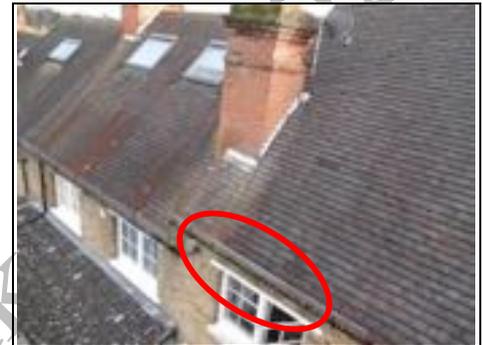
This is a pitched tiled roof. Some of the tiles have become displaced. They are likely to be nibbed tiles as there is a close boarded roof beneath, although we cannot be certain of this. Deterioration can be caused by water getting underneath these tiles (wind driven rain) and spalling occurring to the nibs. Unfortunately with this construction of roof (close boarded) there is no way of being able to check exactly what is going on.

Displaced tiles.  
Tile guard at bottom  
Aerial view – 360 photo

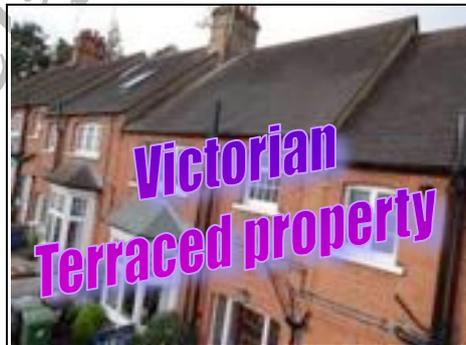
The property sits on a sloping site. There are render steps in the roof and these could allow some dampness in.

Step in roof  
Aerial view – 360 photo

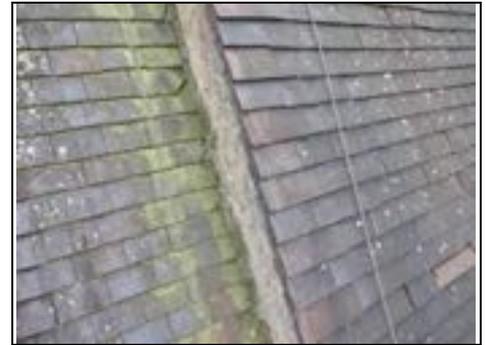
Step in roof  
And moss on tiles  
Aerial view – 360 photo

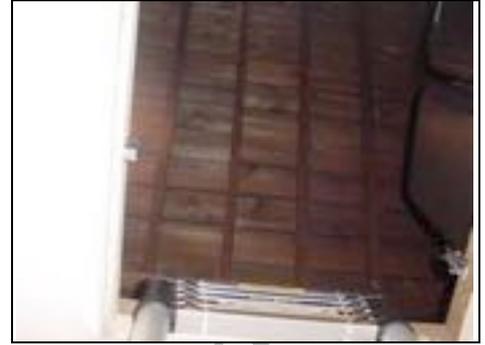
The internal of the roof is close boarded and as such you do not have a secondary protective layer in the form of a protective underlayer, which modern roofs tend to have. It is important in a roof such as this that you do keep it well ventilated to reduce the chance of dampness getting into the close boarding.

Close boarding

**ACTION REQUIRED:** We recommend periodic inspection of the roof. We were originally going to recommend a roofer for the day but we do feel on reflection that this may well cause more damage than good unless the work is carried out very carefully.

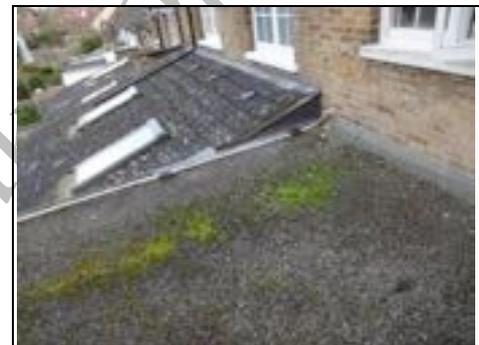
In this particular case we can see moss is sitting on the roof and the roof and we would term this as a flat, flat roof and as such we would ultimately recommend that it is re-roofed, although we consider that patch repairs can take place for some time, although you do need to bear in mind it can be hard to find problems on roofs covered with chippings.

Moss on rear left flat roof  
Aerial view – 360 photo

**ACTION REQUIRED:** Budget for a roof replacement with a warm roof.

**ANTICIPATED COST:** In the region of £2,500 to £5,000, depending upon how the roof is detailed and if it is insulated. We would also add a lead flashing. Please obtain quotes.

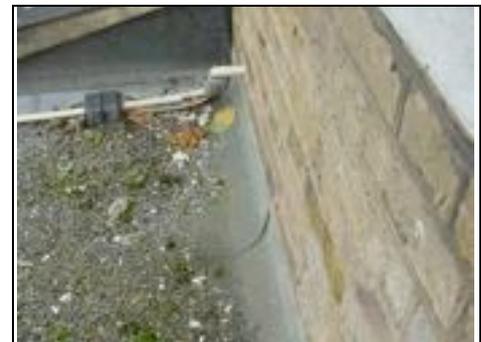
Felt flashing,  
we prefer a lead flashing

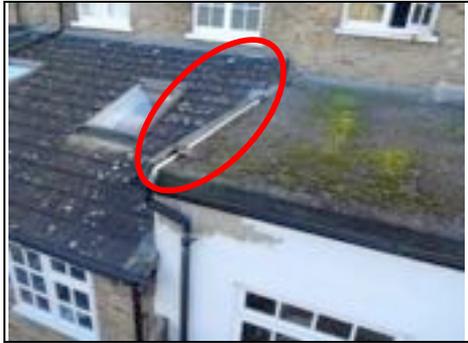
There is a condensing pipe from the boiler which has a long run across the flat roof which then discharges into the downpipe. We have read about condensing pipes that have a long run being susceptible to freezing up.

Condensing pipe from boiler  
Aerial view – 360 photo

We would seek advise from a Chartered Institute of Plumbing and Heating Plumber/Heating Engineer, who is Gas Safe registered, regarding the condensing pipe. At the moment it does look to also be partly blocking the downpipe.

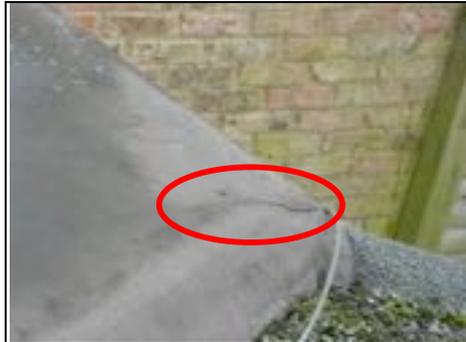
Splits in asphalt

**ACTION REQUIRED:** Make good splits in asphalt.

**ANTICIPATED COST:** In the region of £500 to a few hundred pounds to repair the asphalt and improve the downpipe; please obtain quotations.

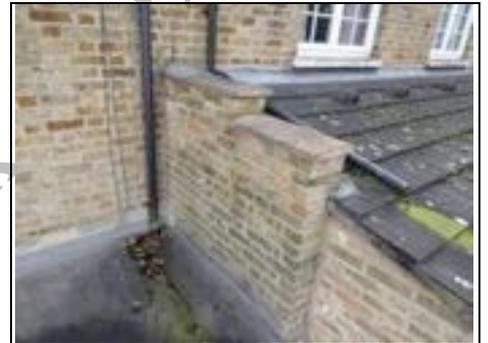
It was noted the downpipe from the main roof discharges onto this roof. Often it is best to put a slate underneath the base of the downpipe to reduce wear or to extend the downpipe so it crossed the roof further. This can be an area of surcharging where the guttering overflows when it rains heavily, which seem to be more common with our weather conditions.

Downpipe discharging onto flat  
roof

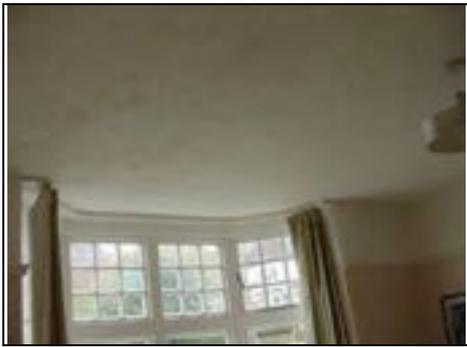
The front bay window roof is covered with mineral felt, rather than a tile covering. There has been some minor movement in the bay, as can be seen by the hairline cracking in the lath and plaster and old style textured paint ceiling internally.

Front bay and textured paint

**ACTION REQUIRED:** We recommend re-roofing with a matching tile. This will also give the opportunity to have a store of tiles should there be any that become loose on the main roof.

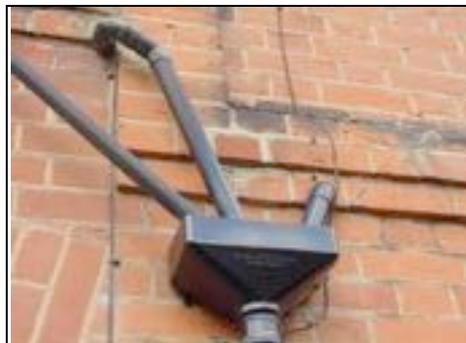
The hopper head on next door's property is overflowing and this may cause problems with dampness getting into your property. It should also be noted that the hopper head takes waste water from your bathroom.

Next door's hopper head  
overflowing

**ACTION REQUIRED:** We recommend you discuss this with the neighbour as it could well be worthwhile you relocating your waste pipes into your own soil and vent pipe.

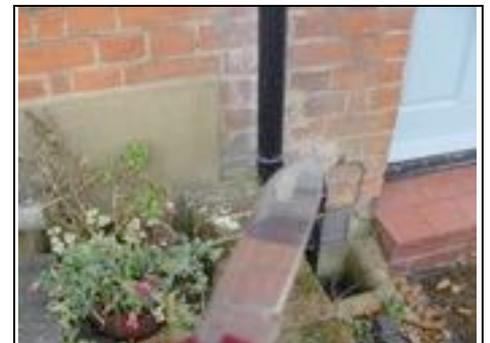
Dampness may get into your  
property from the overflowing  
hopper head

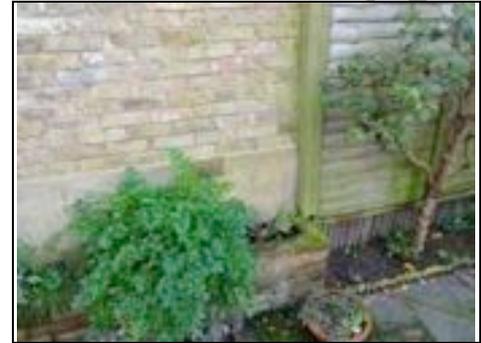
As mentioned, the property sits on a sloping site. It runs from the left to right and from the front to rear of the property. For example, the ground level on your neighbour's side to the left looks far higher.

Next door's floor height shows amount of slope on site  
Aerial view – 360 photo

It could be that you will get dampness occurring after heavy rainfall or indeed during wetter months as a result of rainwater travelling from the upper to lower areas. This may be why at the time of our survey the dampness was relatively minor and that you will get considerably more during the wetter winter months.

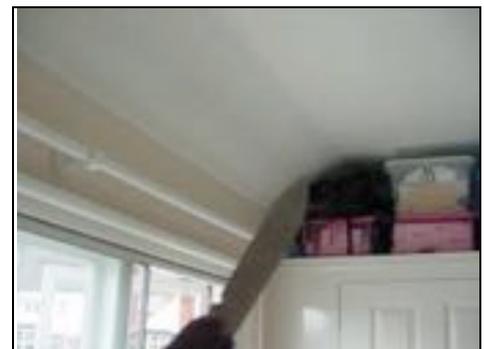
Due to the way the first floor rooms are formed partly within the roof you also have an above average chance of cold bridging occurring and black mould, particularly if you do not amend the air circulation and condensation issues previously mentioned.

Rooms formed partly in roof

**ACTION REQUIRED:** Please see our article in the Appendices of this report.

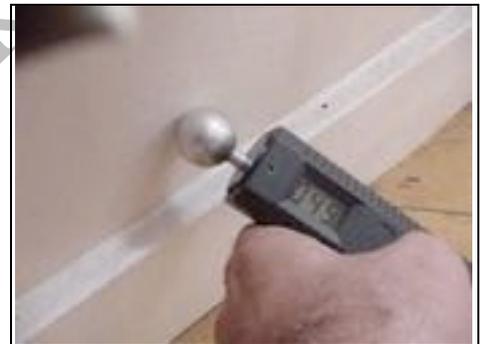
On the day of the survey the damp readings we took with our Gann meter showed dampness to be minimal with the exception of the rear left corner. We believe most of the higher readings probably related more to condensation.

Checking for rising damp

**ACTION REQUIRED:** We would recommend you meet with next door to see what is happening on their side of the property and whether they have dampness, and as mentioned we would also live in the property to see if dampness occurs.

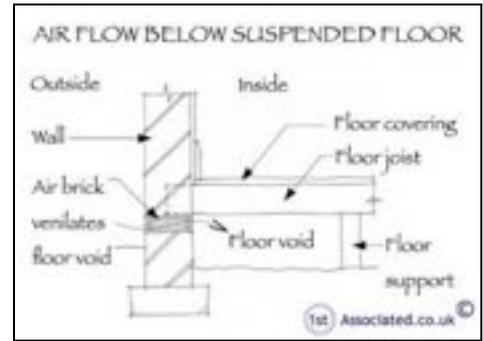
The floor is slightly springier than is ideal to the front bay. There may be some wet rot within the embedded timbers.

Suspended timber floor

**ACTION REQUIRED:** If the opportunity arises we would open up this area.

We would also recommend that all the plants to the front of the property are removed, the ground level lowered and to ensure that all the airbricks are clear and that there is a through flow of air from front to rear. This could also help reduce the dampness that has been found in the property generally, in conjunction of course with you managing the condensation as previously explained.

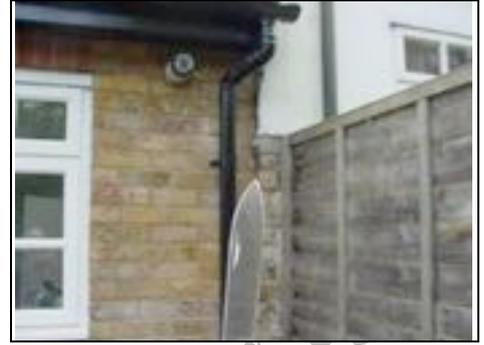
When we went into next door's property (right side) the fence of the boundary did not seem to match. In our experience with boundaries there is generally an element of uncertainty, even with Deeds and plans when these are scaled up. There is generally room to manoeuvre and discuss in the surveyor's world of approximately one meter.

Where is the boundary?

**ACTION REQUIRED:** Inspect the Deeds to see if they have any measurements on them which can identify exactly where the boundary is if this is important to you.

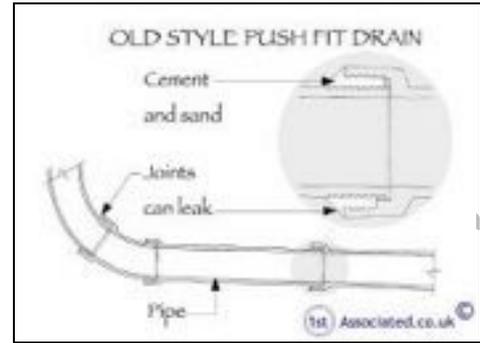
In older properties, such as this, drainage was often push fitted together rather than bonded together which means that they may leak over the years. Whilst we have lifted the manhole cover to the front of the property the only true way to find out the condition of the drains is to have a closed circuit TV camera report to establish the condition of the drains. In this age of property there have often been leaks over the years.

Push fit drain

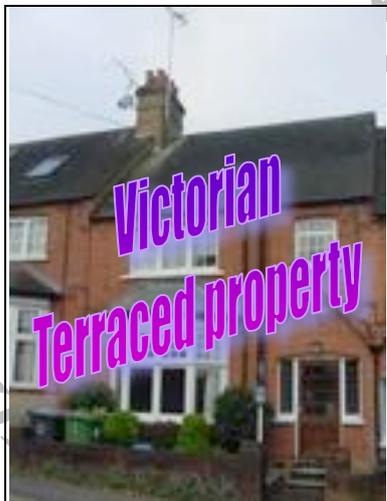
Front left chimney

This chimney is covered with render, with a lead flashing and numerous chimney pots. From what we could see from ground level it looked in slightly below average condition considering its age, type and style. Areas of render are coming away.

We noted an aerial attached to the chimney, which we are not keen on as it cuts into the render rather like a cheese wire cutting into cheese.

**ACTION REQUIRED:** Please see our comments in the Executive Summary.

Periodically inspect the chimney.

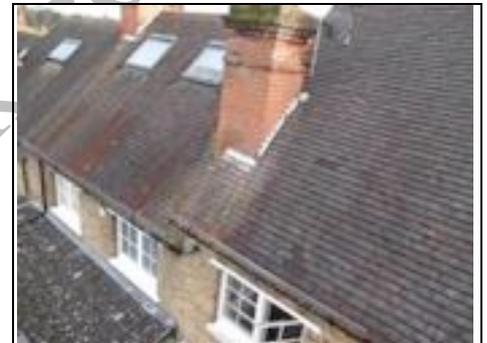
Main roof

The main roof is pitched and clad with tiles and from ground level these looks in average condition considering the roof's age type and style.

With this age of roof there will usually be a few missing or displaced tiles, this is not uncommon. Probably the most unusual thing is the tile guard to the rear which does lead us to believe that perhaps quite a number of tiles have come away at some point in time.

**ACTION REQUIRED:** Please see our comments in the Executive Summary.

Carry out periodic inspections and maintenance of the roof, as required.

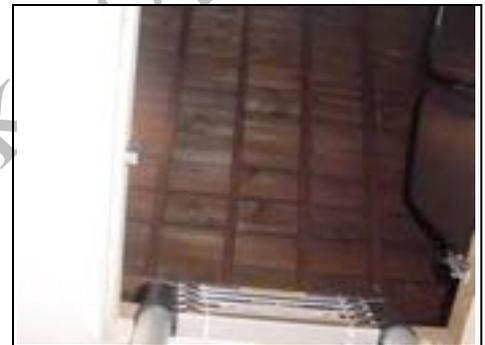
Close boarding

The property has a close boarded roof. It is covered with tiles which are likely to be nibbed tiles and has no protective under layer. This means that wind driven rain can get underneath the tiles and indeed we can see that this is happening from the staining within the roof.

We are always in a Catch-22 with regard to this type of roof as although it is letting in some rain water it is not letting in that much. We have taken guidance from the adjoining roofs which show that these haven't been replaced.

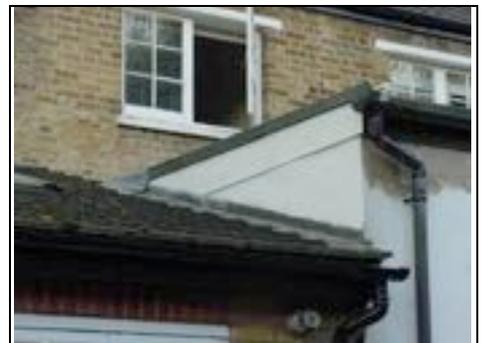
We discussed that there may a problem where the flat roof meets next door's property but the leadwork does look reasonable.

Flat roof meeting next door's low level pitched roof

**ACTION REQUIRED:** Please see our comments in the Executive Summary.

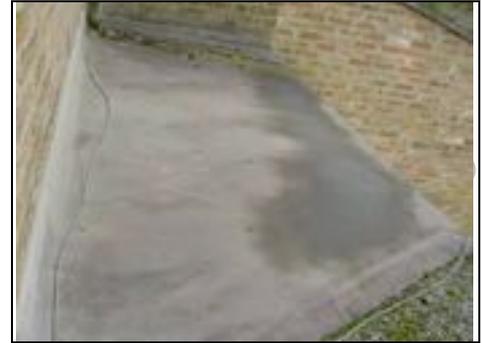
Rear right flat roof

This is covered with asphalt, which we consider to be the best roofing material, although we did note splits in the asphalt.

We noticed that the main roof downpipe is discharging directly onto this roof.

**ACTION REQUIRED:** Please see our comments in the Executive Summary.

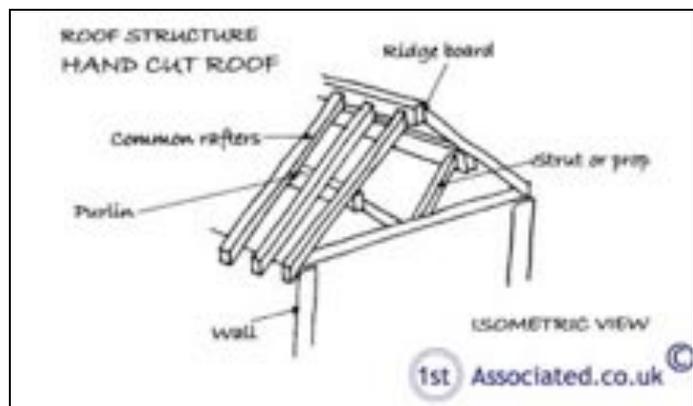
This type of roof structure has what is known as a cut timber roof. This is a roof that is purpose made and hand built on site. Without the original design details we cannot categorically confirm that there are no defects; however it is in line with what we typically see, with perhaps the exception of the support of the purlins.

Cut timber roof

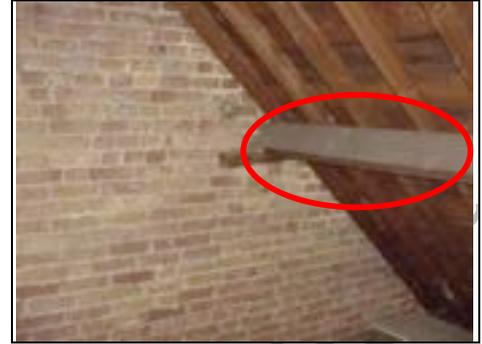
Purlins need periodic inspection

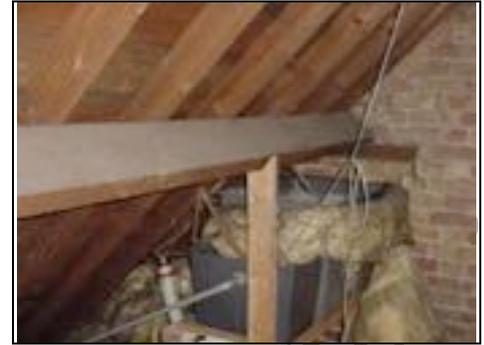
Water tank

There is a water tank in the roof.

**ACTION REQUIRED:** We would always recommend a lid on a water tank. The water tank should be drained down and cleared of any debris etc. (we have seen dead birds and other unmentionable things in these tanks). As you are often cleaning your teeth with this water it is best that it is as clean as possible!

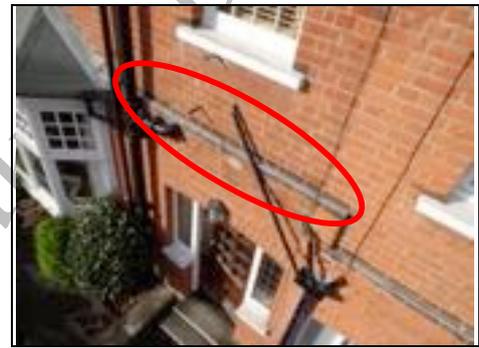
Originally they realised how soft these bricks were and added a lead flashing on there.

Lead flashing on brickwork

**ACTION REQUIRED:** We recommend an experienced builder gradually removes all cement mortar and replace with lime mortar.

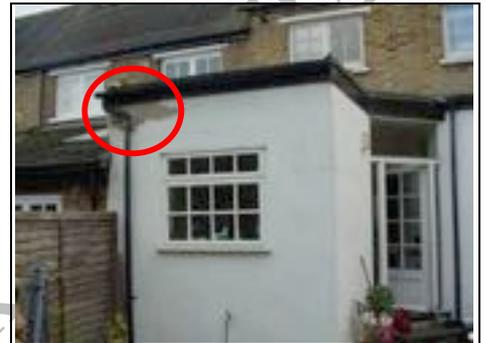
Painted render to rear extension with unpainted area around gutter

We noted that the render was unpainted around the rear gutter which could be due to a leak/repair. We have carried out a tap test (literally hitting the render with the back of a hammer). We found it to be in average condition for its age, type and style.

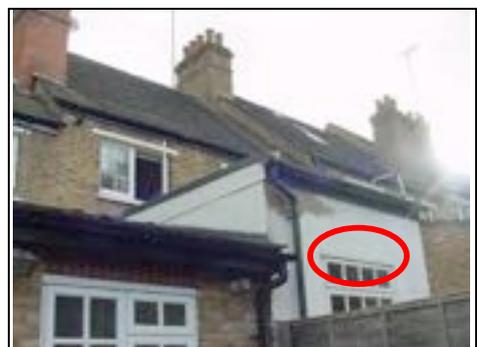
In this case we found no drip detail to the window.

No drip detail above window

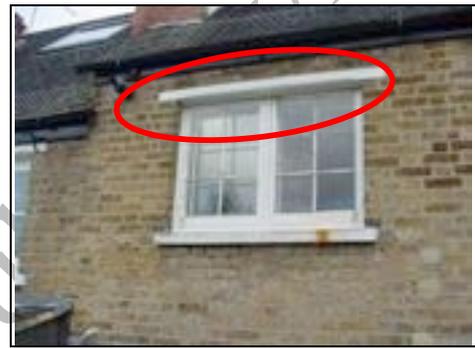
Timber lintel

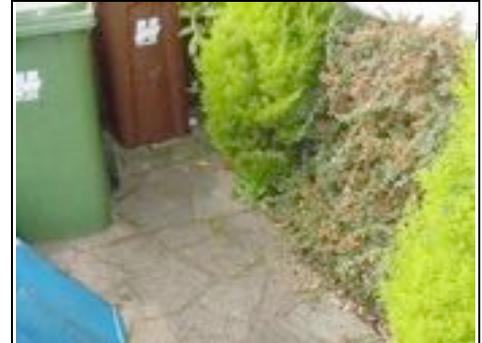
However, there are small trees and bushes to the front that will need removing/cutting back, which will also then expose the airbricks to help the flow of air under the property.

Bushes and trees to front

**ACTION REQUIRED:** Cut back bushes/small trees to front.

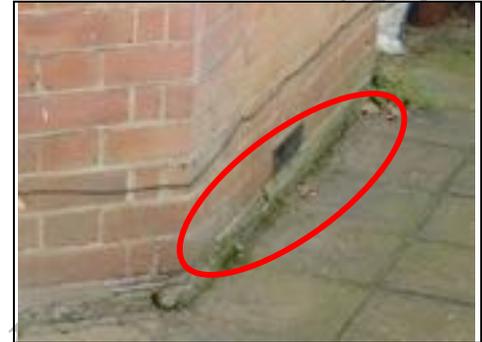
DPC to next door property

We noted a DPC to the next door property which does not have the two courses/150mm gap between the DPC and the ground due to high ground level. The same may have happened on your property but we simply cannot see it.

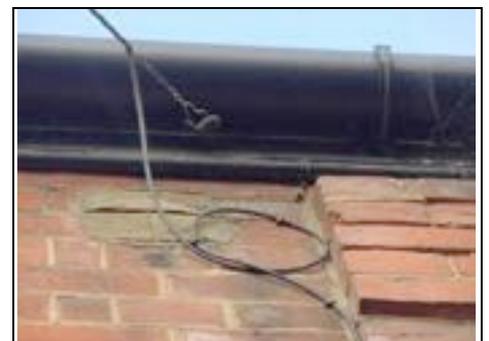
Blocked up air vent from bathroom

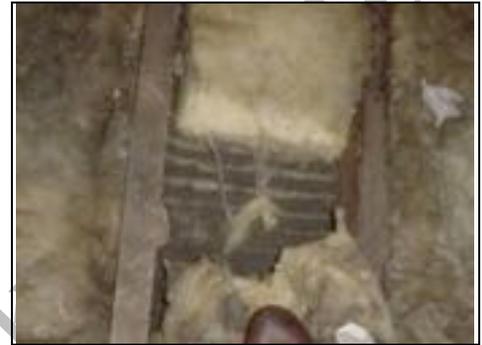
Where we could see the ceilings from the roof space we could see that they were lath and plaster.

Some of the ceilings have textured paint on them which may have an asbestos content.

**ACTION REQUIRED:** Please see our comments in the Executive Summary. Lath and plaster ceiling noted in roof space

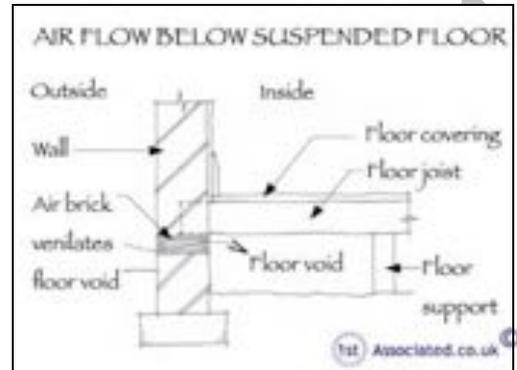
**ACTION REQUIRED:** You need to expose the air bricks to the front and may need to add extra air bricks.

Suspended timber floor

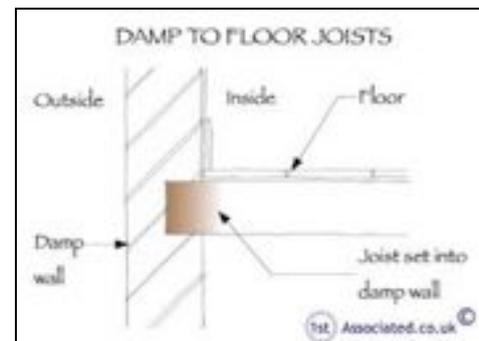
Embedded timbers

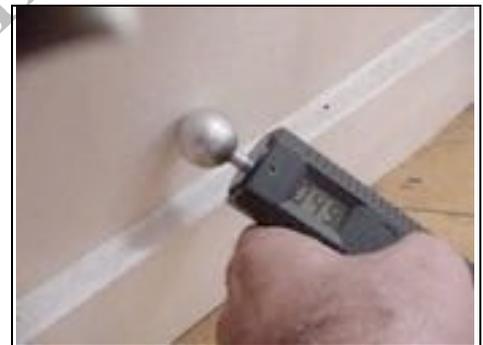
A visual inspection and tests with a moisture meter have been taken to the perimeter walls. In this particular case we have found minor dampness in the property.

Testing for rising damp in front bay

**ACTION REQUIRED:** Please see the Executive Summary.

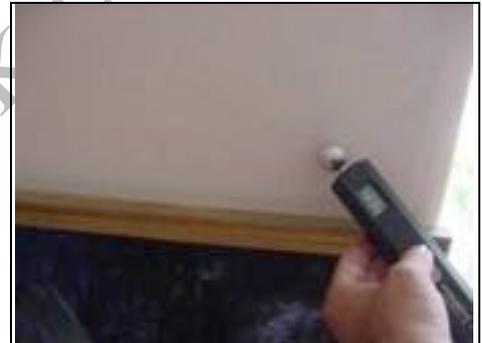
We used a resistance meter on the external walls. We have not found significant dampness.

Testing for lateral dampness

**ACTION REQUIRED:** Please see our comments in the Executive Summary.

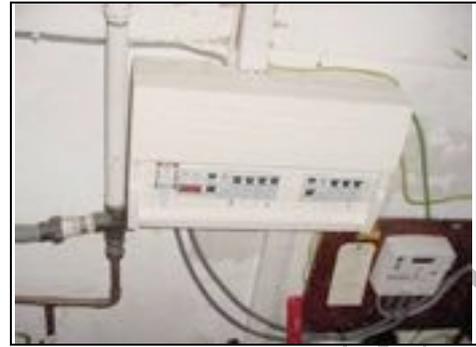
The electric fuses and consumer units were located under the stairs. The fuse board looked to be from the 1980's/1990's and better are now available.

Fuse Board

**ACTION REQUIRED:** Check whether there are relevant certificates.

As the property is changing occupancy an Institution of Engineering and Technology (IET) test and report and any recommendations should be carried out by a NICEIC registered, or equivalent, approved electrical contractor or similarly approved.

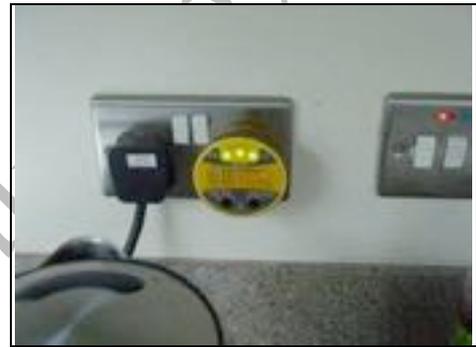
We carried out an earth test in the kitchen area to the socket point that is normally used for the kettle, this proved satisfactory.

Earth test

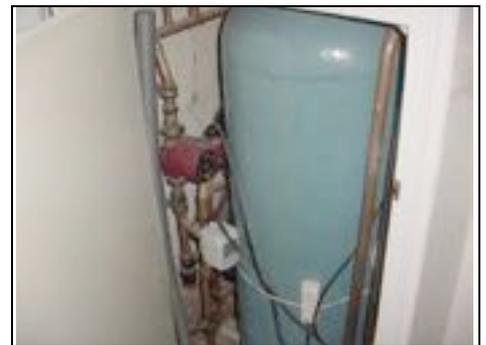
There is a hot water cylinder located in a cupboard in the rear right bedroom. It is factory insulated, which indicates that it is relatively new (in this case we mean in the last 30 years). This cylinder will therefore have a good thermal efficiency, although not as good as the more modern hot water cylinders.

Hot water cylinder

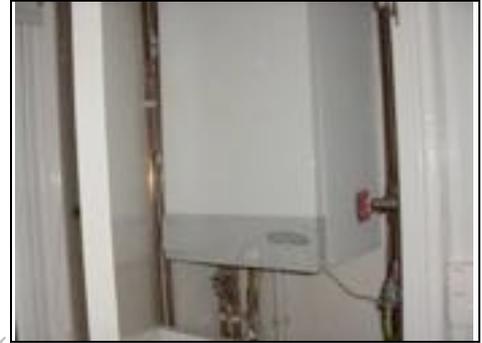
The wall mounted Icon boiler was located in the rear right bedroom. This is a make we do not often come across and parts may therefore be hard to obtain.

Our limited inspection of the hot water and central heating system revealed no evidence to suggest any serious defects but we would nevertheless recommend that the system be tested and overhauled before exchange of contracts and that a regular maintenance contract be placed with an approved heating engineer.

Icon boiler

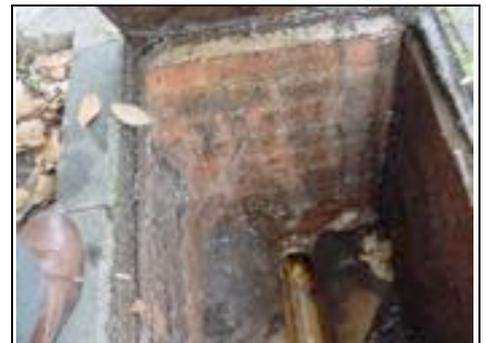
We duly lifted the cover and found it to be free flowing at the time of our inspection.

From what we could see it is brick built.

Manhole
