RESIDENTIAL BUILDING SURVEY

Kingston Upon Thames

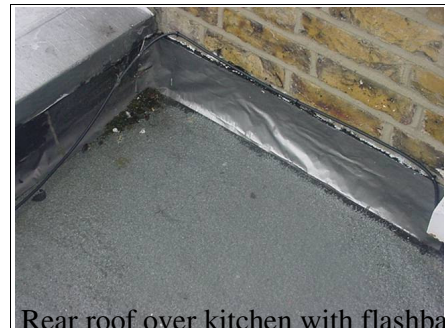
There are two flat roofs to this property, one to the loft conversion, which is not visible (we can only see about five percent of it), and one to the rear of the property. However what we can see gives us cause for concern. We can also see the rear flat roof which has been nailed in places, a practice that we don't believe is best practice.

Flashband is a sticky backed felt which is best used for temporary repairs only.

Rear roof over kitchen with flashband

ACTION REQUIRED: It is likely the roof will be okay for years to come as it is relatively new. We would however recommend a roof window or roof opening is added to the main roof to give access to the roof and to view it. We would be more than happy to comment on any photos that you take.

We would also recommend ultimately that you add insulation to the flat roof areas and a high performance felt.

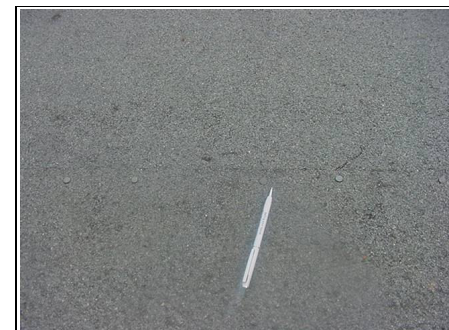
Nails to rear flat roof over kitchen

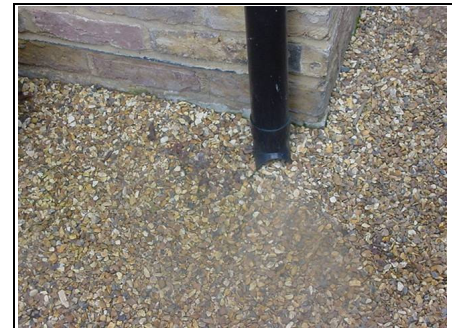
We often find that where properties have been altered and extended such as this one, that not enough thought is given to the gutters and downpipes and they need attention. We can see an overflowing gutter to the rear left hand side. There is also to the front left hand side a downpipe that is not fixed properly which is possibly the cause of the dampness in the front bedroom to the ceiling although alternatively it could be wind driven rain. We could also see a downpipe to the side porch extension that discharges on the ground rather than a soakaway, (a cost saving measure that often occurs these days).

Rainwater gutters discharging onto the ground rather than into a soakaway

ACTION REQUIRED: Stand outside the property next time it rains heavily and see how the property deals with the rainwater. We would recommend this is carried out by the summer of 2012.

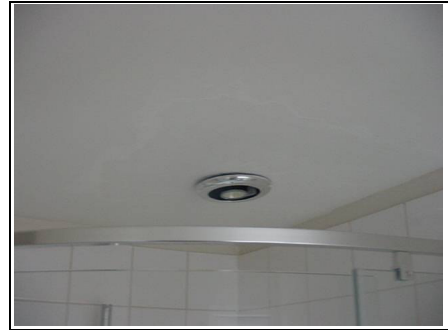
There are various high humidity areas such as the bathroom, shower room and the kitchen that we would recommend large extract fans with humidity extracts situated in the walls. This will then reduce the amount of moist air travelling around the property and condensation and dampness associated with this. This is particularly the case where there are colder walls such as in the top floor shower room and adjoining potentially colder rooms for example the top floor bedroom without any heating.

Fan to shower room – in our experience they don't work particularly well

ACTION REQUIRED: Add large extract fans with humidity thermostat controls by the summer of 2012.

ANTICIPATED COST: A few hundred pounds per extract fan including fitting of the electrics; please obtain quotations.

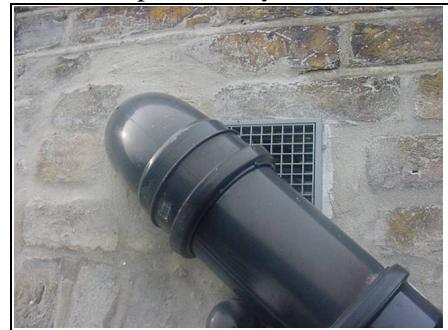
Extract from bathroom covered by seal and vent pipe

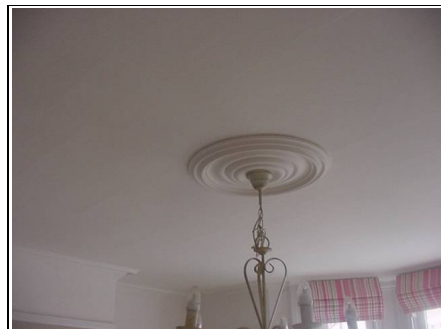
Skimmed ceiling

ACTION REQUIRED: You need to understand this is a characteristic of the property and as such there may be hairline cracking to the walls and to some of the ceilings where these have had a gypsum plaster skim coat.

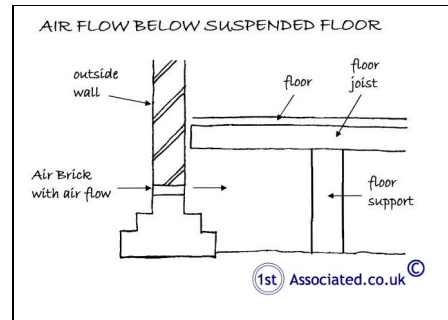
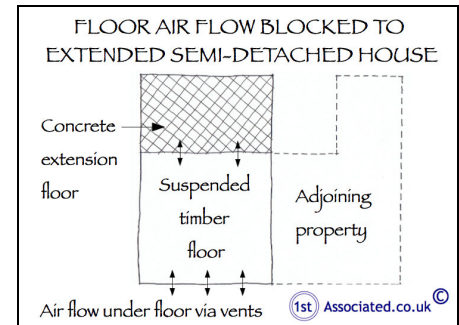
The ground floor of the property has a suspended timber floor. This requires airbricks underneath it to vent it to stop rot from occurring. Unfortunately we cannot see the floor due to the laminate boarding.

Just a reminder that the laminate floor is quite springy – you may wish to have this re-laid particularly in the kitchen/dining room area.

Laminate floors everywhere, even under the stairs so we weren't able to see the real floor boarding

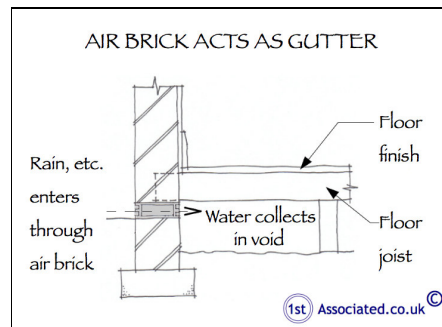
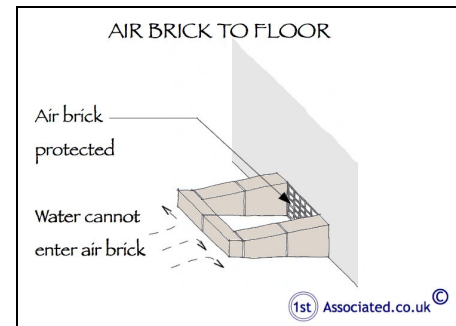
Airbricks are so important to allow an airflow underneath the property and they help reduce/lower the chances of wet rot, woodworm and dry rot. If you recall, we showed you the airbrick near the front door that looked to be acting as a gutter although it is on a slight fall.

ACTION REQUIRED: All the airbricks need checking, particularly the one near the door, next time it rains heavily (you will already be outside in the rain looking at the gutters so also make sure you look at the airbricks). If it is acting as a gutter then it will need protecting (please see the above sketch). We would reiterate you also need to check the other airbricks are clear and allowing a through flow of air. Where a property has been extended such as this it can actually block up the airflow.

ANTICIPATED COST: We would expect that you will need to add airbricks at a cost of a few hundred pounds, possibly a thousand pounds as it is an awkward job; please obtain quotations.

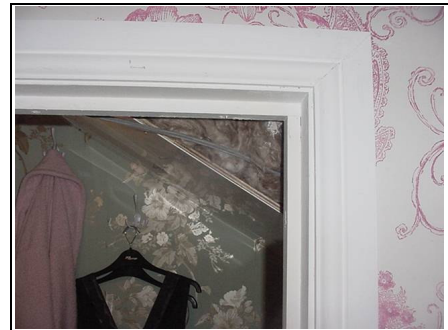
Whilst generally we would say that the house is presented/painted to sell, if you recall, we mentioned that the internal painting around the stairwell on the first floor didn't feel to be finished in some areas or it only had one coat of paint and was rough to touch. There is also the area of the unfinished ceiling to the top floor in the front bedroom.

Unfinished ceiling

ACTION REQUIRED: You will need to allow some time/money to complete the redecoration.

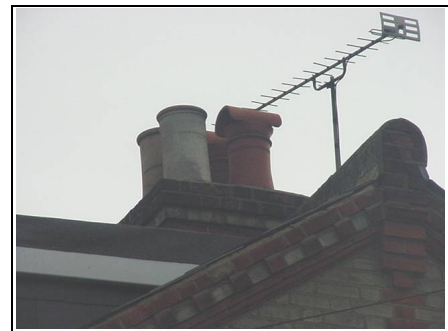
Chimney one

This chimney is brick finished with four chimney pots, two of which are yours. The flashings weren't clearly visible. We had a very limited view of it, so we cannot really comment on its condition. This is another reason why we would recommend forming the roof hatch into the flat roof area to check the condition of the chimney. It would of course be much easier to repair it from the flat roof if it needs repair.

ACTION REQUIRED: Form the roof hatch to inspect the chimney.

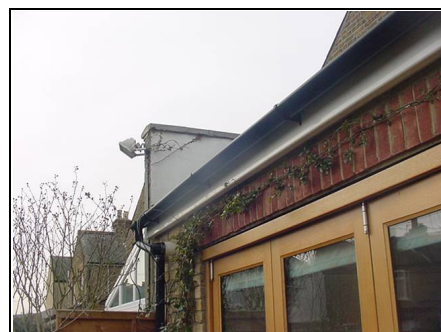
Vent from the boiler just visible to the rear corner of the extension

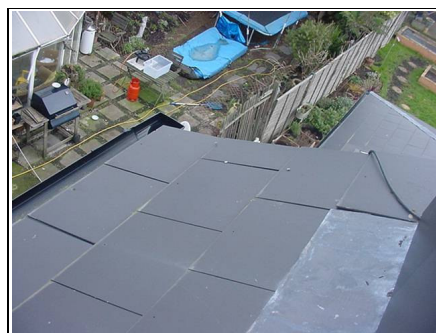
The main roof is pitched and clad with manmade slates and, from ground level, this looks in average condition although our view was limited.

Close up of manmade slates

ACTION REQUIRED: Carry out periodic inspections and maintenance of the roof, as required.

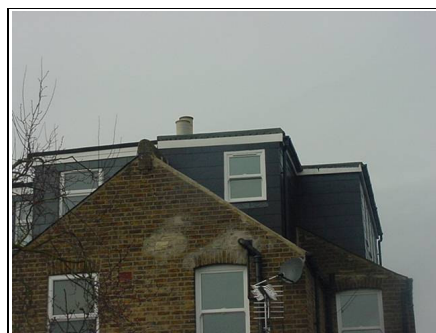
Dormer roof

We have concerns over the flat roof from the small amount that we can see. Please see our comments in the Executive Summary.

ACTION REQUIRED: We would recommend a roof hatch is added so that you can access the flat roof. Carry out periodic inspections.

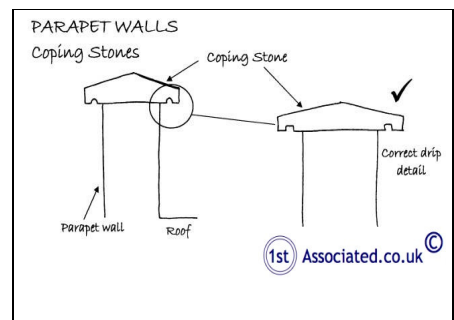
The original coping stone has been completely covered in a flashband.

Finally, we were only able to see approximately eighty percent of the parapet wall at low level; therefore we have made our best assumptions based upon what we could see. A closer inspection may reveal more.

ACTION REQUIRED: The whole of the parapet detail needs looking at. This should be carried out in conjunction with your neighbour. We did knock on the neighbour's door but unfortunately no-one was in at the time of our survey. We would recommend that you speak to them prior to purchasing the property as we wouldn't be at all surprised if dampness is getting in this area. We would recommend lead flashings and the rebuilding of the parapet wall to a higher level and proper coping stones being added.

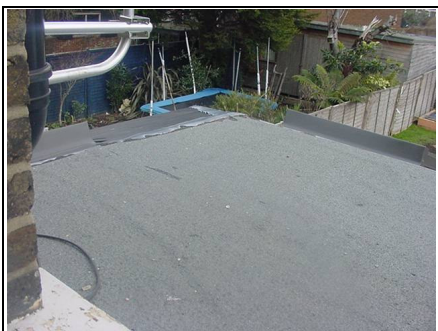
Flat roof to rear over kitchen/dining room area

There is a large rear flat roof accessible from the bathroom window. We have commented earlier with regard to the parapet wall and this should be read in conjunction with that. Our concern is that although it is a very new felt, it has been nailed in place, which we rarely come across these days. Whilst it is our preferred mineral felt, it doesn't look to be a high performance felt. We often find with flat roofs, regardless of whether they have a guarantee or not, if they don't have a certain fall on them, they can be problematic. As you know from our discussions we would much prefer to have flat roofs that have a fall of fifteen degrees and are insulated which we believe is possible in this case and probably to the main dormer flat roof as well.

ACTION REQUIRED: Please see our comments in the Executive Summary.

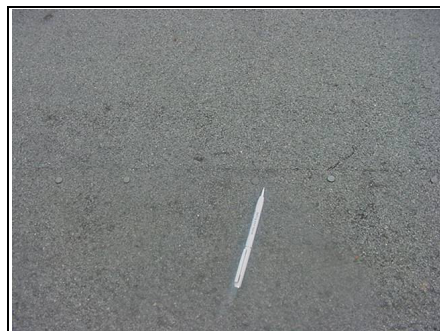
Flat roof nailed – very unusual

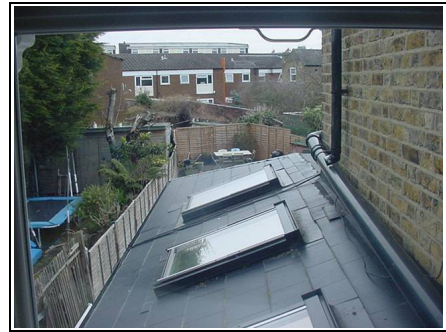
There is a small pitched roof to the rear which does give the impression of a pitched roof at ground level, known as a sudo-pitch. Our concern would be the roof windows within this area.

Roof windows at low level

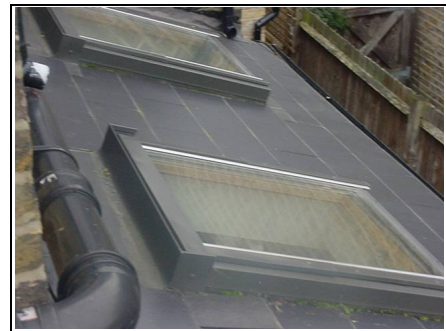
Roof windows

The property has a number of roof windows in the rear extension. Whilst they are a modern factory made unit, they are in an awkward location as the roof is relatively shallow and within the kitchen you can get fairly high levels of condensation. We noted there was some moss around then. Whilst a nice design feature there may be problems in years to come.

It seems inevitable with roof windows that they will sooner or later leak. If this doesn't occur then they seem prone to condensation. Keep a cloth handy!

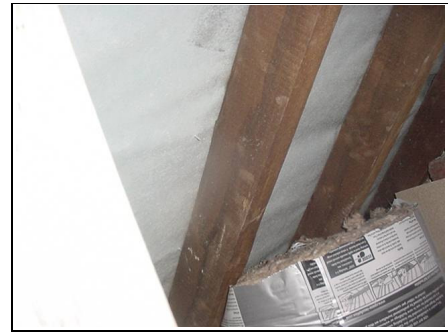
View of the roof timbers

Our examination was very limited. In the area inspected we didn't see anything unusual for its age, type and style. It is, however, feasible that there are problems in the remainder of the roof that are hidden.

ACTION REQUIRED: The only way to be 100 per cent certain is to have sections of the rooms plaster cut to see the structure.

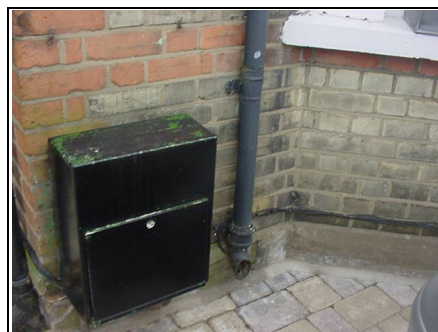
Metal downpipe

The property has a mixture of the original metal gutters and downpipes and plastic. Please refer to our comments in the Executive Summary with regards to the awkward layout. Metal gutters and downpipes of this age will need maintenance. If regularly maintained it lasts longer than plastic, in our experience.

ACTION REQUIRED: Please see our comments in the Executive Summary. We would recommend you stand outside the property next time it rains heavily and see how well the drains cope with the rainwater particularly looking at the guttering and the joints. We would also recommend that the gutters and downpipes are cleaned out, the joints are checked and the alignment checked to ensure that the gutters fall towards the downpipes.

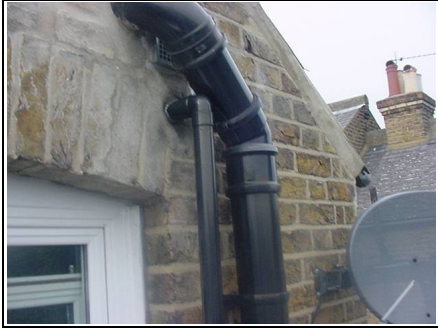
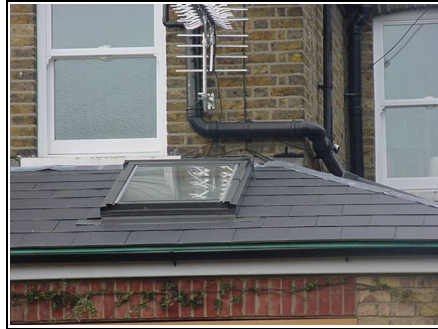
The property has plastic soil and vent pipes. There is a very awkward run of soil and vent pipes, which includes blocking up the extract from the bathroom and then runs all the way along the length above the kitchen at roof level. In our experience this would be prone to blockages.

Awkward soil and vent pipe

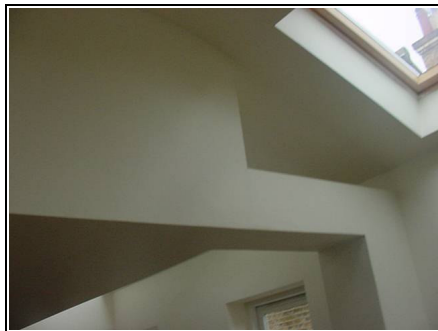
Structural frame visible

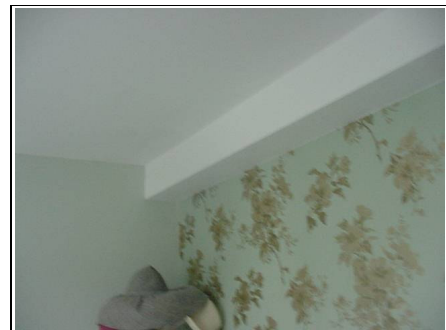
Steel added

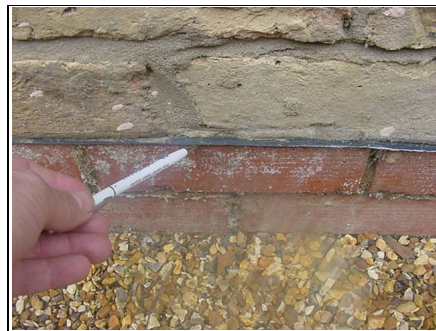
Damp proof course

All modern properties should incorporate a damp proof course (DPC) and good building practice dictates that a differential of 150mm (6 inches) should be maintained between the damp proof course and ground levels. In this case, we cannot see a DPC in the older property but we can it in the newer extensions as we would expect. It is slightly low in the newer property.

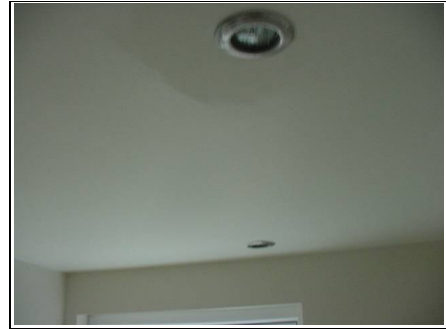
Blemishes in the ceiling in room in roof

ACTION REQUIRED: Please see our comments in the Executive Summary.

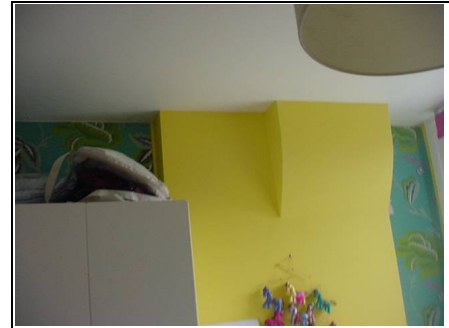
We can see the chimney breasts on the right hand side of the property (all directions given as you face the front of the property) as these have been made into nice features and we can see it at roof level however it is the chimney that we have referred to as chimney two which should be to the rear of the property that seems to have been removed, although the present owners advised that they didn't remove it.

Removed/amended chimney

ACTION REQUIRED: It may be that we haven't been able to see it or it may be that it has been removed, either way your Legal Advisor needs to check and confirm that it has been removed properly with Building Regulations and Planning Permission if so required.

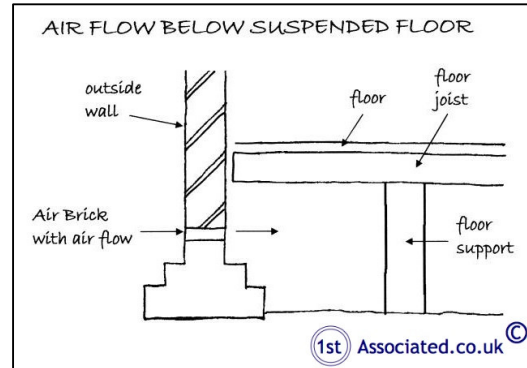
There is a mixture of a suspended timber floor to the front of the property, which requires air movement underneath to minimise wet rot, dry rot and woodworm, and a solid floor to the rear.

ACTION REQUIRED: Please see our comments in the Executive Summary.

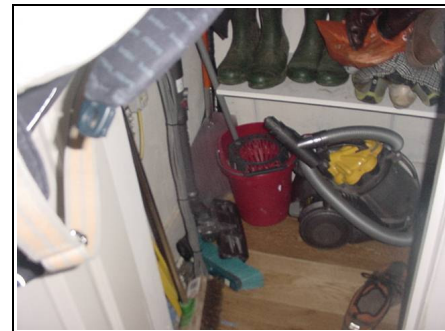
The floors to the rear felt solid underfoot so we have assumed that they are constructed in concrete. However, we have not opened up the floors or lifted the laminate. In theory the solid floors should have air vents underneath although we rarely find this.

Laminate floors everywhere, even under the stairs so we weren't able to see the real floor boarding

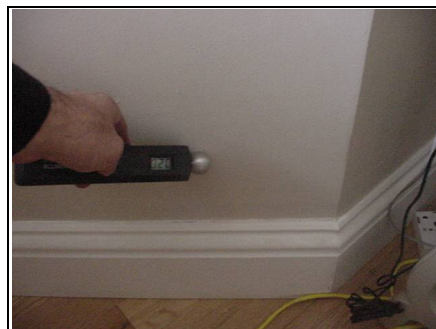
Testing for rising damp

A random visual inspection and tests with a moisture meter have been taken to the perimeter walls. In this particular case some of the walls were dry-lined so we couldn't take readings, however where we could take readings we didn't find excessive dampness considering the properties age, type and style. Our concern is what is going on under the floor.

ACTION REQUIRED: Please see the Executive Summary.

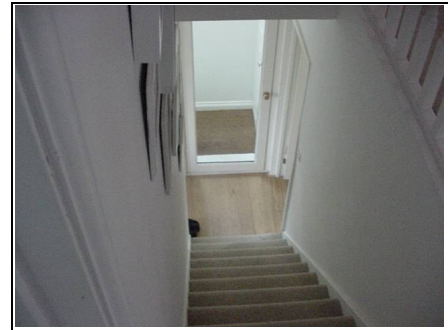
We were unable to examine the underside of the stair timbers due to it being lined, which precluded our inspection, so we cannot comment further upon the stair structure. We can, however, say that the lining gives a resistance to the spread of fire if such circumstances were to occur.

Steep stairs

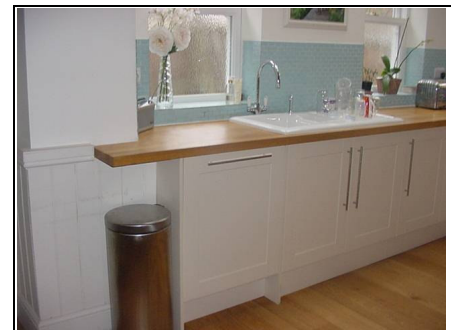
Kitchen

We found the kitchen in average to above average condition. We were advised it was relatively newly fitted. We have not tested any of the kitchen appliances.

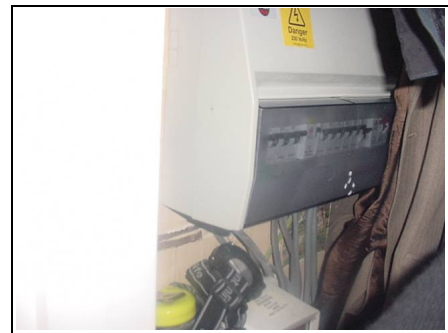
The electric fuses and consumer units were located under the stairs. The fuse board looked newish although better are now available.

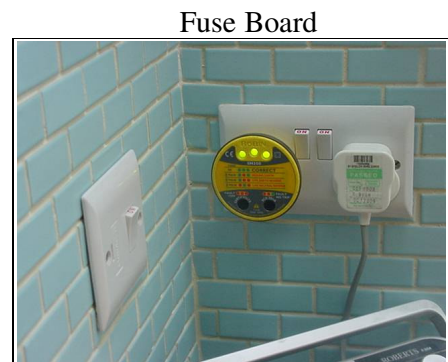
We carried out an earth test in the kitchen area to the socket point that is normally used for the kettle, this proved satisfactory.

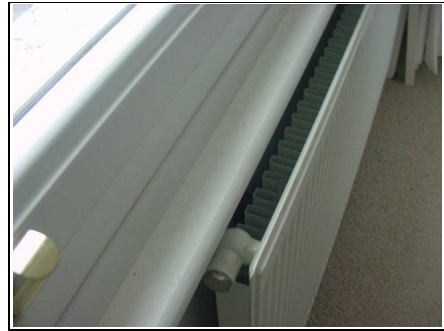
If you recall there are a number of single panel radiators in the property. There was no heating at all in the top floor front bedroom as far as we could see and there was an electric heater to the rear bedroom. We feel it is likely that you will need to amend the heating.

Radiator to front bedroom – may need to increase this

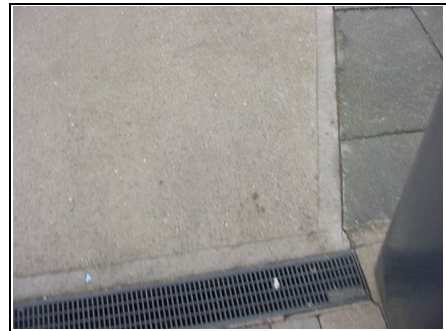
Running gulley to the front of the car parking area
