RESIDENTIAL BUILDING SURVEY

Shooters Hill,
SE18

FOR
Ms A

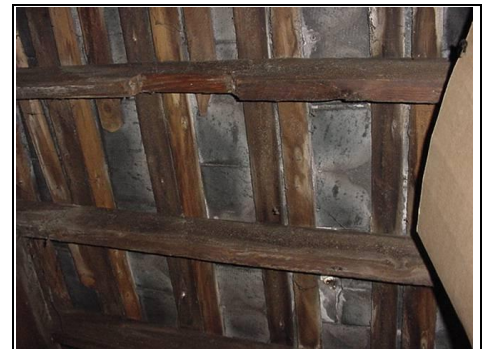
Slate Roof

The slate roof is probably original as there is no protective underlayer beneath it. Without a protective underlayer it means that wind driven rain can get into the structure. We would add that we could also see light in some areas indicating that some slates are missing/moved/broken meaning the roof is leaking.

ACTION REQUIRED: As a short term measure you can overhaul the entire roof. Particular attention needs to be paid to the valley gutter area. Again it should be noted that we weren't able to get a good view of the roof due to the mass of insulation which prevented us from accessing it properly. There may be other problems that are hidden such

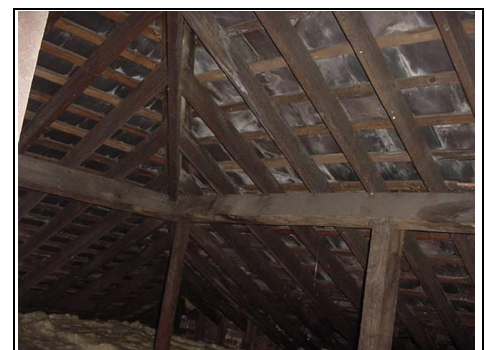
Dampness visible to the timbers.
The darker areas are dampest.

We could see the dampness in the timber that could ultimately lead to rot.

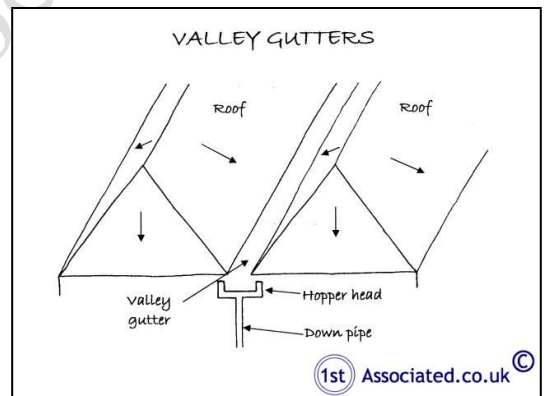
3.0) **Valley Gutter**

There is a valley gutter to the property that cannot be seen properly from the front but can be seen from the rear and in the roof space. These are generally considered problematic areas and we think that dampness is getting in which will lead to rot on the roof structure.

ACTION REQUIRED: We recommend that a roof light or access panel of some sort is put into the pitch of the roof so that the valley gutter can be seen, accessed and cleaned. Please note we did not gain access to the valley gutter and our view within the roof was limited due to the mass of insulation. Please note you may need local authority approval to add a roof light/access panel.

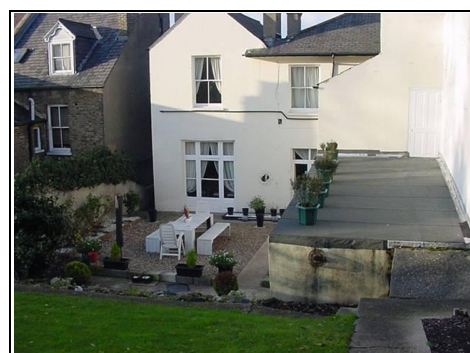
Kitchen roof

Very unusually the kitchen roof is formed in concrete with a felt covering. We were able to see the concrete, possibly with an asbestos content, roof by lifting the ceiling tiles in the kitchen. The felt covering looks to be in

reasonable condition although where there is Flashband flashing around the roof we would much prefer to see this replaced with lead as generally Flashband is considered a temporary repair material.

The whole concept of having a concrete roof within the kitchen of a residential property is not ideal as condensation can occur and cause what is known as cold bridging (please see the article in the appendices) Ideally we would much prefer a standard roof construction of timber. However you do have to be careful as it may somewhere be connected to your adjoining neighbours property.

ACTION REQUIRED: Further investigation is required. Have a “cup of tea meeting” with your next door neighbour on the left hand side to check the construction of their rear area and to see if they have altered or amended their roof. We would also have an asbestos check on this roof to see if there is any asbestos content. You also need at the very least to use a ‘rust stop’ agent to stop the rusting that we can see.

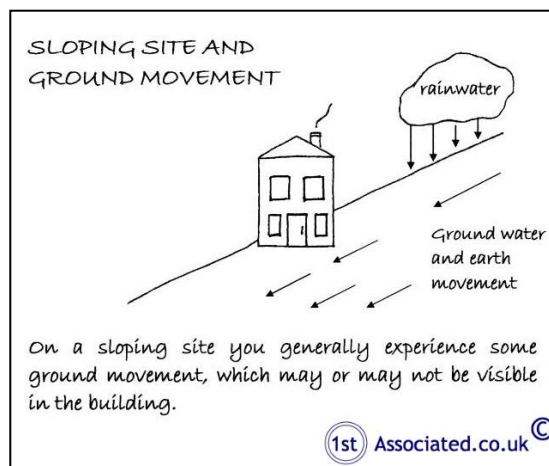
6.0) On a sloping site and kitchen

Any property on a sloping site is more susceptible than one on a flat site; it is simply the laws of gravity. Foundations normally allow for such occurrences, particularly in new properties. There can still be some minor movement

The kitchen stands out as an area where the sloping site really will affect it as part of it is directly against the ground level. This means that dampness will get into this area unless tanking has taken place or a good French gulley.

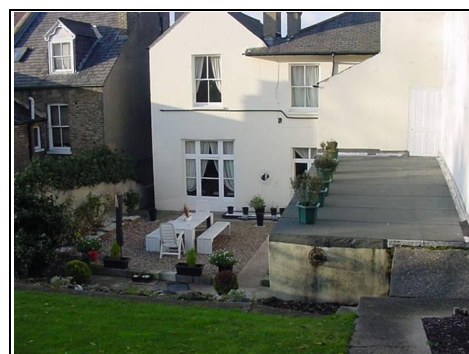
Kitchen same level as ground

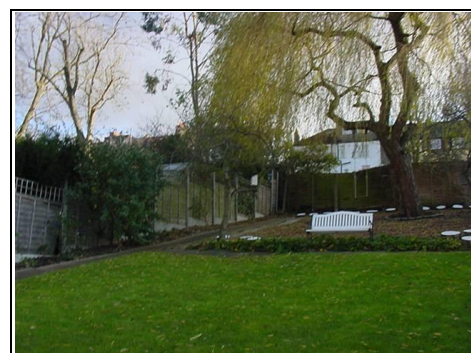
There is a Willow tree in the garden at the top of the sloping site. We would add that this can help hold the ground together although Willows are renowned for having a very long root system that can ultimately affect the foundations of the property.

Willow tree on slope

ACTION REQUIRED: You need arboricultural advice with regards to maintaining this Willow tree.

ACTION REQUIRED: Get an arboricultural report carried out.

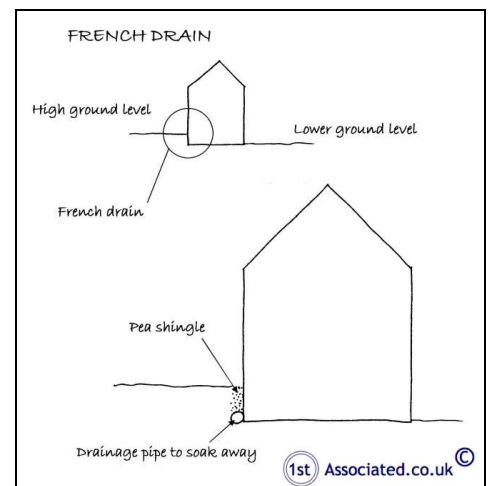
Dampness was found particularly to the rear of the property. We noted the high ground levels.

Dampness found in dining room due to the ground levels

ACTION REQUIRED: We would recommend lowering the ground level and ideally adding a French drain.

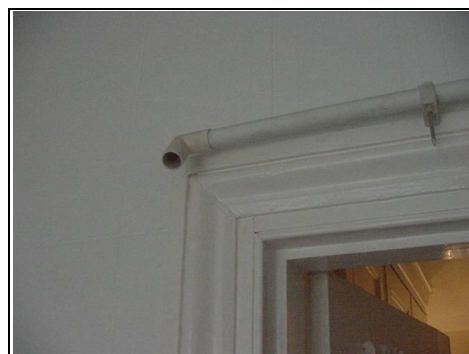
We spoke to the owner about both these items and she advised that the pipe work is redundant and there is an old boiler system in the master bedroom.

Redundant pipe work

ACTION REQUIRED: Open up area to check its condition and see if the boiler and pipe work needs removing.

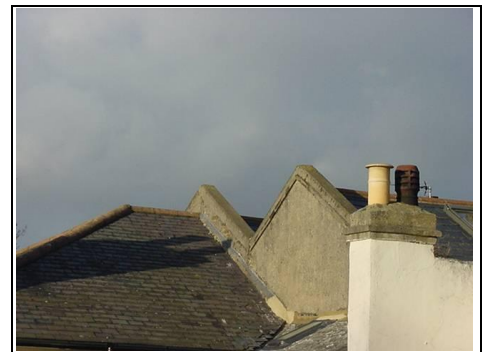
Rear left hand parapet wall

In this case there is a substantial parapet wall to the rear left hand side and also one to the front. We think we can see vegetation growing out of this parapet wall which as mentioned previously concerns us as this means that dampness is getting in.

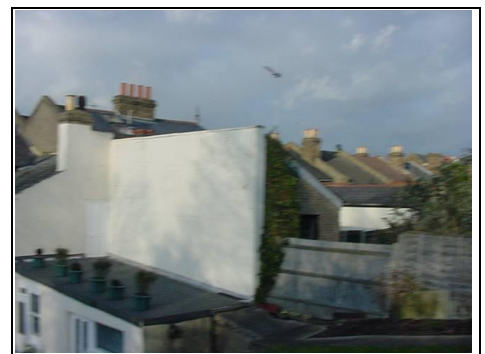
Rear substantial parapet wall

This photo (sorry it's blurred) shows the substantial painted parapet wall to the rear and adjacent to the kitchen. You can see the next door neighbour has extending against this pitch roof construction. You will have a responsibility/liability to keep it watertight.

We can see that there is strapping in this wall which indicates there has been retaining work.

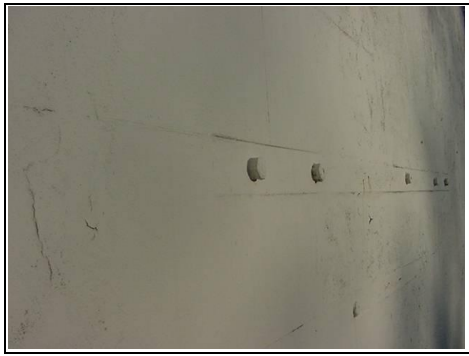
Strapping to rear parapet wall

ACTION REQUIRED: This should be inspected at the same time as the chimneys and no later than the summer of 2013.

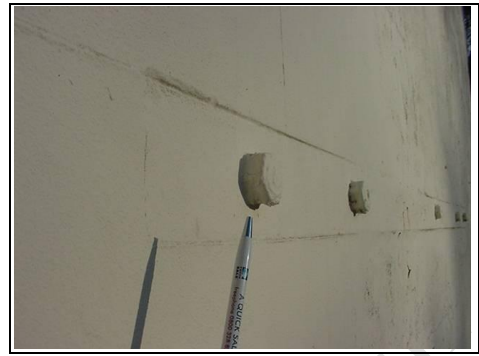
Strapping to parapet close up

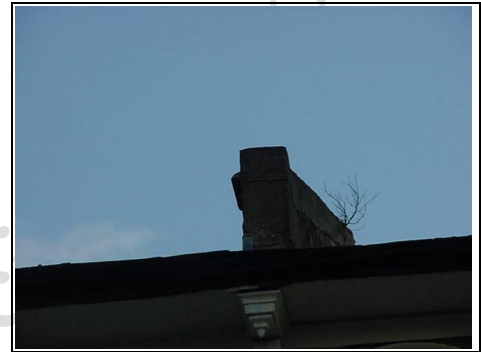
Front parapet wall

Finally, we were only able to see approximately sixty percent of the parapet wall, although the view was restricted. Therefore we have made our best assumptions based upon what we could see. A closer inspection may reveal more.

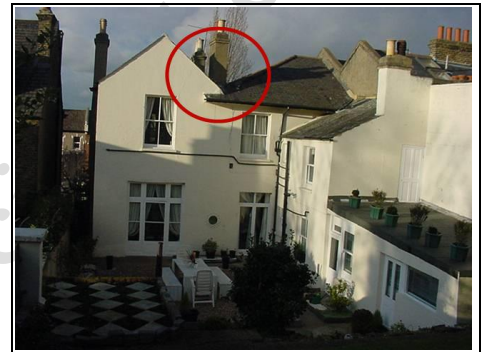
Circle shows where roofs meet and form valley gutter.

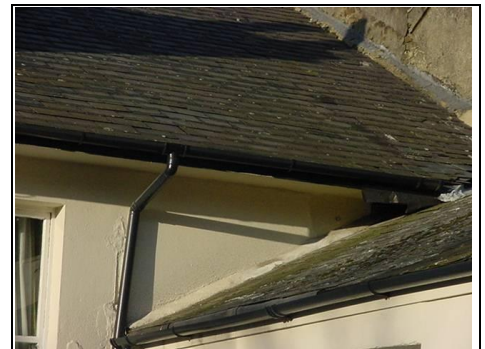
These are original slate coverings and from our view within the roof we can see that there is light coming through and therefore dampness will be getting in.

Main slate roof joining rear roof

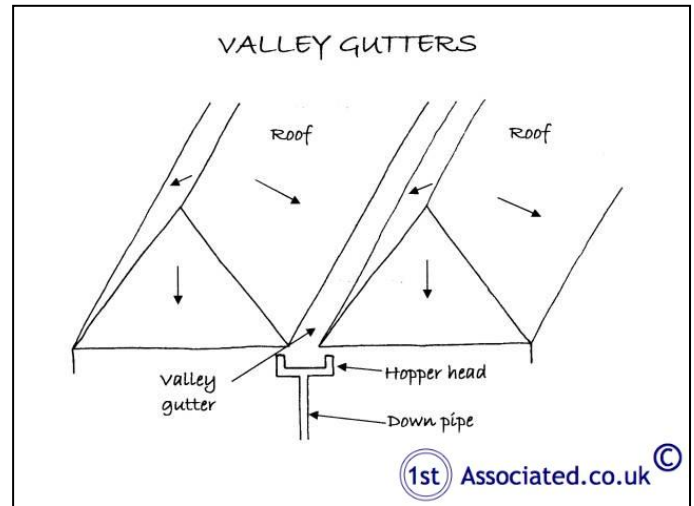
Awkward Junctions

There are some awkward junctions to the rear of this roof and unfortunately the flashing looks to have deteriorated which in turn will mean dampness will get in. We could not gain access to the rear roof properly and we were very limited on our movements within the main roof due to the mass of insulation (we would not recommend this amount of insulation in this age of property).

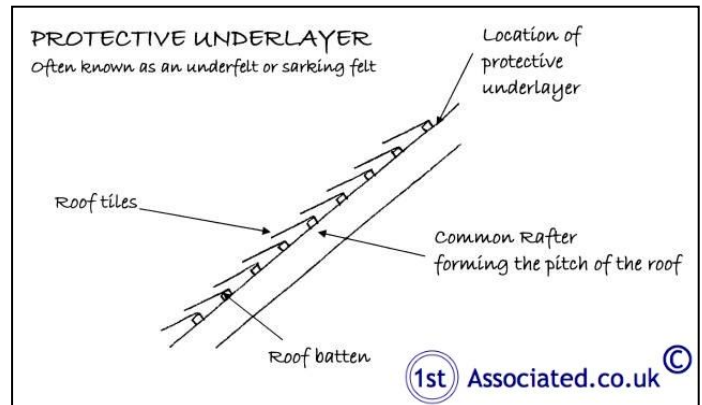
In this case this roof doesn't have a protective underlayer. It simply has the slates protecting the property.

Most importantly we can see that dampness is getting in.

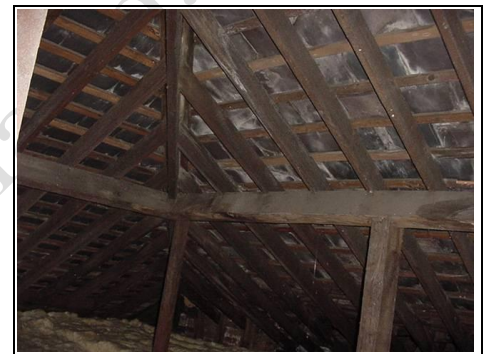
No protective underlayer and dampness getting in

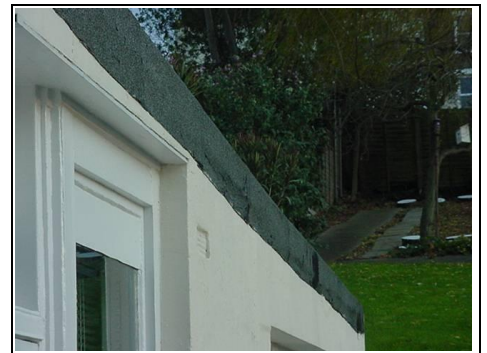
The detailing leaves a lot to be desired. There is no proper gutter as far as we can see and also the flashing has been repaired many times.

As far as we can see any rainwater will run off the roof and down the walls of the property causing dampness and deterioration.

Flat roof with no gutter

ACTION REQUIRED: The detailing needs to be improved with the addition of guttering and the flashings need to be replaced with lead flashing.

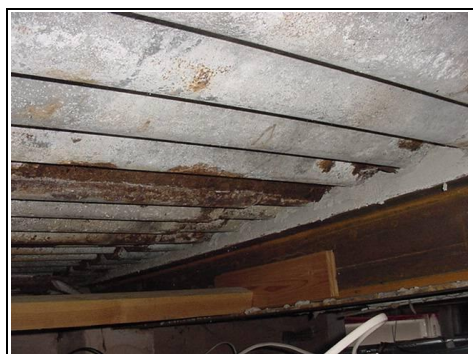
We spoke at some length about this within the Executive Summary but we want to re-emphasize that it has not been possible to identify what this roof decking is formed of. We have removed the ceiling tiles in the kitchen and found what looks to be a concrete finish but also found rusting which indicates it may be a reinforced concrete which makes sense for this size of roof.

Possible concrete roof

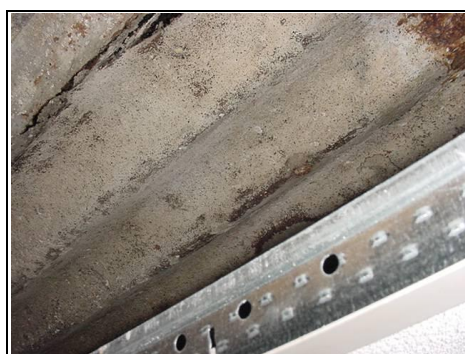
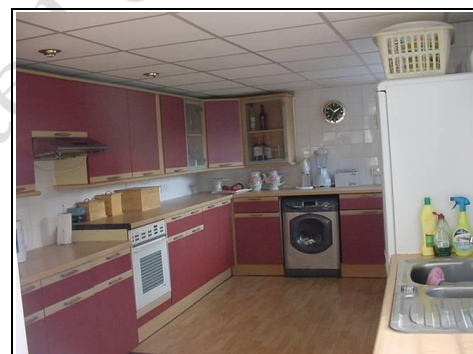
Tiles on kitchen ceiling

We can also see what looks like a tar under the roof which looks like it was an attempt at making it waterproof.

Finally there is an outside chance that asbestos is in the cement ceiling. Asbestos anywhere in the property increases the costs considerably when it needs removing.

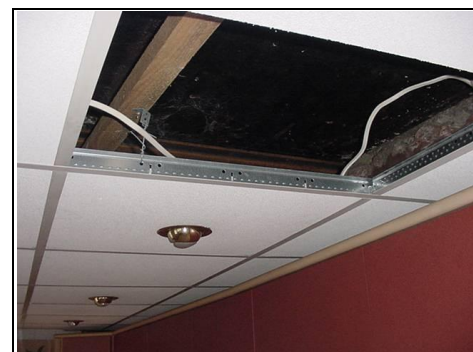
Tiles removed to see into roof

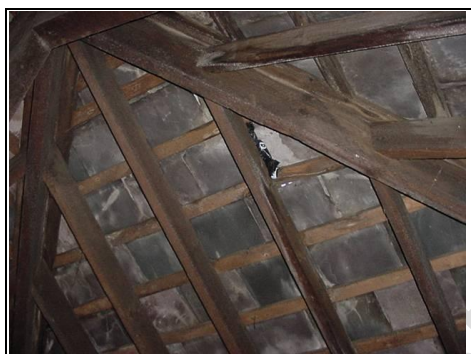
Front Left hand side roof showing dampness getting in.

Our examination was limited by the general configuration of the roof, and the mass of insulation which restricted our viewing from the loft hatches. What we could see was generally found to be in poor condition for its age, type and style. This is for two reasons.

1. Rain is getting through and this is visible in the damp timber.
2. The amount of insulation is starting to cause mould to the timbers due to lack of air circulation.

ACTION REQUIRED: A lot of work is required to these roofs. We would ultimately recommend re-roofing. Due to our limited view we would also recommend that the roofs are cleared and we will re-inspect. The only way to be 100 per cent certain is to have the roof cleared and checked.

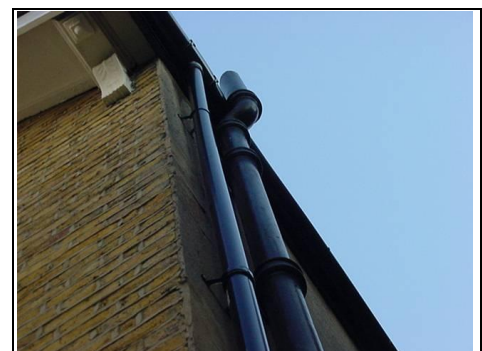
These are plastic and are located to the left hand side and rear of the property. There have been a lot of additions to the soil and vent pipes including very long runs of down pipe that look to have no fall on them at all.

Soil and vent pipe

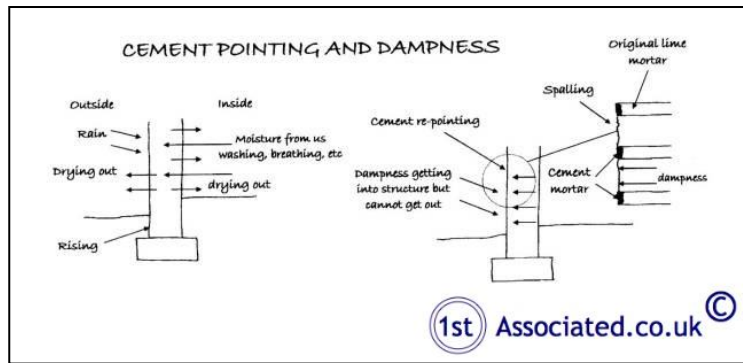
We would draw your attention to the cement mortar re-pointing that has been carried out on the exterior of the property that we feel is not appropriate to this building. Originally it will have been built with a lime-based mortar and this is what should be used for any re-pointing in the future.

The use of cement mortar causes deterioration to brickwork and does lead to the face of the bricks deteriorating, which in turn leads to dampness. This is a very important point

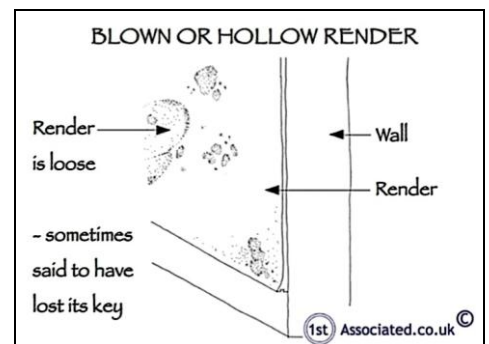
We can see some cracking in the render and these need to be sealed as soon as possible. We would remind you that any hairline cracks that appear, which tends to be the case with render, need to be sealed as soon as possible to stop dampness and water getting in and causing blisters and hollow areas.

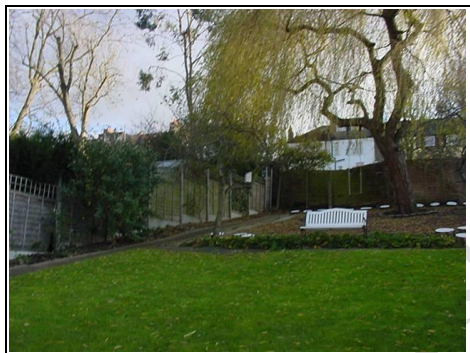
We were pleased to see the Willow at the rear from the point of view that it will hold the sloping site earth together and looks to be far enough away. However the tree at the front of the property, although we believe it has a small root ball, will affect it.

Willow Tree to the rear of the property

ACTION REQUIRED: You need to consult an arboriculturalist in the summer of 2012. We are not tree surgeons.

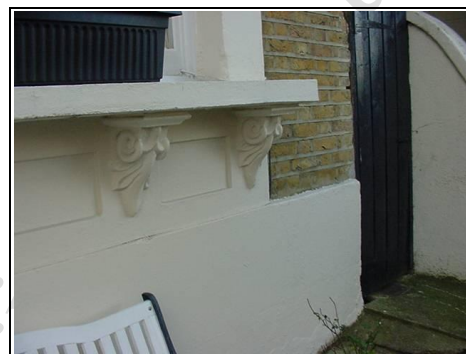
All modern properties should incorporate a damp proof course (DPC) and good building practice dictates that a differential of 150mm (6 inches) should be maintained between the damp proof course and ground levels. In this case, the render detail went right down to the ground both to the front, side and rear of the property. We would much prefer to see a bell mouth detail to the base this would then reduce the chances of dampness.

Render down to the ground

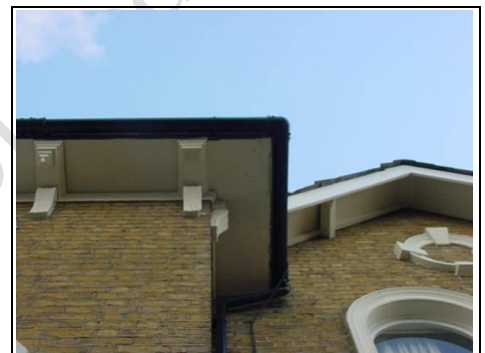
Decorative fascias and soffits to the front

ACTION REQUIRED: We recommend work in the summer of 2013 in the form of repair and redecoration. Make sure gutters and downpipes are watertight before carrying out any work on fascias and soffits.

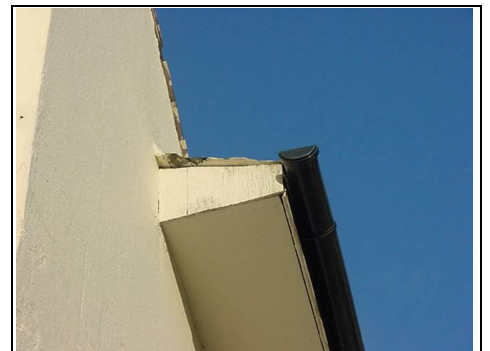
Plain Fascias and soffits to the rear

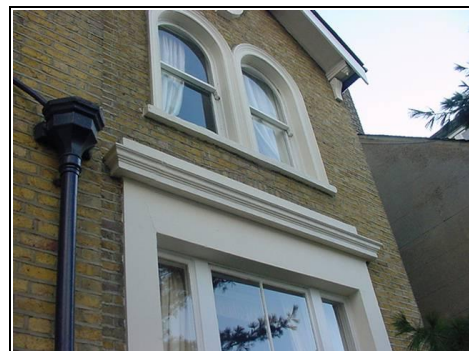
The property has some magnificent large single glazed timber sliding sash windows and doors. We would comment that the sliding sash window was a revelation in its day. We also find that some of these stick when we try to open them as was the case in this instance.

Sash windows

ACTION REQUIRED: We would refer you to our comments in the Executive Summary about rotten windows and also the lintels.

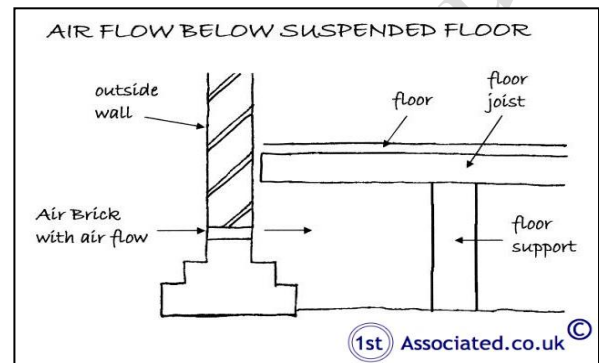
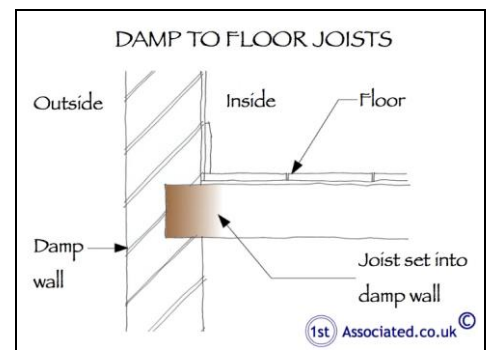
The floors of the property are suspended timber floors with embedded timbers. The danger with this type of floor is the embedded timber starts to rot. Whilst repairs can be carried out they are awkward. In this instance we have not been able to view these properly as we have not been able to gain access into the cellar area properly.

Stored items in cellar

ACTION REQUIRED: the whole cellar area needs clearing out to give us proper access before you legally commit to purchase the property.

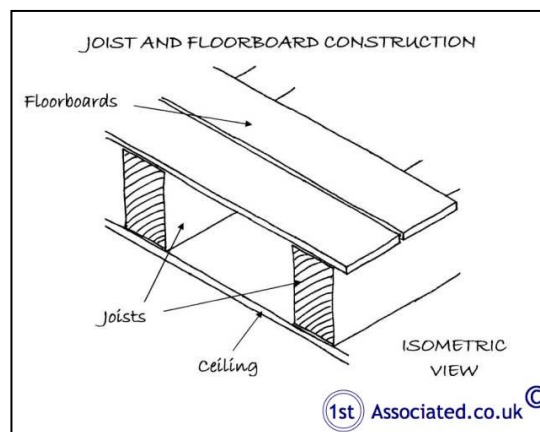
We have assumed that the first floor construction is joist and floorboards with embedded timbers, as this is typical in this age of property. We would expect some damage and deterioration to the floors. We noted woodworm patterns within the floors.

There are also exposed timbers which could cause deterioration to the floor itself.

ACTION REQUIRED: Ideally the floor needs opening up to have an examination carried out.

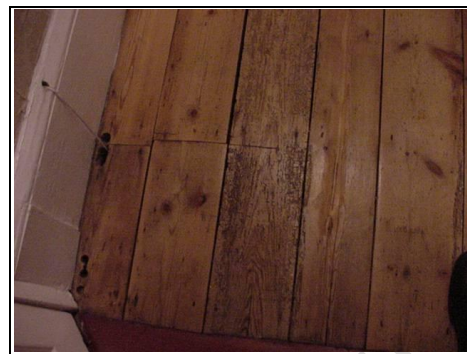
In this instance there is a mass of insulation within the roof that limits our view. We did notice to some of the exposed floor boards that there were signs of old woodworm. It is most important to establish whether woodworm is active or not. Many good old properties will have non-active woodworm. In this case we think there is a possibility of woodworm activity although we did not note any that was 'structurally significant'. In many properties there is an element of woodworm that is not active. Our inspection was restricted by insulation covering some of the timbers in the roof, as it is restricted throughout the property by general fixtures and fittings.

Woodworm

ACTION REQUIRED: If you wish to be 100 per cent certain that there is no woodworm the only way would be to check the property when is emptied of fixtures and fittings etc.

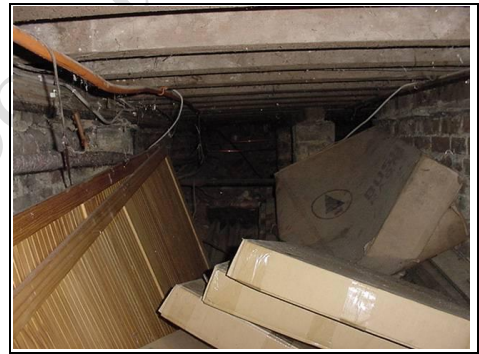
The cellar is accessed via the flaps as you enter the property. We could not access the cellar properly because of the amount of stored items.

Large amount of stored items in cellar

ACTION REQUIRED: We are more than happy to return to view the cellar once it has been cleared.

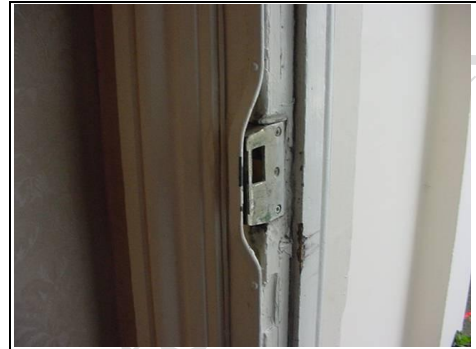
We noted a security box externally but we are advised that it is no longer in working order. This can still act as a deterrent. We also noted a London bar on the front door. Other than that there are very limited security features. A good alarm system should not only help reduce break-ins but also your insurance. We are not experts in this field and therefore cannot comment further.

London Bar on front door

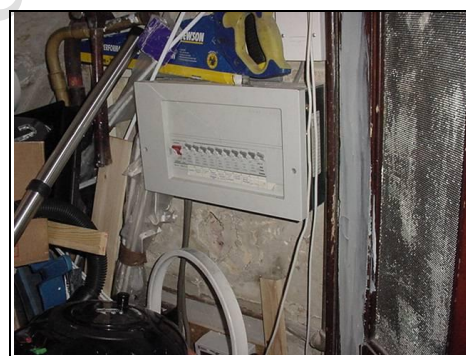
The electric fuses and consumer units were located under the stairs. The fuse board is from the 1980's/1990's and looked dated and better are now available.

1980's/1990's Electric fuse board

ACTION REQUIRED: Enquire about upgrading it.

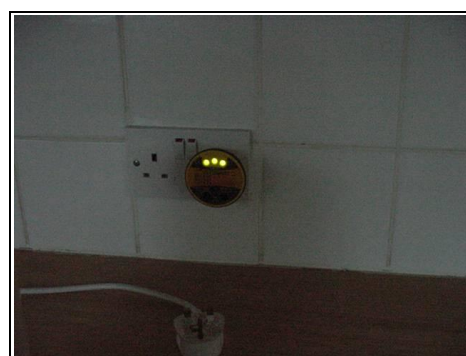
Earth Test

We carried out an earth test in the kitchen area to the socket point that is normally used for the kettle, this proved satisfactory. However we are concerned about the condensation that may be occurring in the kitchen area which is not ideal.

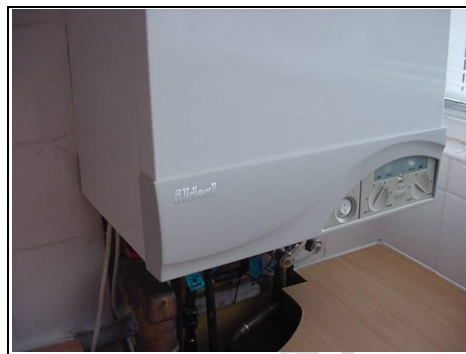
Boiler in Kitchen

The boiler was located in the kitchen and it is manufactured by Ideal and the model type is Cibi HE.

Our limited inspection of the hot water and central heating system revealed no evidence to suggest any serious defects but we would nevertheless recommend that the system be tested and overhauled before exchange of contracts and that a regular maintenance contract be placed with an approved heating engineer.

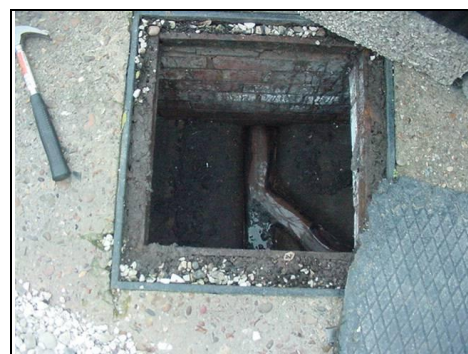
Rear Middle Manhole

We duly lifted the cover and found it to be free flowing at the time of our inspection.

From what we could see it is brick built.

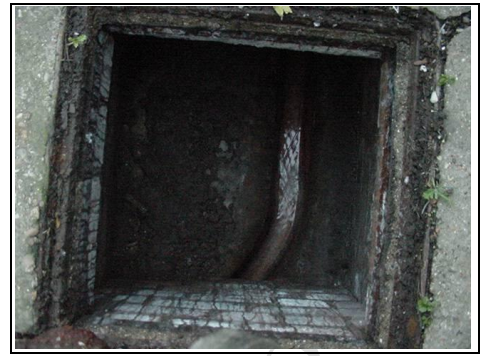
Rear Right hand side

We duly lifted the cover and found it to be free flowing at the time of our inspection.

From what we could see it is brick built.

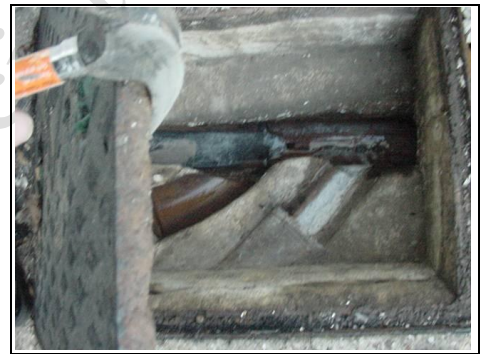
Manhole three

We duly lifted the cover and found it to be free flowing at the time of our inspection.

From what we could see it is finished in concrete.

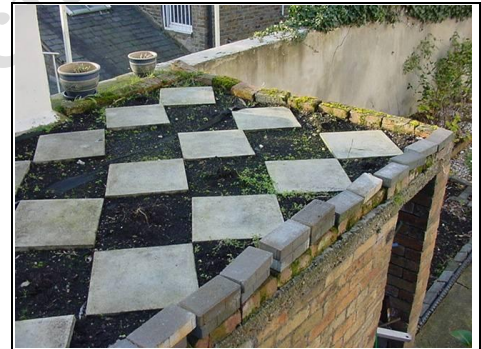
There is an outbuilding to the right hand side of the property which has this unusual checkerboard roof. We cannot imagine it is waterproof and it should be considered a very basic construction.

Outbuilding roof

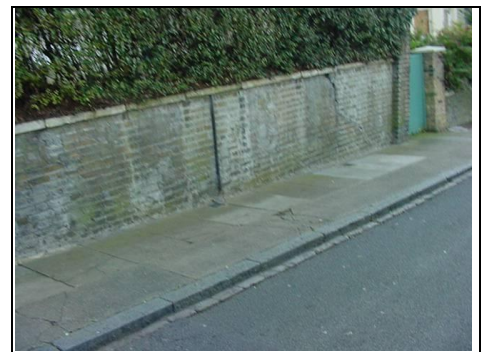
As the property sits on a sloping site we would much prefer to see the front retaining wall with weep holes but we couldn't see them in this instance. You can see from the whiteness how water is getting through it.

Retaining wall to the front

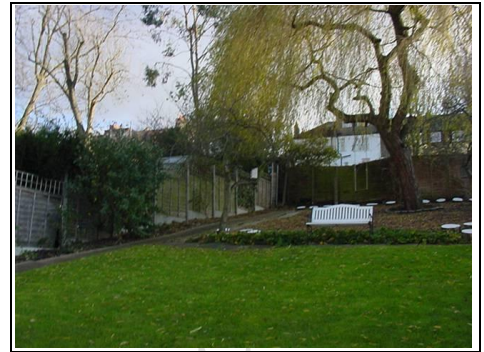
Rear Garden

The rear garden is a considerable sloping site and you therefore need to expect that rainwater will discharge to the bottom section whenever it rains.

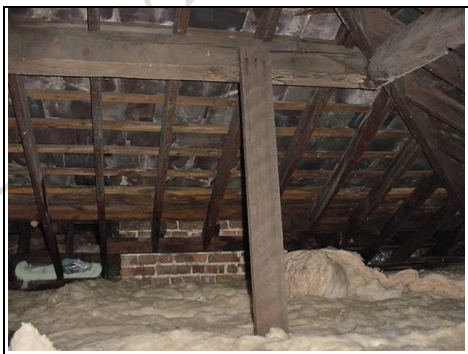
Dampness and condensation in the timbers

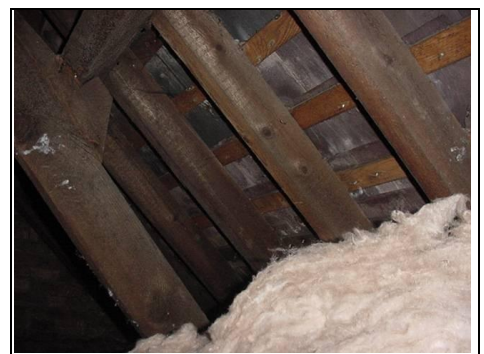
Unfortunately in this instance our inspection has been very limited due to the mass of insulation and we did not have access to the cellar.

Mass of insulation
