# RESIDENTIAL BUILDING SURVEY

London  
South East

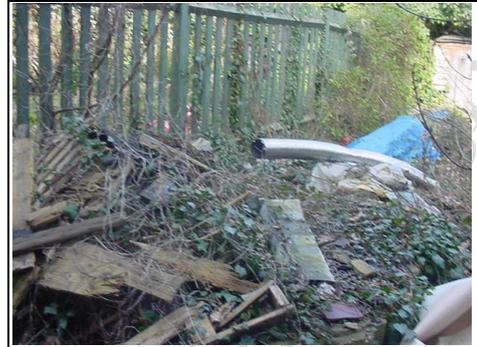
Rubbish to the side needs clearing

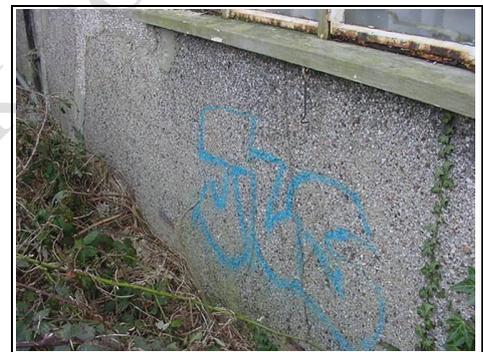
As an aside, there is also graffiti to the render to the rear which needs cleaning which is difficult on pebbledash render.

Graffiti

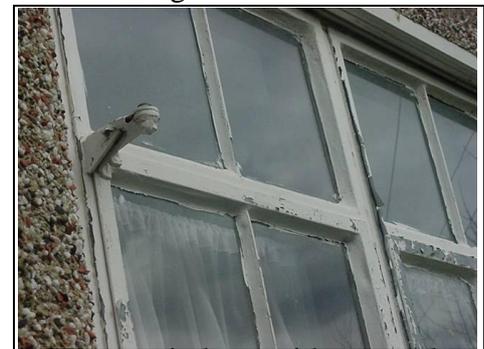
Newer windows with external hinges

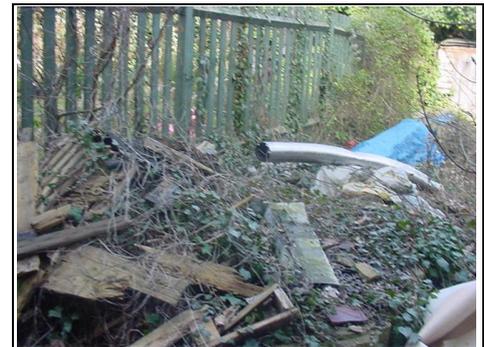
Generally the garden needs clearing. We would estimate it will take a few skips. Recently we have been surprised at the cost of skips but also would add in this instance it will be particularly difficult to position the skip anywhere suitable due to the restrictions in the road and access.

Rubbish needs removing

**ACTION REQUIRED:** You are likely to need a 'white van man' to help remove the rubbish.

**ANTICIPATED COST:** In the region of £500 to £1,000 to clear the garden properly and tidy it up. You may find that you have particular items in the garden that need a special licence to tip. Please obtain quotations.

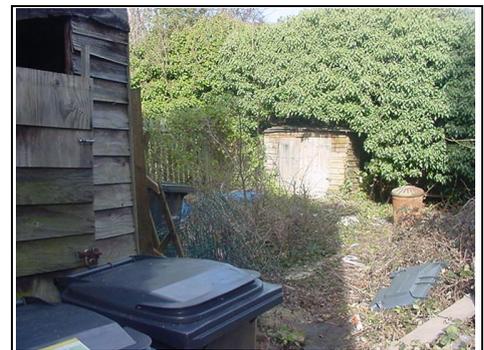
Overgrown garden

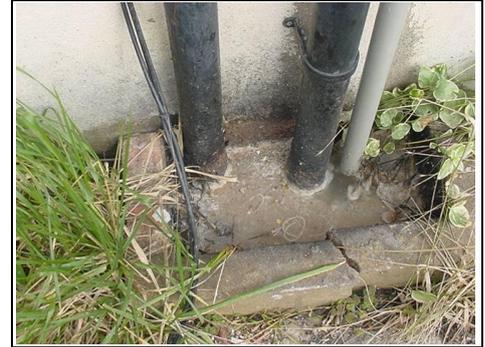
As far as we can see the drains were blocked/backing up and the outside gulleys to the front and rear. We would also add that when we turned the kitchen tap on, it ran rusty water for quite a while.

Blocked gulleys

**ANTICIPATED COST:** A few hundred pounds for the clearing of the drains and camera work; please obtain quotations.

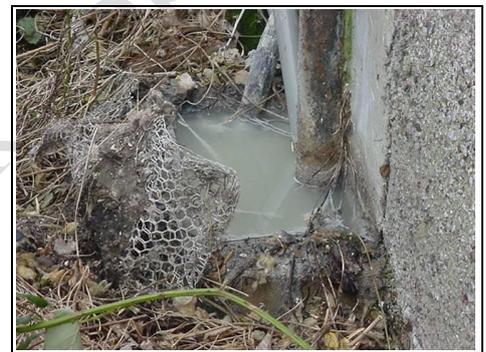
There may be a collapsed drain for example.

Rear drain blocked

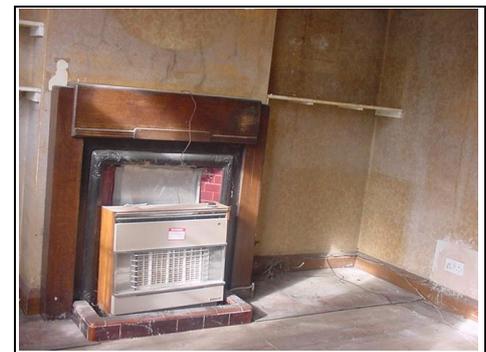
The heating was electric, we didn't test this. Whilst modern day electric heating can be very efficient and neat and tidy, this was an old style system. We noticed the condemned electric fire. It seems likely there is gas into the property. It is worth looking at a gas central heating system.

Condemned electric fire

**ACTION REQUIRED:** General improvements to the heating system.

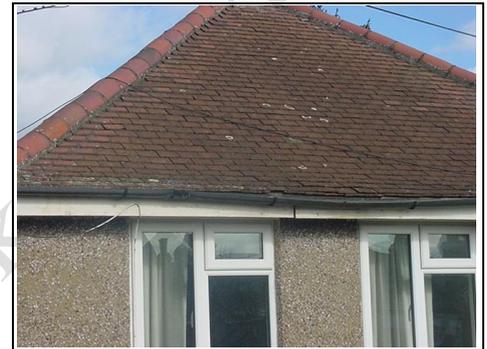
The main roof is hipped, pitched and clad with concrete tiles and, from ground level, this looks in below average condition considering the roofs age, type and style. With this age of roof there will usually be a few missing or displaced tiles, these need repairing/replacing.

Roof tiles

**ACTION REQUIRED:** Please see our comments in the Executive Summary. Carry out periodic inspections and maintenance of the roof, as required. We would emphasise that we have not had access within this roof which is what we need ideally to establish its condition. We would be more than happy to return and visit to inspect if you can arrange access with the top floor owners.

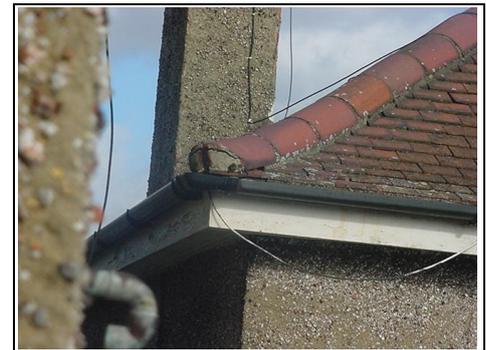
Close up of hipped roof

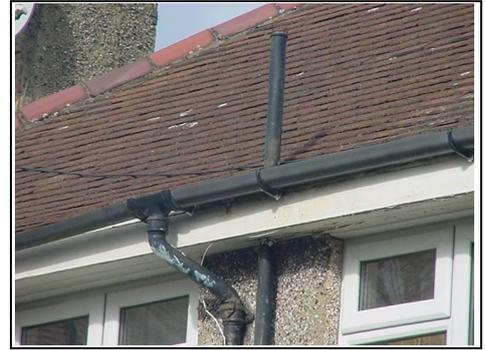
The property has cast iron soil and vent pipes. Cast iron of this age will always need regular maintenance which these haven't had in the past.

Soil and vent pipe

**ACTION REQUIRED:** Maintain the soil and vent pipe and/or replace.

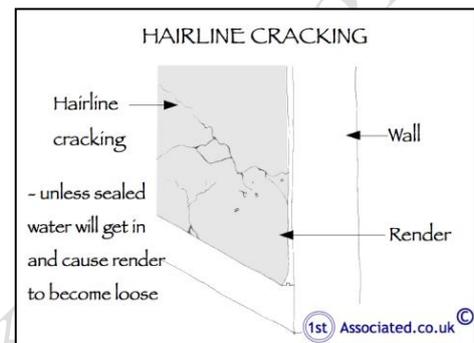
We would divide this into structural cracking and hairline cracking. We feel that the cracking to the rear of the property has potential to be structural cracking however there is also hairline cracking which needs to be sealed as soon as possible to stop dampness and water getting in causing sections of the render to need to be re-rendered.

**ACTION REQUIRED:** Please see our comments in the Executive Summary.

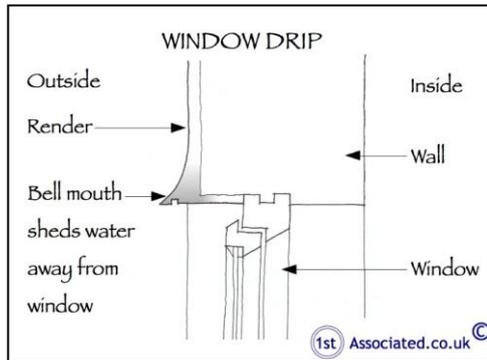
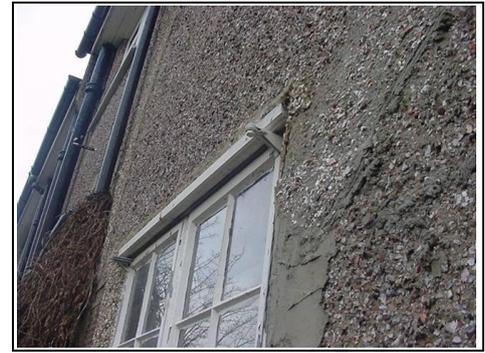
In this case we found a small drip detail over the windows although it is not formed in render.

Window drip

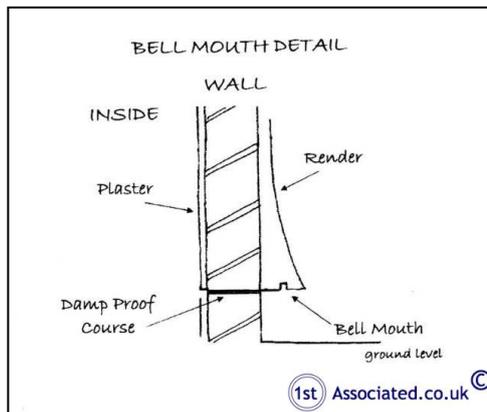
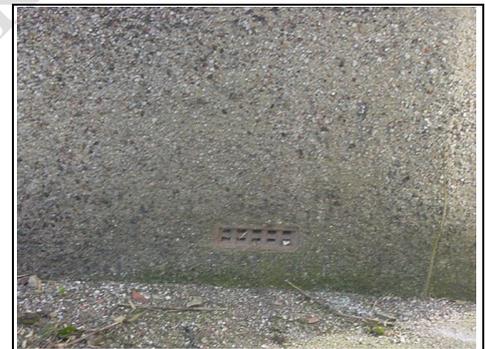
To the base of the render there was no bell mouth detail therefore it is susceptible to dampness to the base of the property.

No bell mouth

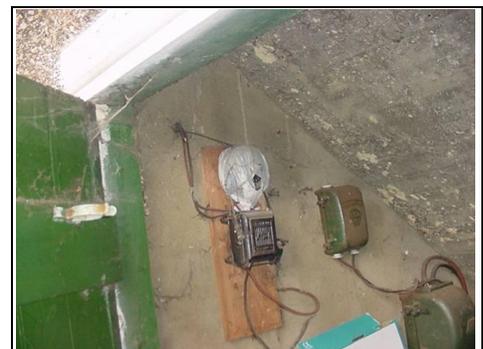
This is a good question. We cannot be 100% certain from what we have seen without opening up the structure. However the adjacent photo was taken underneath the stairs giving us an indication that the walls are concrete which means we would take an educated guess that this property has been built from reinforced concrete.

Concrete

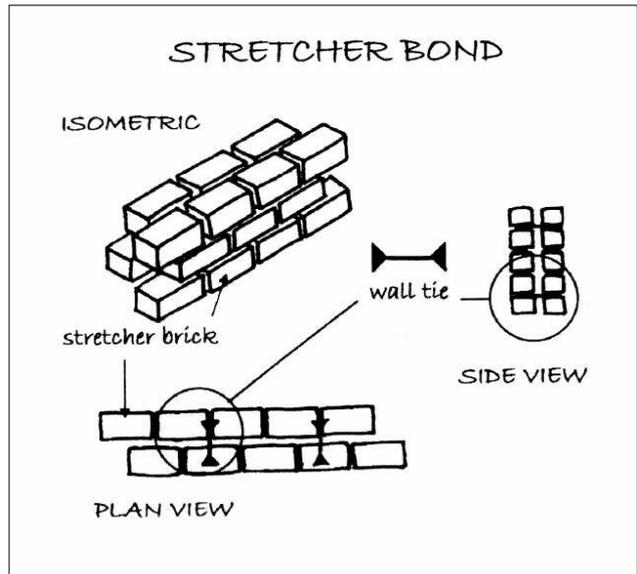
There is a very small amount of brick on the stair areas in a Stretcher Bond formation. This may have been added at a later date.

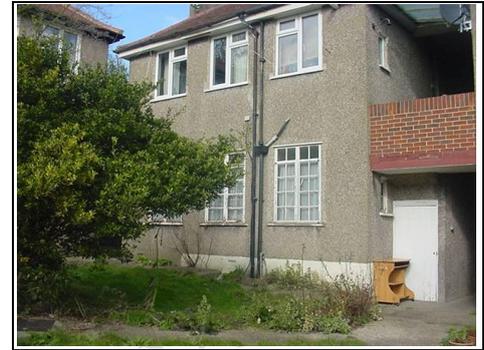
There are no trees within influencing distance of the property although there are some bushes nearby which would benefit from maintenance.

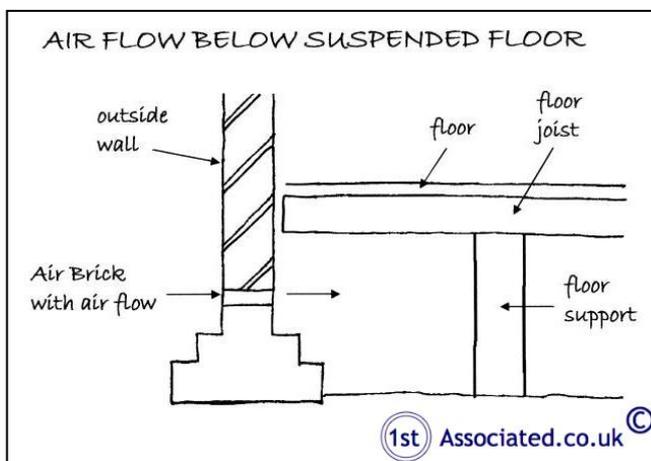
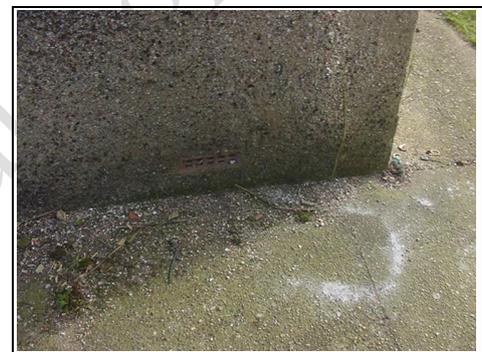
Air brick

Air bricks are essential to have a through flow of air as this helps to reduce the chances of wet rot, dry rot and woodworm.

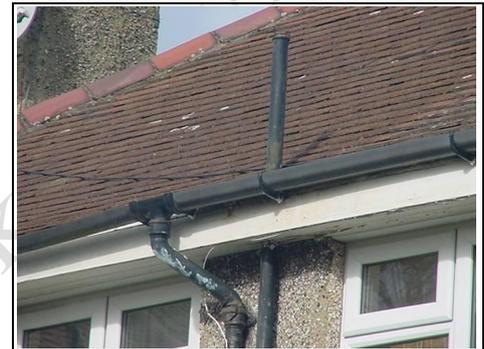
The fascias and soffits are timber. They are painted and we would comment they are in average condition for their age, type and style which is surprising given the condition of the gutters and downpipes.

Painted timber fascias and soffits

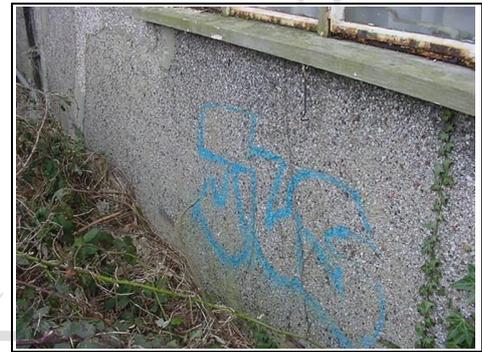
Normally we would be talking about repainting in this section, however in this instance we just want to talk a little bit about how difficult it is to patch repair pebbledash render and how obvious it is if it is not done well. In our experience it is very rarely done well. In this case you have the difficulty of repairing hairline cracks, the difficulty of repairing major cracks and also the difficulty of removing graffiti which will be very difficult to do without leaving signs that you have done this. The only items that need painting are such things as the fascias and soffits and the cast iron gutters and downpipes should you decide to keep them as well as doors and windows, although we feel it is very unlikely that you will keep the windows!

Graffiti

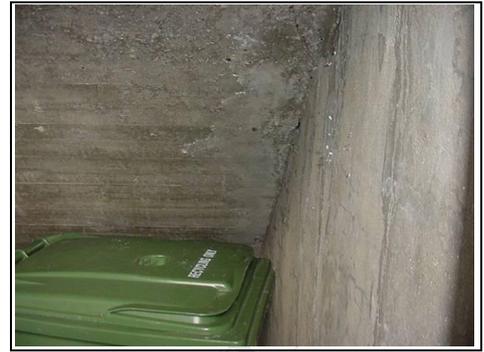
It is difficult to establish what the perimeter walls are. Again we would take an educated guess that concrete or a blockwork has been used. The only area that we could see was within the stairway which showed a concrete wall.

Concrete walls under stairway

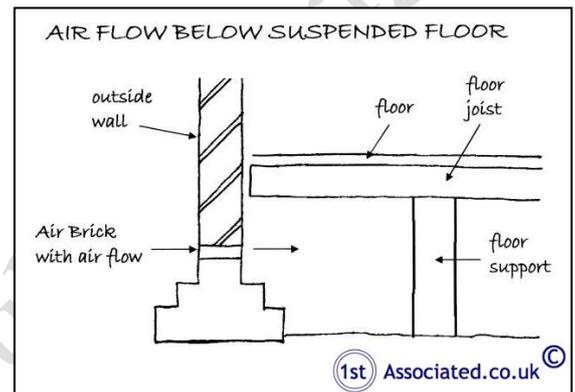
Quite surprisingly the property has a suspended timber floor. We say surprisingly although in earlier years most floors were suspended timber.

A suspended timber floor requires air movement underneath to minimise wet rot, dry rot and woodworm.

**ACTION REQUIRED:** We recommend you check all airbricks are clear.

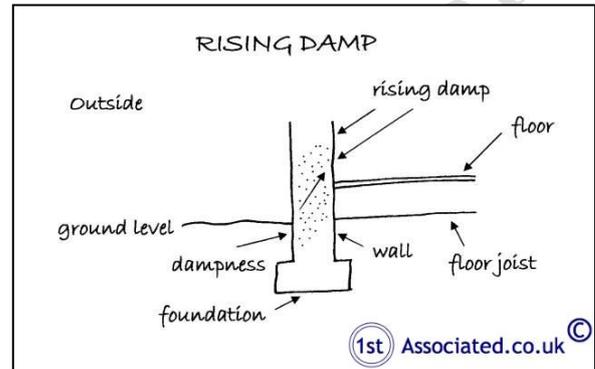
A random visual inspection and tests with a moisture meter have been taken to the perimeter walls. In this particular case we have found rising damp.

**ACTION REQUIRED:** Please see the Executive Summary.

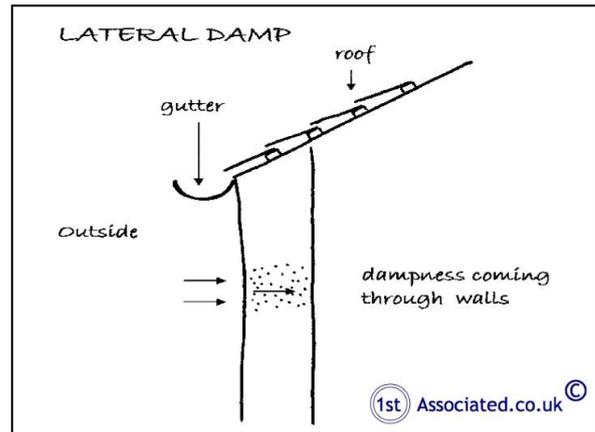
We used a damp meter on the external walls. We have found dampness.

### **ACTION REQUIRED:**

Please see our comments in the Executive Summary.

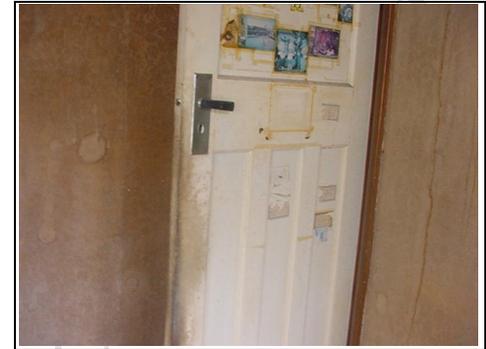
The doors are a panel door, typical of what we see in 1930's to 1950's properties therefore likely to be original.

Internal Door

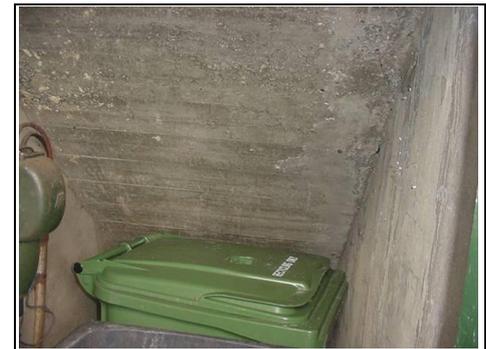
There is a staircase leading up to the upper floor flats which is formed in concrete. We can see this in the under stair cupboard. We also noted there were some old electrics which need isolating.

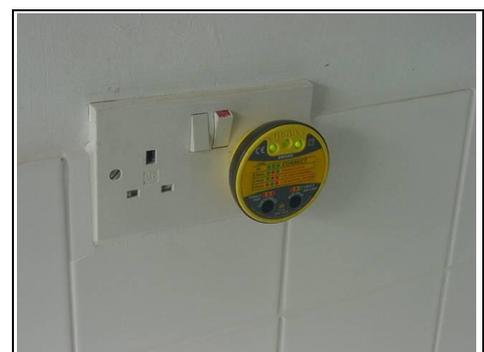
We carried out an earth test in the kitchen area to the socket point that is normally used for the kettle, this proved satisfactory.

Earth test

**ACTION REQUIRED:** As the property is changing occupancy an Institute of Electrical Engineers

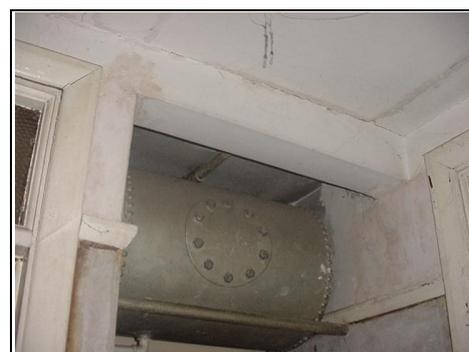
The Cold Water Cistern was located in the hallway entrance area. We are not certain whether it is still in use.

Cold Water Cistern

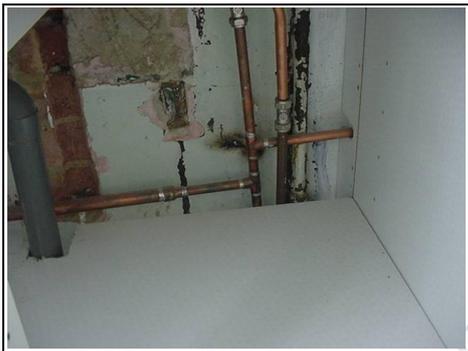
The plumbing, where visible, comprises copper and cast iron piping and possibly some lead pipes. No significant leakage was noted on the surface, although most of the pipework is concealed in ducts and floors.

Copper piping

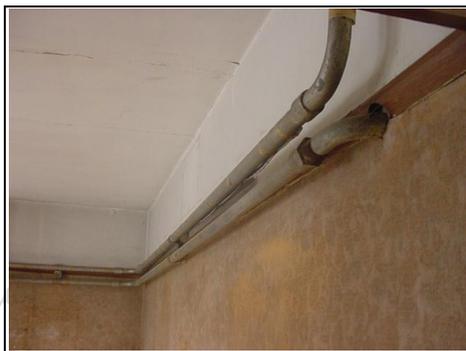
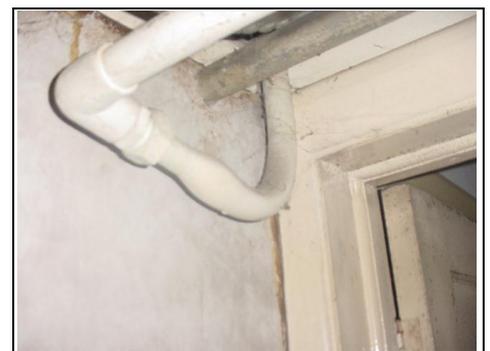
Possibly lead pipes

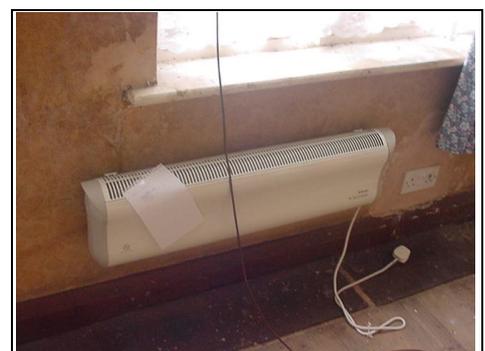
The heating was via electric heaters. We have not tested these.

Electric heating

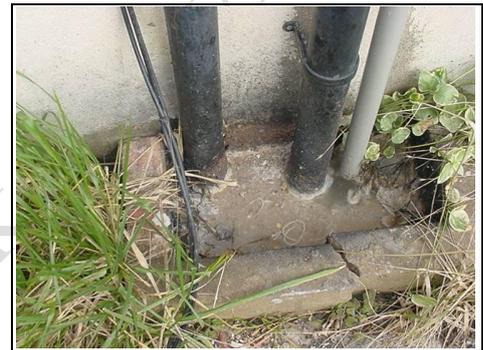
The cold taps have been run for approximately quarter of an hour in the bathroom and kitchen. The gulleys did block and back up in that time.

Gulleys blocked

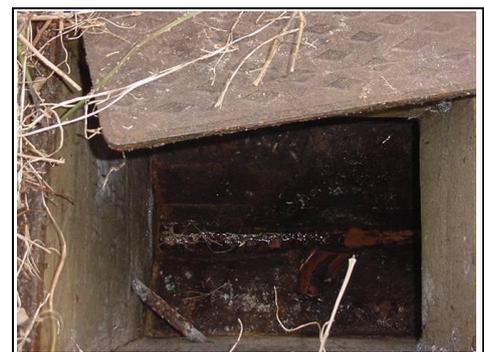
We duly lifted the cover and found it to be free flowing at the time of our inspection.

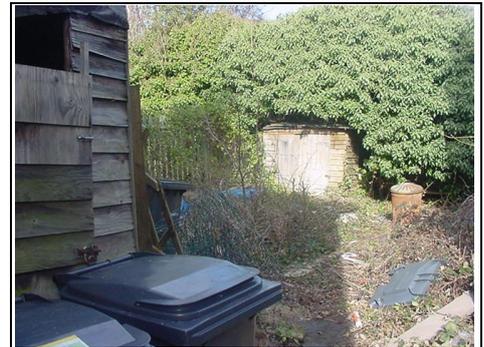
There are good sized gardens which we assume are shared. The gardens were overgrown.

**ACTION REQUIRED:** Your Legal Advisor to check and confirm.

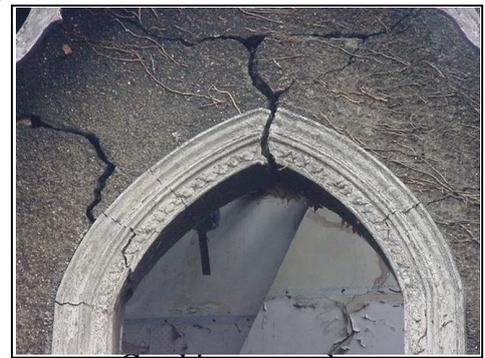
Cracking to render

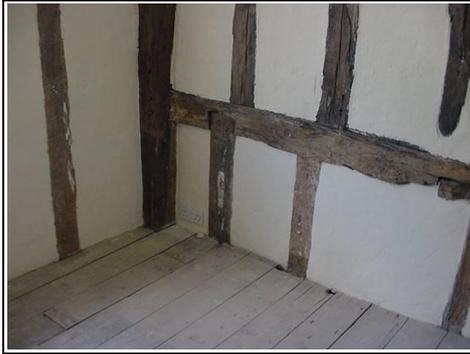
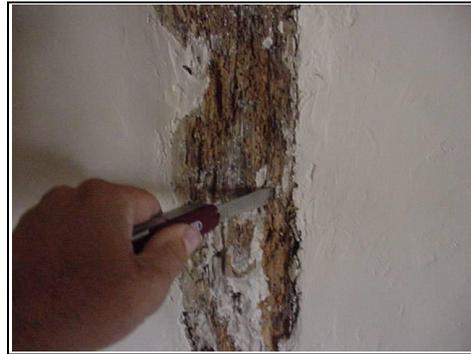
Render can be hiding all sorts of problems in an old property such as in this photo woodworm and wet rot to the timber frame

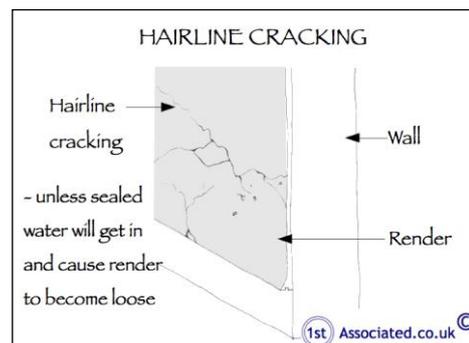
A modern cement render is much harder than an older lime render and works well more modern properties that do not move very much. However unfortunately it is often used on older properties where you can get the differential movement between the two properties which can cause hairline cracking.

We would always recommend filling hairline cracks as quickly as possible.

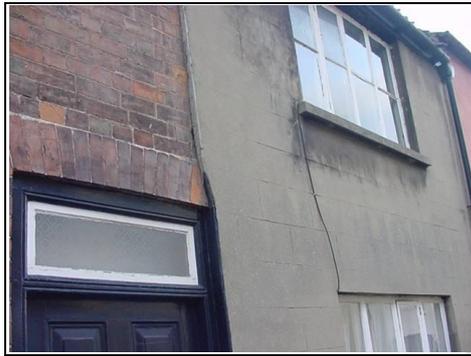
Cement Stucco render – you can tell it is cement from the colour and you can also see the pattern staining below the window.

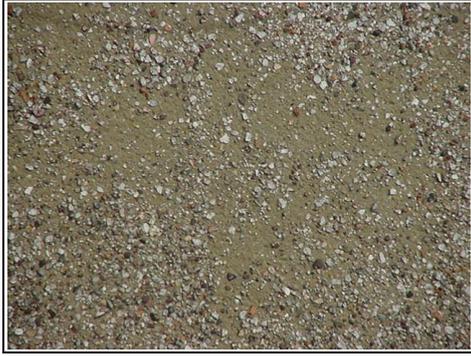
Peashingle coming away

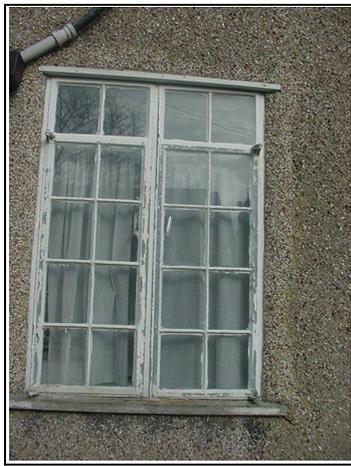
If you look closely this relatively new window has been put in place with a different texture of pebbles around the window compared with the original pebbledash.

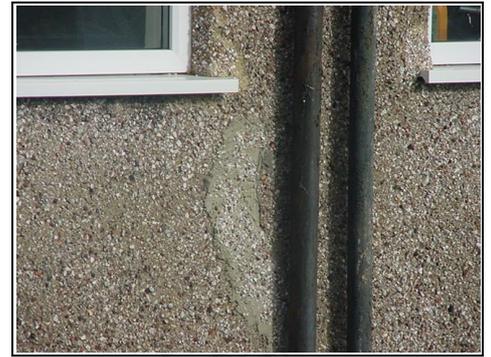
Peashingle badly repaired where there is a crack beneath that has been hidden

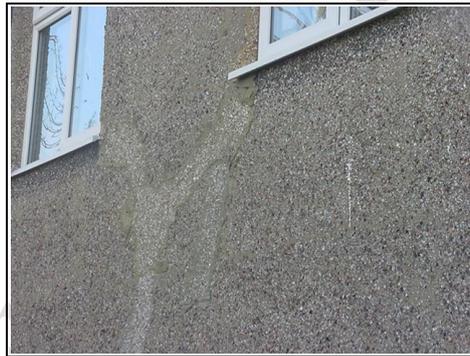
An area where Peashingle has been better repaired but still stands out where there is cracking beneath it.

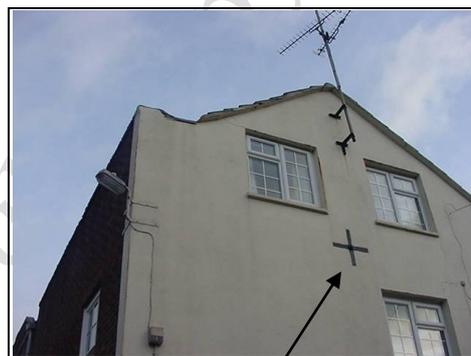
You can see the tie bar to the right hand side centre of the photo this render could be hiding all sorts of cracking beneath it.

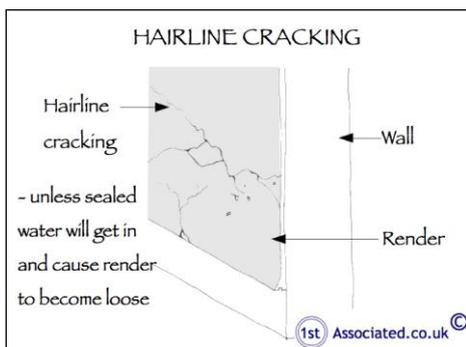
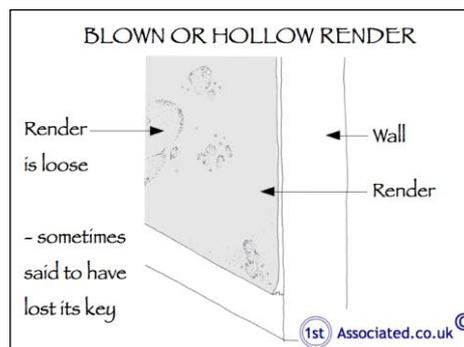
Cracking to render can be caused by the structure beneath and the cracking can be in the render.

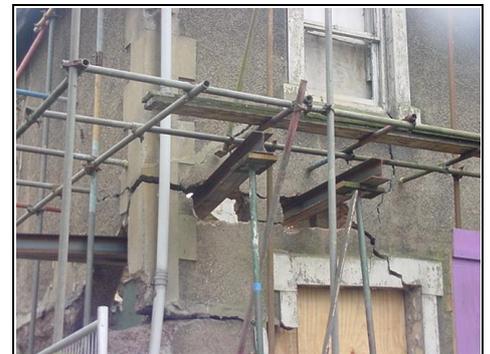
This is known as structural cracking and this is where the problems in the property are so bad that even though it has been rendered over the cracking resurfaces.

A property with problems, these cracks are structural!

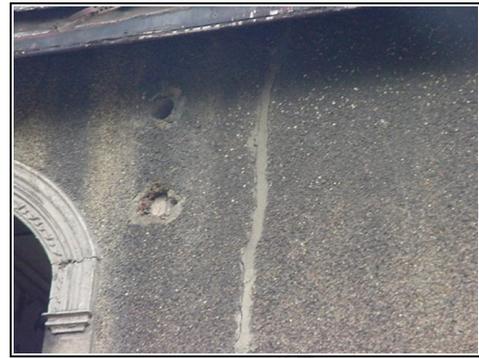
Crack brought about by expansion and contraction of the building.

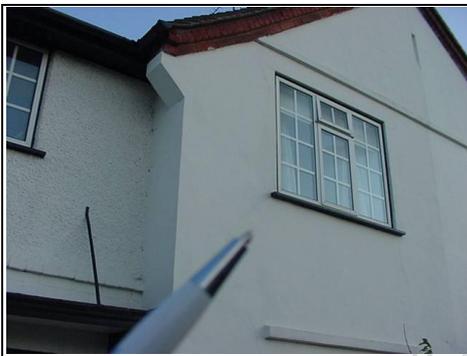
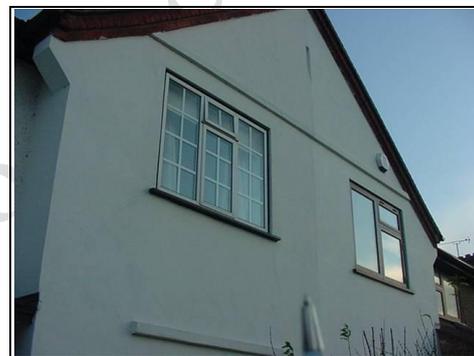
Pen indicates hairline cracking

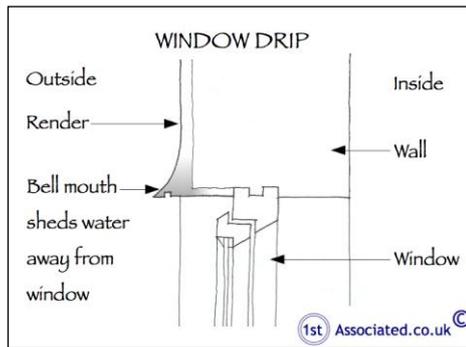
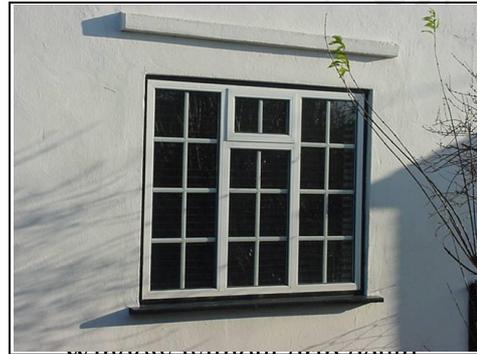
window without drip detail

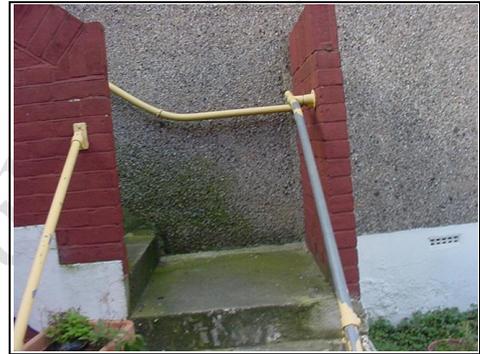
Green mould is often visible to render and sometimes black mould which is a sure sign of dampness.

Green mould to render
