JOB REFERENCE: XXXX

RESIDENTIAL BUILDING SURVEY

XXXX
Braintree
Essex
CM7 XXX

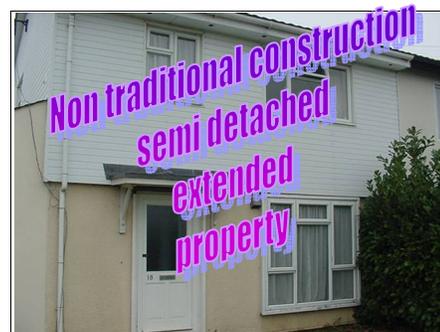
This is a metal frame non traditional building which has been partly updated with new roofs and new parts to the roof structure. In addition the walls have been clad and there has been upgrading of the metal single glazed windows to double glazed plastic windows (without trickle vents with the exception of the extension).

This is how your property now looks with the render added and the various alterations and amendments

ACTION REQUIRED: Your Legal Advisor needs to confirm exactly what sort of metal frame house it is and then we would be able to advise you further. It should be remembered that non-traditional construction is a characteristic of the property and as such you need to be happy to live with this and the limitations it has.

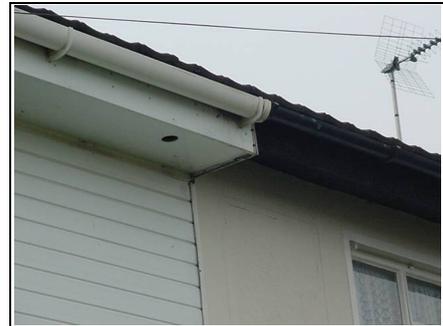
Fascias and soffits

We could see some asbestos had been left in where the chimney had been replaced (this can be seen from within the roof). It is very likely that there is other asbestos left in for example the fascias and soffit boards where we can now see a new plastic board but there may be an asbestos one behind it.

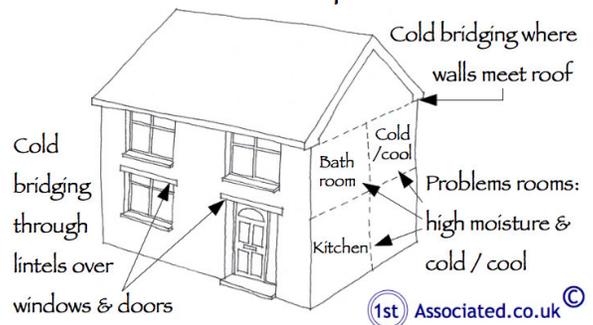
COLD BRIDGING / CONDENSATION - A few examples

There is a mixture of things that combined together to give the higher risk of condensation than usual. These range from some of the radiators being internal on the ground floor to a lack of trickle vents to the windows to the extract from the humidity generating bathroom and kitchens being too small.

Cold bridging is caused by a colder element in the structure allowing coldness to pass through the structure much quicker when warm moist air is present in the property

ACTION REQUIRED: Increase the size of the extract fan in the bathroom and kitchen and make them humidity controlled.

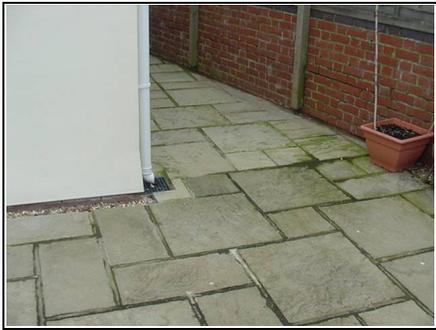
Retaining wall

Whilst the retaining walls in your garden have weep holes we noted that the retaining walls to the left hand side (all directions given as you face the property) to your neighbours did not and the wall had suffered.

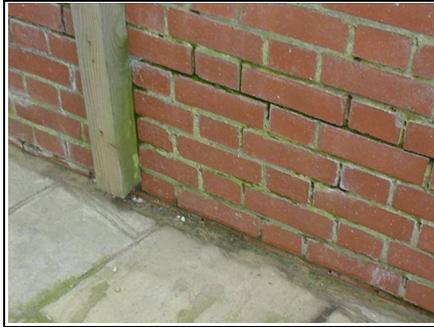
Close up of retaining wall

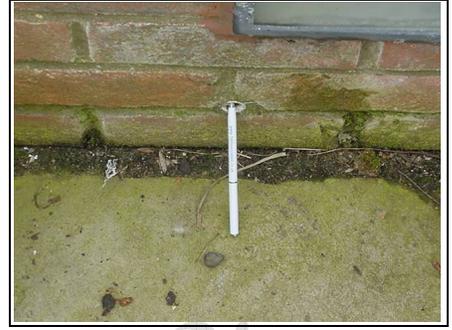
Weep holes to rear wall

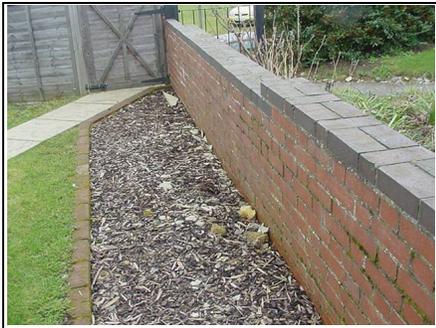
Left hand boundary wall to the front of the property would benefit from re-pointing

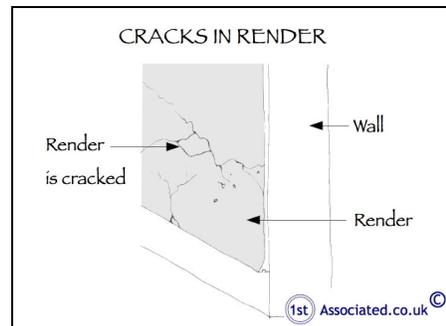
6.0) Crack in render to the rear of the property

To the rear of the property there is a crack to the smooth render that has been added. This could be for a number of reasons, we feel the most likely is that there is too much cement in the render mix or the applied render is too thin. Or finally, and it is something we do need to make you very aware of, the cracking could relate to problems within the metal structure.

Crack to render at the rear of the property

ACTION REQUIRED: As mentioned earlier in this report we would recommend opening up to examine the base of the columns in the structure at the existing owners cost.

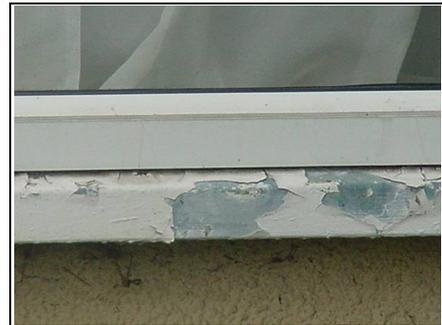
One characteristic of the property is a metal frame around the windows which will cause cold bridging, possibly condensation and will be in need of re-painting regularly.

Close up of metal surround to window

ACTION REQUIRED: You need to check that you are happy with this characteristic as well as the other characteristics of a non traditional constructed building as you cannot change them without literally re-

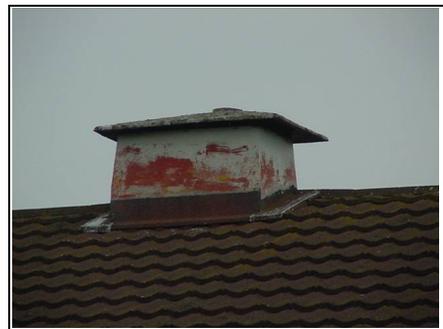
Chimney originally looked like this

ACTION REQUIRED: Remove the asbestos and periodically inspect the chimney as in particular sometimes dampness does get in around the flashings.

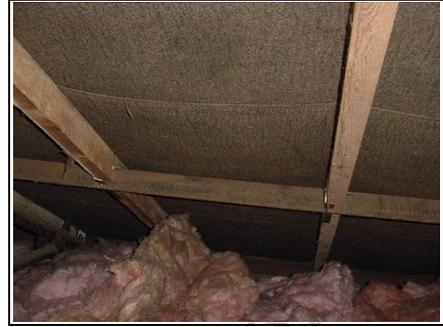
When we inspected the loft space we found a Hessian base Bitumen membrane. This type of membrane has been used since the 1960s. We would imagine a re-roofing was carried out in the 1970s. We generally found it to be in average condition, with damage in some areas which is what we typically find.

This photo shows the common rafters (the ones that form the pitch of the roof) and the dark area between is the underlayer.

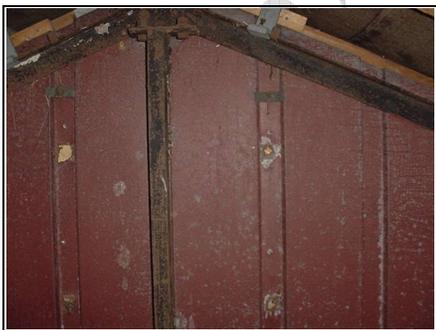
Please see our comments in the Executive Summary with regard to the rust that we could see in these areas and also our thoughts with regard to increasing the ventilation of the roof to reduce any possibility of condensation.

Gable end original metal

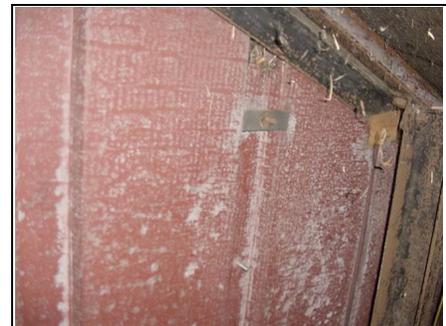
Just a reminder that your outside wall is a metal sheet

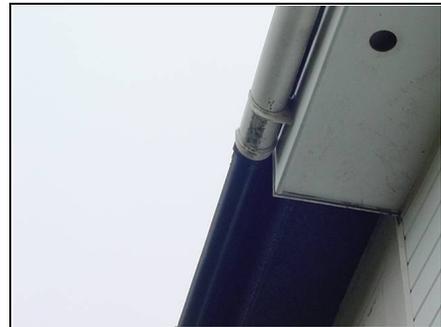
Different style guttering

ACTION REQUIRED: We would always recommend you stand outside the property next time it rains heavily and see how well the drains cope with the rainwater particularly looking at the guttering and the joints. We would always recommend that the gutters and downpipes are cleaned out, the joints are checked and the alignment checked to ensure that the gutters fall towards the downpipes.

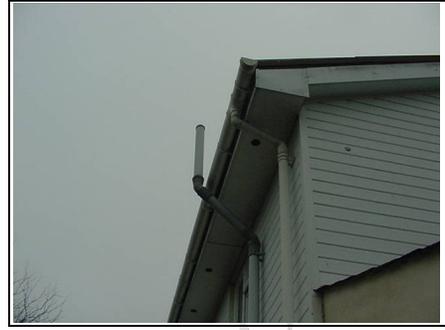
Soil and vent pipe

The property has plastic soil and vent pipes visible, originally this would have been asbestos, we could not see any of this remaining it does need to be checked when you are looking at the asbestos lining to the old chimney.

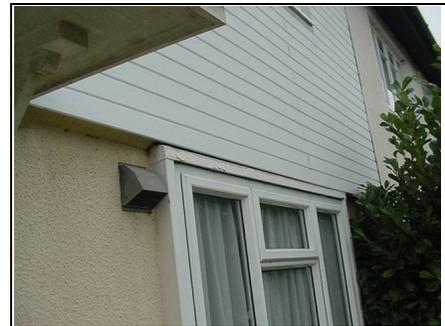
The walls to this property are finished in a mixture of stipple and smooth render. The stipple render is to the front and the smooth render is to the rear.

Cladding and stipple render to the front

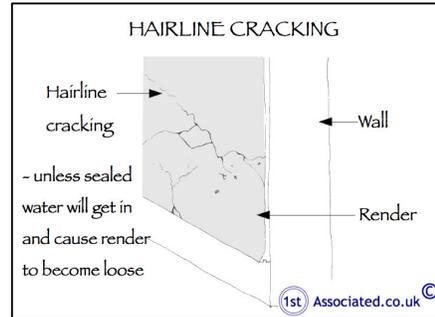
There is cracking to the render at the rear which may relate to movement in the structure as often around windows as they are openings in the structure and therefore weak points such movement can be seen.

This movement could relate to expansion or deterioration of the metal frame which is why we are recommending opening up of the structure.

There is some hairline cracking to the rear which needs to be sealed as soon as possible to stop dampness and water getting in causing sections of the render to need to be re-rendered.

Cracking to render at rear

ACTION REQUIRED: Please see our comments in the Executive Summary.

There is a fair amount of painted render to the front and the side of this property that will need painting periodically. The rear of the property would benefit from painting as soon as possible as a protective layer and of course the sealing of the crack to the render around the rear window.

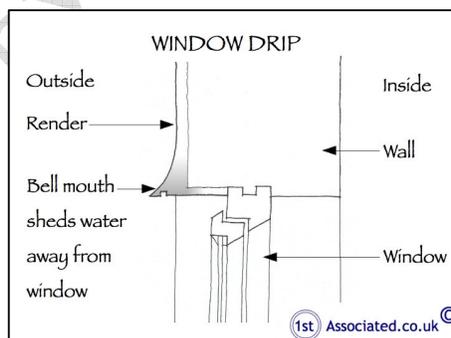
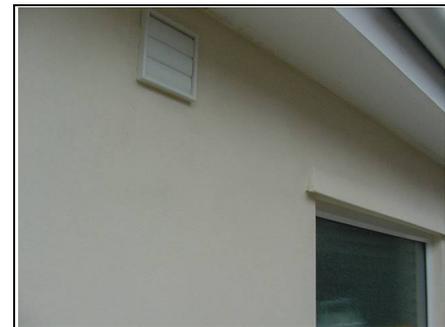
Window drip

In this case we found a drip detail over the windows.

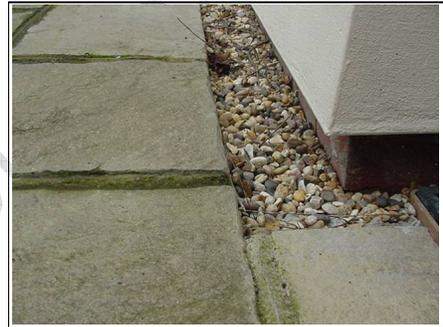
No bell mouth

ACTION REQUIRED: Lower the ground slightly.

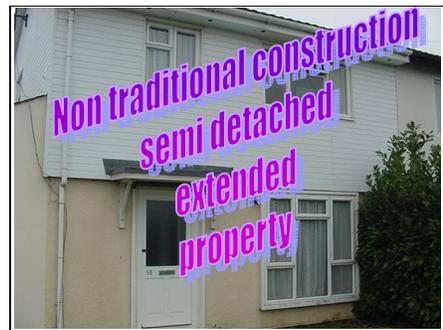
Cladding

The property has plastic cladding as do many of the surrounding properties and looks as if it was carried out as part of a larger contract. The cladding looks to be from what is considered to be the cheap to middle end of the market; today better is available.

Our concern is there is a lack of thermal insulation where the cladding is which means that the rooms may not be as warm as you may wish.

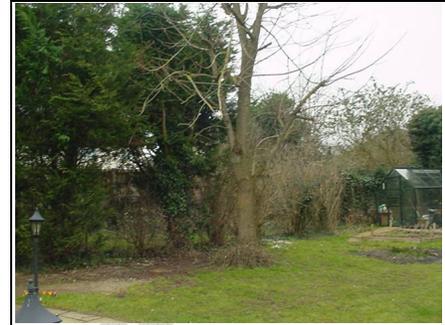
There are trees nearby but we would say they are outside influencing distance of the property.

The tree is located in the rear garden

ACTION REQUIRED: Regular maintenance of the tree is required.

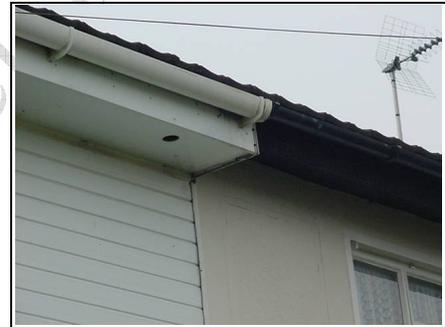
Fascias and soffits

The fascias and soffits are plastic with vents. We would comment they are in average condition for their age, type and style. Please note our comments with regard to the lack of a feel of ventilation in the roof which needs to be checked whether the air vents are clear. Also there may well be asbestos fascias and soffits hidden underneath this as often we find they are not cleared.

ACTION REQUIRED: Check the vents to the main roof are clear and working and not for show only!

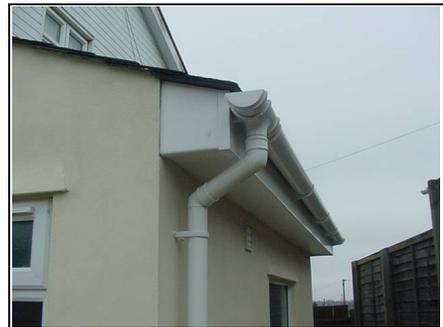
The fascias and soffits to the extension do not require vents as they have a breathable protective felt.

Fascias and soffits on extension without vents as it has got a breathable felt

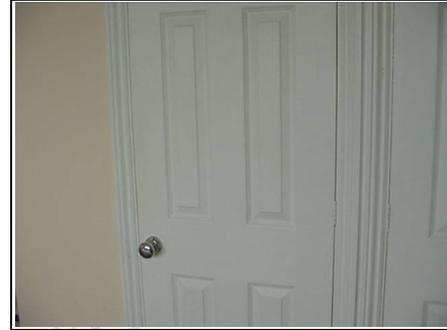
The original doors have been replaced with a modern hollow core panelled doors.

Hollow core panelled door

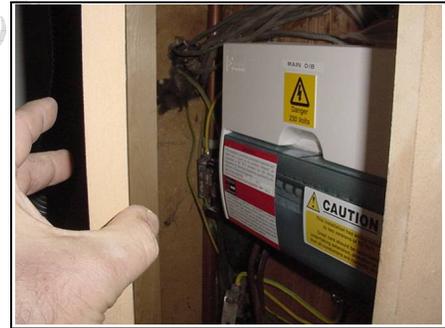
Fuse Board

The electric fuses and consumer units were located under the stairs. The fuse board looked relatively new.

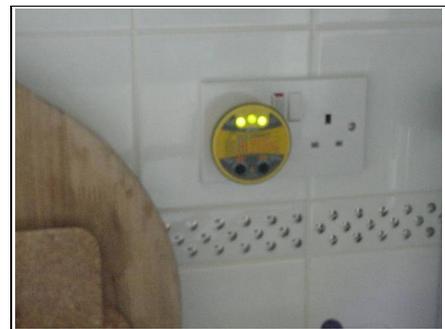
Earth Test

We carried out an earth test in the kitchen area to the socket point that is normally used for the kettle, this proved satisfactory.

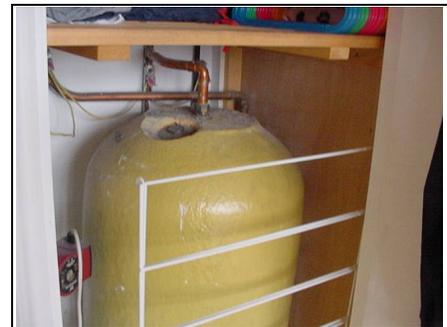
Hot water cylinder

There is a hot water cylinder located in a factory insulated, which indicates that it is relatively new (in this case we mean in the last 30 years). This cylinder will therefore have a good thermal efficiency, although not as good as the more modern hot water cylinders.

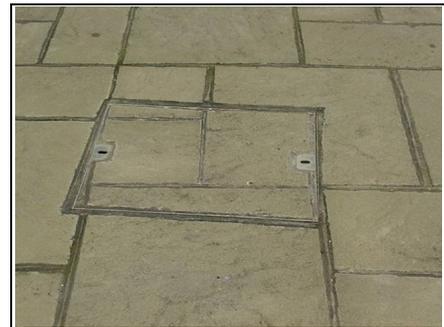
Manhole

We were unable to lift the manhole at the time of our inspection and therefore cannot comment.
