# RESIDENTIAL BUILDING SURVEY

Tenbury Wells,  
Worcestershire  
WR15 XXX

FOR

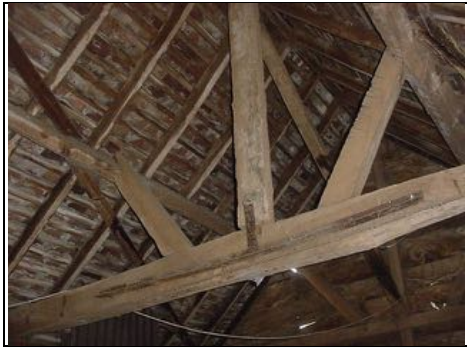
Kingpost truss roof of sorts stabilised with a metal brace

There are two kingpost truss roofs; a more modern one to the main house and a medieval style kingpost in the barn with metal brackets and metal cable to help stabilise it.

**ACTION REQUIRED:** Repair work required to both roof structures.

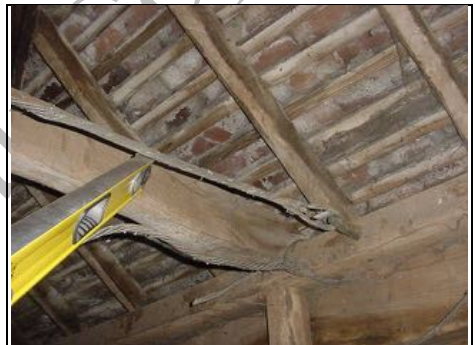
Tension wire

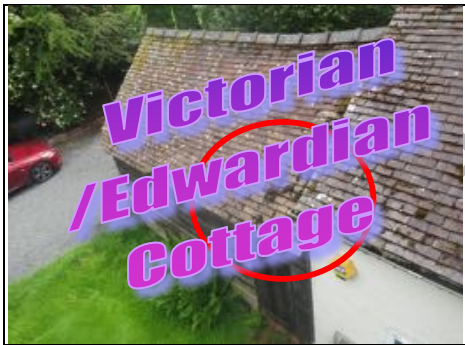
Ad hoc roof work is required generally to both roofs and specifically to the barn roof to make it watertight.

Barn roof

**ACTION REQUIRED:** We would recommend the moss is cleared with a soft brush and carry out ad hoc repairs to the roofs. The main repairs are required to the barn. Add lead flashing between the main house roof and the barn roof. Care needs to be taken when on the barn roof until the structure is stable.

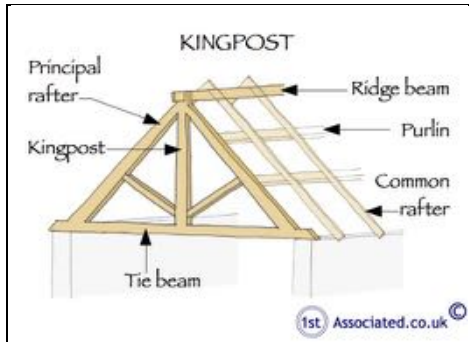
Interestingly, the kingpost to the house looks relatively new, in this case we mean the last fifty or so years. However, looking at the tiles externally it does not look like any work has been carried out to these.

Kingpost

**ANTICIPATED COST:** For repairs to existing roofs and possibly new kingposts we would set aside the sum of £2,500 - £5,000; please obtain quotations.

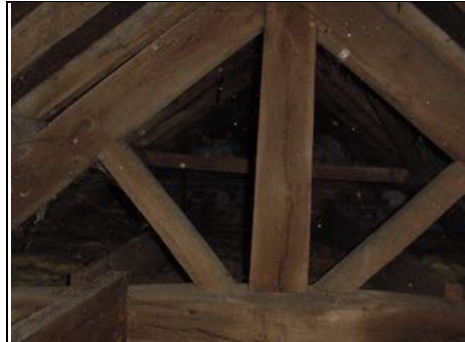
King post roof of main house

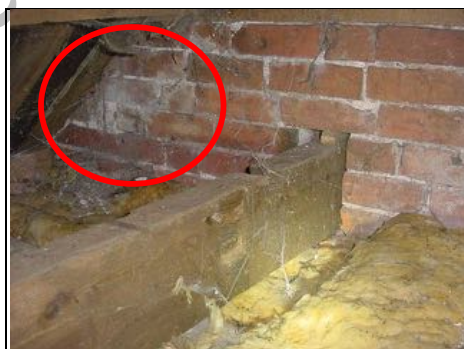
Dampness to right gable

**ACTION REQUIRED:** Repoint and repair the gable end walls and stop the dampness getting in with repairs to the roof. Monitor the woodworm using woodworm traps whilst you live in the house with the heating on!

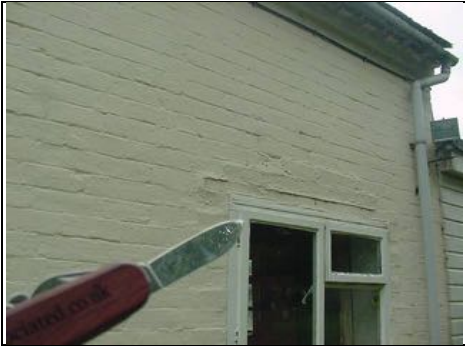
Movement around window

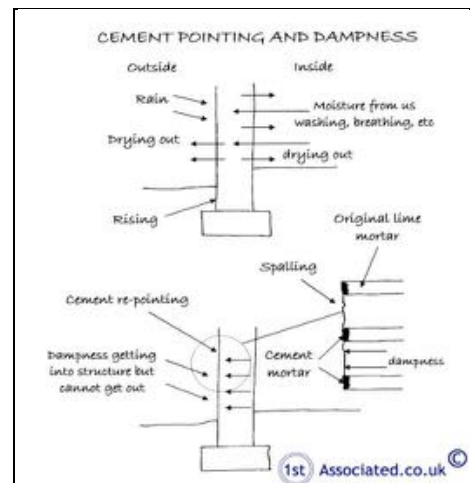
Walls need to breathe

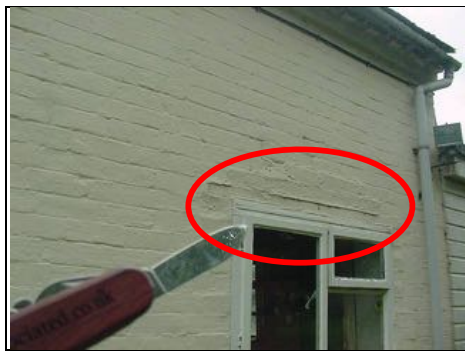
To the front of the property there are timber lintels. It may well be worth taking these out completely. You can replace them with a timber lintel or with a metal lintel.

Timber lintel

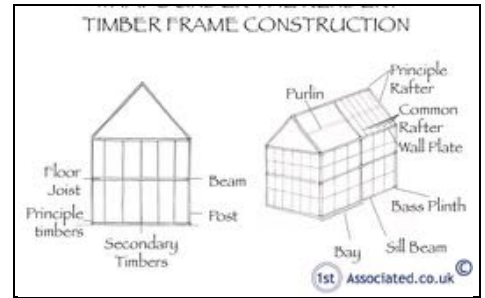
There is some unusual timber work in the building for example the kingpost roof in the main building which looks relatively new. It may be that this was once a timber frame structure and it has had brick walls built around it over the years; we simply do not know. It would be great to speak to someone from the family who owns this property.

Timber frame structure

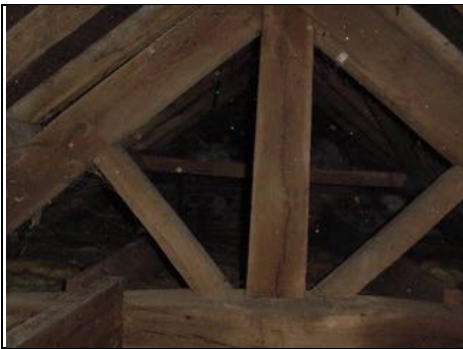
Kingpost truss roof

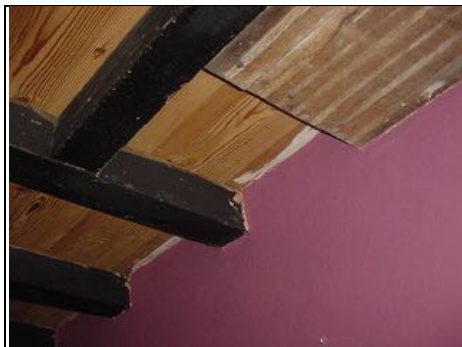
Timber to underside of ceiling/floors

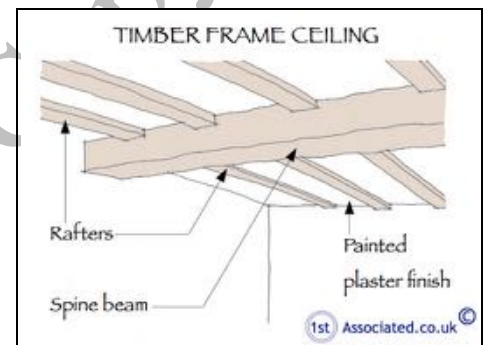
Timber frame ceiling

**ACTION REQUIRED:** It would be interesting to find out the history of this property and look at any old photographs.

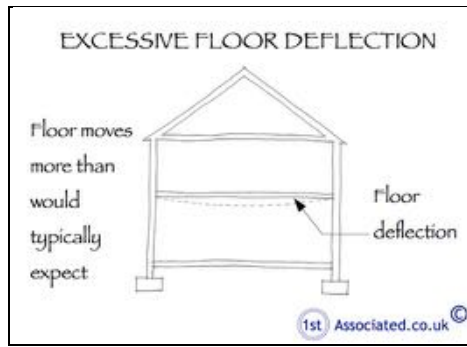
Excessive floor deflection

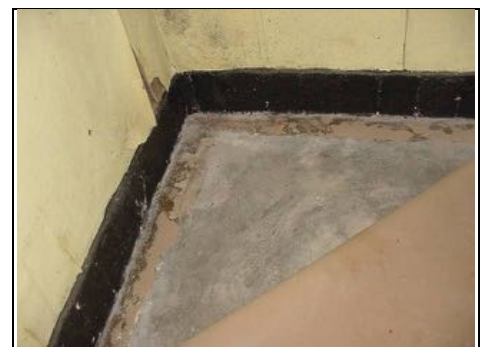
We discussed whether a timber floor could be put on top of it; normal good practice would be to batten particularly if an oak floor was going in as we discussed. You could in theory scabble/cut back the concrete floor. There should have been a screed of 50 to 75mm put on it before you have the concrete underneath. With this type of property in the middle of nowhere it really is anyone's guess what has happened. You could take a core sample of the floor to see what is in it before you did anything. We would add that if you were going to do a lot of work to the floor we would add a warm floor heating system as well.

Concrete floor

**ACTION REQUIRED:** Live in the building and see how dry it gets as this floor will act like a piece of blotting paper. We mentioned elsewhere within this report about lowering the ground level which should help.

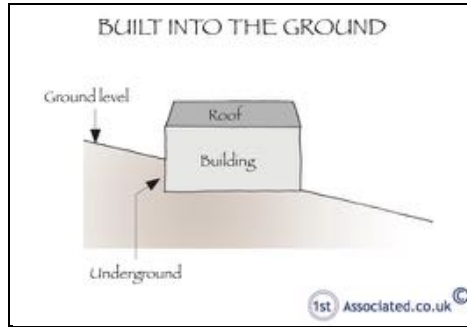
High ground level

**ACTION REQUIRED:** We would recommend that you reduce the ground level around the building wherever possible and add a drain around the building in the form of a French drain, traditionally approximately a shovel width by two shovels deep and in more recent times it has a perforated pipe at the base of it to take the water away to a drainage system.

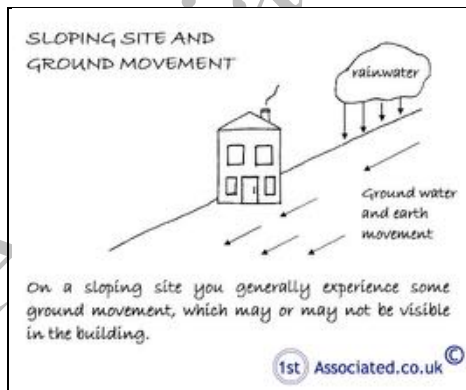
In addition, the property sits on a sloping site (sketch is an exaggeration of slope of course) and because of this rainwater and ground water need to travel from the top of the site (car port/barn area) to the bottom and doing this brings dampness into the building. Sloping sites are not as good as level sites and buildings on them are integrally unstable. You need to understand this is a characteristic of any building sitting on a sloping site.

Sloping site

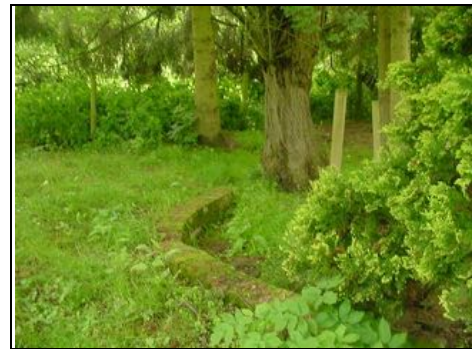
Sloping site

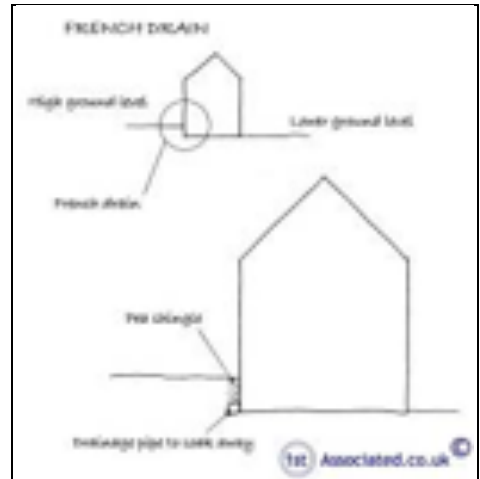
French drain

**ANTICIPATED COST:** To add a French drain system around the property and also form a drainage system of soakaways is quite expensive. We would expect costs in the region of £2,500 - £5,000; please obtain quotations.

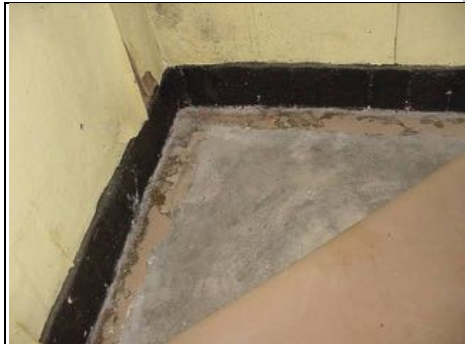
The property suffers from some condensation/black mould which could relate to how the building has been lived in, i.e. it has been heated but not aired by opening of the windows, extract fans, etc. (in fact, it would be difficult to open some of the windows).

Mould to corner

**ACTION REQUIRED:** We would recommend large good quality humidity controlled extract fans are added to the kitchen, the bathroom and any areas that are used for drying clothes internally during winter months (we would assume that clothes will be dried externally during the warmer months). By large extract fans we mean 150mm.

**ANTICIPATED COST:** We would anticipate costs between £250 - £500 per extract fan depending upon the wiring required. We always recommend quotes are obtained before work is agreed/commenced.

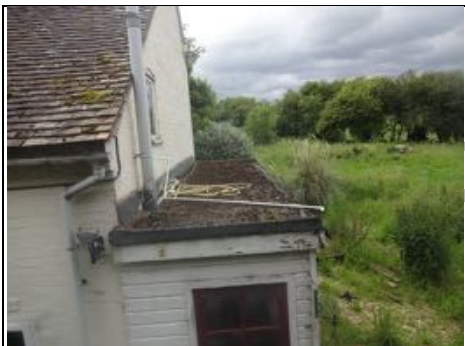
There is a storm porch running the length of the right-hand gable. The roof was covered with moss indicating that it is a flat roof and water is not discharging from it.

Flat roof to porch on right

**ACTION REQUIRED:** We would suggest you clear the roof to see its condition and it is probably best if you put a layer of felt over the top of it and check the flashings. Also, add guttering. Ultimately, we would recommend that you put a pitched roof on this.

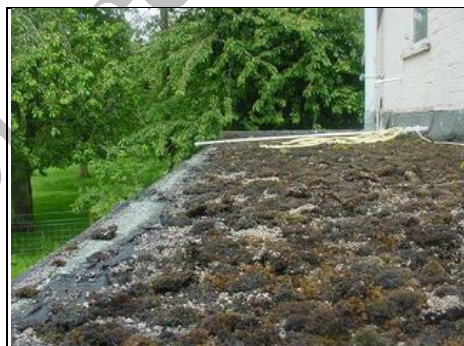
Moss to flat roof

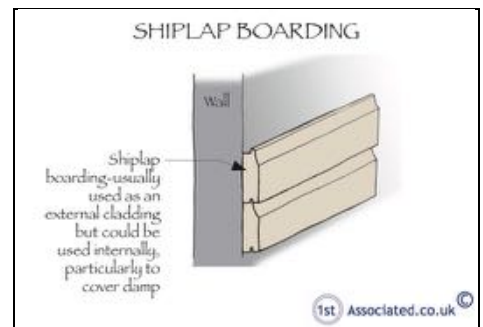
Shiplap boarding

**ACTION REQUIRED:** We recommend stripping back all of the shiplap boarding, adding insulation between the timber frame and then putting new shiplap boarding on the entire structure and redecorating. There would be some associated repairs with this around the windows and doors as well as adding the guttering of course.

**ANTICIPATED COST:** £1,500 - £3,000 depending on whether you are happy with some DIY work; please obtain quotations.

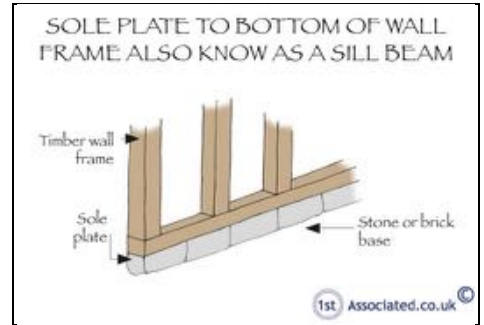
As mentioned you need to carry out work to the structure of the roof and also the repairs to the roof tiles as well as adding guttering. This in turn will then stop the mould and the dampness that we can see for example to the rear base of the barn. Rainwater is discharging onto the brickwork and to the front it is discharging onto the timber sole plate.

Sole plate

Guttering needs to be added to the barn. Once you have added gutters you then need to replace the shiplap boarding to the side and to the gable end, you may well be able to re-use some of the cladding. By adding guttering to the building will make it a lot better.

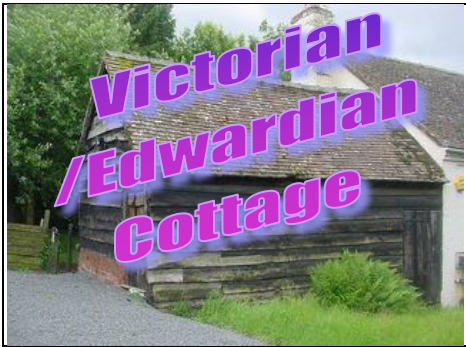
No gutters

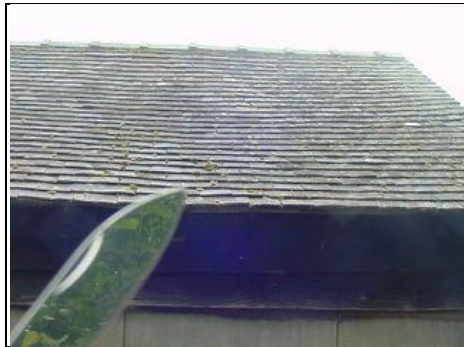
Water discharging down front of barn

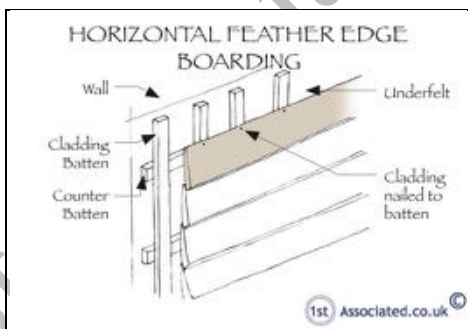
Feather edge boarding

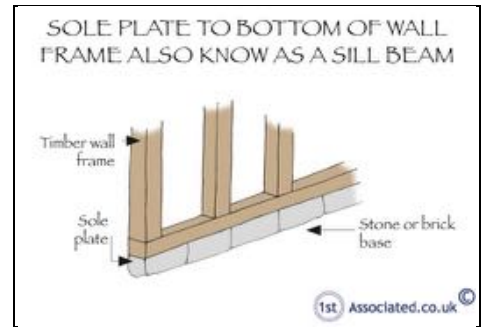
We discussed converting this into a kitchen area which means it would have to be brought up to modern day standards. The framework within the barn is 600mm to 700mm wide; we would expect it more typically to be 400mm to 450mm.

Sole plate

**ACTION REQUIRED:** The timber that we knife tested is not doing too badly. We would suggest extra timbers are added in between the existing timbers and that repairs are carried out to some of the existing timbers including the sole plate that had some wet rot in it. There was not an excessive amount considering it was a sole plate.

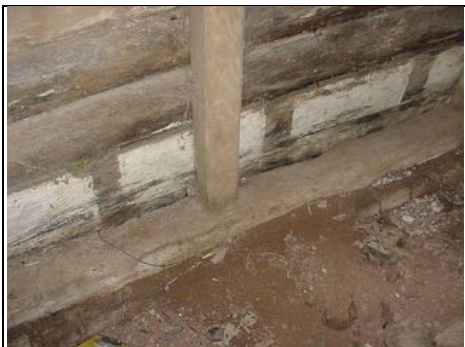
Sole plate and vertical timbers

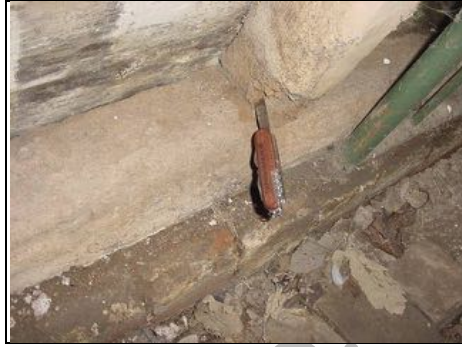
Base of vertical timbers

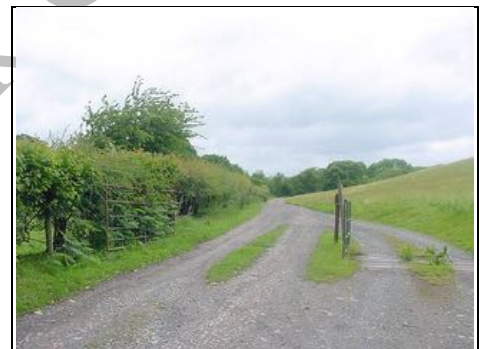
Private access road

**ACTION REQUIRED:** You need to ensure your solicitor checks as to what your liabilities are and repair responsibilities with regard to the road.

**ANTICIPATED COST:** These searches should be included in your solicitor's searches. The costly part would be if you have a liability to maintain the road; please obtain quotations.

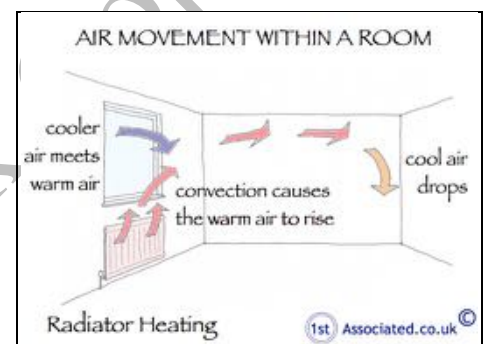
We noted the radiators are internal in some areas. This is often carried out on cheaper central heating systems to save the labour and piping costs of positioning the radiators underneath the windows. However, it then reduces the air movement in the room, which can lead to black mould.

Air movement

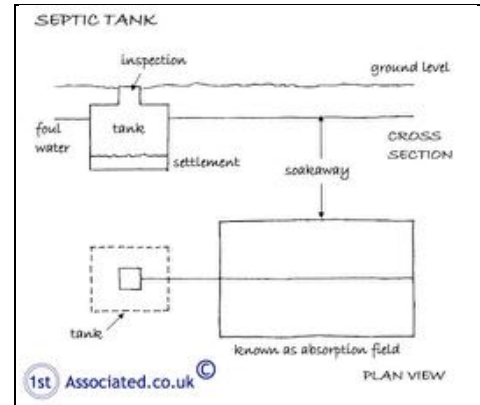
We assume the property has a septic tank however we were unable to find where the septic tank is. It is usually at the lower end of the site which would be the right end. There was no obvious manhole/drainage system to indicate where it is.

Septic tank

**ACTION REQUIRED:** Your legal advisor to specifically ask where the septic tank is.

We would recommend that you have the septic tank emptied and whoever empties it takes photographs of the outside and most importantly the inside and we are provided with the telephone number of the company emptying it to discuss with them.

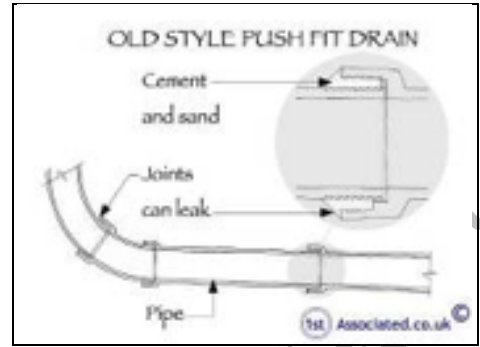
In older properties, such as this, drainage was often push fitted together rather than bonded together which means that they may leak over the years. Whilst we ran the tap for 15 minutes without any build up or blockages the only way to be one hundred percent certain of the condition of the drains is to have a closed-circuit TV camera report.

**ACTION REQUIRED:** We would recommend a closed-circuit TV camera report of the drains.
