JOB REFERENCE: EX41963/RBSG2E/MH/MB2

## RESIDENTIAL BUILDING SURVEY

XXXXXX  
Northampton  
XXX XXX

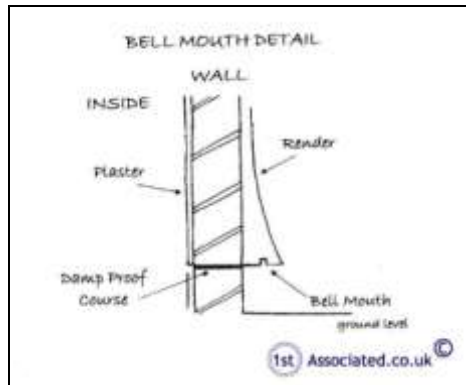
To the rear of the property there is a large area of painted render which looks like it has been finished in a harder cement mortar. We could also see cracking in it and what looks like cement mortar repairs as well. We would prefer a bell mouth detail here.

Bell mouth detail

**ACTION REQUIRED:** Interestingly, if you look to add drip details on this we would discuss it with the Listed Building Officer before you do it. Although it is a defect it may be considered part of the style of this property.

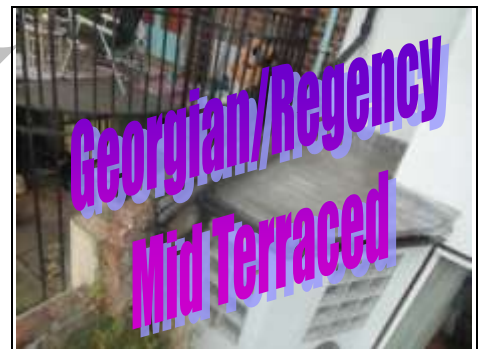
- 1) Lower ground floor front room changed to a utility/bathroom area
- 2) Rear room changed to kitchen area
- 3) Associated rear right area changed from toilet to boiler room
- 4) We can also see some fairly modern alterations such as the glass to the front of the property.

Toilet area changed to boiler room

**ACTION REQUIRED:** We would recommend legal advisors obtain a full list from the present owners as to what they have and have not done and what they consider previous owners have not done. Then arrange an informal 'cup of tea' meeting with the Listed Building Officer and show them the list and ask if they have a photographic record of the property as many local authorities do have. We noted it was originally listed on

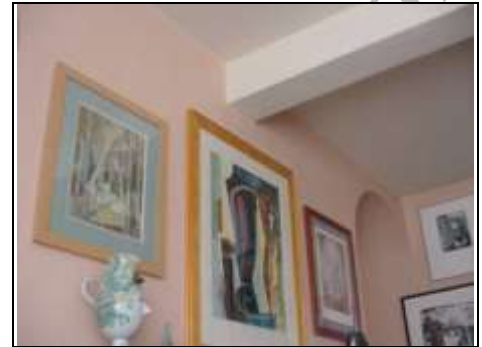
As with many properties of this age walls have been removed and the stairs have been altered for example today on the ground floor where the beam is you would be required to have a 450mm for it to be supported however the property has obviously stood the test of time.

No return to removed wall

The owner advised the extension and reposition of the staircase was carried out in xxxx.

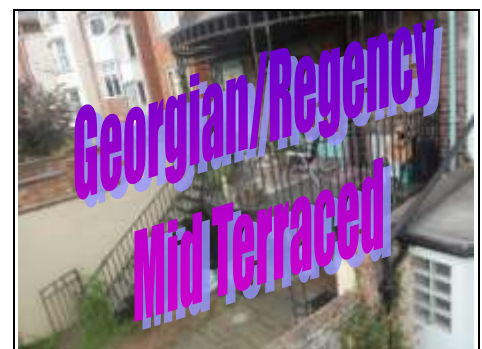
Next door have an upper ground floor level balcony which is a nice design we believe however it does mean that when they are sitting out in their garden they overlook your garden which may or may not suit you, it certainly would not suit us. You may wish to revisit to check this.

Next doors balcony overlooks your garden

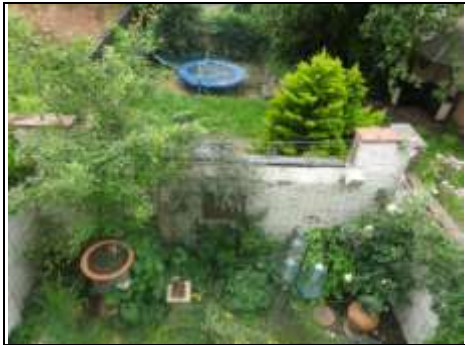
The rear garden wall is slightly unsafe and worse for wear. We could see it is built in a red brick which is starting to deteriorate and also some of the capping is not ideal, possibly because of the conifers and trees nearby. We tend to find that garden walls are built without proper foundations.

Rear garden wall and surrounding garden

**ANTICIPATED COST:** We recommend you set aside the sum of £500 to £1,000 (five hundred pounds to one thousand pounds) assuming that the adjoining owners will also pay some money.

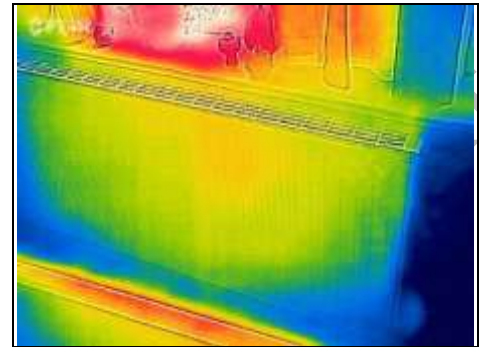
We gave the owners the opportunity to turn the heating on and warm the house up for a ten minute test however unfortunately we could not get any of the radiators warm.

Heating not working

There is a Baxi boiler located in the kitchen. We are advised the boiler was installed in xxxx. We would recommend that the system be tested and overhauled before exchange of contracts and that a regular maintenance contract is placed with an approved heating engineer.

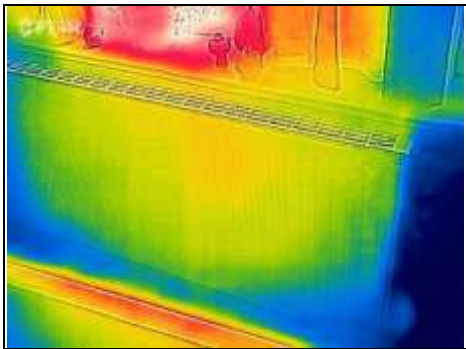
Heating not Working

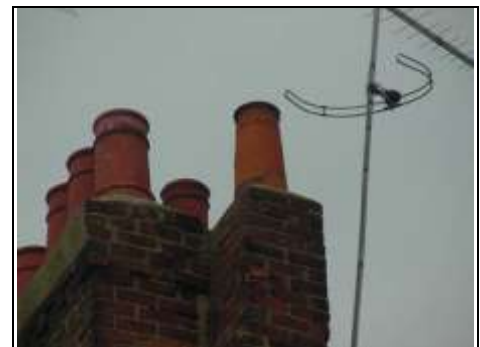
This is a large brick chimney with a lead flashing and numerous chimney pots. From what we could see from ground level we noted some deterioration to the soft red brick.

We noted aials attached to the chimney which we are not keen on as it cuts into the brickwork rather like a cheese wire cutting into cheese.

Closer view of chimney

**ACTION REQUIRED:** Check the chimney when carrying out the high level roof work as it is built in soft red brick.

**ANTICIPATED COST:** Set aside a few hundred pounds; quotations required.

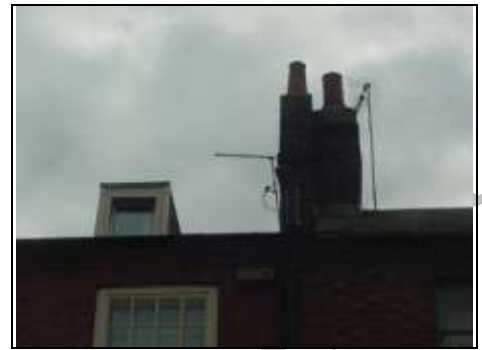
The property has a dormer window to the front and rear which were very difficult to view. The dormer window roof and cheeks are made from lead, we could not see any leaks internally. They have metal double glazed windows.

Front dormer window

**ACTION REQUIRED:** The dormers need to be checked when high level work is being carried out.

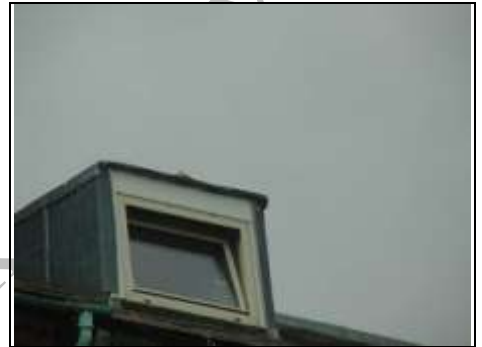
Rear dormer window

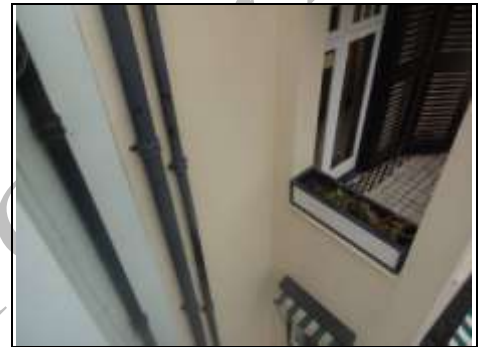
The property has cast iron gutters and downpipes which are fairly typical of what we see; they are in average condition for their age, type and style. There may be some rust however our inspection was limited from ground level.

There may be some minor leaks but most people would be happy to live with these providing repairs are carried out within the next six to twelve months.

Cast iron downpipes

**ACTION REQUIRED:** We would recommend you stand outside the property next time it rains heavily and see how well the drains cope with the rainwater particularly looking at the guttering and the joints.

We also recommend that the gutters and downpipes are cleaned out, the joints are checked and the alignment checked to ensure that the gutters fall towards the downpipes.

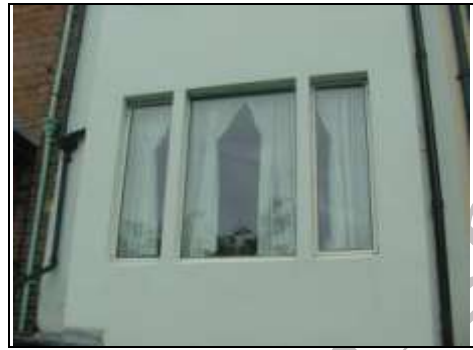
In this case we found no drip detail to the windows.

No drip detail

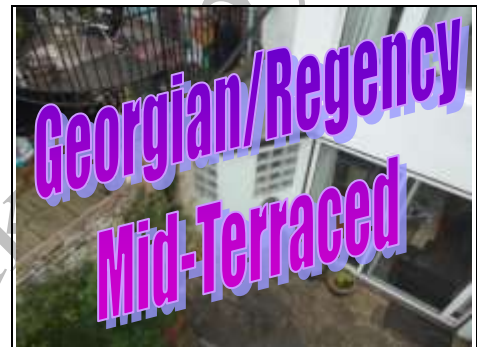
In properties of this age it is unlikely that a damp proof course would have been built in originally however, often they have had damp proof courses added at a later date. In this case we could not see a damp proof course.

Unable to see damp proof course

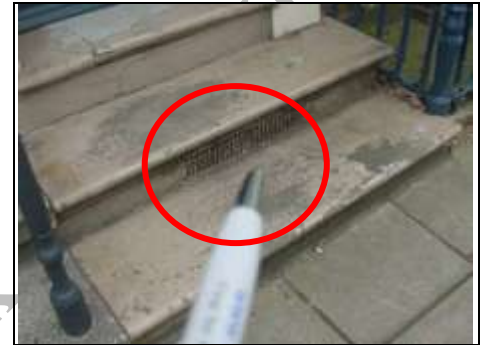
Air bricks are essential to have a through flow of air as this helps to reduce the chances of wet rot, dry rot and woodworm. In this case we noted an airbrick to the front giving an airflow to the lower ground floor/basement.

Air brick to front

**ACTION REQUIRED:** Ensure the airbricks are clear.

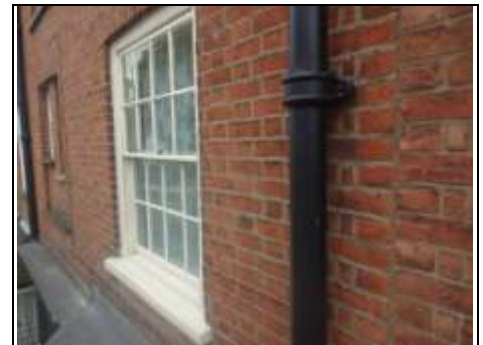
The property has sliding sash Georgian style windows to the front of the property with more modern double glazed metal framed windows to the rear - we are advised these replaced crittal style windows to the rear bay; we would be very interested to see if there was any listed building consent on this. We were advised the windows were replaced in xxxx.

Georgian window

**ACTION REQUIRED:** Your legal Advisor needs to check and confirm if there has been any listed building consent for alterations to windows.

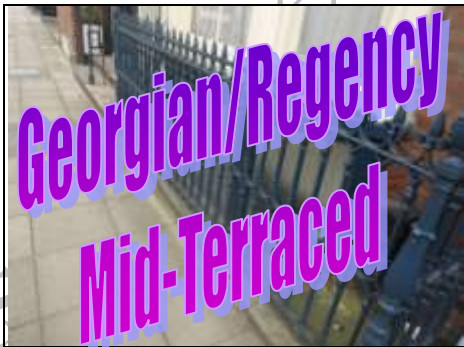
We think the area that is glazed gives natural light into the downstairs bathroom/utility room. This will be susceptible to dampness and water getting into this area.

Glazed area below railings area

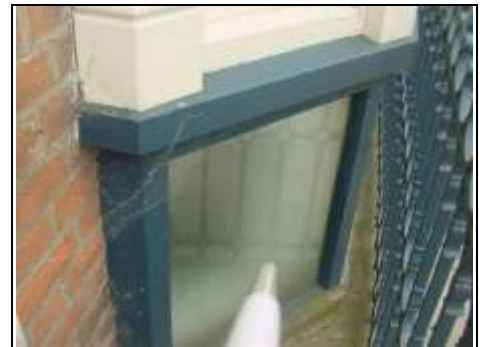
Glazed area

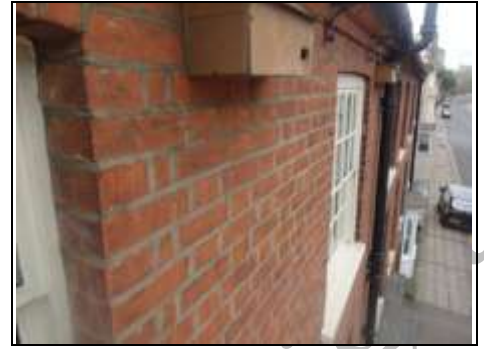
We noted a nesting box for swallows to the front of the property.

Nest for swallows

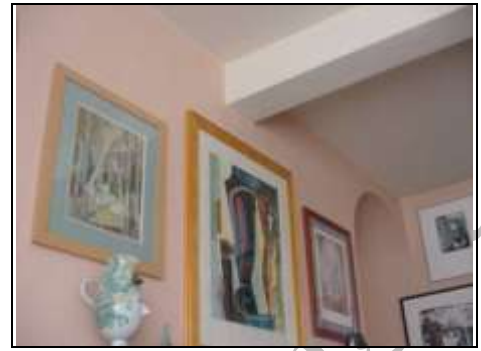
These are, we believe a mixture of solid and studwork construction. It is impossible to determine the construction without opening up the walls and we have therefore taken an educated guess. Some walls look to have been removed to accommodate the altering of the staircase.

No return to removed wall

**ACTION REQUIRED:** Please see our comments in the Executive Summary.

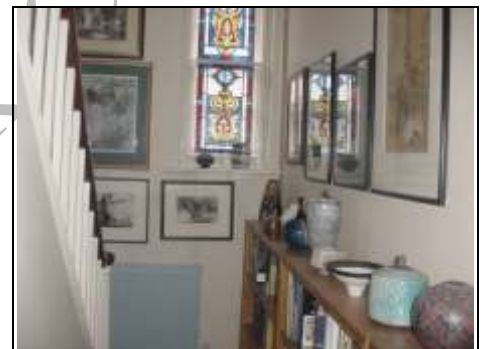
Again, we cannot be 100% certain of the wall construction without opening them up which goes beyond the scope of this Report. Normally we would look to see if the walls had a smooth finish; it is very difficult to gauge when there are so many pictures on the walls.

Pictures limited our view

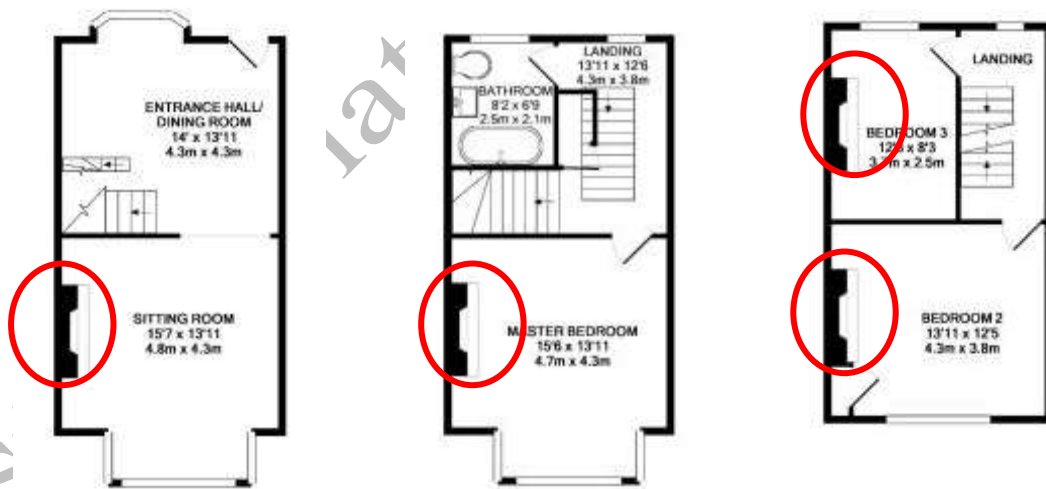
## Missing chimney breasts

During our question and answer session with the owners we discussed missing chimney breasts. The layout plans show one chimney to the upper ground floor and first floor and two chimneys to the second floor. These were probably removed when the staircase was altered.

Your Legal Advisor needs to specifically check with the Local Authority for removed chimneys and associated chimney breasts and Building Regulations Approvals and advise by e-mail immediately if chimney breasts are found to have been removed. We would recommend opening up the structure to check the condition. If we are not advised we will assume the relevant Building Regulations Approval has been obtained.

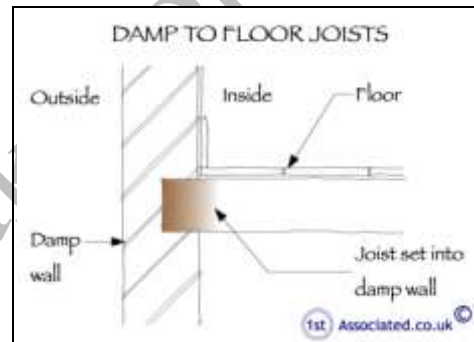
We have assumed that the first floor construction is joist and floorboards with embedded timbers, as this is typical in this age of property.

Embedded timbers

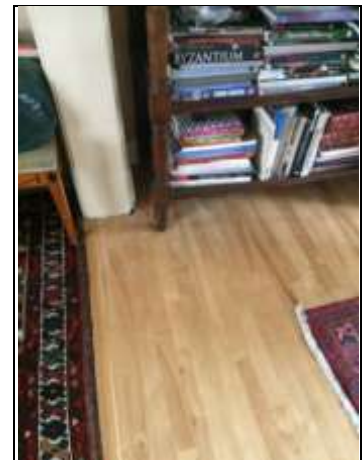
We normally find these floors have undulations and are not level and true however in this case as laminate floor is used in some areas this hid the true condition of the floors.

Laminate floor to upper ground floor

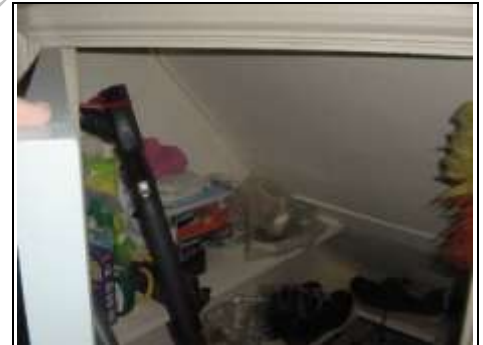
We were unable to examine the underside of the stair timbers due to it being lined where we could see it, which precluded our inspection, so we cannot comment further upon the stair structure. We can, however, say that the lining gives a resistance to the spread of fire if such circumstances were to occur.

Stairs lined

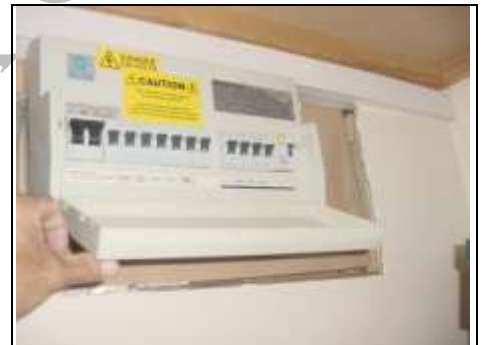
The electric fuses and consumer units were located in the utility room/shower room on the lower ground floor. The fuse board looked 1980's/1990's and better are now available.

Fuse Board

**ACTION REQUIRED:** As the property is changing occupancy an Institution of Engineering and Technology (IET) test and report and any recommendations should be carried out by a NICEIC registered, or equivalent, approved electrical contractor or similarly approved.

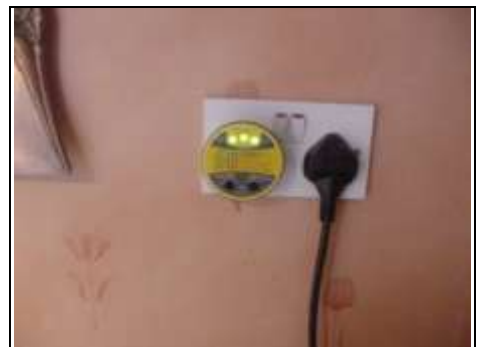
We carried out an earth test in the kitchen area to the socket point that is normally used for the kettle, this proved satisfactory.

Earth test

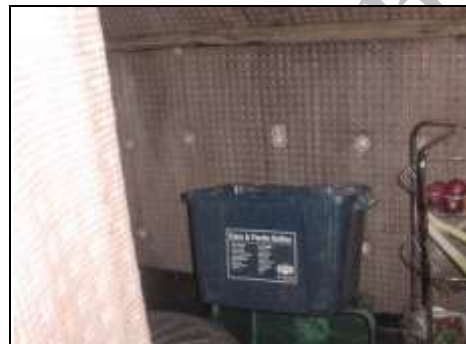
We are advised that the property has mains gas.  
The consumer unit is located in the lower ground floor/basement in the under road storage area.

Gas meter in under road storage area

**ACTION REQUIRED:** As a matter of course it is recommended that the entire gas installation is inspected and made good, as necessary, by a Gas Safe registered contractor. Thereafter the installation should be serviced annually.

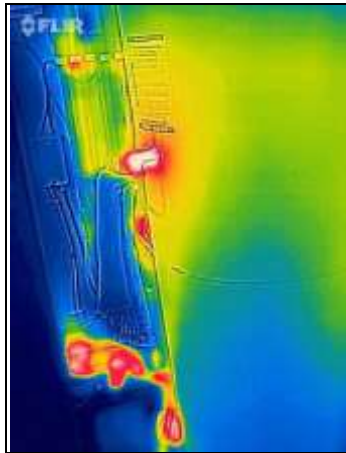
There is an unvented water heater within the boiler room to the rear right.

Unvented hot water cylinder

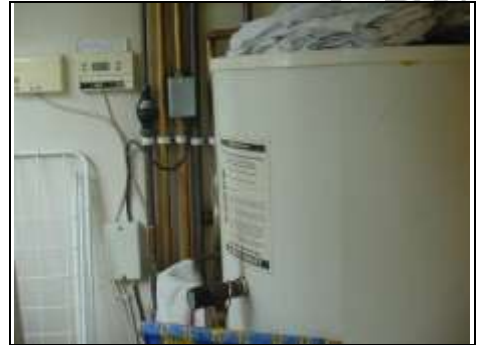
Hot water cylinder

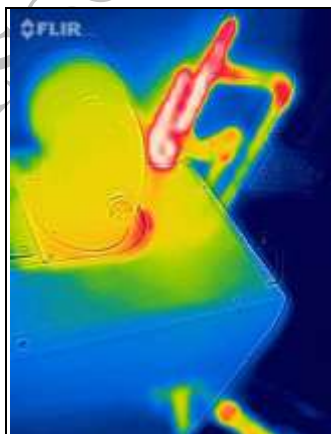
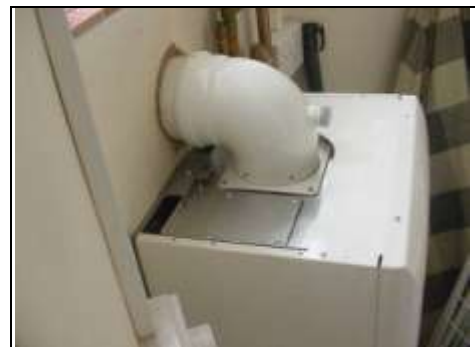
There is a Baxi boiler located in the kitchen. We are advised the boiler was installed in xxxx. The heating was last serviced in xxxx.

Baxi boiler

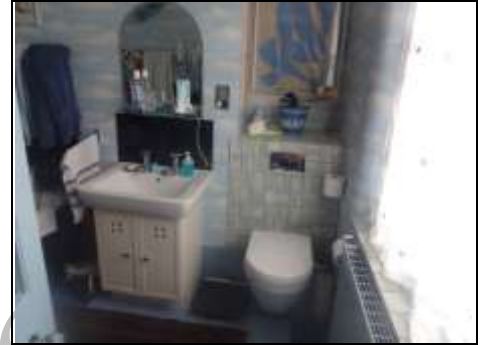
The first floor has a three piece bathroom suite, consisting of a bath, wash hand basin and WC, which looks in average condition.

Front bathroom

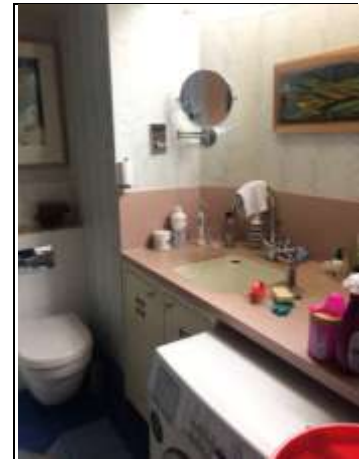
The lower ground floor/basement has a utility room/shower room comprising a shower, wash hand basin and WC which looks in average condition with some dampness as we would expect in a basement location.

Utility room/shower

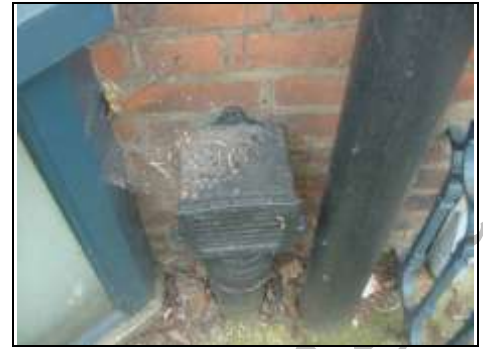
To the front of the property there is a deep vent we assume to the drains.

Deep vent to drain

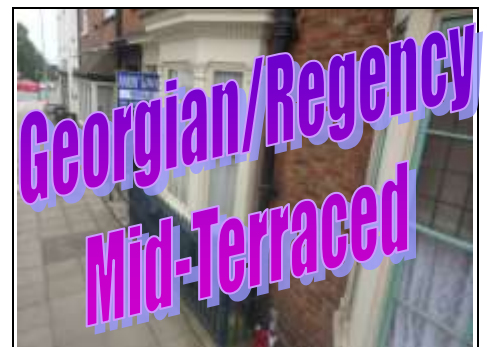
The front of the property sits directly onto the pavement.

Front sits directly onto pavement
