RESIDENTIAL BUILDING SURVEY

Hertfordshire

INDEPENDENT CHARTERED SURVEYORS

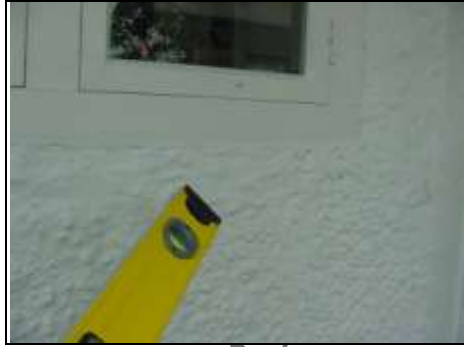
We are having slight difficulty obtaining information to understand exactly what work has been carried out. As with most underpinning work it is now hidden. In this case there are some undulations and poorer quality repairs to the painted render and there are different coloured paving slabs and the tree with the drain next to it however we do not have the exact details of what was carried out. We have the plans with piles around the kitchen area (please see overleaf). We were also given a cross section of piling work however were also advised this was not carried out. We would like to see sketches, drawings and details of information with regard to what has been carried out.

Undulations in the wall

ACTION REQUIRED: Your legal advisor to provide and email electronic information pack to us on all the work carried out thereafter we can comment further.

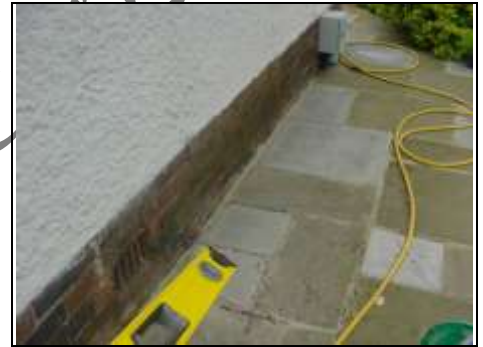
Area of underpinning

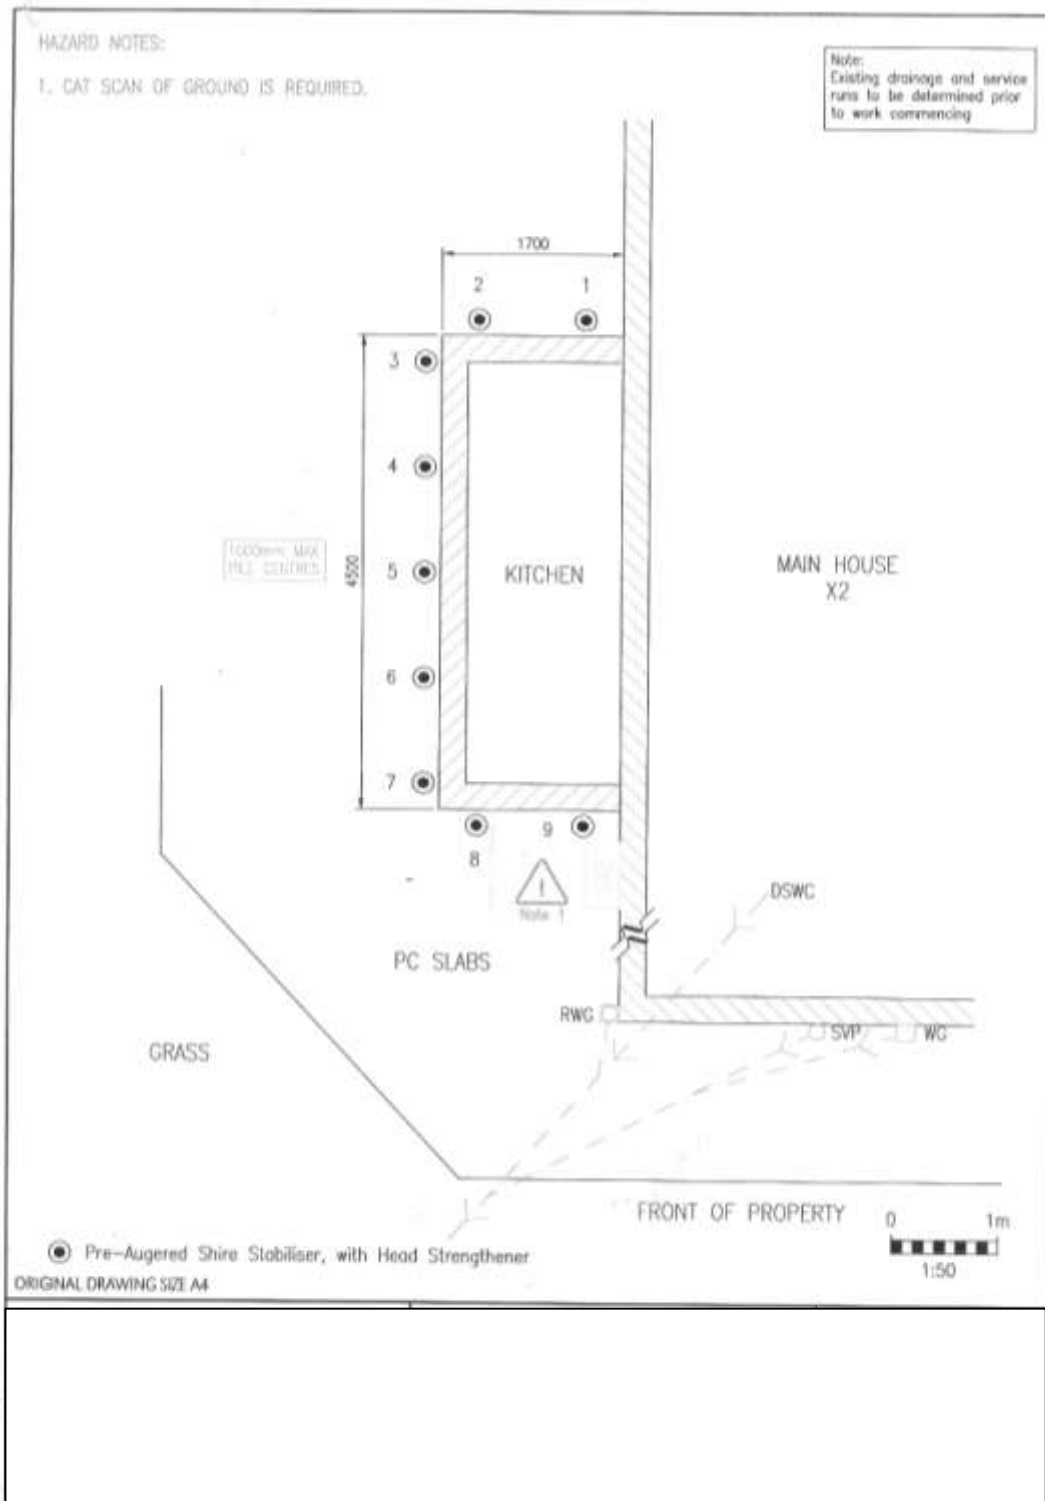
Location of Underpinning

Information on the underpinning work was limited. We would request that we see a full copy of the underpinning documentation.

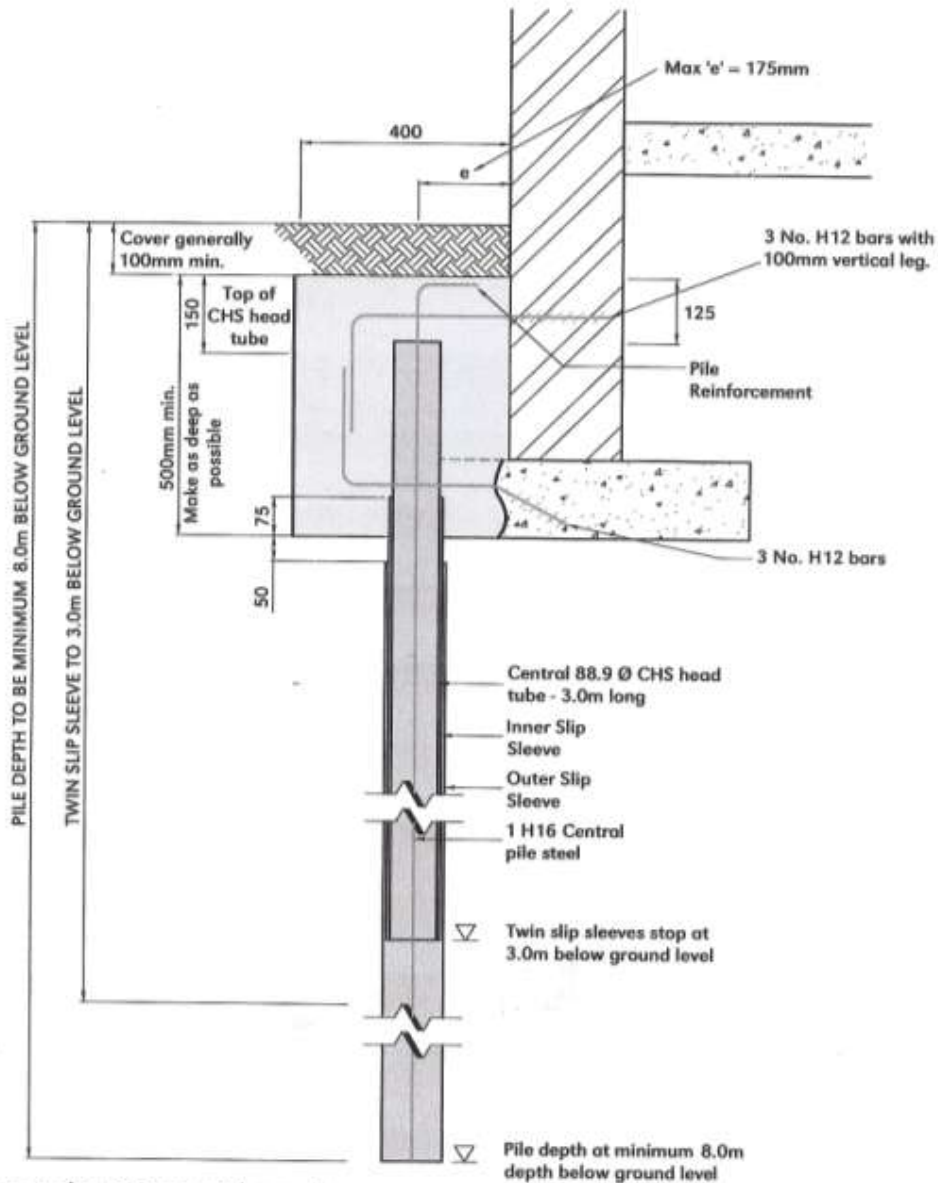
Remedial Connection Detail 3.2.1 Solid Wall & Concrete Foundation - 800-500mm Deep with cover to cap

(Owner advised this was not the type of piping system that was used on the property however it does interestingly show it going down to a depth of eight metres)

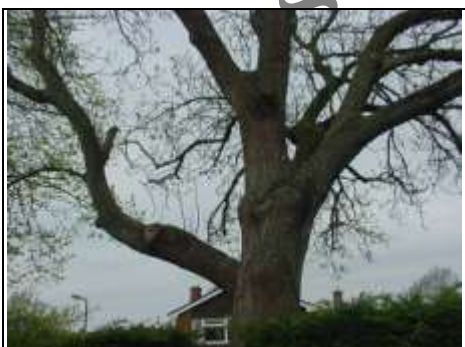
Tree roots in drains

Trees surrounding the property

You also would be best to have a closed circuit TV camera report of the drains to ensure there are no tree roots in the drains.

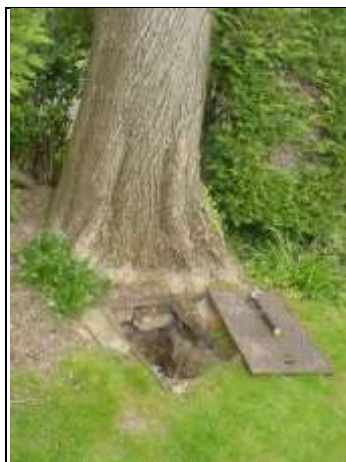
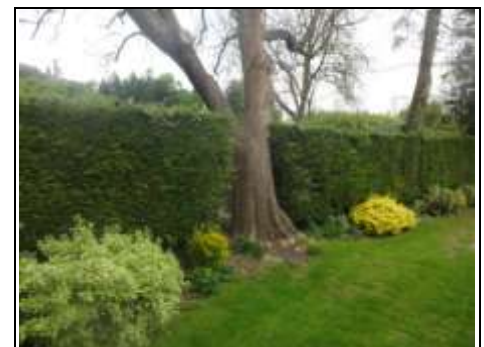
Tree with manhole to base

It is very unusual to have a drain with a tree on top of it as there is at this property. As mentioned, we do feel the tree roots are likely to get into the drains. We can see that the manhole is distorted and deteriorated and it is only a matter of time before the roots affect the drainage on this property.

ACTION REQUIRED: We recommend a closed-circuit TV camera report to establish the condition of the drains and partial rebuilding of the manhole.

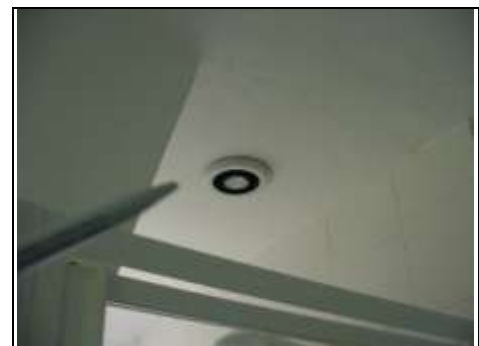
The extract systems in the bathroom and the en-suite are via light extracts and extract into the thatch which we are not keen on. We would recommend these are relocated so they extract to external air however, often this is easier said than done.

Extractor in the bathroom

ACTION REQUIRED: We would recommend large good quality humidity controlled extract fans are added to the kitchen, bathroom, en-suite and any areas that are used for drying clothes internally during winter months (we would assume that clothes will be dried externally during the warmer months). By large extract fans we mean 150mm.

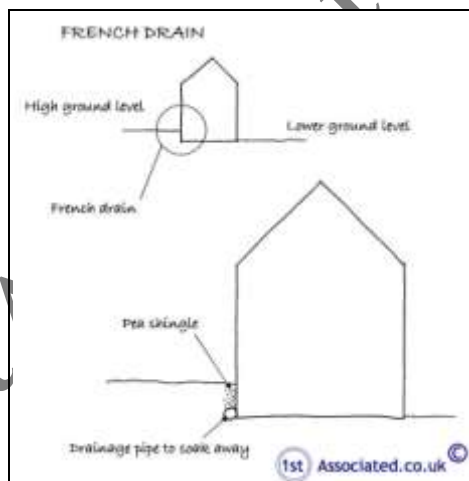
French drain

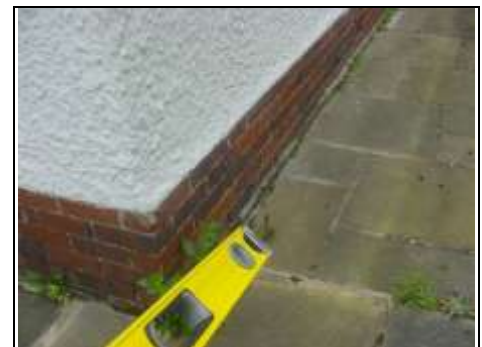
It does look like water discharges against the property at the base. Ideally we would recommend a French drain against the building and also the paving slabs being adjusted so they run away from the building.

Water marks against the building

ACTION REQUIRED: Once you have established what the ground conditions are and seen the property when it has rained heavily it may be

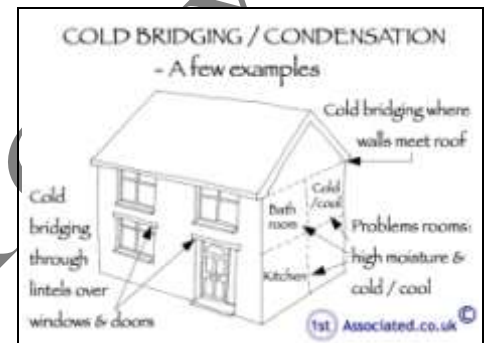
Cold bridging is caused by a colder element in the structure allowing coldness to pass through the structure much quicker when warm moist air is present in the property, often caused by things like having a shower or a bath, cooking or washing, particularly if you are drying washing on the radiators. This is also caused by the general climate which results in condensation on the element.

Cold bridging/thermal bridging

ACTION REQUIRED: Please see our comments with regard to adding large good quality humidity controlled extract fans.

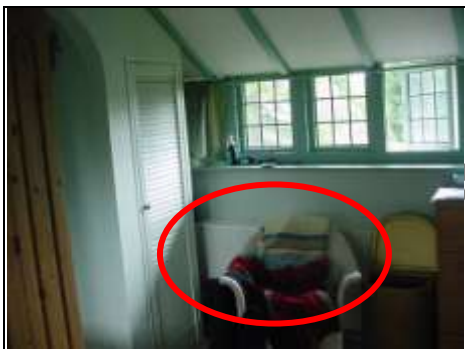
There is a mixture of single and double panel radiators.

Double panel radiator

ACTION REQUIRED: We would recommend these are changed to double panel convection radiators and thermostatic radiator valves etc. are checked and ensured they are in working order. It is probably worth a pressure flush of the system as well.

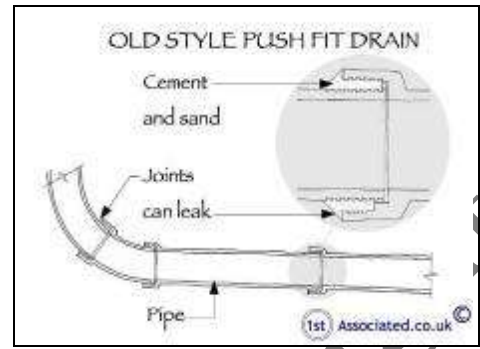
Whilst we have lifted the two manholes covers to the front left hand side of the property one of which is practically under a tree, the only true way to find out the condition of the drains is to have a closed-circuit TV camera report to establish the condition of the drains. In this age of property there have often been leaks over the years.

Push fit drain

Closed-circuit TV camera report to establish the condition of the drains.

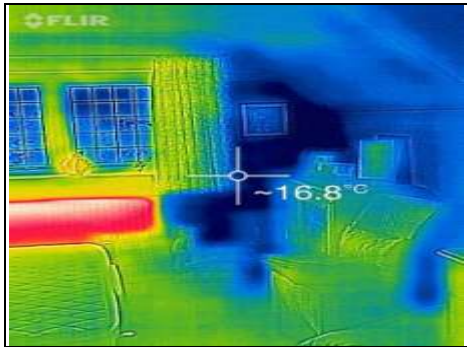
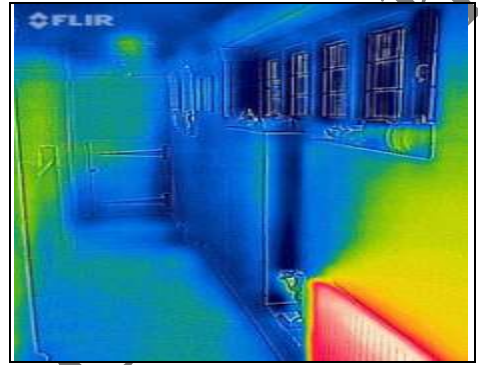
Colder walls in upstairs bedroom

Cold walls

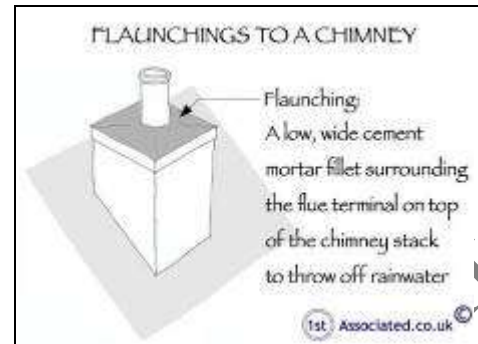
Unfortunately, we were unable to see the top of the chimney properly known as the flaunching, we therefore cannot comment upon them.

Flaunching

ACTION REQUIRED: Periodically inspect the chimney. Anticipate ad hoc repairs in the next few years to both the chimney and the flashing. The sooner the work is carried out the better.

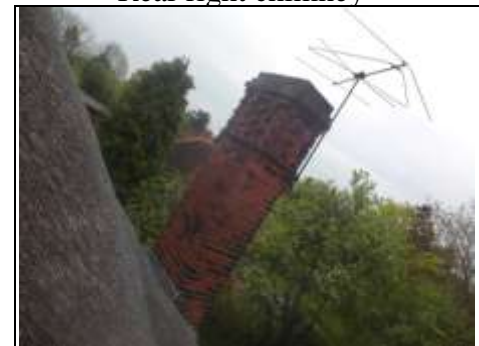
Rear of chimney

Again, we noted an aerial attached to the chimney; please see our previous comments particularly as the bricks seem to be a relatively soft red brick.

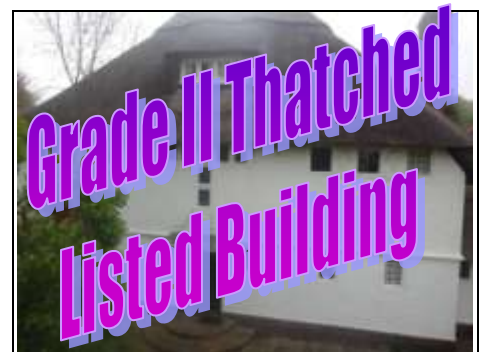
We could not see the sides particularly well however where the front sections of the dormers are formed in windows, where we could see these, they would benefit from some redecoration. Please see the Windows Section of this Report.

Front dormer

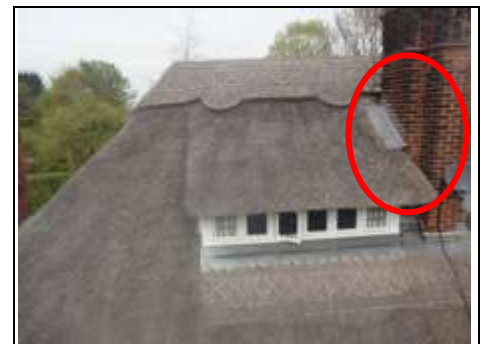
There is a type of dormer window formed within the roof, one to the front and one to the rear of the property. They have a thatched roof. The one to the rear is particularly susceptible to water getting in where it meets the chimney.

Rear dormer window susceptible to water getting in

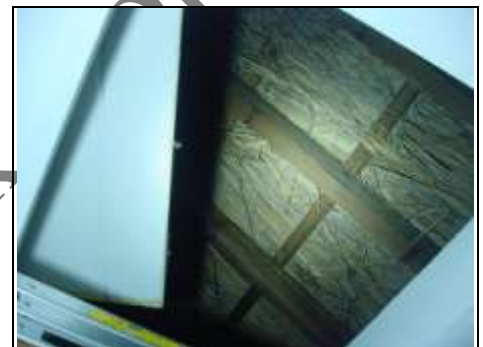
To the side roof visible from within the first floor office area we can actually see the back of the reed. It also looks like there may have been some straw used at some point in time; it is difficult to tell as there is limited access to the roof.

Back of reed within first floor office area

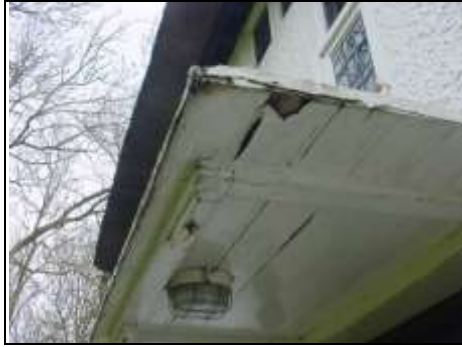
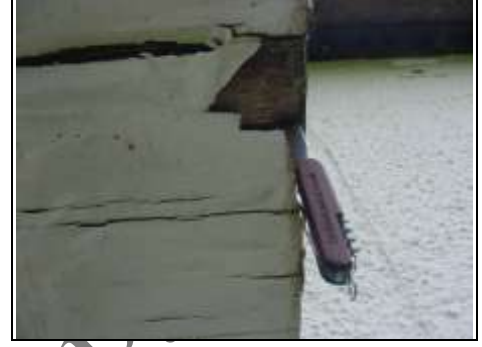
Rot

Knife test

ACTION REQUIRED: Repair and redecorate.

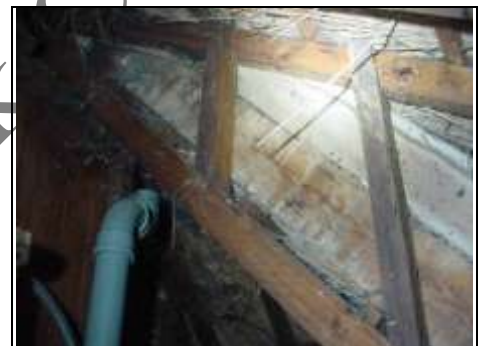
Staining to timbers

Our examination was very limited therefore it is not possible to give a definitive comment as to the quality of the roof as we could only see five to ten percent of it. We would be more than happy to revisit when the roof is being thatched and comment further.

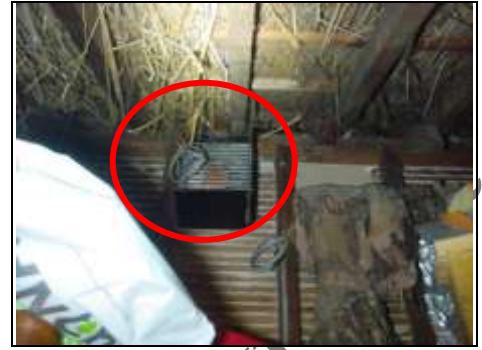
We can often identify the age of an electrical installation by the age of wiring found in the roof. In this case we had a very limited view of the roof. We could see an old extract fan; it does look like the extract is discharging to the roof which is what the owner confirmed when asked during our question and answer session.

Old extract

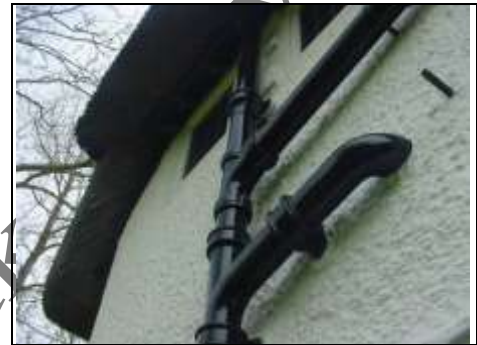
The property has cast iron soil and vent pipes. Cast iron of this age can crack and rust and needs regular maintenance.

Soil and vent pipe

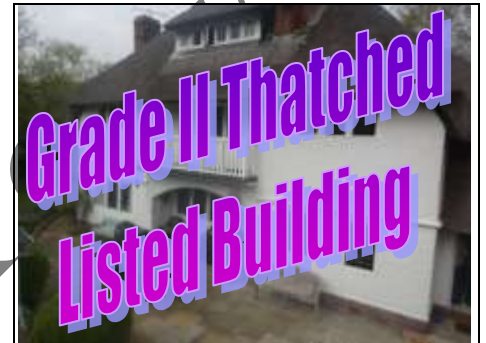
We are always wary when we see rendered properties as often the render can hide a lot such as in this case what work has or has not been carried out to the underpinning.

Render

We have carried out a tap test (we usually hit the render with the back of a hammer, in this case we hit it with our hand as the owner was present and we did not want to appear to be damaging the property). We found it to be in average condition for its age, type and style.

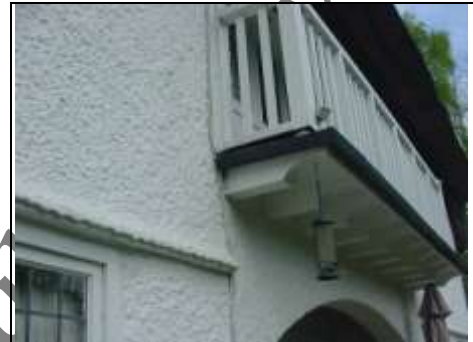
In this case we found a drip detail to the ground floor windows. With rough cast render there is an argument that drip details are not required.

Close-up of drip detail above windows

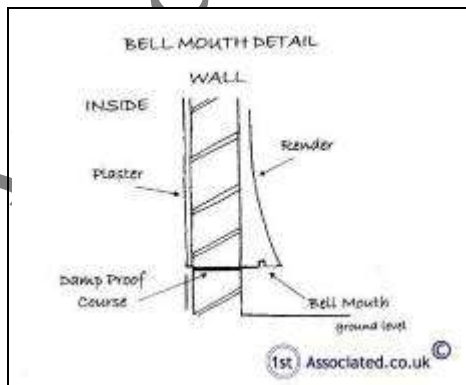
To the base of the render there was no bell mouth detail. As such there is some weathering to the brickwork.

Bell mouth detail

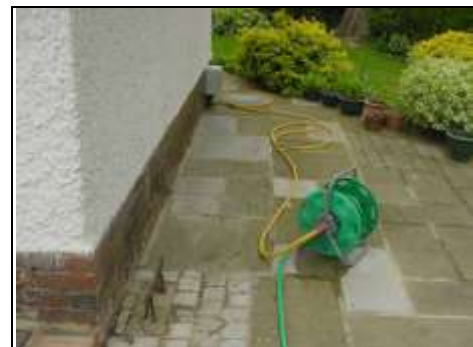
Weathering to brickwork

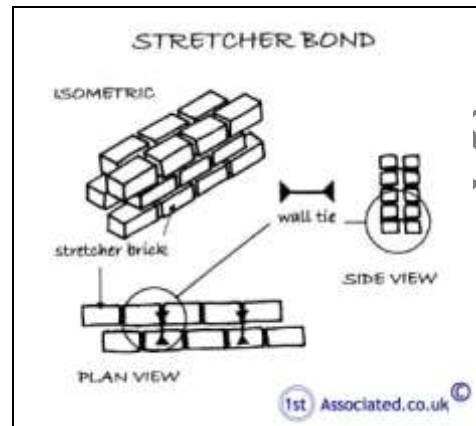
Stretcher Bond brickwork

ACTION REQUIRED: Repoint

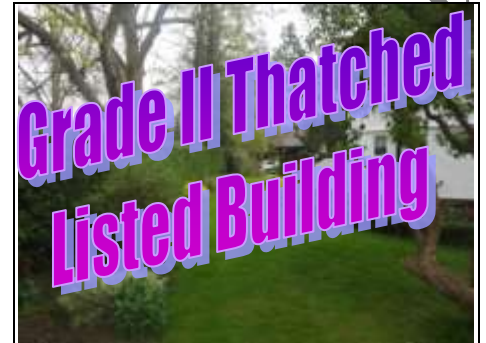
There are trees in influencing distance of the foundations; you need to speak to your insurance company regarding this. The trees will have an impact on the soil condition and also affect the outside of the property with shading the thatch and reducing the air movement around the property.

The trees are located to the front and rear garden
Aerial view – 360 photo

We would recommend an arboriculturalist (not a tree surgeon) is asked to view the trees and give a ten year plan for maintenance.

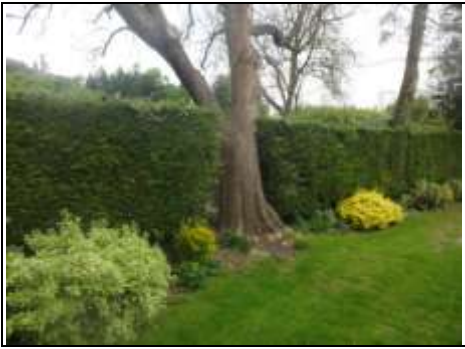
Tree on manhole
Aerial view – 360 photo

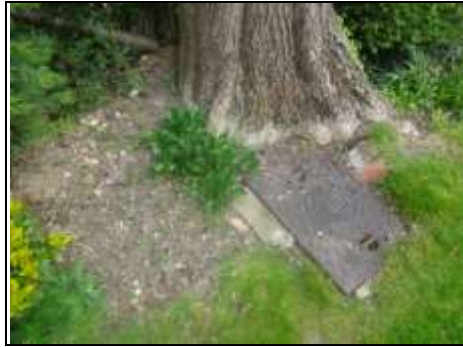
Tree on the manhole

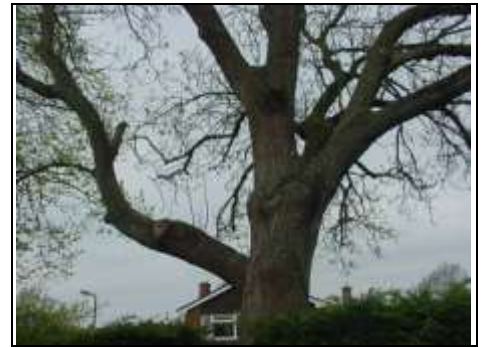
Substantial tree

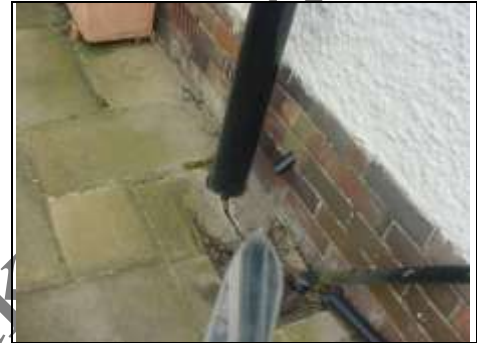
In properties of this age it is unlikely that a damp proof course (DPC) would have been built in originally. However, often they have had damp proof courses added at a later date. In this case, we cannot see a DPC due to the render however there should be a DPC in this age of property.

Damp proof course not visible

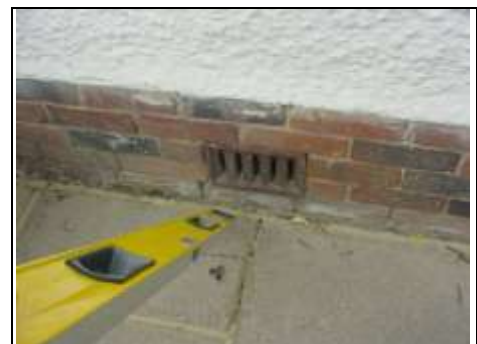
Air bricks are essential to have a through flow of air as this helps to reduce the chances of wet rot, dry rot and woodworm. In this case the airbricks are slightly lower than we would like; we would prefer to have two bricks from ground level. Also, in some areas, the water seems to be tipping towards the building. Please see our comments with regard to a French drain and releveling the paving slabs.

Air brick

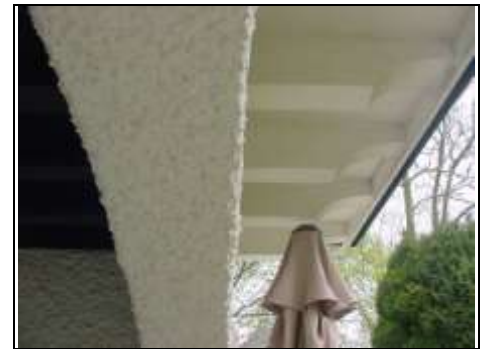
Timbers painted white

ACTION REQUIRED: The property, to us, looked relatively recently painted which could be hiding some deterioration. We spoke to the owners about this during our question and answer session who advised that it was last painted four years ago externally and interestingly they said painted every year internally.

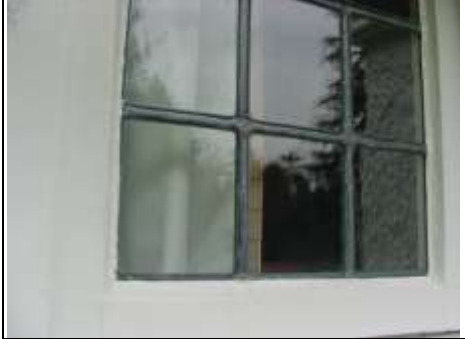
The property has single glazed timber windows with square leaded lights. The windows are in below average condition.

Single glazed with square leaded lights

ACTION REQUIRED: We would comment that the windows would benefit from redecorating the sooner the better ideally no later than 2018 with associated repair.

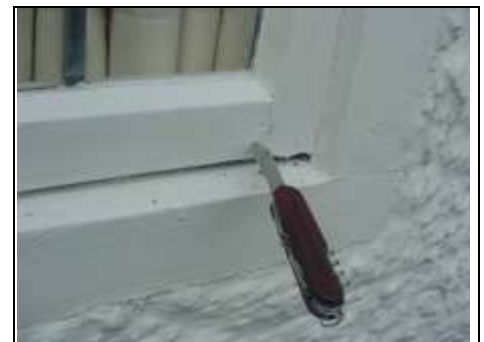
We have tested the windows by pushing a knife into a random selection. We generally tend to do the lower windows as access is easier. In this case we also tested the top floor windows. It was the top floor windows that appear to not have been painted recently.

Knife test

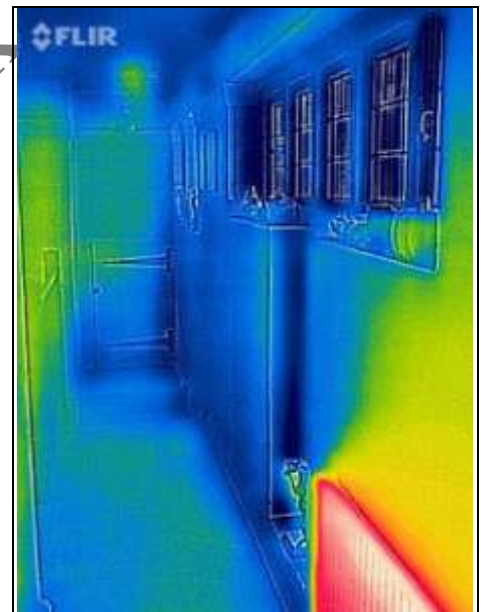
Originally these possibly would have been lime plastered; they were certainly cold when we thermal imaged them although you do have to remember the property has not been specially warmed up for thermal imaging. Our concern is there may be condensation and black mould on the perimeter walls. To be clear, we believe this is a higher risk that you would typically find on this age, type and style of property.

Cold walls

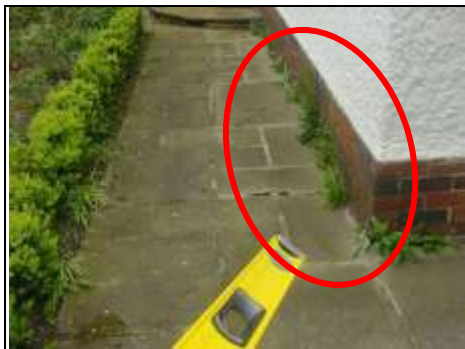
Vegetation

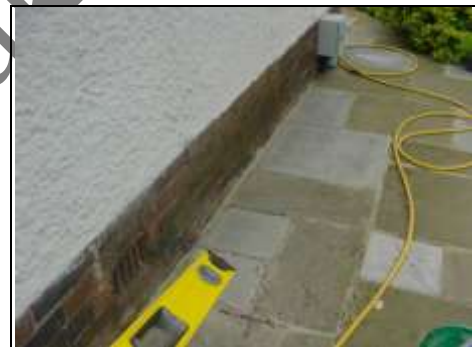
The ground is tipping towards the vents and could be acting as gutters.

Ground tipping towards vents

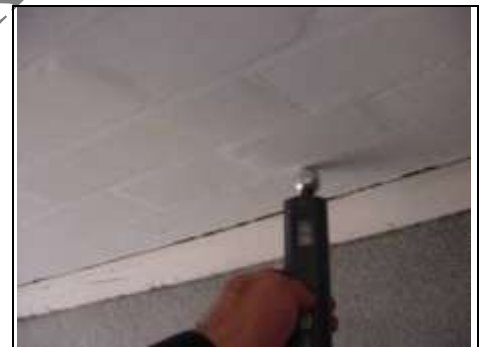
A visual inspection and tests with a moisture meter have been taken to the perimeter walls. In this particular case we have found no significant rising damp however we would comment that the property may suffer from condensation.

Testing for rising damp

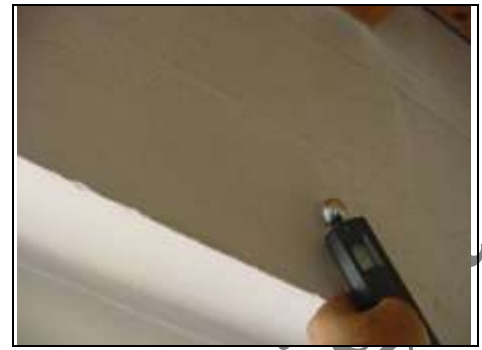
We used a resistance meter on the external walls. We found it to be in line with what we would expect for this age, type and style of property.

Testing for lateral dampness

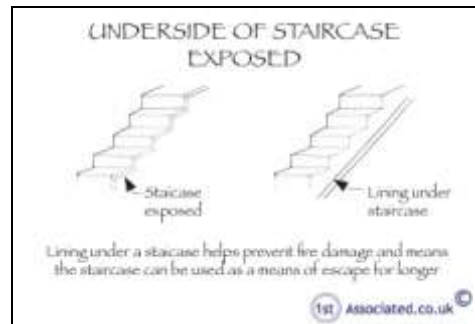
Underside of staircase exposed

ACTION REQUIRED: We would recommend the staircase is lined.

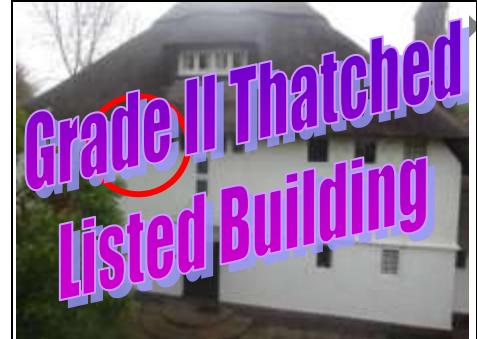
We can see a box to the front and the rear of the property however the owners advised there is no alarm so we assume this is just an imitation alarm box. You need to make further enquiries.

Security alarm to the front
Aerial view – 360 photo

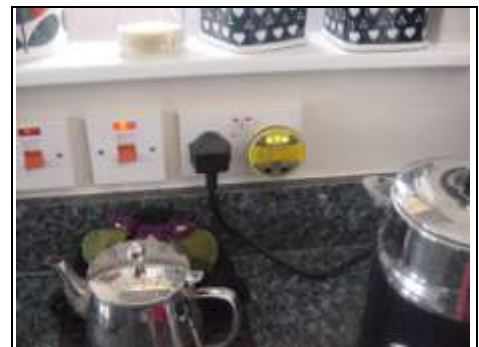
We carried out an earth test in the kitchen area to the socket point that is normally used for the kettle, this proved satisfactory.

Earth test

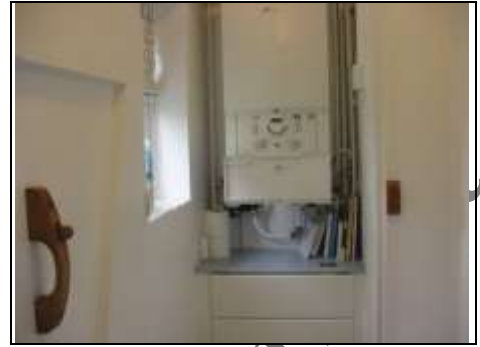
Boiler

The boiler was located in the cloakroom, it is manufactured by Worcester.

Our limited inspection of the hot water and central heating system revealed no evidence to suggest any serious defects, but we would nevertheless recommend that the system be tested and overhauled before exchange of contracts and that a regular maintenance contract is placed with an approved heating engineer.

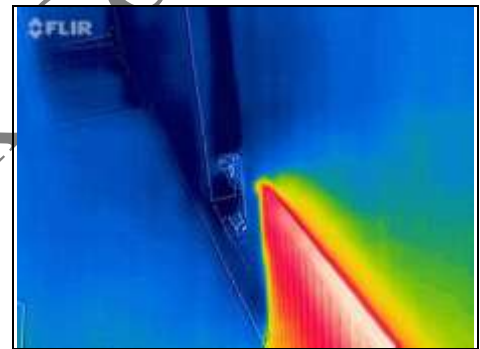
The owner / occupier at our request turned on the heating for approximately ten minutes. We checked the radiators and these were warm.

Ten minute test
(Radiator is red)

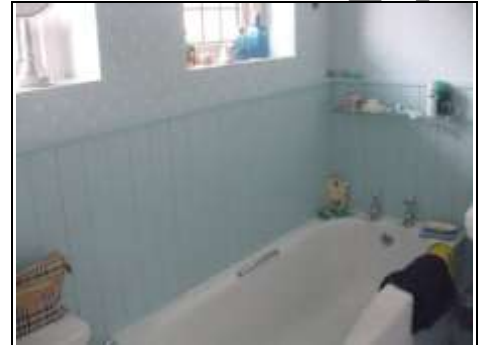
Bathroom

The property has a four piece bathroom suite, consisting of a shower, bath, wash hand basin and WC, which looks in average condition, subject to some day-to-day wear and tear, as one would expect.

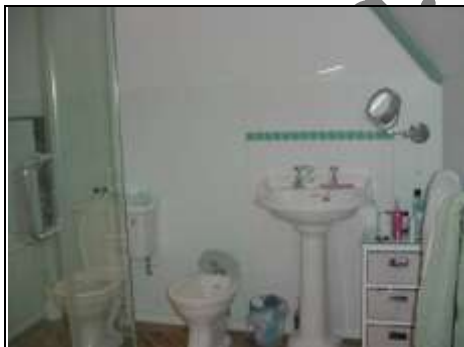
En-suite to master bedroom

The property also has a four piece en-suite shower room, consisting of shower, wash hand basin, bidet and WC which looks in average condition. We noted a shallow shower tray; we have come across problems with these leaking.

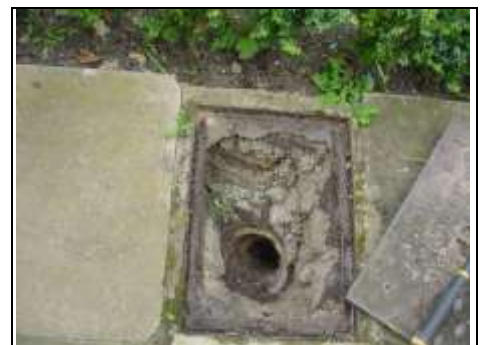
We duly lifted the cover and found it to be free flowing at the time of our inspection.

From what we could see it is concrete built.

Front left manhole by the kitchen

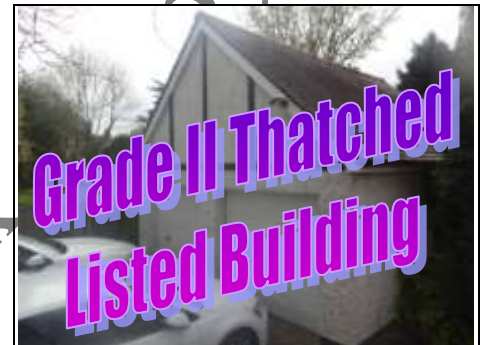
Rear left garage

There is a double garage to the rear left. Cracking was noted within the garage.

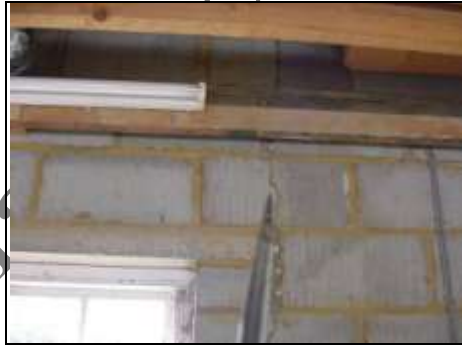
Cracking

ACTION REQUIRED: Your legal advisor to check and confirm if the cracking in the garage has been noted to the insurance company.
