# RESIDENTIAL BUILDING SURVEY

Hertfordshire

## **EXECUTIVE SUMMARY**

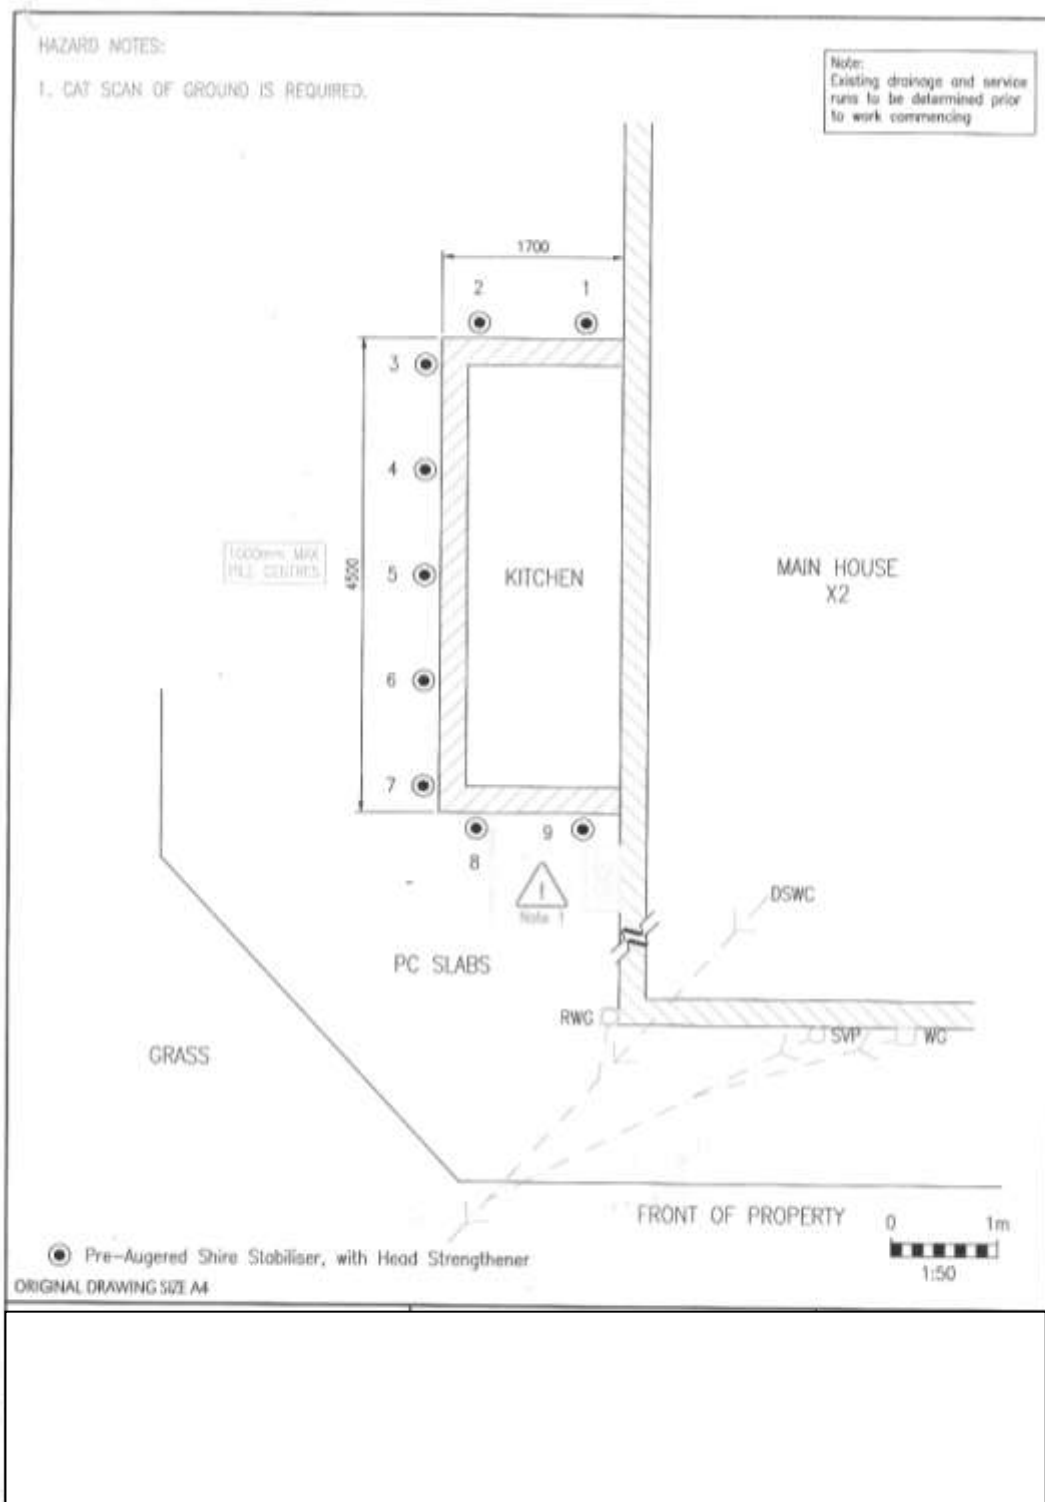
## Location of Underpinning

We are having slight difficulty obtaining information to understand exactly what work has been carried out. As with most underpinning work it is now hidden. In this case there are some undulations and poorer quality repairs to the painted render and there are different coloured paving slabs and the tree with the drain next to it however we do not have the exact details of what was carried out. We have the plans with piles around the kitchen area (please see overleaf). We were also given a cross section of piling work however were also advised this was not carried out. We would like to see sketches, drawings and details of information with regard to what has been carried out.

Information on the underpinning work was limited. We would request that we see a full copy of the underpinning documentation.

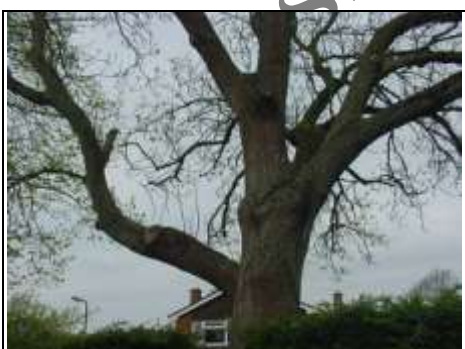
Trees surrounding the property

There are many large trees to the property. We believe the trees may be blocking sunlight from the thatch and also tends to restrict the airflow around the building which is causing accelerated deterioration.

It is very unusual to have a drain with a tree on top of it as there is at this property. As mentioned, we do feel the tree roots are likely to get into the drains. We can see that the manhole is distorted and deteriorated and it is only a matter of time before the roots affect the drainage on this property.

Trees will have a considerable effect on this property and the surrounding grounds and the sub-soil. Depending on the type of tree this will also have different root systems, etc. which is why we are recommending an arboriculturalist (not a tree surgeon) is asked to look at all the trees in the surrounding area to ensure you have a full understanding of what is going on.

You also would be best to have a closed circuit TV camera report of the drains to ensure there are no tree roots in the drains.

**ACTION REQUIRED:** We recommend a closed-circuit TV camera report to establish the condition of the drains and partial rebuilding of the manhole.

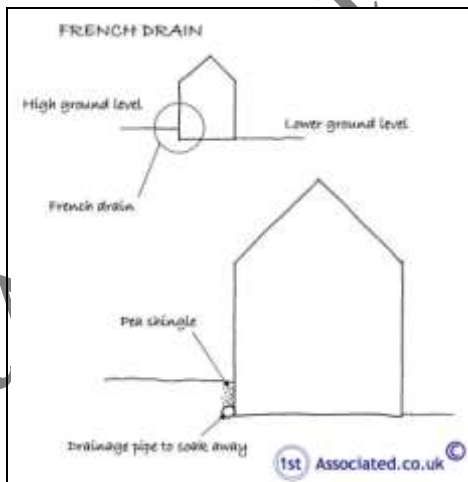
It does look like water discharges against the property at the base. Ideally we would recommend a French drain against the building and also the paving slabs being adjusted so they run away from the building.

**ACTION REQUIRED:** Once you have established what the ground conditions are and seen the property when it has rained heavily it may be

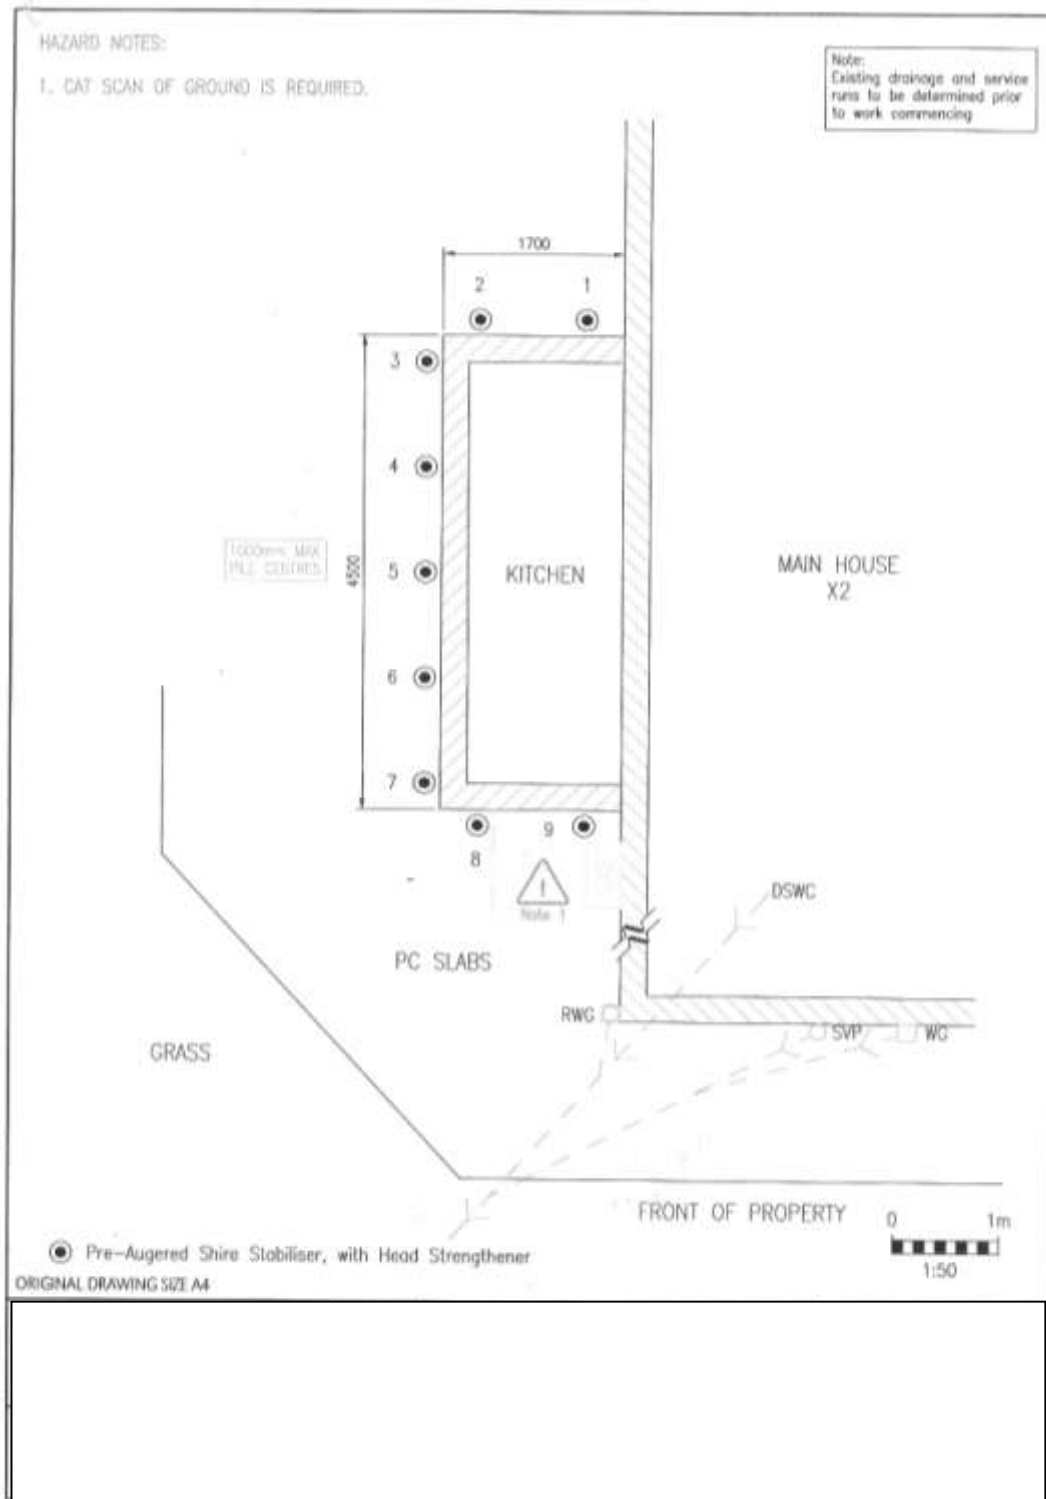
# Location of Underpinning

Information on the underpinning work was limited. We would request that we see a full copy of the underpinning documentation.
