RESIDENTIAL BUILDING SURVEY

XXXXXXXXXXXXXX

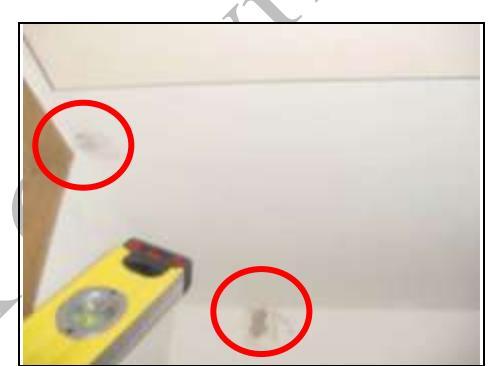
Signs of dampness in airing cupboard/boiler room

ACTION REQUIRED: This is part of the problem explained within the next section. We would recommend further investigation is carried out, ideally by removing part of the roof and part of the cladding internally. We feel an idea area to open up is the rear right hand side adjacent to the internal shower room.

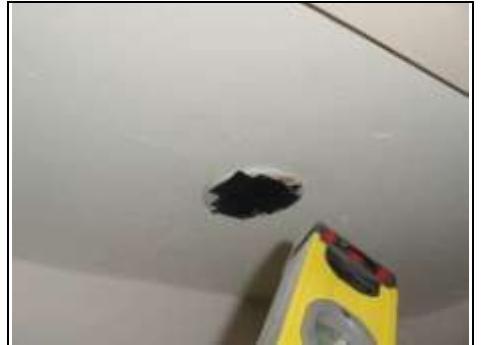
The light in the airing cupboard was also blocked up, which is also a tell-tale sign of a roof leaks as the rainwater tends to follow the electric wires down and leak out through the light.

Light blocked up in airing cupboard

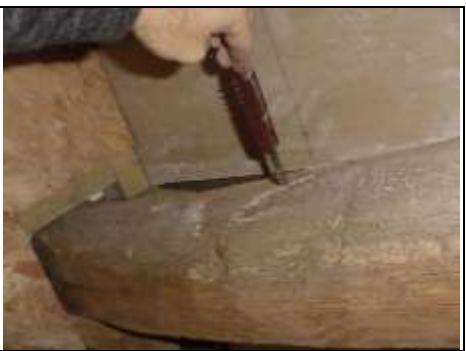
Knife test of roof timbers

Where we can see the structural timbers we can see there has been woodworm. We also have concerns with regard to the condition of the roof timbers.

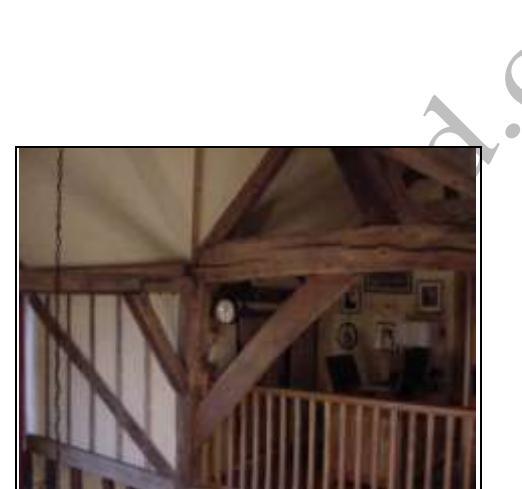
We explained how in turn this could have an affect with regard to the lateral restraint of the whole property.

Indeed we can see some relatively new metalwork in the property. Our concern is this metalwork looks to be tying the structure together as opposed to giving structural support.

Brace between post (vertical timber) and beam (horizontal timber)

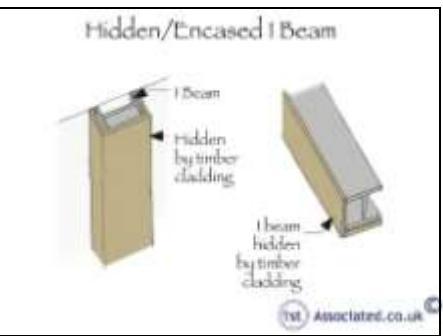
Splits in modern timbers in kitchen/breakfast room – may be an I-beam behind this

If a metal frame has been inserted into the property this would alleviate some of our concerns with regard to timbers that are cracking, deteriorating strength due to woodworm/termites and/or timbers that have been removed completely.

ACTION REQUIRED: Your solicitor to make enquiries and forward to us before you commit to purchase the property.

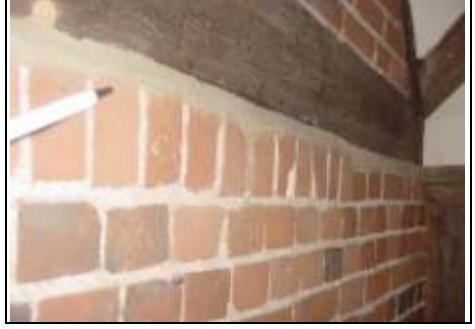
9.0) <u>Repairs to party wall on right hand side</u>

We would comment on the right hand side there seems to have been some repair work carried out to the party wall to the cement mortar which is a different colour to the lime mortar, which is not an appropriate repair.

If the lime mortar is moving this would concur with our thoughts that there is some movement in the property and certainly cement mortar will not last very long compared with lime mortar in this particular instance.

Repairs to party wall on right hand side

ACTION REQUIRED: Replace with lime mortar.

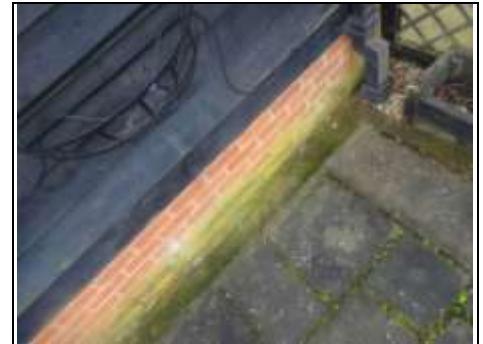
Close up of moss to bricks to rear

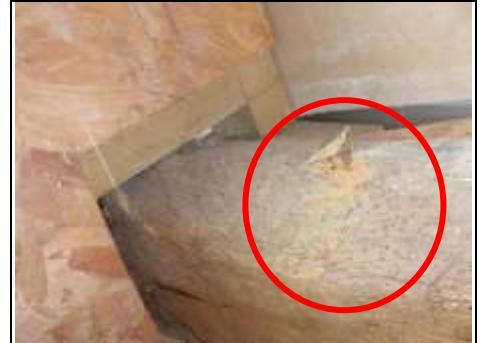
Usually we would be able to see the back of the roof structure better, however in this case the two roofs are both dry lined/boarded out and we have not been able to see the majority of the timbers. The timbers that we can see have suffered from woodworm, although we believe this is historic; please see our further comments in the woodworm section of the report.

Signs of woodworm to purlin on right side of roof

ACTION REQUIRED: Ideally open up an area of the roof before you commit to purchase the property; we suggest to the rear right hand side where there has been previous repairs, preferably above the rear right hand en-suite shower room.

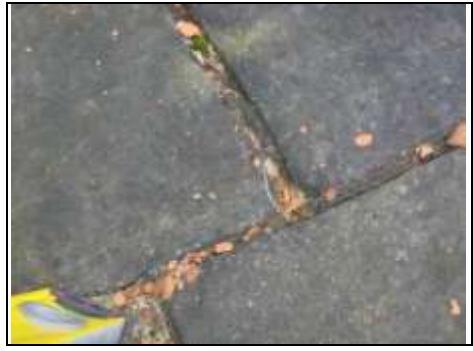
Moss to ground

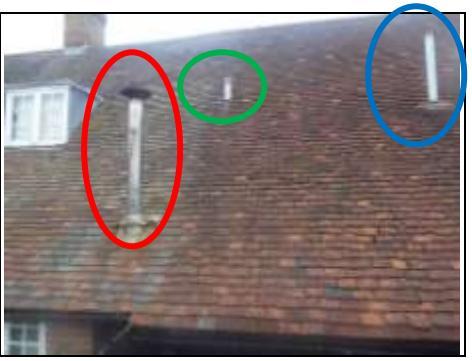
Metal flue (red oval), small flue to middle is from an extract fan (green oval) and soil and vent pipe (blue oval)

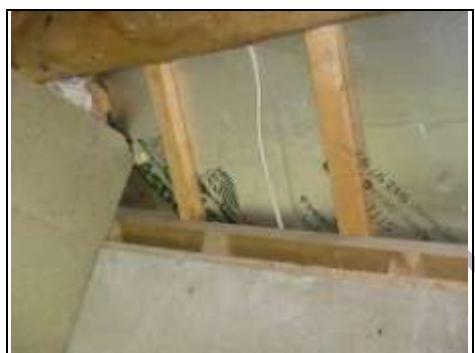
Relatively modern insulation

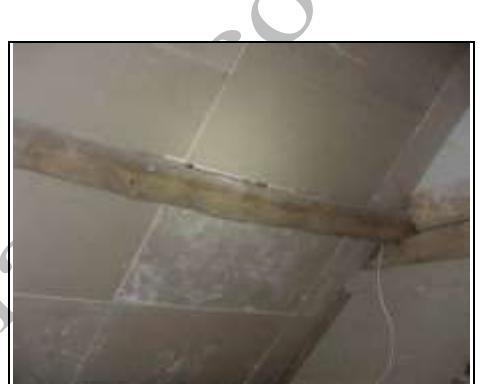
There are small roofs to the left and the right hand side. In both cases we were unable to see the protective underlayer (assuming there is one as there would not have originally have been one) as the roof is boarded out/dry lined.

Boarded out/dry lined roof to left hand side

ACTION REQUIRED: Ideally we would like to open up the roof to see what its construction is, both from the protective underlayer and the roof structure.

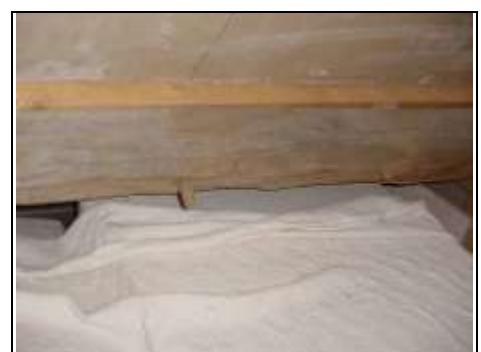
Boarded out/dry lined roof to right hand side

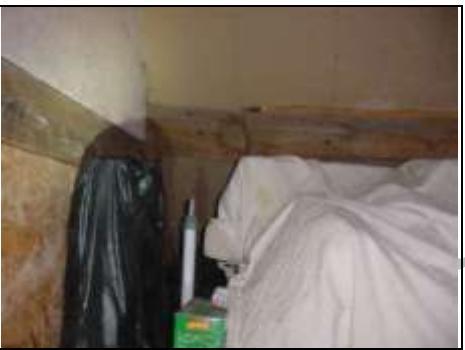
Our examination was limited by the general configuration of the roof, the lining and the insulation and the stored items. What we could see was generally found to be in below average condition considering its age, type and style. It is also feasible/more than likely that there are further problems in the roof that are hidden.

Roof void to right side

ACTION REQUIRED: We recommend the roof is opened up, especially also over the internal shower room area.

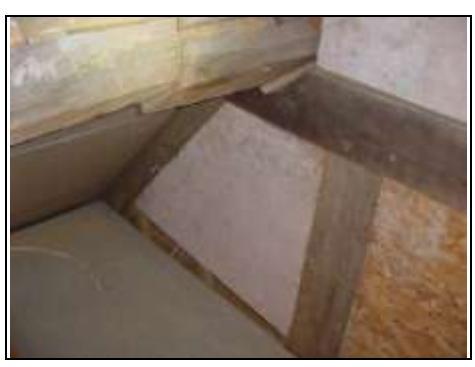
Timber blocking access above internal rear shower room

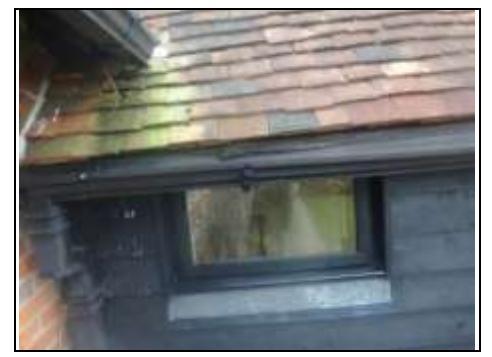
Felt coming down into gutter Aerial view – 360 photo

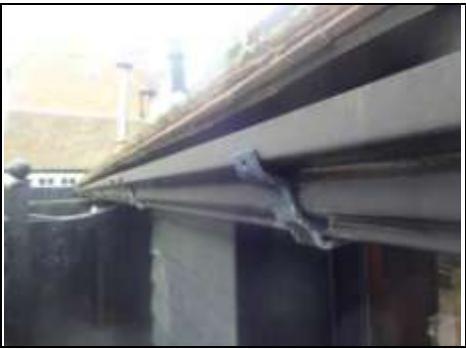
Brackets not fitted very well Aerial view – 360 photo

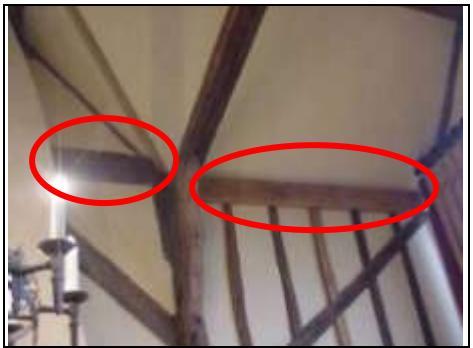
Wall plate, old (left) and new (right)

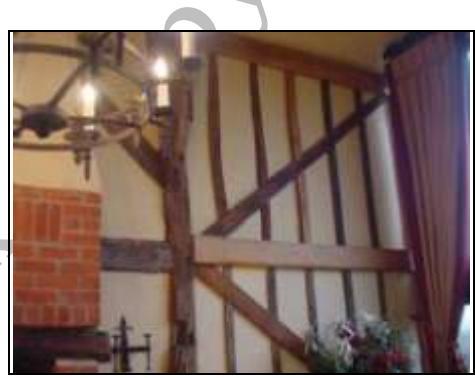
These are various infill panels filled with a relatively modern plaster from what we can see, although it did have a pargeting/rough finish to it in many areas.

In other areas there was a discrepancy in the panelling width so it is difficult to ascertain what was and was not present. Possibly the best area showing the timber is to the right hand gable end.

Infill panels between the timbers

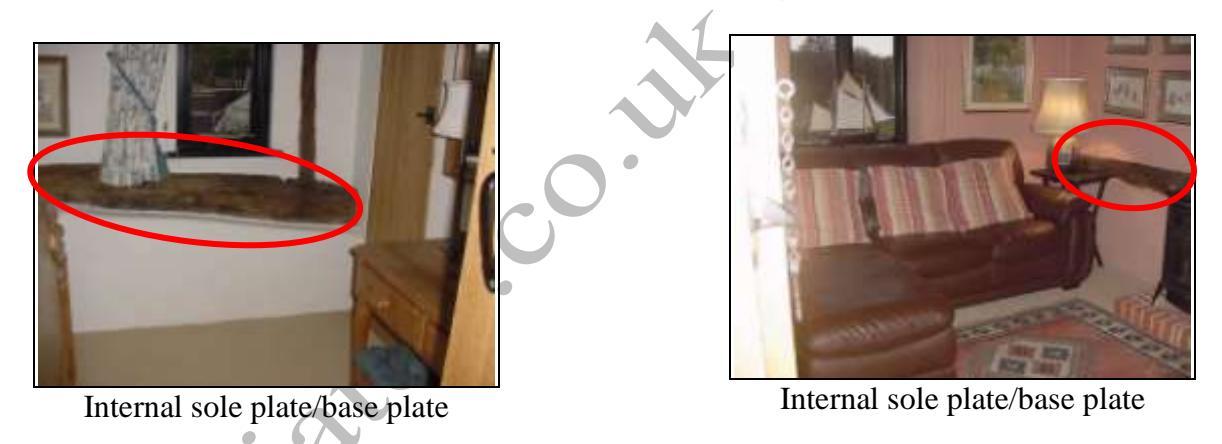
Often the most important part of these is the sole plate/base plate which is at the base of a wall which can be affected by dampness, causing wet rot and dry rot and general deterioration. As this ground floor sole plate effectively forms the base of the timber frame.

What concerns us with the sole plate/base plate is that it is hidden in many areas and also our thermal imaging pictures showed a fair amount of coldness / dampness in the area.

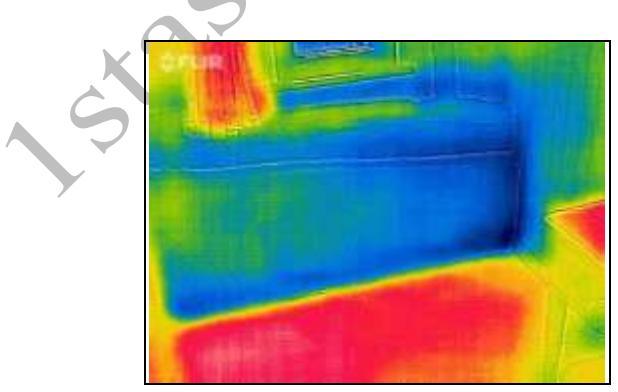
Coldness/dampness in blue areas near the sole plate/base plate

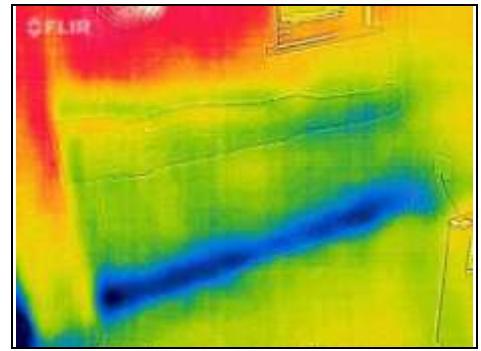
Coldness/dampness in blue areas near the sole plate/base plate

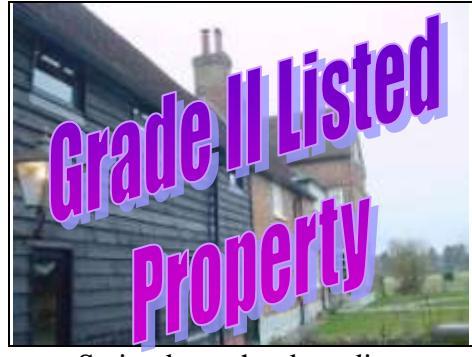
The walls are clad with stained weather boarding. There have been repairs in some areas and it also looks to have been relatively recently redecorated which may well be to help the sale of the property.

Stained weather boarding

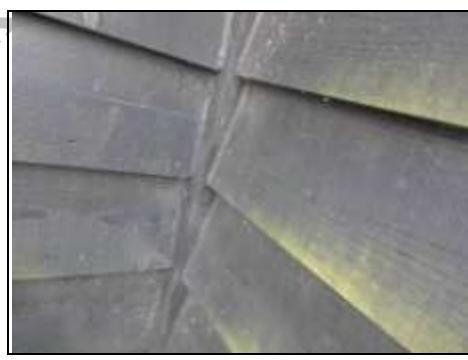
To the rear of the property we could certainly see green mould.

Green mould to rear weather boarding

ACTION REQUIRED: Please see our comments in the Executive Summary.

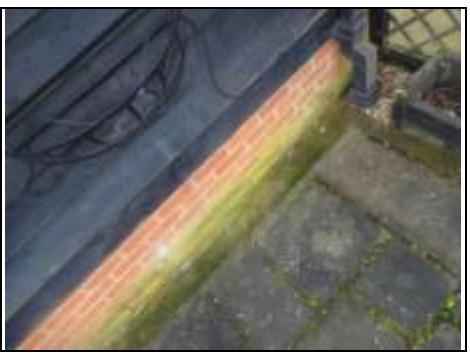
Dampness was noted to the rear of the property externally. You can see from the thermal image photo below where the blue area shows coldness, which in turn often means there is dampness in the area, although there was no visible sign of it in this instance.

Close up of moss to bricks to rear

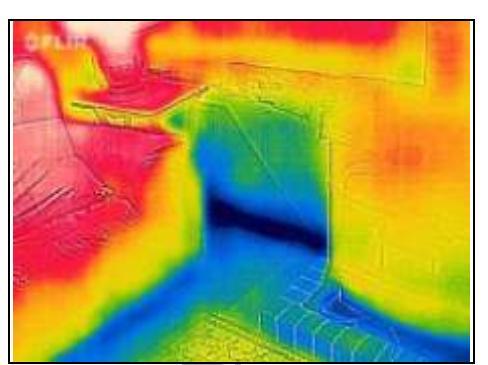
Blue indicates coldness in the snug, which in turn often means there is dampness in the area although there was no visible sign of it

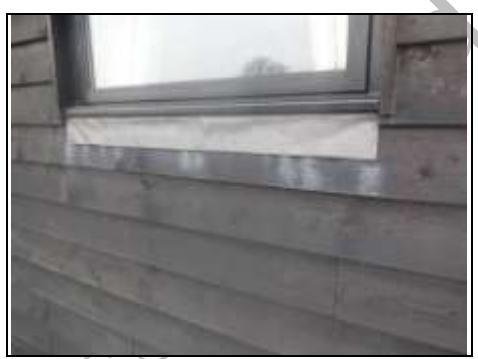
We would comment there is modern lead detailing underneath the windows, ideally it should also be above the windows.

Modern lead detailing underneath windows

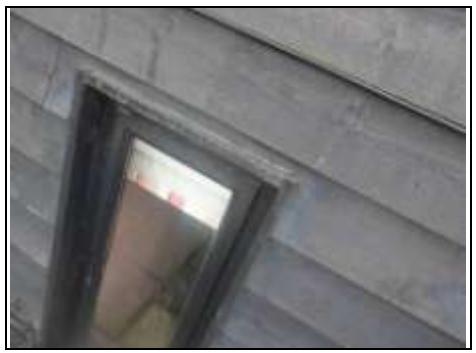
No lead detailing above windows

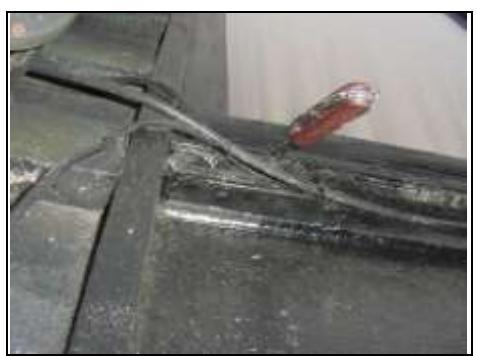
In this instance there was an above average amount of rot to the windows.

Knife test into timber

ACTION REQUIRED: Repair, prepare and redecorate.

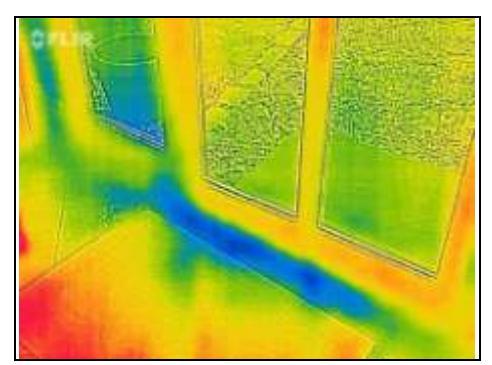
Thermal image of coldness coming in under windows/doors at low level

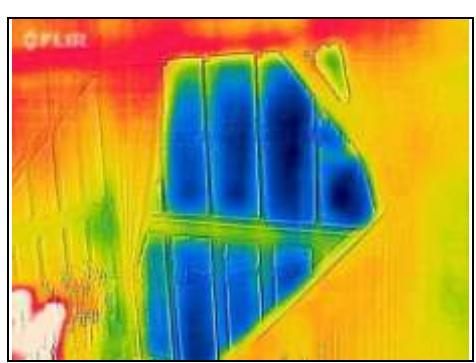
Thermal image of windows to rear where the doors used to be. The blue showing the coldness

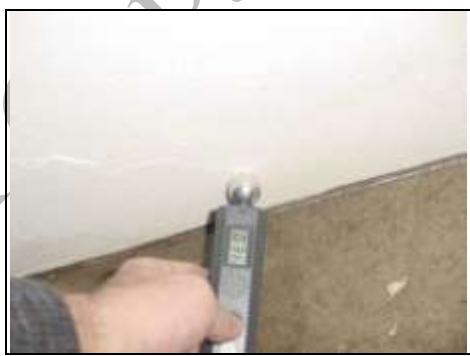
We did get some higher readings, also our thermal imaging did show that there were some signs of dampness.

Reading of 36 to front external wall

ACTION REQUIRED: Please see our comments in the Executive Summary with regard to the moss to the rear and the forming of a French drain.

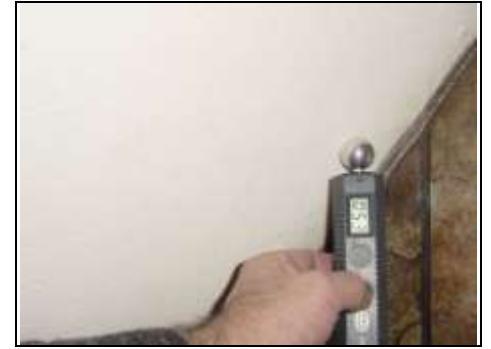
Reading of 53

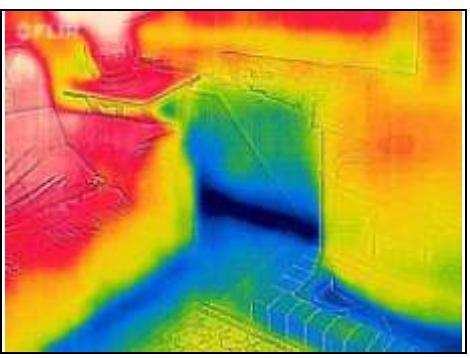
Thermal image of the rear left room, colder areas in blue

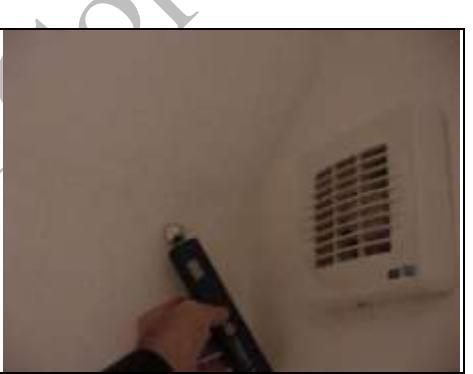
We did notice signs of a different shade of paint to the rear internal bathroom. This to us indicated that there may be dampness coming through or condensation occurring on the wall.

Testing for lateral dampness

ACTION REQUIRED: Please see our comments in the Executive Summary about having good quality large humidity controlled extract fans installed in all humidity generating areas.

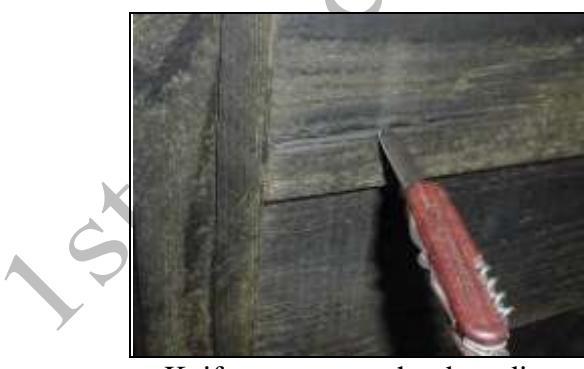
We could see some wet rot to the window surrounds and to the weather boarding. There are also signs of mould/moss to the weather boarding.

Knife test on weather boarding

ACTION REQUIRED: There will be some work required to the window surrounds. The weather boarding will also need some work and re-staining within the next few years; the sooner the better.

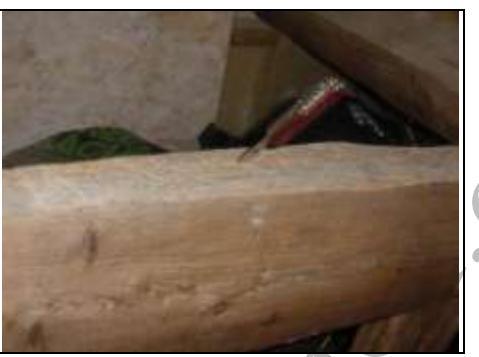
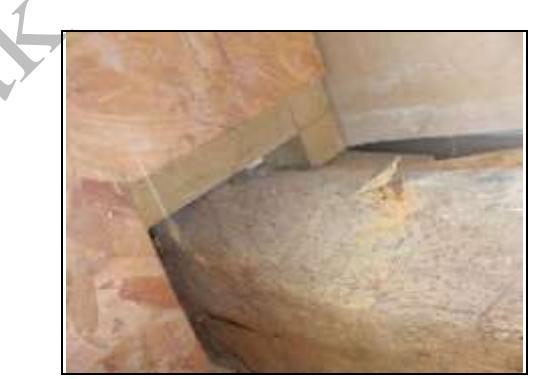
The roof is the main area that we look for woodworm as well as the actual traditional timber structural frame. Within the roof we found visual signs of woodworm activity although it has not caused what we would term 'structurally significant' damage.

Mass of woodworm, but no frass in left side of roof

Woodworm and softness in rear right purlin in right roof void

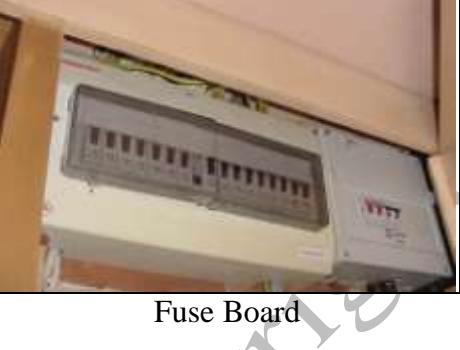
Fuse Board

The electric fuses and consumer units were located in the galley way on the right hand side. The fuse board looked to be from the 1980's/1990's and better are now available. In an older property a defective fuse board can be particularly dangerous.

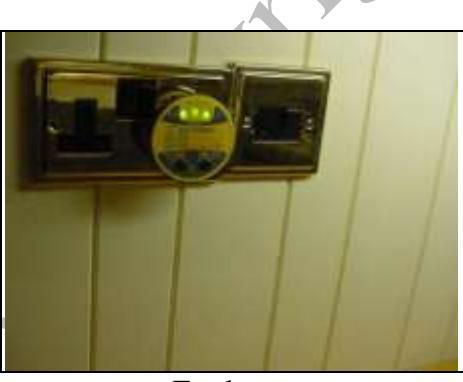
Earth test

We carried out an earth test in the kitchen area to the socket point that is normally used for the kettle, this proved satisfactory.

ACTION REQUIRED: As the property is changing occupancy an Institution of Engineering and Technology (IET) test and report and any recommendations should be carried out by a NICEIC registered, or equivalent, approved electrical contractor or similarly approved.

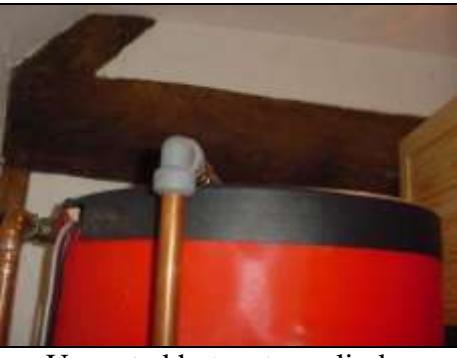
There is a hot water cylinder located in the airing cupboard, which is a modern unvented cylinder.

Unvented hot water cylinder

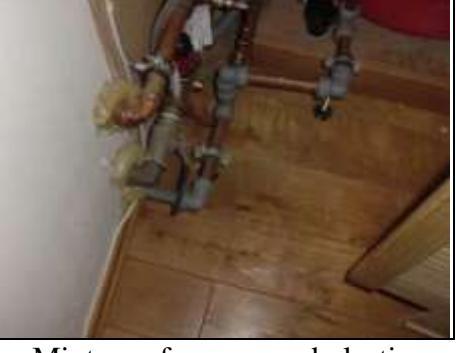
Mixture of copper and plastic piping

piping. We are not keen on this arrangement as they tend to leak where they join. No significant leakage was noted on the surface, although most of the pipework is concealed in floors, walls and ducts.

ACTION REQUIRED: We recommend having all copper or all plastic pipes.

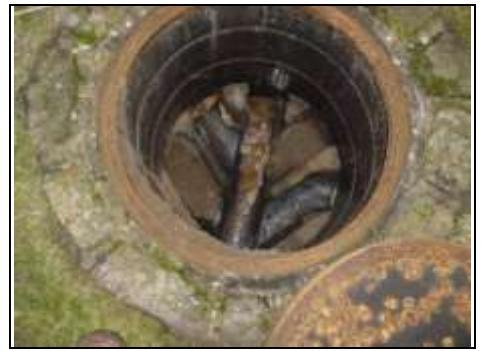
We duly lifted the cover and found it to be free flowing at the time of our inspection.

From what we could see it is plastic built.

Manhole to front right

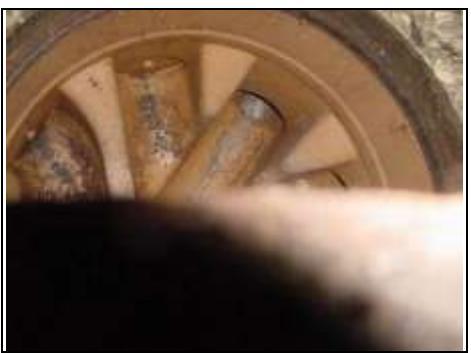
We duly lifted the cover and found it to be free flowing / blocked at the time of our inspection.

From what we could see it is plastic built.

Manhole to left side (lid partly in way)

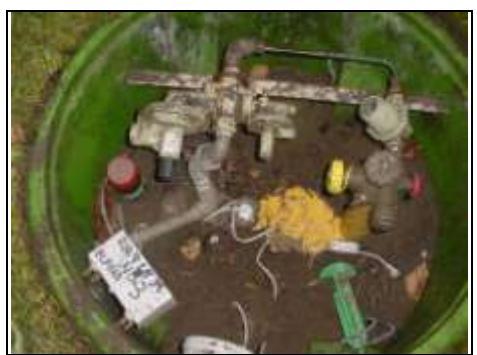
We believe this relates partly to the water meter.

Manhole front right, looks to relate partly to water meter

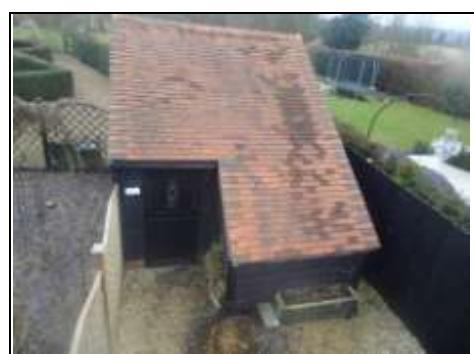
Outbuilding Aerial view – 360 photo

There is an outbuilding to the rear which we viewed externally but did not enter. It had a clay tile double pitched roof, with weather board wall cladding.
