RESIDENTIAL BUILDING SURVEY

London

INDEPENDENT CHARTERED SURVEYORS

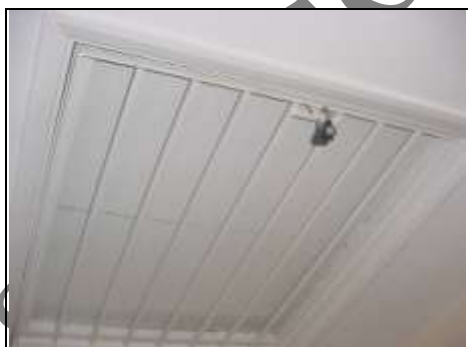
Roof access locked shut

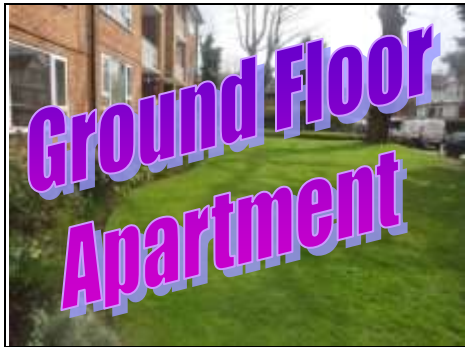
Whilst the property does not look like it sits on much of a slope, we would term this as sitting on a sloping site from side to side and from some extent from front to back as well and because of this rainwater and ground water need to travel from the top of the garden to the bottom with the building in the way. Sloping sites are not as good as level sites and buildings on them are integrally unstable. You need to understand this is a characteristic of any building sitting on a sloping site.

Sloping site

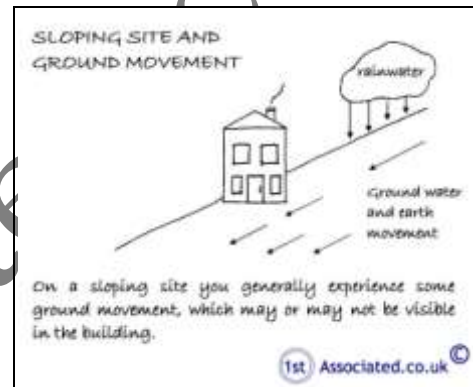
Sloping site

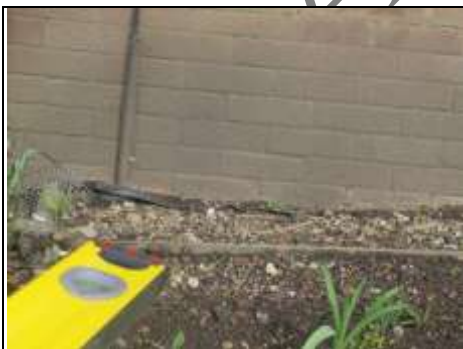
Whilst we did not obtain high damp meter readings at the time of our survey we do believe there is a potential for dampness in the property particularly to the rear where the ground level has risen above the damp proof course and in some cases almost to the airbricks.

Rainwater hits the ground and bounces back onto the wall

We would recommend reducing the ground level to the rear and adding a French drain.

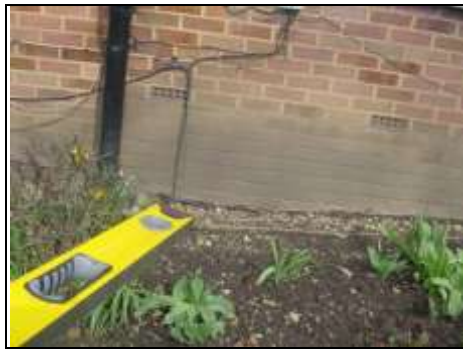
Darkening of bricks to rear

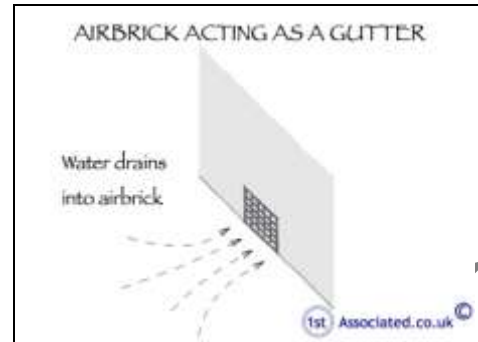
The property has a suspended floor which needs an airflow underneath it. The airbricks which should ventilate the floor unfortunately are so low they are acting as gutters.

Airbrick acts as gutter

ACTION REQUIRED: Reduce the ground level as much as possible. If for any reason this cannot be done we would recommend the airbricks are protected as shown in our sketch.

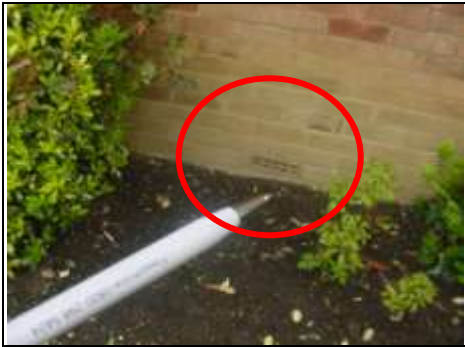
Airbrick acting as gutter

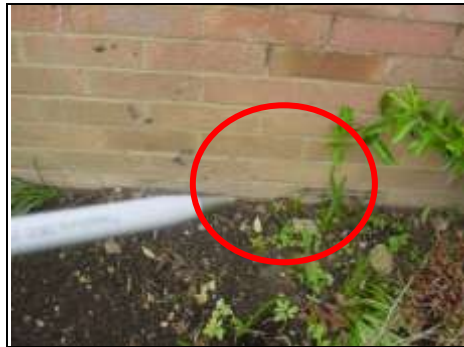
Airbrick almost covered in earth and acting as a gutter

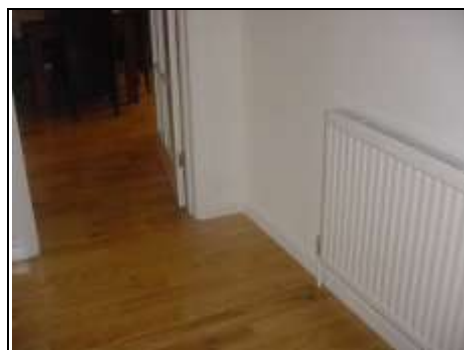
We could see airbricks to the front and the rear of the property indicating that an airflow had been required underneath the building which often relates to a suspended floor, however the spring/deflection in the floor particularly that we saw at first floor level does denote that it may be a timber sprung floor.

Unable to view floors

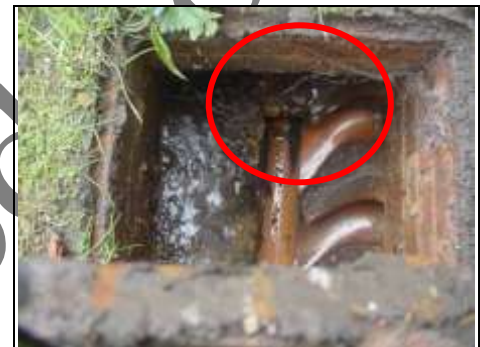
We noticed a small movement to the rear wall. This may have been due to leaks where the drains run parallel to the rear wall. When we lifted the drains one of the manholes had a small amount of tree root in it.

Roots in rear left manhole

ACTION REQUIRED: The building is probably insured on a block insurance. We do not expect what we have seen to be a major problem. The only way to be one hundred percent safe is if the existing owners take out an insurance claim, advising that the cracking has been noted by a structural surveyor (this should cost them nothing other than time to write the letter). This usually means that the insurance company will carry out a monitoring exercise (the Building Research Establishment recommend monitoring any cracks for a minimum of one year) to establish if there is any progressive movement. Your future liability will be limited to the cost of the excess on the insurance providing the insurance company is happy for you to take over the insurance claim.

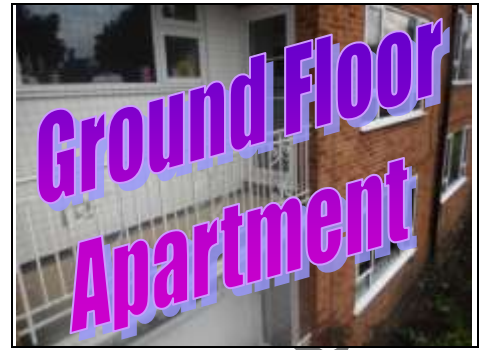
There appears to be a pigeon problem to the building with pigeon netting and also the anti-landing spikes. We specifically asked the owner about pigeons (if you recall) and she advised that there had not been any pigeon problems for a while.

Pigeon netting to property above

ACTION REQUIRED: You can spend all day and every day trying to get rid of pigeons. We believe you need to accept this is a characteristic of this property and be happy to live with it.

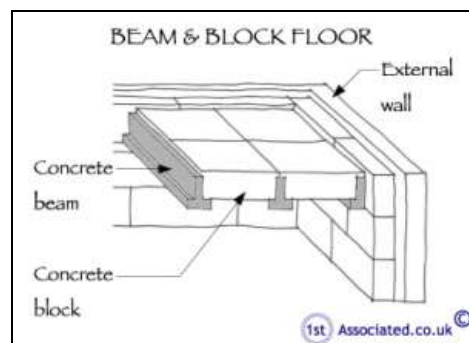
This relates to noise that vibrates through the structure. When we inspected upstairs (if you recall you were with us) we were shown in the front lounge which is directly over downstairs front lounge how the floor reverberated (deflects) when it is walked on. We have not seen the floor construction however from talking to xxxxx the maintenance manager it would seem there is a concrete beam and block floor or similar. Unfortunately if these are deflecting/vibrating there is very little that can be done without major works.

Beam and block floor

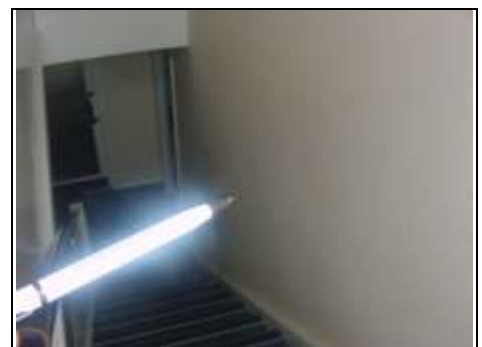
The communal areas were slightly below standard with slightly above average marking on the walls. We generally prefer where there is some sort of protection on the walls; even a handrail will tend to help the walls last better.

Marks to walls

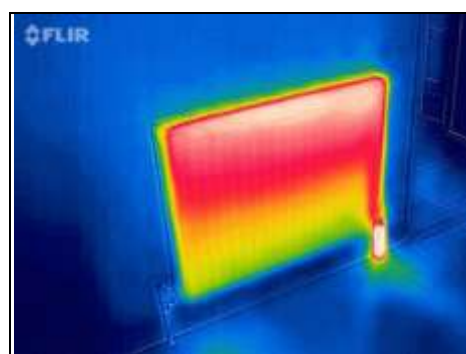
Thermal image photo of radiator

The heating was turned on during the course of the survey and we had it turned up higher. We would however recommend that the system be tested and overhauled before exchange of contracts and that a regular maintenance contract is placed with an approved heating engineer, unless the existing owner can provide service records.

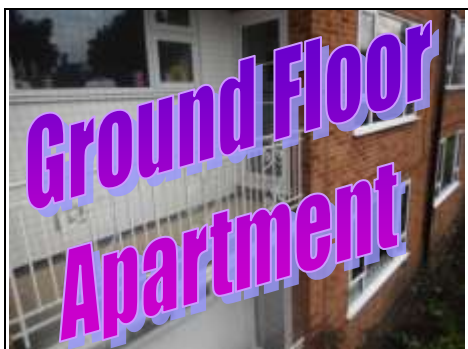
Pigeon netting to property above
Aerial view -360 photo

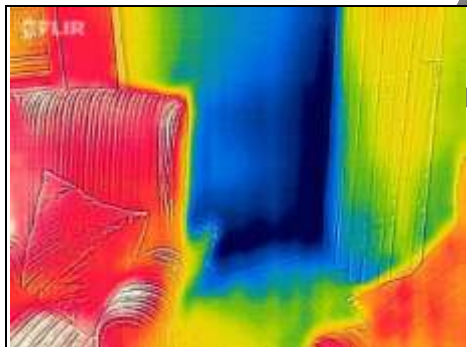
Photo of lounge – both walls colder than we would expect

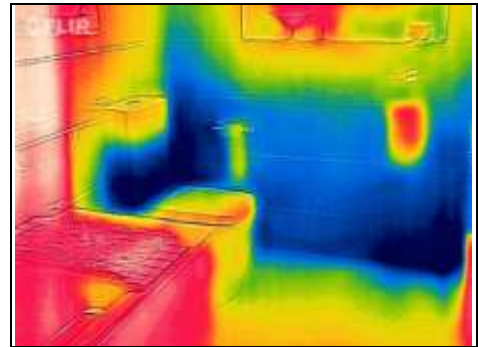
Testing for rising damp in rear bathroom (blue indicates cold areas which could also be damp)

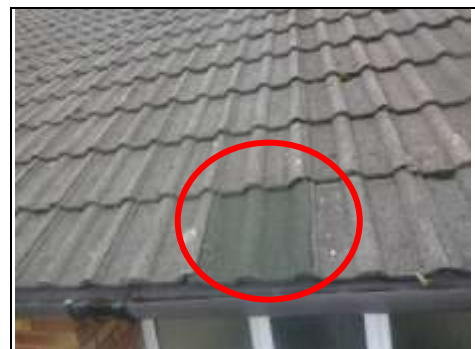
With this age of roof there will usually be a few missing or displaced tiles, this is nothing unusual.

Replacement tile
Aerial view -360 photo

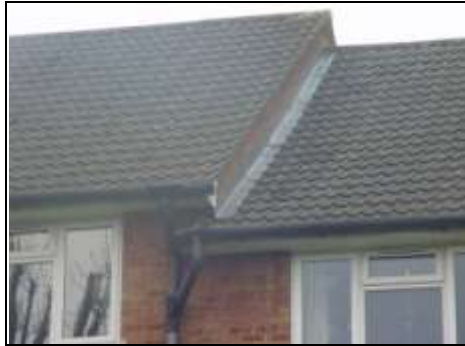
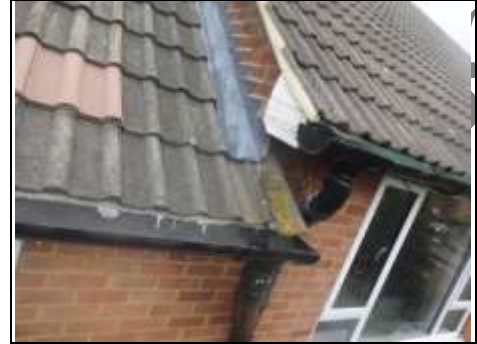
There is a step in the roof as there is a sloping site to this property from side to side and from front to back. Weak areas are always flashings, in this particular case it looks like it has been repointed.

Step in roof

Close up of step in roof
Aerial view -360 photo

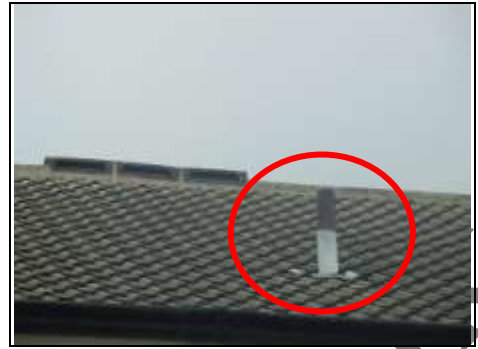
Flue to roof

We were not able to establish what the flue to the front is. It looks more akin to a flue from a boiler.

ACTION REQUIRED: Your legal advisor to ask the existing owner/management company.

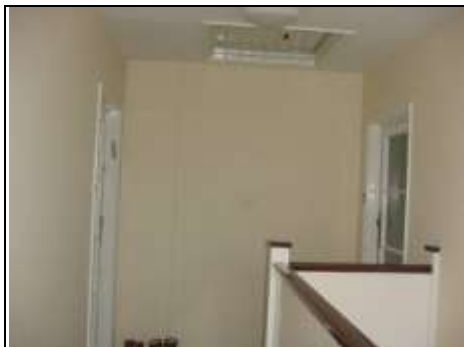
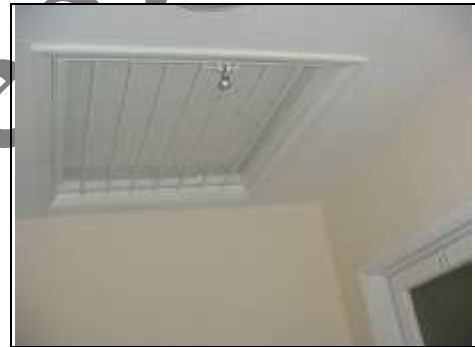
There was an access hatch on the top floor landing, however this was locked shut at the time of our inspection.

Roof access on top floor landing

Roof access locked shut

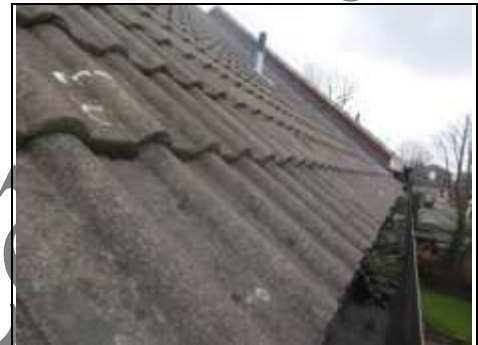
The gutters and downpipes are plastic. They are in average condition for their age, type and style.

There may be some minor leaks but most people would be happy to live with these providing repairs are carried out within the next six to twelve months.

Gutter to front
Aerial view -360 photo

ACTION REQUIRED: The clearing of the gutters, etc should be part of the maintenance being carried out by the maintenance company. Your legal advisor to check and confirm that the gutters are included in your service charge.

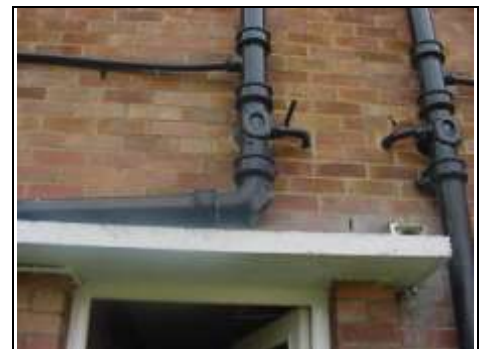
The property has cast iron soil and vent pipes to the rear of the property which looked in average condition for their age, type and style.

Soil and vent pipe to rear

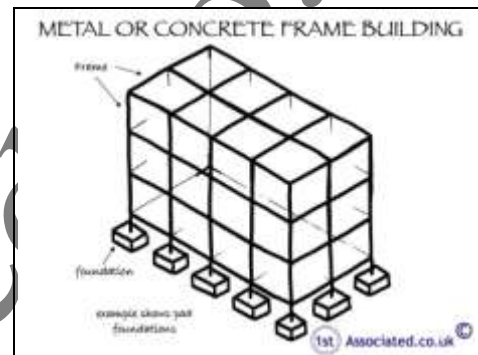
We believe this building will probably have a structural frame.

Structural frame

ACTION REQUIRED: Please see our comments in the Executive Summary.

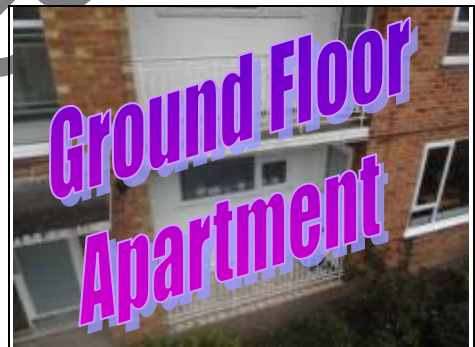
There are some relatively small areas of white painted render for example to the balcony area. These looked in average condition for their age, type and style at the time of our inspection. They will need regular redecoration. This is the type of item that should be on the planned maintenance schedule.

Render panel to balcony
Aerial view -360 photo

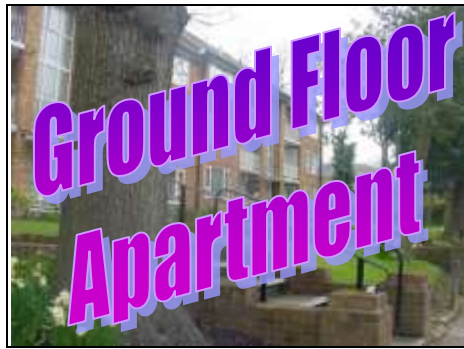
Trees

There are trees within what we would term as influencing distance but you do need to speak to your insurance company as they may have a different interpretation for insurance reasons.

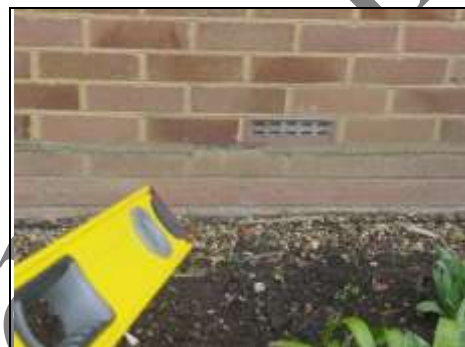
All modern properties should incorporate a damp proof course (DPC) and good building practice dictates that a differential of 150mm (6 inches) should be maintained between the damp proof course and ground levels. In this case, we can see a damp proof course to the front. To the rear the damp proof course is becoming hidden/is hidden by the raised ground level.

Damp proof course just below airbrick to front

ACTION REQUIRED: Reduce ground level. Please see our comments in the Executive Summary.

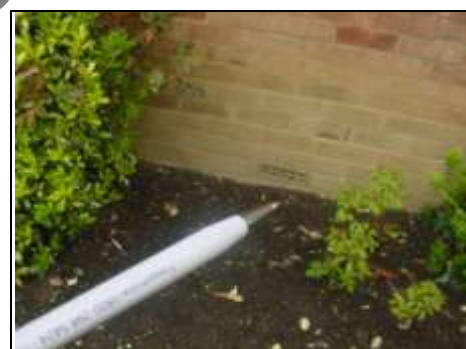
Raised ground level to rear

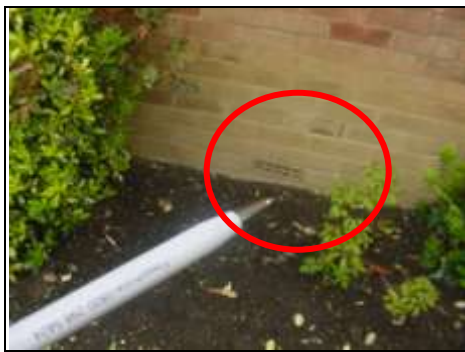
Air bricks are essential to have a through flow of air. In this case the airbricks which should ventilate the floor unfortunately are so low, they are acting as gutters.

Airbrick acting as gutter

ACTION REQUIRED: Lower ground level as there is a possibility of dampness. Please see our comments in the Executive Summary.

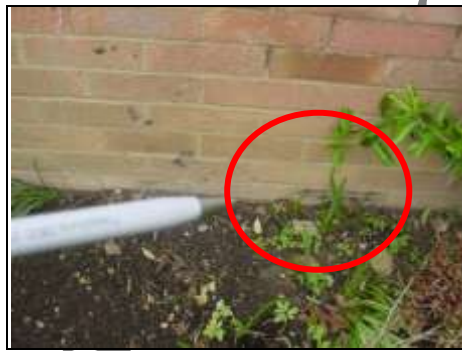
Airbricks acting as gutters

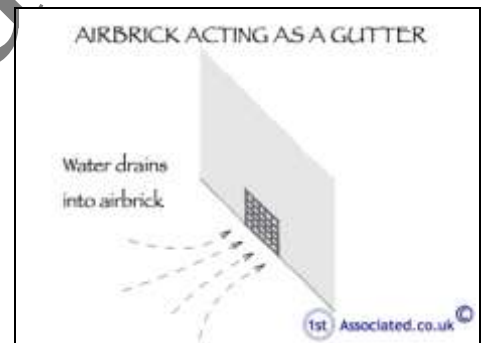
Airbrick acts as gutter

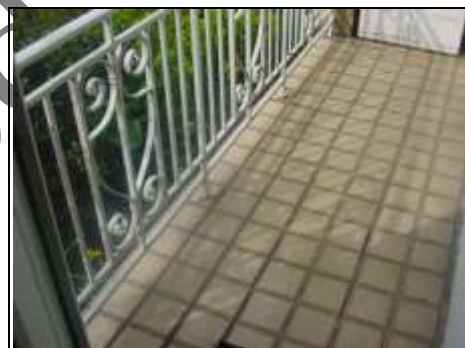
The tiling to the balcony area is slightly weathered.

Floor tiles to balcony

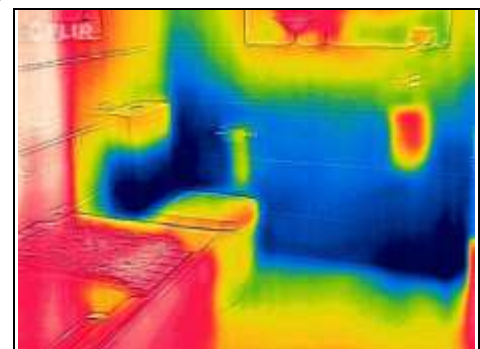
A random visual inspection and tests with a moisture meter have been taken to the perimeter walls. In this particular case we have not found rising damp, however we do believe there is a significant possibility of rising damp.

Testing for rising damp in rear bathroom (blue indicates cold areas which could also be damp)

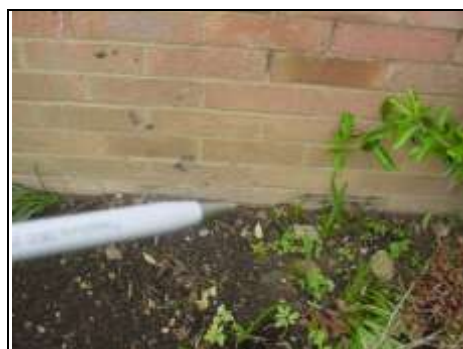
High ground level

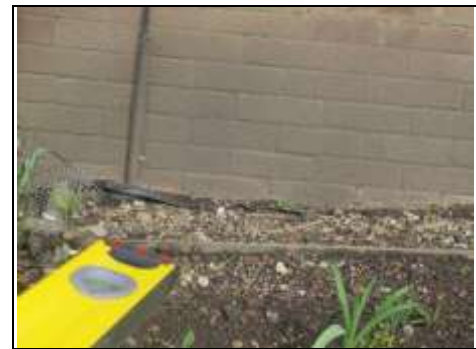
Rainwater hits the ground and bounces back onto the wall over the damp proof course

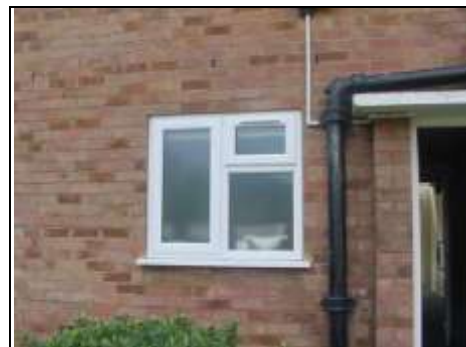
Bathroom

We did not notice an extract fan from the bathroom or kitchen therefore you may get some condensation. A way of helping to reduce condensation is to have good large extract fans with humidity controlled thermostats within the kitchens and bathrooms and also in any areas where you intend to dry clothes which are moisture generating areas.

ACTION REQUIRED: We would recommend large humidity controlled extract fans be added to kitchens, bathrooms and any rooms where you intend to dry clothes.

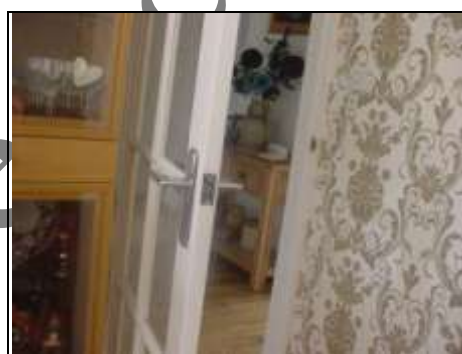
The property has painted flush doors and glazed internal doors. We cannot see a British standard safety kite mark on the glazed doors and we therefore assume that this glass is not safety glass, therefore it can shatter; we recommend the glass is replaced.

Glazed internal door

ACTION REQUIRED: Please see our comments in the Executive Summary with regard to the glazed doors in the communal/shared area.

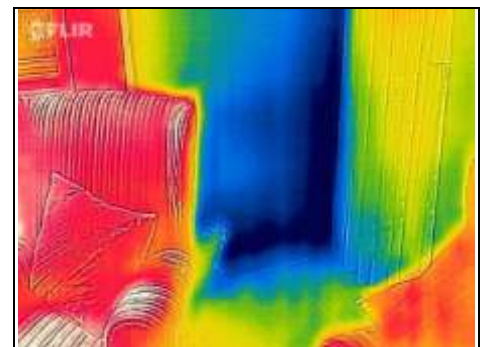
Thermal imaging photo of lounge – both walls colder than we would expect

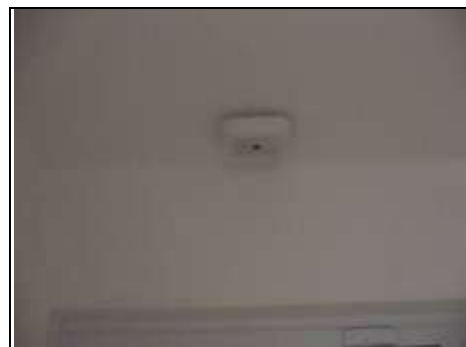
Battery operated fire alarm

ACTION REQUIRED: Your Legal Advisor to confirm whether this is the case.

We would recommend, for your own safety, that smoke detectors be installed. We would always recommend a hard wired fire alarm system and are also aware that some now work from a wireless signal which may be worth investigating. Whilst fire is relatively rare it is in a worst case scenario obviously devastating.

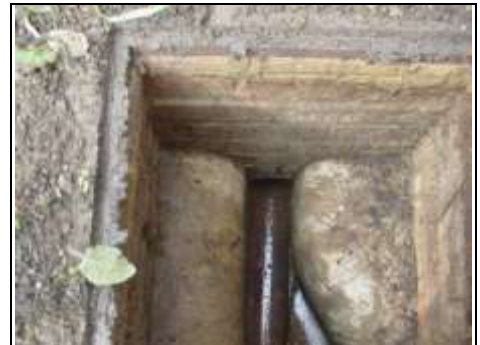
Front right manhole

We duly lifted the cover and found it to be free flowing at the time of our inspection.

From what we could see it is brick built.

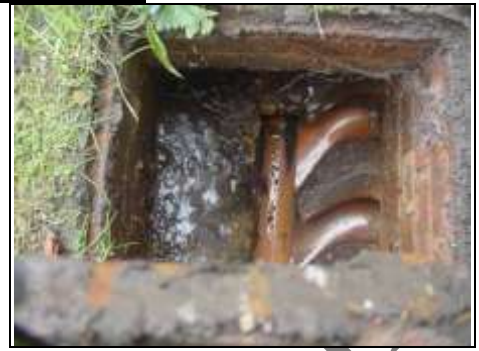
Rear left manhole

We duly lifted the cover and found it to be free flowing at the time of our inspection. We noted tree roots within this drain.

From what we could see it is brick built.

ACTION REQUIRED: Please see our comments in the Executive Summary.

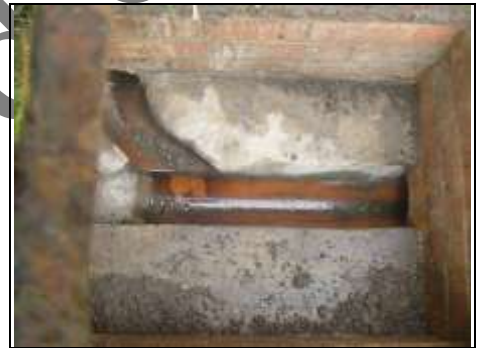
Rear right manhole

We duly lifted the cover and found it to be free flowing at the time of our inspection.

From what we could see it is brick built.

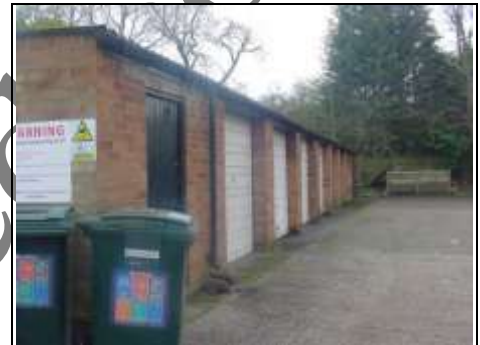
There are garages to the rear; however we are advised this property does not have a garage.

Garages that are not part of the property

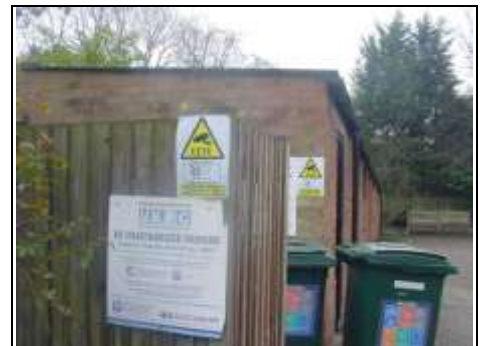
Bin area and parking notice

Parking is roadside parking on a first come first serve basis. There may be parking permits. There was very limited parking available on the day of our inspection.

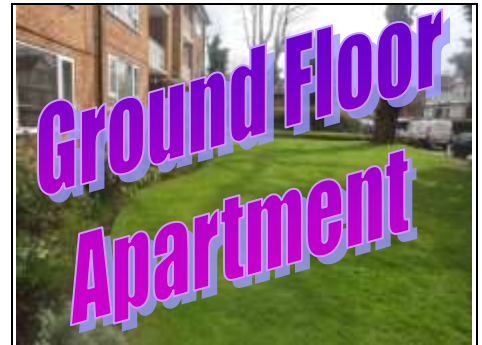
Front garden

The communal gardens were in good order at the time of our inspection.

ACTION REQUIRED: Please see our comments in the Executive Summary with regards to trees.

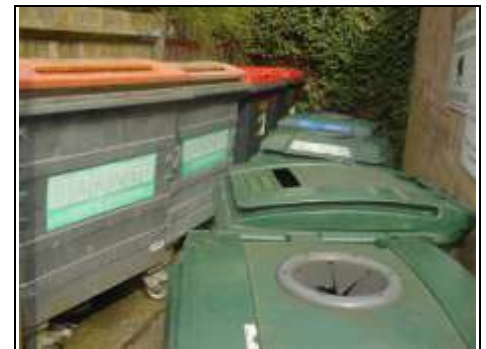
Bins

There is a bin area to the rear next to the garages.
