# RESIDENTIAL BUILDING SURVEY

Tenbury Wells,  
Worcestershire  
WR15 XXX

INDEPENDENT CHARTERED SURVEYORS

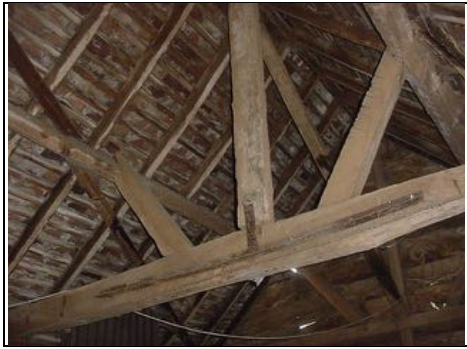
Kingpost truss roof of sorts  
stabilised with a metal brace

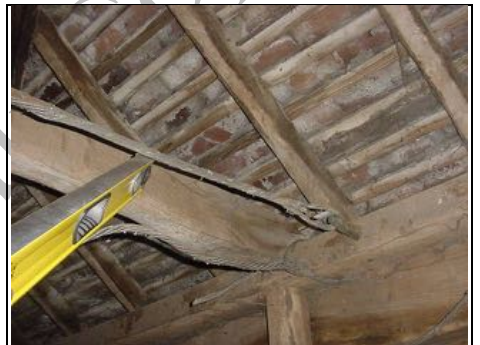
Tension wire

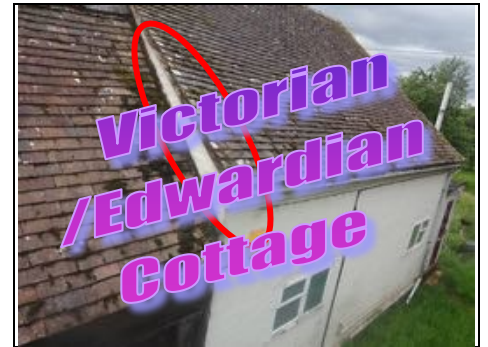
### 2.1) Step between main roof and barn

This is an area where often dampness gets in. A cement flashing has been used; we would much prefer a lead flashing.

No lead flashing between barn and main building

**ACTION REQUIRED:** We would recommend the moss is cleared with a soft brush and carry out ad hoc repairs to the roofs. The main repairs are required to the barn. Add lead flashing between the main house roof and the barn roof. Care needs to be taken when on the barn roof until the structure is stable.

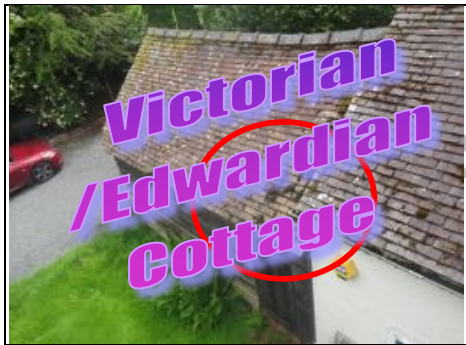
Ad hoc roof work is required generally to both roofs and specifically to the barn roof to make it watertight.

Barn roof

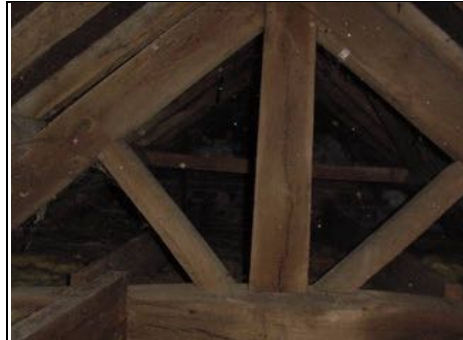
Interestingly, the kingpost to the house looks relatively new, in this case we mean the last fifty or so years. However, looking at the tiles externally it does not look like any work has been carried out to these.

King post roof of main house

**ACTION REQUIRED:** Repair work required to both roof structures.

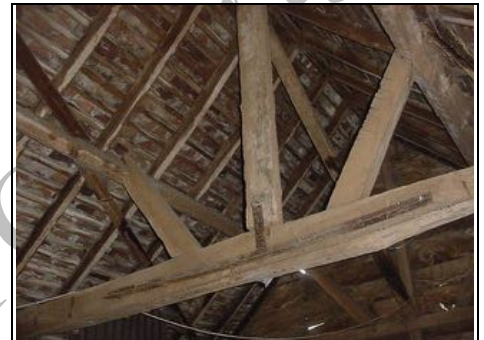
There are two kingpost truss roofs; a more modern one to the main house and a medieval style kingpost in the barn with metal brackets and metal cable to help stabilise it.

Barn has medieval style kingpost truss of sorts stabilised with a metal brace

We spoke about having an exposed roof in the barn and possibly one for the first floor. If this is the case, we would recommend adding additional timbers possibly additional Kingposts. We would recommend making the two structures separate to each other; at present the barn seems to sit against the main building.

**ANTICIPATED COST:** For repairs to existing roofs and possibly new kingposts we would set aside the sum of £2,500 - £5,000; please obtain quotations.

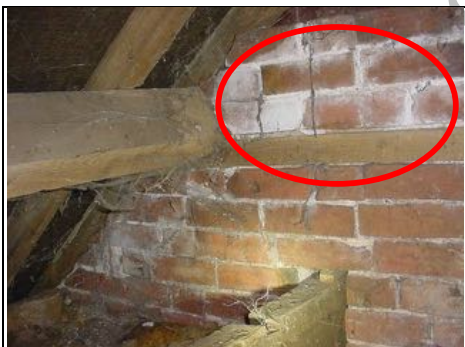
Dampness coming in through walls

**ACTION REQUIRED:** Repoint and repair the gable end walls and stop the dampness getting in with repairs to the roof. Monitor the woodworm using woodworm traps whilst you live in the house with the heating on!

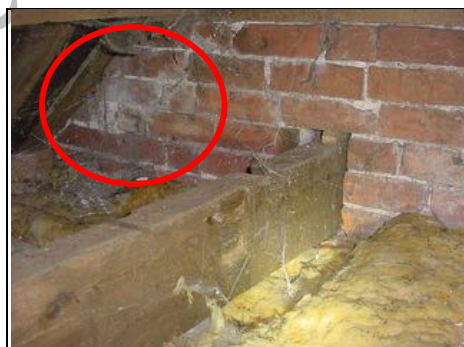
Dampness to right gable

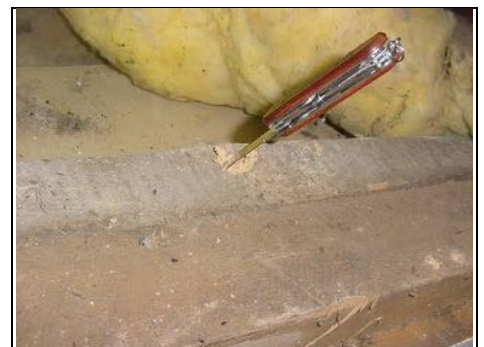
The roof area is slightly damp and we noted woodworm. It is very difficult to confirm whether it is still active, we would air on the side of it not being active as we could see some new timbers in the roof that do not seem to have woodworm.

Woodworm

The only true time we know for certain is during the woodworm breeding season of the spring months.

We always recommend having traps for the woodworm to make sure they are active as many of the holes that are treated by 'woodworm specialists' are flight holes where the woodworm has flown away and they are effectively treating nothing.

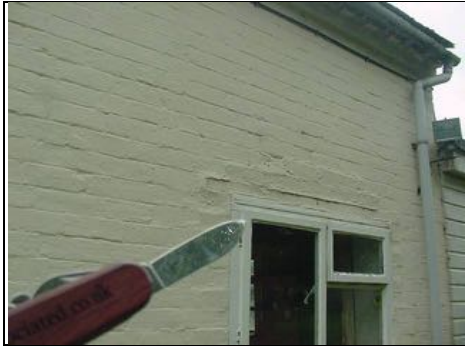
Movement around window

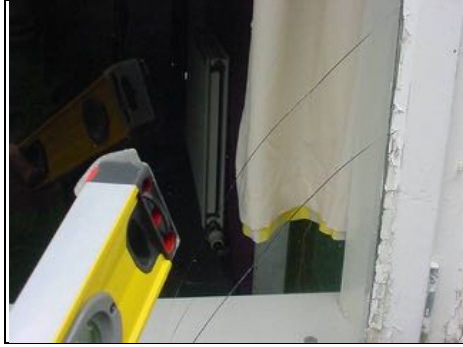
Cracked glass possibly indicating there is movement in the property

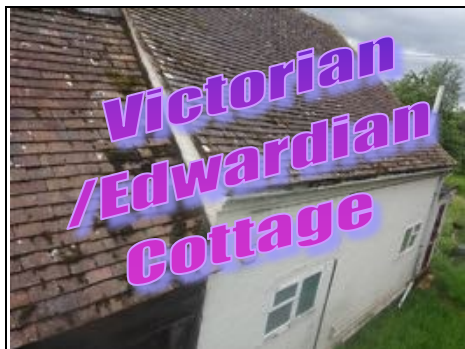
Again, once you have carried out repairs to the main roof check the guttering actually catches the rainwater (which you can only do next time it rains heavily by standing outside the property). It does look like it may be running down the wall which is why there is moss to the rear of the property which has been painted over. As well of course as this being partly to do with the overgrown trees.

Front guttering needs checking

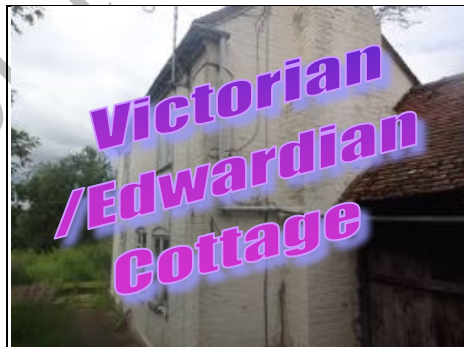
Rear guttering allowing water to discharge down the wall causing moss

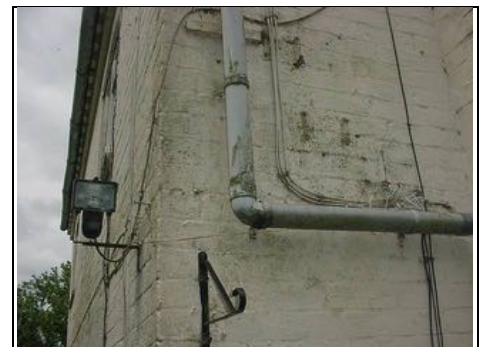
Awkward downpipes to rear left of main house

The rainwater discharging down the building is also damaging the timber lintels that we can see to the front of the property.

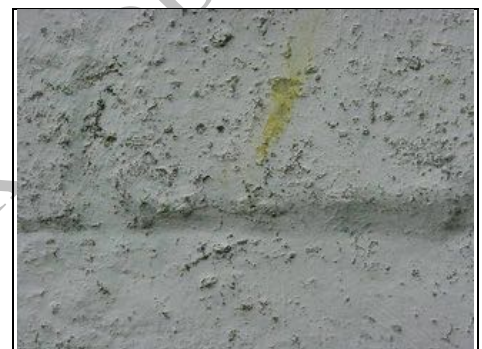
The walls to the main house are paint finish onto a red brick (relatively soft) in a Flemish bond brickwork. We can see moss has been painted over to the rear of the building. This could be misalignment of gutters (as mentioned) and also the surrounding trees.

Painted over moss and mould

**ACTION REQUIRED:** There is a lot of work required to the walls once you have stopped the water discharging down them by mending the gutters and get them back to a state where they are breathing again. Gently and gradually remove the modern paint that has been painted over the lime with a soft brush ensuring the brickwork is not damaged and then repoint and redecorate using a lime wash or modern microporous paint. This is likely to take several summer months (sunny days). We would anticipate this work to be carried out over a few years. Within it we would also incorporate repairs to the timber lintels and also underneath the windows which look to have been repaired in some areas with a modern cement rather than a lime plaster.

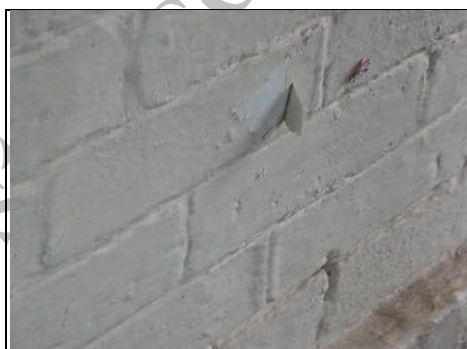
A wrong type of modern paint has been used which has painted over a lime wash. Luckily the lime is rejecting the modern paint so it is starting to peel away. You need the walls to breathe.

Paint flaking revealing lime wash behind

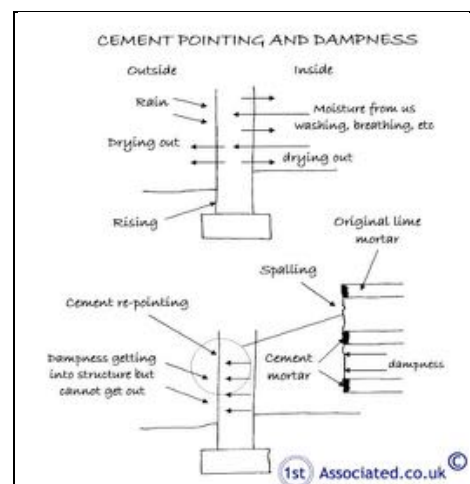
Walls need to breathe

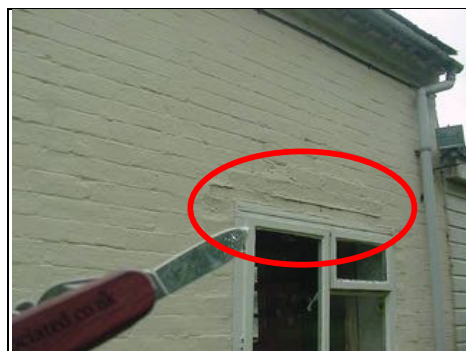
Timber lintel

To the front of the property there are timber lintels. It may well be worth taking these out completely. You can replace them with a timber lintel or with a metal lintel.

At the same time as carrying out repairs to the windows you will also need to check the lintels above them as we have already mentioned. Many of them are timber and may need replacing/repair.

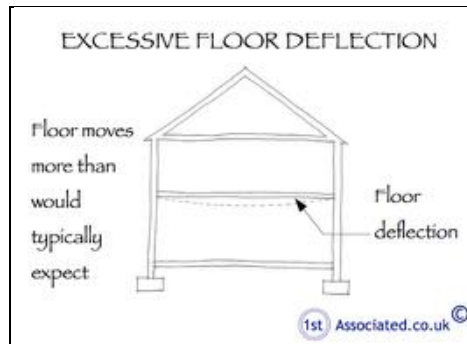
Excessive floor deflection

**ACTION REQUIRED:** Add additional timbers in although there is an exposed floor structure so it may not be possible without covering this area over.

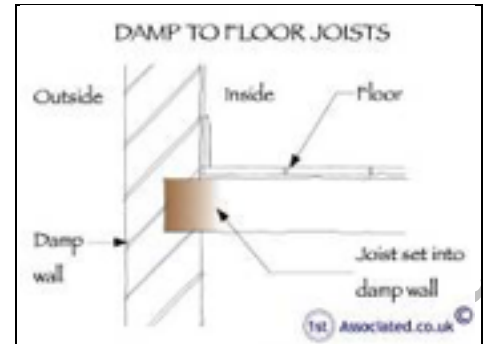
Damp to floor joists

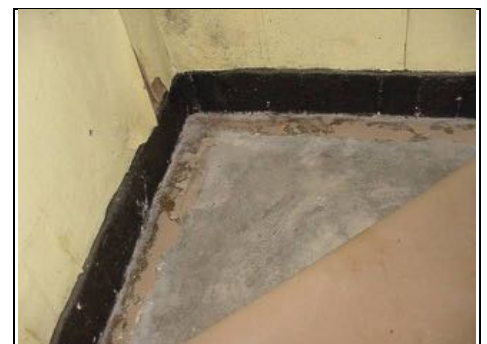
Concrete floor

We discussed whether a timber floor could be put on top of it; normal good practice would be to batten particularly if an oak floor was going in as we discussed. You could in theory scabble/cut back the concrete floor. There should have been a screed of 50 to 75mm put on it before you have the concrete underneath. With this type of property in the middle of nowhere it really is anyone's guess what has happened. You could take a core sample of the floor to see what is in it before you did anything. We would add that if you were going to do a lot of work to the floor we would add a warm floor heating system as well.

**ACTION REQUIRED:** Live in the building and see how dry it gets as this floor will act like a piece of blotting paper. We mentioned elsewhere within this report about lowering the ground level which should help.

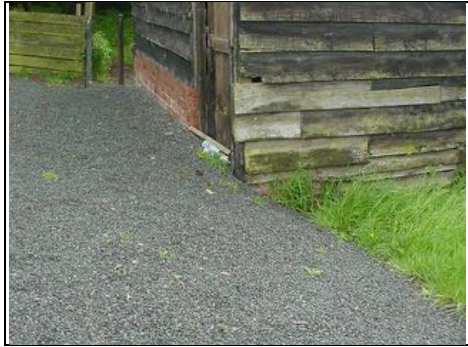
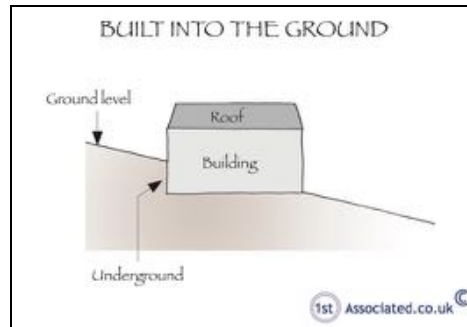
Both the house and the barn sit on a sloping site and to some extent suffers from a high ground level. There has been a build up to the area where the parking is and there is also concrete added around the building to form a pathway. All of this also allows dampness to get into the building.

High ground level

**ACTION REQUIRED:** We would recommend that you reduce the ground level around the building wherever possible and add a drain around the building in the form of a French drain, traditionally approximately a shovel width by two shovels deep and in more recent times it has a perforated pipe at the base of it to take the water away to a drainage system.

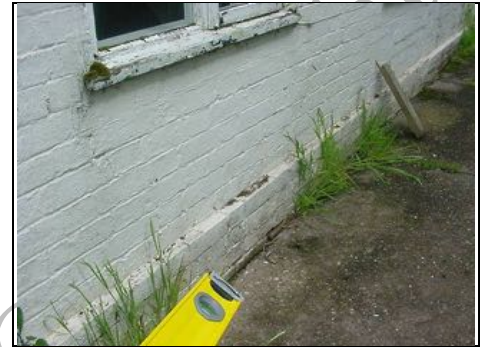
Grass growing against property/dampness

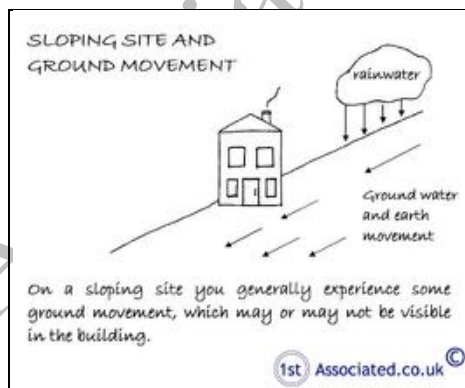
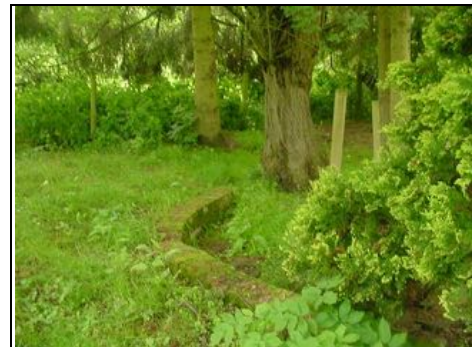
In addition, the property sits on a sloping site (sketch is an exaggeration of slope of course) and because of this rainwater and ground water need to travel from the top of the site (car port/barn area) to the bottom and doing this brings dampness into the building. Sloping sites are not as good as level sites and buildings on them are integrally unstable. You need to understand this is a characteristic of any building sitting on a sloping site.

Sloping site

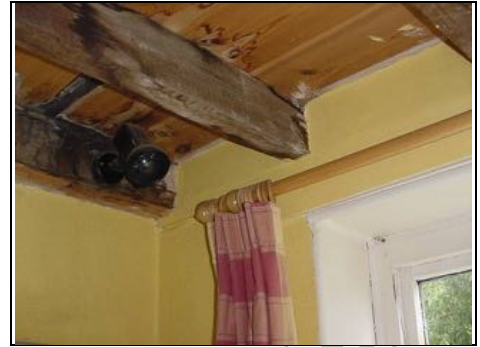
Dampness to timbers in rear lounge

**ACTION REQUIRED:** This is something that you will need to investigate further as work proceeds. We mentioned carrying out work to the roof and flashing which may rectify this problem.

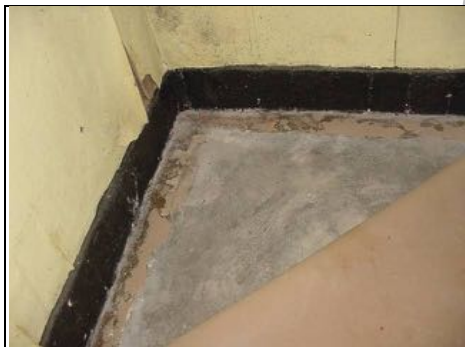
The property suffers from some condensation/black mould which could relate to how the building has been lived in, i.e. it has been heated but not aired by opening of the windows, extract fans, etc. (in fact, it would be difficult to open some of the windows).

Mould to corner

**ACTION REQUIRED:** We would recommend large good quality humidity controlled extract fans are added to the kitchen, the bathroom and any areas that are used for drying clothes internally during winter months (we would assume that clothes will be dried externally during the warmer months). By large extract fans we mean 150mm.

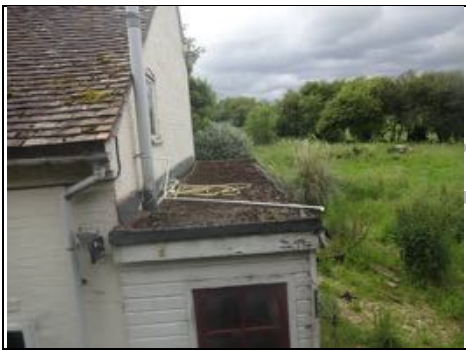
There is a storm porch running the length of the right-hand gable. The roof was covered with moss indicating that it is a flat roof and water is not discharging from it.

Flat roof to porch on right

**ACTION REQUIRED:** We would suggest you clear the roof to see its condition and it is probably best if you put a layer of felt over the top of it and check the flashings. Also, add guttering. Ultimately, we would recommend that you put a pitched roof on this.

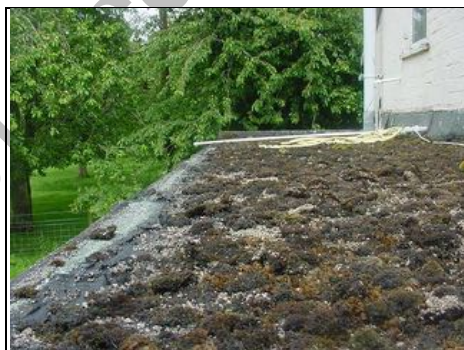
Moss to flat roof

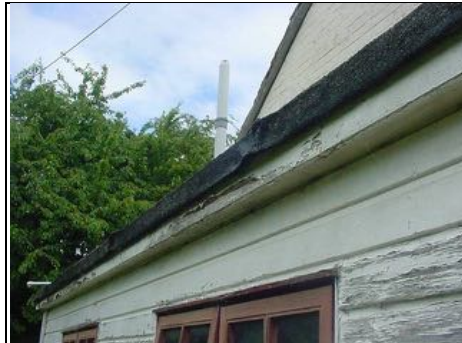
No gutters

**ACTION REQUIRED:** We recommend stripping back all of the shiplap boarding, adding insulation between the timber frame and then putting new shiplap boarding on the entire structure and redecorating. There would be some associated repairs with this around the windows and doors as well as adding the guttering of course.

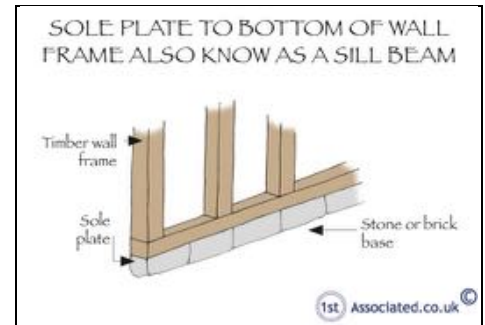
As mentioned you need to carry out work to the structure of the roof and also the repairs to the roof tiles as well as adding guttering. This in turn will then stop the mould and the dampness that we can see for example to the rear base of the barn. Rainwater is discharging onto the brickwork and to the front it is discharging onto the timber sole plate.

Sole plate

Guttering needs to be added to the barn. Once you have added gutters you then need to replace the shiplap boarding to the side and to the gable end, you may well be able to re-use some of the cladding. By adding guttering to the building will make it a lot better.

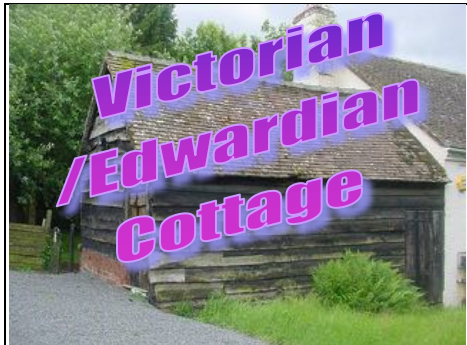
No gutters

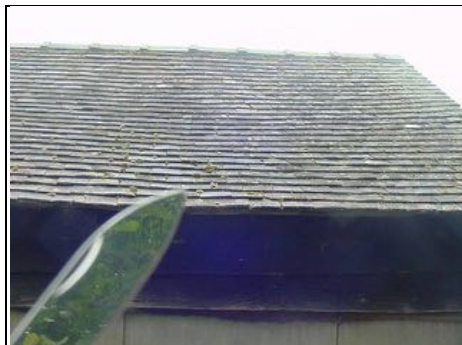
Water discharging down front of barn

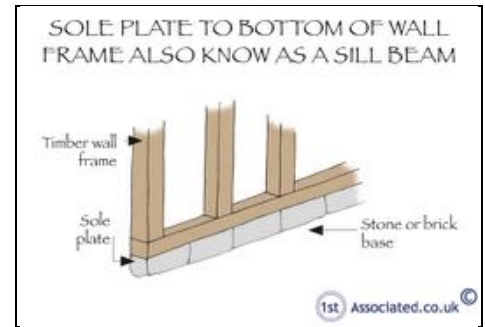
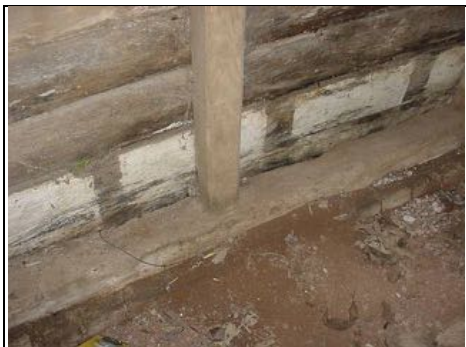
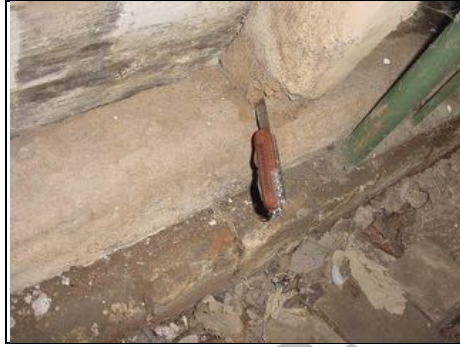
We discussed converting this into a kitchen area which means it would have to be brought up to modern day standards. The framework within the barn is 600mm to 700mm wide; we would expect it more typically to be 400mm to 450mm.

Sole plate

Sole plate and vertical timbers

Base of vertical timbers

**ACTION REQUIRED:** The timber that we knife tested is not doing too badly. We would suggest extra timbers are added in between the existing timbers and that repairs are carried out to some of the existing timbers including the sole plate that had some wet rot in it. There was not an excessive amount considering it was a sole plate.

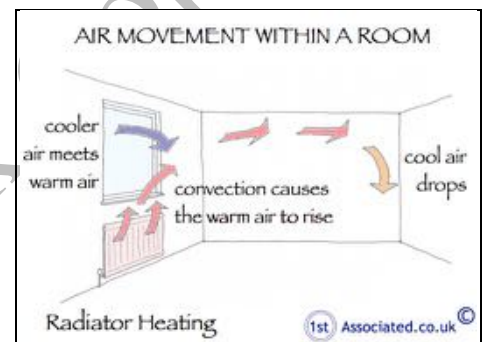
We noted the radiators are internal in some areas. This is often carried out on cheaper central heating systems to save the labour and piping costs of positioning the radiators underneath the windows. However, it then reduces the air movement in the room, which can lead to black mould.

Air movement

**ACTION REQUIRED:** Qualified heating engineer to establish whether boiler is working. This would be worth carrying out before you purchase the property as this would be a major cost.

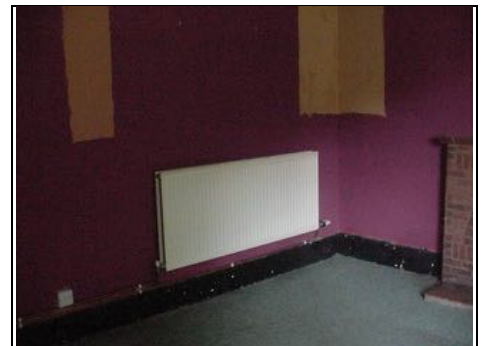
Internal radiators

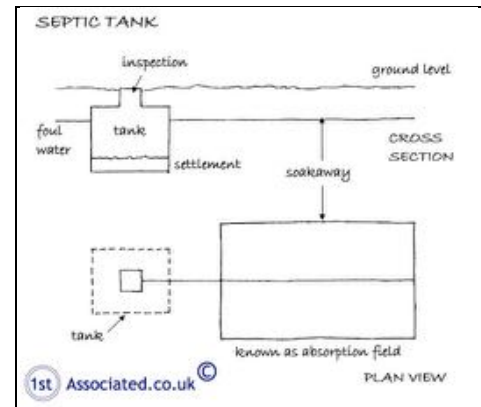
Septic tank

We assume the property has a septic tank however we were unable to find where the septic tank is. It is usually at the lower end of the site which would be the right end. There was no obvious manhole/drainage system to indicate where it is.

**ACTION REQUIRED:** Your legal advisor to specifically ask where the septic tank is.

We would recommend that you have the septic tank emptied and whoever empties it takes photographs of the outside and most importantly the inside and we are provided with the telephone number of the company emptying it to discuss with them.

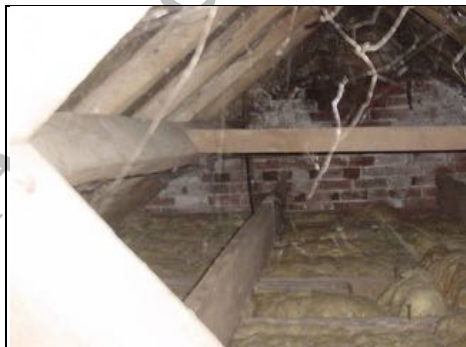
This chimney is painted brick finished with two chimney pots. From what we could see from ground level it looked in below average condition considering its age, type and style with plants growing from it. We are not sure what the flashing is; we could see internally that there was dampness coming in from the chimney.

Dampness internally to chimney

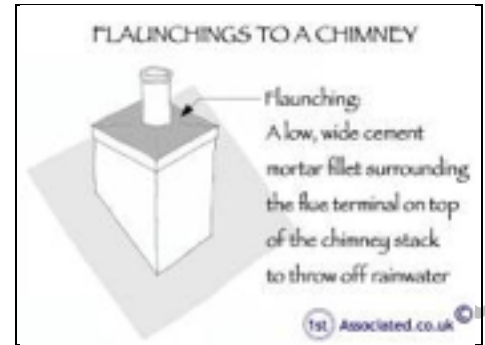
Flaunching

Unfortunately, we were unable to see the top of the chimney properly known as the flaunching, we therefore cannot comment upon them.

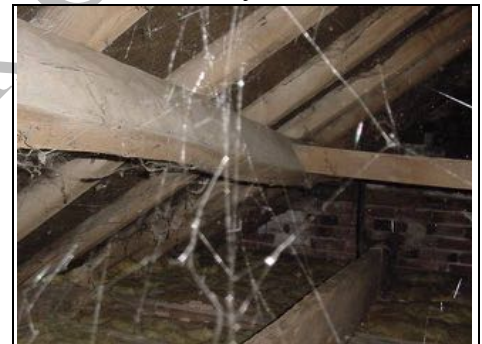
When we inspected the loft space we found a Hessian based Bitumen membrane. This type of membrane has been used since the 1960s. We generally found it to be in average condition, with damage in some areas which is what we typically find.

This photo shows the common rafters (the ones that form the pitch of the roof) and the dark area between is the underlayer.

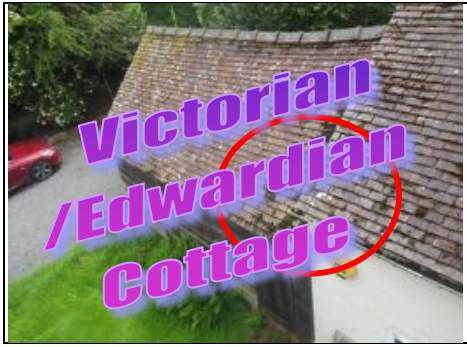
Barn roof

The barn roof is pitched and clad with clay tiles and, from ground level, this looks in slightly below average condition considering the roofs age, type and style. Again, this roof was not as bad as we were expecting; the main problem with working on the barn roof is the stability of the barn structure. We would only carry out work without putting weight on the barn.

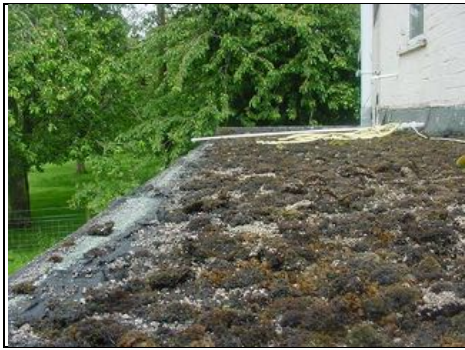
There is a storm porch with a flat roof running the length of the right-hand gable. The roof is in below average condition and was covered with moss indicating that it is a flat, flat roof (we would expect to see a fall of about fifteen degrees) and water is not discharging from it, it is more likely to be discharging into it. We can see this with the discoloration to the decking beneath it.

Moss to flat roof

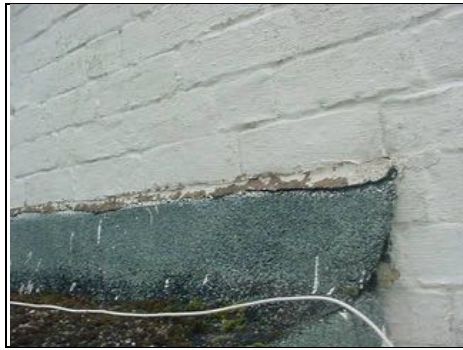
Flashing starting to come away

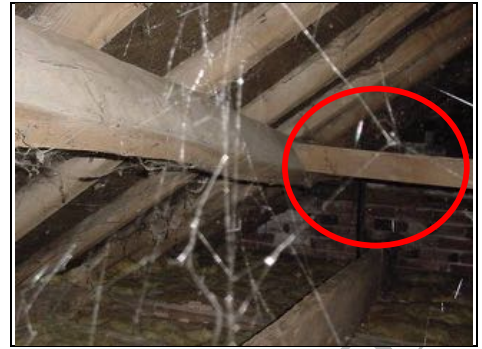
Collar added

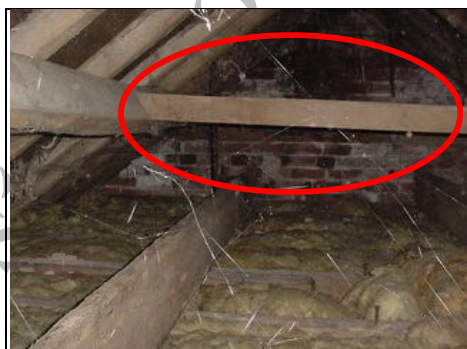
New collar to left gable end

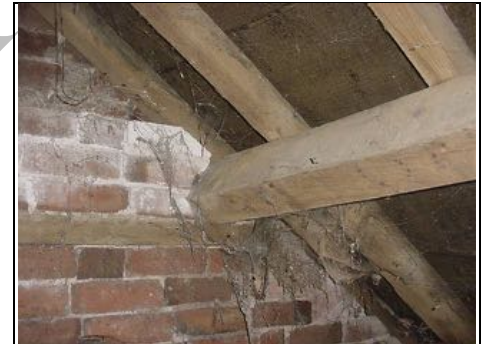
Dampness is coming through.

Salts coming through the wall

**ACTION REQUIRED:** Please see our comments in the Executive Summary.

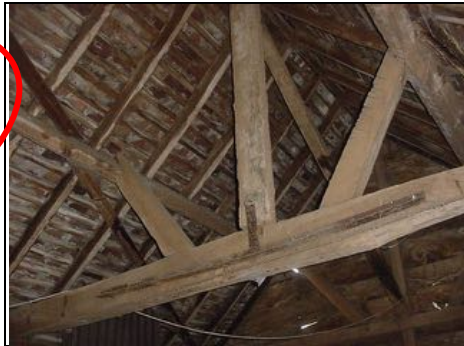
Kingpost roof of sorts stabilised with a metal brace

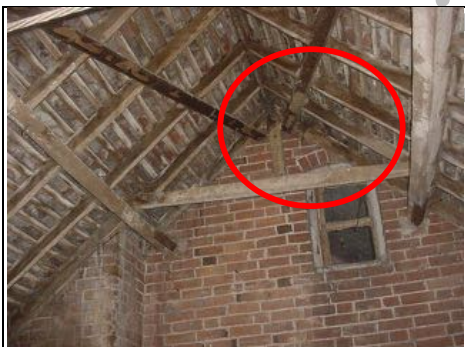
The barn has a medieval king post truss. Having said that, the two strut timbers to the left and right of it look to be replacements. As dampness has come into the roof the purlin ends have rotted away and angle irons were added.

Angle irons

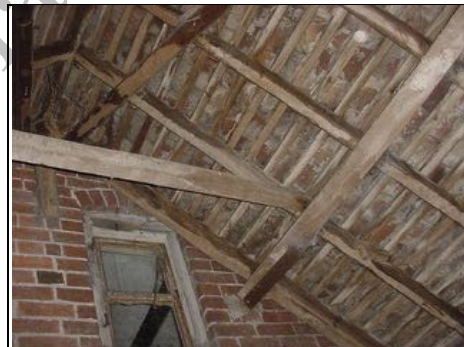
Dampness coming into roof  
Purlin end rotted away and angle iron added

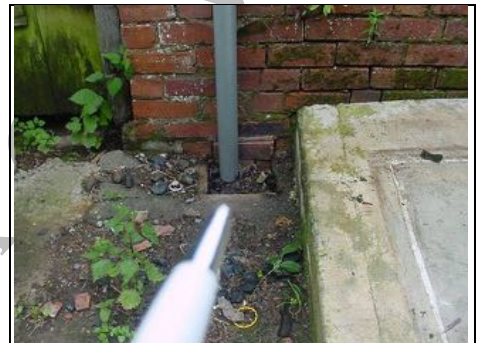
Downpipes discharge into gully

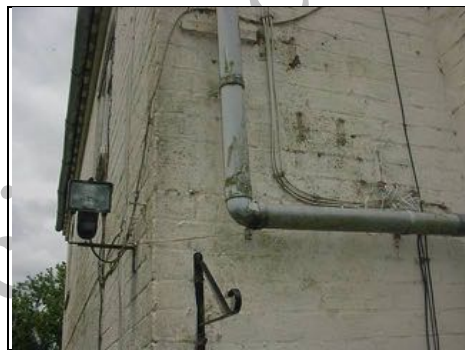
The gutters and downpipes are plastic to the rear and look to have been added at a later date probably replacing cast iron gutters. The gutters to the front we could not make up our mind as to whether these are cast iron or not. There are in below average condition for their age, type and style and we believe they are allowing water to discharge down the property, particularly to the rear.

Awkward and unusual downpipes to rear left of main house

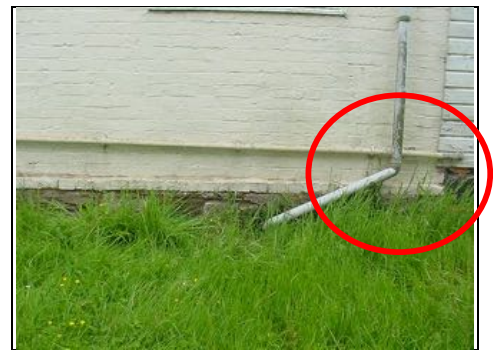
Guttering at front discharges against building to front right

We would recommend you stand outside the property next time it rains heavily and see how well the drains cope with the rainwater particularly looking at the guttering and the joints. We also recommend that the gutters and downpipes are cleaned out, the joints are checked and the alignment checked to ensure that the gutters fall towards the downpipes.

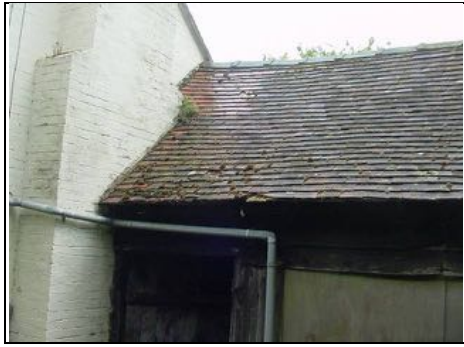
No guttering to barn (cement flashing where barn meets main building)

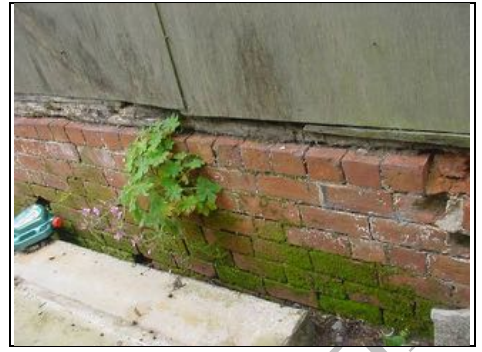
Dampness to base of barn due to not having gutters

The brickwork is being badly affected by the lack of guttering to the barn. Once there is a guttering added this will be far better. There is also a boarded-up window in this area which we would like to see the boarding removed to inspect the condition of the timbers beneath it.

**ACTION REQUIRED:** Please see our comments in the Executive Summary.

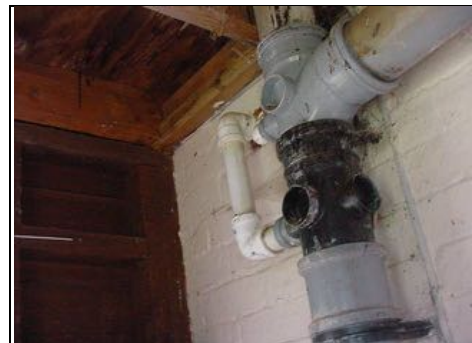
Leaking soil and vent pipe

The soil and vent pipes are plastic. Repair leaking soil and vent pipe.

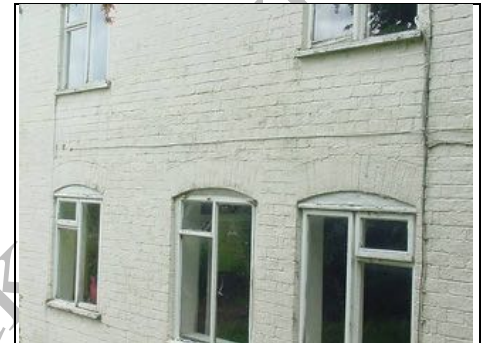
Painted brickwork

Generally Flemish Bond brickwork is liable to penetrating dampness internally, dependent upon the condition of the brickwork and the exposure to the weather. It is essential that external faces be kept in good condition. In this case, it has been painted with a modern paint that seals it rather than allowing it to breathe. There is a lime wash underneath it which would have allowed it to breathe. It is rejecting some of the modern paint so it possible to remove it however this is a laborious task.

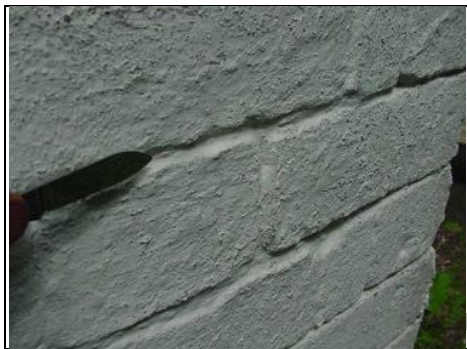
Pointing required

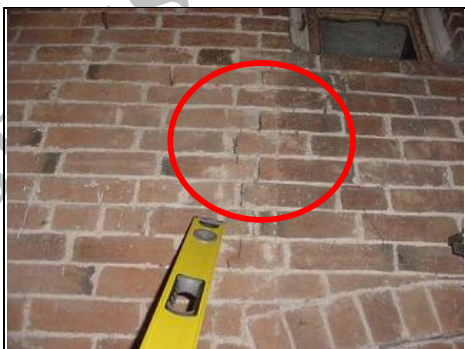
We would remind you that there was cracking to the left gable. There are also cracks elsewhere within the property.

Cracking to left gable

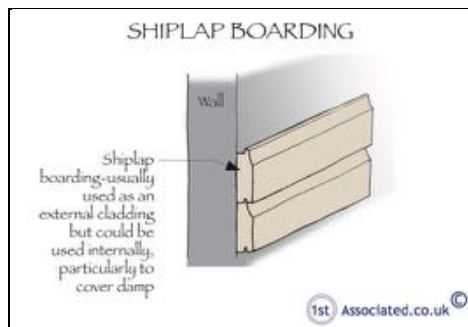
The shi lap boarding needs repair and redecoration. It may be better to remove and start again.

Shi lap boarding

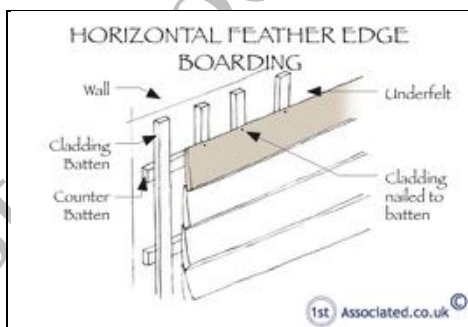
Repair and redecoration required.

Feather edge boarding

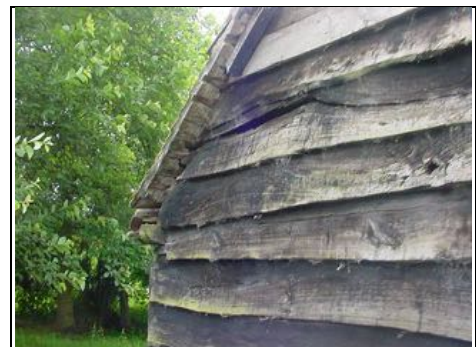
Cladding to barn

**ACTION REQUIRED:** Please see our comments in the Executive Summary.

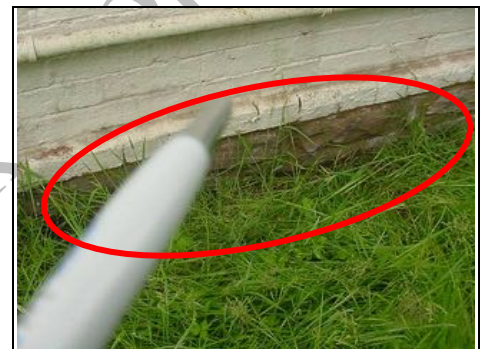
We can see an old stone area to the base of the front of the property. It was interesting as this building may have once had stonework with a timber frame on top of it.

Stonework beneath painted brickwork

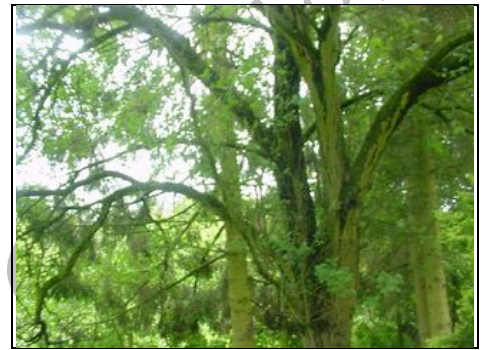
There are trees within what we would term as influencing distance but you do need to speak to your insurance company as they may have a different interpretation for insurance reasons.

Trees need cutting back

**ACTION REQUIRED:** The trees need cutting back. Please see our comments in the Executive Summary.

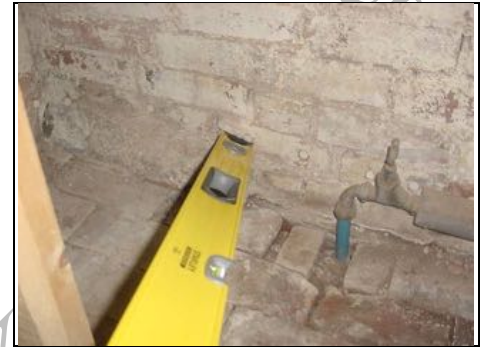
In this case, we can see an inserted damp proof course has been added. We feel that these damp proof courses are practically useless.

Damp proof course added

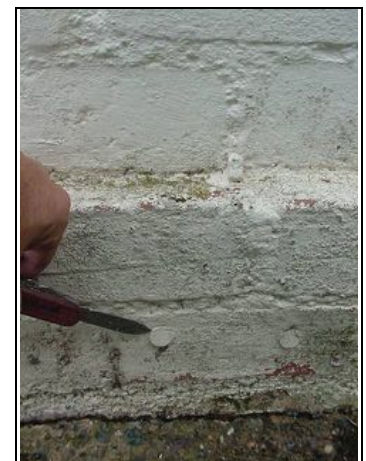
Inserted damp proof course

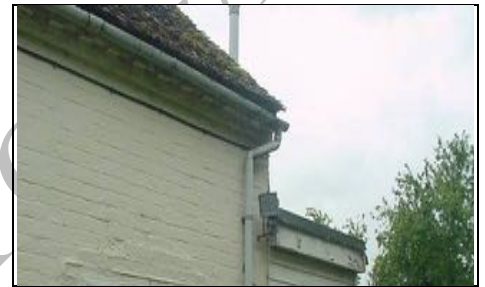
It is difficult to see whether there are any fascias and soffits on the main building. There is what is known as a dog tooth corbelling which may be part of the problem with fixing the guttering at high level. To the storm porch there is a fascia and soffit board however has not got gutters fixed to it and would benefit from a gutter being added.

Dog tooth corbelling

**ACTION REQUIRED:** Make sure gutters and downpipes are watertight before carrying out any work on fascias and soffits.

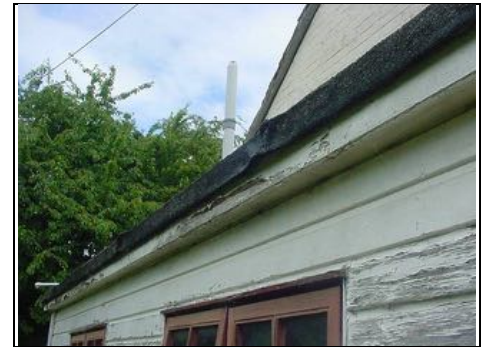
Fascias and soffits to storm porch

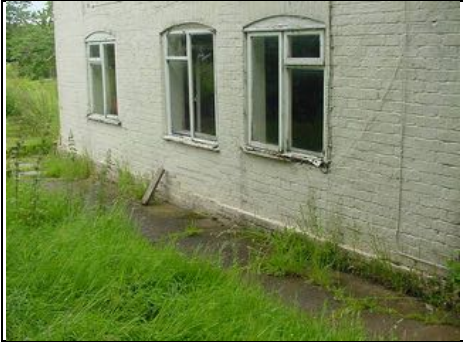
The property has timber casement windows. The windows are in poor condition and many are flush rather than set back which means that the rainwater has caused a lot of deterioration. There is one window with cracked glass indicating some movement in the property. This may be because it is saturated with water.

Sills missing to rear windows

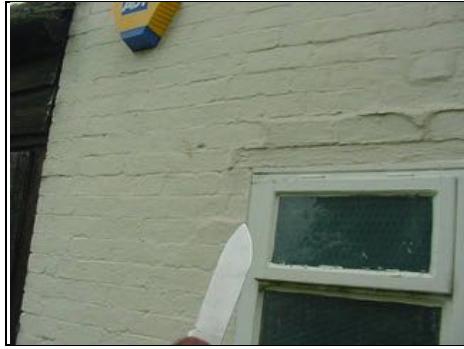
Window put in flush and timber lintel above

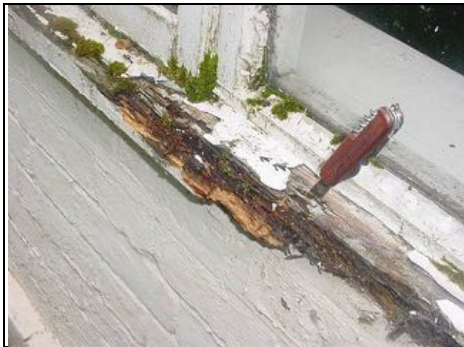
Rot to sills

We noted lots of wet rot! For example, to the cladding to the porch and barn and the windows, the window frames were coming completely away. There is soft rot to the sole plate and the timber frame it is built upon. There is a lot of repair work required, in some areas it would be more economical to replace such as the windows for example as they were never a particularly good quality.

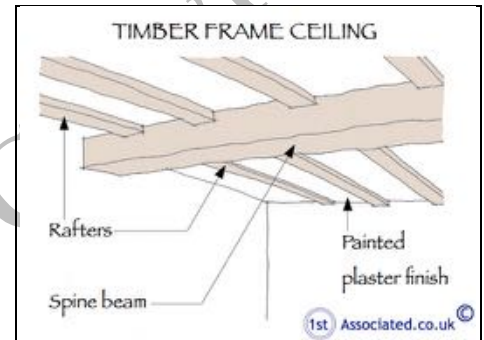
A spine beam is visible on the ground floor. Whilst this is a very traditional way of building a ceiling/floor it does have very modern joist hangers which just about sums up the timber in this building. It seems to be a contradiction of old and new work and needs further investigation.

Timber frame ceiling

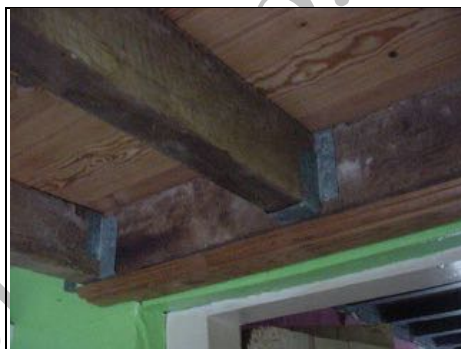
Modern joist hangers

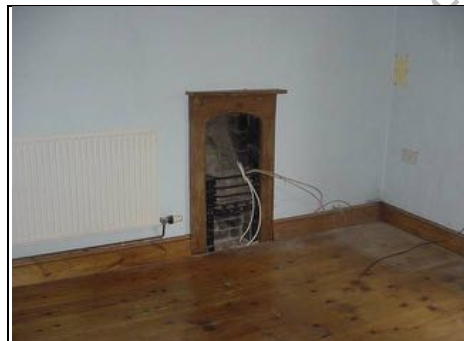
The chimney breasts are located to the left-hand side (all directions given as you face the front of the property). Externally the chimney is in poor condition and has a tree growing from it. No-one is living in the property therefore no chimneys were in use at the time of our survey.

Fireplace at rear left bedroom

**ACTION REQUIRED:** We assume you will be looking to open up the chimney again, in which case it needs to be swept and checked that a lining is in place and working satisfactorily.

**ANTICIPATED COST:** In the region of £500 - £1,000 to put a new lining in, maybe more depending upon the condition of the chimney; quotations required.

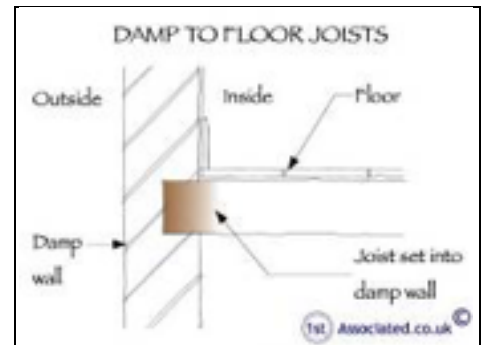
We have assumed that the first-floor construction is joist and floorboards with embedded timbers and joist hangers. As mentioned this first floor/ceiling is a contradiction of a mixture of old and new timber techniques.

Embedded timbers

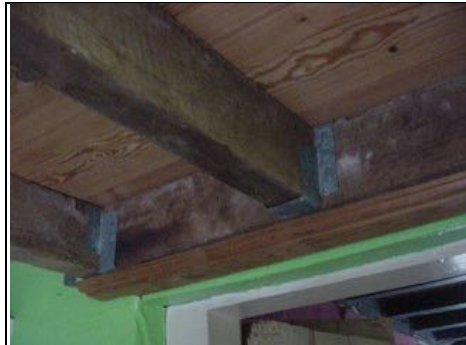
Timber joist hangers to support floor

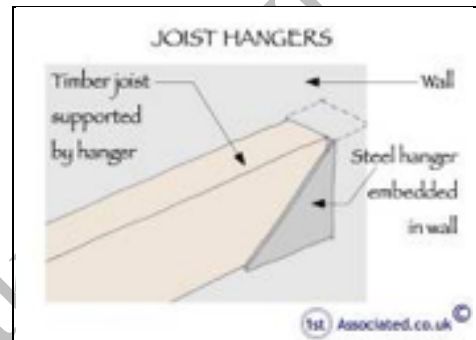
Joist hangers

**ACTION REQUIRED:** Please see our comments in the Executive Summary with regards to deflection.

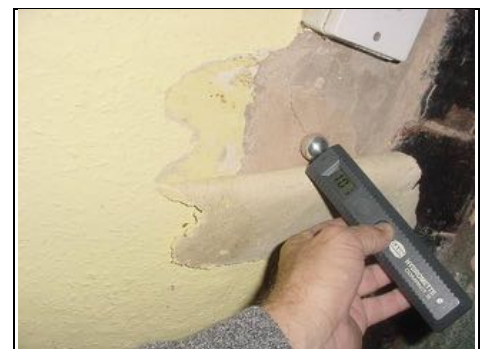
A visual inspection and tests with a moisture meter have been taken to the perimeter walls. In this particular case we have found significant rising damp.

High damp meter reading of 101

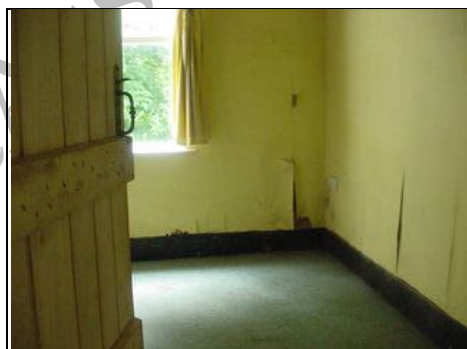
At the time of the inspection there were signs of condensation/black mould in the rear right room and the left room. The improvements that we have mentioned will help considerably.

Black mould in rear right room

**ACTION REQUIRED:** We would recommend large good quality humidity controlled extract fans be added to kitchens, bathrooms and any rooms where you intend to dry clothes.

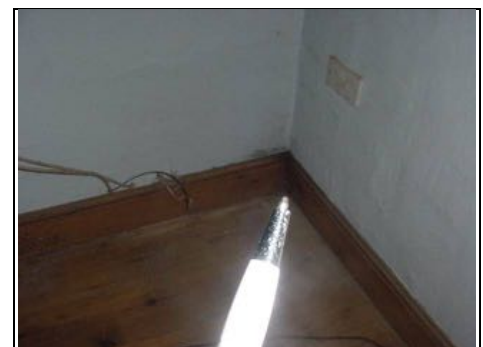
Black mould

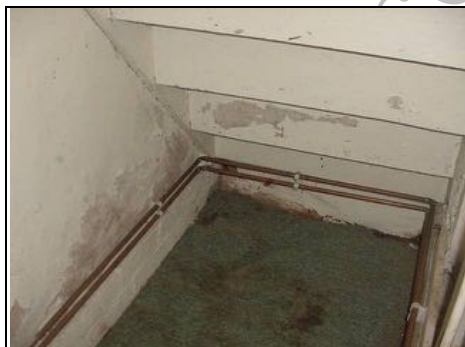
We noted that the underside of the staircase was exposed. It is more normal today to have a half hour fire barrier to stop fire spreading from the ground floor to the first floor in a worse case scenario. You may wish to take a view on whether you add this.

Stairs not lined

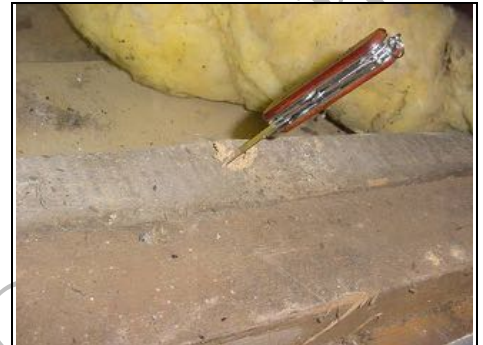
The roof is the main area that we look for woodworm. Within the roof we found visual signs of significant woodworm activity or woodworm.

Woodworm

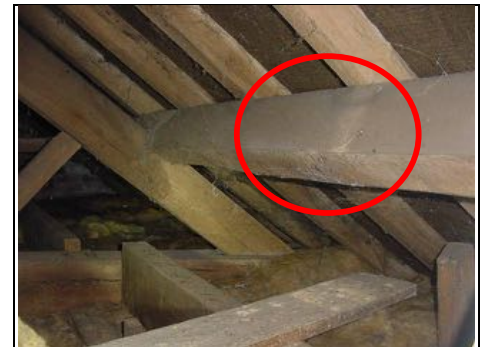
We would comment in this instance that there looks to be frass onto the board which we did not see at the time of our inspection; we have only noticed this on the photographs however photographs can be deceptive with the way light is thrown upon them.

Frass?

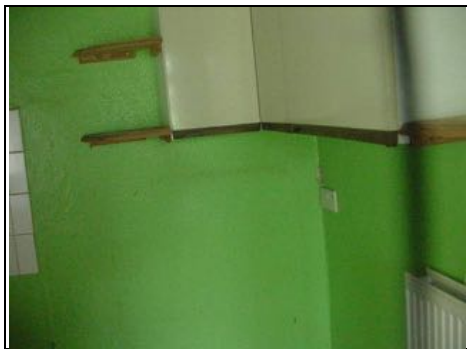
Internal decorations are generally very colourful from the lime green of the kitchen to the yellow of the rear right dining room to the purples of the lounge area. The plaster is deteriorating. Please see our comments in the Executive Summary as to how to repair this prior to redecorating.

Lime green of kitchen

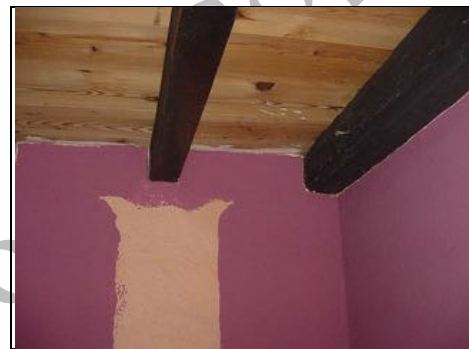
Purple of lounge

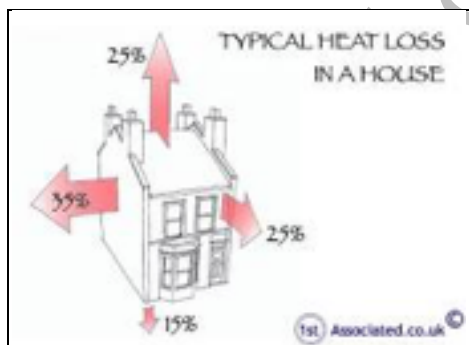
Some roof insulation was present although not to current Building Regulations requirements of 300mm. In this instance, there is 200mm to 300mm.

Typical heat loss

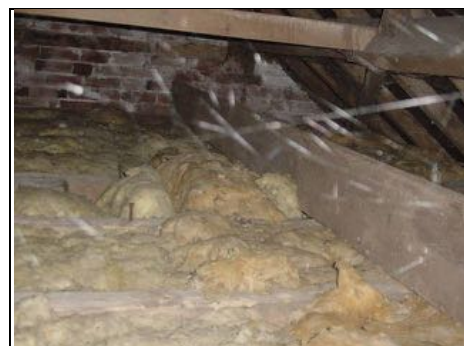
Mass of insulation

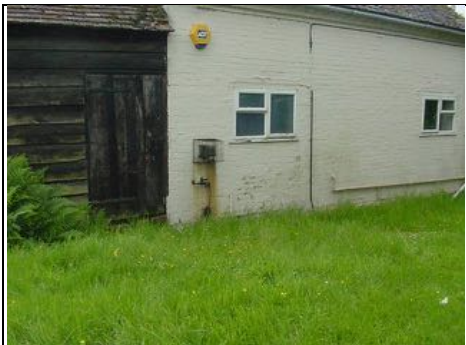
We can see a box to the front of the property. We can only assume that a security system has been installed and we are not sure whether it is working or not, there were cameras and warnings. You need to make further enquiries.

ADT alarm system

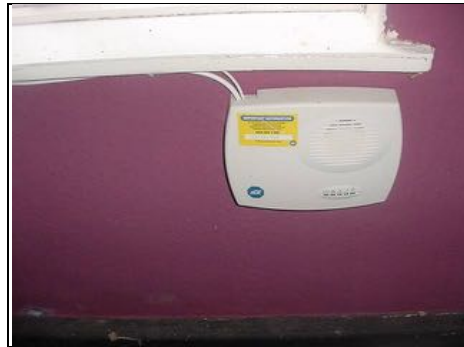
Alarm

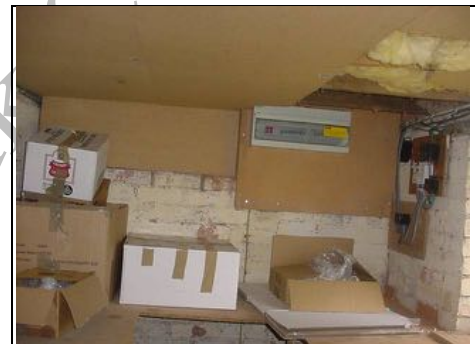
Fuse Board

The electric fuses and consumer units were located in the Services cupboard off the barn. The fuse board looked more modern than we were expecting. It looks like it has been upgraded relatively recently (last ten to twenty years). Some of the switch points were fairly new. However, we do have concerns there is older wiring in the property. We really do not think it is worth the risk of carrying out all the refurbishment work you are going to do without having a test and report on the electrics and having it upgraded with such things as extra socket points, etc.

**ACTION REQUIRED:** Due to the amount of work you are carrying out we believe it is worth having the electrics checked and as the property is changing occupancy an Institution of Engineering and Technology (IET) test and report and any recommendations should be carried out by a NICEIC registered, or equivalent, approved electrical contractor or similarly approved.

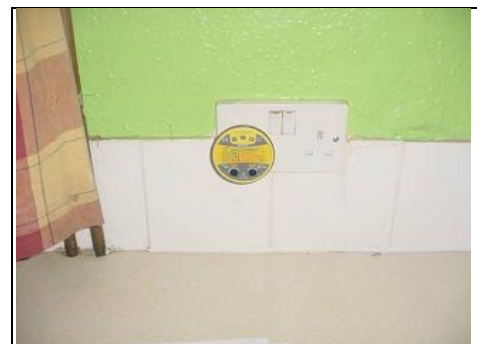
Earth test

We usually carry out an earth test in the kitchen area to the socket point that is normally used for the kettle. In this case the electrics were switched off therefore we were unable to test.

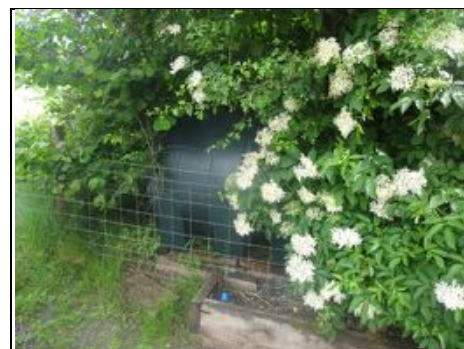
We were pleased to see that the oil tanks are plastic. These usually replace the older metal tanks that can rust and they typically have a double lining, meaning that if they leak they leak into the outer lining.

Oil tank near parking area

**ACTION REQUIRED:** Your legal Advisor needs to check and confirm whether there is any guarantee or warranty available with the tank.

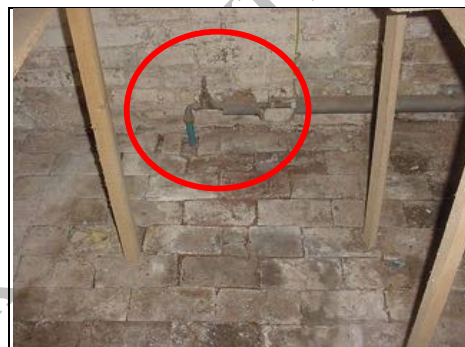
Water supply

We noted that there was a stopcock within the services room however as the owner was not present we could not ask our usual questions.

The stopcock and other controlling valves have not been inspected or tested for operational effectiveness.

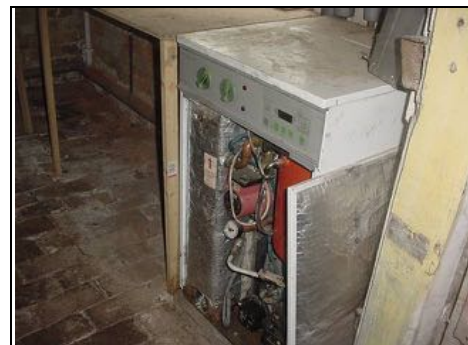
Boiler

There is a floor mounted boiler located in the Services cupboard off the barn within the main house. It would be great if the boiler was working; you need to have it checked or ask the estate agents/existing owners to switch the heating on.

Our limited inspection of the hot water and central heating system revealed no evidence to suggest any serious defects but we would nevertheless recommend that the system be tested and overhauled before exchange of contracts and that a regular maintenance contract be placed with an approved heating engineer.

**ACTION REQUIRED:** We recommend you return to the property with the estate agent to turn the heating on to ensure it is working.

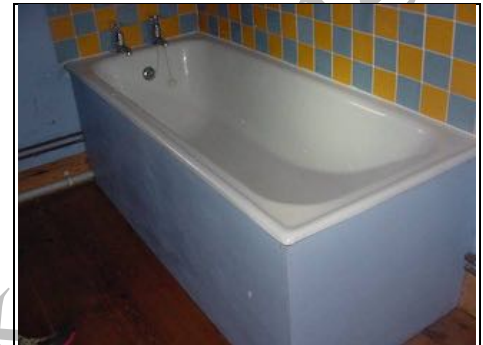
The property has a three-piece bathroom suite, consisting of we believe a cast iron bath, wash hand basin and WC, which looks in average condition.

Cast iron bath
