# RESIDENTIAL BUILDING SURVEY

Tenbury Wells,  
Worcestershire  
WR15 XXX

INDEPENDENT CHARTERED SURVEYORS

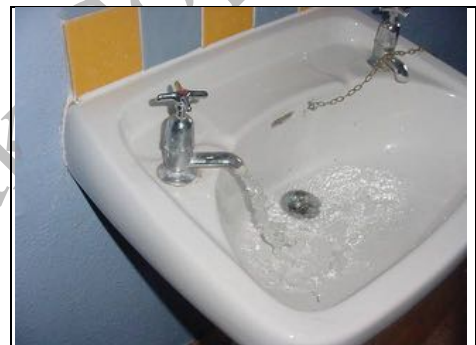
The cold taps have been run for approximately quarter of an hour in the bathroom. No build up or back up was noted.

Running tap

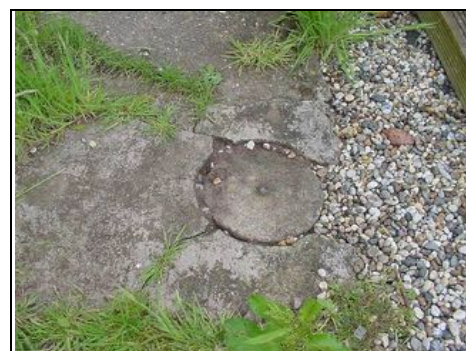
We did not lift the manhole cover therefore are unable to comment.

Drain we didn't lift

**ACTION REQUIRED:** We would recommend a closed-circuit TV camera report of the drains.

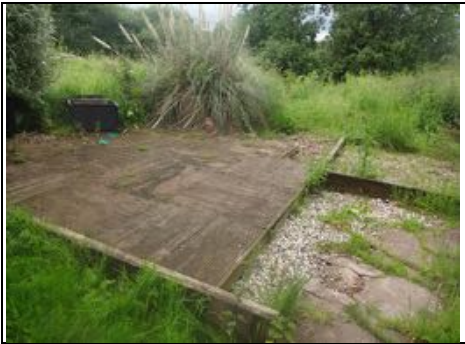
Decking

We are finding decking is becoming slippery over the years when not regularly maintained and can be an ideal space for living under for wildlife.

**ANTICIPATED COST:** In the region of a few hundred pounds to remove the decking and make good; quotations required.
