# COMMERCIAL BUILDING SURVEY

Prepared by:

INDEPENDENT CHARTERED SURVEYORS

Firstly, may we thank you for your instructions. We have now undertaken an independent Building Survey (formerly known as a Structural Survey) of the aforementioned property.

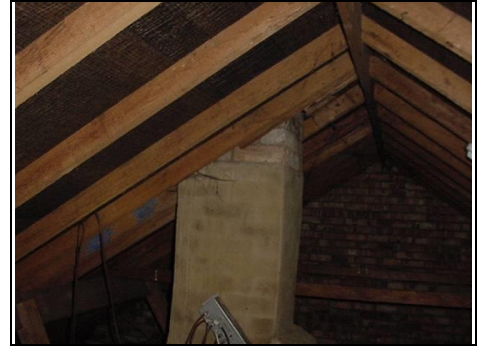
Timbers in main roof

We wish to reiterate this issue as it needs to be read in conjunction with the following comments. The main roof has a common rafter of about 75mm to 100mm (3 inches to 4 inches) when we would expect a deeper common rafter of 150mm plus.

**ACTION REQUIRED:** This is a characteristic that you need to understand and accept as part of this building as it is not possible, without partially rebuilding the property, to resolve the issues. To summarise the issues these could relate to a greater susceptibility to movement, deflection and noise transfer and limitations on how the property can be altered.

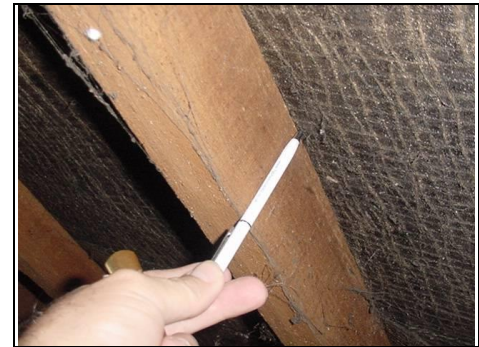
Close up of timbers

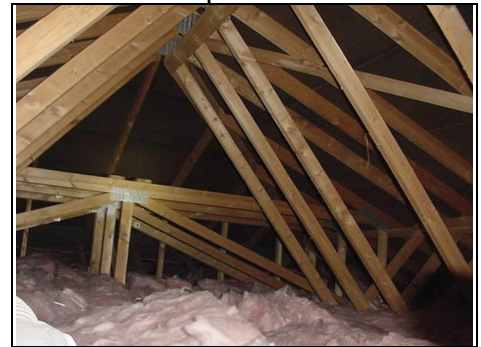
More typical timber thickness in the prefabricated truss roof to the rear left side single storey extension

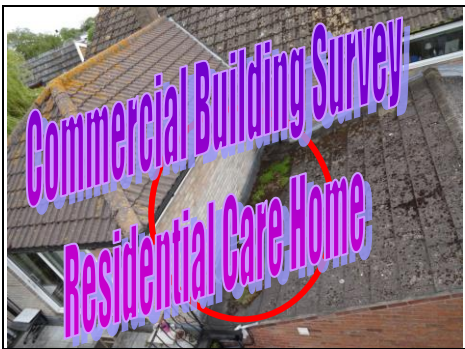
There are a few valley gutters to the property; they need to be kept clean. For example the front valley gutter is covered with moss. We can also see that there is deteriorating felt and flashings have come loose and indeed we can see that they have been repaired many times.

Valley blocked with moss, etc

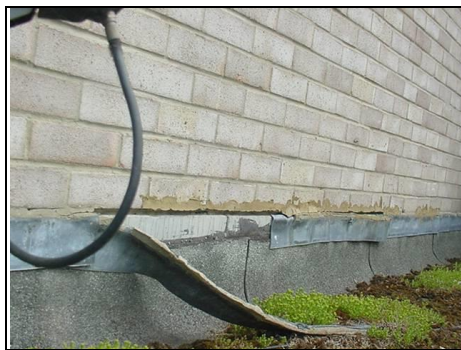
Lead falling off

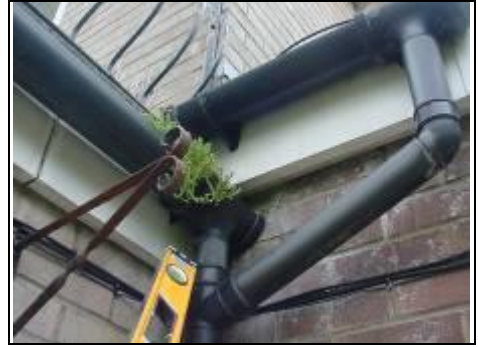
Vegetation growing out of gutters

**ACTION REQUIRED:** We would recommend that the gutters and downpipes are cleaned out, the joints are checked and the alignment checked to ensure that the gutters fall towards the downpipes. Regularly clean gutters.

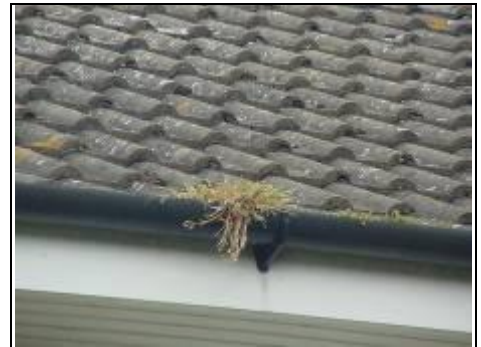
Grass in gutters

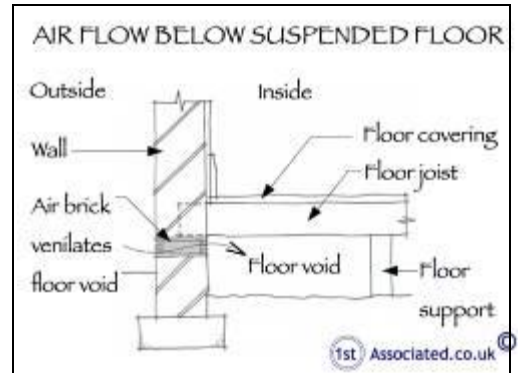
The property partly has a suspended timber floor, predominantly to the centre portion of the original property and to the rear left side. When you walk on the floor it feels lower underfoot and slightly reverberates. We recommend that you revisit and experience this once you have read the following.

Suspended timber floor

**ACTION REQUIRED:** Open up the suspended floor to check its condition and also protect the airbricks.

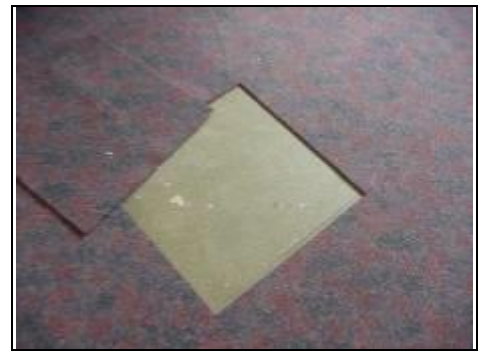
Timber decking indicating a suspended timber floor

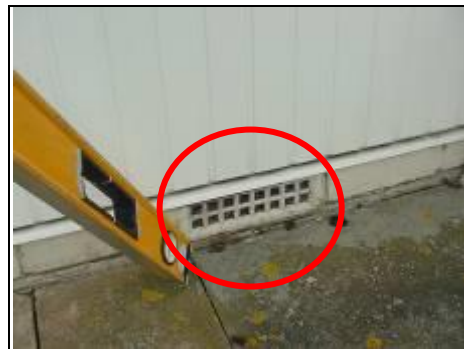
As the property has a suspended timber floor it needs an airflow underneath it to minimise wet rot, dry rot and woodworm. We noted airbricks, some of which looked to be very close to ground level and will be acting as gutters and need protecting.

Airbrick acting as gutter

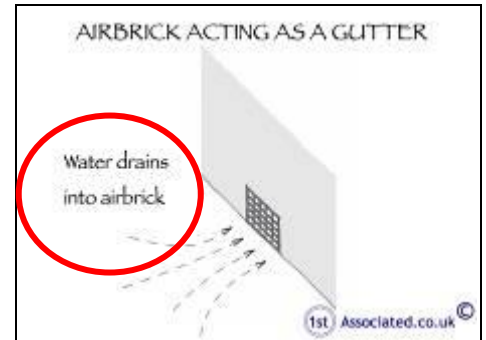
Airbrick acts as gutter

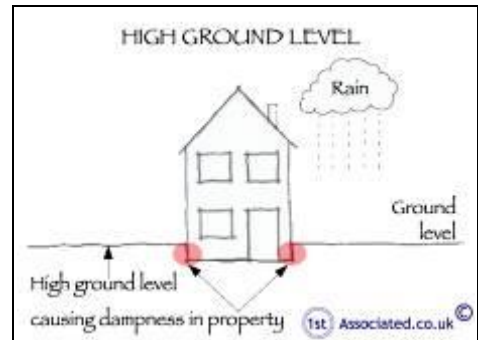
As an aside, we noted that around the building in general there were some areas the soil is slightly high not giving the two courses of brick between the ground and the damp proof course.

High ground level

**ACTION REQUIRED:** Ideally we would like to see a French drain added. We would suggest the ground level is lowered. We would be more than happy to comment on any photographs sent electronically to us.

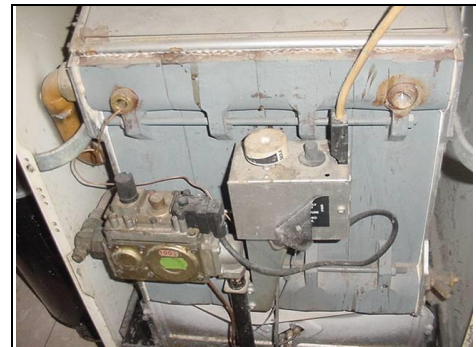
There are two old floor mounted boilers in the kitchen. We noted that there is also a mixture of old and new radiators.

Back of boiler

**ACTION REQUIRED:** We recommend complete new central heating system throughout the property.

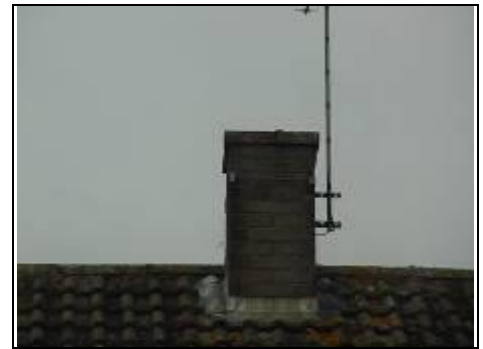
This chimney is brick finished with a lead flashing. From what we could see from ground level it looked in average condition considering its age, type and style.

We noted that there are aerials on this chimney which can cause damage and cut into the chimney like a cheese wire into cheese.

Chimney one

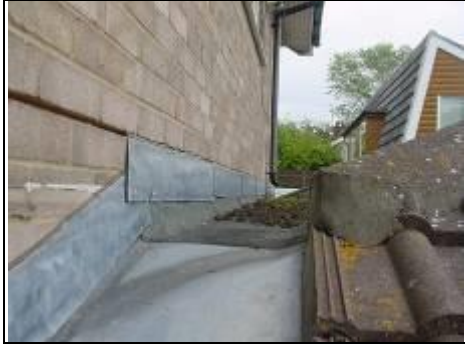
Valley gutter between main building and right side with vegetation

**ACTION REQUIRED:** Please see our comments in the Executive Summary.

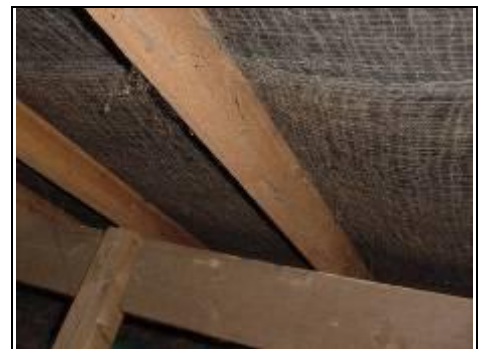
When we inspected the loft space we found a Hessian base Bitumen membrane. This type of membrane has been used since the 1960s. We generally found it to be in average condition, it is damaged in a few more places than we normally find.

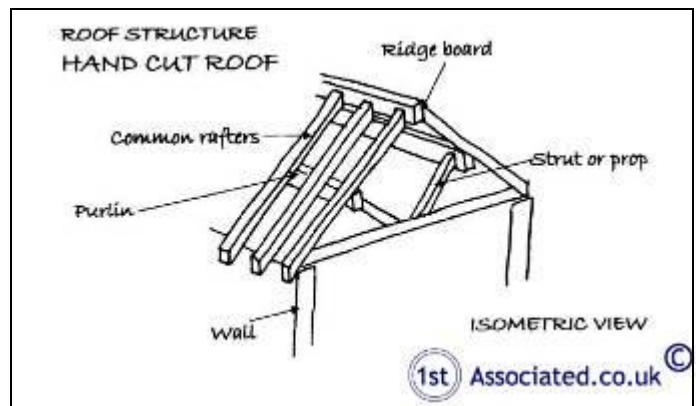
This type of roof structure has what is known as a cut timber roof to the main roof and a prefabricated truss roof to the hipped roof. Without the original design details we cannot categorically confirm that there are no defects. The timbers were below average size.

Cut timber roof

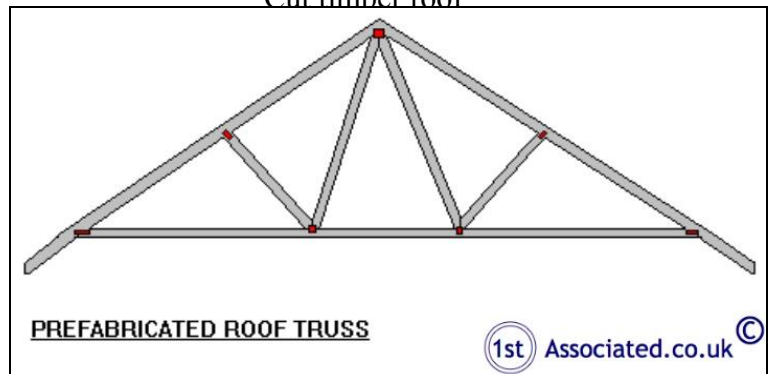
Pre-fabricated roof

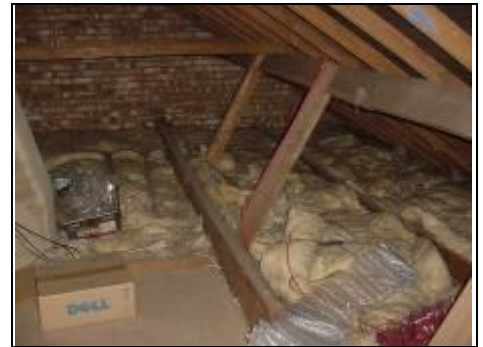
Our examination was limited by the general configuration of the roof, the insulation and stored items. What we could see was generally found to be in average condition for its age, type and style. It is, however, feasible that there are problems in the roof that are hidden.

General view

**ACTION REQUIRED:** Please see our comments in the Executive Summary. The only way to be 100 per cent certain is to have the roof cleared and checked.

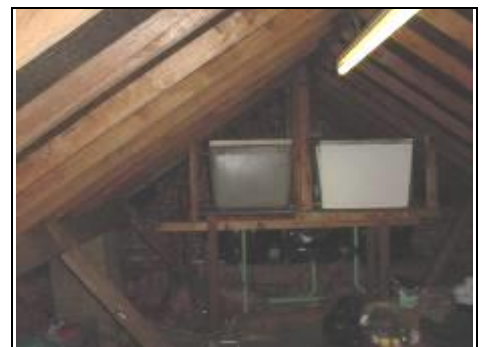
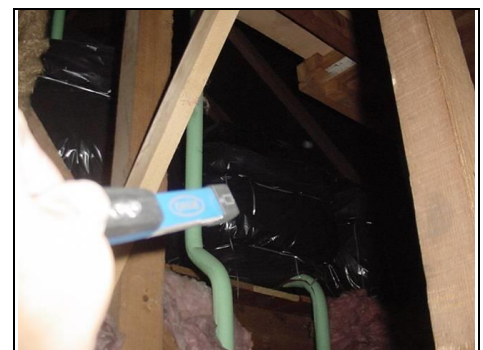
There were plastic water tanks. The main water tanks are hidden below the water tanks visible in the photograph.

Old water tanks

Water tanks below old water tanks

We would always recommend that water tanks be drained down and cleared of any debris etc. (we have seen dead birds and other unmentionable things in these tanks). As you are cleaning your teeth with this water it is best that it is as clean as possible!

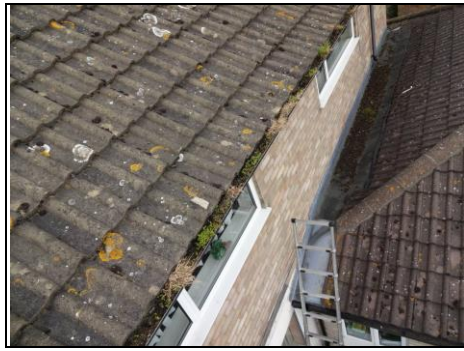
The gutters and downpipes are plastic. They are in below average condition for their age, type and style with vegetation visible.

Gutters full

We would always recommend that the gutters and downpipes are cleaned out, the joints are checked and the alignment checked to ensure that the gutters fall towards the downpipes.

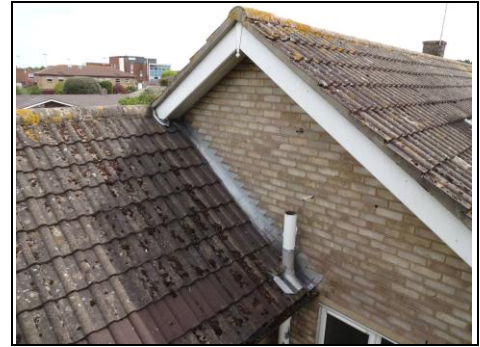
The original soil and vent pipe is visible to the gable end of the property.

Soil and vent pipe

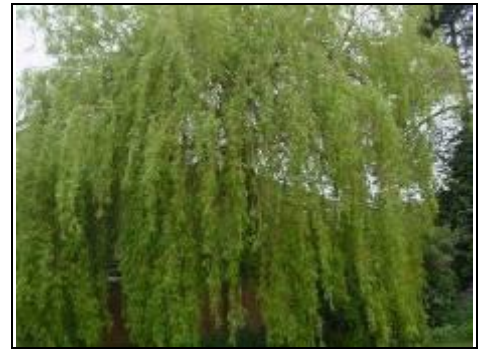
There are trees within what we would term as influencing distance but you do need to speak to your insurance company as they may have a different interpretation for insurance reasons.

Weeping willow

**ACTION REQUIRED:** We would recommend an arboriculturalist (not a tree surgeon) is asked to view the property and give a ten year plan for maintenance.

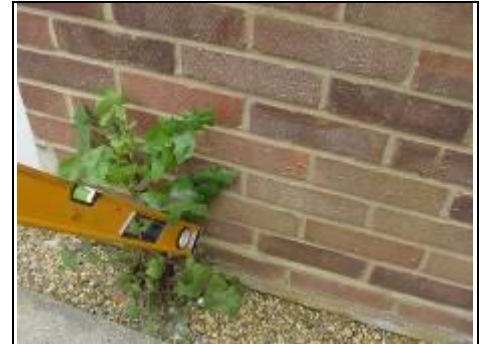
All modern properties should incorporate a damp proof course (DPC) and good building practice dictates that a differential of 150mm (6 inches) should be maintained between the damp proof course and ground levels. In this case, we can see a damp proof course (DPC) which is slightly too low.

DPC slightly too low

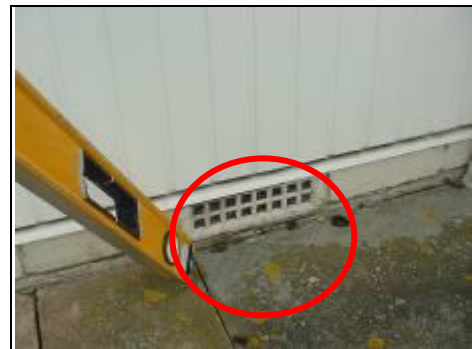
Air bricks are essential to have a through flow of air as this helps to reduce the chances of wet rot, dry rot and woodworm. In this case we noted an airbrick acting as a gutter.

Airbrick acting as gutter

We have not visually seen any significant dry rot during the course of our inspection. Please see our comments with regards to the airbricks acting as gutters, there is a possibility of dry rot being under the floor.

**ACTION REQUIRED:** We would recommend that the floors are opened up to check their condition.

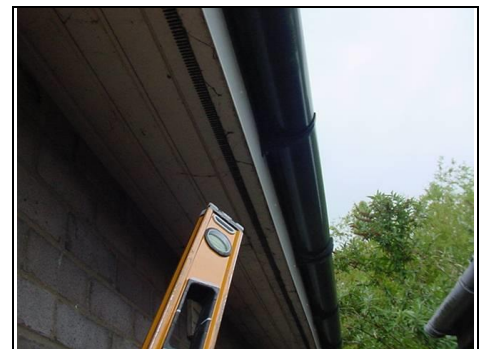
The fascias and soffits are a mixture of timber and plastic, possibly overlaid. Some of the soffits are vented and some are not vented. We would comment they are in average condition for their age, type and style.

Fascias

**ACTION REQUIRED:** As you are aware the gutters are full of vegetation, etc and need clearing. Once they have been cleared we recommend that you check a section to the main roof of the fascias and soffits by drilling into it to see if it has timber beneath. Make sure gutters and downpipes are watertight before carrying out any work on fascias and soffits.

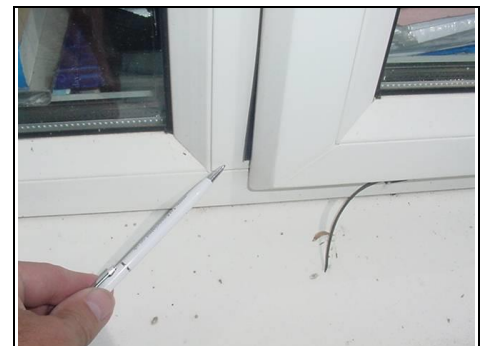
The property has plastic double glazed windows with trickle vents which generally look to be of an average quality. Some of the double glazed units were out of alignment which could relate to movement or it could relate to someone trying to break into the property.

Some double glazed units out of alignment

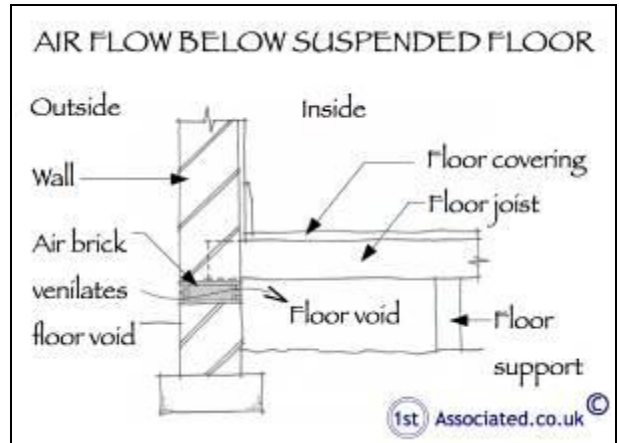
The property has predominantly a suspended timber floor to the centre portion of the original property and to the rear left hand side which require air movement underneath to minimise wet rot, dry rot and woodworm, and a solid floor to the remainder.

Suspended timber floor

We would comment in this instance that there is a possibility of woodworm in the floor so it does need opening up to check its condition.

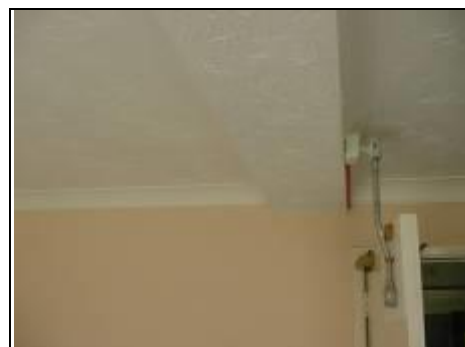
There are three chimneys we can see. At the time of the survey no chimneys were in use. There were some original chimneys to the building when it was a house and there was one to the right hand side which has been used as a flue and a boiler. This needs to be checked whether it is still in use; we could not see any indication that it was.

Chimney breast in bedroom six

There was some dampness getting in around the chimneys.

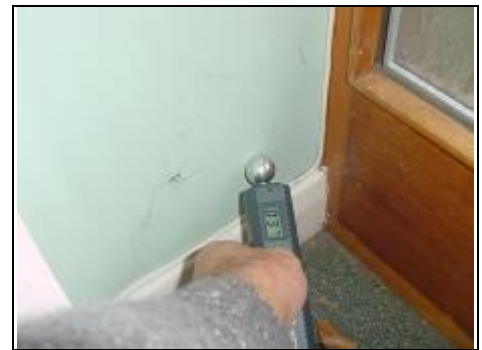
A visual inspection and tests with a moisture meter have been taken to the perimeter walls. In this particular case we have found some minor rising damp which is possibly due to the property being empty and the slightly high ground levels.

Testing for rising damp

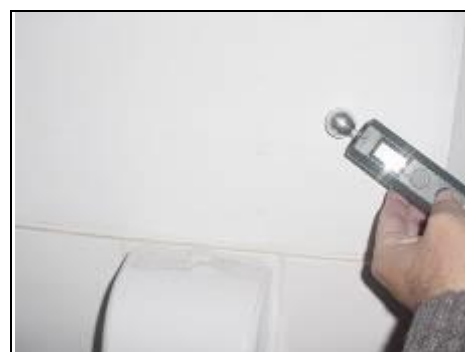
We used a resistance meter on the external walls.  
We have not found significant dampness.

Testing for lateral dampness

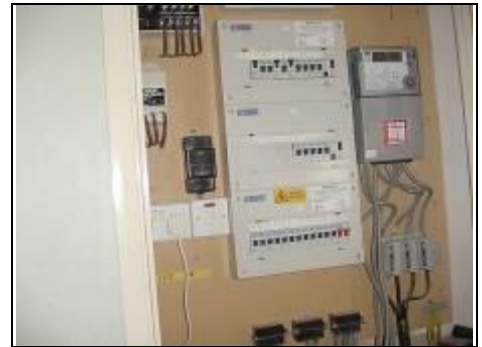
The electrics are located in a cupboard within the hallway. This area should have a level of fire rating as required by the fire officers.

Electrics

**ACTION REQUIRED:** We would recommend a specialist electrical contractor is appointed prior to the legal commitment to purchase this property to offer estimates to re-wire to an Institution of Engineering and Technology (IET) standard.

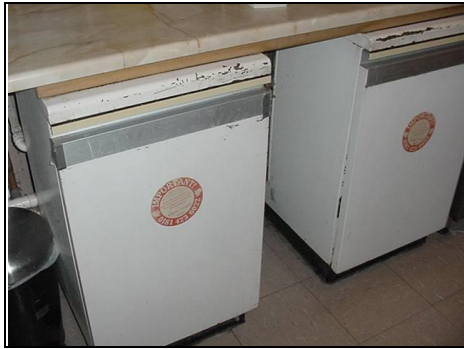
The property has two floor mounted boilers (no model name visible) located in the kitchen on the ground floor. There are hot water cylinders which are factory lagged which means they are relatively new (last twenty years). There is a mixture of old and new radiators which you may wish to convert to new convection heaters.

Boilers in kitchen

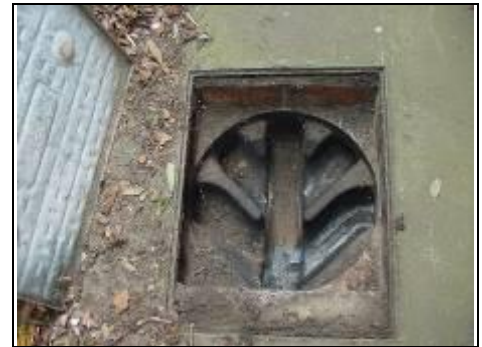
Manhole one rear left

We duly lifted the cover and found it to be free flowing at the time of our inspection.

From what we could see it is plastic built.

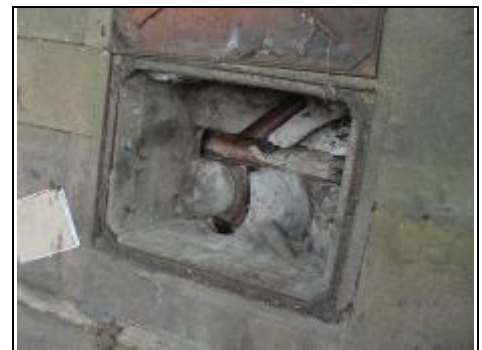
Manhole two middle left

We duly lifted the cover and found it to be free flowing at the time of our inspection.

From what we could see it is cement finished.

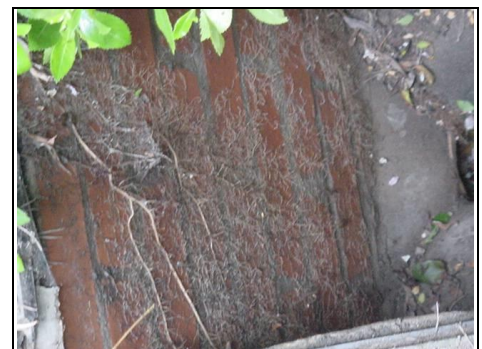
Manhole three front left

We duly lifted the cover and found there were roots visible.

From what we could see it is brick built.

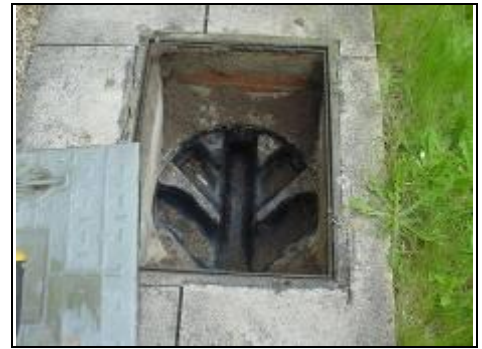
Manhole four front middle

We duly lifted the cover and found it to be free flowing at the time of our inspection.

From what we could see it is plastic built.
