RESIDENTIAL BUILDING SURVEY

New Malden,
KT3 XXX

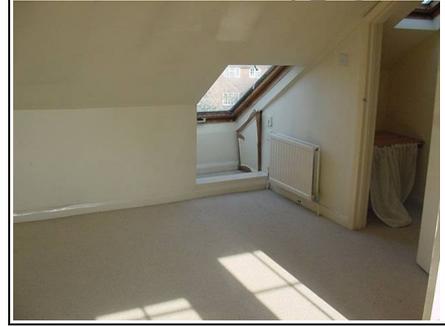
Top floor bedroom

The loft has been converted to form a bedroom and shower room area.

It is unusual for roof windows to be at the front so you need to check that these have Planning Approval. We are aware that sometimes you get Planning Approval based upon these being a fire exit.

ACTION REQUIRED: Your legal adviser needs to check and confirm that all Local Authority Approvals have been obtained, including Planning Permissions, Building Regulations and also that Party Wall Agreement has been gained.

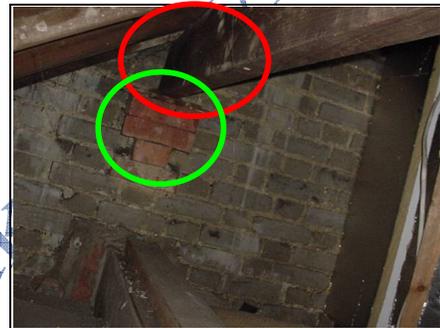
Purlin (red circle)
supported by bricks
(green circle)

1. Remove the cement flashings on the parapet walls and replace with a lead flashing to accommodate the movement in the structure.
2. Have additional support for the purlin so it is not literally sitting on a pile of bricks. For example, these can be cemented together.

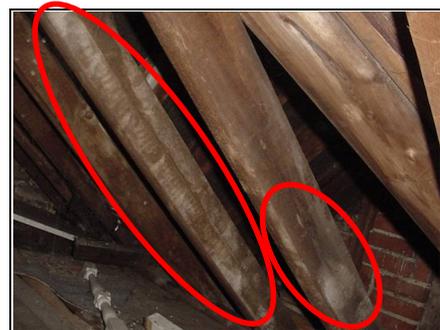
- 2.2) There looks to have been some movement in this roof that has allowed some dampness to get in. We can see salts on the common rafters.

Salts on common rafters

ACTION REQUIRED: We recommend that you make the building watertight by the following four stages:

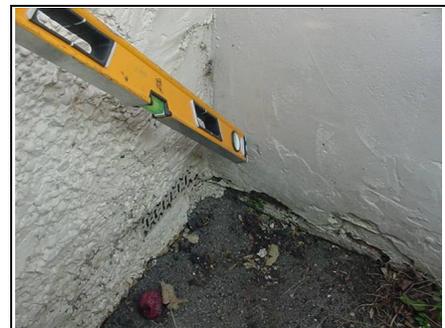
No bell mouth detail

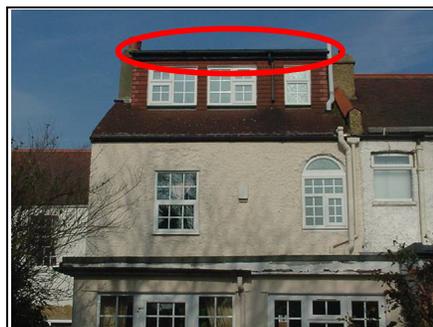
The property has high level flat roofs that are predominantly hidden; we are not keen on these.

High level flat roof to the dormer

We feel there may be problems starting to occur on this main roof, given the condition of the lower level flat roof, but it is simply not possible to know without seeing the roof but we do think it would be sensible to budget for carrying out repair works.

ACTION REQUIRED: We would ideally recommend that a roof window, or some sort of access, is added to enable you to go on the roof.

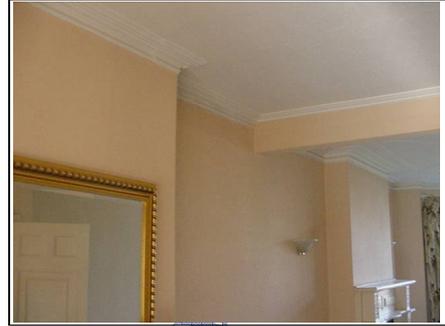
At some point in time the internal walls have been removed. As you are aware as we demonstrated this to you, there is more deflection to the first floor rooms and we would typically expect. This is probably because the lintel that has been put in at ground floor level, together with no pier, is not the size that we would now use and such works should have had Building Regulation Approval, although we often find it has not.

Wall been removed without pier

It is very difficult to advise with regard to this, but you could in theory remove the existing lintel and put in a new pier and lintel. However we could equally argue it has stood the test of time.

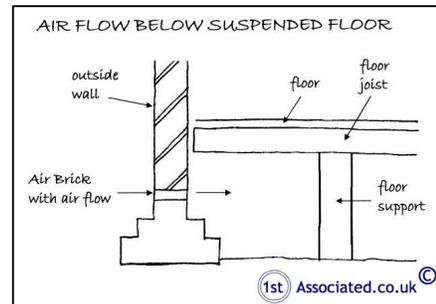
This property has a suspended timber floor. The air bricks are very low and will be acting as gutters and it is likely that there will be some dampness under the floor.

Suspended timber floor

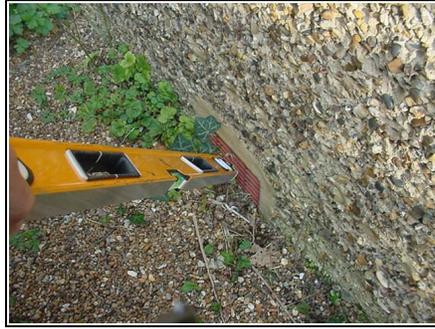
Air brick acting as a gutter to right hand side of property

We have mentioned already we have found some dampness to the rear kitchen area which is likely to be contributed to by this poor detail.

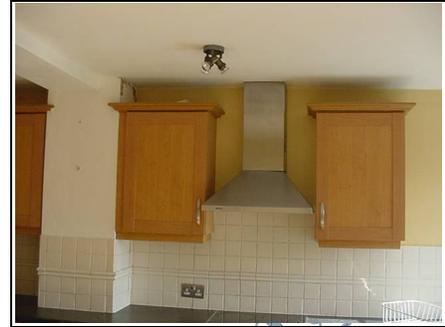
There are no extractions to the bathroom, shower room or the kitchen. This type of construction is liable to black mould, which is currently visible in the top floor bedroom and also within some of the cupboards and on the ground floor.

This filter in the kitchen is not an extractor

ACTION REQUIRED: We would recommend large humidity controlled extract fans be added to kitchens, bathrooms and any rooms where drying clothes takes place. You also need to discuss this with any tenants that you have and educate them with regard to the reasons behind black mould. You will then need to redecorate the property.

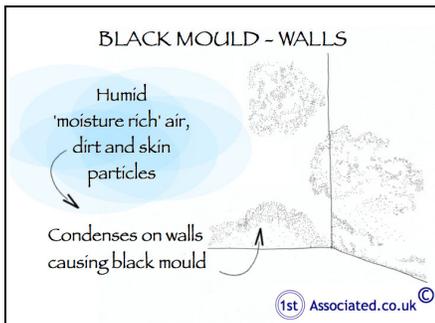
Black mould

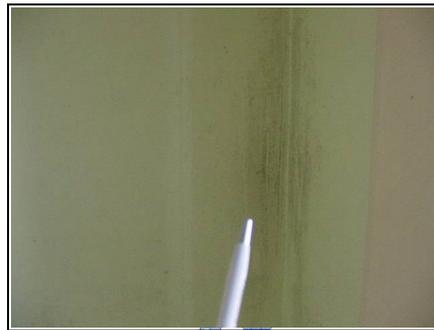
Black mould in cupboard

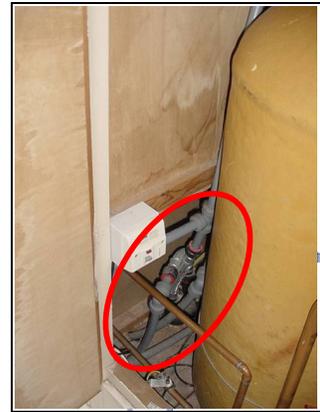
1. The flat roof leaking or the bathroom leaking, for example showers sometimes leak when they are stood in, and also the plastic pipes that have been used around the cylinder, which we are not keen on as we find these do tend to leak.

Plastic piping

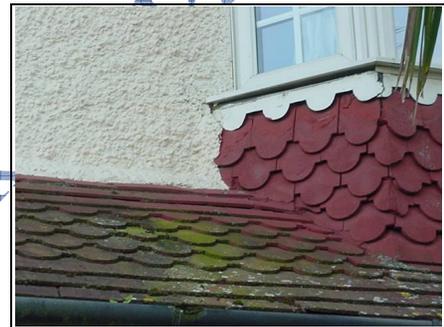
4. Areas of vegetation growing from long term leaking of water cistern and possibly water discharging against the wall.

Areas of vegetation

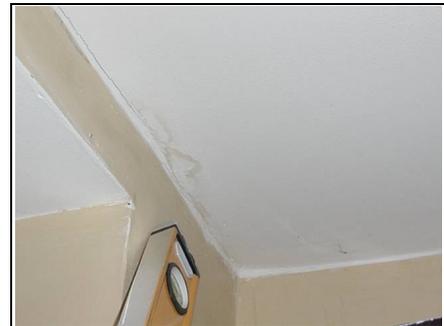
3. Dampness below bathroom in hot water cylinder area.

Dampness in ceiling below bathroom

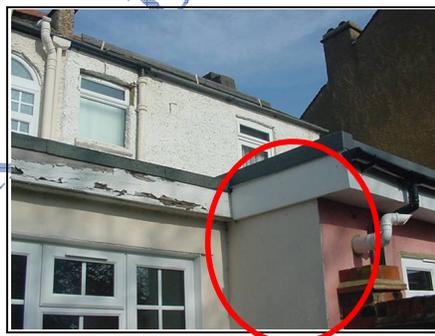
To the rear of the property the next door property has extended their property. This may be on your land or on the boundary of your land. Either way what is known as a Party Wall Notice should have been obtained by the people carrying out the development.

Next door's extension trespassing on your land

ACTION REQUIRED: You need to obtain a Party Wall Notice in relation to this matter (see our comments in Party Wall Agreements) and also your legal adviser to check and confirm that Local Authority Council Approval has been obtained.

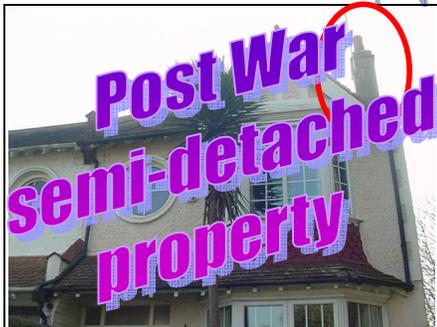
Chimney front right side

This chimney is render finished with two chimney pots. We cannot be certain what material the flashing is. From what we could see from ground level it looked in average condition considering its age, type and style, although we could see some moss to the flashing and some spalling to the chimney pots, which indicates water is sitting in these areas.

ACTION REQUIRED: Periodically inspect the chimney.

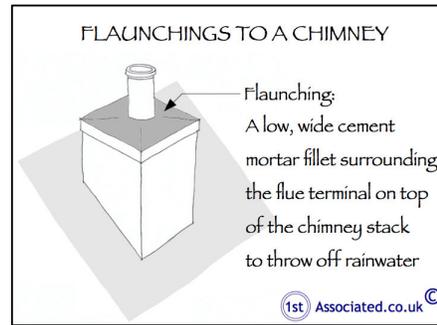
Flaunching

Unfortunately we were unable to see the top of the chimney known as the flaunching, we therefore cannot comment upon further.

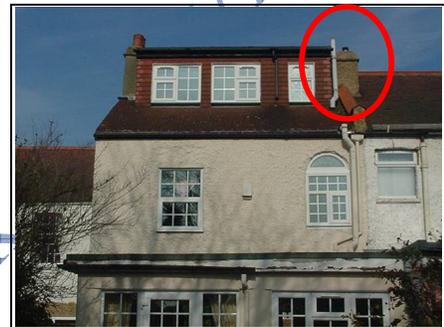
Rear left chimney (directions given from the front of the property)

We had a limited view of this chimney. This chimney is render finished, with one chimney pot.

ACTION REQUIRED: Again, periodically inspect the chimney.

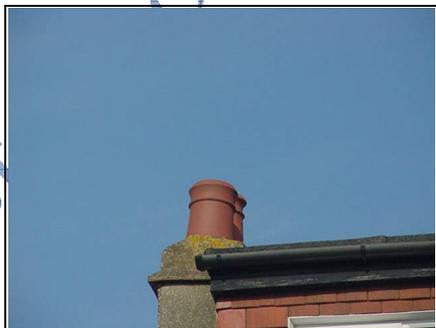
Rear chimney

Again we had a limited view of this chimney. It is render finished, with two chimney pots and what looks to be a lead flashing. We could see moss on the top of the chimney, indicating water could be sitting on it causing possible dampness.

ACTION REQUIRED: Inspect chimney periodically.

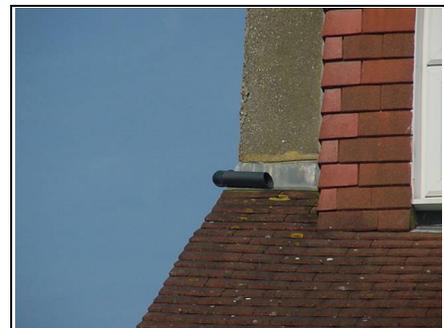
Base of chimney

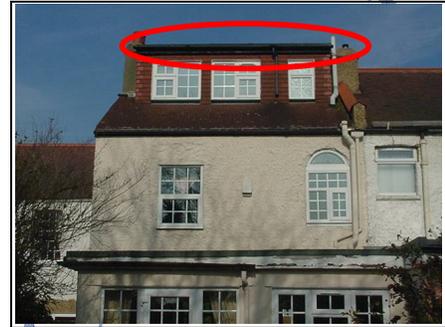
Dormer window

It has a flat roof and the cheeks of the dormer are formed with vertical tiles. Generally we could comment for their age, type and style they are in average condition.

These flat roofs are prone to thermal heat gain during the summer and heat loss during the winter. Depending upon the insulation levels this may be acceptable or not.

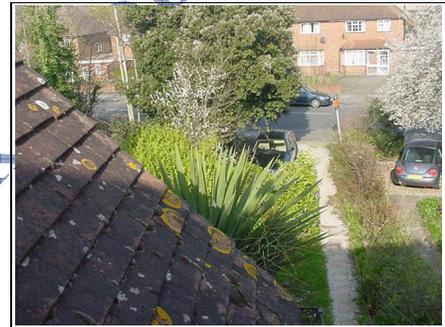
Concrete roof tiles

Typically this type of property would have had clay tiles, however these look to be concrete tiles in the majority of cases, due to their rougher finish. They look in average condition considering their age type and style, however having said that there does look to be some dampness getting into the front of the property.

With this age of roof there will usually be a few missing or displaced tiles, this is nothing unusual.

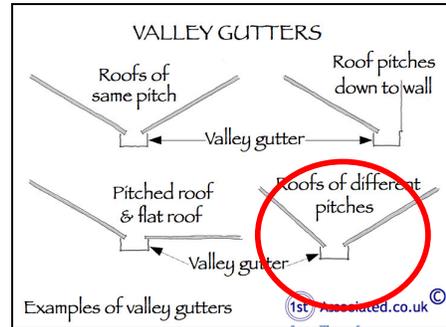
Valley gutters

There is a valley gutter to the front of the property. These areas are often problematic as they are difficult to reach. In this instance we can see the valley gutter is full of moss and needs cleaning.

ACTION REQUIRED: Clean valley gutters. See our previous comments regarding handyman work.

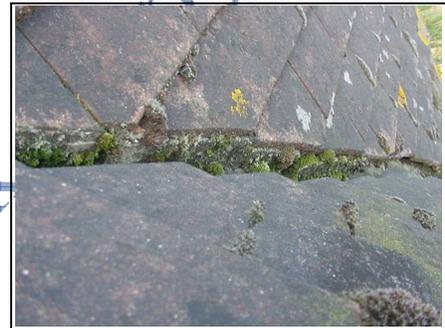
Moss gathering in valley gutter

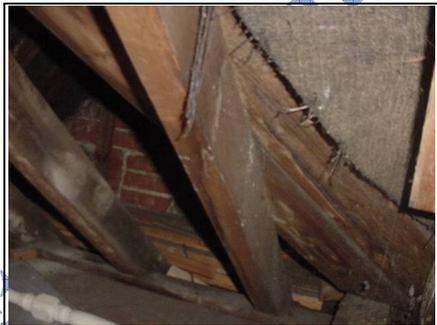
When we inspected the loft space we could see some roofing felt and also some close boarding. Originally this property would have had a feather edge close board. We can see some felt, although we had a limited view; approximately 10% of the entire roof.

The felt would normally offer a second protective layer, which is why we are surprised at seeing the salts on the timbers, which we mentioned earlier, and this does need further investigation.

Felt and close boarding

ACTION REQUIRED: See our comments in the Executive Summary.

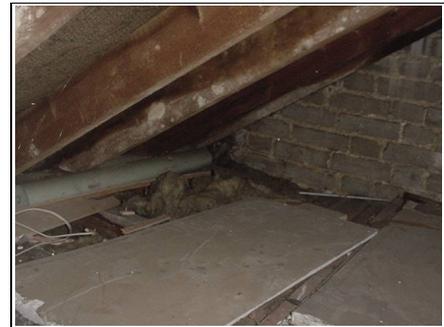
Felt areas in roof void

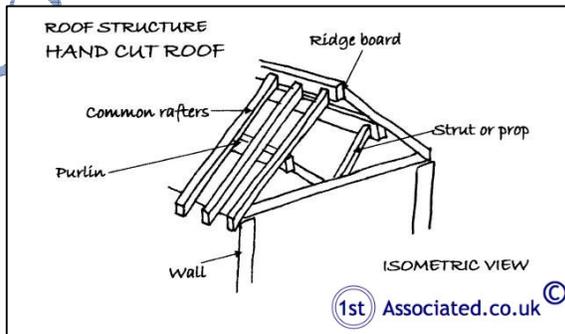
Cut timber roof

It is typical condition of what we typically see, with the exception of the brick propping of the purlin and the salts that can be seen on the timber, and there is next to no insulation in the roof, it has actually been added into the internal wall partitions.

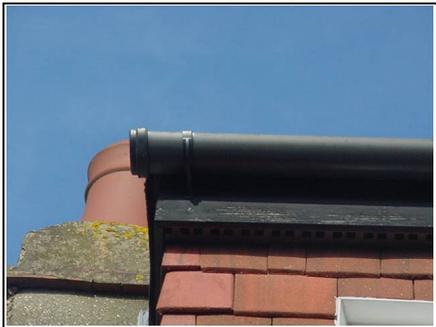
Plastic gutters

The property has plastic gutters and downpipes. Some are in below average condition, requiring clearing and repair.

We also recommend that the gutters and downpipes are cleaned out and repairing, all joints need checking and check the alignment to ensure that the gutters fall towards the downpipes.

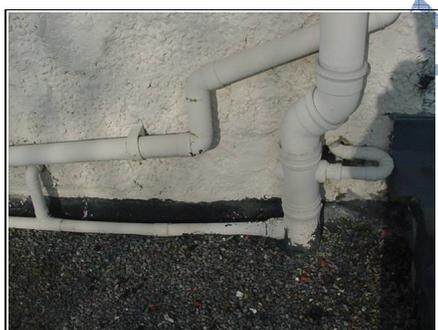
Awkward soil and vent pipe

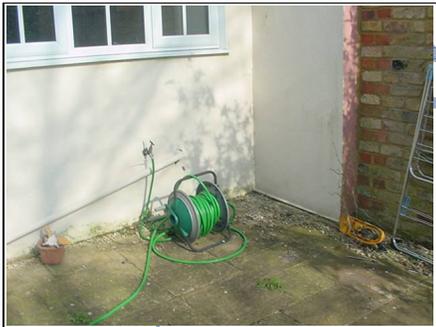
The external walls are finished in a roughcast render to the original part of the property and modern render to the newer parts.

Older style render meets modern render to rear

ACTION REQUIRED: Please see our comments in the Executive Summary.

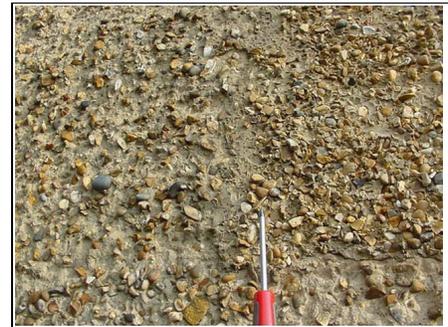
Different sorts of render, with modern pebbledash to the right hand side

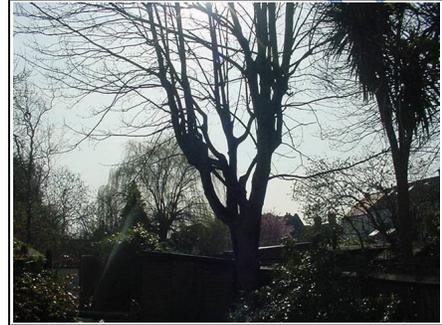
Tree in rear garden

There is a tree within what we would term as influencing distance but you do need to speak to your insurance company as they may have a different interpretation for insurance reasons.

ACTION REQUIRED: We would recommend an arboriculturalist (not a tree surgeon) is asked to view the property and give a ten year plan for maintenance.

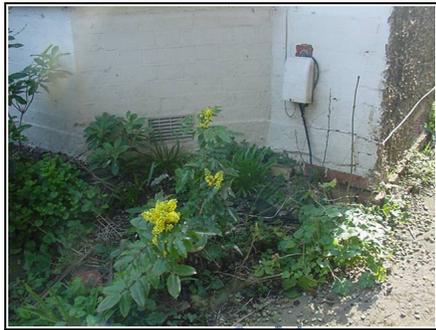
Air brick to front

Air bricks are essential to have a through flow of air as this helps to reduce the chances of wet rot, dry rot and woodworm. In this case the air bricks to the front and right hand side (all directions given as you face the property) are acting as gutters.

ACTION REQUIRED: Protect air bricks and ensure they are clear.

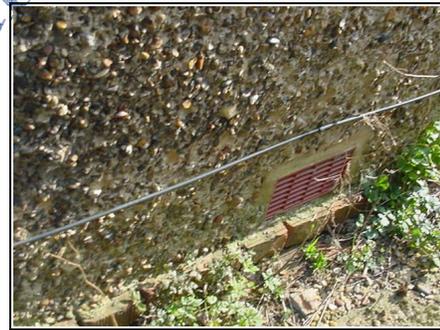
Air brick acting as a gutter to side of property

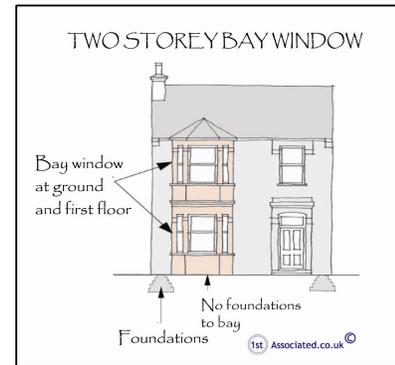
Originally these would have been constructed with a wet plaster, possibly a lime plaster. There is likely to be no foundations under the bay. In addition to this, when the original windows were replaced with plastic there can be some movement.

No foundations under bay window

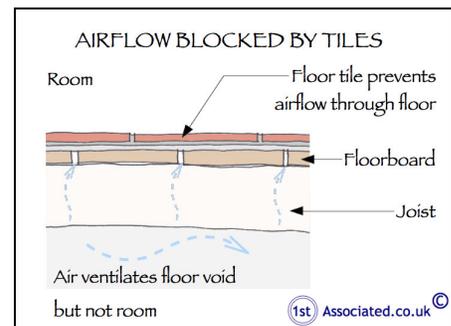
The ground floors of the property are suspended timber floors which require air movement underneath to minimise wet rot, dry rot and woodworm. The laminate flooring stops it from breathing.

Floor stopped from breathing by being covered over

ACTION REQUIRED: Please see our comments in the Executive Summary.

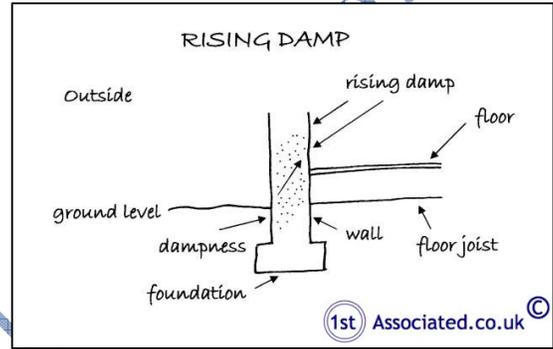
Rising damp

A visual inspection and tests with a moisture meter have been taken to the perimeter walls. In this particular case we have found significant rising damp due to high ground level and lack of a bell mouth detail to the render.

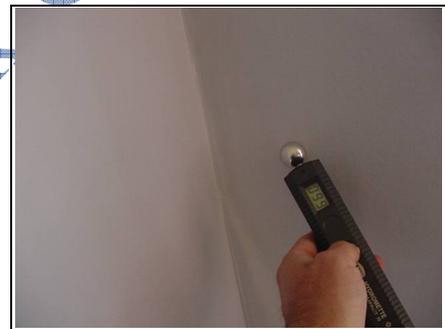
We used a resistance meter on the external walls. Generally we have not found any significant dampness. We did find one or two areas where the damp readings were significantly higher than we would expect, even in an empty property, but these seem to relate to cracks in the render externally, but they equally could relate to leaking gutters.

High damp meter readings in rear right hand bed

ACTION REQUIRED: Please see our comments in the Executive Summary.

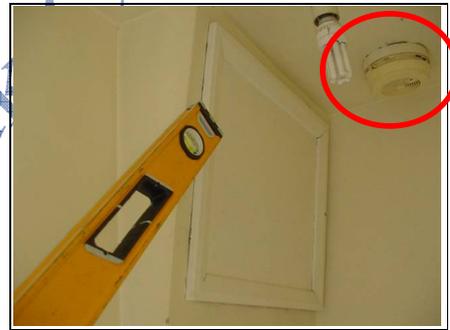
Some smoke detectors were noted, we believe these to be battery operated.

Smoke detector

ACTION REQUIRED: We would recommend, for your own safety, that additional smoke detectors are installed. We would always recommend a hard wired fire alarm system and are also aware that some now work from a wireless signal which may be worth investigating. Whilst fire is relatively rare it is in a worst case scenario obviously devastating.

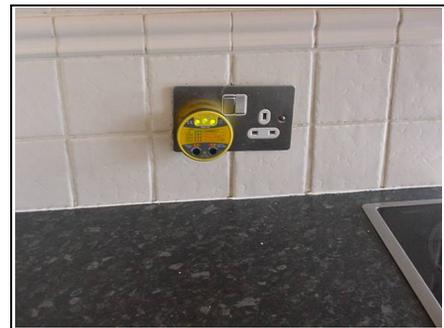
We carried out an earth test in the kitchen area to the socket point that is normally used for the kettle, this proved satisfactory.

Earth Test

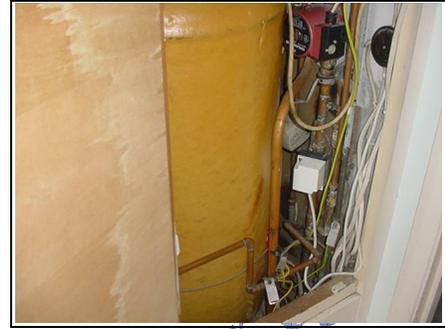
Hot water cylinder

We noted it has plastic piping, which we are not keen on as it can be prone to leaking, and we much prefer to see copper piping.

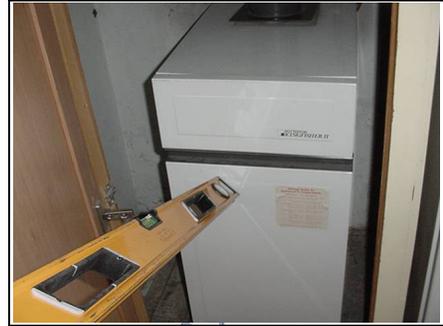
The floor mounted Kingfisher boiler was located in the kitchen. This is an older style boiler, however many say that these last far longer than newer boilers.

Our limited inspection of the hot water and central heating system revealed no evidence to suggest any serious defects but we would nevertheless recommend that the system be tested and overhauled before exchange of contracts and that a regular maintenance contract be placed with an approved heating engineer.

Floor mounted Kingfisher boiler

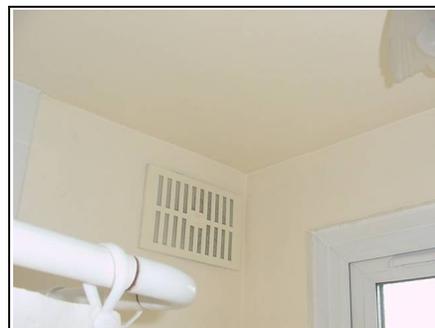
Vent – no proper extraction

ACTION REQUIRED: Please see our comments in the Executive Summary regarding to black mould and how you need to extract in the bathrooms.

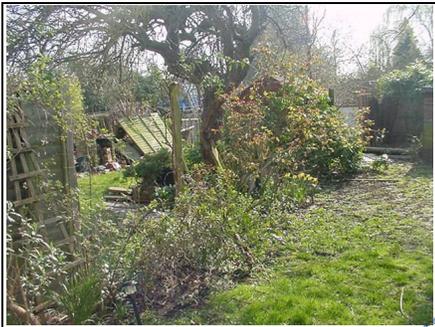
The fence to the left is down, which will be your responsibility.

The left hand fence is completely down

ACTION REQUIRED: Repair fence to left hand side.

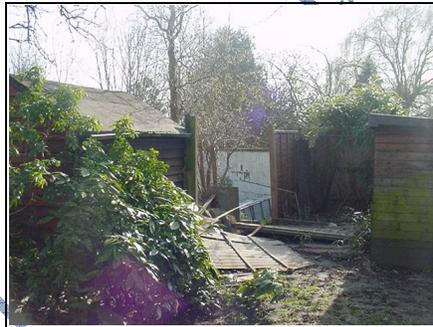
Another fence down
