RESIDENTIAL BUILDING SURVEY

XXXXXXXXXX,
Walworth,
London
SE17 XXXXX

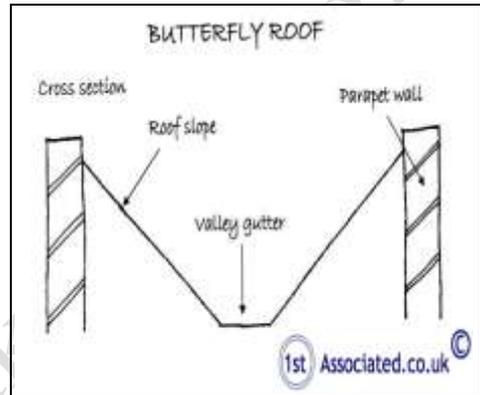
As you are aware we have not been able to physically get onto the roof so we utilised an aerial photograph. As we have not been able to get onto the roof, it is to some extent, still unknown and which is a major issue. From what we could see it is a London Butterfly roof that has been modified by the addition of concrete tiles and additional timbers together with I-Beams that have been added centrally below the valley gutter. We would of course prefer to have been able to get onto the roof. From the damp staining that can be seen in the property from the first floor there are still likely to be problems. These may be from one off occurrences such as wind driven rain or snow, nevertheless they need to be solved.

The valley gutter on the London Butterfly roof, there is staining visible indicating dampness is getting in.

ACTION REQUIRED: We would recommend adding a roof window to the London Butterfly roof to allow access to the roof and examination. Ideally this should be before you purchase the property so that we can return and view the roof. In our experience the owner is unlikely to allow this however we would still ask. Our concern is that the leaks that are coming through, although relatively minor, may be difficult to resolve, possibly due to fundamental

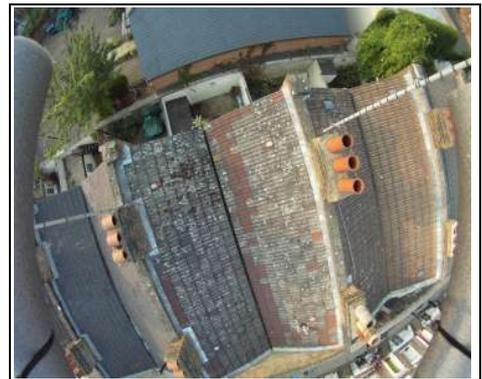
Aerial photo

From what we could see from the aerial photo the roof is vented with older style mushroom vents formed in plastic. We could not physically see these in the roof (we would expect to see cut sections into the felt). We would always recommend ventilation to roofs such as this to minimise deterioration and attacks from woodworm.

ACTION REQUIRED: We recommend adding additional vents. These may be at roof level or to the end gables.

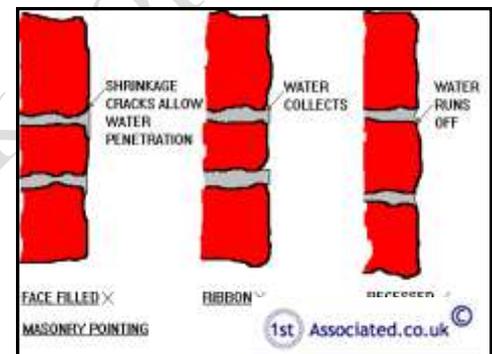
Masonry Pointing

Cement mortar falling out to the front of the property. If you recall we took a bit out.

ACTION REQUIRED: You need to employ an old style, term served, brick layer for the next few years to use a stiff brush once or twice a year on the cement and re-point in a lime mortar until a good proportion of it is replaced. The Bricklayer needs to be skilled in the use of lime.

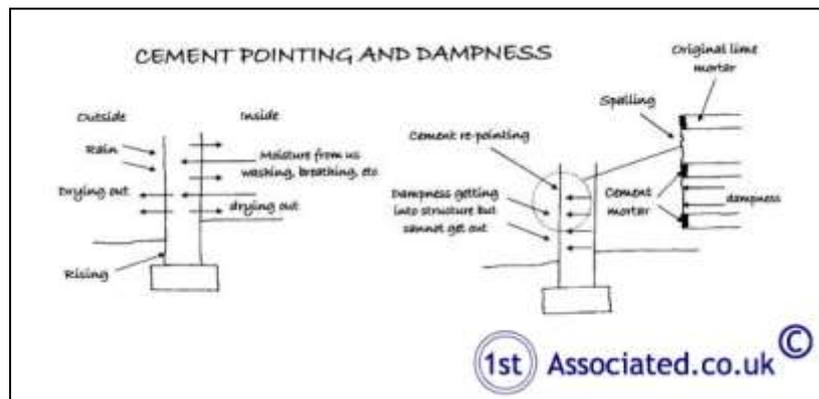
Cement Pointing

Unfortunately the cement re-pointing, whilst well meaning, is not appropriate for this type of construction. A cement mortar has been used rather than a lime based mortar. We recommend you use lime mortar in any future repairs

regardless of what the builders say! Using lime mortar will limit further damage to the brickwork, which is almost impossible to repair successfully. However, we would add that many, if not most, of the properties that are re-pointed are re-pointed wrongly; it is only in recent years that we have discovered the problems that can occur from it.

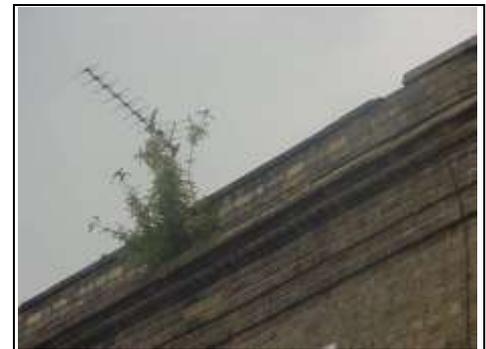
Plant growing from the cornice

Plant growing on another cornice nearby

ACTION REQUIRED: Remove the plant and check the detail as we believe a ledge has been formed that water sits on. This may originally have been a lead detail. When you access the roof you will be able to check this by looking to see what details other people have on the cornices of their properties.

ANTICIPATED COST: The plant needs to be removed and the detailing made watertight probably by re-pointing or using mastic. The work is likely to cost a few hundred pounds plus any scaffolding costs to gain access if it cannot be done over hand over the cornice; please obtain quotations.

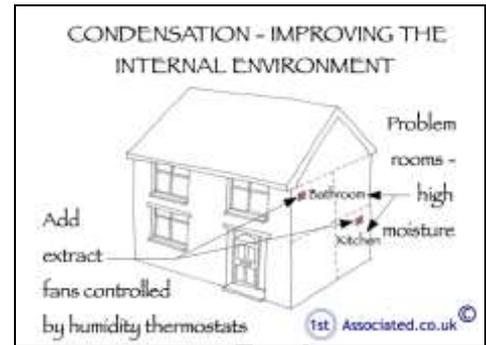
Condensation

This age, type and style of property can be more prone to condensation than a more modern property. We feel the best way to reduce the chances of condensation is to remove any excessive moisture from the area it is created in as quickly as possible.

ACTION REQUIRED: We would recommend that large extract fans are added to the kitchens, the bathroom and the shower room. These should be humidity controlled which means they will switch themselves on and off at the set humidity level.

ANTICIPATED COST: In the region of £250 - £750 (two hundred and fifty pounds to seven hundred and fifty pounds); please obtain quotations.

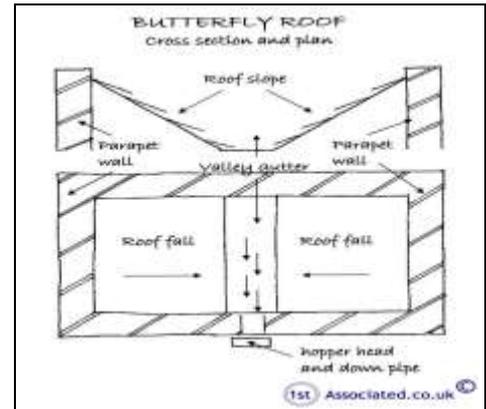
Butterfly roof

There are two areas of dampness. One of them is where the dampness generally runs centrally to the top floor and is approximately where the valley gutter is on the London Butterfly roof.

However there is one damp area to the front left hand side which as you know we investigated but could not see any obvious way that the water is getting in. We think perhaps it is getting in via the pronounced brick string detail to the front where it sits on the ledge (a similar place to where the plant is growing and sits). On reflection this could also be damp because of the valley gutter.

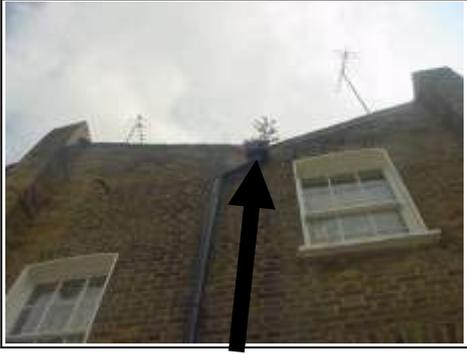
Plant growing in the hopper head to the rear of the property. This could be allowing dampness in at first floor level

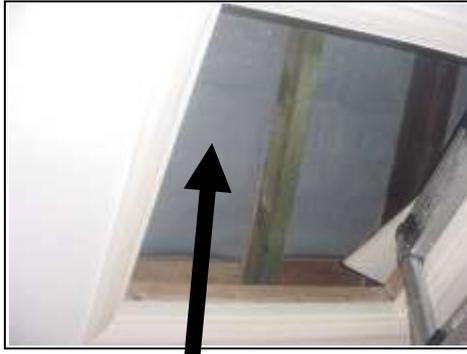
Plastic underlayer in part of roof could be causing condensation that in turn may be causing some of the dampness

To the right hand side roof there is a hessian based bitumen underlayer. This type of membrane has been used since the 1960's. To the left hand side roof and going underneath the valley gutter is a plastic protective underlayer. This type of underlayer is no longer used as it sweats and as mentioned in the Executive Summary it could be the reason for getting dampness into the structure.

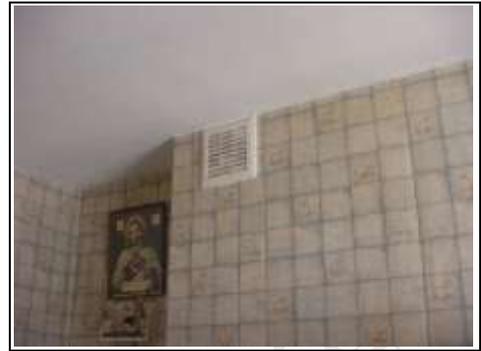
All chimneys should be vented if they are not being used. From what we can see the chimneys have been enclosed using a hog back tile.

Vent to chimney breast in kitchen

ACTION REQUIRED: You should check and confirm this with the existing owners.

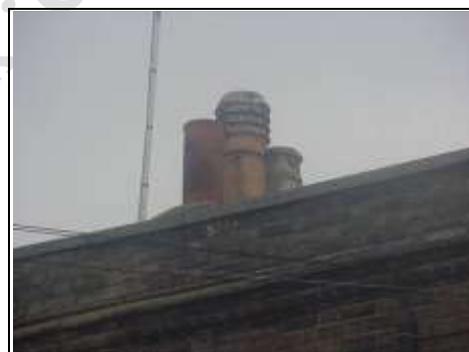
Chimney

We can see very little of the chimneys from ground level (see our photo). From viewing the photo that you had taken we could see two chimneys to the left hand side, one to the front and one to the rear. Both of these are brick built with a lead flashing and there is hog back tiling, meaning that the chimneys have been closed off and vented. Unfortunately the photos are not detailed enough to comment further.

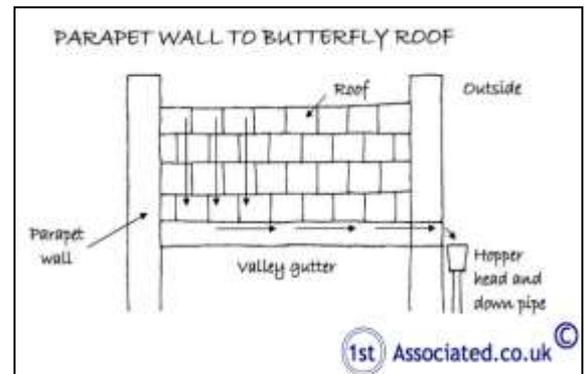
Parapet wall to butterfly roof

The parapet walls are again visible on your aerial photo but not from ground level. They look to have a coping stone on them and taking an educated guess we would think they are brick finished. We can see from the photo there is a lead flashing.

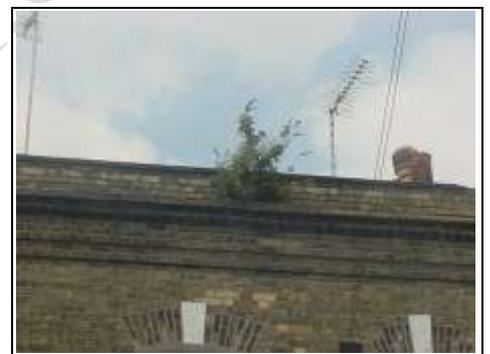
To the front of the property is the cornice. This is the area where we think there may be problems. We can see from your aerial photos that there is a lead flashing behind it and what looks to be a rendered wall. To us this is a good detail providing that the coping stone has a suitable drip detail on it to keep the water away from the wall. We suspect, as we mentioned in the Executive Summary, that water is sitting on the pronounced string detail (the bit of the brick that protrudes).

Cornice to the front of the property

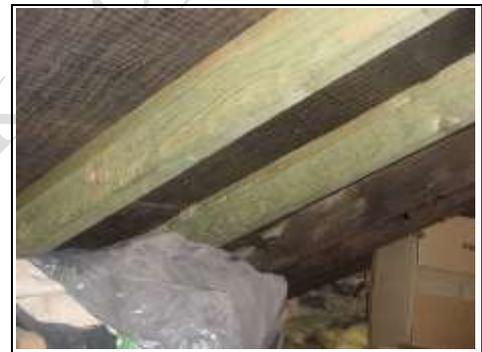
Right hand roof-This photo shows the common rafters (the ones that form the pitch of the roof) and the dark area between is the protective underlayer.

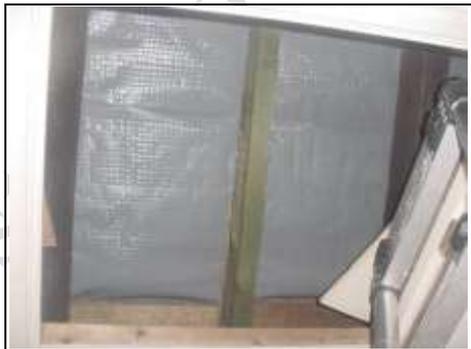
Torn protective underlayer - right hand roof.

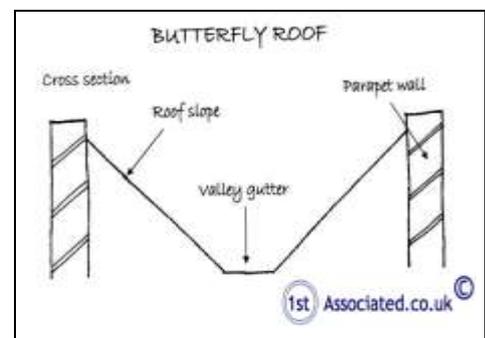
This is a cut timber roof with a double pitch that has a valley in the centre. In this particular case, in addition, I-Beams have been positioned to the centre of the valley. We would say that this is good as the central valley is often the area where problems occur.

Butterfly roof

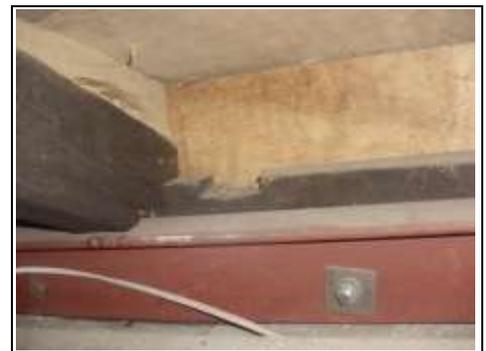
Steel beam

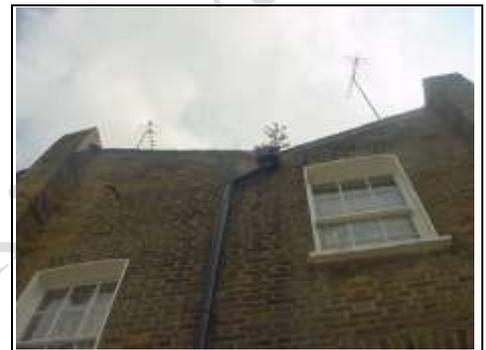
An integral part of the main roof is the central valley gutter which is always a weak area. We mentioned earlier that the gap looked quite small in the valley gutter and this will encourage it to block.

Hopper head to the rear of the London butterfly roof

ACTION REQUIRED: initially we would obviously clear out the vegetation growing. In the long term we would recommend that you have a larger hopper head fitted.

ACTION REQUIRED: We would recommend you stand outside the property next time it rains heavily and see how well the drains cope with the rainwater particularly looking at the joints. We would also recommend that the hopper heads and downpipes are cleaned out and the joints are checked. As already mentioned we would recommend that the hopper head is replaced with a larger one.

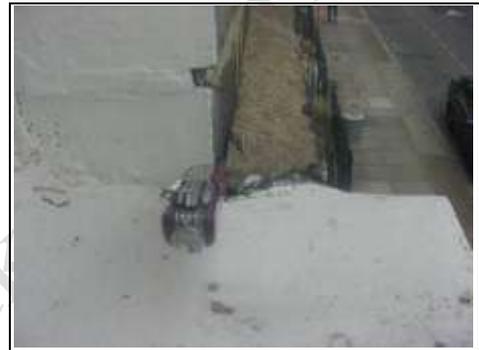
Brick work stringer with a cement fillet. The knife in the gap shows how dampness can get behind it

The problem with using cement mortar is that it is brittle and these properties move and as such you get hairline cracking as demonstrated by the knife in the photo above left

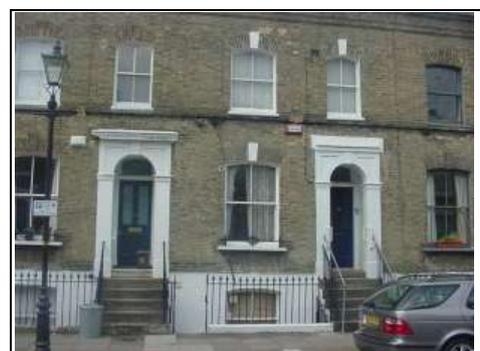
We can see that dampness is getting into the render. Please see our comments within the Executive Summary and as mentioned we believe it has been painted with a plastic

Render at low level

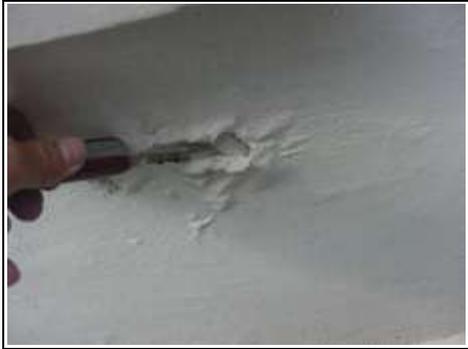
It does look as if this property has been painted to sell externally. We feel there will be quite a few problems with the dampness in the property.

Dampness escaping. The property has been painted with the wrong type of paint and does not allow the property to breathe.

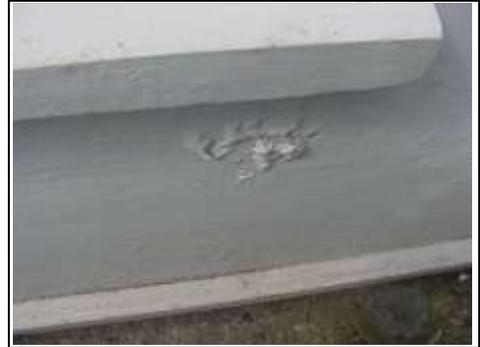
Painted to sell

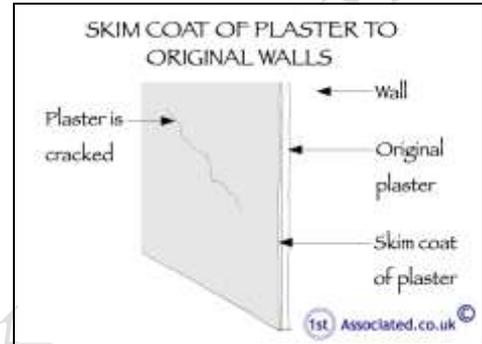
Skim coat of plaster

Hairline cracking

Hairline cracking is a result of dampness and differential movement in the property.

ACTION REQUIRED: In many cases painting will hide the cracks although you may have to do some filling in some areas. We much prefer a traditional lime based plaster in old properties such as this. However it will be very difficult to remove the skim coat of gypsum plaster.

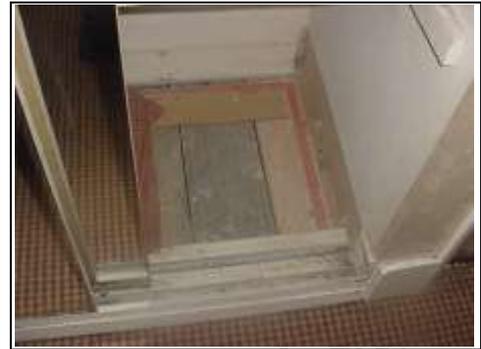
New floorboards in the cupboard may relate to central heating being put in or it may relate to woodworm problems

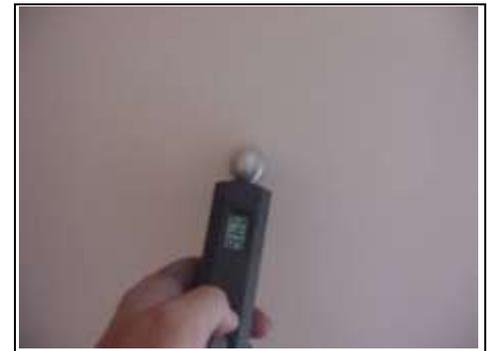
A random visual inspection and tests with a moisture meter have been taken to the perimeter walls. In this particular case we have found a higher reading than we would expect to the front of the property.

Testing for rising damp

ACTION REQUIRED: Please see our comments with regard to the render.

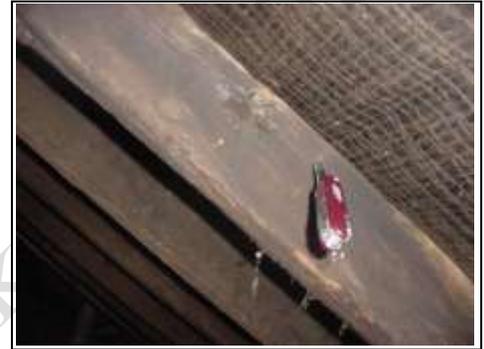
Checking for woodworm

Within the roof we found no obvious visual signs of woodworm activity or indeed signs of past woodworm activity that has caused what we would term 'structurally significant' damage. In many properties there is an element of woodworm that is not active. Our inspection is usually restricted by insulation covering some of the timbers and general stored items in the roof, as it is restricted throughout the property by general fixtures and fittings.

ACTION REQUIRED: If you wish to be 100 per cent certain that there is no woodworm the only way would be to check the property when is emptied of fixtures and fittings etc.

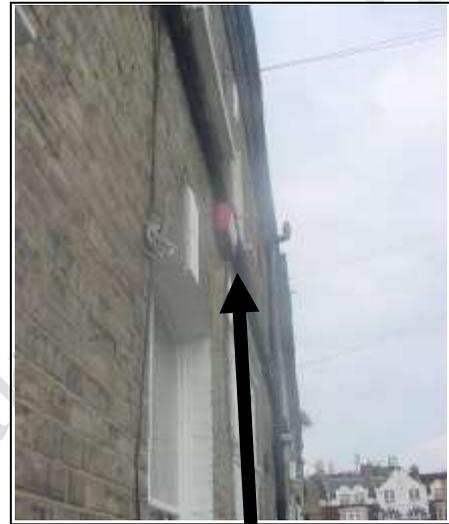
Security box

There is an alarm box on the property but we did not note any indications of a working alarm system internally.

ACTION REQUIRED: Further information should be obtained from the vendor.

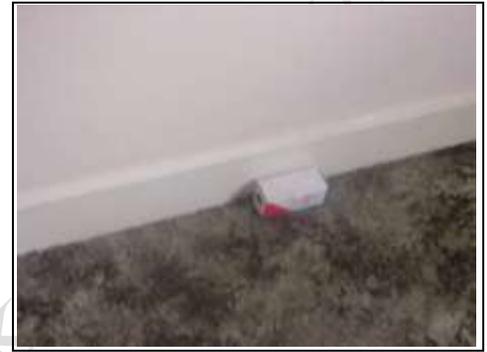
Rodent trap

You may have noted the rodent traps that were in one of the rooms.

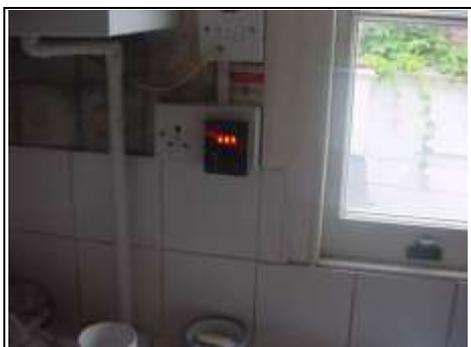
Earth Test in the house

We carried out an earth test in the kitchen areas of the lower ground floor flat and in the main house to the socket points that are normally used for the kettles, these both proved satisfactory.

ACTION REQUIRED: As the property is changing occupancy an Institute of Electrical Engineers (IEE) test and report should be carried out by a NICEIC registered and approved electrical contractor or equivalent.

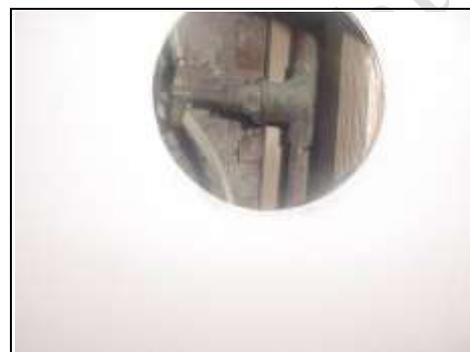
Stopcock to lower ground floor.

We noticed that the controlling stopcock is located on the lower ground floor flat just near to the exit of the property.

It is important that its presence is established in case of bursts or leaks. The stopcock and other controlling valves have not been inspected or tested for operational effectiveness.

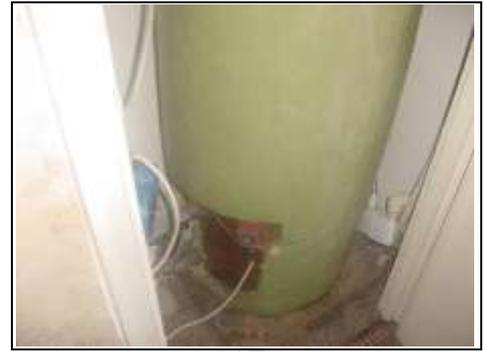
Factory Insulated Cylinder

There is a hot water cylinder. This is factory insulated, which indicates that it is relatively new (in this case we mean in the last 30 years). This cylinder will therefore have a good thermal efficiency, although not as good as the more modern hot water cylinders. Of course we cannot tell if this was working or not. From a visual inspection this does need to be tested.

ACTION REQUIRED: Test the hot water cylinder and the heating system via a plumber or engineer before you commit to purchasing the property.

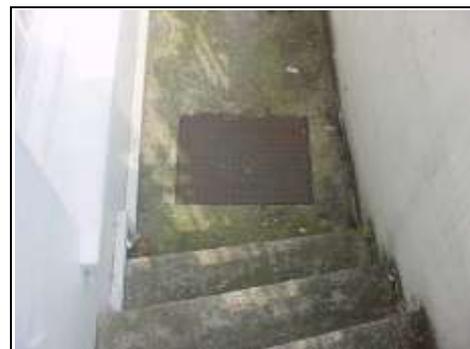
Inspection Chamber / Manhole One –front

We could not lift this manhole.

We could not lift this.

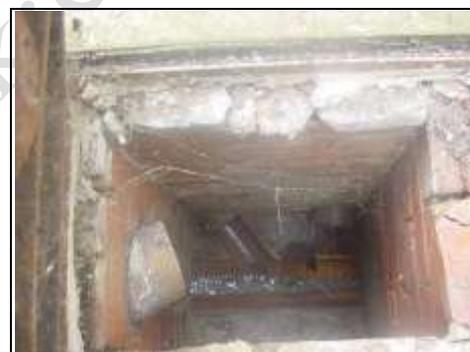
Manhole

We duly lifted the cover and found it to be free flowing at the time of our inspection.

From what we could see it is brick built

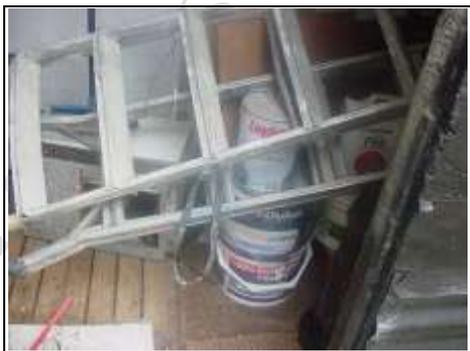
Full of paint, certainly a sign that the property has been painted to sell!

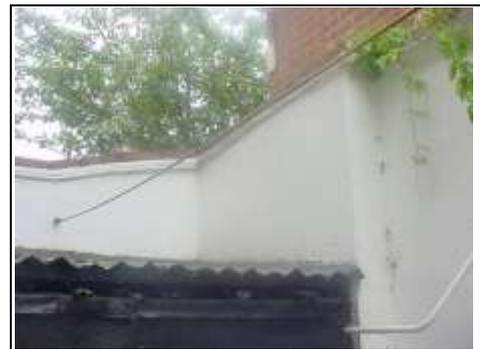
Corrugated roof on shed. We definitely wouldn't store anything valuable in here.
