COMMERCIAL BUILDING SURVEY

Mr XXXXXX

INDEPENDENT CHARTERED SURVEYORS

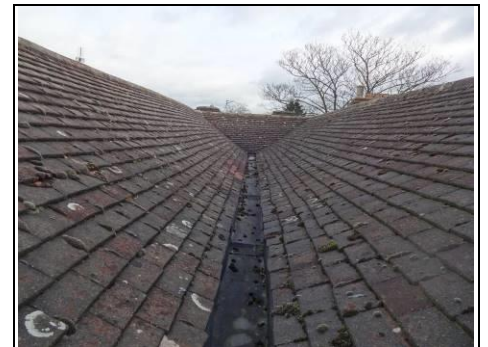
The hidden valley gutter to the main roof is a good example of an area which is allowing some dampness to get into the building and will cause deterioration over time.

Hidden valley gutter
on main roof
Aerial view – 360 photo

We were pleased to see that you have good access to this area (although it could be made safer) from the landing via a loft hatch internally. Externally a safe access is needed, which some thought needs to be given to.

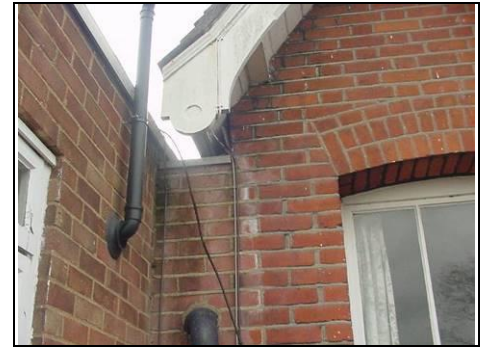
There is a second hidden box gutter to main roof where it meets the flat roof. This is an area where regular cleaning is needed.

Second hidden box gutter to main roof overflowing

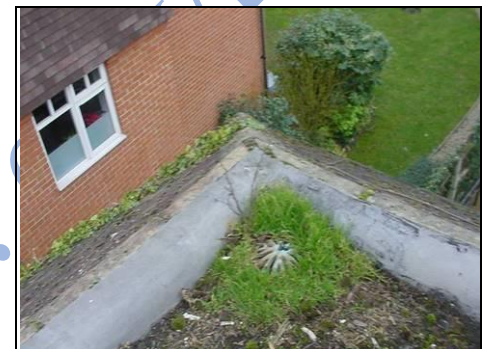
At the time of our inspection the left two store flat roof had grass growing around the gutters which will block any water from getting away from it in due course. This area needs clearing.

Blocked gutter on flat roof to left side

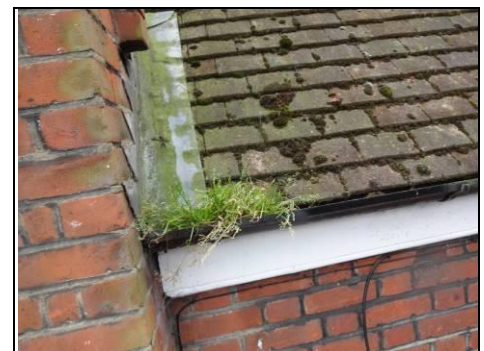
Blocked gutters
Aerial view – 360 photos

ACTION REQUIRED: Clear all gutters, downpipes, valley gutters and box gutters to allow rainwater to discharge from the roofs.

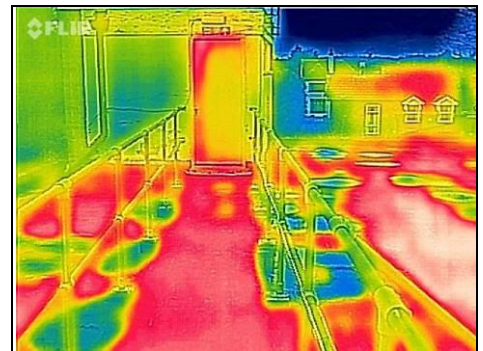
The main flat roof over the two storey extension (attached to rear of the main property) has ponding/water sitting upon it which will accelerate its deterioration. The very fact that water is sitting on it is not a good sign, as despite the name of the flat roof indicating it should be flat, generally we would expect there to be a fall of 12 to 25 degrees.

Thermal imaging looking towards
lift area.

The red areas represent heat.
The blue areas represent ponding

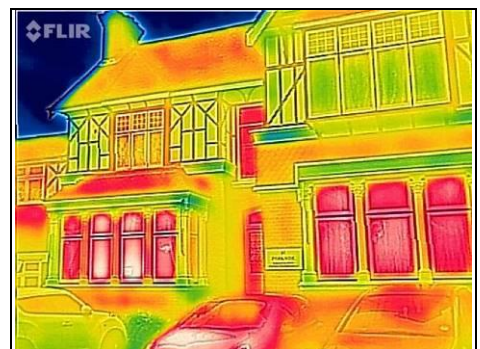
There is a fair amount of heat from the areas that we typically come across, such as around the perimeter of the windows and doors, as well as flat roofs.

Front of property showing energy coming through windows and doors and from main roof

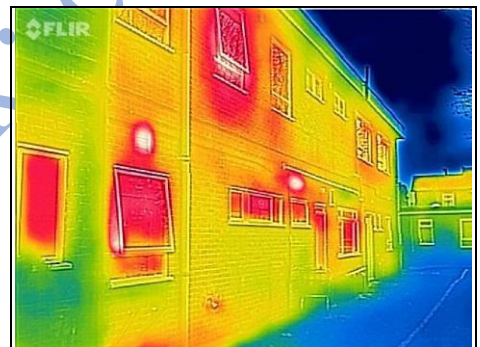
Heat coming through windows on right side of property

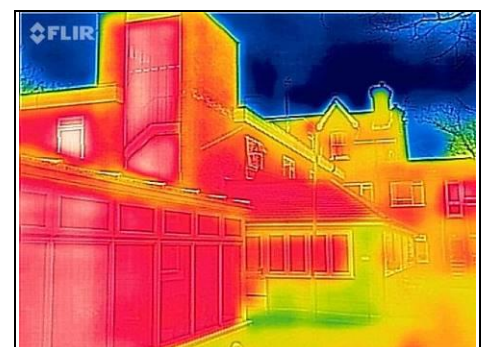
Heat coming through glazing to rear left side

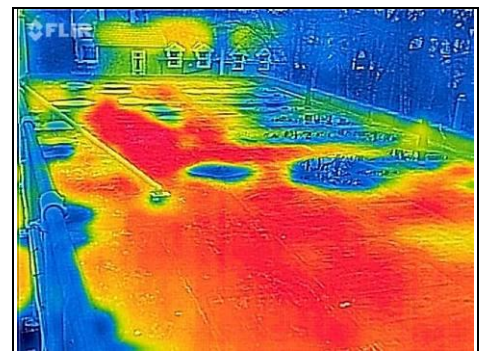
There was heat loss showing in this area. If we combine the re-roofing with also the adding of insulation, cut to falls, to ensure you have a definite fall on the roof, and ideally finish with a performance felt which we feel would be the best way forward.

Heat coming out of rea flat roof - blue areas show the ponding on the roof

We suggest you open up a section of the ceiling to see exactly how it is constructed.

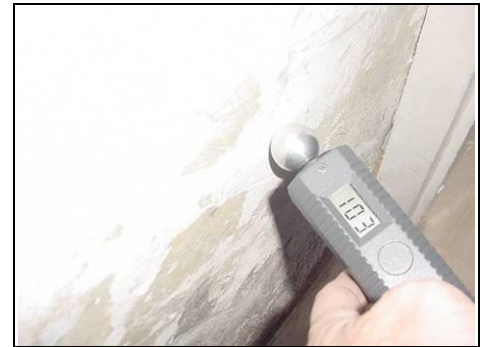
High damp readings in basement

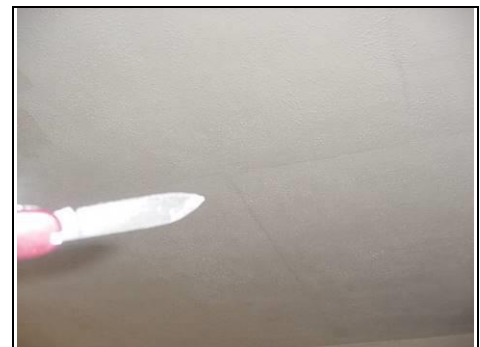
Textured paint may contain asbestos

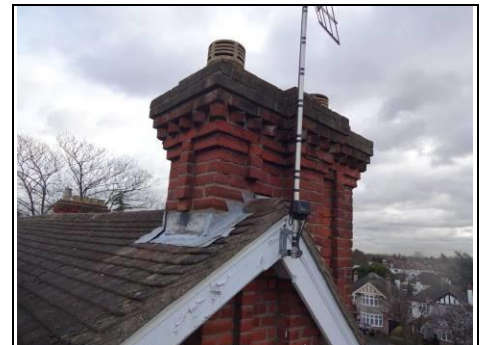
Front left chimney

ACTION REQUIRED: Ad hoc repointing and periodically inspect the chimney.

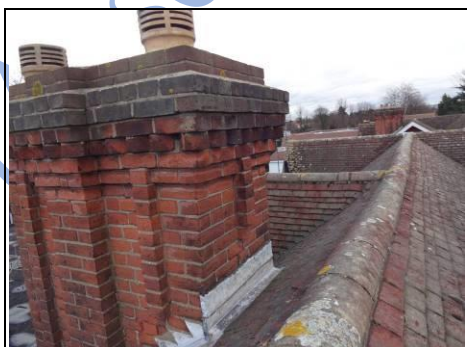
The way the chimneys are detailed is that there is an area that can catch vegetation etc to the rear of the chimney which could lead to dampness getting into the property.

Trap behind rear left chimney
Aerial view – 360 photo

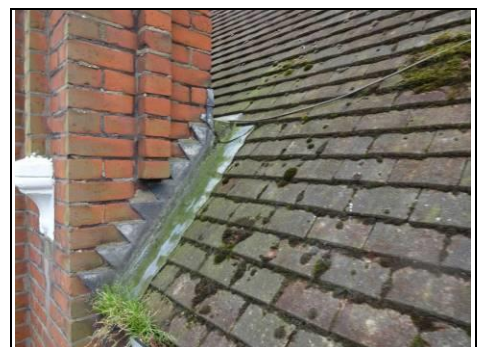
Trap behind front right chimney
which is catching vegetation
Aerial view – 360 photo

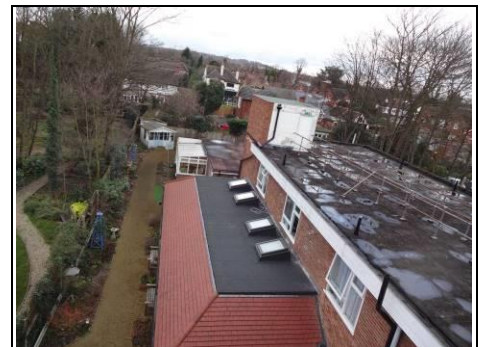
These are four fairly roof windows which all look to be on a slight angle. Although the roof was not accessed from our photo they do look to be in reasonable condition.

Roof windows on roof to left side
Aerial view – 360 photo

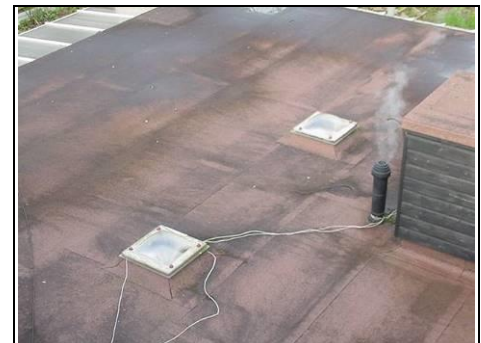
There are three domed purpose made roof windows to the rear single storey flat roof. They look in average condition for their age, type and style.

Rear roof windows
Aerial view – 360 photo

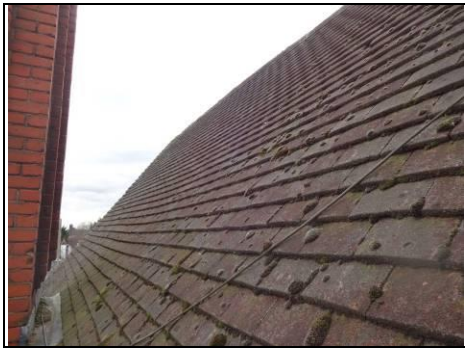
The main roof is pitched and clad with a clay tile. From ground level, this looks in average condition considering the roofs age type and style, with some mossing to the tiles as we would expect.

With this age of roof there will usually be a few missing or displaced tiles; this is nothing unusual.

Close up of main roof tiles to right side

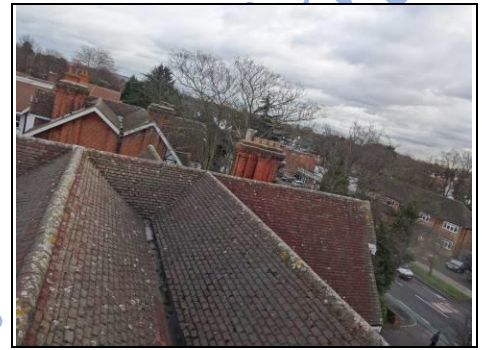
Main roof with hidden valley gutter

Monitor the dampness within the front and if it still continues then have a close inspection of the main roof.

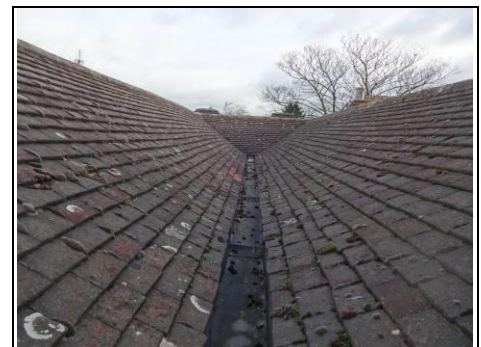
Close up of hidden valley gutter on main roof below box gutter
Aerial view – 360 photo

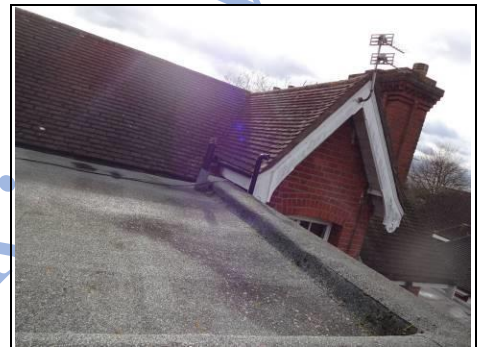
Rear box gutter
Aerial view – 360 photo

We recommend somebody accesses the roof and ensure it is cleared.

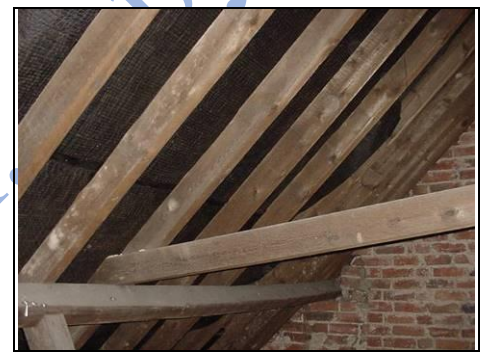
When we inspected the front loft spaces we found a Hessian base Bitumen membrane. This type of membrane has been used since the 1960s. We generally found it to be in average condition, it is damaged in a few more places than we normally find.

This photo shows common rafters in the front roof (the ones that form the pitch of the roof), the dark area between is the underlayer

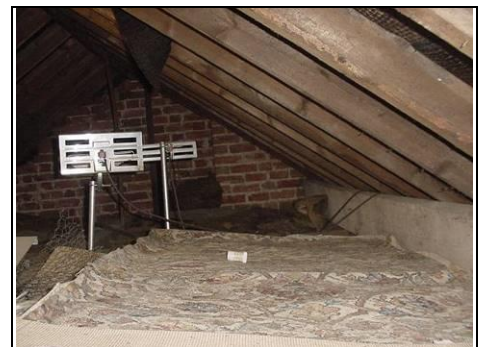
Hessian based bitumen membrane within rear roof

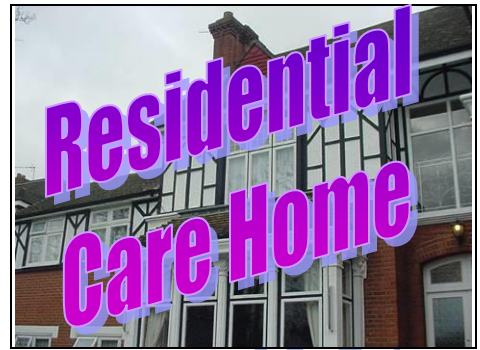
There are two pitched roofs to the front of the property; one single storey and one at first floor level over oriel bay window. We would comment that both are in average condition for their age, type and style.

Small pitched roof

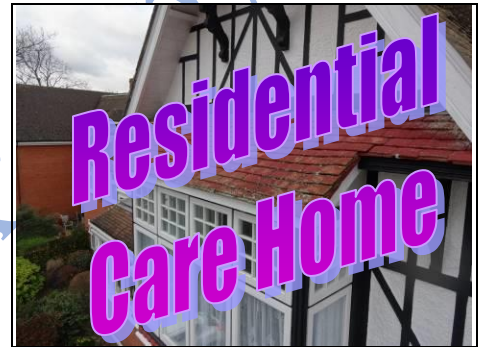
Oriel window roof

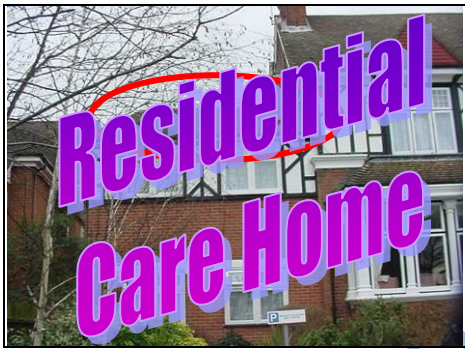
This is a flat, flat roof without a fall, with a tiled pseudo-pitch to the side. This is generally a flat roof with vegetation and grass growing around the gutters and areas of ponding.

Two storey flat roof to left side
with tiled pseudo-pitch

ACTION REQUIRED: We recommend this becomes a warm roof with insulation cut to falls.

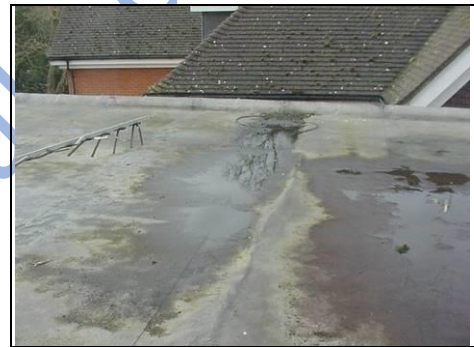
Two storey flat roof to left side

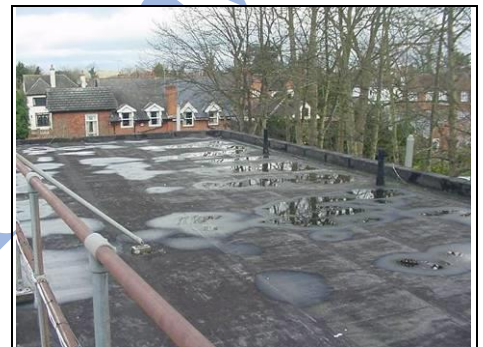
This is a large felt covered flat, flat roof that has ponding and patch repairs. We noted an area in one of the guest rooms where a leak has occurred.

Ponding on two store left flat roof
Aerial view – 360 photo

ACTION REQUIRED: We recommend this becomes a warm roof and insulation cut to falls.

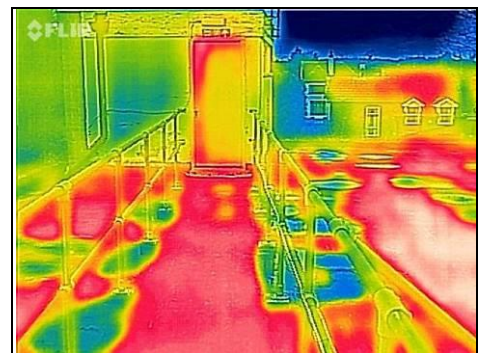
Thermal imaging looking towards lift area.

The red areas represent heat.
The blue areas represent ponding

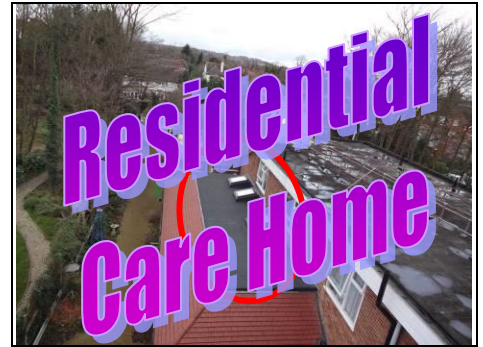
This is relatively new, with four roof windows. We could see no obvious signs of defects.

Rear left roof
Aerial view – 360 photo

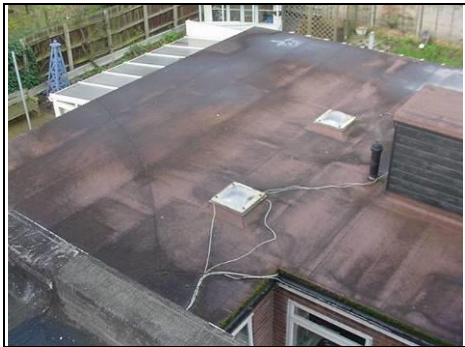
We would comment that this roof was weathered.

Left side of roof showing weathering of mineral felt
Aerial view – 360 photo

ACTION REQUIRED: Patch repairs.

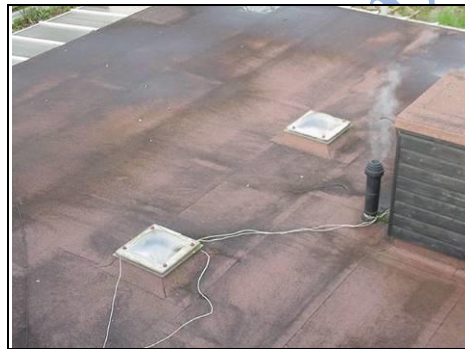
Middle of rear single storey flat roof
Aerial view – 360 photo

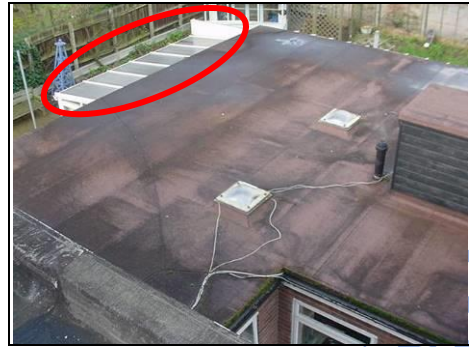
This is a glazed lean-to. This area was not visited during our inspection, but often this type of roof can be problematic.

Rear glazed lean-to roof
Aerial view – 360 photo

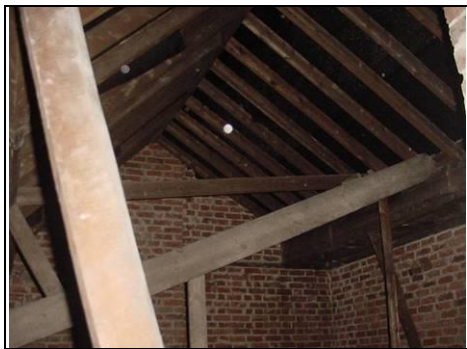
In the front roof our examination was limited by the general configuration of the roof and the insulation. What we could see was generally found to be in slightly below average condition for its age, type and style.

General view of inside of the front roof

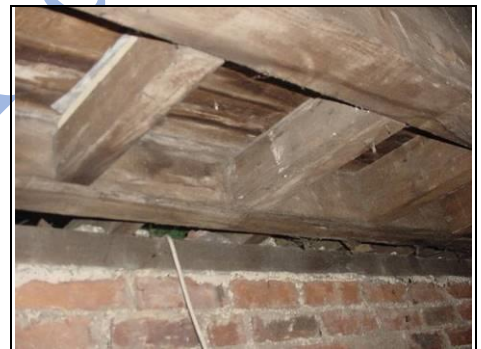
Timbers in front roof

Deflection to the purlins and dampness coming in from valleys

We noted minor deflection to the purlins and dampness coming in via the valley gutters to the front.

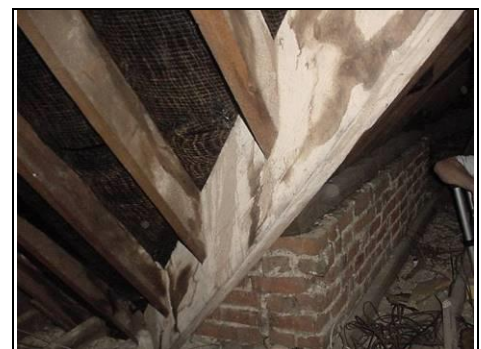
Dampness coming into valley gutter at front of property

ACTION REQUIRED: Monitor the dampness within the front and if it still continues then have a close inspection of the main roof.

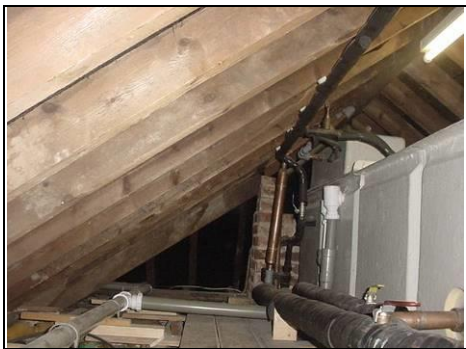
The rear roof is a shallow roof and there are stored items and a mass of insulation which limited our view of the joists. What we could see was generally found to be in average condition for its age, type and style. It is, however, feasible that there are problems in the roof that are hidden.

General view of left of rear roof

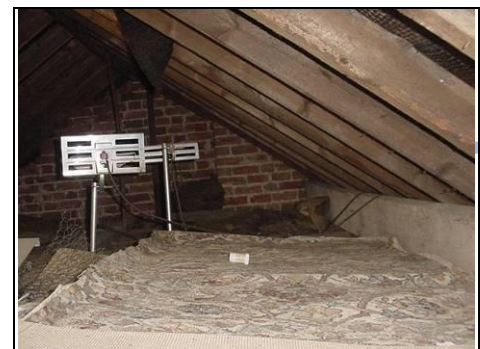
General view of right side of rear roof with mass of insulation

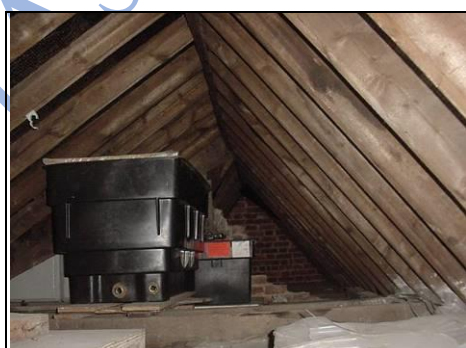
There was a number of plastic water tanks in both the front and rear roofs. You may wish to review these and reduce their number. At one time we believe there was a requirement to have 24/48 hours of emergency water for a building such as this but we are unsure whether this is still a requirement, as today we generally see modern buildings without water tanks.

Water tanks in the front roof

We would always recommend that water tanks be drained down and cleared of any debris etc. (we have all sorts in water tanks over the years!).

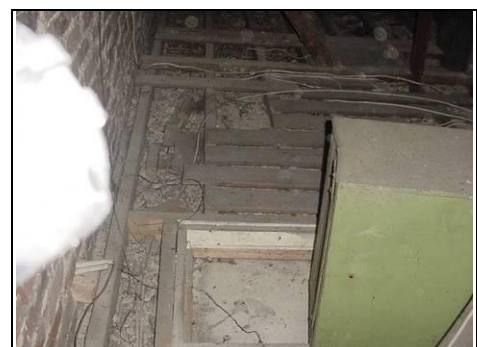
Access up to water tanks needs improving with a man safe system

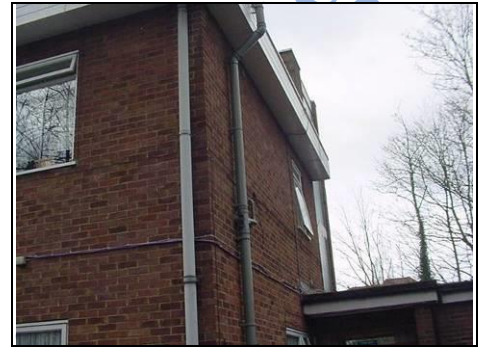
The gutters and downpipes are predominantly plastic, there may be some original cast iron remaining. They are in slightly below average condition for their age, type and style.

Downpipes

Grass growing from guttering

We noted more examples of grass growing from gutters than we would expect to see, however we do appreciate that many of the gutters are high level and difficult to access.

We recommend you stand outside next time it rains heavily to see how the gutters and downpipes are performing. We would always recommend that the gutters and downpipes are cleaned out, the joints are checked and the alignment checked to ensure that the gutters fall towards the downpipes.

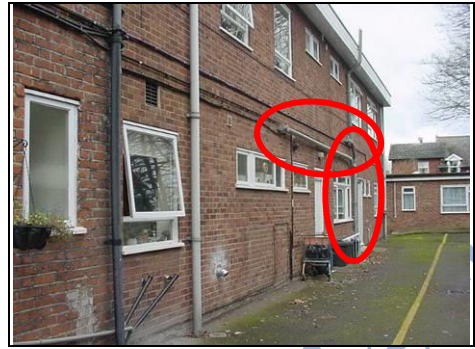
Long run to soil and vent pipes

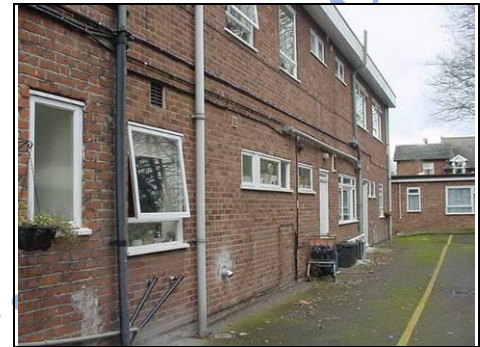
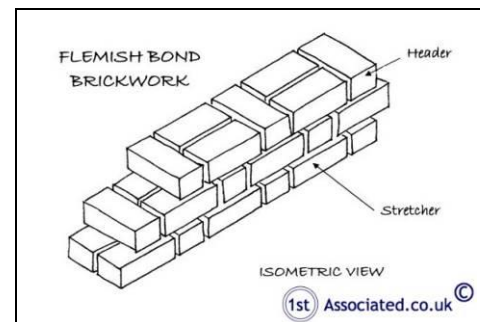
Flemish bond brickwork

Generally Flemish Bond brickwork is liable to penetrating dampness internally, dependent upon the condition of the brickwork and the exposure to the weather. It is essential that external faces be kept in good condition. In this case they are in average condition.

ACTION REQUIRED: Some ad-hoc repointing to be carried out when the chimney work is being carried out during the warmer months. We generally recommend a mortar mix is made and allowed to dry to ensure it matches with the existing mortar.

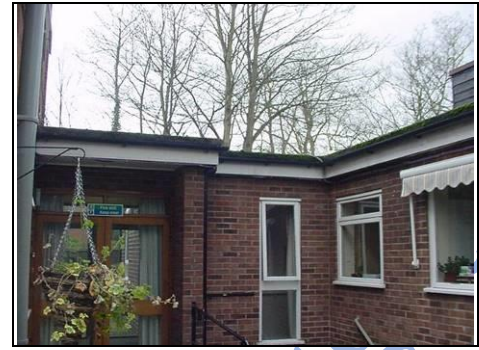
Stretcher bond brickwork to rear extension

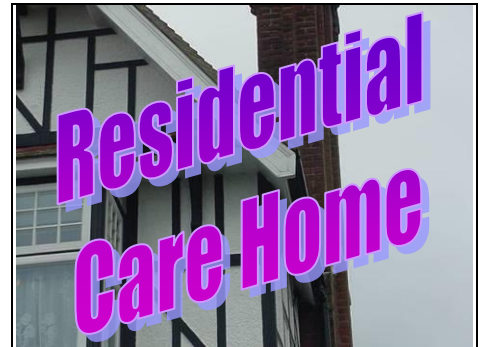
The external walls are finished in a painted render with decorative timber to the front of the property at first floor level. It looked in average condition for its age, type and style from ground level.

Painted render with decorative timbers

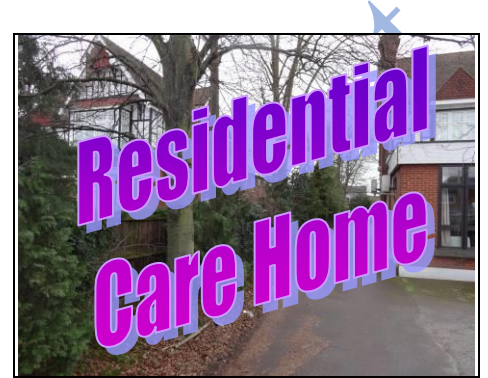
There are trees within what we would term as influencing distance but you do need to speak to your insurance company as they may have a different interpretation for insurance reasons.

Trees running down right side of boundary on neighbour's property

ACTION REQUIRED: Please see our comments in the Executive Summary.

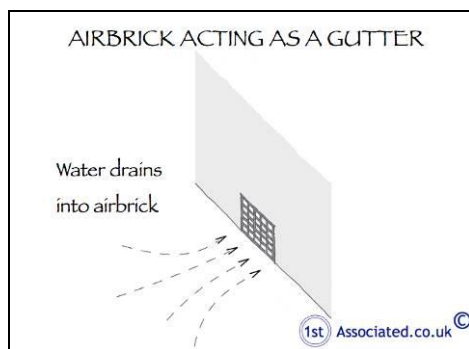
Airbricks acting as a gutter

ACTION REQUIRED: They look to be acting as gutters, adding to the dampness already in the basement area.

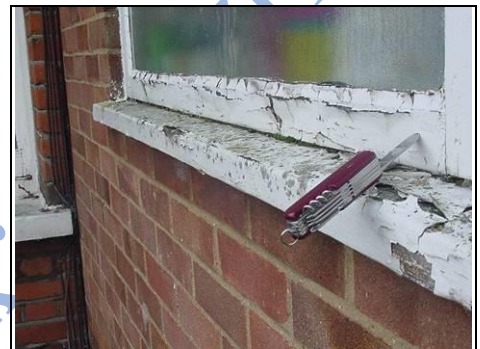
Rotten timber to accommodation area on top floor

We noted significant wet rot in the fascias and soffits and we believe there is some in the timber windows.

Fascias and soffits need repair/replacement as soon as possible. The timber windows need repair and redecoration depending upon what your strategy is.

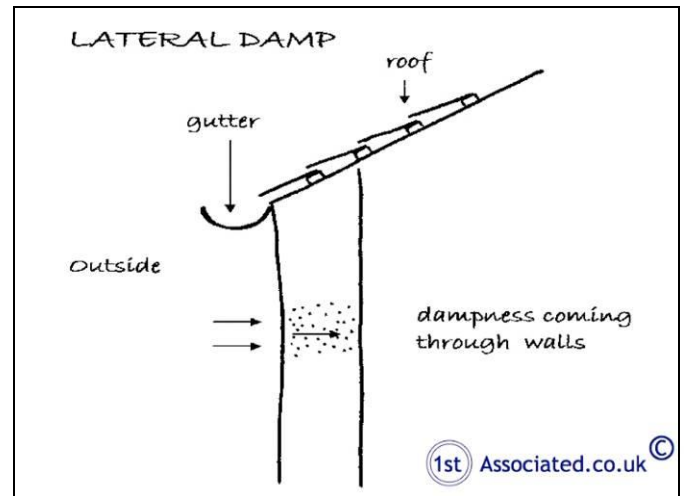
Lateral damp

We used a resistance meter on the external walls. We found damp meter readings in the basement area again.

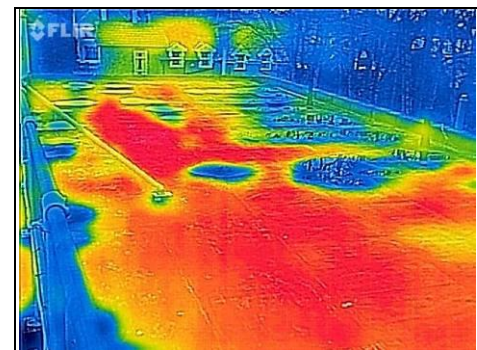
Heat coming out of rea flat roof - blue areas show the ponding on the roof

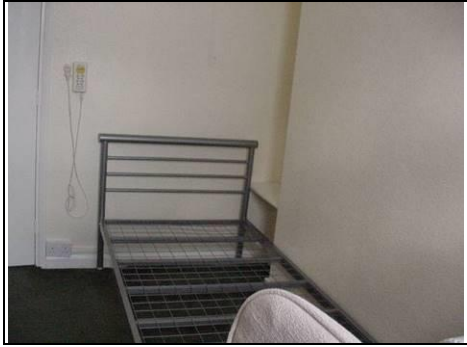
Bedroom 2.
Small bedroom – you can possibly
extend into the store next door

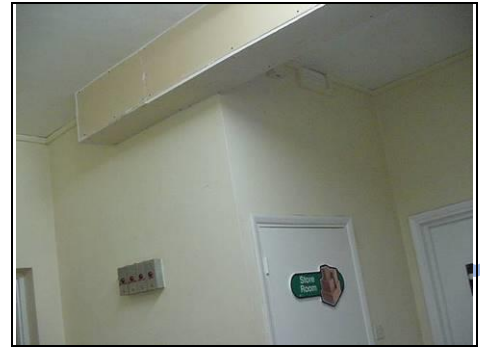
Unfinished plasterboard that looks
to be from a waste pipe

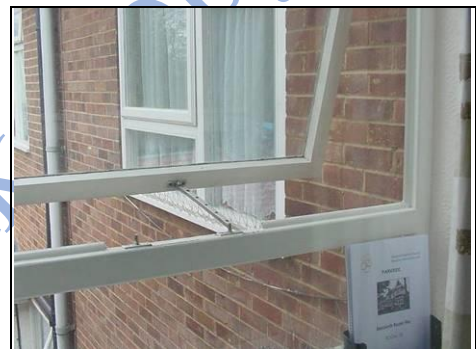
Window needs a restrainer adding
to it

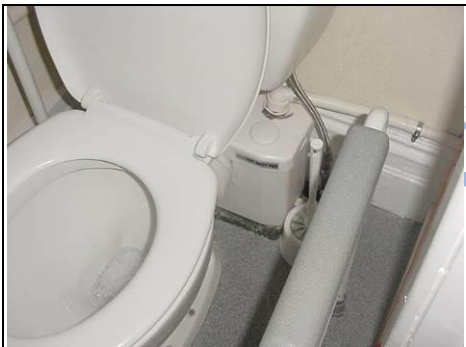
En-suite toilet with macerator
(which we are not keen on)

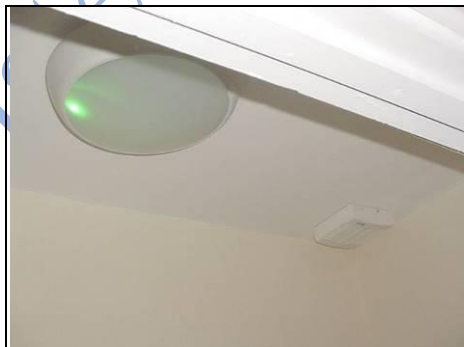
Lighting needs improving

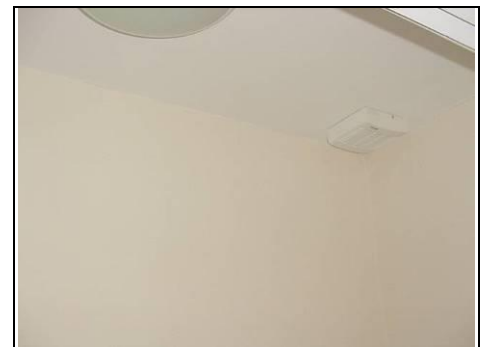
Small extract in toilet

ACTION REQUIRED: We would recommend large good quality humidity controlled extract fans be added to kitchens and toilets.

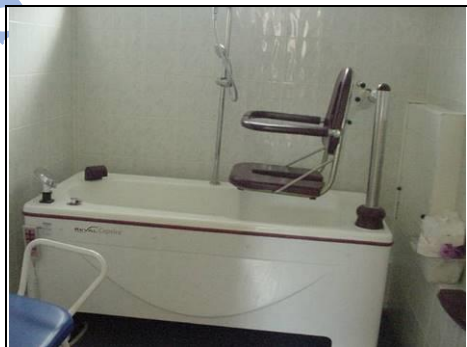
Bathroom
with standalone bath _____ Marketing by: _____

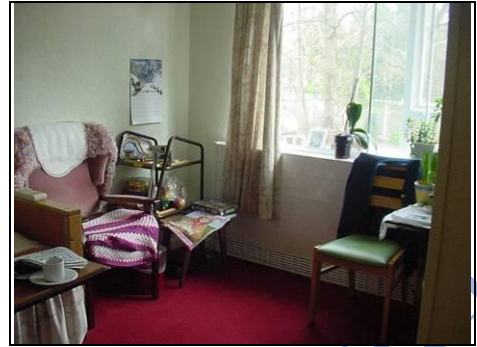
Bedroom looking towards window

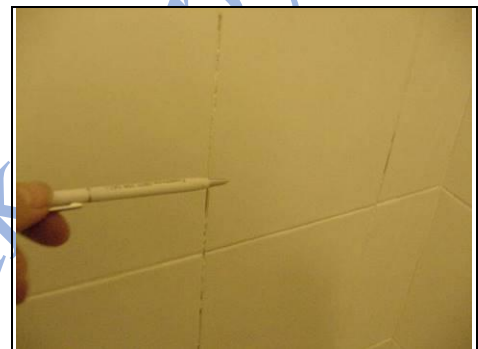
Weathering to tiles in en-suite
