PROPERTY REPORT

XXXX
City of London,
EC3V XXX

We have been instructed to inspect and prepare a Report and Schedule of Condition for XXXX, City of London, EC3V XXX. We inspected the property on XXXX

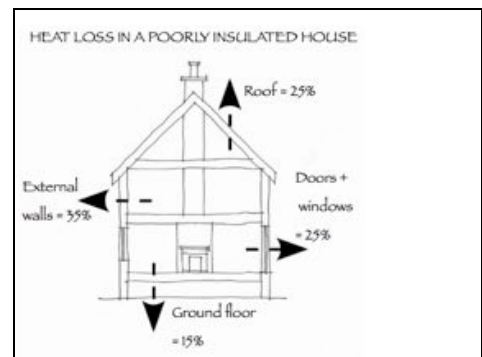
There is no insulation within the roof of this structure and it is difficult to establish if having insulation will be a good idea or not as it may cause both surface condensation and interstitial condensation.
