SCHEDULE OF CONDITION

XXXXX
Northampton
Northamptonshire
NN1 XXX

Prepared by:
[XXXXXX](#)
INDEPENDENT CHARTERED SURVEYORS

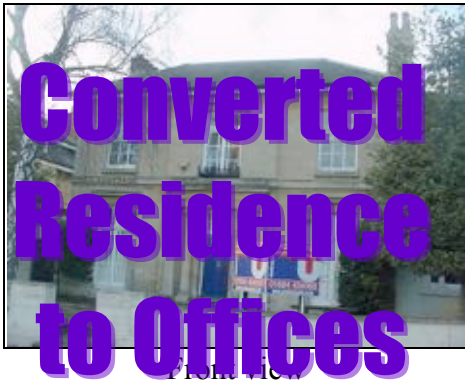
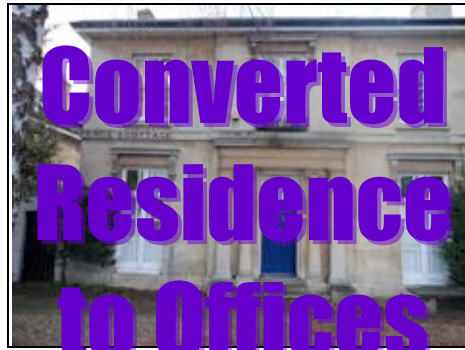
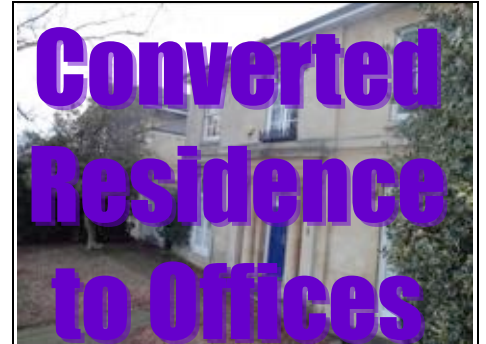
Front External Elevation

DESCRIPTION	CONDITION	ACTION REQUIRED
<p>Chimneys:</p> <p>Front right side chimney Right side rendered chimney with four chimney pots</p>   <p>Front left side chimney Rendered, with brick top and chimney pots</p>	  <p>Newly rendered in an inappropriate cement mortar Repairs visible</p>   <p>Repairs to render visible. Hairline cracking.</p>  	<p>Repair, prepare and redecorate</p>   <p>Repair, prepare and redecorate</p>

<p>Render deteriorating Horizontal cracking</p>

<p>Roofs:</p> <p>Main roof:</p> <p>Shallow pitched clad with slates. Lead cappings to the ridges</p>	<p>Average Few broken slates.</p>

<p>Fascias and Soffits:</p> <p>Painted timber</p>	<p>Dated</p>  	<p>Repair, prepare and redecorate</p>
<p>Walls:</p> <p>Coursed stonework with quoins with ledge details (inherent design defects)</p> <p>Ionic columns around entrance</p>   <p>Render to side extension</p>   <p>Air vents to cellar</p>  	<p>General damage. Ledge details catching water, allowing dampness into building</p> <p>DIY quality repairs to base of columns</p>   <p>Cracking to right side</p>     <p>Acting as gutters</p>  	<p>Professionally repair stonework</p> <p>Exclude from lease</p> <p>Or</p> <p>Professionally repair stonework.</p> <p>Exclude cracking and movement from lease.</p> <p>Existing landlord to make an insurance claim and to advise of how it is proceeding.</p> <p>Protect air vents</p>

<p>External Detailing:</p> <p>Windows:</p> <p>Style sliding sash windows</p>   <p>Doors:</p> <p>Two French doors, Grill in front of right side French doors</p>  	<p>Flaking paint and bare timber visible.</p>   <p>Deteriorating</p>  	<p>Repair, prepare and redecorate.</p> <p>Repair, prepare and redecorate.</p>
---	---	---

<p>Repair, prepare and redecorate</p>

<p>Clear vegetation from gutters.</p> <p>Ensure all gutters are watertight and falling towards the downpipe and clear.</p> <p>Repair downpipes and secure as necessary, ensure downpipes are clean and clear.</p>

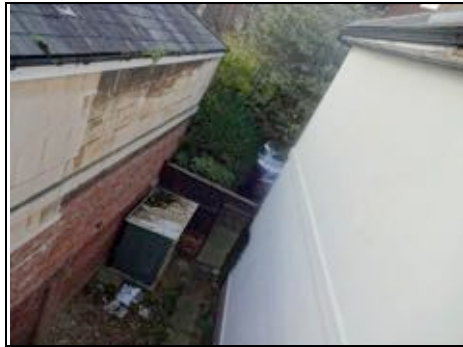
Fascias and soffits deteriorating

All gutters and downpipes viewed from ground level.	Vegetation sitting in gutters. Rusting cast iron. Leaking – looks to be long term due to the rusting and paint flaking.

Fascias and Soffits: Painted timber	Weathered and deteriorating. Looks to be an area that has been replaced.

Repair, prepare and redecorate
Walls: Cement based render and plaster Brickwork to lower area	Inappropriate cement mortar for this age, type and style of property.

Exclude from lease Or Ensure all gutters are watertight and falling towards the downpipe and clear. Repair downpipes and secure as necessary, ensure downpipes are clean and clear.

Deteriorating	As this is a listed building we recommend removing cement mortar and replacing with lime based breathable render Ad hoc repointing

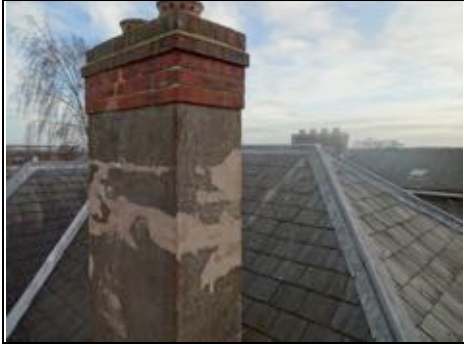
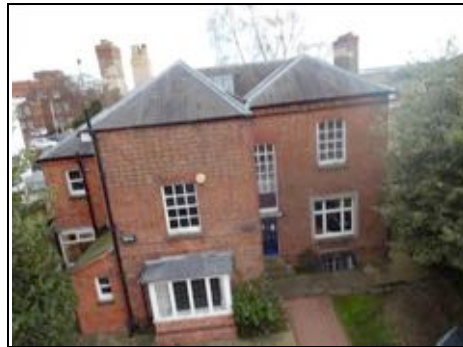
Rear External Elevation

DESCRIPTION	CONDITION	ACTION REQUIRED
Chimneys:		See front elevation
Roofs: Main roof Shallow pitched slate roof with lead ridges, partly vented Hidden valley gutter	Some slipped slates and damaged

<p>All gutters and downpipes viewed from ground level.</p>	<p>Vegetation sitting in gutters. Rusting cast iron. Leaking – looks to be long term due to the rusting and paint flaking.</p>   <p>Awkward detail with rainwater pipe running length of rear left</p>

<p>Fascias and Soffits:</p> <p>Painted timber</p>	<p>Weathered and deteriorating</p>	<p>Repair, prepare and redecorate</p>
<p>Walls:</p> <p>Flemish bond brickwork</p>

<p>Chemical damp proof course injected</p> <p>Metal diagonal grills protecting the light well to the cellar windows</p>	<p>Inappropriately repointed in cement mortar causing dampness internally. Pattern staining Moss to lower parts of wall</p> <p>Some rebuilding to rear right kitchen area</p>

<p>Cracking rear corner</p>

<p>Rusting</p>

See front elevation We recommend landlord makes hatches to access roof.

<p>Exclude from lease</p> <p>Or</p> <p>Repairs to gutters and downpipes as soon as possible and secure as necessary.</p> <p>Ensure all gutters and downpipes are watertight and falling towards the downpipe and clear.</p>
<p>Soil and vent pipes</p> <p>Two cast iron soil and vent pipes; one to middle right and one to rear right</p>

<p>Repair, prepare and redecorate</p>

<p>Ad hoc repointing in lime mortar</p> <p>Exclude from Lease</p> <p>And/or</p> <p>Landlord to put in an insurance claim for the cracking / movement.</p> <p>Repair</p>

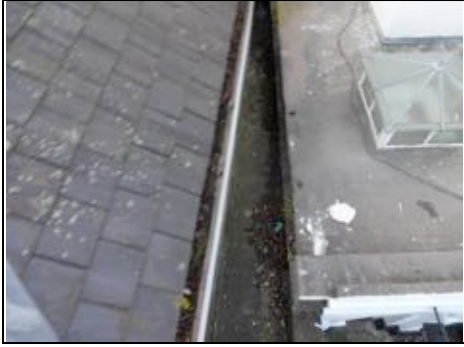
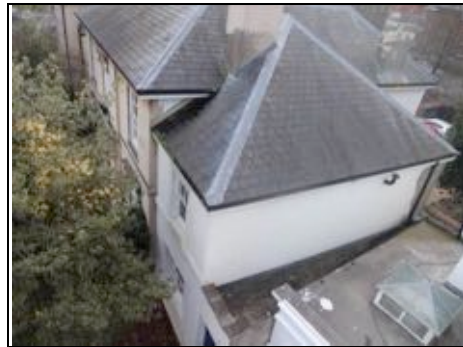
Right External Elevation

Close up box gutter
Aerial view – 360 photo

DESCRIPTION	CONDITION	ACTION REQUIRED
Chimneys:		See front elevation
Roofs: Main roof Pitched, clad with slates		See front elevation
Right side single storey flat roof Covered with asphalt (assumed)	Leaking Repairs visible

<p>Debris visible and water sitting in it. Leaking, causing dampness into the building</p>

<p>All gutters and downpipes viewed from ground level.</p>	<p>Rusting and long outstanding leak, leading to growth of vegetation in top of adjoining wall</p>

Fascias and Soffits: Painted timber	 Deteriorating	 Repair, prepare and redecorate
Walls: Newly rendered in inappropriate cement mortar Flemish bond brickwork to base	 Inappropriate cement mortar that will trap dampness in the property. Area of render not painted to rear

<p>Exclude from lease And/or</p> <p>Ensure all gutters are watertight and falling towards the downpipe and clear.</p> <p>Repair downpipes and secure as necessary, ensure downpipes are clean and clear.</p>

Replace cement render with lime based render that is breathable and more appropriate for this age, type and style of building.

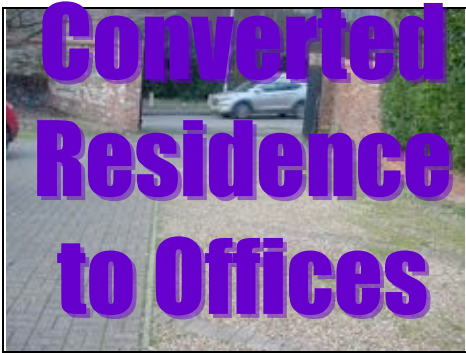
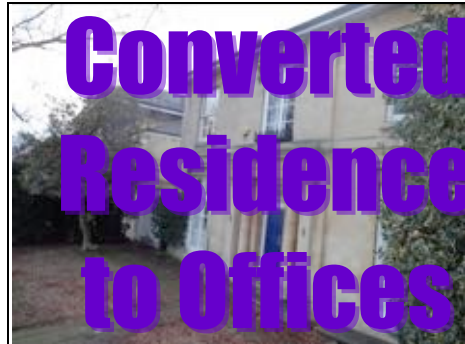
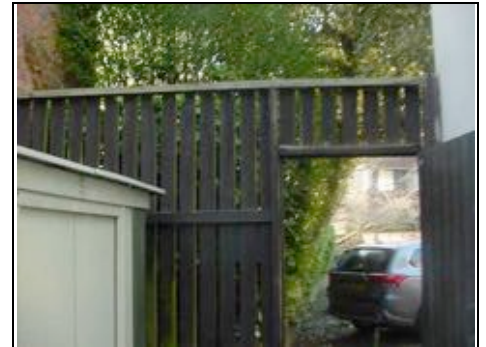
Outside Areas

<p>Rusting</p> <p>Close to perimeter wall</p>

<p>Boundary wall Painted, part stucco rendered</p>  	<p>General deterioration and cracking. The capping stone does not appear to have a large enough drip detail and some capping stones missing.</p>  	<p>Repair, prepare and redecorate</p>
<p>LEFT SIDE:</p> <p>Shared garden wall</p> <p>Two cross walls, going side to side: Cross wall no. X to left front Painted</p>   <p>Cross wall no. X to rear left Part brickwork, part vertical timbers with open slats and smoking unit.</p>   <p>Ledge and brace gate</p>	<p>Deteriorating</p> <p>Deteriorating Vegetation growth</p>   <p>Moss covered and rotting. Rusting smoking unit.</p>   <p>Deteriorating</p>  	<p>Ad hoc repairs and repointing</p> <p>Repair, prepare and redecorate and remove vegetation.</p>   <p>Repair/replace</p>   <p>Repair, prepare and redecorate</p>

<p>Rear wall Brickwork</p>	<p>Deterioration and old tarring visible and spalling brickwork and holes</p>	<p>Clean and repair/rebuild</p>

<p>Repair, prepare and redecorate</p> <p>Arboriculturalist report (not a tree surgeon) to confirm what work is required and maintain trees.</p> <p>Level and make safe</p> <p>Remove</p>

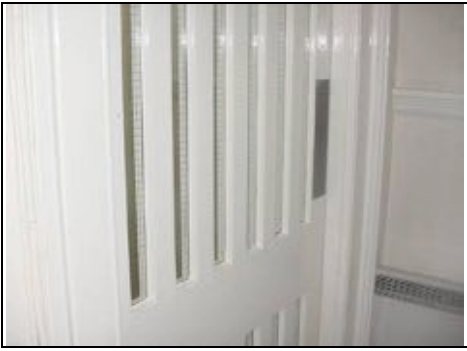
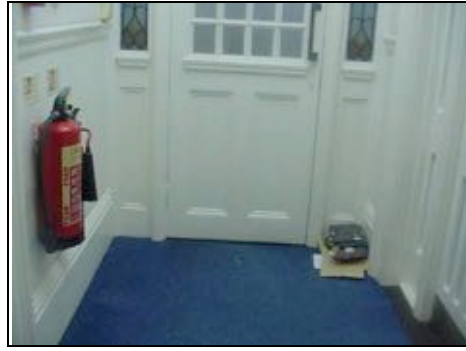
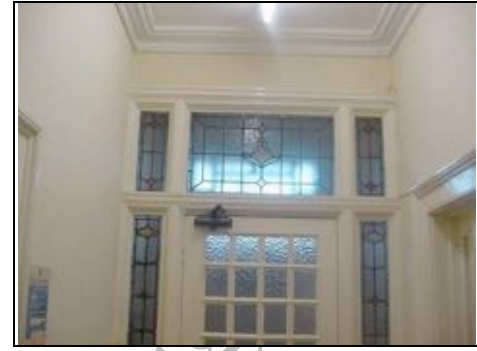
Front Entrance Lobby

DESCRIPTION	CONDITION	ACTION REQUIRED
Ceilings: Woodchip wallpaper Decorative mouldings	Dated	Repair, prepare and redecorate
Walls: Woodchip wallpaper Embossed wallpaper Double dado rail	Dated	Repair, prepare and redecorate
Floors: Carpet tiles	Some wear	Deep clean or replace

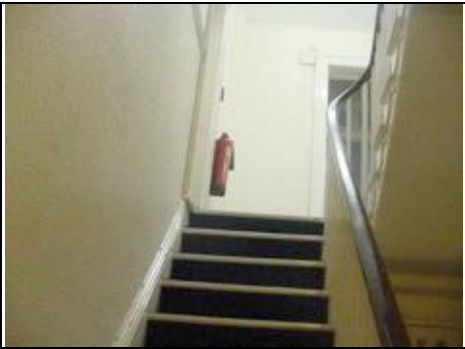
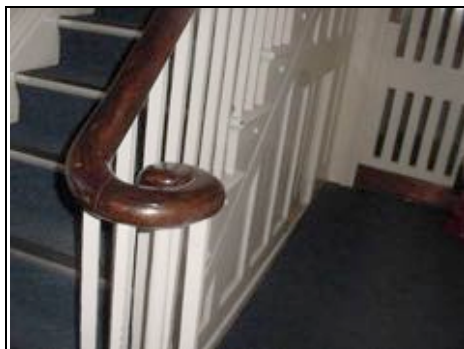
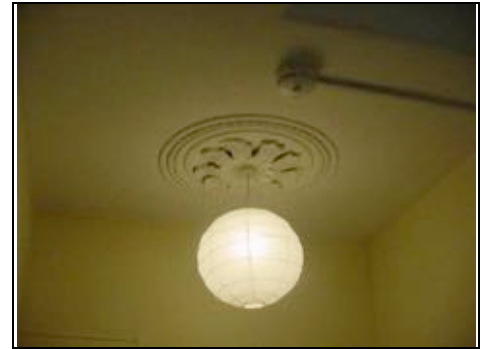
Central Corridor and Staircase

DESCRIPTION	CONDITION	ACTION REQUIRED
<p>Ceilings:</p> <p>Woodchip paper</p> <p>Decorative ceiling rose</p>	<p>Dated</p> <p>Hairline cracking</p>	<p>Repair, prepare and redecorate</p>
<p>Walls:</p> <p>Woodchip paper</p> <p>Painted timber dado rail</p>	<p>Marked and dated</p>	<p>Repair, prepare and redecorate</p>
<p>Floors:</p> <p>Carpet tiles</p> <p>Large skirting boards</p>	<p>Worn</p> <p>Dated</p>	<p>Deep clean or replace</p> <p>Repair, prepare and redecorate</p>

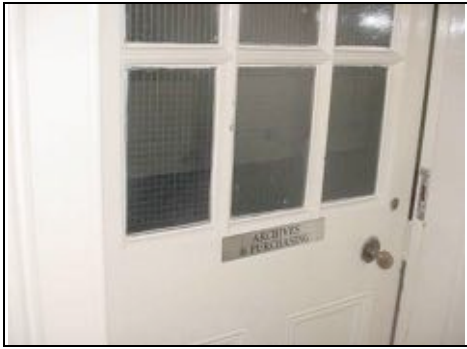
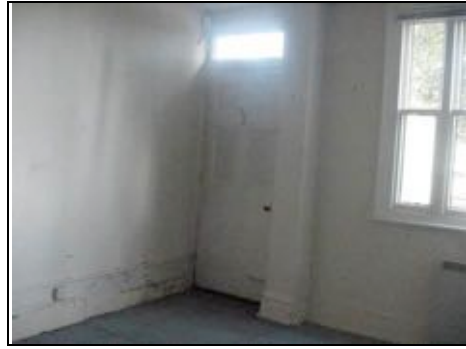
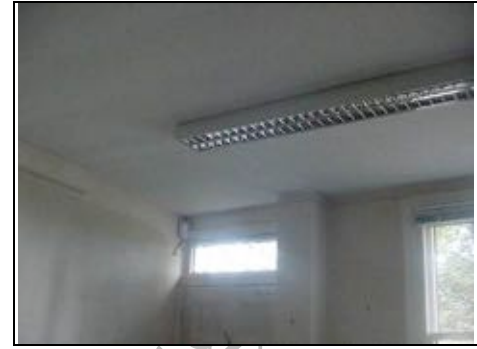
Front Right Office

Category 2 style lighting

DESCRIPTION	CONDITION	ACTION REQUIRED
<p>Ceilings:</p> <p>Woodchip paper</p>	Dated	Repair, prepare and redecorate
<p>Walls:</p> <p>Woodchip paper</p> <p>Built in cupboards</p> <p>Fireplace - vented</p>	Dated Dampness visible Blown plaster	Repair, prepare and redecorate
<p>Floors:</p> <p>Carpet</p>	Worn	Deep clean or replace
<p>Detailing:</p> <p>Windows:</p> <p>Victorian sliding sash window</p>	Dated	Repair, prepare and redecorate

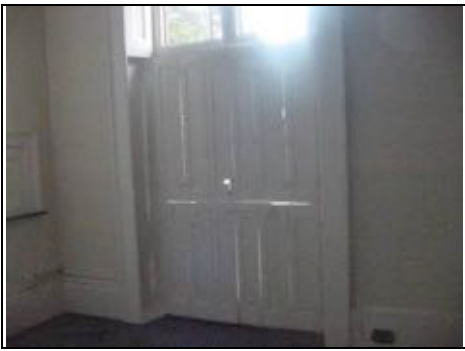
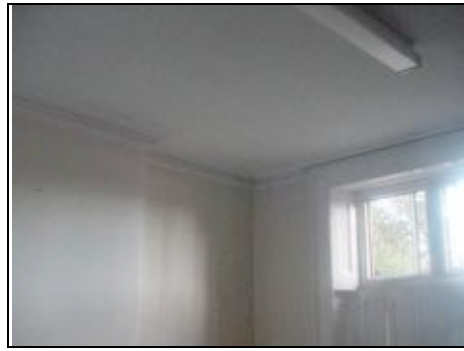
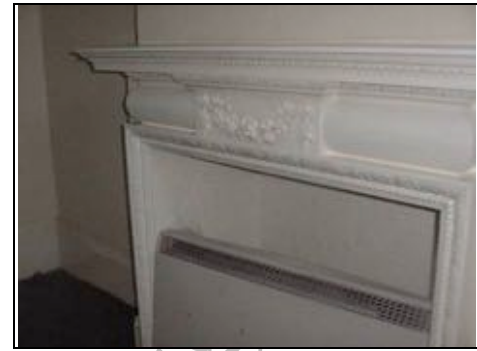
Front Middle Office

DESCRIPTION	CONDITION	ACTION REQUIRED
<p>Ceilings:</p> <p>Woodchip paper Decorative moulding</p>	<p>Dated</p>  	<p>Repair, prepare and redecorate</p>
<p>Walls:</p> <p>Painted</p>   <p>Fireplace, with electric fire in front</p> <p>Serving hatch</p>	<p>Dry rot - painted over</p>   <p>Marked</p>  	<p>Exclude all dry rot from lease</p> <p>Repair, prepare and redecorate</p> <p>Repair, prepare and redecorate</p>

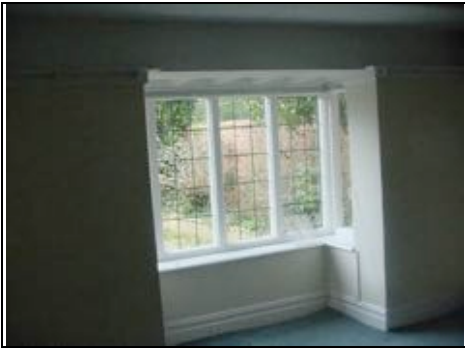
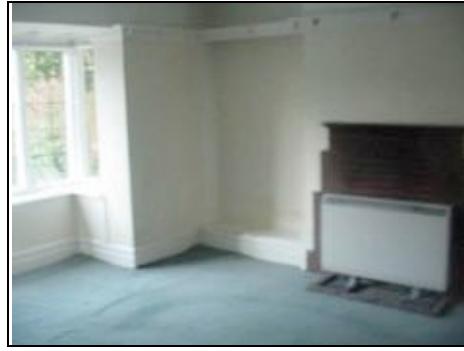
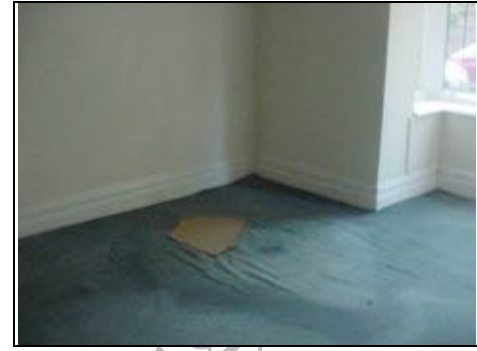
Rear Middle Office

DESCRIPTION	CONDITION	ACTION REQUIRED
<p>Ceilings:</p> <p>Picture rail</p> <p>Woodchip paper</p>	Dated	Repair, prepare and redecorate
<p>Walls:</p> <p>Painted</p> <p>Fireplace, with electric heater in front</p>	<p style="text-align: center;">Dampness visible at low level</p> <p style="text-align: center;">Marked</p>	<p style="text-align: center;">Resolve dampness</p> <p style="text-align: center;">Repair, prepare and redecorate</p> <p style="text-align: center;">Clean</p>
<p>Floors:</p> <p>Carpet</p>	Below average	Replace

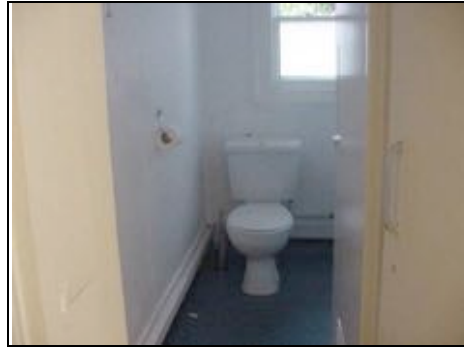
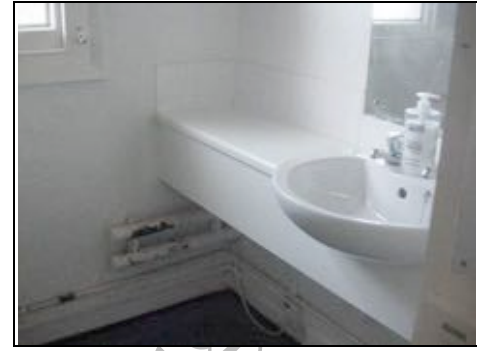
DESCRIPTION	CONDITION	ACTION REQUIRED
<p>Ceiling:</p> <p>Woodchip paper</p>	Dated	Repair, prepare and redecorate
<p>Walls:</p> <p>Woodchip paper</p>	<p>Dampness visible</p> <p>Hairline cracking</p>

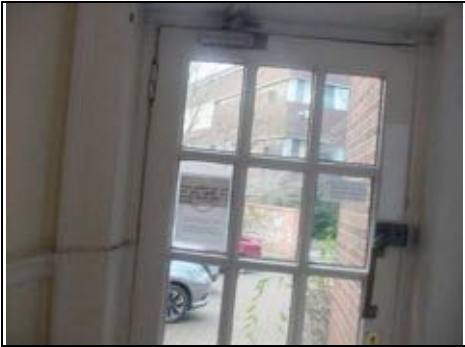
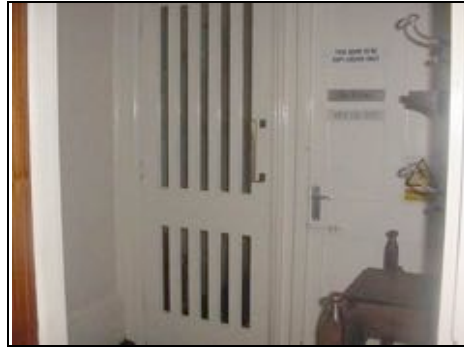
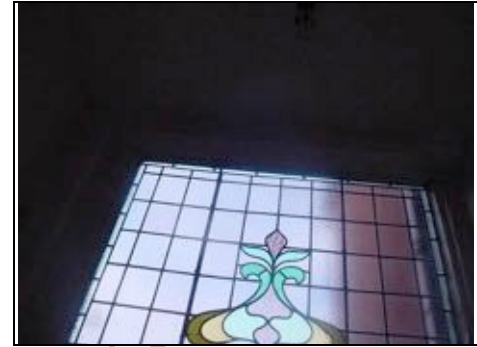
Rear Entrance and Lobby Area

DESCRIPTION	CONDITION	ACTION REQUIRED
<p>Ceilings:</p> <p>Woodchip paper</p>	Dated	Repair, prepare and redecorate
<p>Walls:</p> <p>Woodchip paper</p> <p>Dado rail</p>	Dated	Repair, prepare and redecorate
<p>Floors:</p> <p>Carpet</p>	Worn	Deep clean or replace

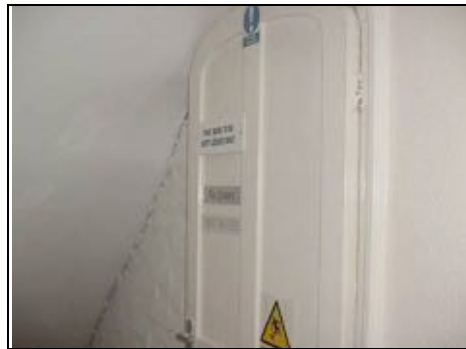
Door to cellar

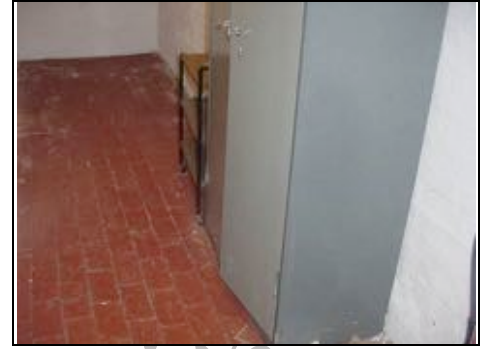
Briquettes

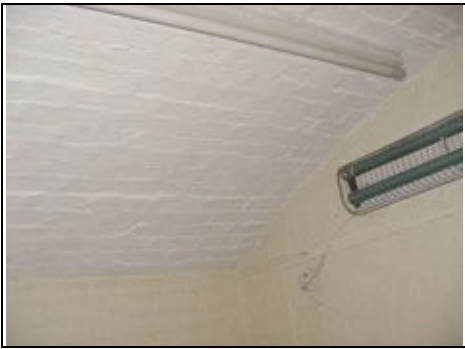
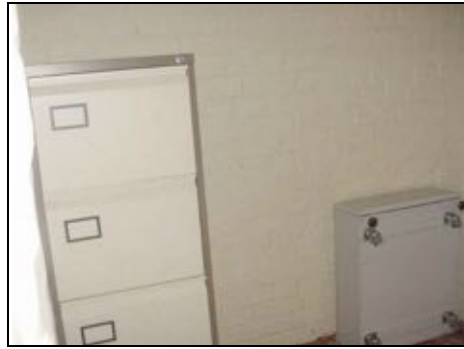
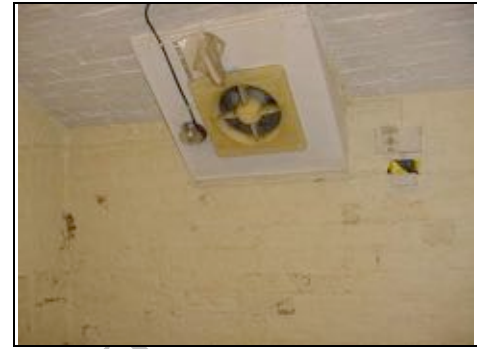
Front Left Area

Electric heater

Front left area

Air vent

DESCRIPTION	CONDITION	ACTION REQUIRED
<p>Ceilings:</p> <p>Painted brick barrel vaulted</p>	Average	Repair, prepare and redecorate
<p>Walls:</p> <p>Painted brick</p>	<p>High levels of dampness Spalling brickwork</p>

Detailing: Windows: Window	 Blocked up	
Services: Two fluorescent lights Extract fan	 One not working Dated	See Services Section Replace

<p>Resolve dampness Repair, prepare and redecorate</p>
<p>Floors:</p> <p>Briquettes</p>	Average	Deep clean

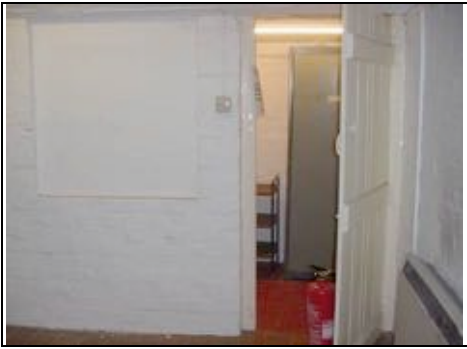
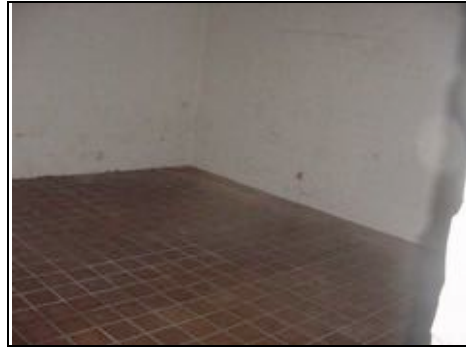
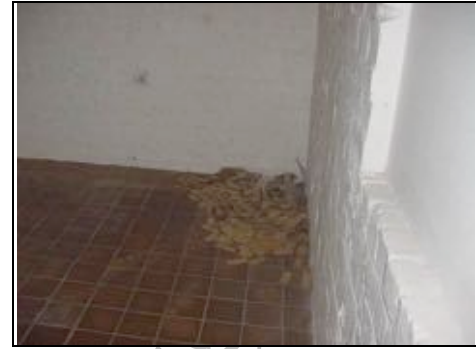
Front Right Area

Door

Front right area

Quarry tiles

DESCRIPTION	CONDITION	ACTION REQUIRED
<p>Ceilings:</p> <p>Painted brick barren vaulted</p>	Average	Repair, prepare and redecorate
<p>Walls:</p> <p>Painted brick</p>  	<p>High levels of dampness Spalling brickwork</p>  	<p>Resolve dampness. Repair, prepare and redecorate</p>
<p>Floors:</p> <p>Modern quarry tiles</p>	<p>Some debris</p>  	<p>Deep clean. Remove debris.</p>

<p>Detailing:</p> <p>Windows:</p> <p>Window</p> <p>Doors:</p> <p>Ledge door</p>	<p>Blocked up</p> <p>Average</p>	<p>Repair, redecorate, prepare and</p>
<p>Services:</p> <p>Lighting</p> <p>Electric heater</p> <p>Surface mounted electrics</p> <p>Fire extinguisher</p>	<p>Being used as a door stop</p>

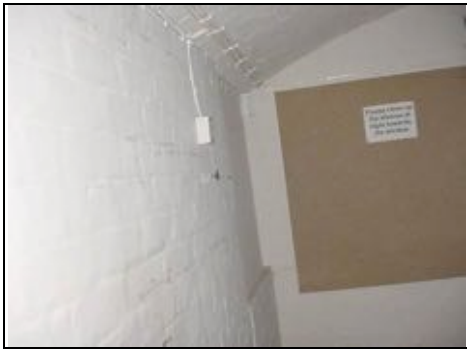
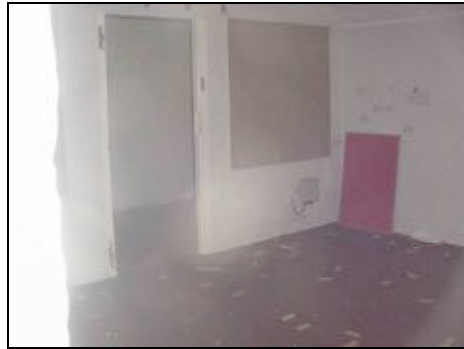
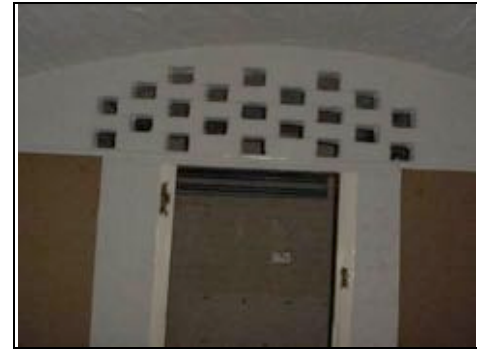
Rear Left Area

Vaulted ceiling

Rear left area

Looking to front

DESCRIPTION	CONDITION	ACTION REQUIRED
<p>Ceilings:</p> <p>Painted brick barrel vaulted</p>	Average	Repair, prepare and redecorate
<p>Walls:</p> <p>Painted</p> <p>Chimney breast to left side</p> <p>Two pin boards</p>	<p>Dampness coming in</p>

Detailing: Windows: Window to rear	Cracked and dated

<p>Resolve dampness</p> <p>Repair, prepare and redecorate</p> <p>Assume previous tenants fixtures and fittings – to be removed by landlord or others.</p>
<p>Floors:</p> <p>Carpet tiles</p>	<p>Worn</p> <p>Waste and storage material</p>	<p>Deep clean or replace</p> <p>Remove</p>

Clean, repair, prepare and redecorate
Doors: Painted panel	Average	Repair, prepare and redecorate
Services: One fluorescent light Electric fire		See Services Section

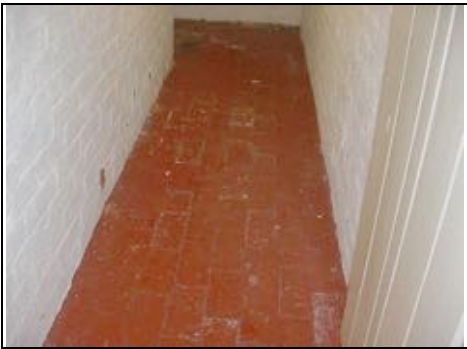
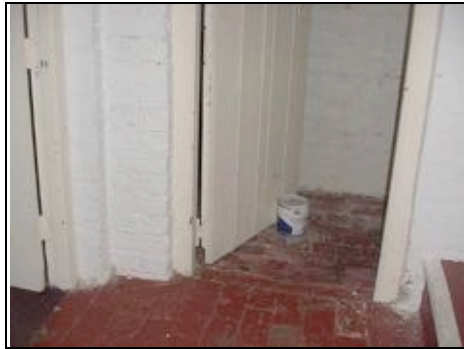
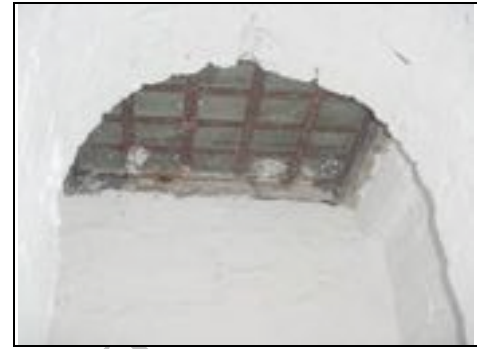
Middle Right Area

Briquettes

Middle right area

Glazed ceiling light to unknown area

DESCRIPTION	CONDITION	ACTION REQUIRED
<p>Ceilings:</p> <p>Painted brick barrel vaulted</p> <p>Glazed ceiling light to unknown area</p>	Average	Repair, prepare and redecorate
<p>Walls:</p> <p>Painted brick</p>	<p>High levels of dampness</p> <p>Painted over</p>

<p>Detailing: Doors:</p> <p>Timber door</p>	<p>Dated</p>	<p>Repair, prepare and redecorate</p>
<p>Services:</p> <p>One fluorescent light</p> <p>Electric fire</p> <p>Pipework; possibly lead</p>	<p>Rusting</p>

<p>Resolve dampness</p> <p>Repair, prepare and redecorate</p>
<p>Floors:</p> <p>Briquettes</p>	<p>Movement in floor</p>

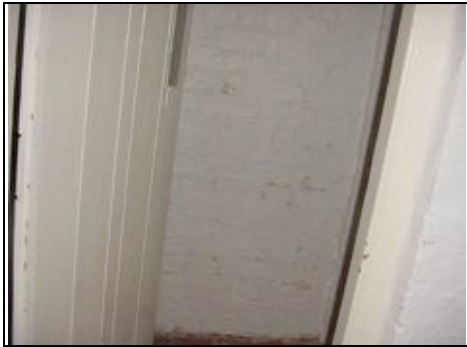
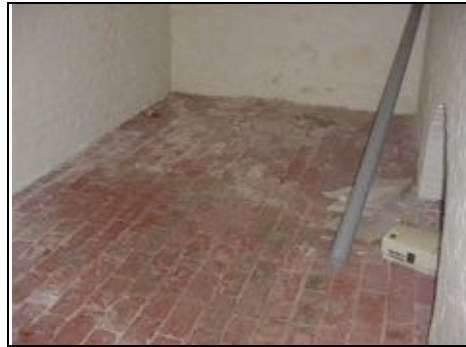
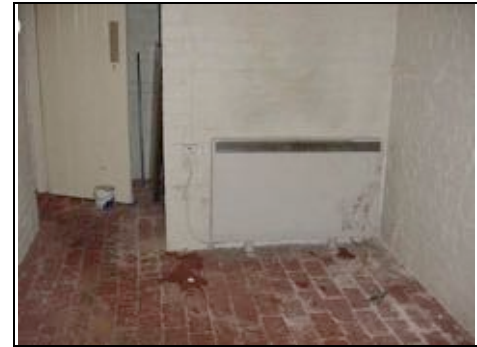
Rear Right Area

Painted brick walls

Rear right area

Electric heater

<p>Floors:</p> <p>Briquettes</p>	<p>Marked. We believe the deterioration relates to water damage.</p>  	<p>Deep clean</p>
<p>Detailing:</p> <p>Doors:</p> <p>Ledge door</p>	<p>Dated</p>  	<p>Repair, prepare and redecorate</p>
<p>Services:</p> <p>One fluorescent light</p>		<p>See Services Section</p>

<p>Resolve dampness Repair, prepare and redecorate</p>

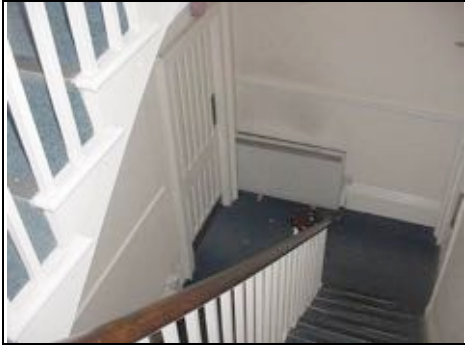
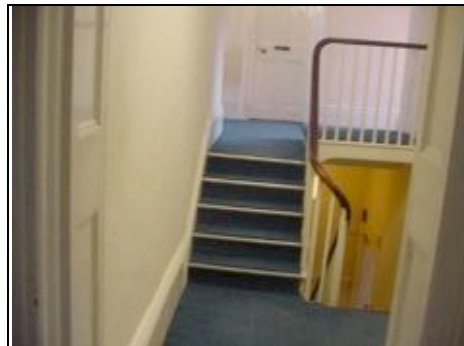
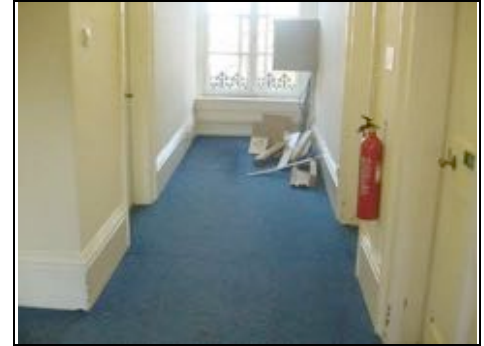
Staircase and Middle Corridor

Staircase

Corridor and steps to right side

Middle corridor

DESCRIPTION	CONDITION	ACTION REQUIRED
<p>Ceilings:</p> <p>Woodchip paper</p>	<p>Dated Hairline cracking</p>

<p>Detailing:</p> <p>Windows:</p> <p>Sliding sash windows with margins to the front and security bars to the rear</p> <p>Doors:</p> <p>Painted panel</p> <p>Staircase:</p> <p>Handrail</p>	<p>Dated and deteriorating</p>   <p>Damaged externally</p>   <p>Marked and dated</p>	<p>Repair, prepare and redecorate</p> <p>Repair, prepare and redecorate</p> <p>Repair, prepare and redecorate</p>
<p>Services:</p> <p>Lighting</p> <p>Computer Server</p>		<p>See Services Section</p>

<p>Repair, prepare and redecorate</p>
<p>Walls:</p> <p>Painted</p> <p>Large skirting boards</p>	<p>Dated</p> <p>Dated</p>	<p>Repair, prepare and redecorate</p> <p>Repair, prepare and redecorate</p>
<p>Floors:</p> <p>Carpet tiles</p>	<p>Worn</p> <p>Debris and waste items</p>

<p>Deep clean or replace</p> <p>To be removed</p>

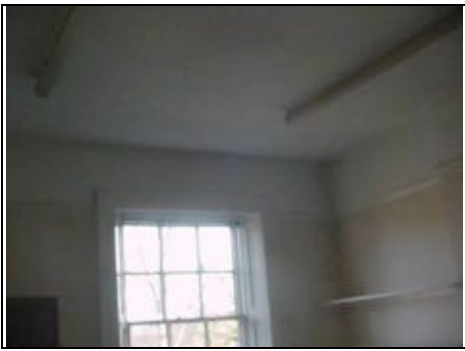
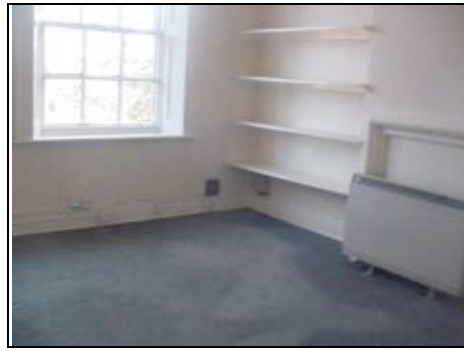
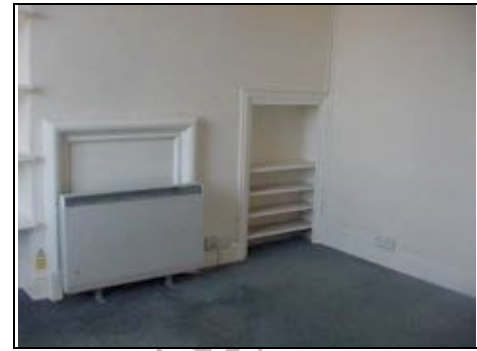
Front Left Through Office

Sliding sash window

Left through office to front

Electric heater in front of fireplace

DESCRIPTION	CONDITION	ACTION REQUIRED
<p>Ceilings:</p> <p>Painted</p>	Dated	Repair, prepare and redecorate
<p>Walls:</p> <p>Picture rail with modern plaster above it</p> <p>Woodchip paper</p> <p>Fireplace with electric heater in front</p> <p>Shelving</p> <p>Cupboard</p> <p>Painted skirtings</p>	<p>Dated</p> <p>Dated</p> <p>Dated</p>	<p>Repair, prepare and redecorate</p> <p>Repair, prepare and redecorate</p> <p>Assume previous tenants fixtures and fittings; to be removed</p> <p>Repair, prepare and redecorate</p>
<p>Floors:</p> <p>Carpet</p>	<p>Worn.</p> <p>Deflection</p>	Deep clean or replace

<p>Detailing:</p> <p>Windows:</p> <p>Double sliding sash windows</p> <p>Doors:</p> <p>Painted flush door, panel to front,</p>	<p>Dated Damage to door internally.</p> <p>Dated Door closer missing</p>

<p>Repair, prepare and redecorate</p> <p>Repair, prepare and redecorate</p>
<p>Services:</p> <p>Two fluorescent lights</p>		<p>See Services Section</p>

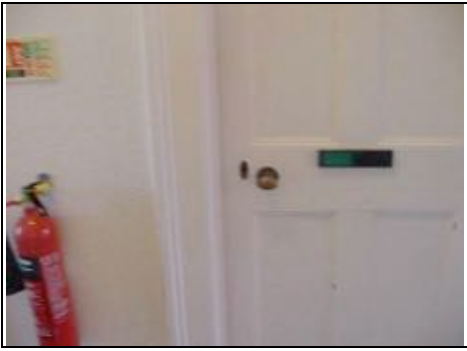
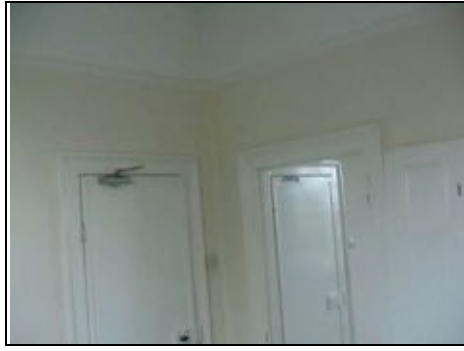
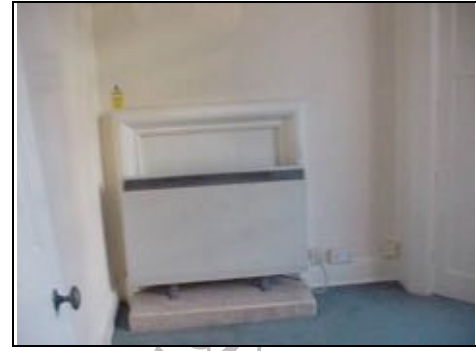
Rear Left Through Office

Entrance door

Rear left through office

Electric heater in front of fireplace

DESCRIPTION	CONDITION	ACTION REQUIRED
Ceilings:		
Woodchip paper	Dated	Repair, prepare and redecorate
Walls:		
Picture rail with modern plaster above it	Dated	Repair, prepare and redecorate
Painted woodchip paper	Marked and dated	Repair, prepare and redecorate
Fireplace

<p>Painted skirtings</p>	<p>Marked</p>  	<p>Repair, prepare and redecorate</p>
<p>Floors:</p> <p>Carpet</p>	<p>Worn</p>  	<p>Deep clean or replace</p>
<p>Detailing:</p> <p>Windows:</p> <p>Double sliding sash windows</p>   <p>Doors:</p> <p>Painted flush door, panel to front, with door closers</p>  	<p>Deterioration and condensation</p>   <p>Heavily marked. Door come off between front and rear office.</p>  	<p>Repair, prepare and redecorate</p> <p>Repair, prepare and redecorate</p>
<p>Services:</p> <p>One fluorescent light</p> <p>Surface mounted wiring</p>		<p>See Services Section</p>

Repair, prepare and redecorate
Cupboard

Assume previous tenants fixtures and fittings; to be removed Repair, prepare and redecorate

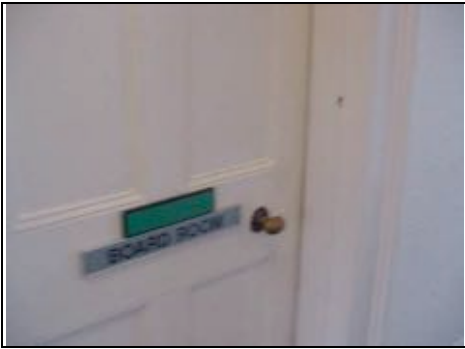
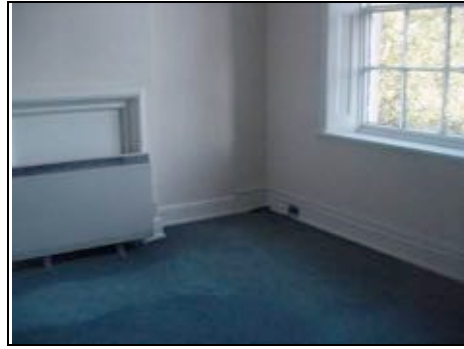
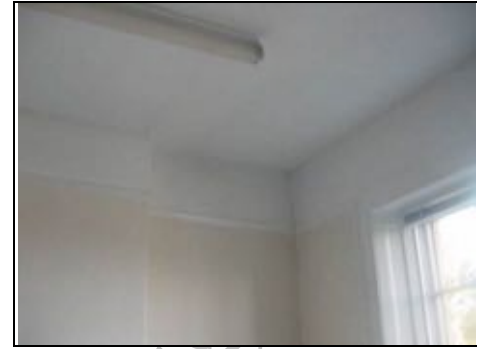
Front Middle Board Room

Entrance door
– marked as Board Room

Front middle board room

Picture rail and ceiling

DESCRIPTION	CONDITION	ACTION REQUIRED
<p>Ceilings:</p> <p>Painted</p>	Dated	Repair, prepare and redecorate
<p>Walls:</p> <p>Picture rail with painted area above</p> <p>Woodchip paper</p> <p>Fireplace with electric fire to the front</p>	Dated	Repair, prepare and redecorate
	Asbestos do not disturb sticker	Asbestos report required.
<p>Floors:</p> <p>Carpet</p>	Worn Deflection	Deep clean or replace

<p>Detailing:</p> <p>Windows:</p> <p>Sliding sash windows</p> <p>Doors:</p> <p>Marked as Board Room Painted, panel externally, flush internally with door closer</p>	<p>Cracked glass Signs of black mould Bare timber visible externally</p>

<p>Marked</p>	<p>Repair, prepare and redecorate</p> <p>Repair, prepare and redecorate</p>
<p>Services:</p> <p>Two fluorescent lights</p> <p>Electric heater</p> <p>Surface mounted wiring</p>		<p>See Services Section</p>

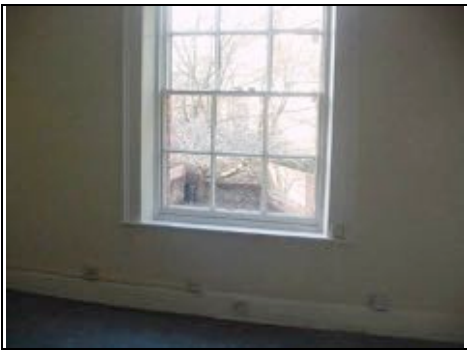
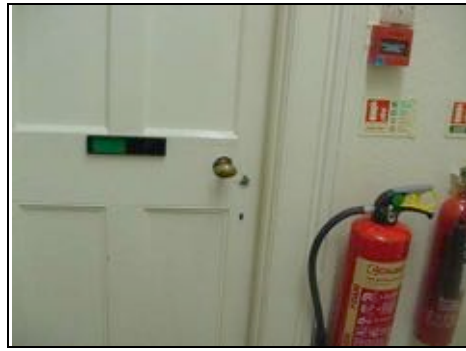
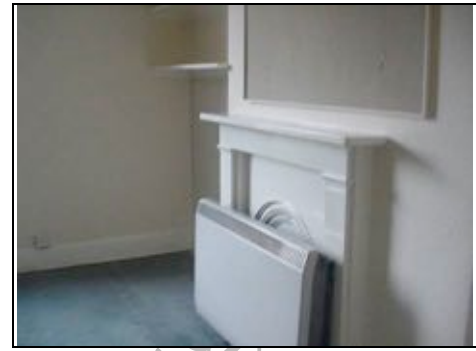
Rear Middle Office

Sliding sash window

Rear middle office

Electric fire in front of fireplace

<p>Repair, prepare and redecorate</p>
<p>Walls:</p> <p>Picture rail with painted area above</p> <p>Woodchip paper</p> <p>Fireplace, hidden by electric heater</p> <p>Painted skirting</p>	<p>Dampness visible</p> <p>Dated</p> <p>Dated</p>

<p>Cupboard under stairs, with shelving and coat hooks</p>  	<p>Hairline cracking in cupboard ceiling Pattern staining where shelves, etc removed</p>  	<p>Repair, prepare and redecorate</p>
<p>Floors: Carpet</p>	<p>Holes</p>	<p>Replace</p>
<p>Detailing: Windows: Sliding sash window</p> <p>Doors: Painted; panel to front, flush to rear, with door closer</p>	<p>Dated</p>   <p>Dated</p>	<p>Repair, prepare and redecorate</p> <p>Repair, prepare and redecorate</p>
<p>Services: Lighting Electric heaters</p>		<p>See Services Section</p>

<p>Resolve dampness. Repair, prepare and redecorate</p> <p>Repair, prepare and redecorate.</p> <p>Repair, prepare and redecorate</p>

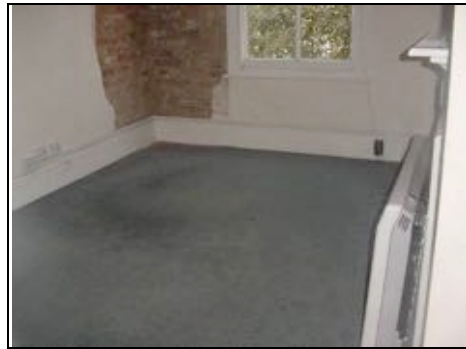
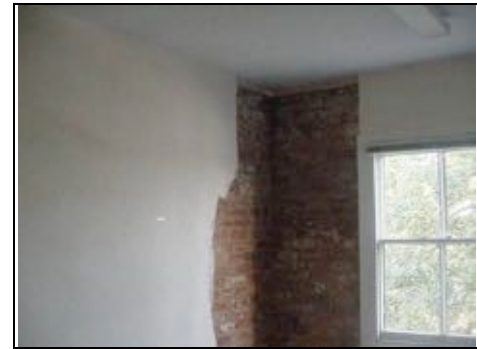
Front right office

Exposed brickwork

DESCRIPTION	CONDITION	ACTION REQUIRED
<p>Ceilings:</p> <p>Woodchip paper</p>	<p>Dated</p> <p>Hairline cracking</p>	<p>Repair, prepare and redecorate</p>
<p>Walls:</p> <p>Painted</p> <p>Exposed brickwork</p>

<p>Dated</p>	<p>Resolve dampness</p> <p>Repair, prepare and redecorate.</p> <p>Note our earlier comments about the property being wrongly rendered in a hard/cement based render which means this property cannot breathe and dampness will continue.</p> <p>Repair, prepare and redecorate</p>
<p>Floors:</p> <p>Carpet</p>	<p>Worn</p> <p>Deflection</p>	<p>Deep clean or replace.</p> <p>Check for rot to joist ends.</p>

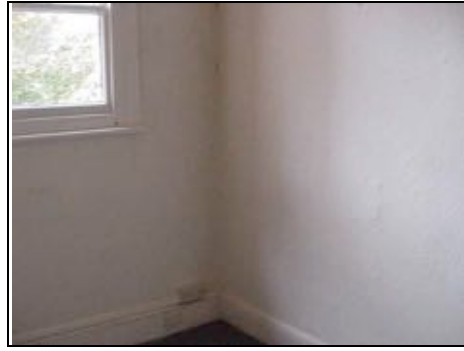
Rear right box office

DESCRIPTION	CONDITION	ACTION REQUIRED
<p>Ceilings:</p> <p>Woodchip paper</p>	Dated	Repair, prepare and redecorate
<p>Walls:</p> <p>Woodchip paper</p> <p>120mm skirting board</p>	<p>Black mould to right corner</p> <p>Dampness coming in</p>

<p>Cracking</p>

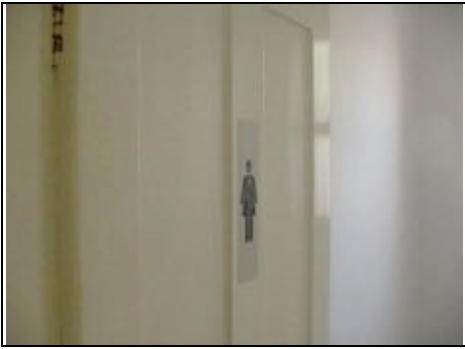
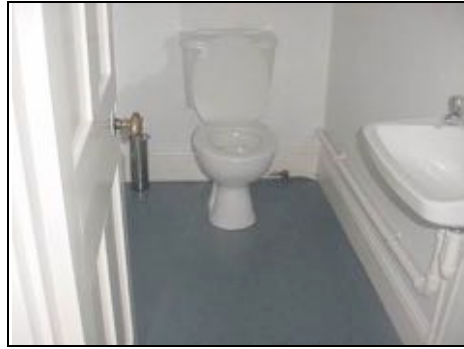
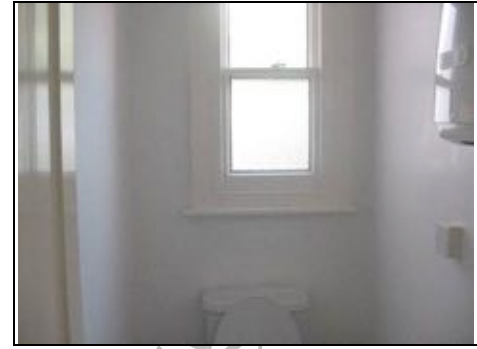
Rear Right Ladies Toilet

Entrance door

Ladies Toilet

Window

DESCRIPTION	CONDITION	ACTION REQUIRED
Ceiling: Painted	Dated	Repair, prepare and redecorate
Walls: Painted	Dated Old fixing points	Repair, prepare and redecorate.
Floors: Safety style flooring	Marked and dated	Deep clean or replace
Sanitary Ware: One WC One older style wash hand basin	Average Average	Deep clean Deep clean

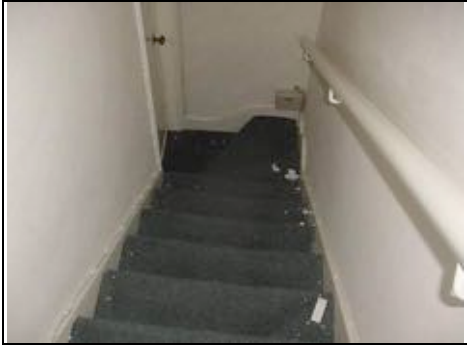
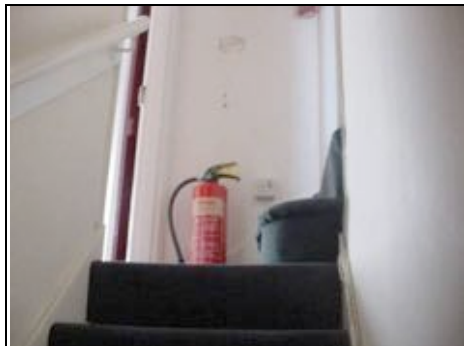
Staircase and Landing

Looking down stairs

Top of stairs and landing

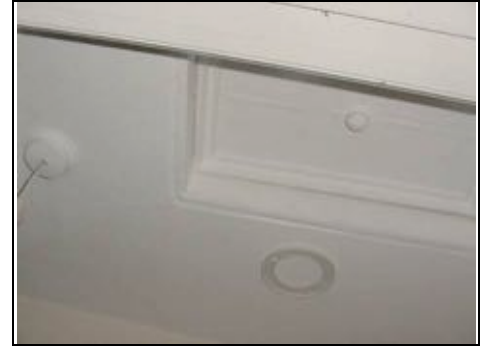
Loft hatch to roof space

DESCRIPTION	CONDITION	ACTION REQUIRED
<p>Ceilings:</p> <p>Painted vaulted</p> <p>Loft hatch to right side roof space.</p>	<p>Dated Hairline cracking</p>  	<p>Repair, prepare and redecorate</p>
<p>Walls:</p> <p>Painted</p>	<p>Dated Hairline cracking</p>  	<p>Repair, prepare and redecorate</p>
<p>Floors:</p> <p>Carpet</p>	<p>Worn</p> <p>Debris and waste material</p>	<p>Deep clean or replace.</p> <p>To be removed</p>

Detailing:		
Doors: Painted panel door	Dated	Repair, prepare and redecorate
Staircase: Balustrades	Dated	Repair, prepare and redecorate
Services:		See Services Section
Lighting		
One fire extinguisher	Fallen off wall	Re-secure

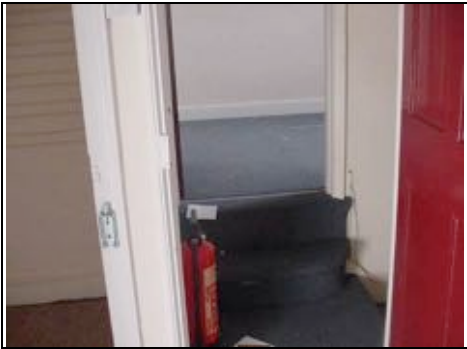
Front Office

Steps up to front office

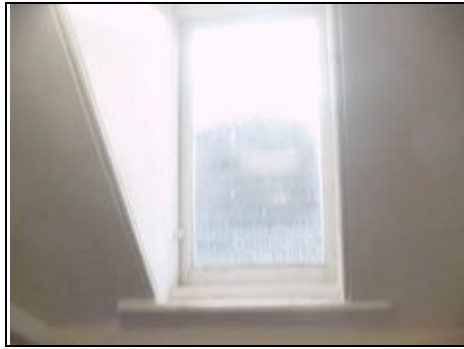
Dormer window

<p>Floors:</p> <p>Carpet</p>	<p>Worn</p>	<p>Deep clean or replace</p>
<p>Detailing:</p> <p>Windows:</p> <p>One dormer window, looking out onto a valley gutter</p>

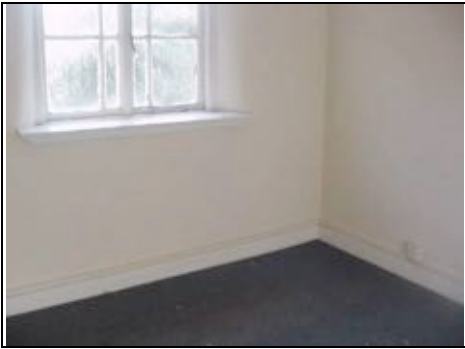
Rear Office

Looking towards window

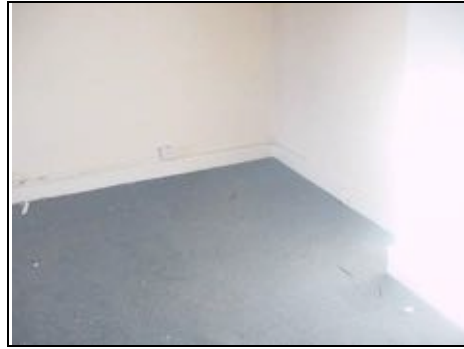
Rear office

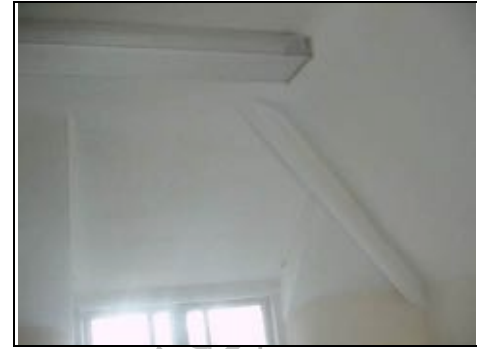
Vaulted ceiling

DESCRIPTION	CONDITION	ACTION REQUIRED
<p>Ceilings:</p> <p>Painted vaulted</p>	<p>Dated Hairline cracking</p>	<p>Repair, prepare and redecorate</p>
<p>Walls:</p> <p>Painted</p> <p>Vented chimney breast</p> <p>Cupboard</p>	<p>Dated Hairline cracking</p>

<p>Resolve dampness</p> <p>Repair, prepare and redecorate</p>
