SCHEDULE OF CONDITION

City of London,
EC3V XXX

We have been instructed to inspect and prepare a Schedule of Condition for XXXX, City of London EC3V XXX. We inspected the property on XXXX

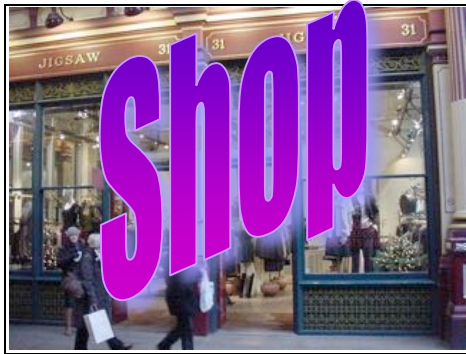
Front view

DESCRIPTION	CONDITION	ACTION REQUIRED
<p>Roofs:</p>	<p>Roof not visible but noted leaks within roof space.</p>	<p>Joint high level inspection with the landlord or landlord's surveyor to be carried out prior to signing of the lease or legal completion of the lease.</p>
<p>Box Gutters and Downpipes:</p> <p>Cast Iron</p>	<p>Not visible.</p>	<p>Joint inspection as above</p>
<p>Walls:</p> <p>Cast iron with infill cladding panels.</p>

<p>Rusting at basement/ground floor level.</p> <p>Deterioration to coving</p>	<p>Repair, prepare and redecorate.</p>

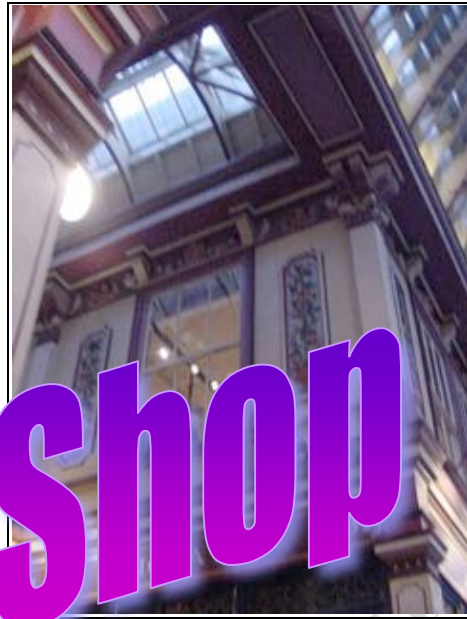
Top of left hand side

DESCRIPTION	CONDITION	ACTION REQUIRED
Roofs:	Not visible	Joint inspection; see front elevation.
Box Gutters and Downpipes: Lead and Cast Iron	Not visible	Joint inspection; see front elevation.
Stone fascia: High level limited view

<p>Walls:</p> <p>Cast iron with infill cladding panels.</p>   <p>First floor level</p>	    <p>Rusting at basement/ground floor level.</p> <p>Deterioration to coving</p>	<p>Repair, prepare and redecorate.</p>
<p>Columns:</p>  	<p>Graffiti</p>	<p>Confirmation is required whether the columns are included in the Lease.</p> <p>Repair, prepare and redecorate.</p>
<p>Decorative frieze:</p> <p>High level Limited view</p>

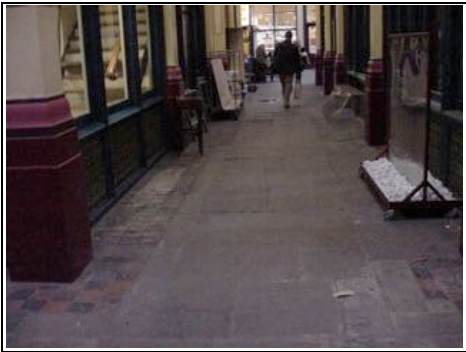
Rear elevation

<p>Lead and Cast Iron</p> <p>Underside of box gutter</p>	<p>Not visible</p>	<p>Joint inspection; see front elevation.</p>
<p>Walls:</p> <p>Cast iron with infill cladding panels.</p>	<p>Rusting at basement/ground floor level.</p> <p>Dated</p> <p>Deterioration to coving</p>	<p>Repair, prepare and redecorate.</p>
<p>Columns:</p>

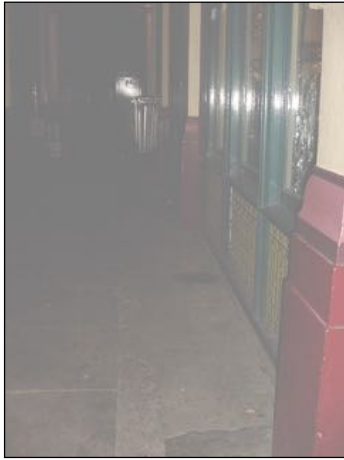
General view of area around property

DESCRIPTION	CONDITION	ACTION REQUIRED
Area around property	Rear left corner heavily marked, stained and undulating.	Re-surfacing

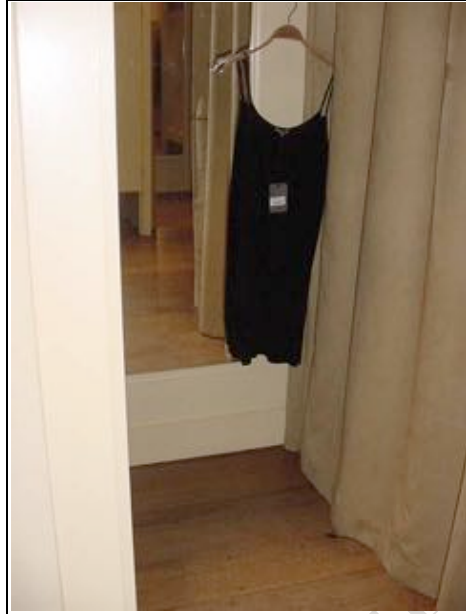
Typical changing room

DESCRIPTION	CONDITION	ACTION REQUIRED
Ceilings: Painted	Dated	Repair, prepare and redecorate.
Walls: Cast iron structural frame Predominately windows Six changing units to end with saloon type doors	Dated Marked and general damage to top of doors	Repair, prepare and redecorate Repair, prepare and redecorate
Counter:	Assumed existing occupiers fixture and fitting which should be removed.

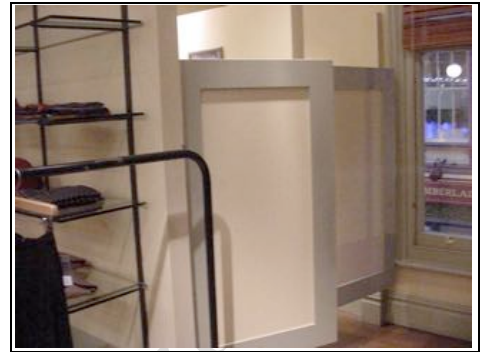
Four changing cubicles

DESCRIPTION	CONDITION	ACTION REQUIRED
<p>Ceilings:</p> <p>White painted ceiling</p>	Dated	Repair, prepare and redecorate
<p>Walls:</p> <p>Four changing cubicles Free standing painted studwork wall</p>	<p>Marked and pattern staining Damage to corners</p>

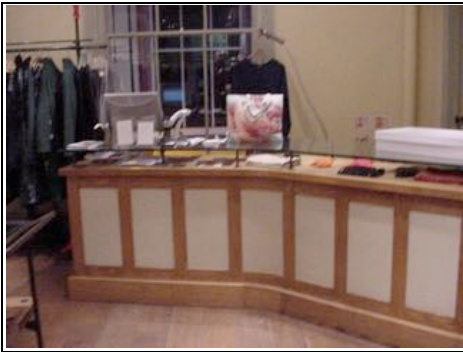
Counter

DESCRIPTION	CONDITION	ACTION REQUIRED
<p>Ceilings:</p> <p>Painted</p>	Dated	Repair, prepare and redecorate
<p>Walls:</p> <p>Painted</p> <p>Pay counter</p>	<p>Dated</p> <p>Assumed existing tenant's fixture and fitting and should be removed</p>	Repair, prepare and redecorate
<p>Floors:</p> <p>Wood</p>	Worn and marked	Sand, fill, repair, prepare and re-stain.

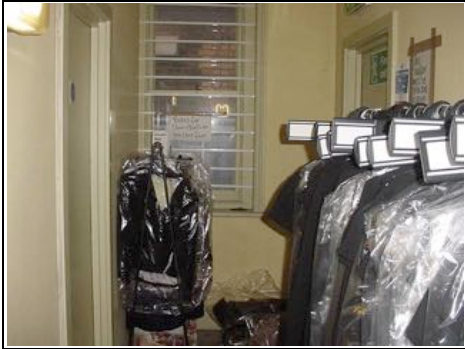
Landing area

DESCRIPTION	CONDITION	ACTION REQUIRED
Ceilings: Painted Access hatch	Dated	Repair, prepare and redecorate
Walls: Painted	Heavily marked and indented
