# PROPERTY REPORT AND NEGOTIATION DOCUMENT

XXXXXXXXXXXXX,  
XXXXXXXXXXXXXXXXXXXXX,  
XXXXXXXXXXXXX,  
XXXXXXXXXXXXX,  
Hampshire,  
XXXXXXX

INDEPENDENT CHARTERED SURVEYORS

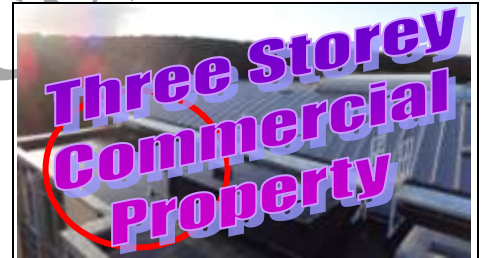
This is where water sits on the roof and in this case we can also see it is coming through the roof.

Ponding to right flat roof

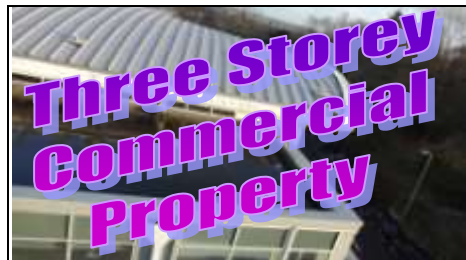
High points on flat roof

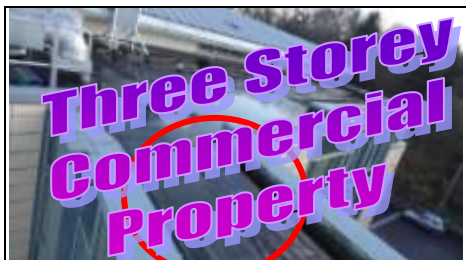
Rucking and ponding on mono-ply roof

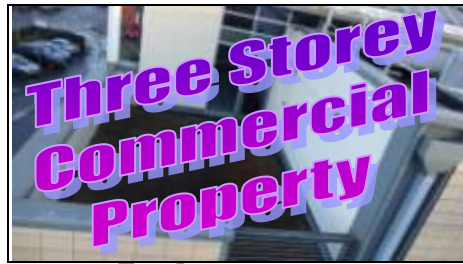
Vegetation growing on roof

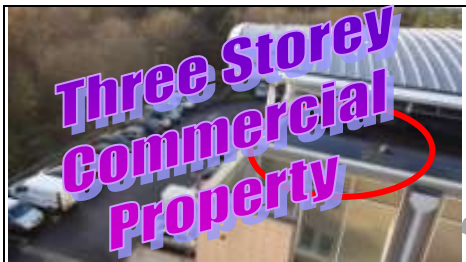
Metal coping over rain cladding with water sitting on it

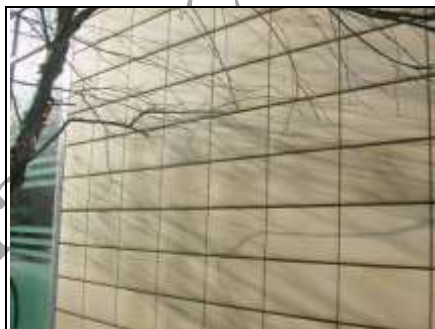
Large areas of the property have a rain cladding system. Again, moss and lichens are starting to discolour this area.

Moss and lichens to rain cladding on left gable end

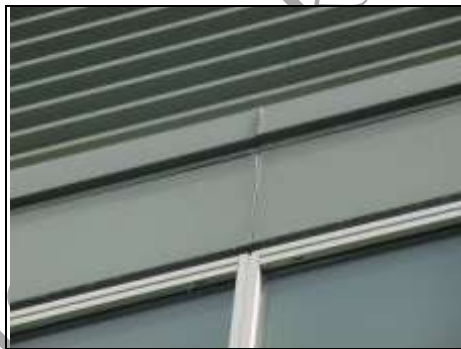
Weathering to joint
