# PROPERTY REPORT

**Warehouse  
XXXX  
XXX Erith,  
Kent. DA8 XXX**

We have been instructed to inspect and prepare a Report and Schedule of Condition for XXXX, Erith, Kent. DA8 XXX

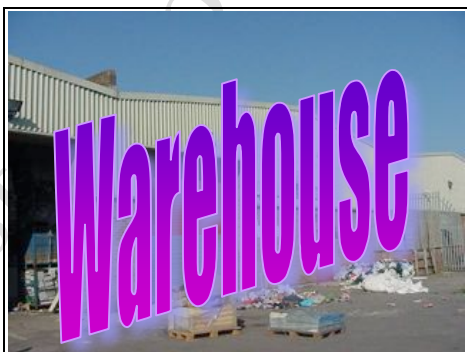
Parking and fly tipping to the rear

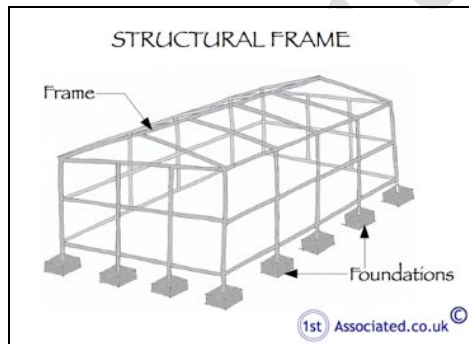
Metal frame warehouse industrial unit  
Four bay example

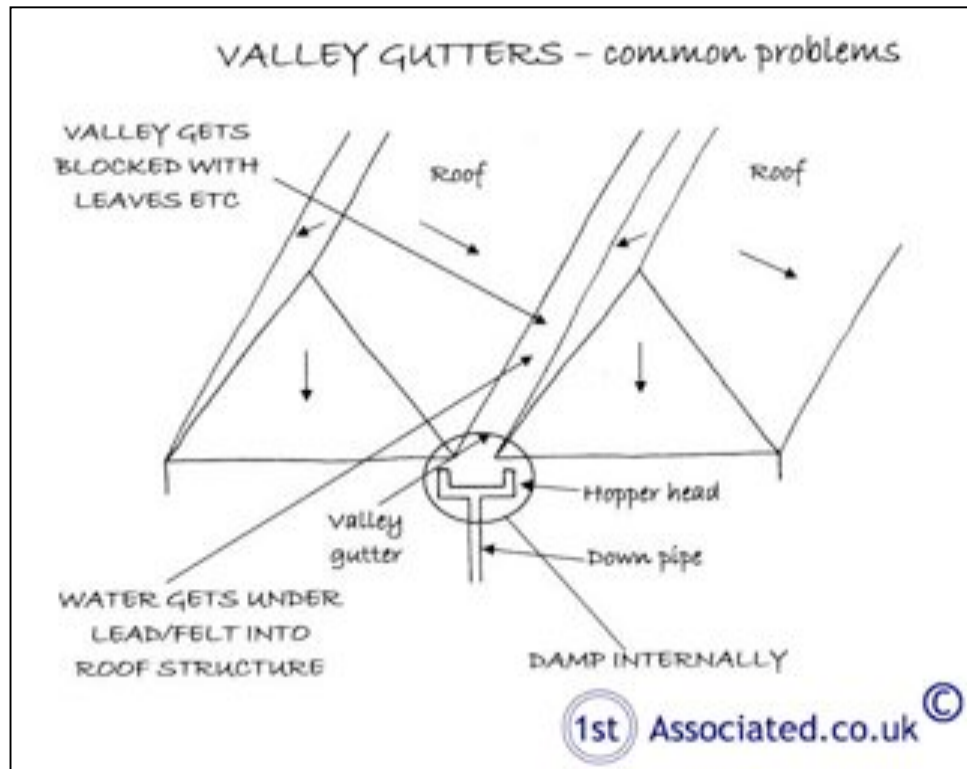
There looks to have been longterm problems with the valley gutters

Valley gutters common problems

leaking both at roof level and also with the downpipes.

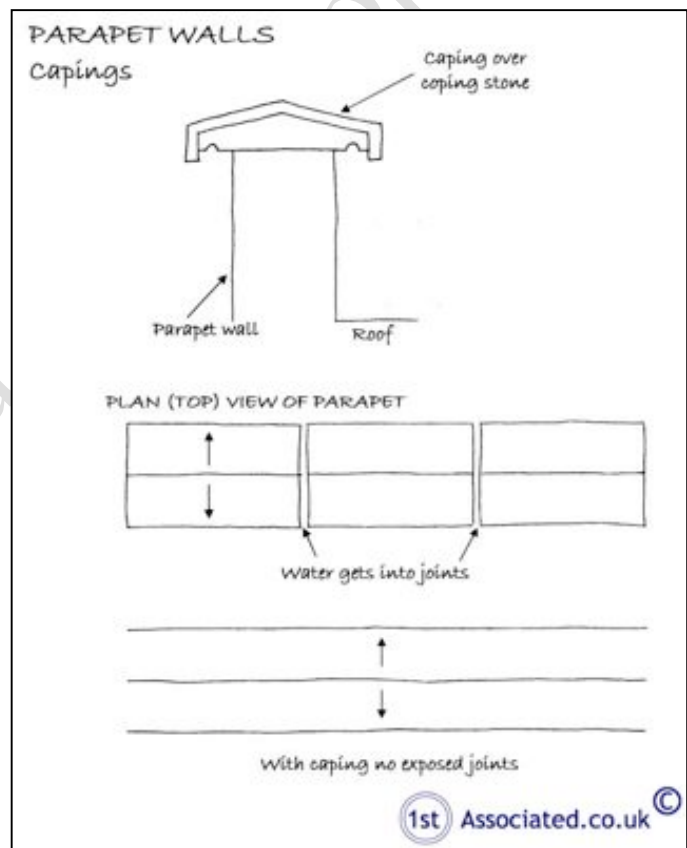
Parapet walls capings

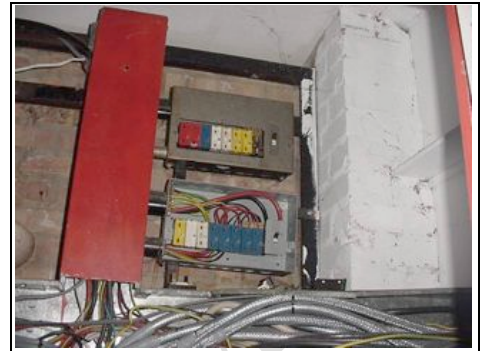
**ANTICIPATED COST:** In the region of £500 - £1000 (five hundred to one thousand pounds) plus any recommendations; please obtain quotations. We noted that quite a lot of the wiring had been ripped out and/or amended so there may be major costs and we would ask that the Freeholder/managing agents reinstall the electrics as these are likely to be part vandalised when the property has been occupied as accommodation as in this case.

Electrics

**ACTION REQUIRED:** We would recommend an Institute of Electricals Engineers (IEE) test and report carried out by a NICEIC registered and approved electrical contractor or equivalent.

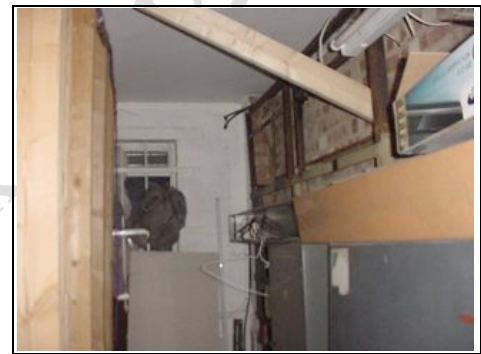
Electric cupboard

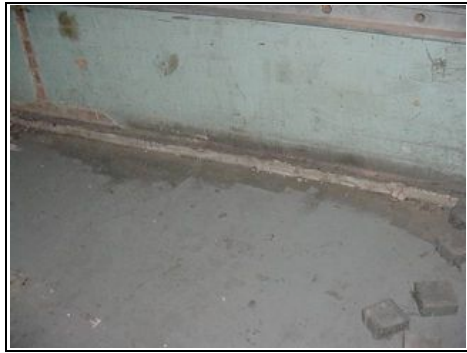
Floor subsidence to the rear of the warehouse

If you were looking to purchase this property we would be saying to buy another property. This certainly needs to be excluded from your lease and we would also only advise taking on the property if the landlord can offer a programme of repairs to the floor.

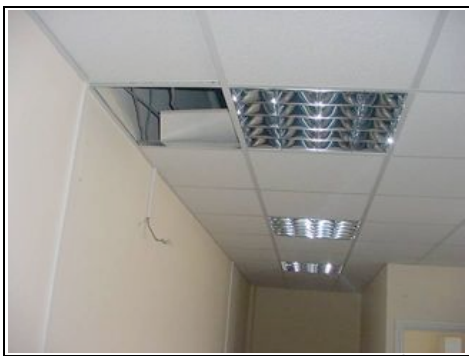
We opened up the suspended ceilings in the right and left offices and unfortunately we were unable to see the made ceiling but we were only able to see previous suspended ceiling tiles. We did however note leaks in the office areas shown by staining to the tiles.

Ceiling opened up

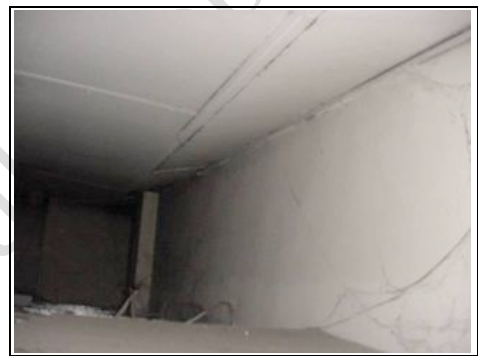
Looking at old suspension ceiling

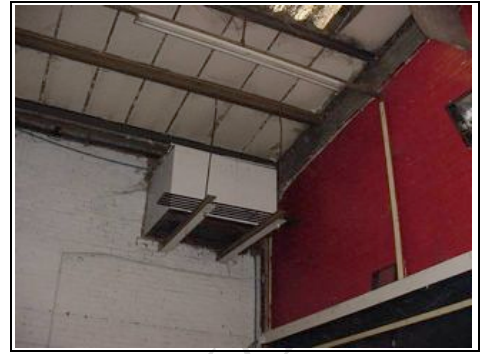
There is a high level unit adjacent to the offices, this may relate to being a water tank or may have been equipment in relation to the lifting device.

High level unit

If there are water tanks in the building we would always recommend that water tanks be drained down and cleared of any debris etc. (we have seen dead birds and other unmentionable things in these tanks).

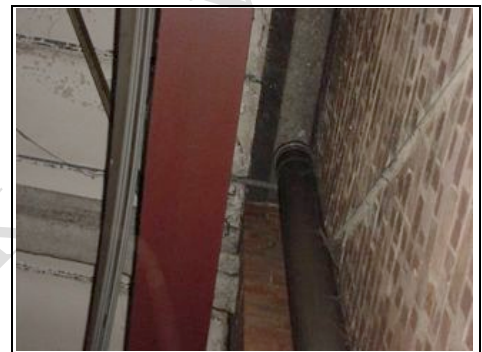
The property's gutters and downpipes are in very poor condition and we feel you should think about replacement.

Looking up at metal valley gutter and black plastic downpipe

**ACTION REQUIRED:** The valley gutters and the downpipes need to be made water tight and the piers need to be opened up to check that there is no rusting to the metal frame.

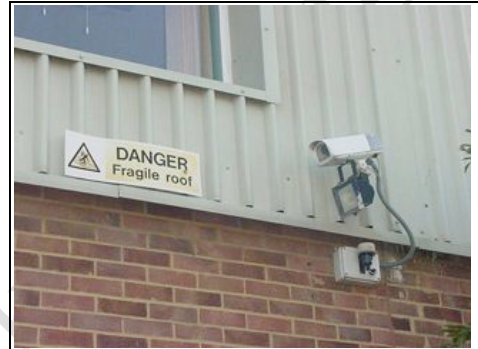
At high level there is metal profile cladding which we noted that the fixing bolts are starting to rust. In addition we noted that in some areas the face of the profile sheeting has been impact damaged. Furthermore in some areas the profile sheeting has been scuffed.

Cladding at high level

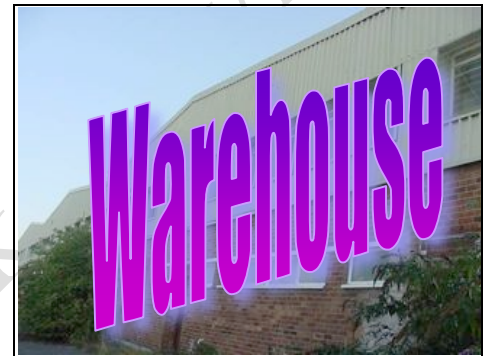
The property has single glazed metal windows. We would specifically comment metal windows are often known as Crittall windows. Typically these windows warp and rust and become difficult to close which in turn makes them draughty. In this instance they do require repair work in the form of easing and adjusting.

Metal windows at high and low level

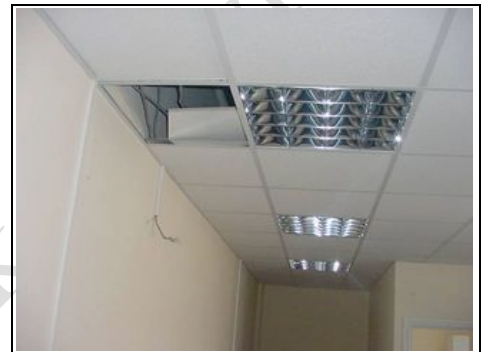
The ceilings are a suspended rectangular ceiling system to the office areas and a square suspended ceiling system to the right hand office. Behind the ceiling tiles is an older rectangular system. We would comment that there is no insulation and as such therefore you will be heating up the entire warehouse in this area which is not ideal with rising fuel costs. We would also draw your attention to the fact that the stains to the ceiling tiles may relate to condensation.

Ceiling opened up

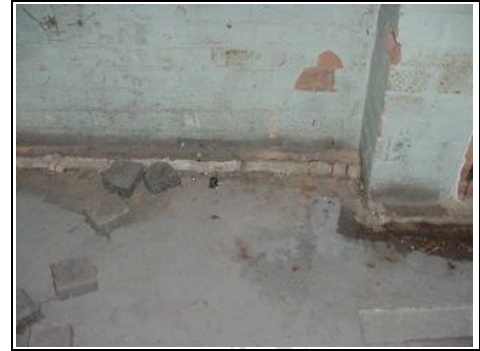
The perimeter walls to the warehouse are unfinished brickwork to the majority of the walls and there are some areas of painted brickwork. Typically a modern finish to a warehouse would have painted walls or finished walls.

Painted brickwork
