SCHEDULE OF CONDITION

INDEPENDENT CHARTERED SURVEYORS

We have been instructed to inspect and prepare a Schedule of Condition for
xx.

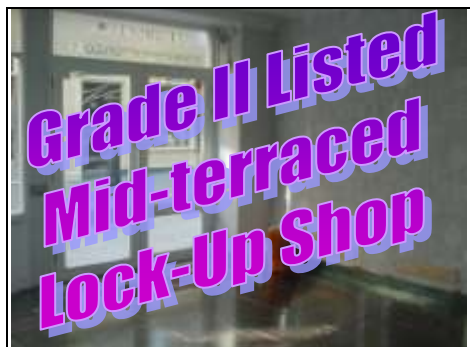
Front elevation left

DESCRIPTION	CONDITION	ACTION REQUIRED
Ceiling: Painted plasterboard	Dated	Repair, prepare and redecorate
Walls: Wallpapered Perimeter walls Solid walls to left and right sides

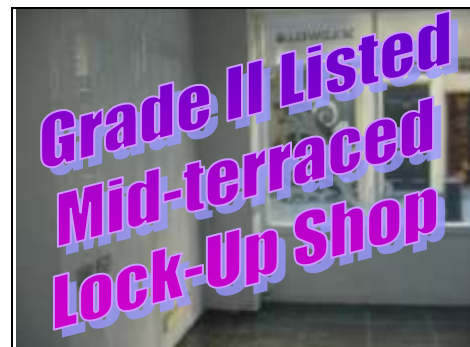
Front elevation right

Detailing:		
Windows:		
front picture window	Dated	Clean, repair, prepare and redecorate / Remove previous tenant's shop front wording tape
Doors:		
glazed entrance door left double doors	Dated	Repair, prepare and redecorate Remove previous tenant's shop front wording tape
Services:		See Services Section
lighting		Needs to be to modern standards required

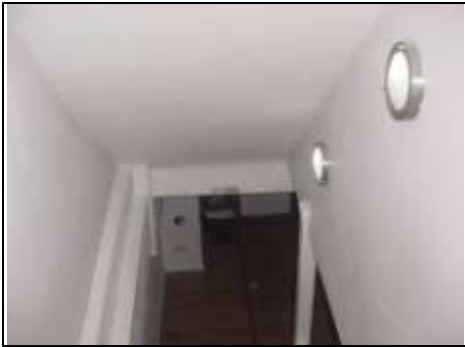
Walls around staircase

DESCRIPTION	CONDITION	ACTION REQUIRED
Ceiling: Painted plaster	Dated	Repair, prepare and redecorate
Walls: Painted plaster	Dated	Repair, prepare and redecorate.
Staircase: Metal clad treads Black nosings	Dated Loose	Repair, prepare and redecorate Secure nosings
Services: Lighting		See Services Section Needs to be to modern standards required

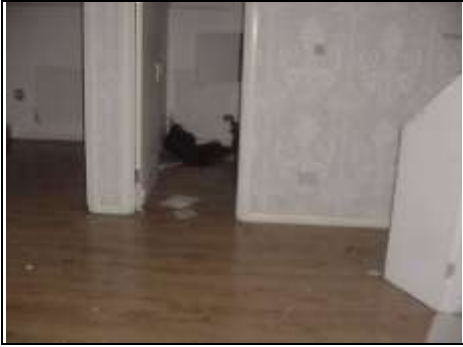
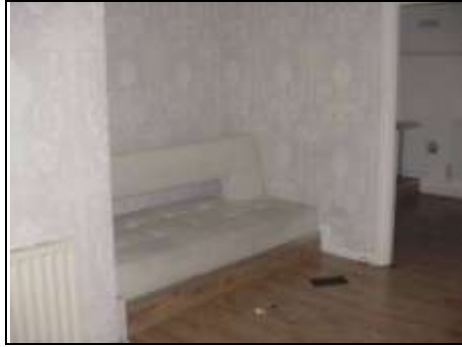
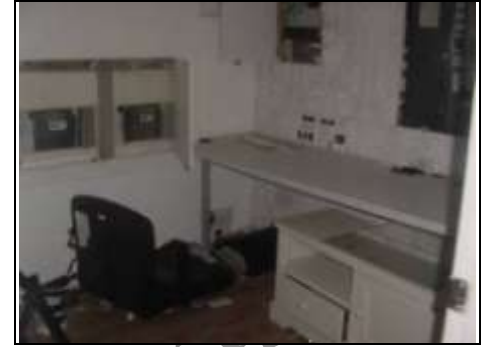
Front left studio/office

DESCRIPTION	CONDITION	ACTION REQUIRED
Ceilings: Painted plasterboard	Hairline cracking	Repair, prepare and redecorate.
Walls: Painted studwork / dry lining (including perimeter walls) Predominantly wallpapered	Dated	Repair, prepare and redecorate.
Floors: Laminate Bench with upstand	Worn Dated	Clean or replace
Detailing: Doors: Flush door	Missing door closer	Add door closer, repair, prepare and redecorate.
Services: Lighting Electrics to left side – boxed in

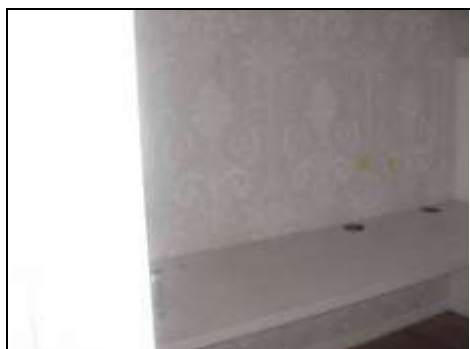
DESCRIPTION	CONDITION	ACTION REQUIRED
Ceilings: Painted plasterboard	Dated	Repair, prepare and redecorate
Walls: Painted Perimeter and Internal Walls studwork / dry lining Shelving	Dated

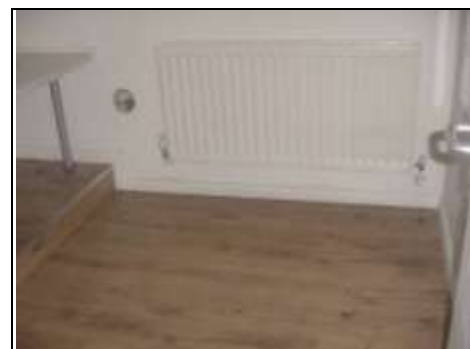
Radiator

Dated	Repair, prepare and redecorate Clean
Floors: Laminate	Worn	Clean or replace
Detailing: Doors: Flush door	Missing door closer	Add door closer, repair, prepare and redecorate
Services: Lighting Internal radiator on perimeter wall		See Services Section Needs to be to modern standards required

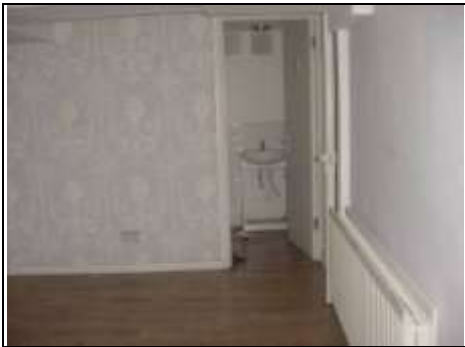
Looking towards WC

DESCRIPTION	CONDITION	ACTION REQUIRED
Ceiling: Painted plasterboard	Dated	Repair, prepare and redecorate
Walls: Wallpaper Perimeter and Internal Walls: Studwork / dry lining	Dated

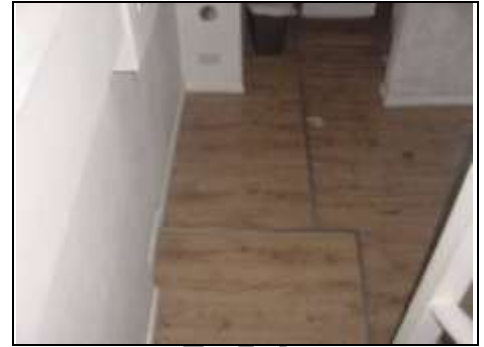
Laminate floor

Dry lining	Repair, prepare and redecorate.
Floors: Laminate	Worn	Clean or replace
Staircase: Cupboard under stairs		
Detailing: Doors: Entrance door	Dated	Repair, prepare and redecorate
Services: Lighting Internal radiator	Dated TRV valve missing	See Services Section Needs to be to modern standards required

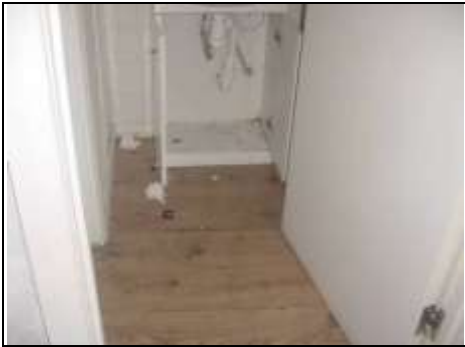
Wash hand basin plumbing

DESCRIPTION	CONDITION	ACTION REQUIRED
Ceiling: Painted plasterboard	Dated	Repair, prepare and redecorate.
Walls: Painted Tiling around wash hand basin Two solid walls: Left wall - WC Right wall - wash hand basin	Dated	Repair, prepare and redecorate.
Floors: Laminate	Worn	Clean or replace
Detailing: Doors: Entrance door	Dated	Repair, prepare and redecorate
Sanitary Ware: One WC One wash hand basin	Dated Dated	Deep clean Deep clean
Services: Lighting Vents		See Services Section Needs to be to modern standards required

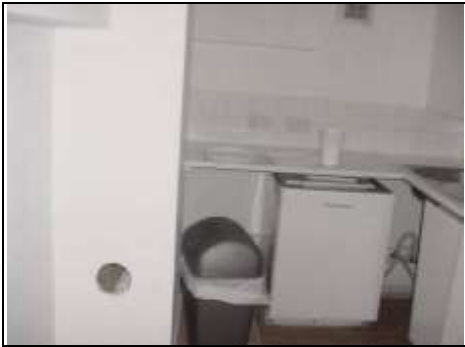
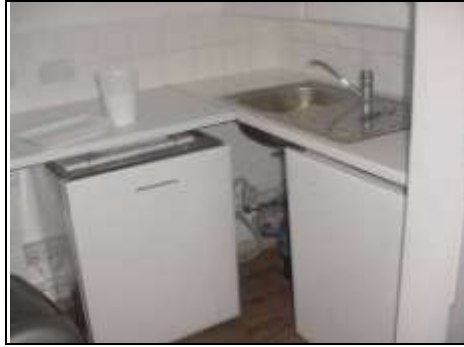
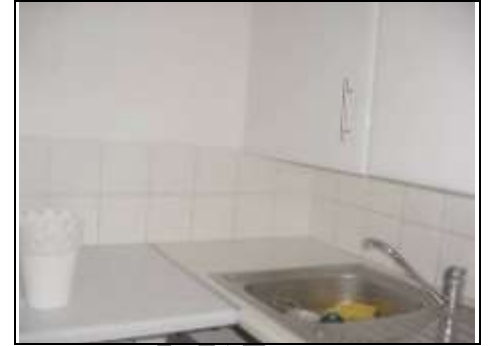
Kitchenette

DESCRIPTION	CONDITION	ACTION REQUIRED
Ceiling: Painted plasterboard	Dated	Repair, prepare and redecorate
Walls: Painted Perimeter and Internal walls studwork / dry lining	Dated	Repair, prepare and redecorate.
One wall mounted unit	Dated	Clean
Shelving	Dated	Clean
Splashback tiling	Dated	Clean
Floors: Laminate	Very worn	Clean or replace
Appliances: Stainless steel sink and drainer	The equipment has not been inspected. We have assumed that the equipment meets the appropriate Local Authority approval and standards.

Detailing: Doors: Entrance door	Dated	Repair, prepare and redecorate
Services: Lighting Water meter to left side		See Services Section Needs to be to modern standards required

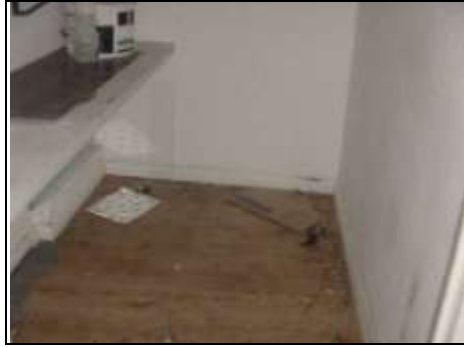
Right studio/office

DESCRIPTION	CONDITION	ACTION REQUIRED
Ceiling: Painted plaster	Dated	Repair, prepare and redecorate
Walls: Painted Perimeter wall Solid wall to right side Internal wall Dry lined/studwork rear wall Vents in rear wall – indicating dampness	Marked Indicating dampness	Repair, prepare and redecorate. Clean and ensure working
Floors: Laminate Laminate step	Worn	Clean / replace
Detailing: Doors: Entrance door	Dated	Repair, prepare and redecorate
Services: Lighting		See Services Section Needs to be to modern standards required
