SCHEDULE OF CONDITION

Wandsworth

We have been instructed to inspect and prepare a Schedule of Condition for
XXXXXXXXXXXXXXXXXXXXXXXXXXXX Wandsworth XXXXXXXXXXXX.

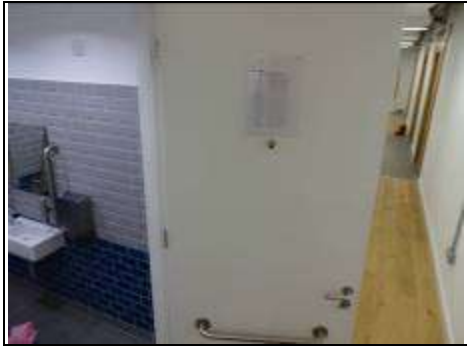
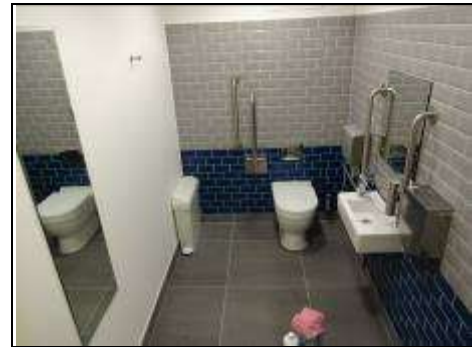
Toilets for the Less Able/Disabled

Disabled toilets

Toilets for less able/disabled

DESCRIPTION	CONDITION	ACTION REQUIRED
Ceiling: Painted One vent	Average	
Walls: Two painted walls Two partly tiled walls	Average Dirty	Being cleaned at time of survey
Floors: Tiled	Dirty	Being cleaned at time of survey
Sanitary Ware: WC Wash hand basin Handrail, etc for disabled	Dirty	Being cleaned at time of survey

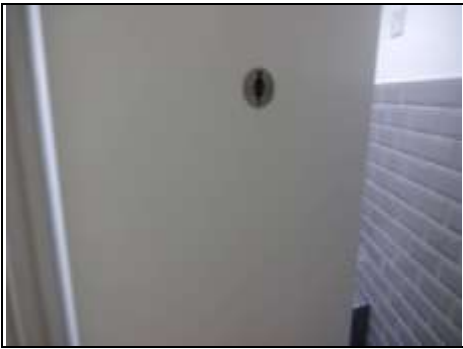
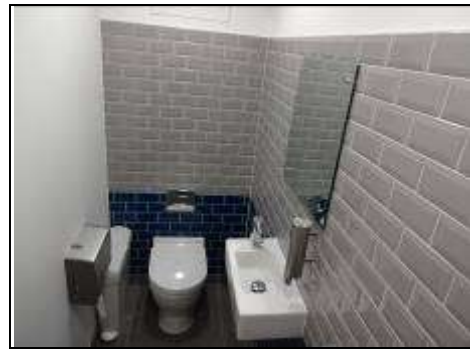
Ladies Toilets

Door to Ladies toilets

Ladies toilets

DESCRIPTION	CONDITION	ACTION REQUIRED
Ceiling: Painted One vent	Average	
Walls: Two painted walls Two partly tiled walls	Average Average	Being cleaned at time of survey
Floors: Tiled	Dirty	Being cleaned at time of survey
Sanitary Ware: WC Wash hand basins	Dirty	Being cleaned at time of survey

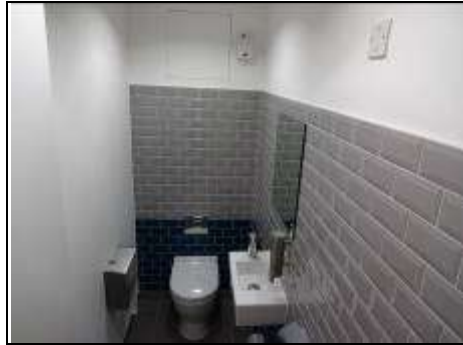
Gents Toilets

Gents toilets

DESCRIPTION	CONDITION	ACTION REQUIRED
Ceiling: Painted One vent	Average	
Walls: Two painted walls Two partly tiled walls	Average Average	Being cleaned at time of survey
Floors: Tiled	Average	Being cleaned at time of survey
Sanitary Ware: WC Wash hand basin	Average	Being cleaned at time of survey
Detailing: Doors:	Average	Being cleaned at time of survey
Services:		See Services Section.

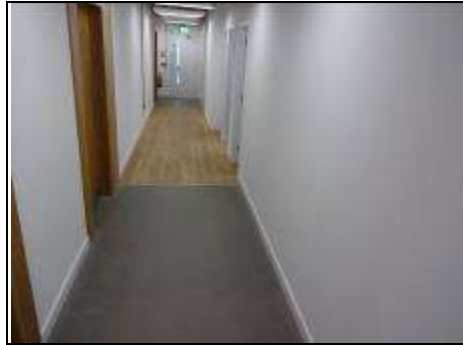
Link Corridor One including Toilets

Link Corridor One

DESCRIPTION	CONDITION	ACTION REQUIRED
Ceilings: Part suspended ceiling	Average	
Walls: Painted	Dated Marked
