SCHEDULE OF CONDITION

We have been instructed to inspect and prepare a Schedule of Condition for xxxxxxxxxxxxxxxxxxxxxxxxxxxx. We inspected the property on xxxxxxxxxxxxxxxx.

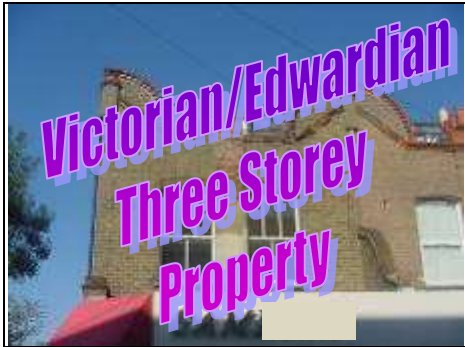
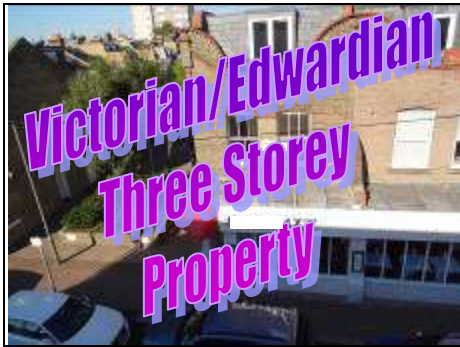
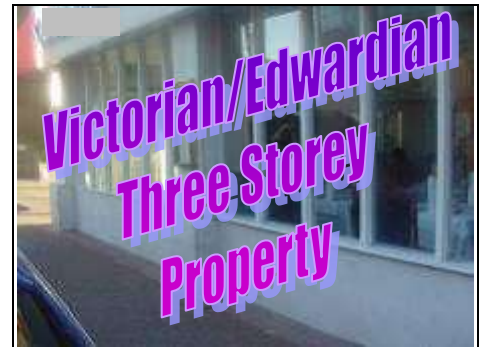
Front External Elevation

<p>Low level flat roofs:</p> <p>Metal covered</p>	<p>Leak to flat roof possibly from box gutter</p>

<p>Deterioration to right parapet wall</p>

<p>Flashband repair on front wall</p> <p>Middle parapet wall</p> <p>Spalling brickwork allowing dampness into property</p>

<p>Repair required to make watertight.</p> <p>See Main Roof if shared liability.</p>
	<p>Small perimeter guttering</p>

<p>Make good deteriorating brickwork.</p>
<p>Two brick parapet walls to front</p>

<p>Replace all spalling brickwork and leave watertight.</p>
<p>Left parapet</p>

<p>Joint high level inspection of the guttering with the landlord's surveyor to be carried out prior to signing of the lease or legal completion of the lease from high level cherry picker or equivalent. See Main Roof.</p> <p>Ensure all gutters are watertight and falling towards the downpipe and clear.</p> <p>Repair downpipes and secure as necessary, ensure downpipes are clean and clear.</p>
<p>Walls:</p> <p>First and second floor: Flemish bond brickwork</p>	<p>Wrongly repointed in cement mortar</p> <p>Brickwork to left side has colourwash</p> <p>Hole where extract fan was</p> <p>Movement around plastic sliding sash windows on right side</p>

<p>Ad hoc repair to deteriorating cement mortar. Replace with appropriate mortar.</p> <p>Make good extract hole.</p> <p>Exclude movement from lease.</p>

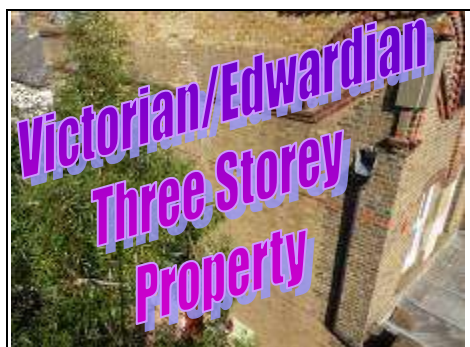
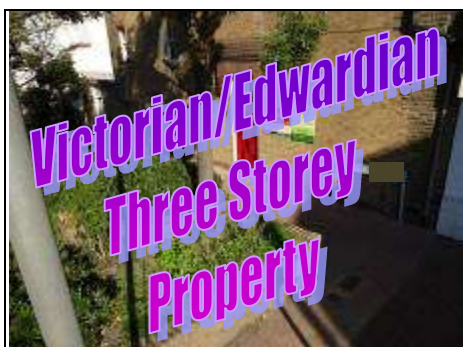
Left External Elevation xxxxxxxxxxxxxxxxxxxx

Cracking to brickwork

DESCRIPTION	CONDITION	ACTION REQUIRED
Roofs: Gable		Shared liability. See Front elevation.
Gutters and Downpipes: Plastic	Hopperhead   Awkward downpipe detail   Poor detailing to downpipe causing dampness	Shared liability. See Front elevation. Ensure all gutters are watertight and falling towards the downpipe and clear. Repair downpipes and secure as necessary, ensure downpipes are clean and clear. Resolve dampness

<p>Walls: Decorative brickwork at roof level forming a coping</p> <p>Flemish bond brickwork Note: different brickwork gable end of building</p> <p>Structural repairs</p>   <p>Vertical cracking through brick and brick joints.</p>  	<p>Spalling to red decorative brickwork</p>   <p>Wrongly repointed in cement mortar</p> <p>Stitching in of bricks, structural repair</p>   <p>Close up of cracks through bricks</p>     <p>Cracking around side of white door</p>	<p>Repair brickwork. Exclude from lease</p> <p>Ad hoc repointing in appropriate mortar.</p> <p>Landlord to place an insurance claim.</p> <p>Landlord to place an insurance claim.</p>
---	---	---

External Detailing: Doors: Red door no. xx giving access we assume to upper floor White door fire exit from restaurant	Dated Dated	Repair, prepare and redecorate. Replace with appropriate fire door ironmongery
---	--------------------	---

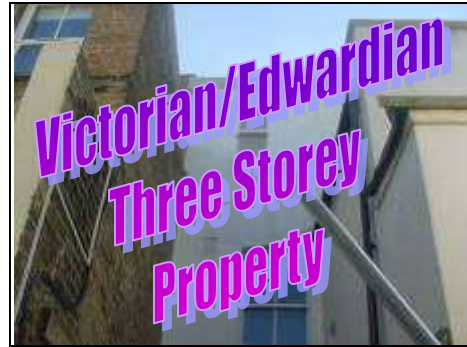
Rear left

Diagonal and horizontal cracking

DESCRIPTION	CONDITION	ACTION REQUIRED
Roofs: High level roofs not visible		Shared liability. See front elevation.
Flat roofs: High level flat roof Storey and a half flat roof	Not visible DIY repair with plastic bag, Bricks holding roof covering in place

Single storey flat roof Asphalt	Roof leaking and flashing needs replacing

Shared liability. See front elevation. Re-roof with a warm roof and replace decking

Re-roof and replace flashing
Gutters and Downpipes: Plastic	Guttering damaged and overflowing

Replace gutters and downpipes. Seal unattached gutter. Ensure all gutters are watertight and falling towards the downpipe and clear. Repair downpipes and secure as necessary, ensure downpipes are clean and clear.
Plastic soil and vent pipe	Soil and vent pipe should discharge at higher level

Amend soil and vent pipe to discharge at higher level
Walls: High level: Render	Movement with diagonal and horizontal cracks

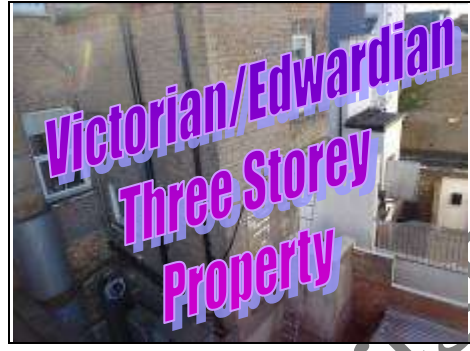
Rear right

High level flat roof finished in mineral felt

DESCRIPTION	CONDITION	ACTION REQUIRED
Roofs: Hidden high level roof Polycarbonate canopy	Canopy over rear right entrance, brickwork sitting over top, this area looks to flood

Shared liability. See front elevation Clear brickwork debris from top of canopy and clean and support.
Gutters and Downpipes: Plastic	Leaking	Ensure all gutters are watertight and falling towards the downpipe and clear. Repair downpipes and secure as necessary, ensure downpipes are clean and clear.

Soil and vent pipe:	Leaks  	Resolve leaks
Walls: Flemish bond brickwork with colourwash	Weathered areas of brickwork  	Ad hoc repointing
External Detailing: Windows: Plastic double glazed windows Timber windows Doors: Flush door	Dated Dated Dated	Clean Repair, prepare and redecorate. Repair, prepare and redecorate.
Services: Large extract system from kitchen   Drain in courtyard	No rodding eyes noted Manhole cover damaged	Check and confirm that it has rodding eyes to clear it. Replace.

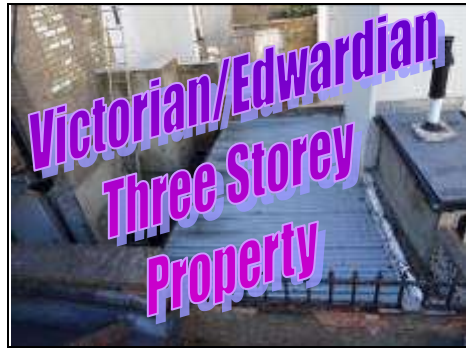
Corrugated iron roof store

DESCRIPTION	CONDITION	ACTION REQUIRED
Roofs: Corrugated iron roof  	Leaking Cement and flashband repairs to the flashings  	Resolve leaks Repair flashings
Gutters and Downpipes: None		Add gutters and downpipes and soakaway
Walls: Mixture of single brickwork and render	Single brick wall which is integrally unstable against corrugated iron food store

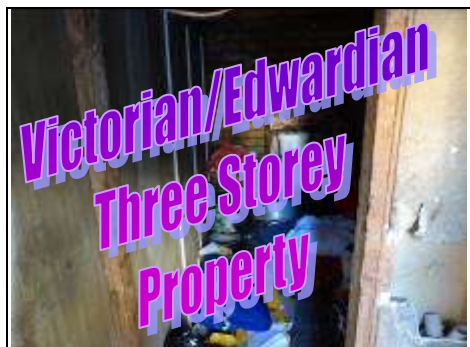
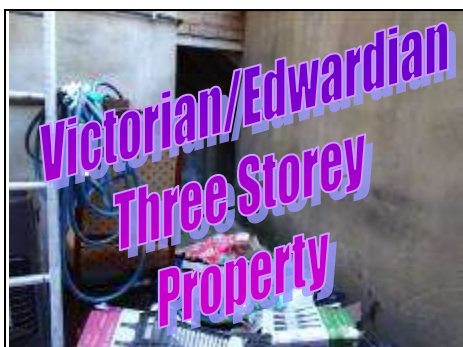
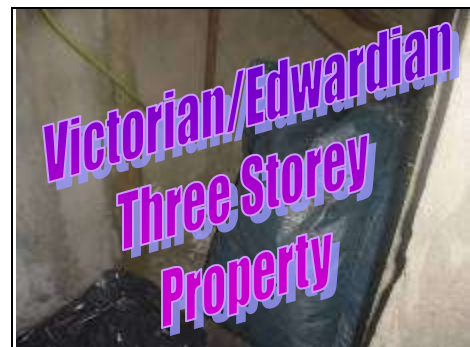
Outbuilding Internal

DESCRIPTION	CONDITION	ACTION REQUIRED
Ceiling: Corrugated iron		
Walls: Internal partition: Divided with partition into two, one side storing food and other side is bin store	Partition damaged  	Repair, prepare and redecorate and make appropriate for food storage.
Floors: Concrete	Uneven	Screed and floor paint.
Detailing: Doors:	No doors	Add doors
Services:		See Services Section
Other:	Rat droppings	Resolve rodent issues

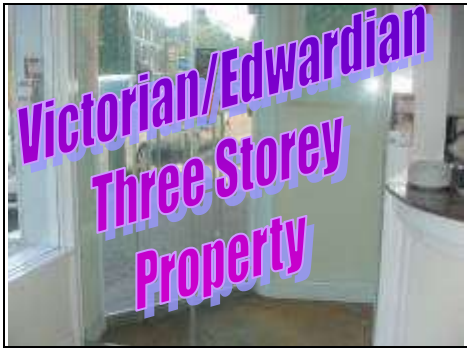
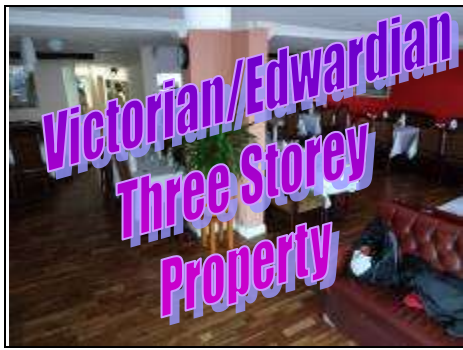
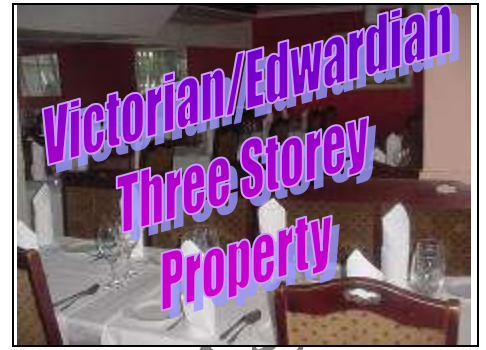
Restaurant

DESCRIPTION	CONDITION	ACTION REQUIRED
Ceiling: Plasterboard and coving  	Water staining for example to front right Dated and marked	Resolve dampness Repair, prepare and redecorate.
Walls: Painted	Dated Cracking to front left pier   Cracking goes down to ground level	Repair, prepare and redecorate. Exclude from lease

Floors: Laminate covered  	Worn particularly high traffic areas For example the entrance and where chairs and tables are sitting	Repair or replace.
Detailing: Windows: Single glazed windows to front in painted timber frame Doors: Glazed doors to left corner Fire Escape:	Dated Dated	Repair, prepare and redecorate Clean Clearly mark fire exits

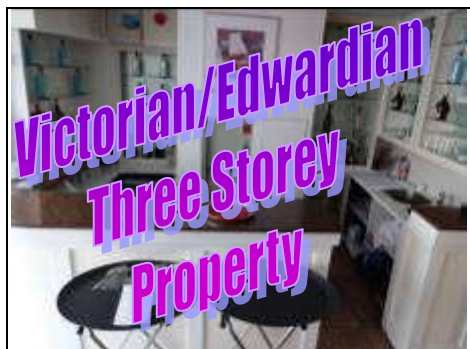
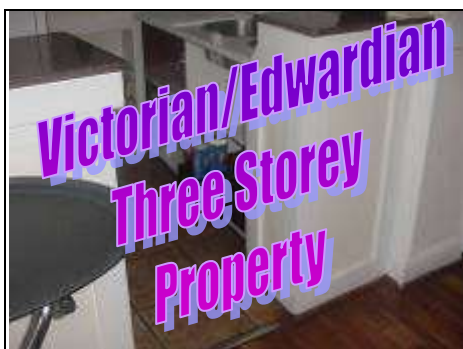
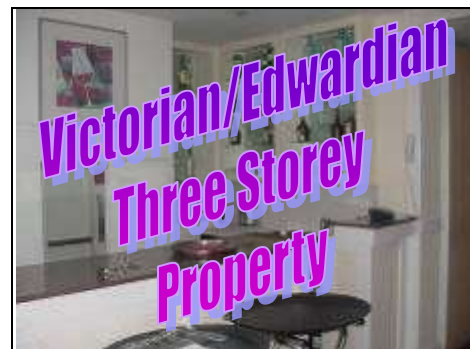
Bar/Servery Area

DESCRIPTION	CONDITION	ACTION REQUIRED
Ceiling: Plasterboard	Dated	Repair, prepare and redecorate.
Walls: Painted	Dated	Repair, prepare and redecorate.
Floors: Floor tiles	Ingrained dirt  	Deep clean or Replace with safety floor
Detailing: Bar Servery: Reconstituted stone top		Deep clean

<p>Painted wood front panelling</p>  	<p>Minor marks and dated</p>	<p>Repair, prepare and redecorate.</p>
<p>Back Bar: Glass shelves and timber</p>

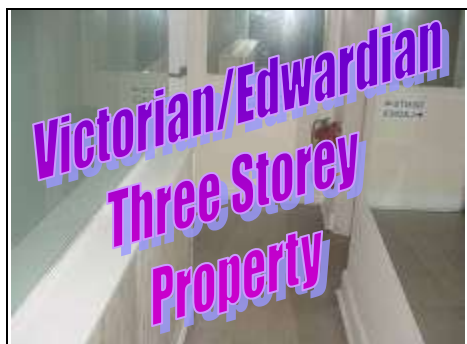
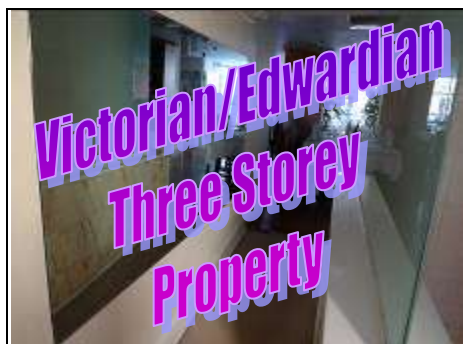
Access corridor to toilets and kitchen (fire exit)

DESCRIPTION	CONDITION	ACTION REQUIRED
Ceiling: Painted plasterboard Painted architrave	Dated Repair to ceiling (rear flat roof has problems)

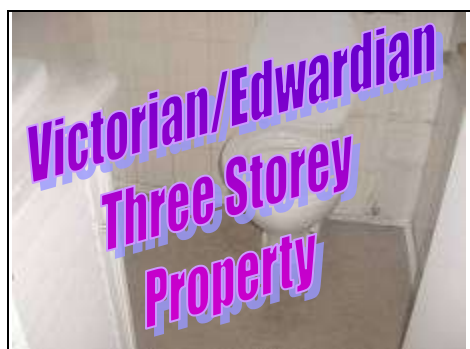
Gents Toilets One

DESCRIPTION	CONDITION	ACTION REQUIRED
Ceiling: Painted	Dated	Resolve leak Repair, prepare and redecorate
Walls: Tiled	Dated	Deep clean and/or replace
Floors: Safety style floor	Dated	Deep clean
Detailing: Doors: Painted flush doors	Dated	Repair, prepare and redecorate

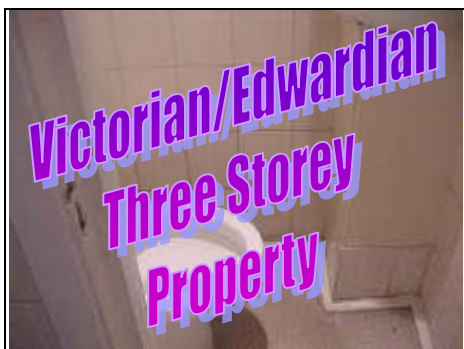
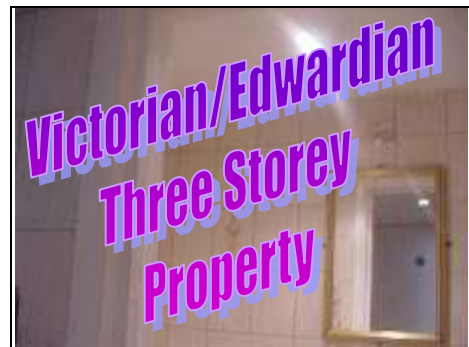
DESCRIPTION	CONDITION	ACTION REQUIRED
Ceiling: Painted	Dated	Resolve dampness Repair, prepare and redecorate
Walls: Tiled	Dated Damaged tiles	Replace damaged tiles and/or re-tile
Floors: Safety style floor	Dated	Deep clean
Detailing: Doors: Painted flush doors	Dated	Repair, prepare and redecorate
Sanitary Ware: WC	Dated.	Deep clean
Wash hand basin	Dated	Deep clean

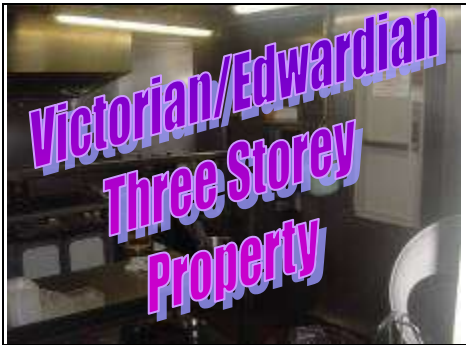
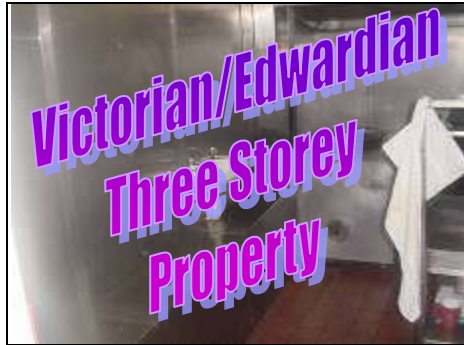
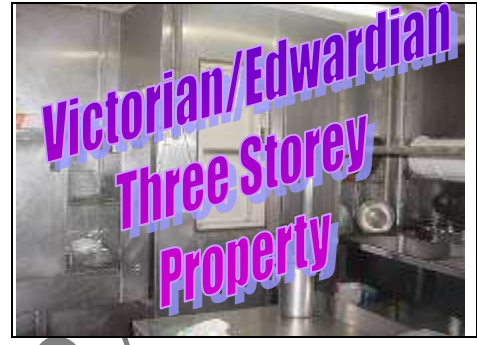
Catering Kitchen Front Left

DESCRIPTION	CONDITION	ACTION REQUIRED
Ceiling: Painted	Dated and grease stained	Deep clean. Repair, prepare and redecorate.
Walls: Stainless steel	Dated and grease stained	Deep clean.
Floors: Quarry tiles

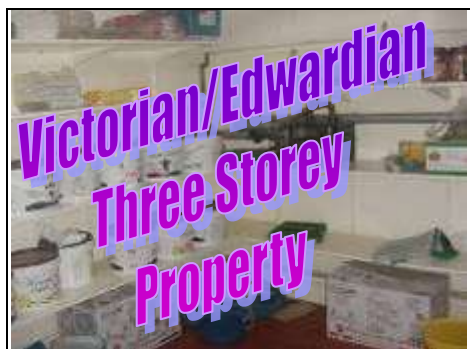
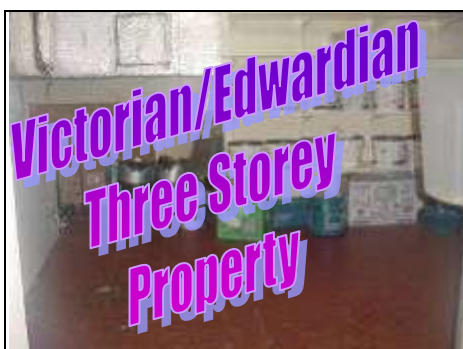
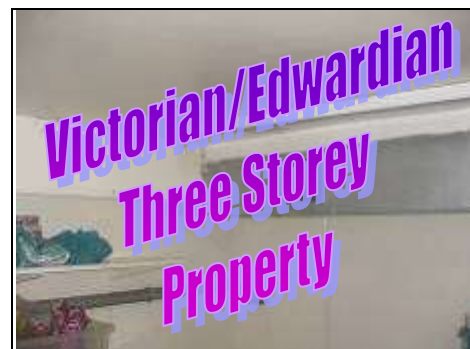
Store Room Front Right

DESCRIPTION	CONDITION	ACTION REQUIRED
Ceiling: Painted	Dated	Repair, prepare and redecorate.
Walls: Painted Dampness

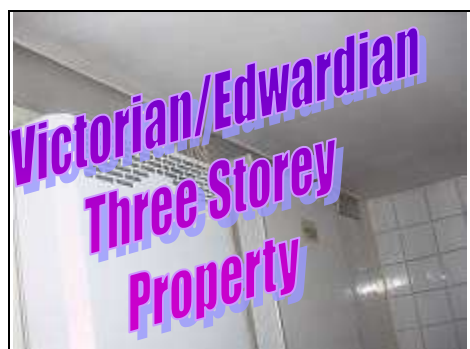
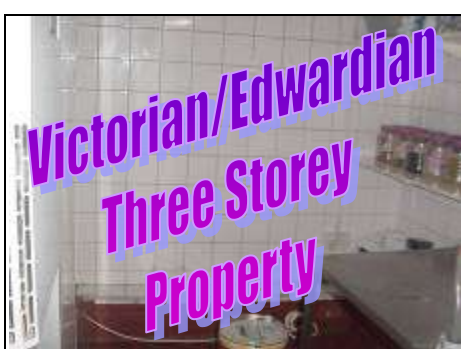
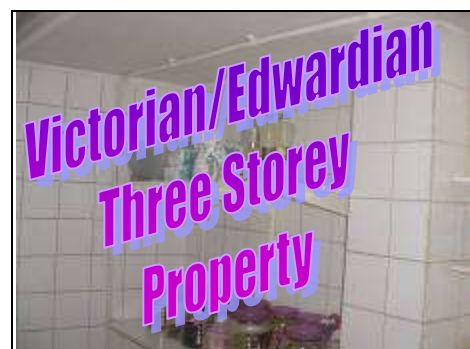
Walk in Fridge Area Rear Left

DESCRIPTION	CONDITION	ACTION REQUIRED
Ceiling: Painted	Marked	Repair, prepare and redecorate.
Walls: Tiled	Marked and cracked	Deep clean and re-tile .
Floors: Quarry tile	Marked	Deep clean/repair or Replace with safety floor
Services: Light	Diffuser missing	See Services Section Replace. Ensure lighting appropriate for area.

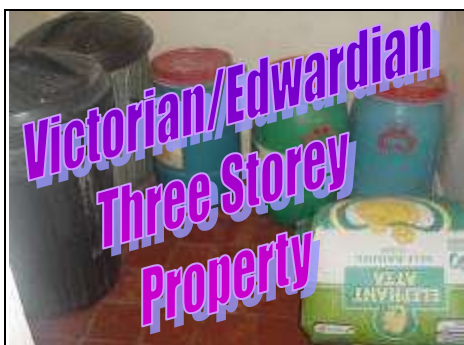
Store middle rear

Piece of cardboard covering hole

<p>Piece of cardboard covering hole to underneath of toilets</p>  	<p>Behind cardboard in wall looking underneath toilets</p>   <p>Floor of toilet above propped up</p>  	<p>Floor needs to be suitably supported in the toilets area</p>
<p>Floors:</p> <p>Tiled</p>	<p>Dated</p>	<p>Deep clean or replace with safety floor.</p>
<p>Services:</p> <p>Other:</p>	<p>Mice traps</p>  	<p>See Services Section</p> <p>Discussions with Health Environmental required</p>
