RESIDENTIAL BUILDING SURVEY

Wells, Somerset BA5

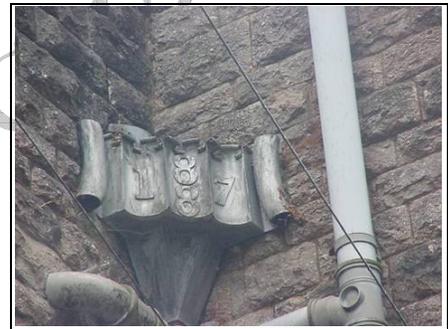
Hopper head showing date 1887

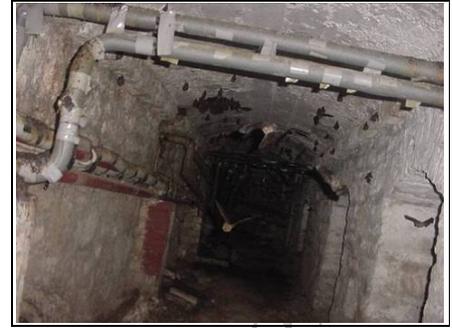
Bats in basement

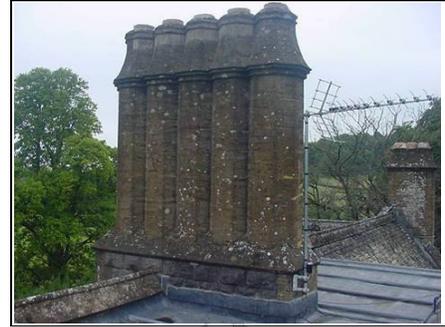
We would also recommend cutting back the trees particularly to the right hand side to enable better sunlight and also some repointing work to the stonework. We would specifically draw your attention to the chimneys on the left and right side which look to be in need of some work although they will be difficult to access other than by scaffold. Scaffold costs on this height of property alone can run into many thousands of pounds due to its height which is why no doubt one of the reasons in the past this work has not been carried out and work has only been carried out on a limited nature to the areas that are easy to reach.

Middle rear chimney

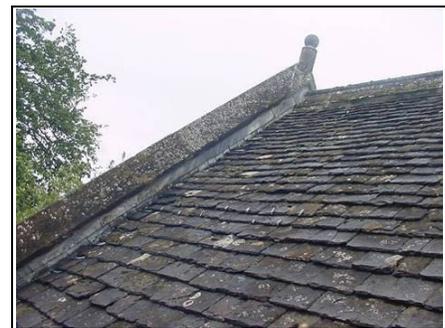
We note that some of the roof stone slates have deteriorated and have been fixed with a lead tingle, which indicates the nails are rusting. Ideally these should be replaced properly. There is also an outside chance the roof has nail sickness, which is where the fixing nails have rusted away and as such then sections of the roof will need to be replaced. This can only really be ascertained by removing sections of the roof and having a close look. It is this risk that we are concerned about with the high level work areas.

If you look closely you can see that lead tingles have been used in the centre of this roof.

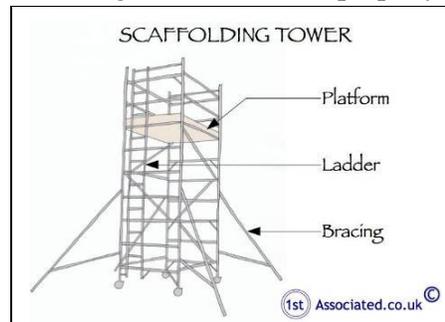
Example of tower scaffold

ACTION REQUIRED: You will need to constantly clean the gutters and hopper heads and downpipes. We recommend you buy a tower scaffold as blocked gutters, valley gutter or hopper head would very quickly cause major problems.

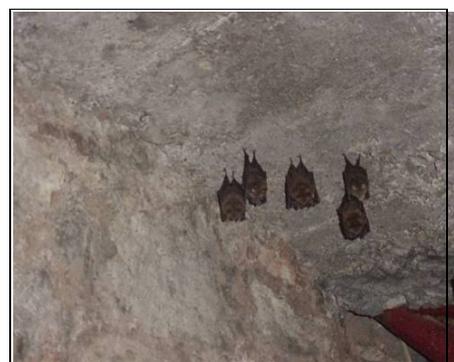
We have carried out a visual inspection of the foundations and viewed the vaulted basement with the bats! We cannot see any unexpected cracks within the external the walls. Our view within the vault was very limited. We believe there may be metal (likely to be cast iron), used as part of a reinforcement of the structure, as this was

Bats in the basement 19

ACTION REQUIRED: We would recommend a detailed inspection of the basement focusing on the condition of any structural steel members and associated repair.

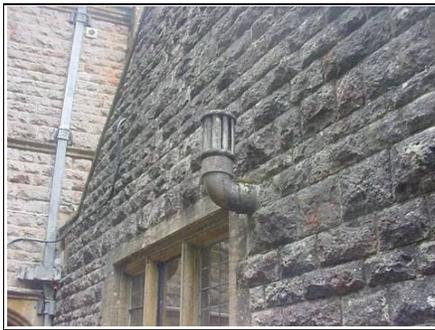
There are various asbestos flues externally and we also expect there to be a flue into the boiler internally. The immersion heater service cupboard on the first floor looks also to have some asbestos.

Asbestos flue

ACTION REQUIRED: You need to get a Local Authority approved asbestos contractor to carry out tests and a report and ideally remove. The problem with having asbestos on the property is anticipated problems for any future purchasers. Please note we are not asbestos surveyors.

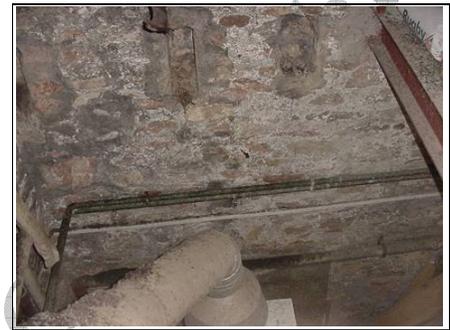
Asbestos going down to boiler in handyman's room and boiler room

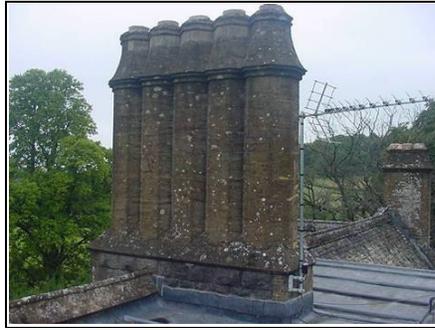
Middle rear chimney

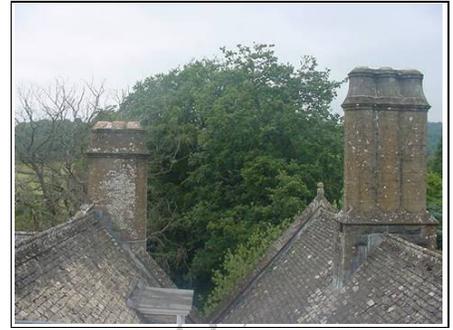
Two right hand chimneys

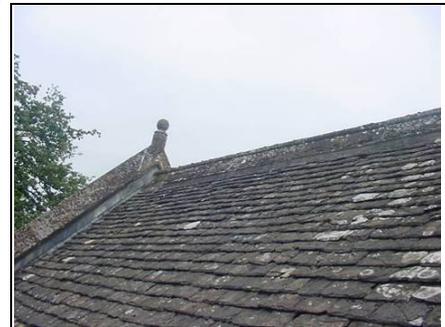
There are stone parapet walls formed to the gable of the roofs. We were pleased to see that these had lead flashings and stone cappings. Whilst it should be appreciated we were viewing them from a distance, what we could see looked in average condition. We noted in the roof damp staining. Please see our comments in the Executive Summary.

Parapet wall

ACTION REQUIRED: You need to closely check the lead flashings around the parapet walls as part of a maintenance programme.

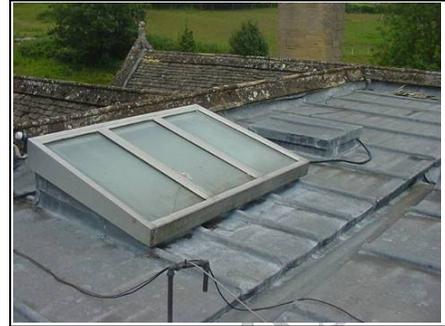
There is a plastic roof window on top of the main roof. It would be worth replacing with a more appropriate roof light that can also give access to the main roof from the corridor below. Consideration should also be given to putting some water tanks actually on the roof.

Roof light

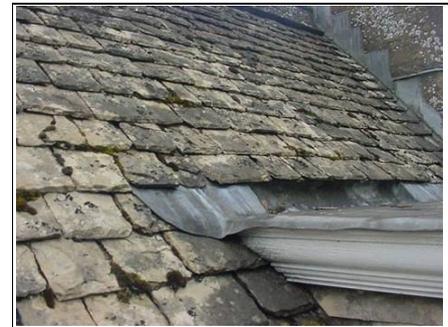
In other areas there is some deterioration to the surface of the stone slates and moss coverings particularly to the left hand side (see below section).

Close up of slates

Having said that, visually internally there are no signs of major leaks and due to the cost of scaffolding to gain access to any areas to carry out repairs we recommend a good maintenance programme rather than replacement.

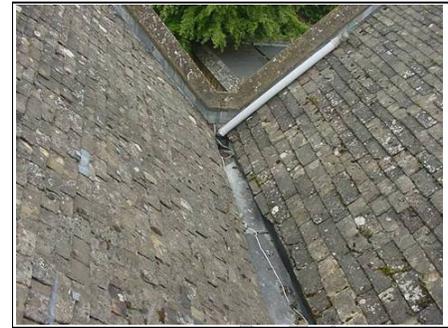
There are numerous lead valleys to the property. First of all, we were pleased to see that they were lead, although we can see that some of them have had Flashband repairs (sticky backed lead) which we consider a temporary repair. It really was in a far better condition than we would expect.

Valley gutter

ACTION REQUIRED: We would recommend that lead repairs are carried out to the roof and valley gutters, where currently Flashband has been used, which we consider a temporary repair product.

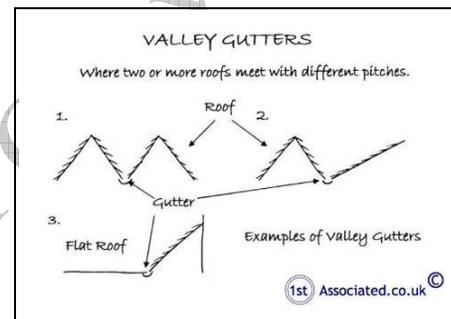
We have been able to examine two of the bases of the valley gutters from within the property (our view has been very limited, as you can imagine, due to the mass of stored items in the cupboards and general configuration of the property not allowing us access), but the two areas that we were able to examine we could see there had been minor leaking but nothing unacceptable.

Valley gutter

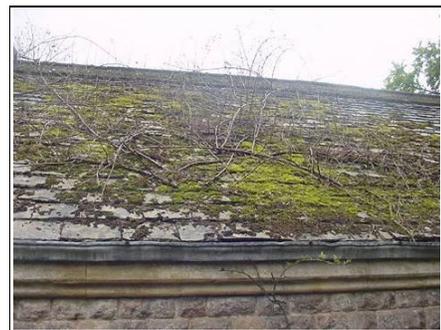
Close up showing excessive moss

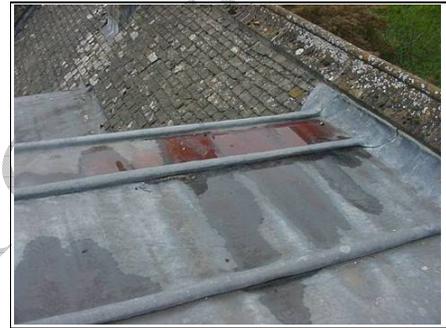
Water ponding

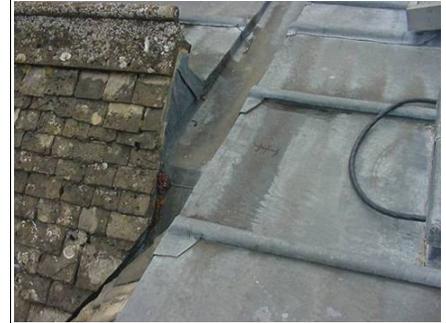
Water ponding

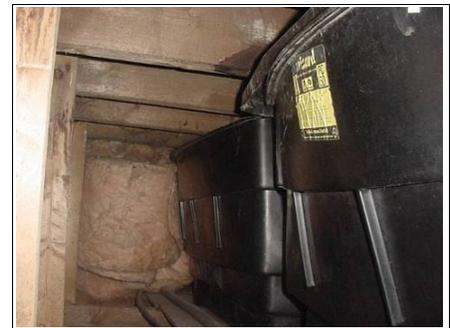
From what we can see water tanks in the flat roof are causing condensation and in turn wet rot to the timber roof above, which has the lead flat roof over this.

Dampness directly above the water tank

ACTION REQUIRED: We recommend lids for the water tanks and venting of the area, although we would add that it is very constricted in these areas and you may wish to look at relocating the water tanks.

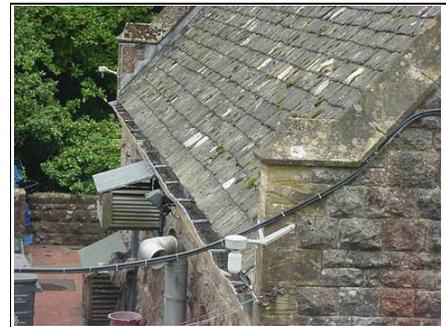
We do however think you need to carry out proper repairs to the gutters and we noted that in the gutters and valley gutters some of them had Flashband repairs and we would also suggest that you review the various methods that Sid uses to get to the roofs to ensure you are happy with them on a health and safety point of view. Please note our earlier comments about buying a tower scaffold.

Lead gutter on left hand side of building

ACTION REQUIRED: A system of regular maintenance of the gutters, hopper heads and valley gutters needs to be carried out to ensure you do not have major water leak problems with this property.

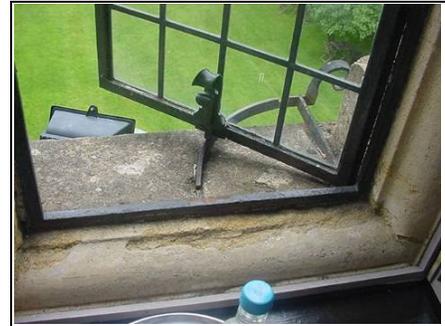
Internal stone repairs to the windows

The tower scaffold of course can be used for stonework repairs, window stonework repairs together with painting of the windows and clearing of the gutters and hopper heads. This can be used for repairs to the stonework, windows sills and windows and accessing some of the guttering.

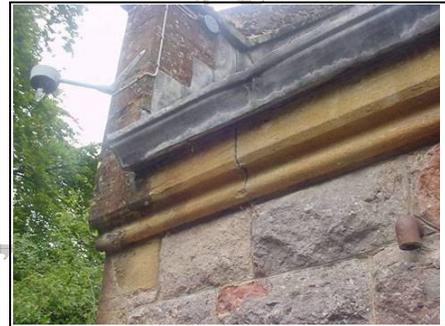
The property has a stone fascia behind the lead guttering. This can of course deteriorate if the lead gutters are leaking. As mentioned we noticed Flashband repairs which may well have been leaking for some time before they were repaired. These areas need to have repair as you go around each elevation. Please see our recommendations in the Executive Summary.

Stone fascia

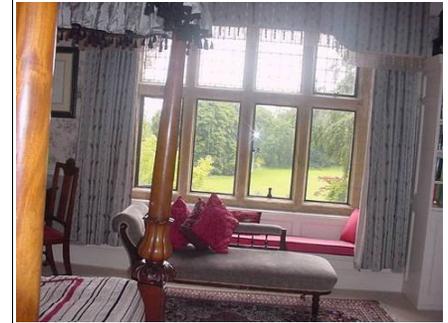
Leaded light window – the large windows give in a lot of light

We would refer you to the walls section where we have talked more about the stone windows but we would comment that the stone window sills and some of the detailing around them are suffering from deterioration, in some areas with moss sitting on them. We would recommend this is removed, this together with allowing more sunlight and air circulation around the building and sensible repairs are recommended within the next few years.

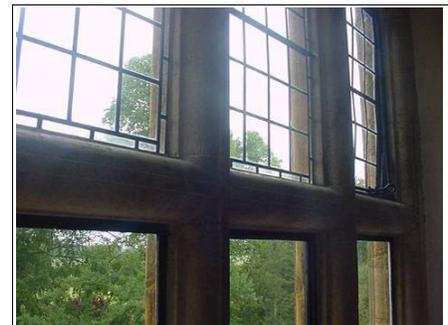
Close up of leaded light windows 52

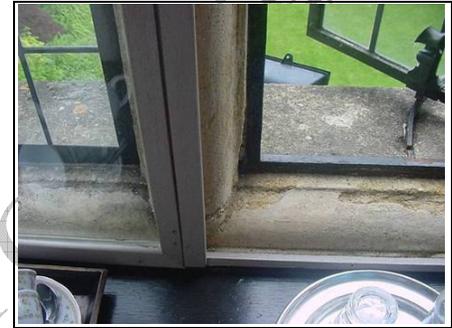
Secondary glazing
and stone repairs if you look closely

ACTION REQUIRED: The metal windows themselves in many cases have suffered from rusting and warping and we can't open them. You will need to diligently work around the property making good the windows and redecoration. As mentioned in the Executive Summary we would recommend that you work elevation by elevation to achieve this task.

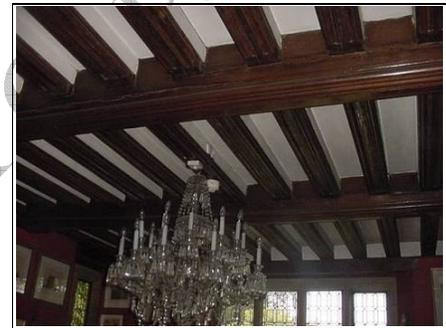
Spine beams

In some rooms we can see spine beams and the floor boards have been used horizontally rather than vertically, as this is typical in this age of property.

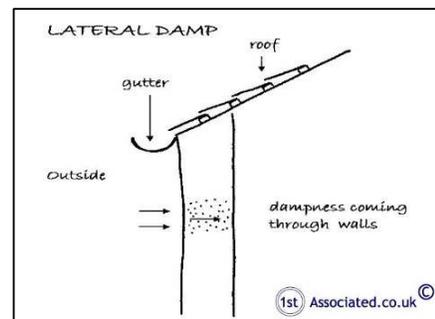
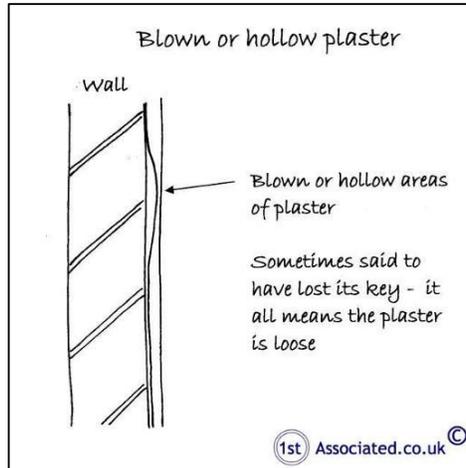
Tests were taken with a moisture meter at random points to the perimeter walls and we did get damage readings. We also noted above average amount of blown plaster, indicating dampness is coming in the walls.

Testing for and finding lateral dampness!

Please see our comments with regard to repointing externally and also checking and keeping the gutters, downpipes and hopper heads, etc, in good condition.

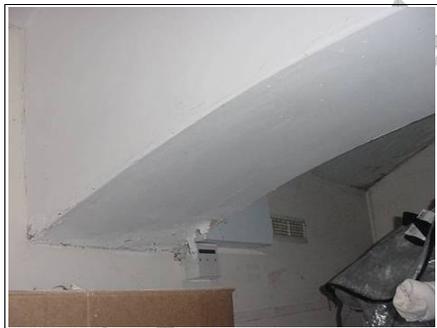
We also noted dampness coming in from the car park into the basement area through to the Prep Room.

Dampness in Prep Room coming from car park area

ACTION REQUIRED: We would recommend some sort of drainage system in the car park to move the water away from the property and around it. Remember this property is on a sloping site and the water needs to get from the top of the site to the bottom and will do so whether it is through the property or around it! Please see our comments in the Executive Summary.

ACTION REQUIRED: Please see our comments in the Executive Summary.

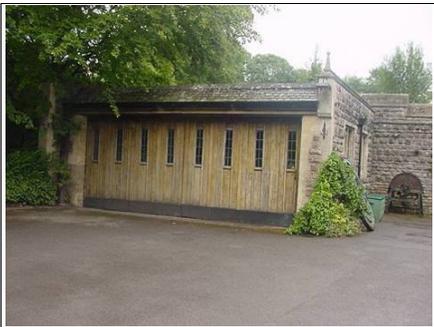
Garage

The property has a double garage. It has a flat roof with a central drainage point, which is liable to blockage from leaves etc, and the tree that overhangs it. It is built in coursed stonework, with timber doors and stone mullion windows with metal casements and leaded lights. We can see it has been repointed in a cement mortar and there is cracking to the rear left hand side. There is also rubble stone walling to the bottom left hand corner.

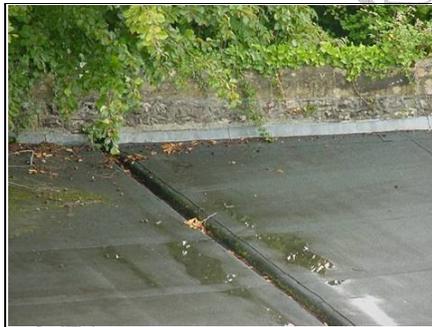
Central drain to flat roof

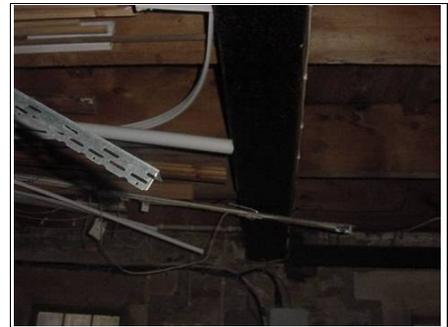
We can see internally that there is a metal beam present that has had some rusting. This indicates that repair work is needed to the roof.

Inside the garage

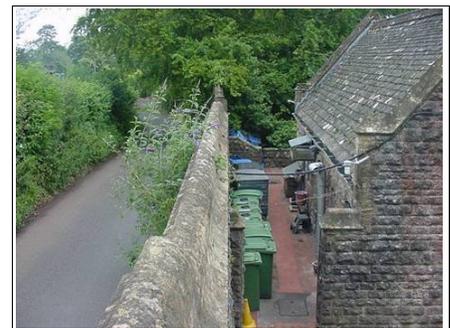
We noted that when we were on the roof of the garage we could see the adjoining road over the boundary wall. This shows just how considerable the change in levels are and how important it is to have a good drainage system in front of the house. We imagine there would have been a great deal of water that has travelled across the car park over the years causing dampness into the front of the property. Please see our comments on this.

Differing ground levels
