RESIDENTIAL BUILDING SURVEY

XXXXXXXXXXXXX,
XXXXXXXXXX,
XXXXXXX,
Middlesex HA3 XXX

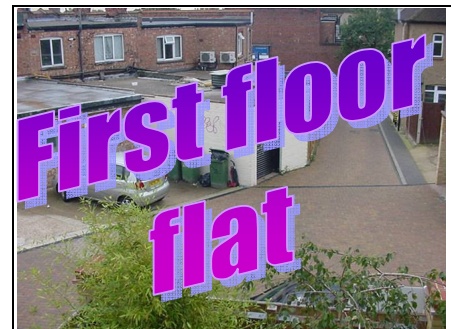
The view from the flats is not the best. Overlooking the entrance driveway it may get some noise. Also overlooking the back of the shops we noticed some fly tipping had taken place.

Overlooking entrance driveway

ACTION REQUIRED: Before you move in we recommend that you speak to other people that live in the property (we could only find one person in on the day of our survey). It may be worth going round at a weekend) and ensure you are happy with the noise level.

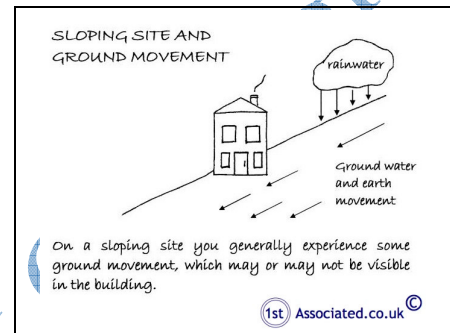
The property is on a sloping site, not quite as steep as the one shown in the sketch but this gives the general idea. There has not been much thought as to how rain water is being managed as when it rains the water will want to go from the top of the site to the bottom of the site.

We noted running gulleys to the adjacent road (right hand side) but we didn't notice anything to manage the water around the property although we weren't able to gain physical access to the back and right hand side and had to view it over a fence.

This has given us particular cause for concern due to the airbricks acting as gutters. Some work needs to be done to these to stop water getting in as we are concerned that the property has a suspended floor due to poor soil conditions. Unfortunately the last thing that you want with poor soil conditions is water pouring into the foundations.

ACTION REQUIRED: You need to bring this to the freeholder's attention before you commit to purchasing the property and insure that a resolution is sorted.

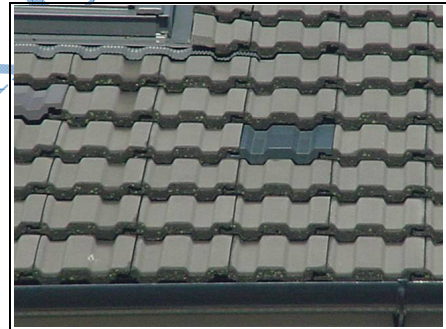
The roof is pitched and clad with concrete tiles. From ground level, this looks in average condition considering the roofs age type and style. We were pleased to see there was a vent in the roof. This should help with any condensation problems, which is a problem that is getting more and more common in modern properties.

Vent in roof

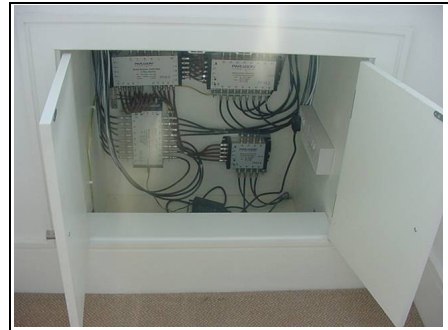
We opened the only cupboard we could find on the top floor landing but unfortunately this was lined.

We weren't able to expect the roof in this particular case.

Lined cupboard on top floor landing

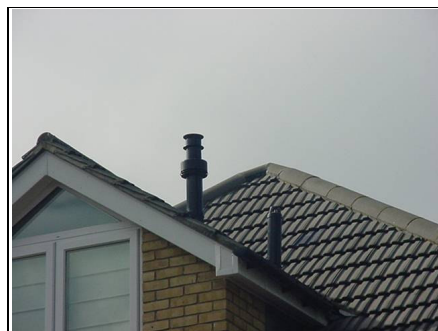
The property has plastic soil and vent pipes. We were unable to see exactly where the soil and vent pipes discharged other than noting a few vents at the front of the property that didn't look to relate to this particular property. They may be visible from the rear of the property but we did not have access to this area.

Vent Pipes

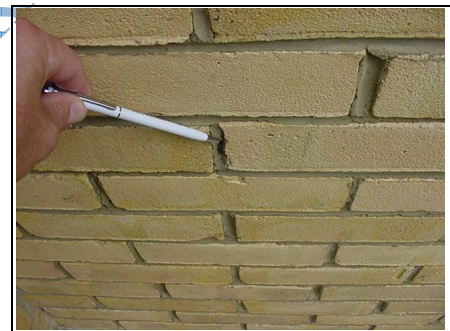
The property is built in Stretcher Bond brickwork. The brickwork is average to slightly below average condition for new brickwork. However we were pleased to see the soft red brickwork detailing.

Brick wall close up

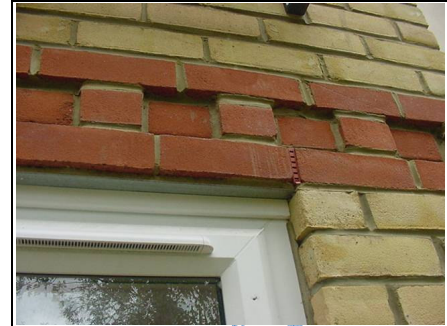
The weep holes indicate there are likely to be cavity trays in the property.

Weep holes

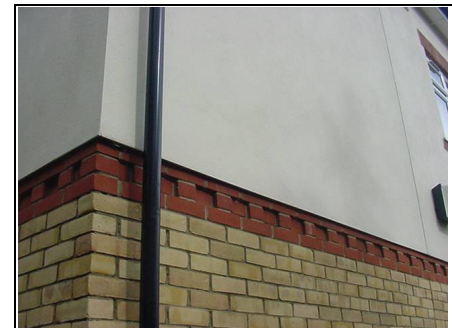
Rendering

There are areas of render to the property. This looks to be cement render and may well be a modern SIP panel which is a structurally insulated panel. We would comment that this type of panel has not been used in the UK for these types of conditions for sufficient time for there to be in use data available. Our experience to date has been mixed the SIP panels are very dependent upon the builder installing them correctly.

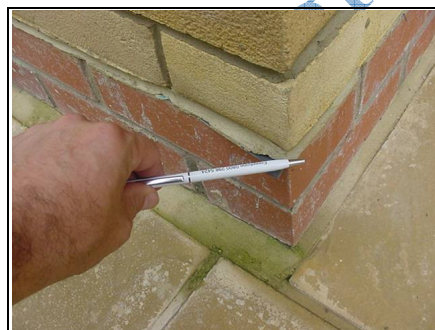
Damp Proof Course

Rather unusually for a new property the floor is suspended and we noted air bricks. This is often used in modern properties where there is a clay soil but we can't be certain in this area in this case. However we would comment that the air bricks are currently acting as gutters.

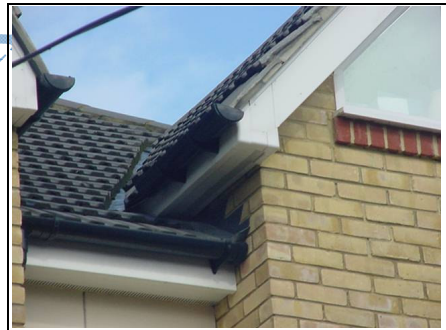
Fascias and soffits

The fascias and soffits look to be plastic. We noted there was a vented grill in the base of the soffits which is good as it shows that some thought has been given to condensation issues in this property.

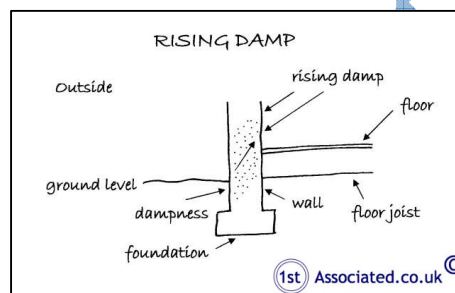
There is no rising damp as you are on the first floor but you may ironically share the cost of any dampness that happens on the ground floor. Whilst this is unusual in newer properties you do have this situation where you have your air bricks acting as gutters on the ground floor. Please see executive summery.

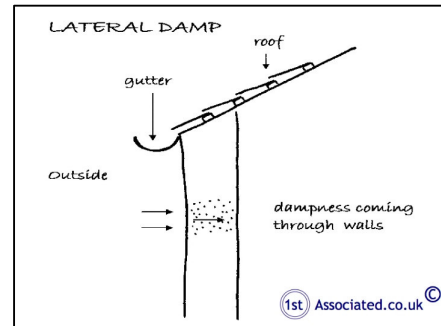
We used a damp meter on the external walls.
We have not found dampness.

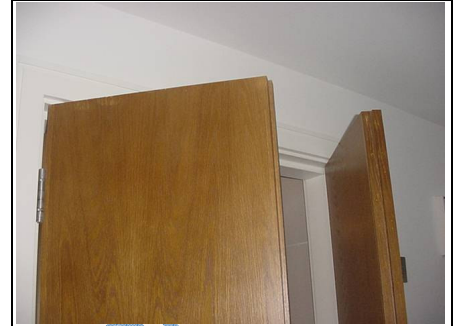
Entrance to bathroom

The property has good quality internal doors and it even has a double entrance door into the bathroom.

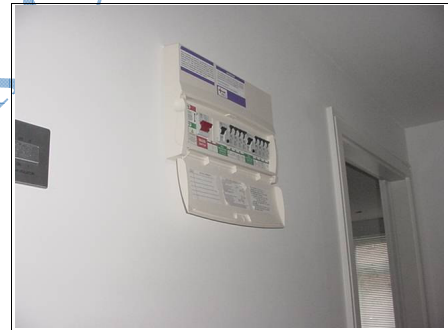
Electric fuse box

The electric fuses and consumer units were located under the stairs. The fuse board looked newish.

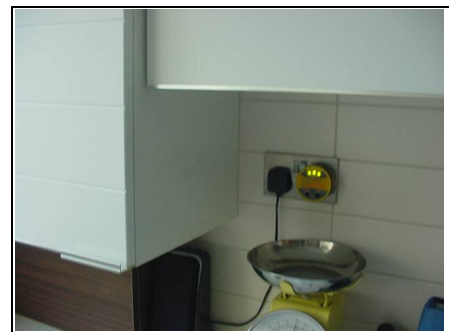
Earth test meter

We carried out an earth test in the kitchen area to the socket point that is normally used for the kettle, this proved satisfactory.

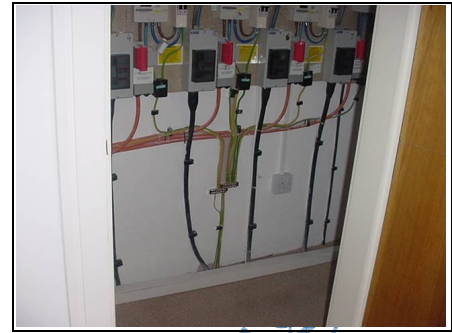
Mains electrics under stairs

The Mains Electrics are located underneath the stairs. Please note our comment about the fire alarm not working

ACTION REQUIRED: Your legal advisor should be able to obtain an up-to-date and suitable inspection certificate carried out by a NICEIC registered and approved electrician or similarly approved. If this is not the case then you need to have a test carried out yourself.

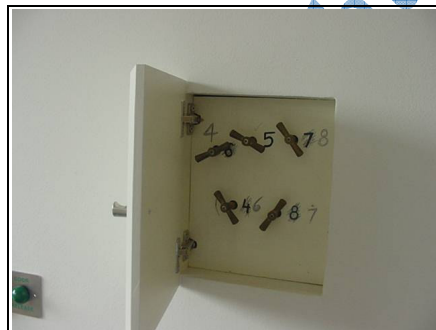
Stopcocks

We found the controlling stopcock is located on the ground floor. There seems to be some confusion over which stopcock was for which. We suggest that you ask the owner if they are aware and if they can give more details.
