RESIDENTIAL BUILDING SURVEY

Ifield, Crawley,
West Sussex, RH11

**Detached
Tudor
Property**

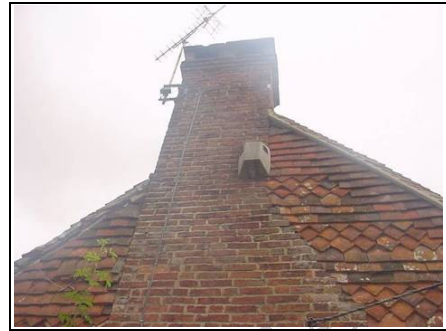
The chimney needs some work generally from repointing. You also need to check to see if it has been repointed in a cement mortar or lime mortar. It looks from ground level to be cement mortar.

We would also recommend a lime coat or similar for the external of the building and you may also wish to look at how to treat the timbers rather than the black and white look which has become traditional (which was introduced by the Victorians). You may wish to lime wash the timbers as well for protection.

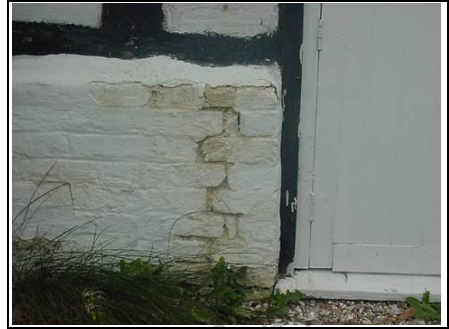
Brick plinth underneath the timber frame

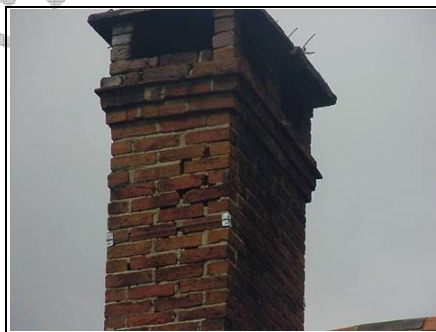
Chimney one

Close up of chimney one

ACTION REQUIRED: We feel the best way forward is to have a close look at the chimney from the top (using the tower scaffold that we have recommended you buy).

ANTICIPATED COST: We would set aside the sum of £750 to £1,500 to carry out repairs/rebuilding work. Please obtain quotations. Ultimately you will need to repoint the chimney in a lime mortar.

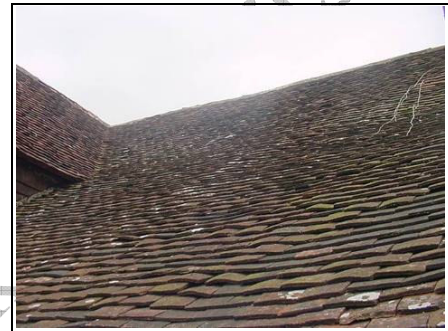
The main roof is pitched and has hand made and machine cut tiles. There is some dampness visible, as we would expect with this age of roof. Often it is created by wind driven rain or more recently we have seen it caused by condensation due to high insulation levels.

Mixture of hand made tiles and machine cut tiles

ACTION REQUIRED: Please see our comments in the Executive Summary.

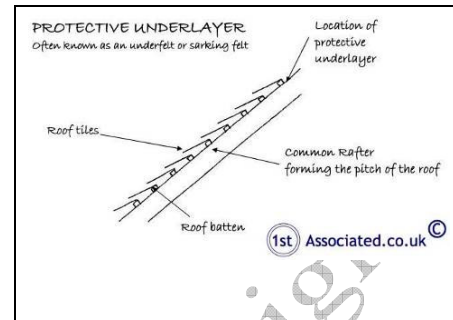
When we inspected the loft space we found there was no underfelt. It is therefore possible that during periods of heavy and prolonged driving rain some water penetration could take place through the roof coverings. At the time of our inspection this was not occurring.

No protective underlayer
(no sarking felt)

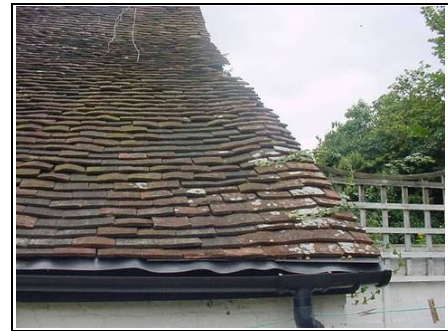
We would add that if you look at the adjacent photo you will see that a protective underlayer, often known as a sarking felt has been added indicating that this roof is likely to have been re-roofed in part since the 1940's/1950's. We much prefer a modern breathable protective underlayer.

Protective underlayer poking out
from underneath the tiles.

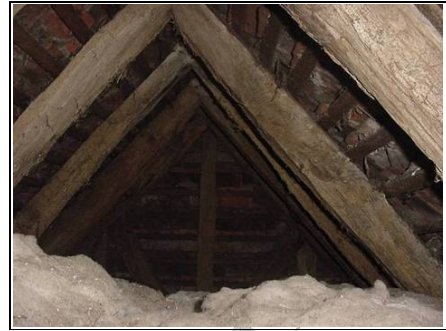
General view of roof

Our examination was limited by the general configuration of the roof, the insulation and a lot of stored items. We generally found that the property has woodworm, whether it is active or redundant we are not absolutely sure. Given what we have seen in the rest of the building we expect some of it to be active, although we did not physically see any in the roof.

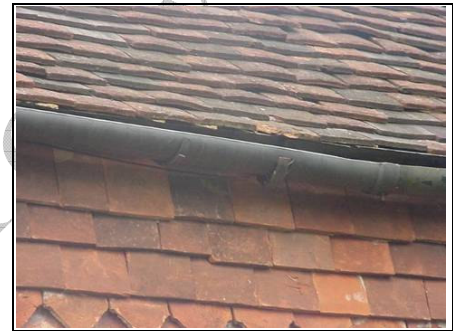
The gutters and downpipes are predominantly plastic, although we believe there is some cast iron remaining. As we showed you the plastic does not have the same strength and integrity as you find with a metal gutter. We suggest these gutters and downpipes are ultimately replaced with metal ones, again subject to the Conservation Officer's approval. However, your first task is to ensure that these gutters are working well and making sure water is being discharged from the property without it being discharged down the property.

Plastic guttering

You need to make this a priority before the winter of 2011, making sure that the gutters and downpipes are working properly and most importantly, discharging away from the building. We are a great fan of water butts as they obviously allow you to use the water on your garden but also they are a good way of ensuring that water gets away from the building. We have even seen a system of several water butts that works very well.

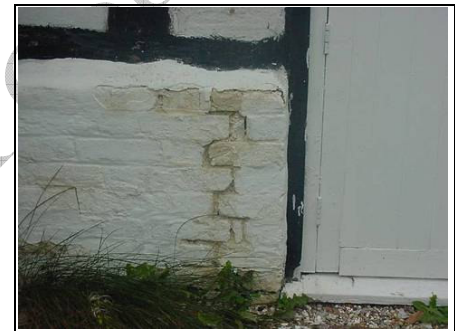
The base of the property has brick walls. These are painted and form a plinth for the timber frame to sit upon. We have seen many various ways of detailing this plinth. The main problem with it is that water sits on it and rolls back to the timber sole plate that is at the base of the timber frame, which sits on this brick plinth. This is what you need to stop from happening. We have seen a very good lead detail, which is no doubt expensive and time consuming to fit.

Close up of base of wall

Initially before the winter of 2011 you need to make sure there is as little water as possible sitting on, or able to sit on, the plinth.

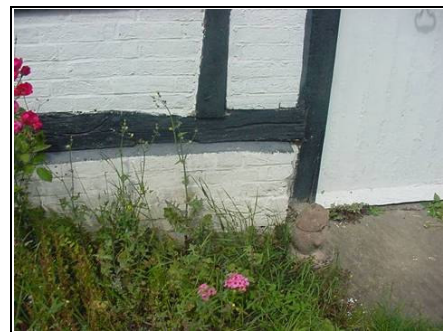
External timber frame with brick infill panel

ACTION REQUIRED: You need to methodically work around the property repairing any damaged timbers. We suggest that you work elevation by elevation.

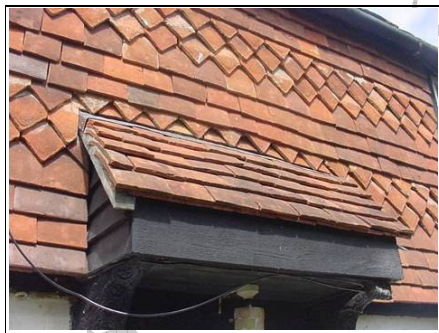
The property has decorative vertical tiling. In some areas this is in good condition, in other areas it needs rebuilding, for example on the left hand gable. Vertical tiles may be fixed directly to a wall or battens, or indeed counter battens. It is necessary to nail all tiles and it is also good practice to use an underfelt and lap the tiles to approximately two inches (30 mm).

We noted vertical tiles coming off to left hand side of building.

Vertical tiling

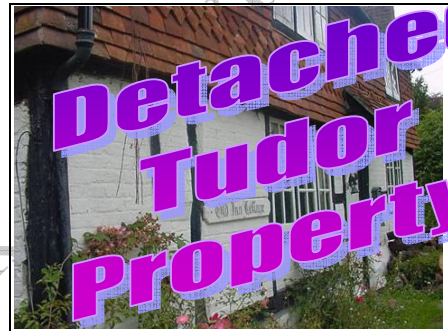
If you wish to continue the black and white look of the building then you will have a lot of redecoration, as this ultimately acts as the raincoat.

Black and white decoration

There are various other ways of treating the timber, such as lime washing it or using an oil. No doubt as your knowledge improves you will come to a decision on what is best for the property. Again you will always need to consult the Conservation Officer.

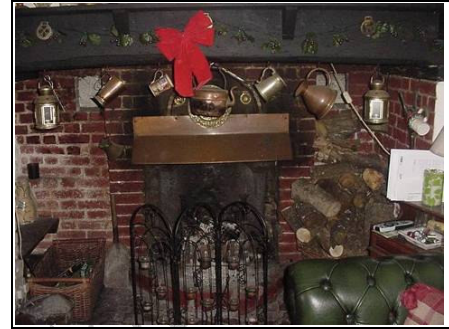
The chimney breasts are located to the left and right hand sides (all directions given as you face the front of the property). We can see that the left hand side forms the inglenook fireplace and to the right hand side forms the corner chimney in the dining room. Both are external brick chimneys and both have been added after the original property was built which is not unusual in this age of property.

Ingenook fireplace

At the time of the survey no chimneys were in use. Any chimneys that you do not propose to use should be capped and ventilated to prevent dampness.

Finally, it is strongly recommended that flues be cleaned and checked for obstruction prior to use to minimise the risk of hazardous fumes entering the building.

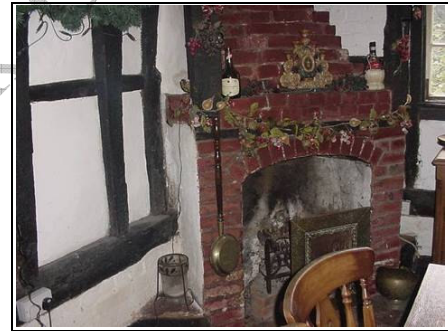
Chimney in dining room

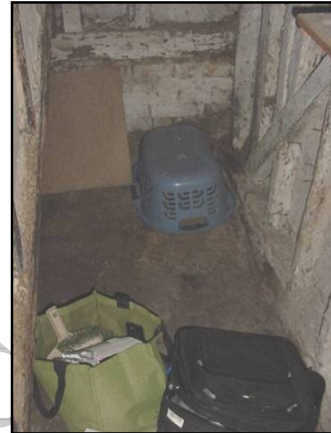
The floors to this property are beaten earth, possibly with a lime covering, with various types of tiles and stone laid directly onto the earth.

Beaten earth under the stair area

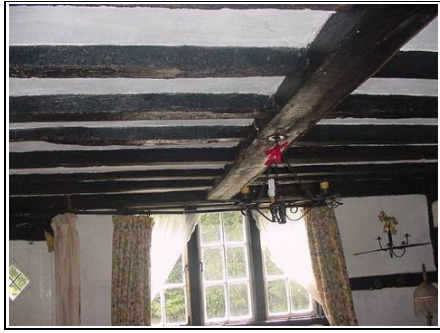
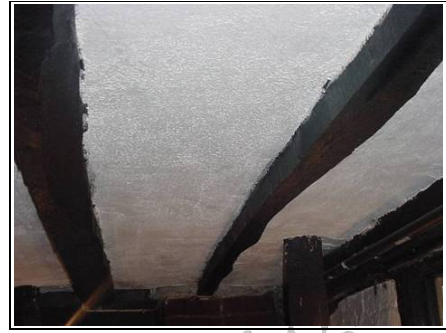
Timbers supporting first floor

The timbers therefore given an element of deflection (springiness) when you walk upon them. This springiness is added to by the woodworm deterioration that we noted within this timber frame. This is another important reason why you need to reduce or get rid of completely the woodworm.

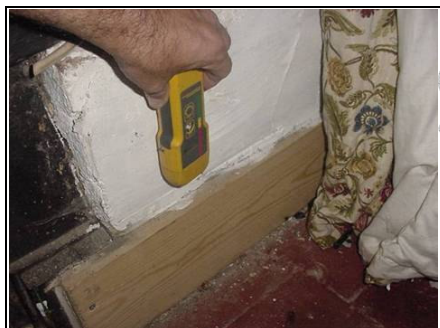
As we would expect in a property of this age it has dampness.

Checking for rising damp

ACTION REQUIRED: Please see our comments in the Executive Summary with regard to how we recommend reducing dampness. You will not get rid of the dampness.

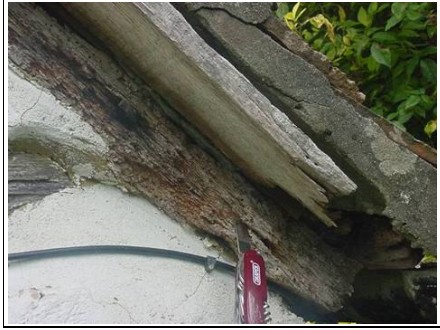
Woodworm was found both old and new, which we believe is active.

Woodworm

ACTION REQUIRED: Please see our comments in the Executive Summary.

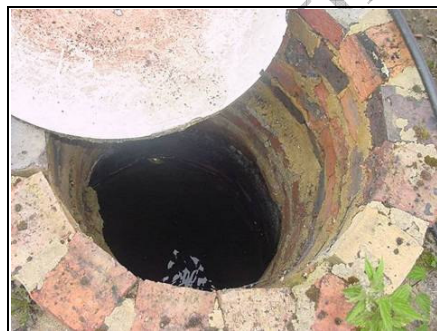
As with any good old property there is a well close to the rear of the property. We have in the past had experience of these causing structural problems with the property but the majority of cases that we see the well and the house live happily next to each other.

Well to the rear of the property

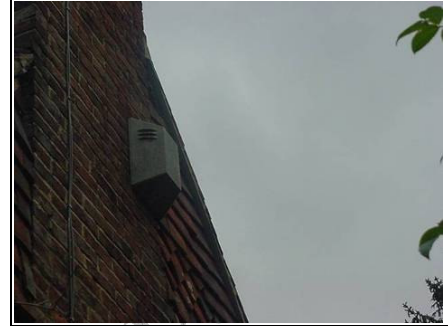
We did note a security alarm box on the outside. We are not certain whether this still works. A good alarm system should not only help reduce break-ins but also your insurance. We are not experts in this field and therefore cannot comment further. Further information should be obtained from the vendor and the installer at a later date.

Alarm box

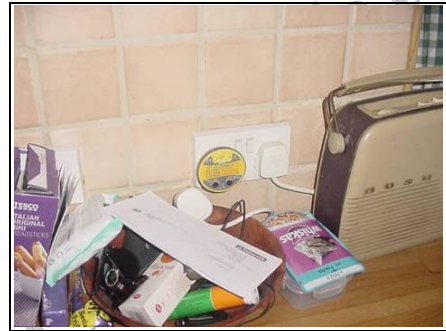
We carried out an earth test in the kitchen area to the socket point that is normally used for the kettle, this proved satisfactory.

Earth test

ACTION REQUIRED: As the property is changing occupancy an IEE report should be carried out by a NICEIC registered and approved electrical contractor.

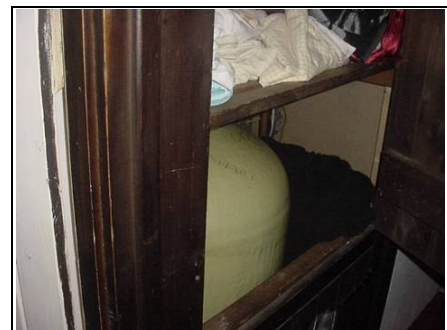
There is a factory lagged insulated hot water cylinder located in the upstairs airing cupboard.

Hot water cylinder which is factory lagged

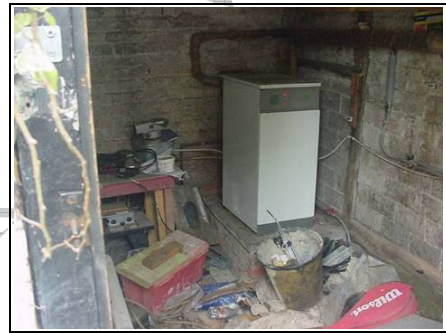
The oil boiler was located in the oil shed, manufactured by Worcester.

Our limited inspection of the hot water and central heating system revealed no evidence to suggest any serious defects but we would nevertheless recommend that the system be tested and overhauled before exchange of contracts and that a regular maintenance contract be placed with an approved heating engineer.

Boiler

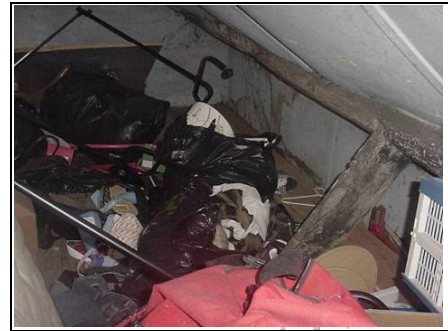
Unfortunately in this instance our inspection has been very limited due to the amount of stored items in the rooms in general, but specifically in the store rooms to the rear of the property which we could not get in. Also we had a very limited view of the roof due to the mass of stored items.

Some of the rooms were full of stored items particularly the rear store and the store rooms/cupboards off each bedroom
