JOB REFERENCE: XXXX

RESIDENTIAL BUILDING SURVEY

Bedfordshire

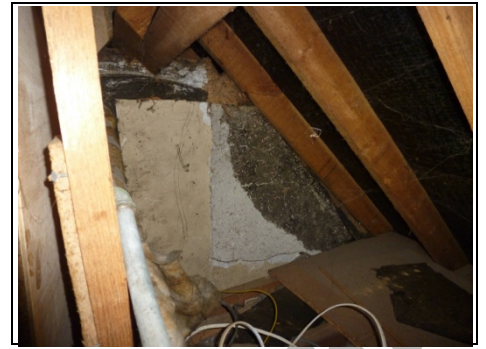
Gable end of building next door

We believe the building has been changed considerably and it looks like a new timber frame has been put in. There may be some old timber frame remaining however the only part we could see was on the left side gable end and we could see some old pargeting render on the right side, both within the roof.

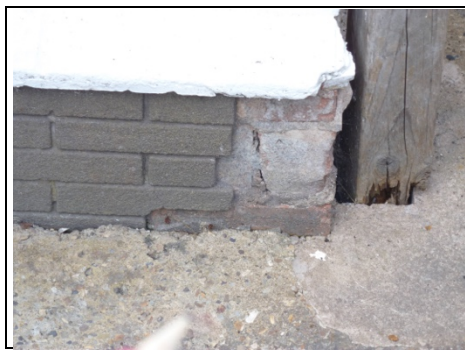
No doubt the people carrying out the work had good intentions however they do not look like they have left much of the original building. There may be some older brick to the base of the building however this has been hidden by a brick tile (we say brick however it is probably pressed concrete to look like brickwork).

Brick tile to base

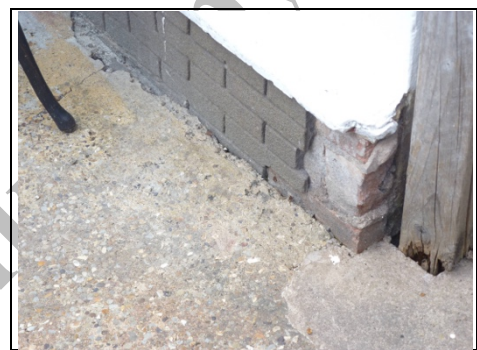
Brick tile to base

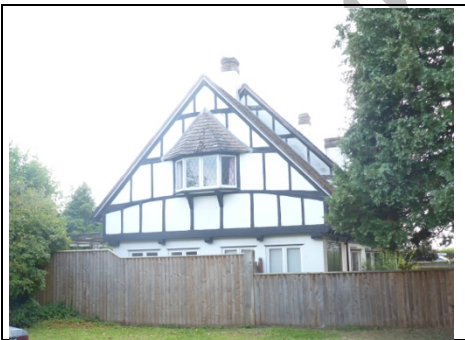
Left gable

There are some timbers visible to the gable end that are starting to rot at high level. This may or may not be part of the original box timber frame. Within the roof space we could see some older timbers therefore care should be taken when examining this area. We would be more than happy to return and help if so required.

ACTION REQUIRED: Repair.

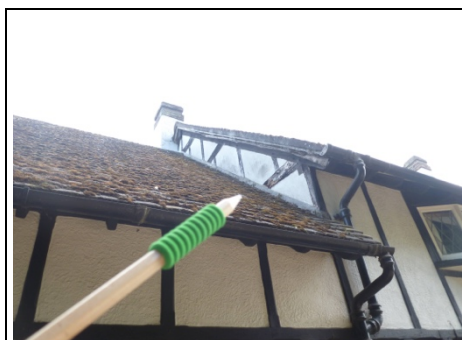
Rot to gable end

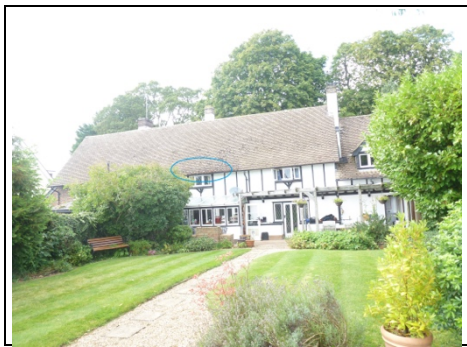
Tile guard

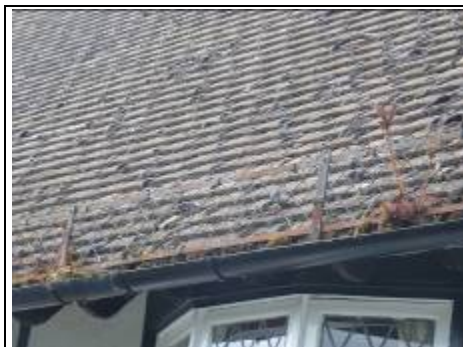
Tile guard rusting

ACTION REQUIRED: Monitor roofs. The difficulty with carrying out work on these roofs is that when you move one tile you have to move a lot of tiles so sometimes these roofs bond themselves together far beyond what you would expect. We would however start to budget for roof repairs.

ANTICIPATED COST: Budget £2,500 - £5,000 for repairs. We would also identify a matching tile and ensure that you have a store of replacement tiles available. Please obtain quotations.

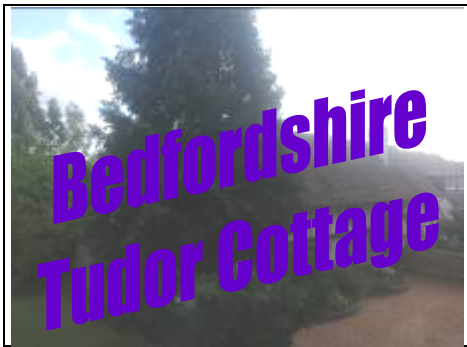
We believe that trees encourage the moss on the roof and also limit sunlight. We would ad that we personally like trees however are aware that not everyone does.

Tree to front
~ Aerial View - 360 Photo ~

ACTION REQUIRED: We recommend maintenance of the trees as soon as possible.

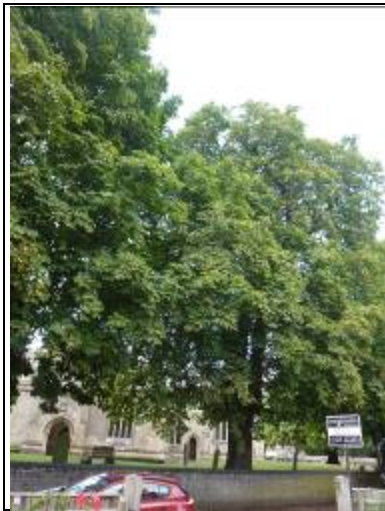
The nice thing about having trees in your garden is that you have control over them and you can let them grow as big as you like or decide not to let them grow and coppice them. The difficulty with other people's trees, such as the church trees across the road and the trees on the boundary of your property, is that you have to persuade other people to maintain them or cut them back.

Trees to church

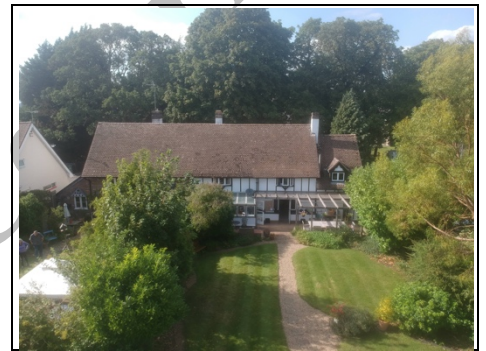
Church trees double the height of the property

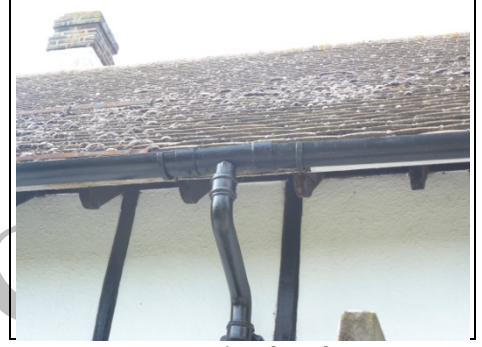
Exposed rafter feet

Rot to timber structure and secondary timbers

There is rot to the timber gable end which we have already mentioned in the high level work. With an older timber frame the quality of timber used was very good. Our concern is with a refurbishment post war the quality of timber may not be as good. We believe it is possible there will be considerable work required to the timber frame.

ANTICIPATED COST: Budget £10,000 - £15,000 for timber repairs; please obtain quotations.

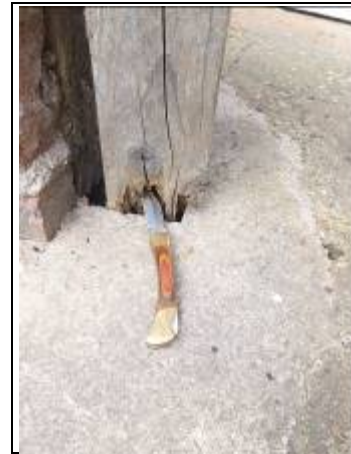
We found rot to the trellis.

Rot to rear trellis

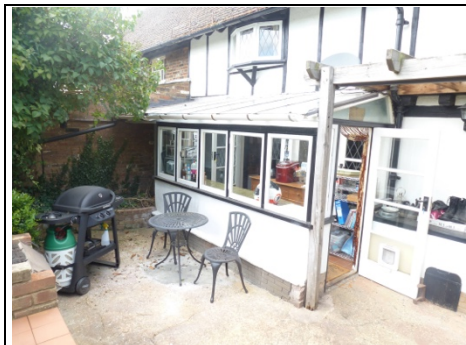
The rear right glazed roof has leaked over the years. We can see it is a known about problem and has been repaired with flashband.

Rear boot room

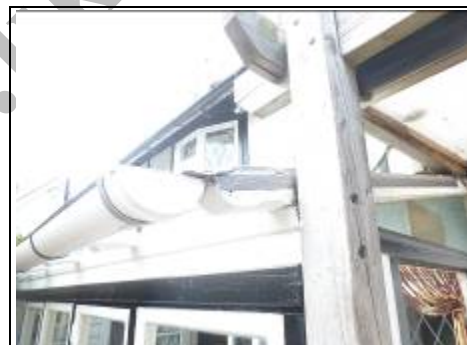
Flashband repair

Flashband is a sticky backed felt which is best used for temporary repairs only.

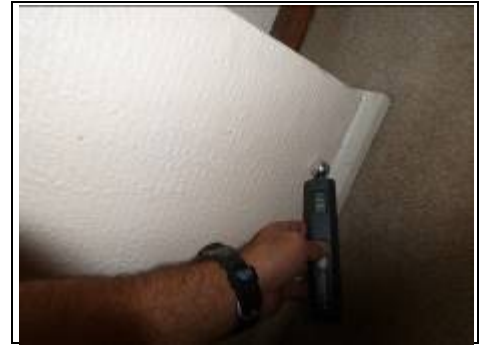
The ground level around the property seems to be slightly high, possibly it is on a slight slope (it is difficult to be certain) and we obtained damp meter readings internally.

High damp meter reading

ACTION REQUIRED: We recommend that you start by lowering the ground level around the property to see if this helps. You may not even notice the dampness in the property and to some extent older properties do need some dampness. If it is problematic then adding a French drain to divert water around the property should help.

ANTICIPATED COST: In the region of £3,000 – £4,500; please obtain quotations.

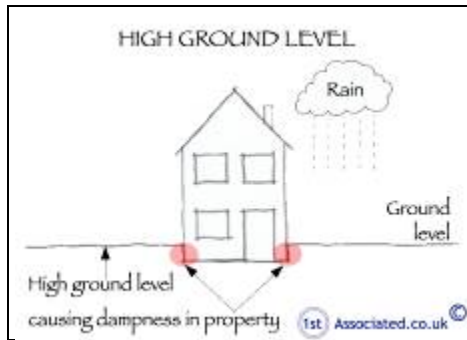
High ground level

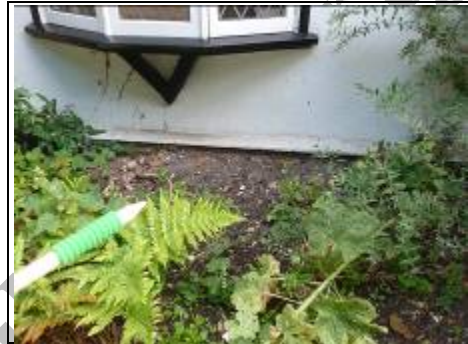
High ground level and render to base

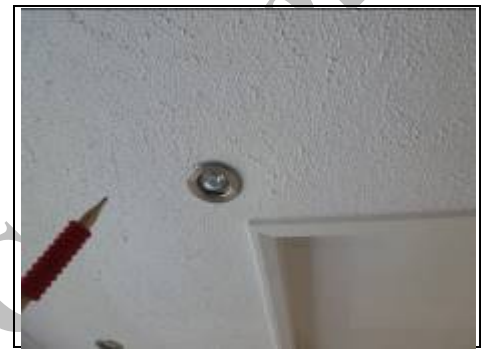
Textured paint

ACTION REQUIRED: The only way to be one hundred percent certain with regards to Asbestos in a property is to have an Asbestos report with samples taken and the recommended action carried out.

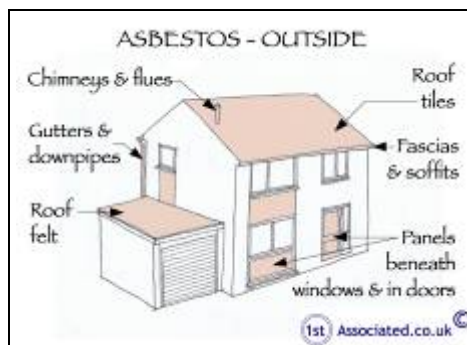
Asbestos - outside

We would always recommend any asbestos is removed from a property as it can not only be dangerous, it can affect the value of the property.

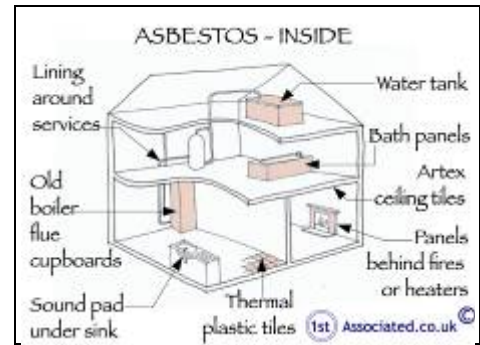
Asbestos - inside

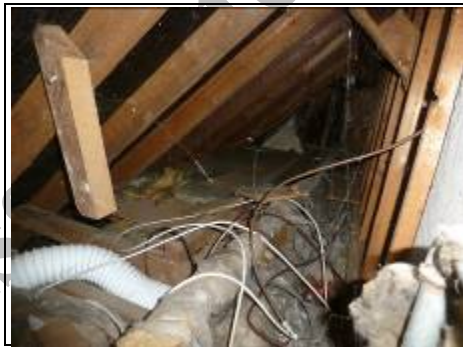
We noted an extract in the bathroom however it is still likely to have condensation as the ceiling is partly built in the roof.

Extract trunking within roof space

ACTION REQUIRED: We would recommend large good quality humidity controlled extract fans are added to the kitchen, the bathroom and any areas that are humidity generating for example areas that are used for drying clothes internally during winter months (we would assume that clothes will be dried externally during the warmer months). By large extract fans we mean 150mm.

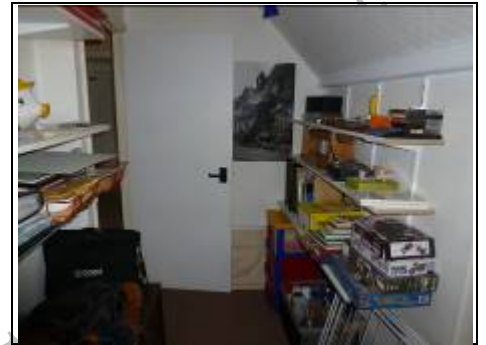
Cold bridging is a feature of this era of property as some of the ceilings are formed partly within the roof.

Ceiling formed partly in roof

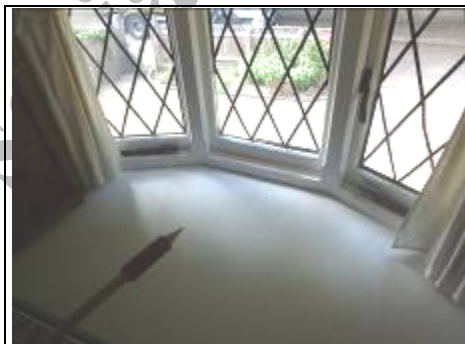
Oriel windows will be cold

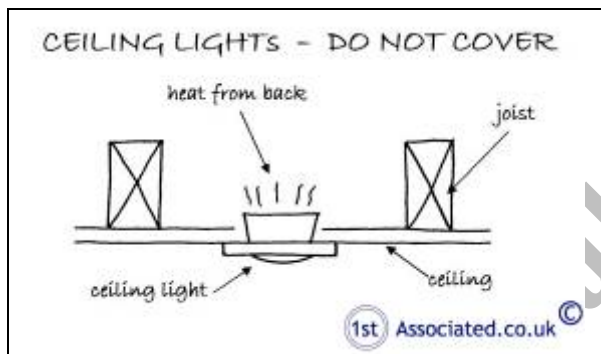
The property has ceiling lights which when we were in the left side of the roof did not seem to have proper covers. We are aware that some modern LED lights and low energy lights do not need covers. These lights are worth checking as there have been fires caused by these lights in the past (we would certainly recommend ensuring they are not covered with anything).

Ceiling lights

ACTION REQUIRED: Electrician to check.

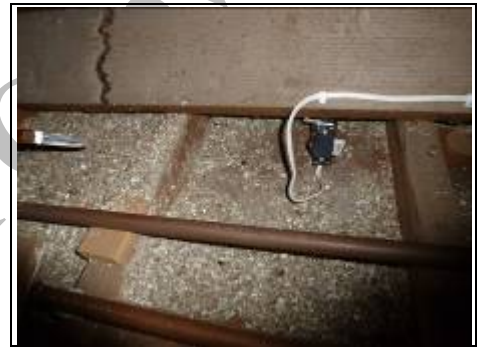
Lights not capped properly

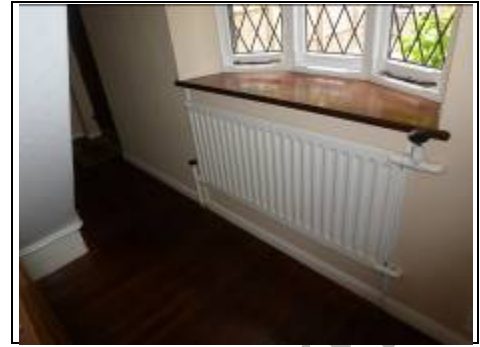
Older style single panel radiator

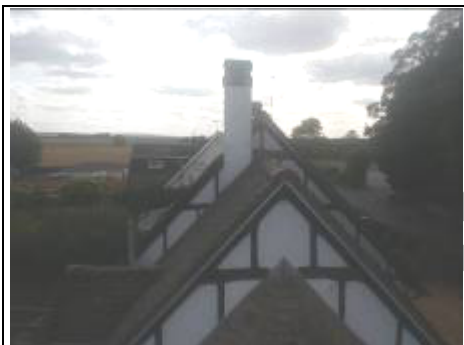
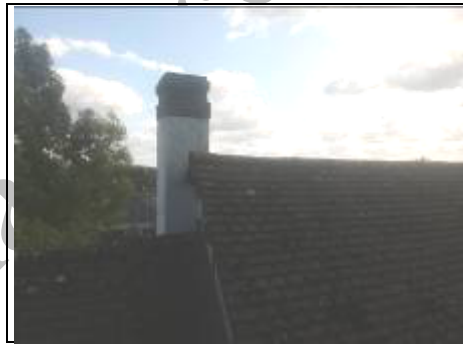
This chimney is painted render finished with a brick top and a lead flashing. From what we could see from ground level it looked in below average condition considering its age, type and style and would benefit from some work due to the cracking.

Left chimney
~ Aerial View - 360 Photo ~

ACTION REQUIRED: Please see our comments in the Executive Summary.

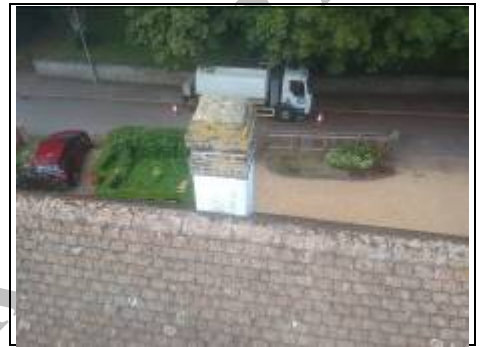
This chimney is render finished with a brick top and lead flashing. From what we could see from ground level it looked in below average condition considering its age, type and style with hairline cracking. The chimney looks to have had some repointing work to the top brickwork; ask the existing owners what work has been carried out and when.

Chimney capped rear view
~ Aerial View - 360 Photo ~

ACTION REQUIRED: When carrying out work to the left chimney we would also recommend work to this chimney.

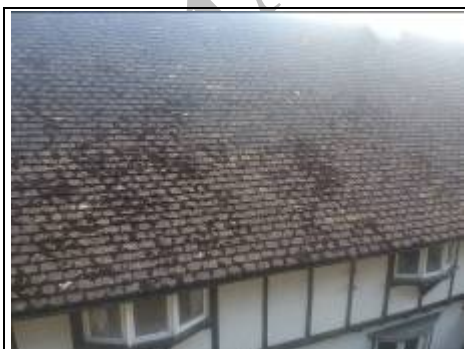
There is some moss on the roof which we believe is causing deterioration to the tiles although we are aware it takes a long time to deteriorate tiles. We recommend removing moss with a soft brush, we do not recommend high pressure cleaning or chemicals are used on a roof. There is a tile guard to the rear over the Georgian wire polished plate glass roof which has been present a while as it is rusting and will need checking.

Moss on roof
~ Aerial View - 360 Photo ~

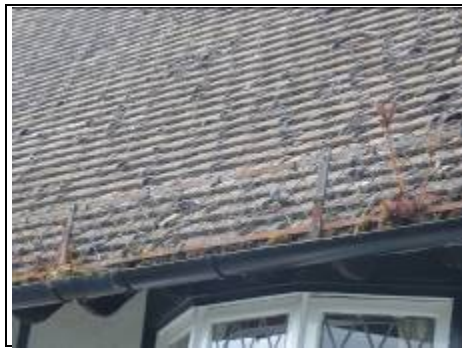
Tile guard rusting

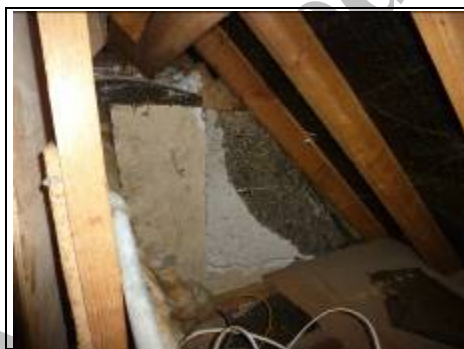
Right roof space

When we inspected the loft space we found a Hessian base Bitumen membrane. This type of membrane has been used since the 1960's. We generally found it to be in average condition, with damage in some areas which is what we typically find.

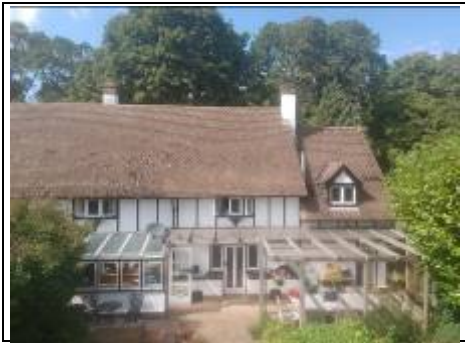
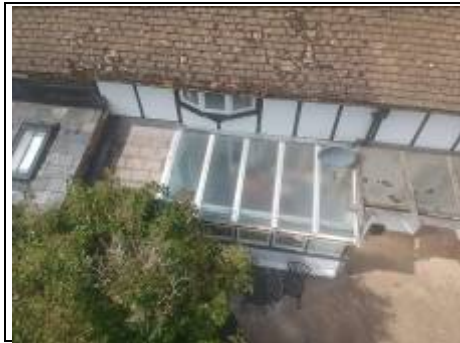
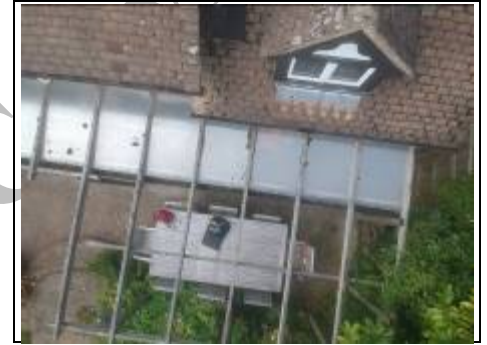
The rear canopy has a Georgian wire polished plate glass roof with flashband repairs. We believe the timber frame that it sits in needs repair. Care needs to be taken with these large sheets of glass.

Rear canopy

Georgian wire polished plate glass
roof

Rear canopy
~ Aerial View - 360 Photo ~

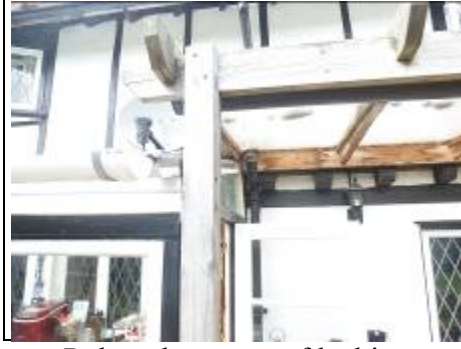
There is a plastic/polycarbonate roof to the trellis forming a covered walkway from the rear of the property to the garage/utility area. Some of the timber looks to be deteriorating on this.

Polycarbonate roof leaking

ACTION REQUIRED: Repair timber.

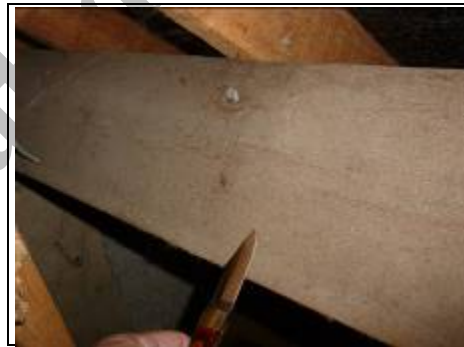
Knife test to purlin

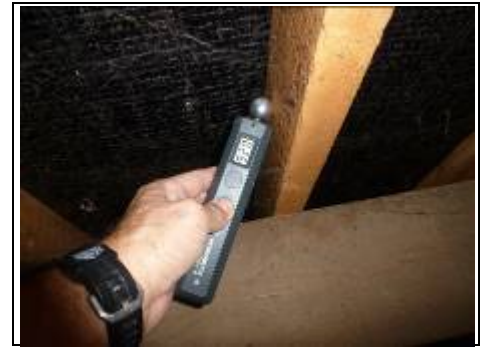
Damp testing common rafter

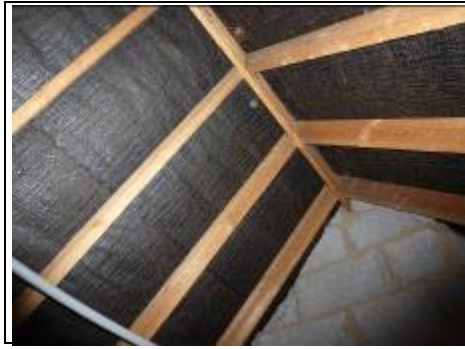
New left roof

This is a modern timber roof which has dampness getting in. We also tested this roof and found dampness; we are not certain how this got in, it may possibly be condensation.

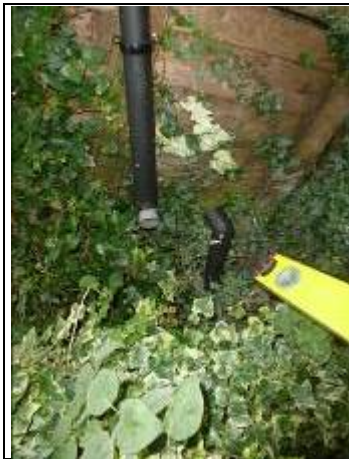
Downpipe to right loose

We also recommend that the gutters and downpipes are cleaned out, the joints are checked and the alignment checked to ensure that the gutters fall towards the downpipes.

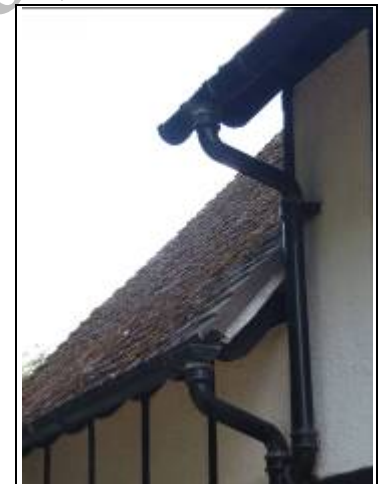
We noted that the property has a mixture of cast iron gutters and downpipes and modern replacement plastic gutters and downpipes. Where these two materials are mixed there are often problems where they join and also in the falls to the outlets. In this particular case we did not see any obvious signs of significant water stains.

Cast iron and plastic gutters to front left

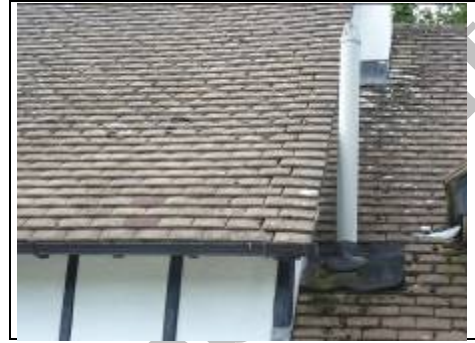
We noted a rubber flashing; we would prefer lead.

Rubber flashing

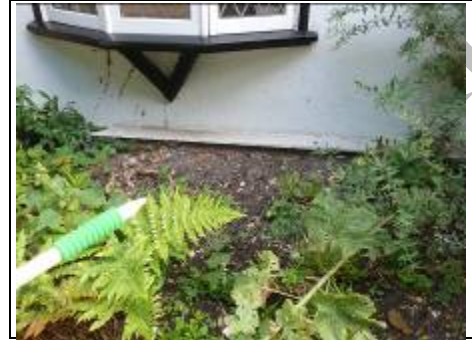
To the base of the render there was no bell mouth detail. We like to see a bell mouth to the base of the property and there to be a gap of two courses of brick.

No bell mouth detail

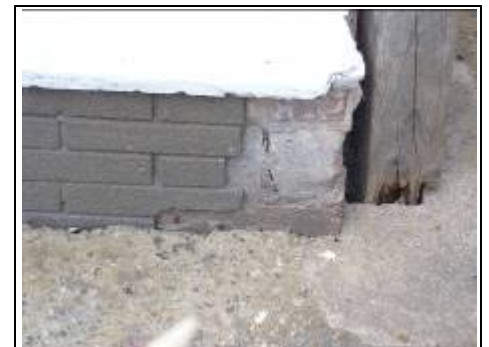
We have mentioned already the unusual brick tile detailing that has been applied to the brickwork to the base of the property in some areas.

Brick tiles applied over top of brickwork

If any work is carried out we would recommend opening up so you can understand the construction at ground floor level, first floor level and whether the timbers are pure timbers or whether they are stick on timbers as we have come across.

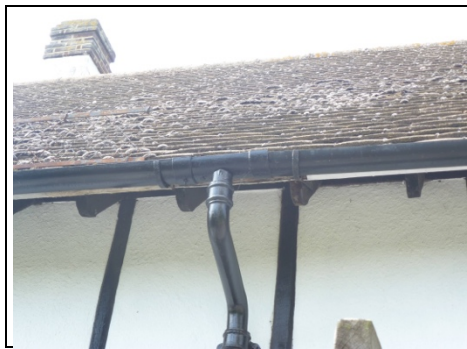
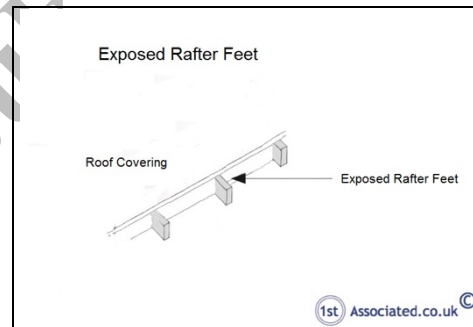
The exposed rafter feet are timber. They are painted and we would comment they are in average condition for their age, type and style.

Exposed rafter feet

ACTION REQUIRED: Make sure gutters and downpipes are watertight before carrying out any work.

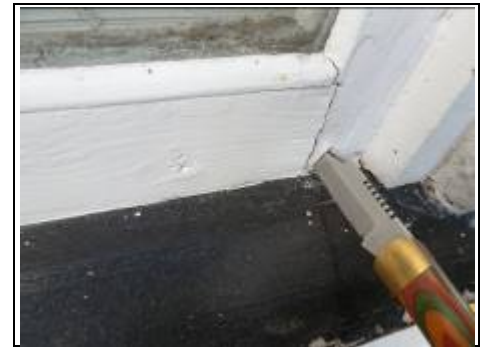
Knife test

We have tested the windows by pushing a knife into a random selection. We generally tend to do the lower windows as access is easier.

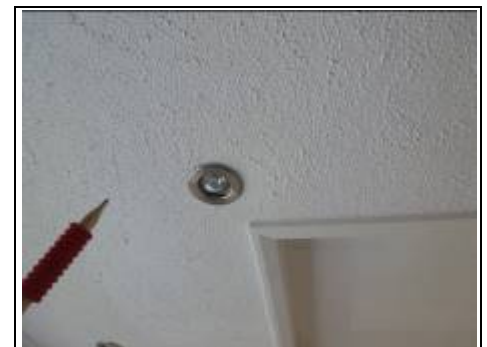
To some ceilings a textured paint finish has been used – commonly known as artex. In older textured paint there can be asbestos content.

Textured paint

ACTION REQUIRED: Please see our comments in the Executive Summary.

The only way to be one hundred percent certain with regards to Asbestos in a property is to have an Asbestos report with samples taken and the recommended action carried out.

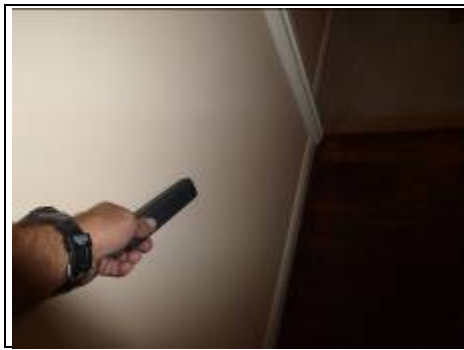
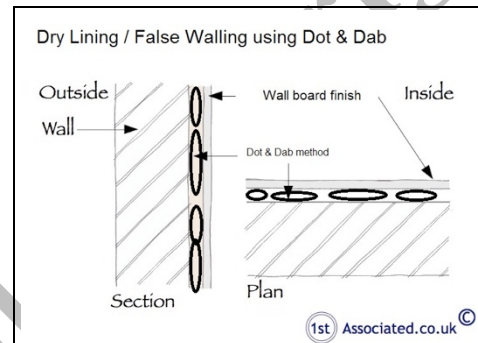
We noted some dry lining to the perimeter walls.

Dry lining

Dry lining/false wall

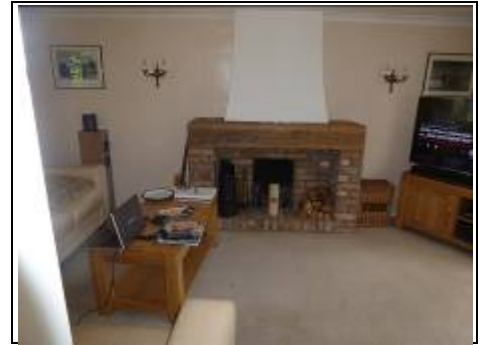
At the time of the survey no chimneys were in use. It looks like the fireplace in the sitting room is regularly used. As mentioned we found cracking to the chimney. This could be more than just surface cracking although we believe this is unlikely. We would recommend the chimney is swept if it has not been swept recently and the lining checked as well.

Fireplace in sitting room

Any chimneys that you do not propose to use should be capped and ventilated to prevent dampness. Any chimneys you do intend to use should be swept and a check should be carried out that a lining is in place.

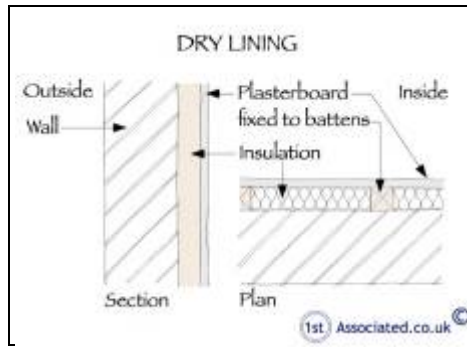
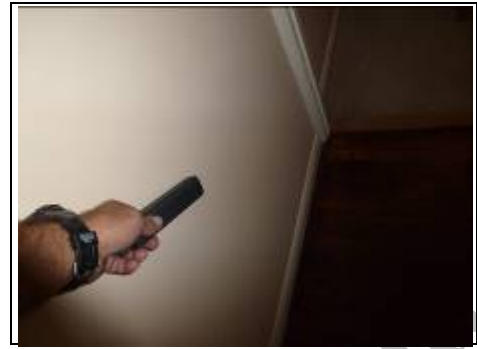
A visual inspection and tests with a moisture meter have been taken to the perimeter walls. In this particular case we have found significant rising damp which we believe relates to the high ground level.

Dry lining

ACTION REQUIRED: Your legal advisor to specifically ask the existing owners what the walls are constructed of and/or open up the walls.

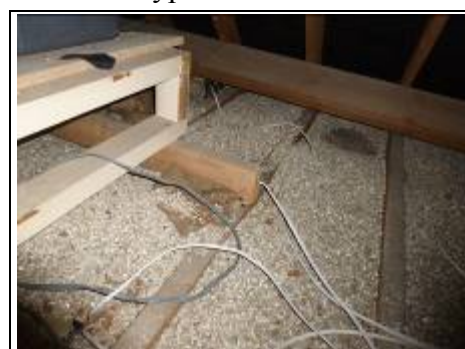
We noted vermiculite insulation which was commonly used in the 1960's/1970's. We rarely see vermiculite insulation in properties these days however once it has been put in it is very difficult to remove as it is thousands of small individual pieces.

There was a scare with this type of insulation which we think related to the US only where it was said to have some asbestos content; we would recommend the property as a whole is checked for asbestos and include checking this material as well.

Vermiculite insulation

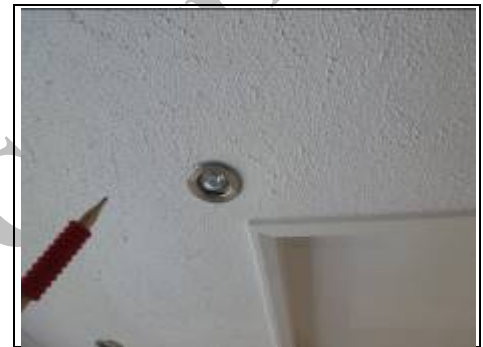
Textured paint

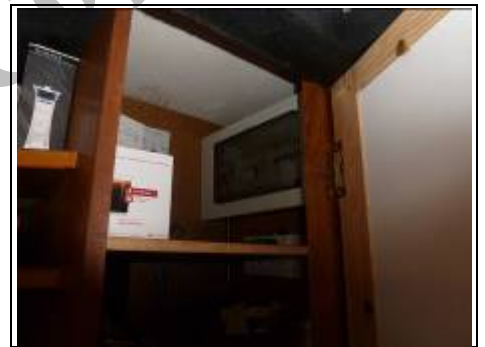
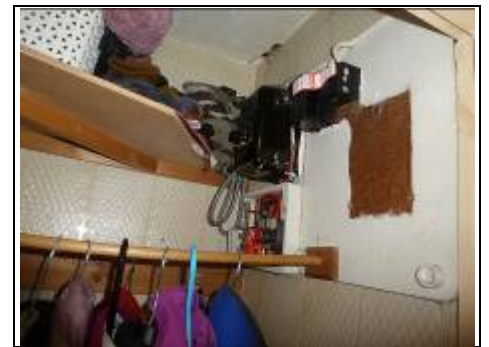
The electric fuses and consumer units were located in the kitchen cupboard. The fuse board looked 1970's-1990's and better are now available. In an older property a defective fuse board can be particularly dangerous.

There is also an old fuse board within a hall cupboard which we assume is redundant; your legal advisor to check and confirm.

Newer fuse board

Old fuse board

ACTION REQUIRED: New fuse board required.

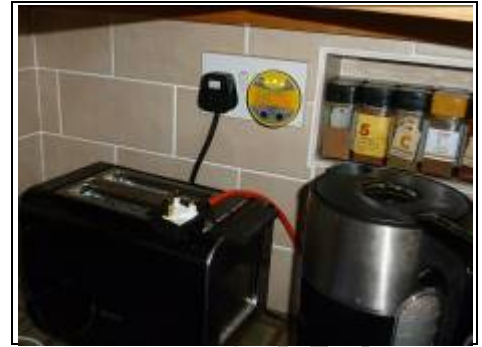
Earth test

We carried out an earth test in the kitchen area to the socket point that is normally used for the kettle, this proved satisfactory.

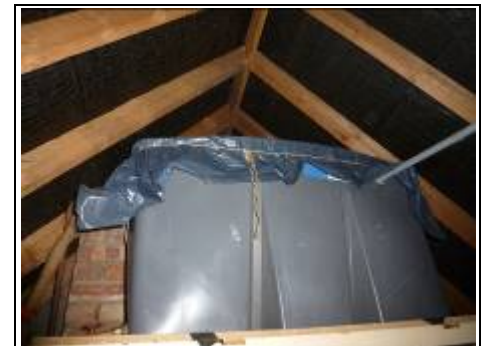
The newer left roof has a water tank, we were pleased to see it had a cover nevertheless we would still recommend it is drained and cleaned.

Water tank in newer left roof

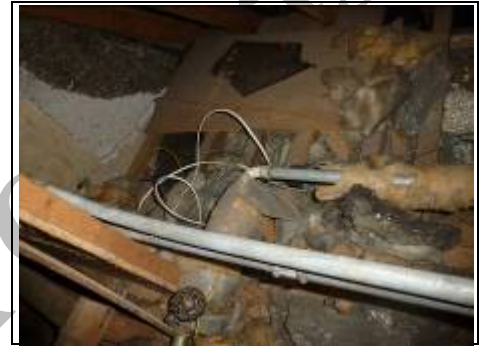
We could see cast iron pipes within the roof space which we assume are redundant.

Pipes within roof space

ACTION REQUIRED: Your legal advisor to check and confirm.

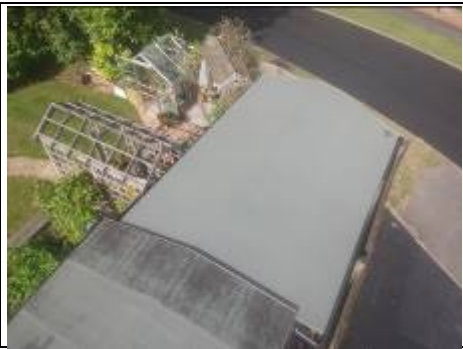
There are basic outbuildings with felt roofs. There is some wear to the felt and dampness is coming in.

Shed roof

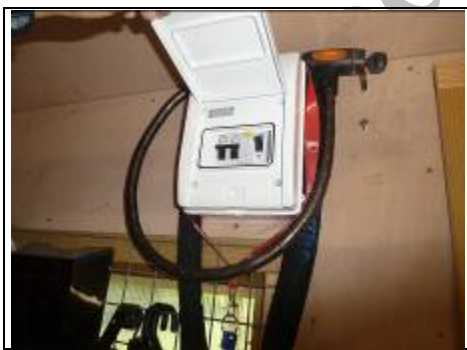
There is a fuse board; confirmation required that the fuse board has been tested.

Fuse board

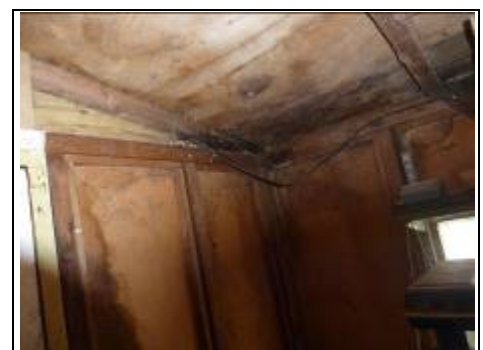
Dampness in shed

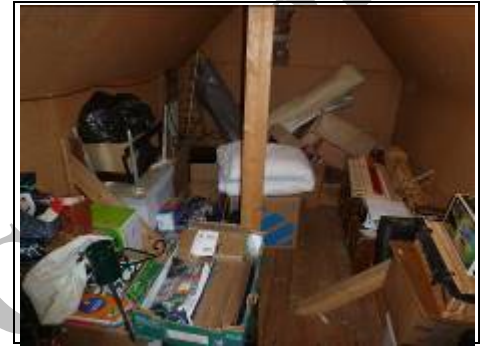
Stored items limited inspection
