JOB REFERENCE: XXXX

## RESIDENTIAL BUILDING SURVEY

Bedford  
Bedfordshire  
MK43 XXX

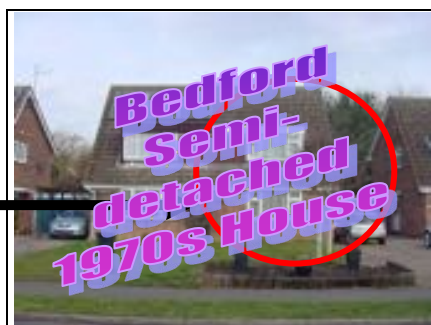
Right side of semi-detached

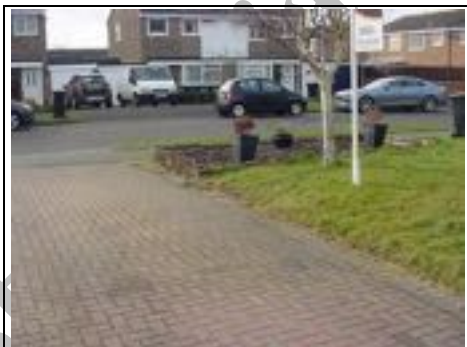
Front drive and garden with tree

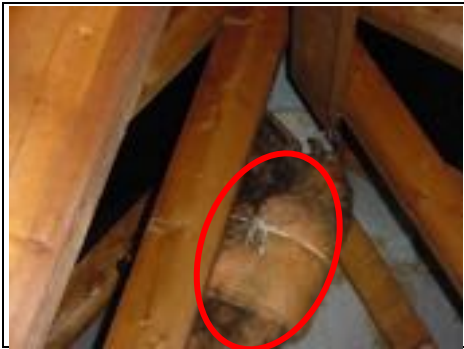
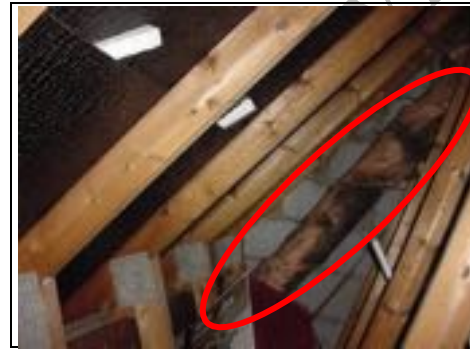
### 1.0) Asbestos flue within roof space

There appears to be an asbestos flue within the roof space. We can only see a small amount of what we believe to be asbestos as we did not have full access due to the mass of stored items within the roof.

Close up of asbestos flue

Asbestos flue

To clarify, the fireplace in the lounge, we believe has the asbestos flue and no chimney as it is vented through the ridge of the property.

Our insurance company requires us to advise we are not asbestos surveyors and advises us to recommend asbestos surveyors are instructed and that you have your own asbestos survey carried out.

**ACTION REQUIRED:** The only way to be one hundred percent certain with regards to Asbestos in a property is to have an Asbestos report with samples taken and the recommended action carried out.

We would always recommend any asbestos is removed from a property as it can not only be dangerous, it can affect the value of the property.

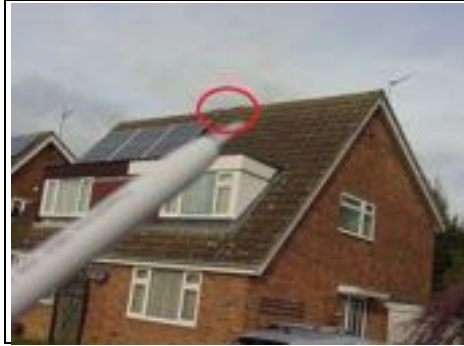
Ridge vents to yours and next doors property

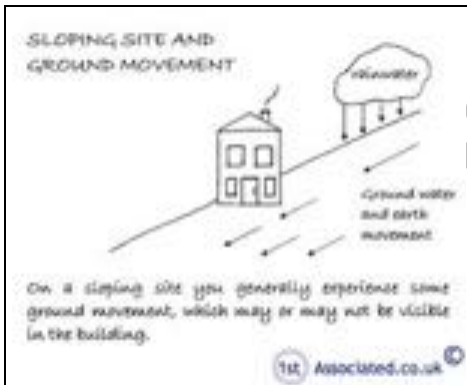
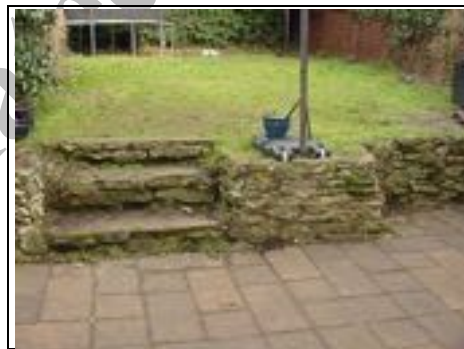
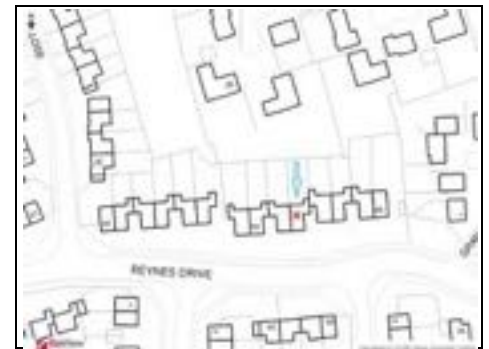
## 3.0) Sloping site

The property sits on a sloping site and because of this rainwater and ground water need to travel from the top of the site to the bottom with the building in the way. As the property slopes towards the house you may get water onto the paved area. Sloping sites are not as good as level sites and buildings on them are integrally unstable. You need to understand this is a characteristic of any building sitting on a sloping site.

Sloping site

Slope towards house

**ACTION REQUIRED:** We recommend a French drain to divert water around the property which will help reduce some of the effects of the sloping site.

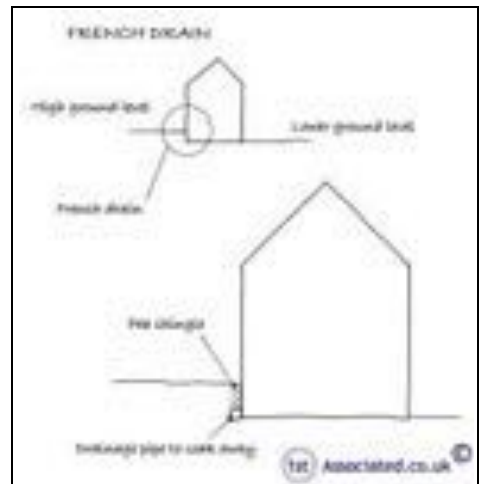
French drain

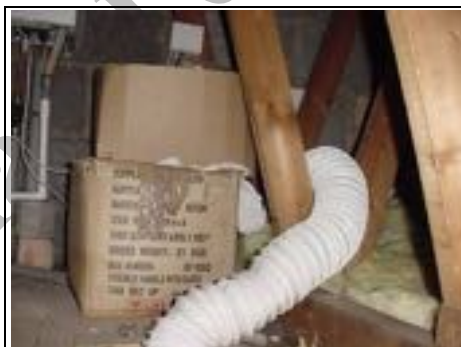
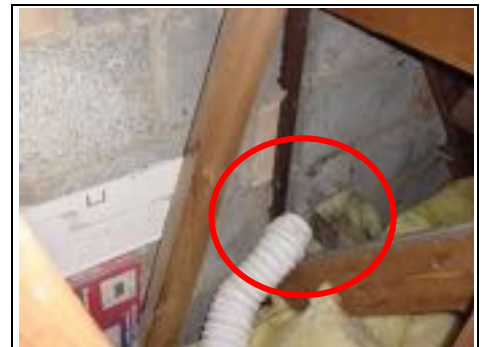
However this property has a fundamental problem with the extract fan within the bathroom discharging humid air into the roof space, this needs to be altered and the extract needs to go to external air as it normally would.

Extract from bathroom

Extract from bathroom discharging into roof

There are lots of stored items within the roof which unfortunately are adding to condensation problems. The stored items include general files, etc and also duvets and clothing, which we believe are acting like a sponge in the roof particularly as the extract fan is discharging humid air from the bathroom into the roof.

**ACTION REQUIRED:** Change extraction flue (also known as elephant trunk!) with an opening in the external wall and vent to external air.

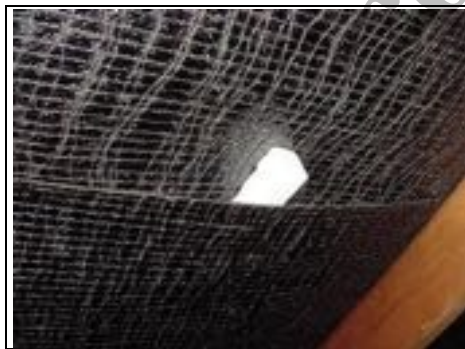
It looks like they have tried to improve airflow within the roof by adding spacers to the protective underlayer. Another way of adding ventilation is to add ventilation to the soffit boards.

Spacer to protective underlayer

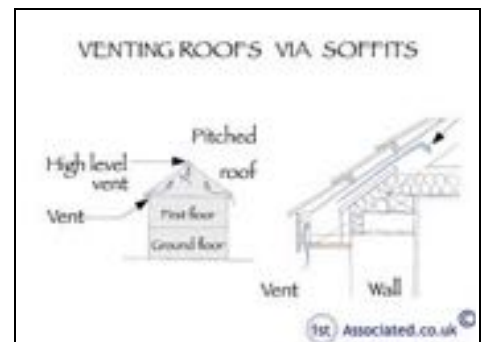
Venting roofs via soffits

**ACTION REQUIRED:** We recommend that the fascias and soffits are redecorated ideally within the next few years during the warmer months when you could look at also adding ventilation to them.

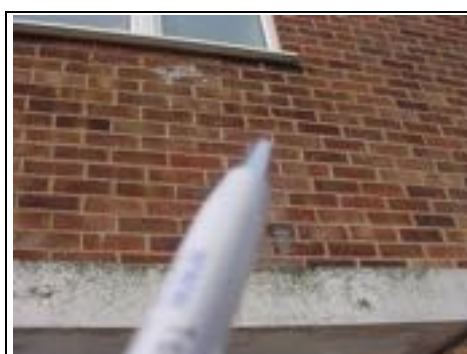
We noted spots to the brickwork which is likely be where insulation has been inserted or there is an outside chance it is wall tie replacement. We spoke to the person who had opened the house for us and they advised that they had contacted the owners and they thought it was wall insulation. However adding wall insulation is not as simple as just putting insulation in as there can be problems with wall tie deterioration and also dampness in the property.

Circular cement fillets where insulation added and/or wall ties

In a worst case scenario the wall ties will need to be replaced however having said that we cannot see any of the horizontal cracking that we would normally expect to see in a situation where the wall ties need repair.

Your legal advisor needs to check whether the insulation has a CIGA Cavity Insulation Guarantee Agency certificate to see if the wall ties were appropriate before the insulation was added as inserted insulation can cause deterioration of the wall ties. Contact CIGA at XXX, telephone XXX. If there is not a CIGA certificate then it does not mean it is necessarily a problem however ideally we would recommend opening up a small section of the wall to check the condition of the insulation and the wall ties.

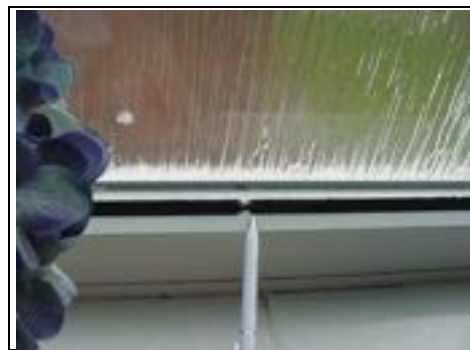
There is deterioration to the seals of the double glazed windows. We could also see black mould to some of the windows; see comments below.

Double glazing rubber seal perished

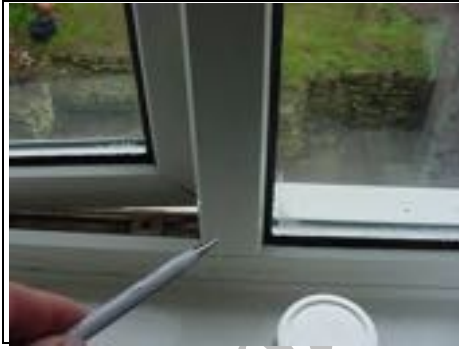
Condensation in rear right bedroom

**ACTION REQUIRED:** We would recommend large good quality humidity controlled extract fans are added to the kitchen, the bathroom and any areas that are humidity generating for example areas that are used for drying clothes internally during winter months (we would assume that clothes will be dried externally during the warmer months). By large extract fans we mean 150mm.

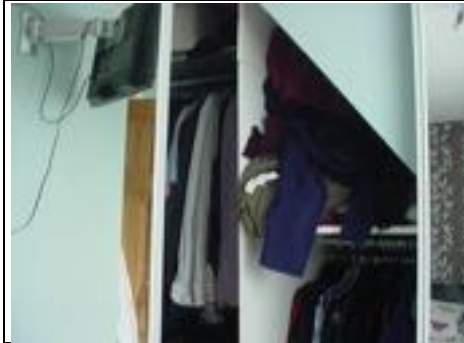
Cupboard underneath the pitch of the roof susceptible to cold bridging

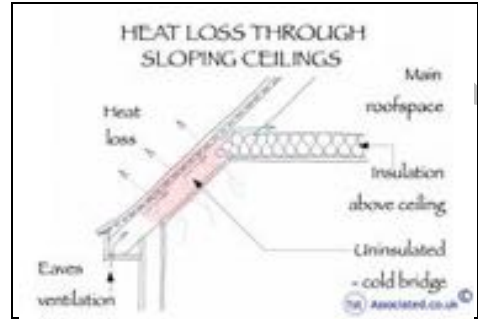
Heat loss through sloping ceilings

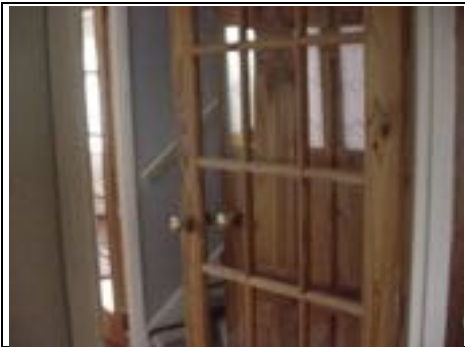
We cannot see a British standard safety kite mark on the glazed doors and we therefore have to assume that this glass is not safety glass and it can shatter.

No safety kite mark to glazed doors

**ACTION REQUIRED:** Check with the owners if this is safety glass or not. We would recommend replacing the glass with safety glass if it is not safety glass.

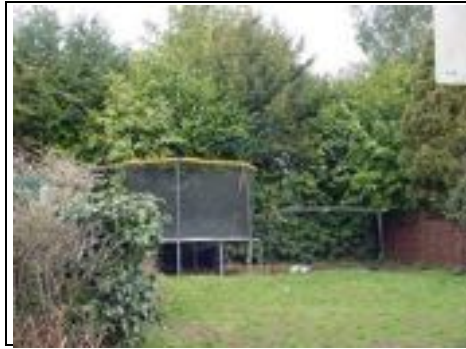
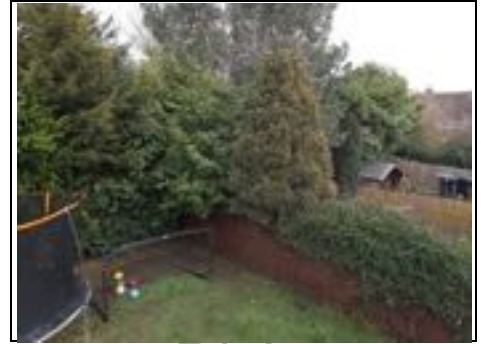
There are overgrown trees to the rear of the rear garden.

Trees to rear

**ACTION REQUIRED:** You need to check who owns the boundary and where exactly is the boundary. Cut back trees and maintain as appropriate.

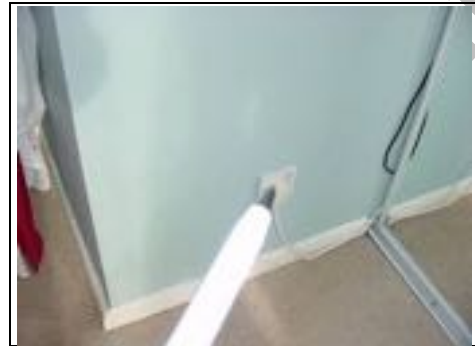
The electrics are dated with not enough socket points. We noted that the socket points are single and there are many extension cables on these.

Single socket

**ACTION REQUIRED:** Add additional socket points and change the single socket points to double socket points, you may wish to use the newer socket points with USB ports (see sketch).

We recommend an Institution of Engineering and Technology (IET) test and report to be carried out by an NICEIC registered and approved electrical contractor or equivalent.

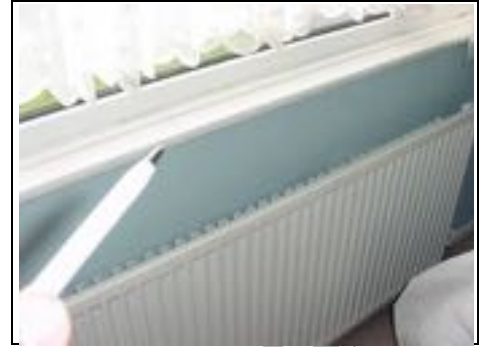
The property has single panel radiators. These may not warm the property to the heat that you desire and also may not get air circulating as quickly as you want particularly in the front bedroom with the dormer roof.

Single panel radiator

**ACTION REQUIRED:** We recommend you upgrade to double panel convection radiators. We would recommend the radiator in the lounge is moved under the window. Originally windows had panels underneath as seen on a nearby property, some have glazed the panels and in your case brick has been put underneath.

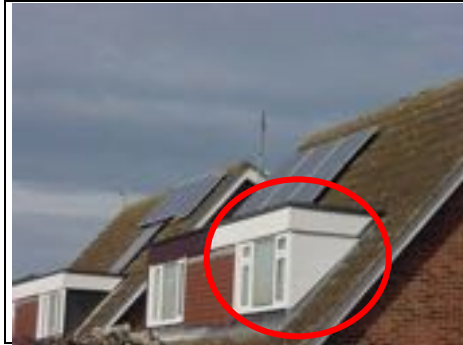
Front dormer

The dormer window has a flat felt roof, the cheeks of the dormer are horizontal boarding and vertical tiling and the windows are plastic double glazed without trickle vents.

Generally we would comment for their age, type and style they are in slightly below condition. We would particularly draw your attention to water tipping/siting on the roof and we can see there has been a repair to the flashing.

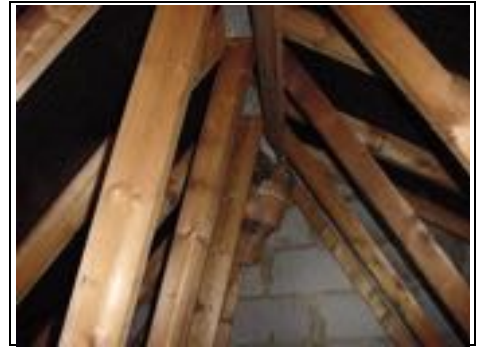
General view of inside of roof

Our examination was limited by the general configuration of the roof, the insulation and mass of stored items. What we could see was generally found to be in average condition for its age, type and style although it may suffer from condensation. It is, however, feasible that there are problems in the roof that are hidden.

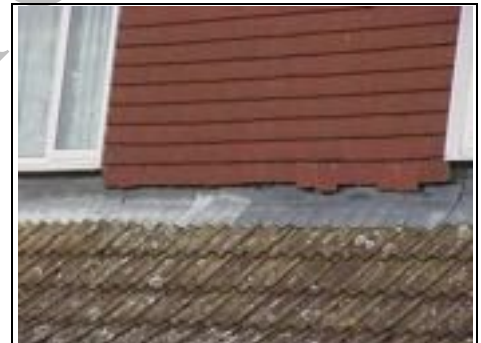
The dormer is clad in vertical tiles. We could see some slipped tiles.

Slipped vertical tiling to dormer

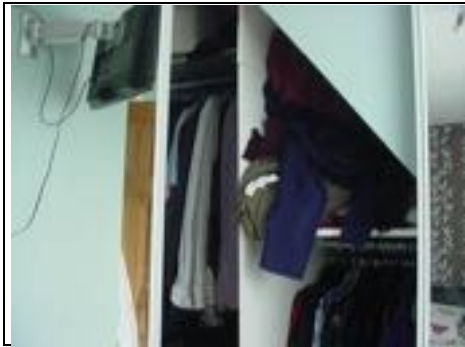
Cupboard underneath the pitch of the roof susceptible to cold bridging

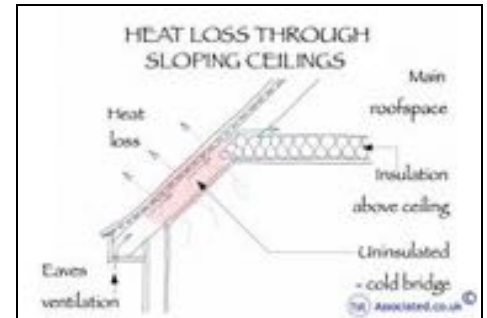
Heat loss through sloping ceilings

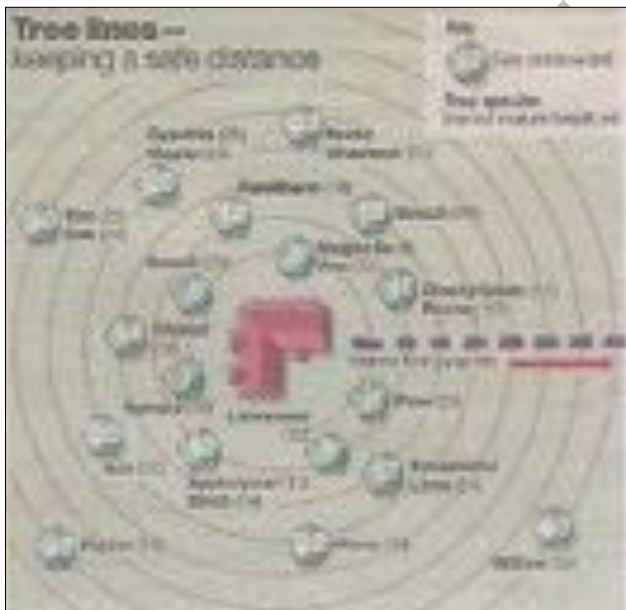
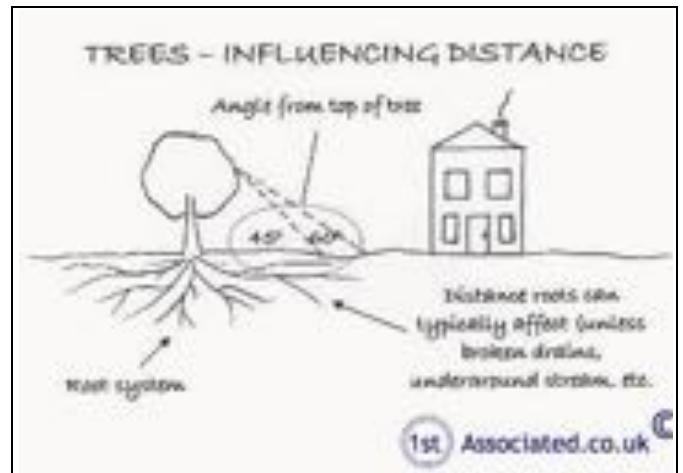
Trees to rear  
~ Aerial View - 360 Photo ~

**ACTION REQUIRED:** We would recommend the trees are cut back and maintained.

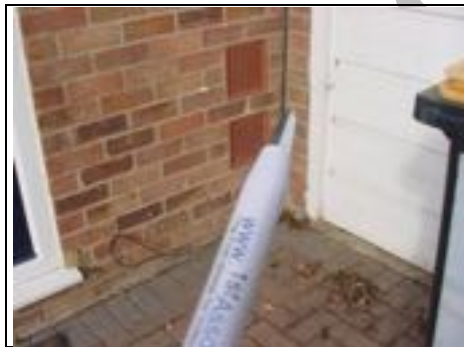
Air bricks are to help air circulation within the property. We are not sure whether they are venting or not. If you recall there was a lot of stored items in the kitchen cupboards.

Airbrick to kitchen

**ACTION REQUIRED:** Ensure the airbricks are clear.

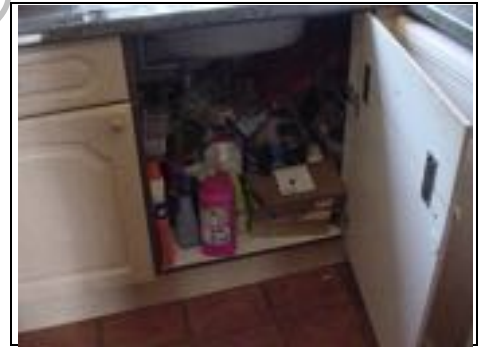
Stored items

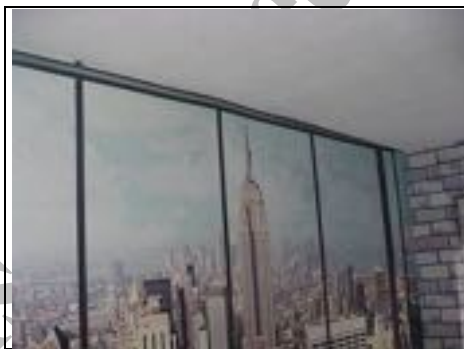
We are not sure whether this is an optical illusion or not, there looks to be a slight dip in the ceiling. There may have been very slight movement in the structure due to the openings on the rear however there are no obvious visual signs on the outside of the roof.

Has there been a lift in the ceiling?

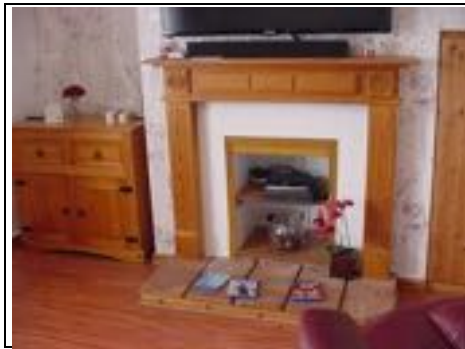
Front fireplace with asbestos flue – do not use unless new chimney installed

**ACTION REQUIRED:** Please see our comments in the Executive Summary with regards to the asbestos flue.

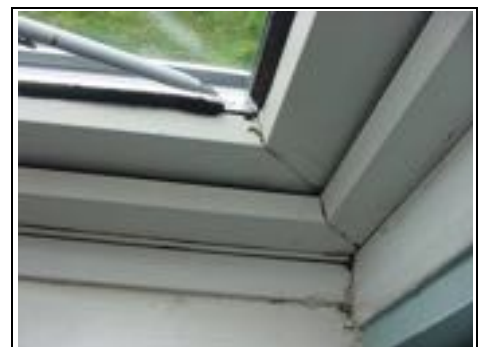
At the time of the inspection there were significant signs of condensation.

Black mould

**ACTION REQUIRED:** We would recommend good quality large humidity controlled extract fans be added to kitchens, bathrooms and any rooms where you intend to dry clothes.

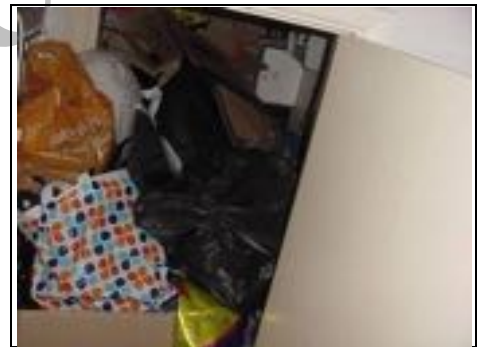
We were unable to examine the underside of the stair timbers due to it being lined where we could see it, which precluded our inspection, so we cannot comment further upon the stair structure. We can, however, say that the lining gives a resistance to the spread of fire if such circumstances were to occur.

Under stairs cupboard full of stored items

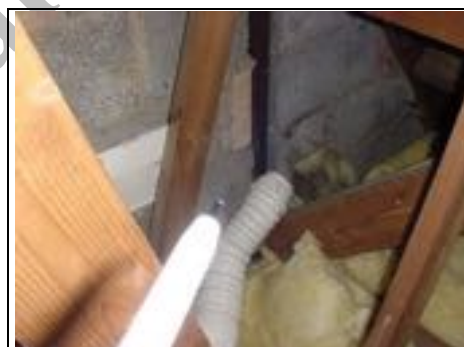
Some roof insulation was present although not to current Building Regulations requirements of 300mm. In this instance there is 200mm to 300mm.

Insulation

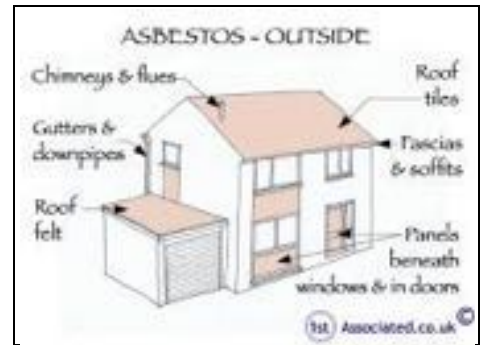
In a property of this age there may well be some asbestos. In this case we have noted asbestos to the flue within the roof space.

Asbestos externally

Our insurance company requires us to advise we are not asbestos surveyors and advises us to recommend asbestos surveyors are instructed and that you have your own asbestos survey carried out.

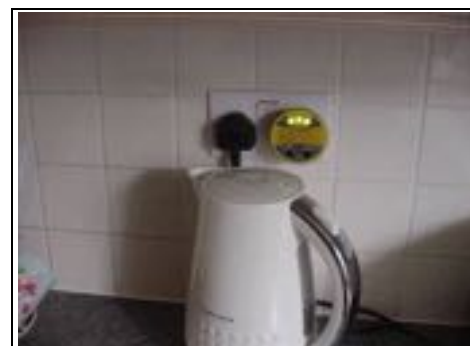
We carried out an earth test in the kitchen area to the socket point that is normally used for the kettle, this proved satisfactory.

Earth test

**ACTION REQUIRED:** As the property is changing ownership an Institution of Engineering and Technology (IET) test and report and any recommendations should be carried out by a NICEIC registered, or equivalent, approved electrical contractor or similarly approved.

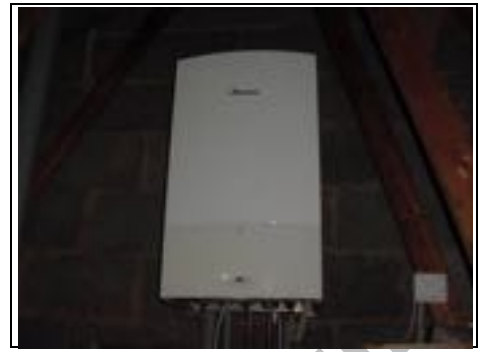
There is a Worcester boiler located in the roof space on the right wall.

Our limited inspection of the hot water and central heating system revealed no evidence to suggest any serious defects but we would nevertheless recommend that the system be tested and overhauled before exchange of contracts and that a regular maintenance contract be placed with an approved heating engineer.

Boiler within roof

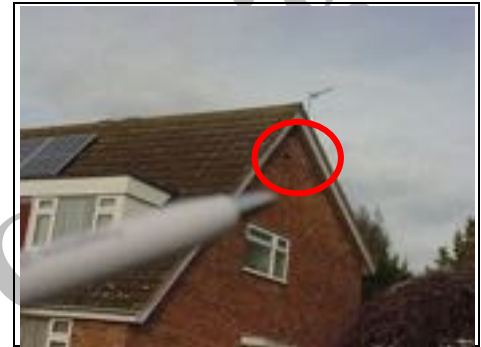
Flue from boiler within roof

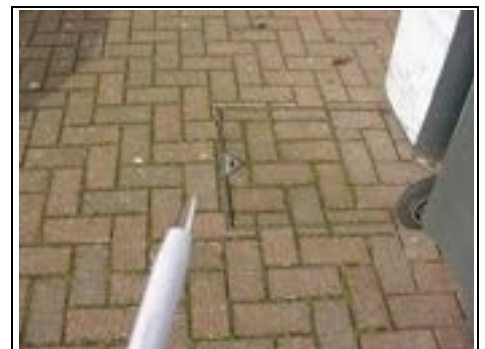
### **Inspection Chamber / Manhole One – Front of garage**

We have not lifted the manhole as it is inset therefore are unable to comment.

Manhole in front of garage

**ACTION REQUIRED:** We would recommend a closed circuit TV camera report of the drains particularly as you are looking at adding to the drains.

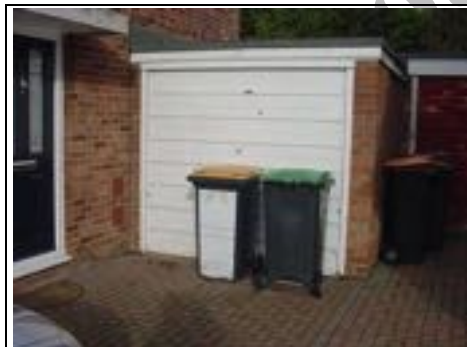
The property has a link garage with a felt roof. The garage has been subdivided with storage to the front and floor and ceiling added to the rear so can no longer gain car access

Garage to front

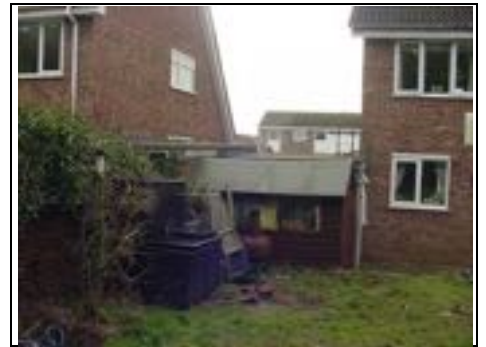
Rear view of garage

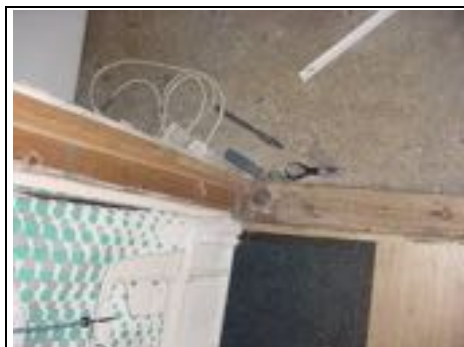
Front concrete floor and rear timber floor

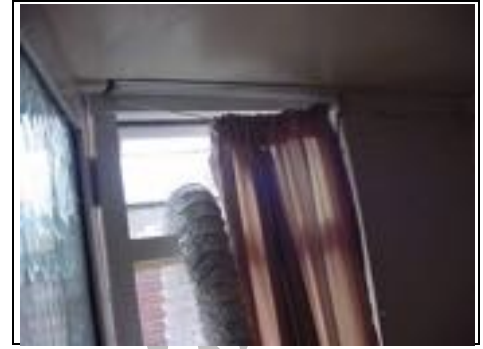
Extract from tumble dryer through window

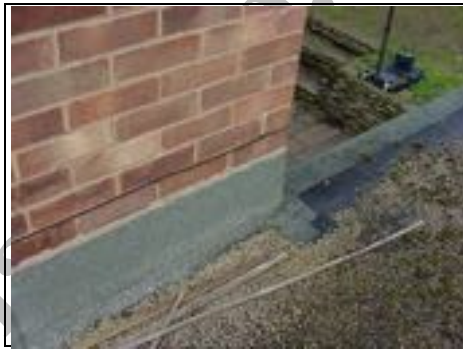
The garage has a flat roof covered in felt with a felt flashing. The water discharges to the rear of the property (in theory) however it is being caught by the shed on the rear. To the front of the property on the right side there looks to be water discharging as there is rot to the fascia board. If you re-roof we would recommend upgrading to a lead flashing as they are more pliable and tend to last longer.

Felt flashing

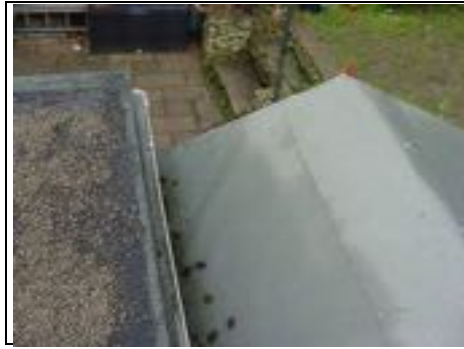
Garage – water discharging on end gutter

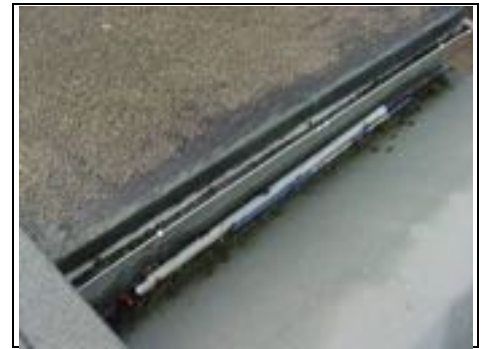
Garage gutter overflowing onto shed

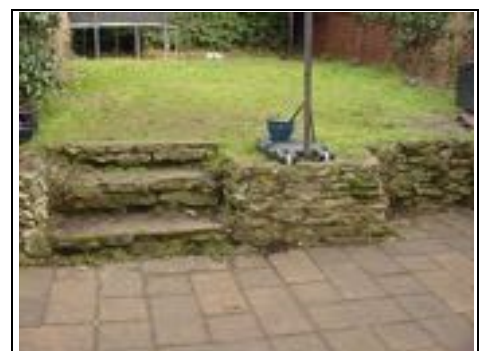
Step in garden due to sloping site
