RESIDENTIAL BUILDING SURVEY

Pre-Cast Concrete Frame House Wiltshire

Mrs X

Prepared by:
INDEPENDENT CHARTERED SURVEYORS

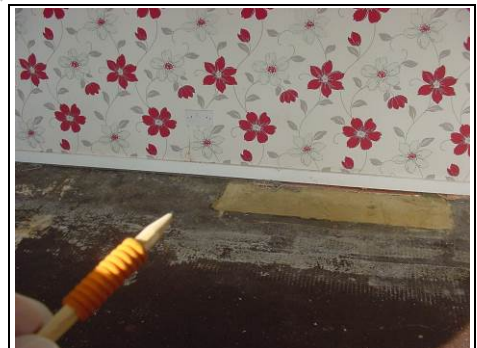
Lounge chimney removed

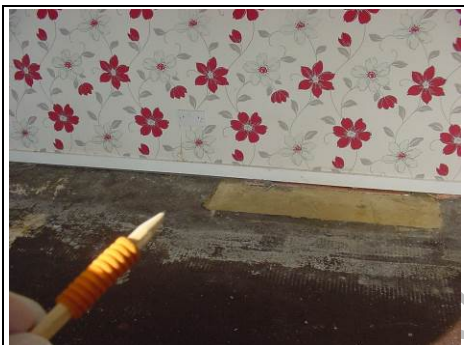
The original chimney has been modified by having the front of the chimney removed, which we can see in the lounge.

Lounge – chimney removed

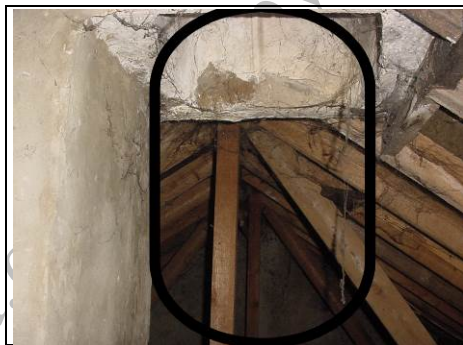
Front of chimney removed in roof space, black oval indicates where that part of the chimney once was

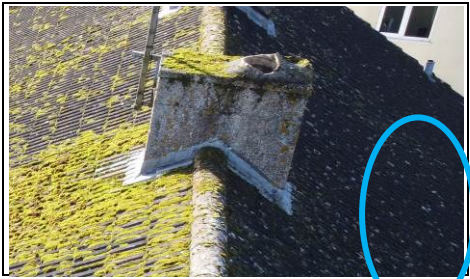
We can see a crack to the rear of the chimney, where there looks to have been a leak coming in for some time as there is rot visible around the chimney.

Close up of chimney
Aerial view – 360 photo

ACTION REQUIRED: You can either repair the chimney externally and then add in new roofing timbers, which work many need scaffolding. Alternatively you may be able to carry out some form of repair internally on a temporary basis.

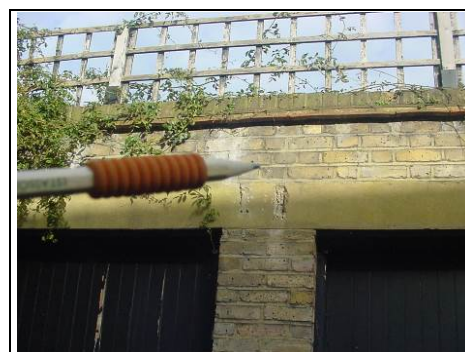
Deterioration to concrete lintel with reinforcement showing through
(Not your property)

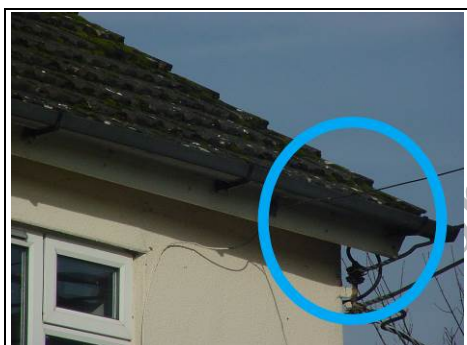
Within the property in the front right bedroom is dampness to the front right corner. As we discussed, the bargeboard has come away slightly and there could be wind driven rain getting into this area. However, we would also add that these sort of corners do attract black mould as then tend to be cold areas.

Front right corner, where approximate area of dampness is

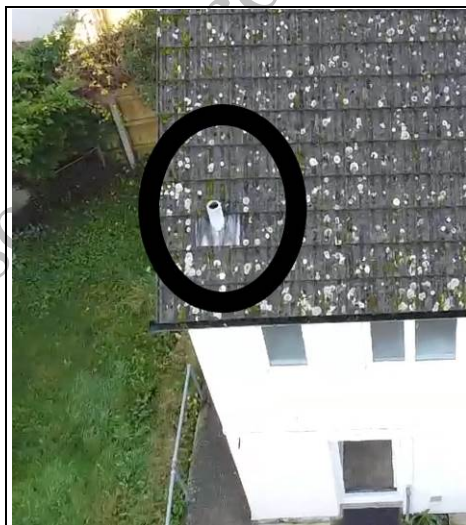
From reading the original specification of this type of building, it would have originally have had asbestos cement sheets on the roof and, as discussed, in the bathroom there are thermo-plastic tiles which do have an element of asbestos. The rear soil and vent pipe may also be asbestos, however it is difficult to see from ground level, or via our aerial photos and needs further investigation.

Soil and vent pipe difficult to view but it may be asbestos?

ACTION REQUIRED: Your legal advisor to specifically ask the owners/Housing Association if there is an asbestos report has been carried out on this property and if so what date and whether the asbestos test took samples. If they have not then you need to carry out your own asbestos report with samples taken and the recommended action carried out.

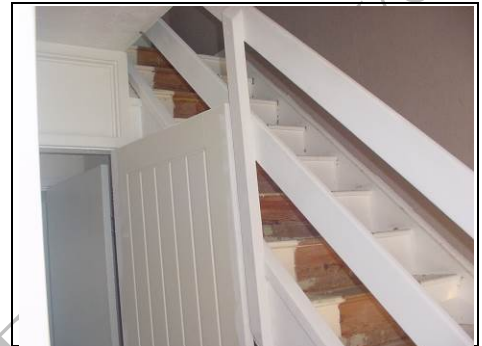
The staircase is not up to modern day standards. A modern day staircase has a limited opening of 100mm sphere (circle), roughly the size of a young person's head, to ensure they cannot fall through the staircase. This is why you typically see a balustrade/newel post etc.

Staircase not up to modern standards

ACTION REQUIRED: Amend staircase to modern day standards.

ANTICIPATED COST: In the region of £500 to £1,000; please obtain quotations.

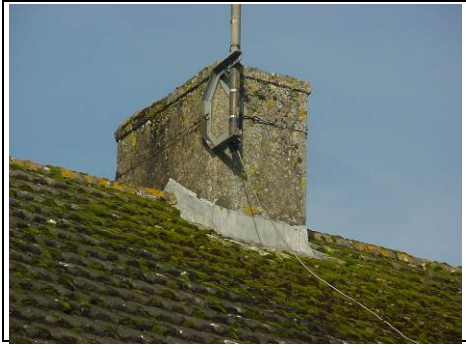
We noted an aerial attached to the chimney which we are not keen on as it cuts into the render and de-stabilises the chimney.

Lead flashing
and aerial attached to chimney

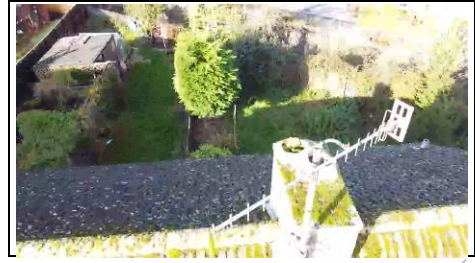
Moss to top of chimney
(flaunching)
Aerial view – 360 photo flashing

ACTION REQUIRED: Please see our comments in the Executive Summary.

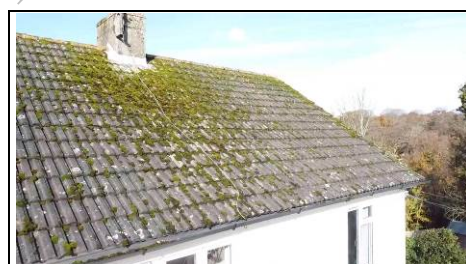
The main roof is pitched and clad with concrete tiles. From ground level, this looks in average condition considering the roof's age, type and style. It has a moss covering.

Concrete tiles with moss covering
Aerial view – 360 photo

ACTION REQUIRED: Carry out periodic inspections and maintenance of the roof, as required.

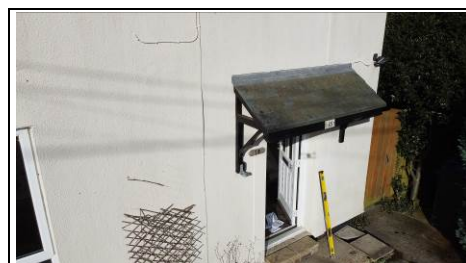
Porch roof
Aerial view- 360 photo

We would comment that GRP does get brittle over time. This looks a fairly basic construction and you may want to rebuild and add a front porch.

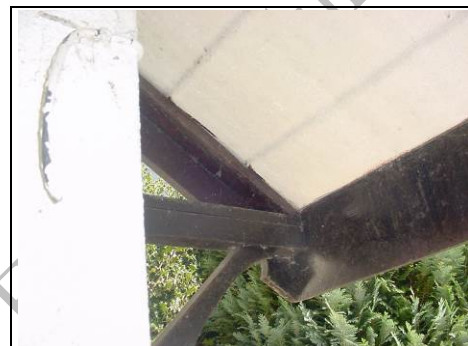
Underside of GRP roof

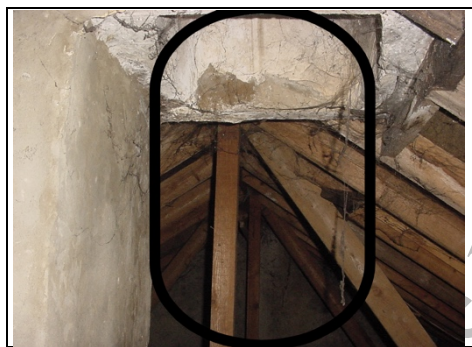
Our examination was limited by the general configuration of the roof and the insulation. What we could see was generally found to be in average condition for its age, type and style, with some dampness coming in around the chimney and the front of the chimney has been removed. It is feasible that there are problems in the roof that are hidden.

Front of chimney removed

ACTION REQUIRED: The only way to be 100 per cent certain is to have the roof cleared and checked.

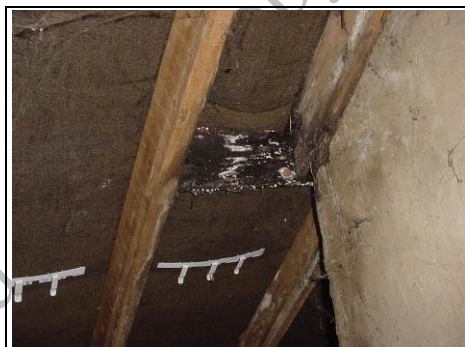
Dampness coming in around chimney

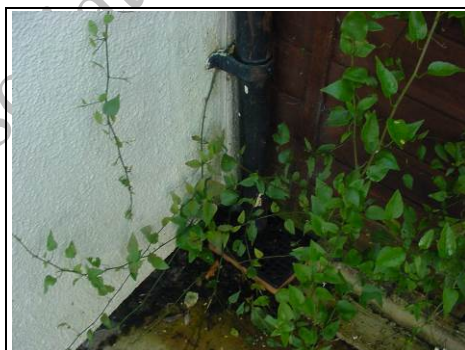
The downpipes feed into shallow surface gullies. We much prefer to see a gully as per the sketch below.

Downpipes feed directly into shallow surface gullies

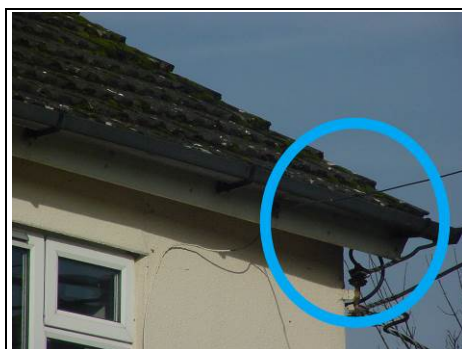
We noted dampness coming into the front right bedroom. It may be that a bargeboard has come loose and wind driven rain is getting in.

Front right corner, where dampness is

ACTION REQUIRED: Repair and/or clean.

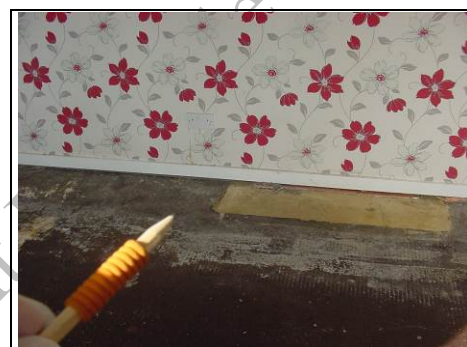
Half of the chimney breasts are located to the left side of the property, as half have been removed. The chimney breast in the lounge is no longer there and has been removed all the way from ground level up to roof level; the one in the kitchen was present. We do not think the chimney is usable in its present form and indeed there is a crack at roof level and it needs various repairs just to make it watertight.

Chimney removed in lounge

ACTION REQUIRED: Please see our comments in the Executive Summary.

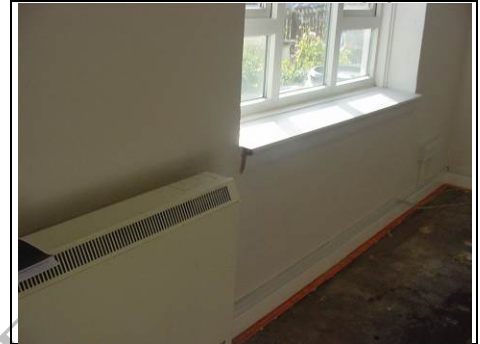
Heating is via electric storage heaters.

Electric storage heater

ACTION REQUIRED: You may wish to upgrade these. Please see our comments in the Executive Summary.

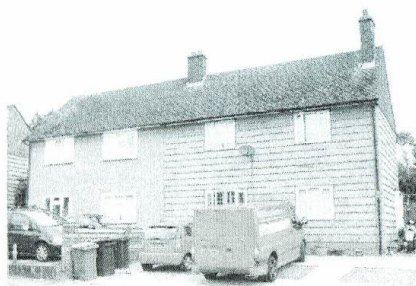
Cornish Unit Type II (upper) and Airey (lower) houses before and after repair.

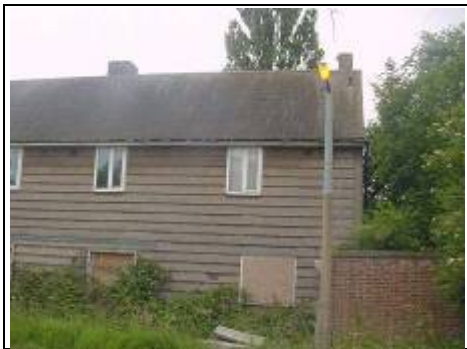
Airey houses were made up of concrete planks and are now generally being knocked down and rebuilt as they are not habitable

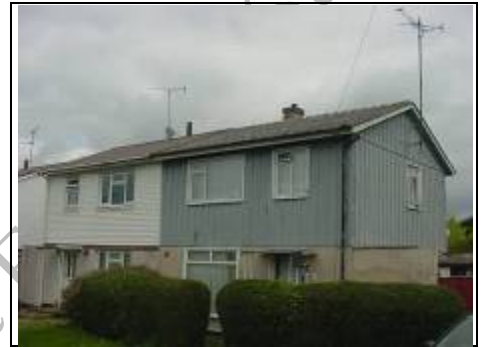
Asbestos roof on BISF house

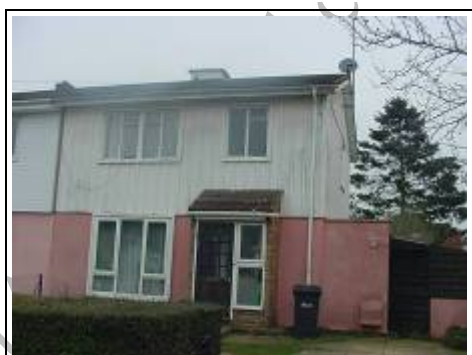
Painted cladding to non-traditional property

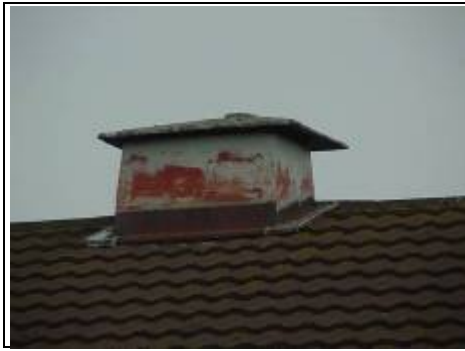
Asbestos original chimney non traditional house

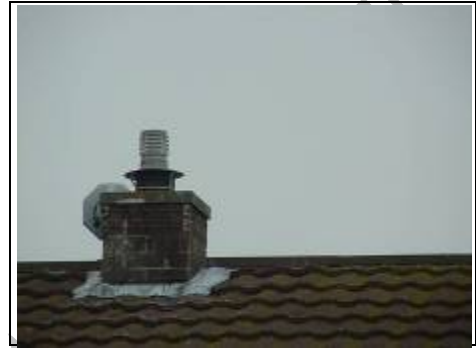
New chimney on a non-traditional house

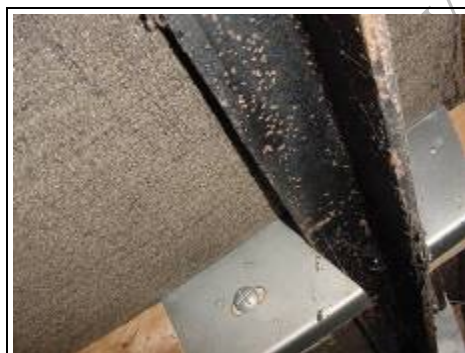
Some fixings replacements/repairs to a non-traditional house

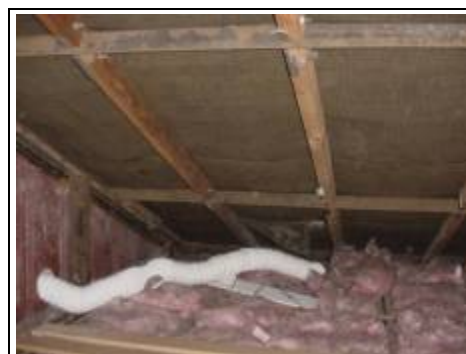
Extract vent to outside often discharges into roof which is essential that they do not in this type of roof

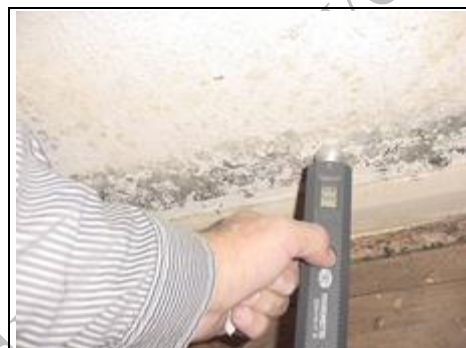
Black mould and high damp meter readings
