RESIDENTIAL BUILDING SURVEY

Non-Traditional Airey, Pre-Cast Concrete Panel construction House

Lincolnshire

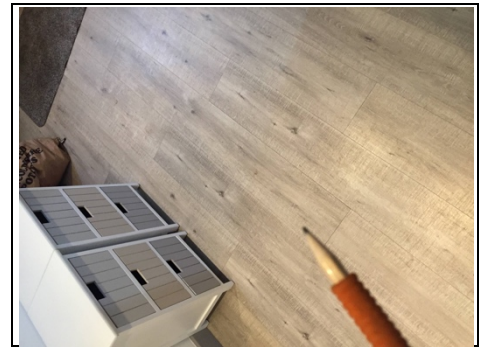
- 1) Roof (see below)
- 2) Cracking to the render
- 3) Water sitting to the base of the property
- 4) Concealed manhole in the corridor

Manhole covered over

ACTION REQUIRED: We would recommend your legal advisor asks for full details with regard to the conversion of the outbuilding. We have noted a few areas of concern:

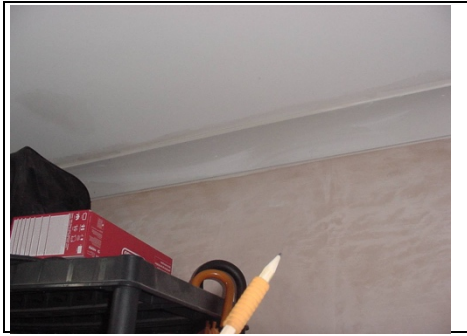
There is dampness visible internally and re-plastering.

New plaster in storage room

ACTION REQUIRED: We would recommend you obtain a discount for the value of a new roof which we would expect to cost in the region of £10,000 - £15,000. You need to obtain quotations before you commit to purchase the property as part of the negotiation as it is difficult to remove this type of roof or get guarantees for it that are worth the paper they are written on.

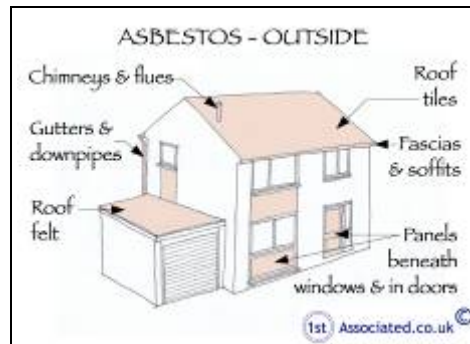
Asbestos - outside

We would always recommend any asbestos is removed from a property as it can not only be dangerous, it can affect the value of the property.

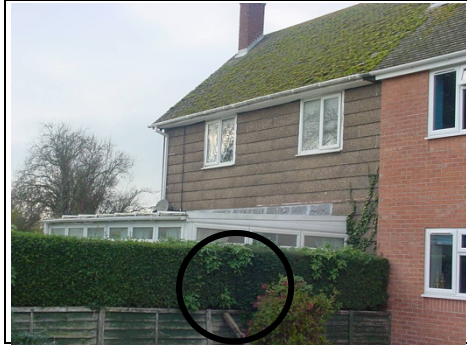
7.0) Rear right boundary fence

You need to establish whose fence is the rear right boundary fence as it is in need of work.

Fence on right side propped up

ACTION REQUIRED: Repair, strengthen and straighten and re-stain. We would recommend concrete posts.

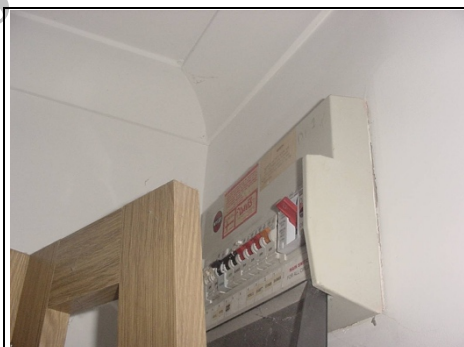
The electrics are 1980s-2000 and better are now available.

Fuse Board in hallway

ACTION REQUIRED: We recommend a new fuse board with a metal casing; modern standards require half hour to one hour fire resistant casing around a fuse board.

An Institution of Engineering and Technology (IET) test and report and any recommendations to be carried out by an NICEIC registered and approved electrical contractor or equivalent.

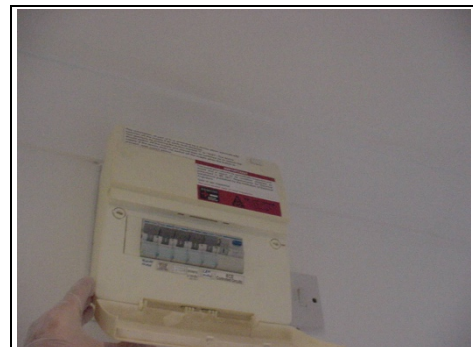
Dated electrics in the corridor between the outbuildings and the main building

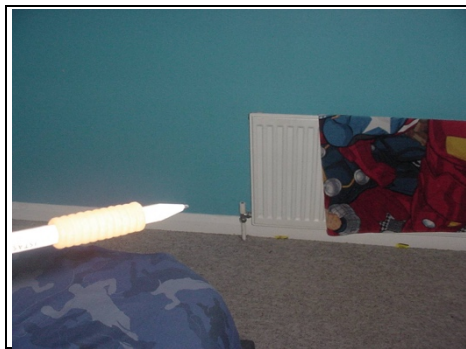
The property has a mixture of double panel radiators and some single panel radiators for example in the rear right bedroom. These may not warm the property to the heat that you desire/modern standards. We much prefer to see double panel convection radiators.

Single panel radiator

ACTION REQUIRED: We recommend you upgrade to double panel convection radiators.

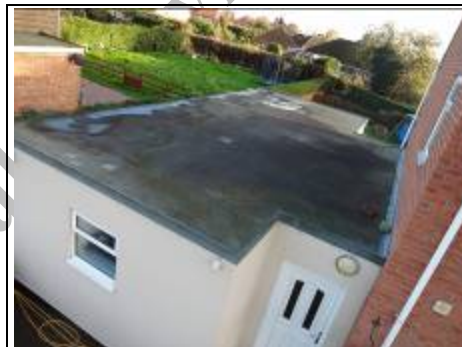
Flat roof
~ Aerial View - 360 Photo ~

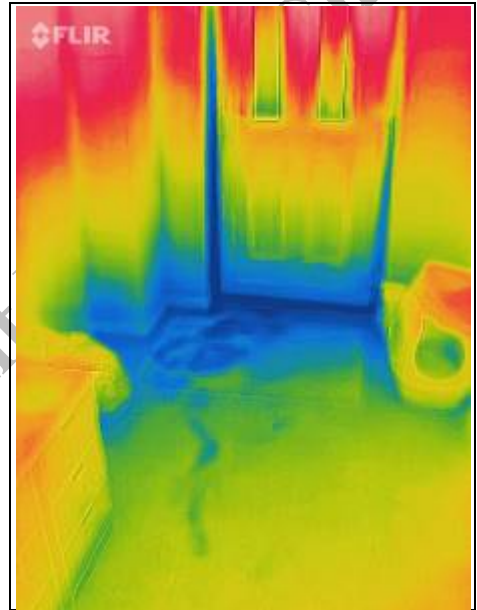
Coldness in link corridor concrete
floor originally from 1960's

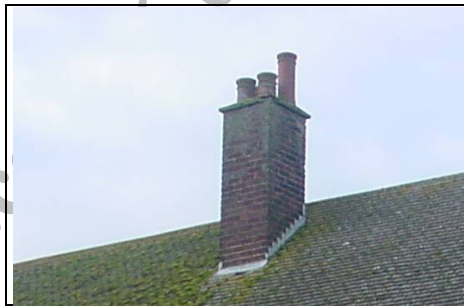
Rear view

Chimney needs repair

Unfortunately, we were unable to see the top of the chimney properly known as the flaunching, we therefore cannot comment upon them.

ACTION REQUIRED: Repair and repoint. Please see our comments in the Executive Summary.

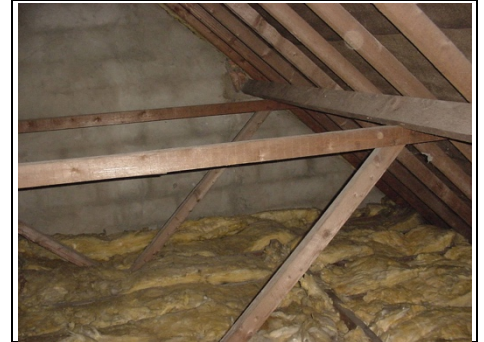
Chimney to right/middle viewed within roof space

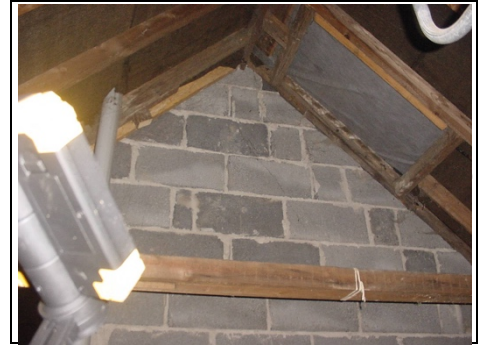
We can see there has been a chimney to the left removed from the pattern we can see in the roof timbers.

Chimney removed to left

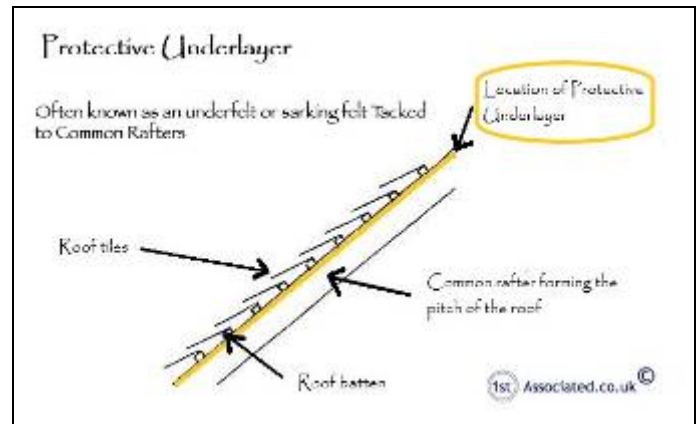
Protective underlayer

When we inspected the loft space we found a Hessian base Bitumen membrane. This type of membrane has been used since the 1960s. We generally found it to be in average condition, with damage in some areas which is what we typically find.

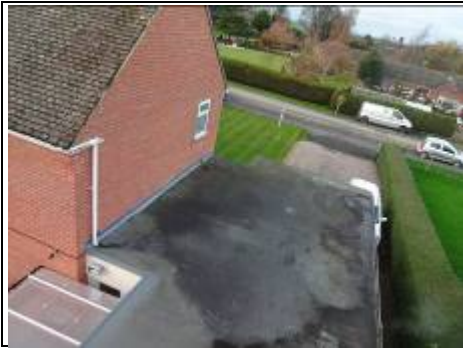
Left flat roof

The Glass Reinforced Plastic (GRP) roof is blistering and in a relatively poor condition considering it is so new. We can see dampness is getting into the structure of the building.

ACTION REQUIRED: Please see our comments in the Executive Summary. Take care if you decide to go on the GRP roof as they can become quite slippery.

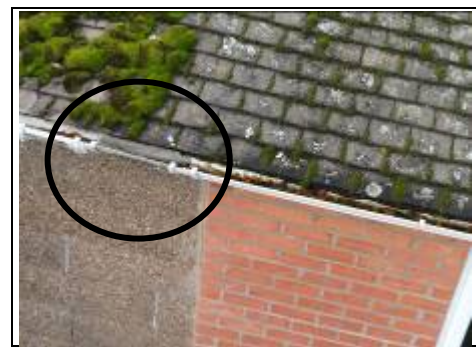
There is possibly an asbestos link gutter to the rear between your property and next door.

Asbestos gutter

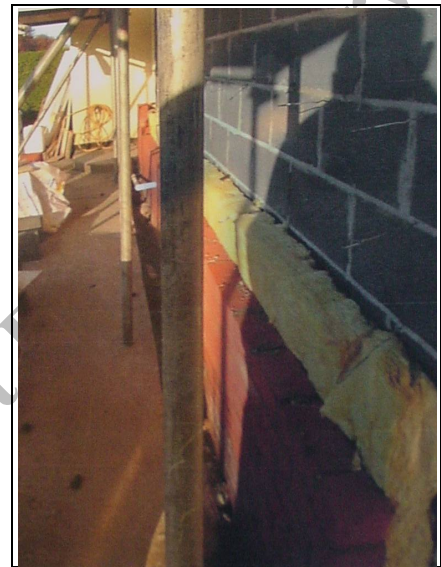
As we understand from our discussions during our question and answer session with the owners, this is a brick and block constructed walls with insulation batts within. We were shown two photographs, ideally we would like to have seen a lot more at different levels of construction.

Work proceeding with blockwork then fibreglass batts and then brickwork

ACTION REQUIRED: Your legal Advisor needs to speak to the contractor and specifically ask them to confirm in writing they carried out the work and produce a specification of what they did and also confirm if there is a guarantee and if it can be passed onto other people.

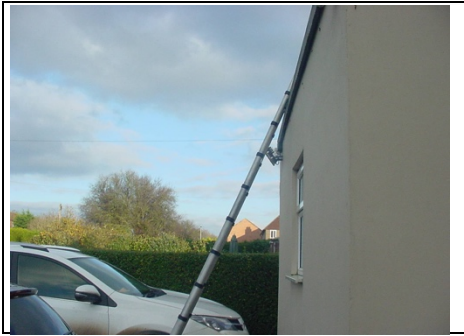
Left side

No detailing to roof

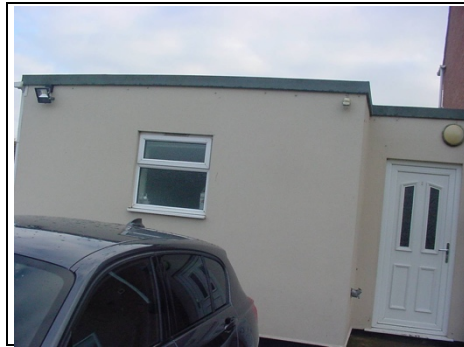
In this case we found no drip detail to the windows. We noted mould and moss around the windows.

No window drip

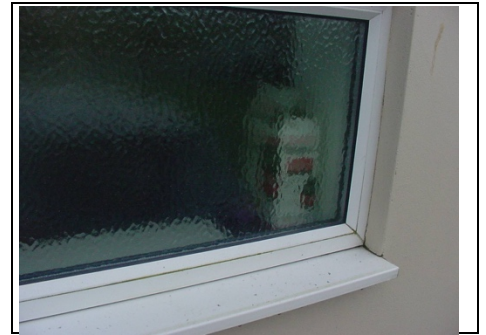
Mould and moss around window

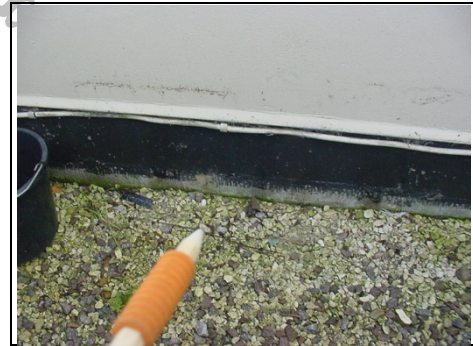
To the base of the render there was a bell mouth detail. There looks to be water sitting at the base of the property from the staining we can see on the left side.

Water sitting to base of outbuilding

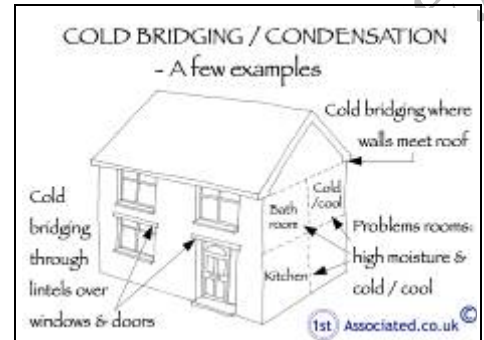
The unusual thing we have found here is that there looks to be metal lintels. Metal lintels do often cause problems with cold bridging. Please see our article in the Appendices at the back of the report.

Cold bridging / thermal bridging

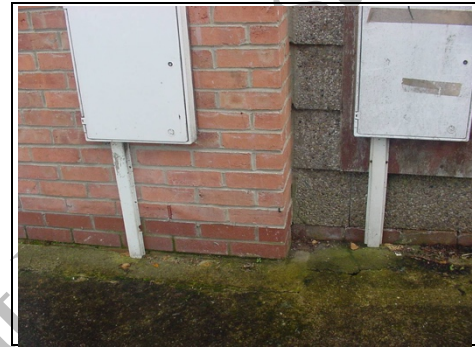
All modern properties should incorporate a damp proof course (DPC) and good building practice dictates that a differential of 150mm (6 inches) should be maintained between the damp proof course and ground levels. In this case we cannot see a DPC however we assume given that this was done in 2015 that one would have been built in as work proceeded.

No damp proof course visible

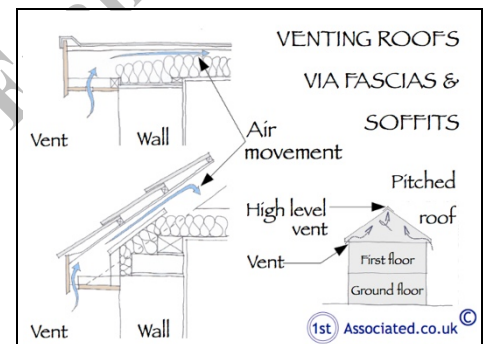
The fascias and soffits are plastic without vents, we were surprised vents had not been added as this helps ventilate the roof and certainly was a requirement in 2015 when this work was carried out on the outside of the property although we do appreciate the focus may have been on replacing the walls.

Vent to soffit

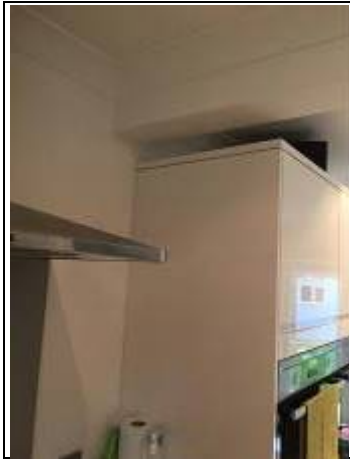
We noted a wall has been removed in the kitchen and there is a beam. This type of alteration should have had building regulations approval.

Beam in kitchen

ACTION REQUIRED: Your legal Advisor needs to check and confirm.

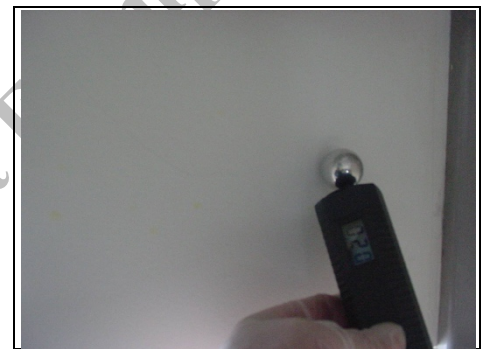
We used a resistance meter on the external walls. Our damp meter readings indicated the walls are likely to be dry lined/false walls

Testing for lateral dampness

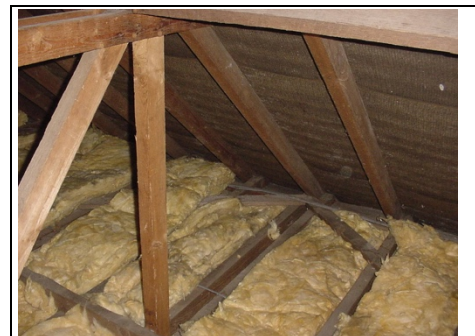
Some roof insulation was present although not to current Building Regulations requirements of 300mm. In this case there is approximately 200mm.

Insulation

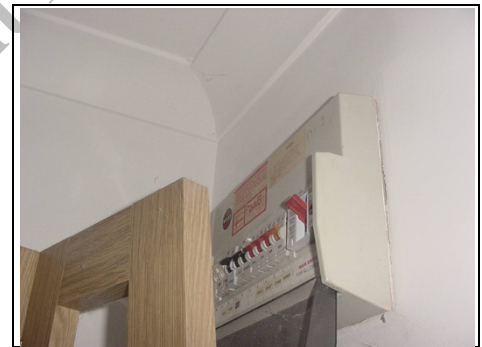
There are two electric fuse boards; one in the hallway and one in the corridor between the outbuilding and the main building. The fuse boards looked 1980's-2000 and better are now available.

Fuse Board in hallway

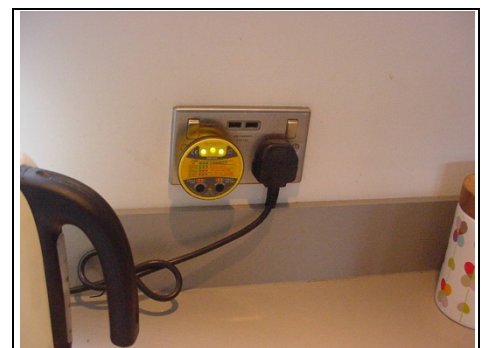
We carried out an earth test in the kitchen area to the socket point that is normally used for the kettle, this proved satisfactory.

Earth test

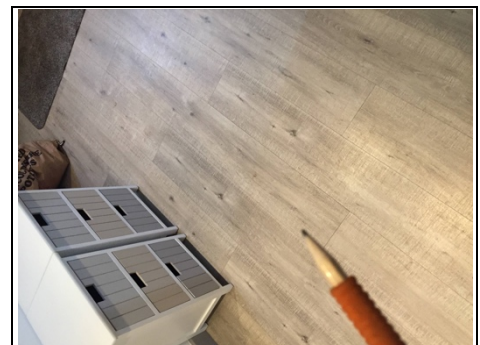
Inspection Chamber / Manhole One - Outbuilding

The manhole has been covered over.

Manhole covered over

ACTION REQUIRED: We would recommend a closed circuit TV camera report of the drains.

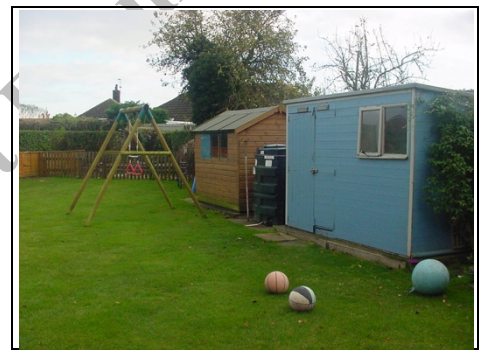
Sheds

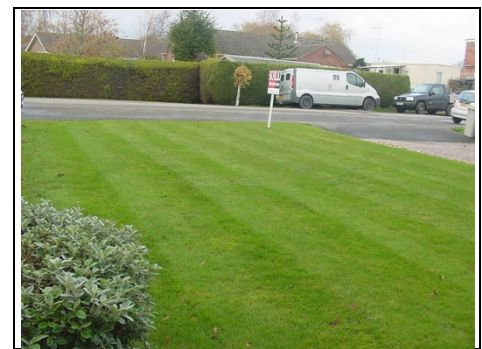
Front garden

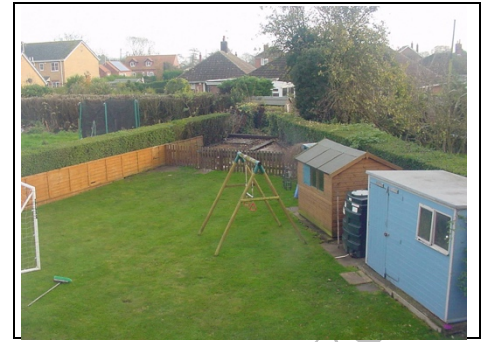
End of triangular rear garden

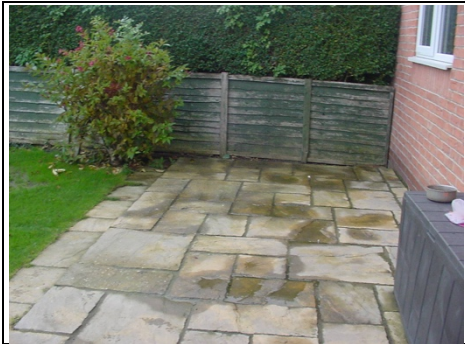
Rear paved area

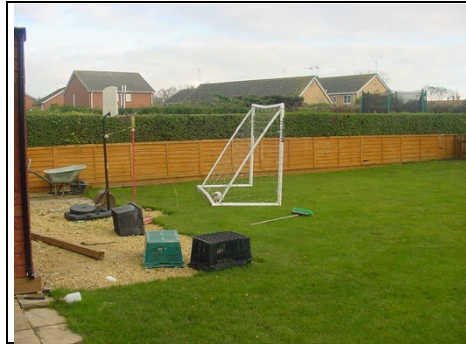
Rear Garden

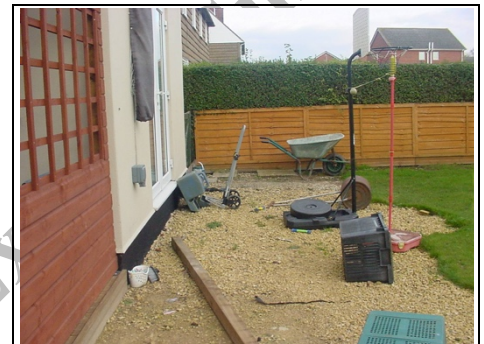
Unmade ground behind outbuilding area

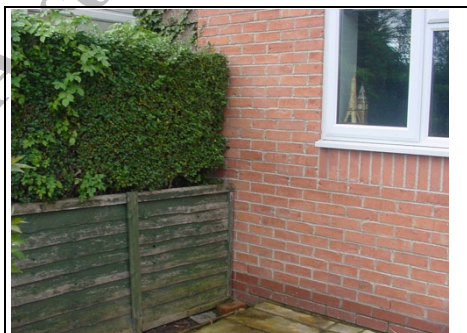
Fence on right side

You need to establish whose fence is the rear right boundary fence as it is in need of work.

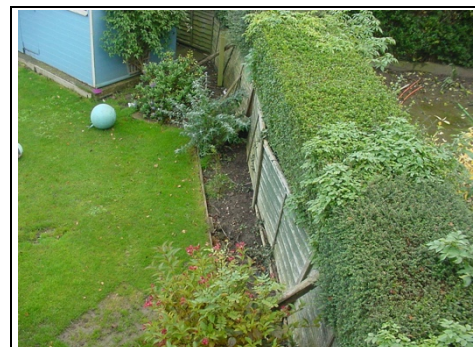
Right fence needs work

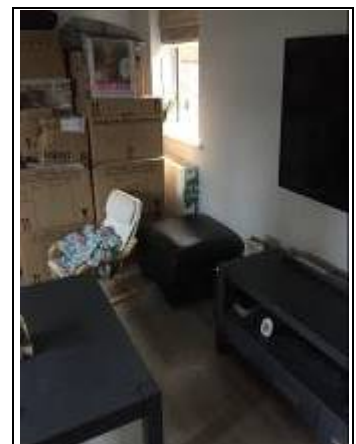
Stored items in lounge

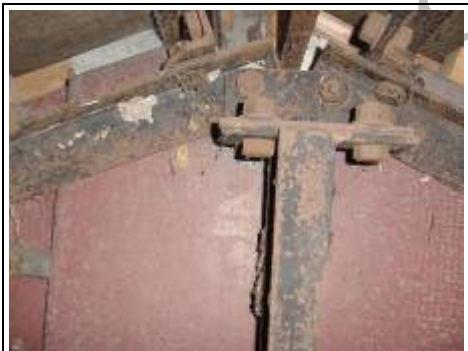
Rusting to a lightweight metal frame or damage or deterioration to the metal frame of a non-traditional house

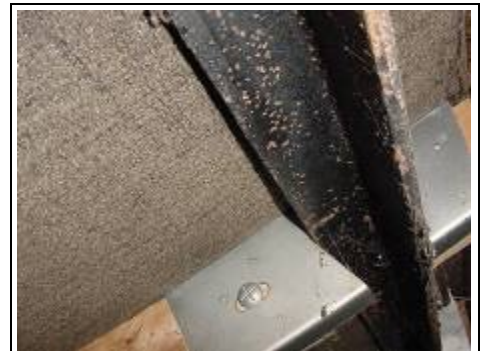
Some fixings replacements/repairs to a non-traditional house

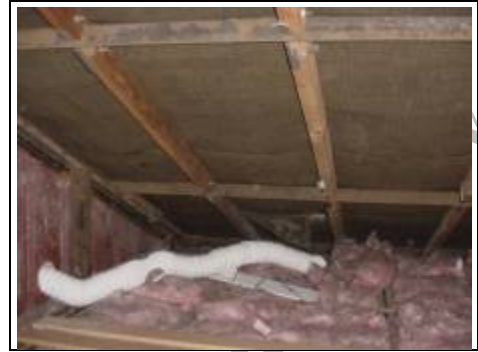
Extract vent to outside often discharges into roof which is essential that they do not in this type of roof
