RESIDENTIAL BUILDING SURVEY

Dyke Pre Cast Concrete Construction House Shropshire

Ms X

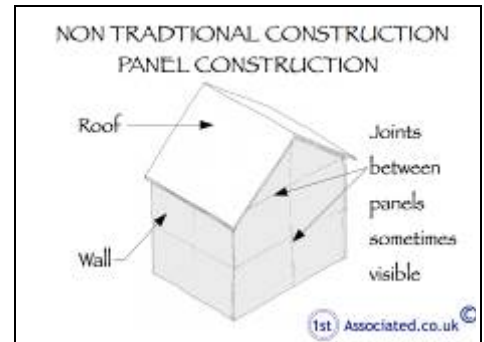
This house has been built using a pre-cast concrete method. We would term this as large panel construction (LPC), using large panels of pre-cast concrete (concrete made in a factory and then brought to the location to be built), lifted into place forming the right and left hand walls and the floors.

Non-traditional panel construction

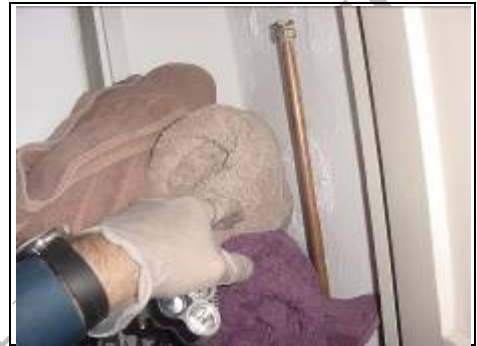
Textured paint

Whilst we cannot see any asbestos, it is noted as one of the problems for surveyors on the Building Research Establishment digest. We did see some textured paint and we are aware that some forms of soft textured paint can incorporate asbestos. Generally local authorities carry out an asbestos report.

Our insurance company requires us to advise we are not asbestos surveyors and advises us to recommend asbestos surveyors are instructed and that you have your own asbestos survey carried out.

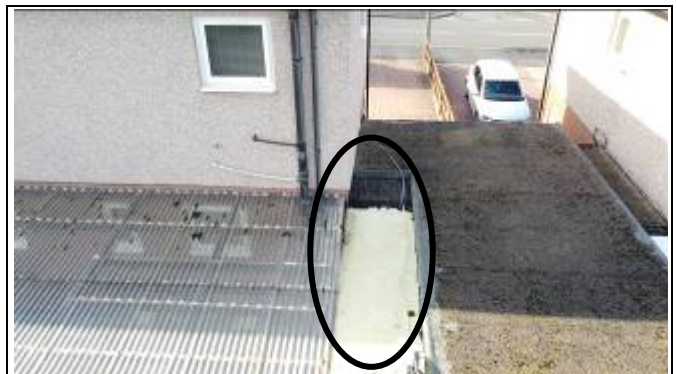
There are areas of the roof that are deteriorating and will be letting water into the roof structure/timber decking/concrete roof.

Outbuilding roofs, link corridor roof (black oval)
~ Aerial View - 360 Photo ~

ACTION REQUIRED: We recommend repairs to the roof. We believe you will probably need to start again with regard to the relatively small area of roof that has deteriorated.

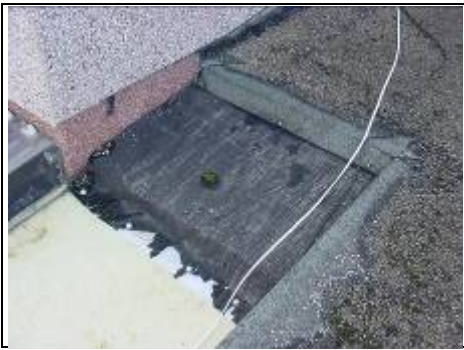
Link corridor roof needs replacing

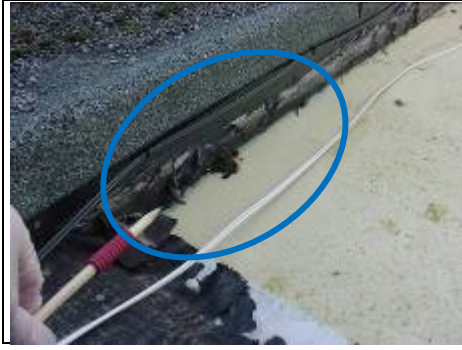
Side detailing where we assume water getting through

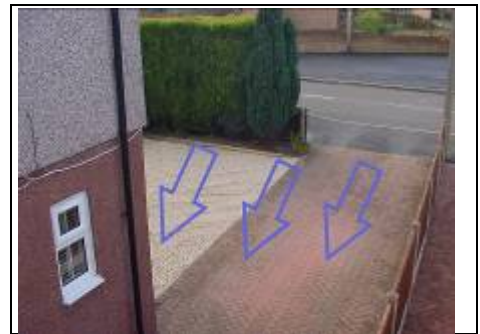
Water has been discharging towards the front of the building. There looks to be a relatively new parking area. Depending upon how this has been built, it could mean that water is being transferred and travelling towards the base of the front of the building.

Sloping site

As far as we can see (but bear in mind that a lot is hidden by the external wall insulation) there was not a problem at the time of our survey. However, we believe in the long term that there will be problems when you are discharging water to the base of this property particularly as the original pre-cast concrete structure will be affected by this dampness.

ACTION REQUIRED: A good way to reduce the dampness to the base is to add a running gully or a French drain. We would recommend this is carried out as soon as possible to limit further damage to the base of the structure.

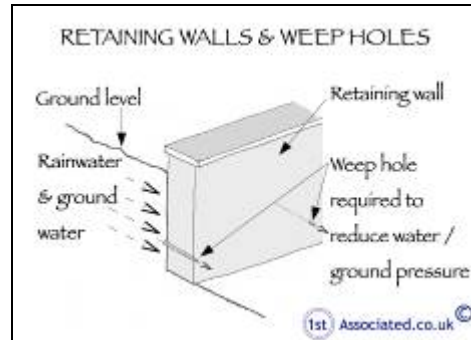
The retaining wall needs weep holes.

Retaining wall needs weep holes

ACTION REQUIRED: Add weep holes.

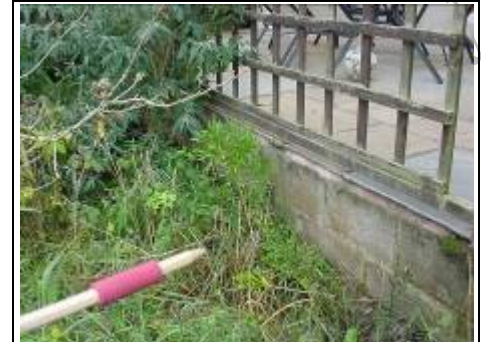
Small retaining wall needs weep holes

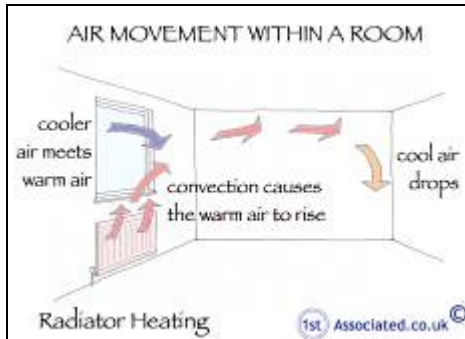
We noted the radiators in some areas are internal/not under the windows which is the usual position. This is often carried out on cheaper central heating systems to save the labour and piping costs of positioning the radiators underneath the windows. However, it then reduces the air movement in the room which can lead to black mould.

Air movement

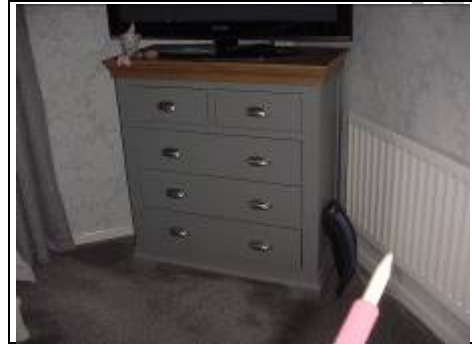
Internal radiator

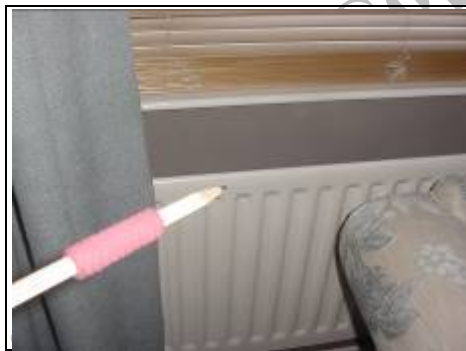
The property has single panel radiators. These may not warm the property to the heat that you desire. We much prefer to see double panel convection radiators.

Single panel radiator

ACTION REQUIRED: We recommend you upgrade to double panel convection radiators and move the radiators underneath the windows as this gives a better circulation of air and reduces the chance of condensation.

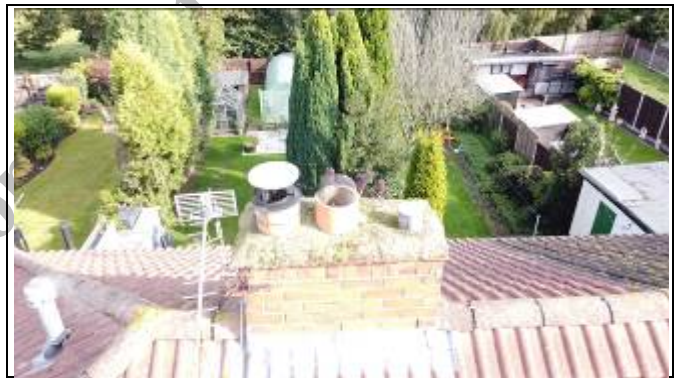
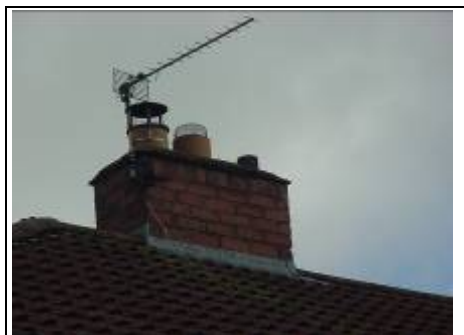
This chimney is brick finished with a lead flashing and three chimney pots, one of which looks to be a flue. From what we could see from ground level it looked in average condition considering its age, type and style with some moss. The flashing looks like it is cracked which may ultimately lead to water getting in but we could not see any dampness to the chimney breast within the roof space.

Chimney and flue
~ Aerial View - 360 Photo ~

Chimney

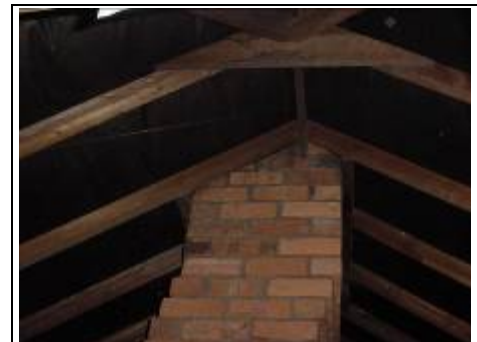
Chimney within roof space

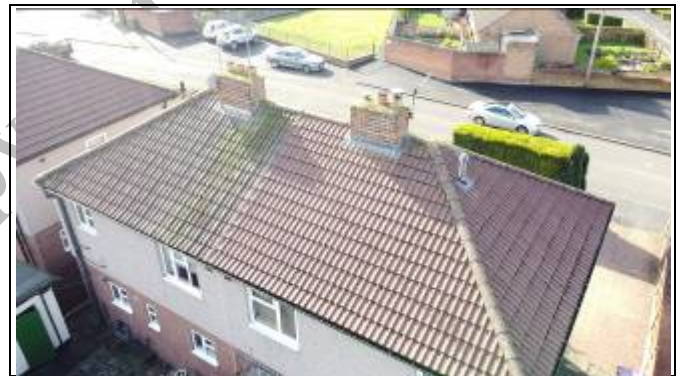
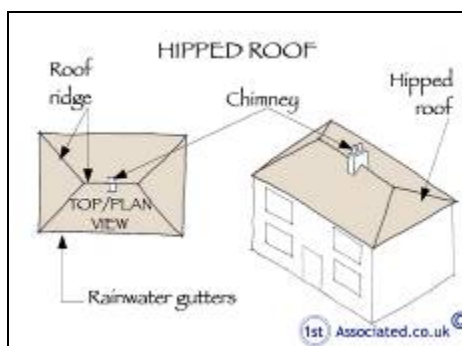
The roof is clad with a concrete tile and, from ground level, this looks in average condition considering the roof's age, type and style. It looks like there is some deterioration starting to occur to the tiles and we noted the roof has a dry ridge.

Hipped roof
~ Aerial View - 360 Photo ~

Hipped roof

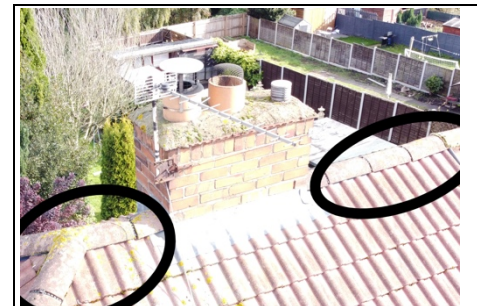
Dry ridge

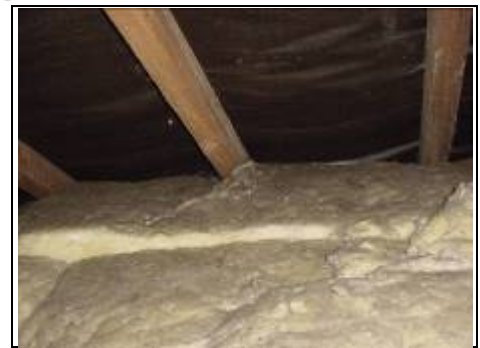
When we inspected the loft space we found a Hessian base Bitumen membrane. This type of membrane has been used since the 1960s. We generally found it to be in average condition, with damage in some areas which is what we typically find.

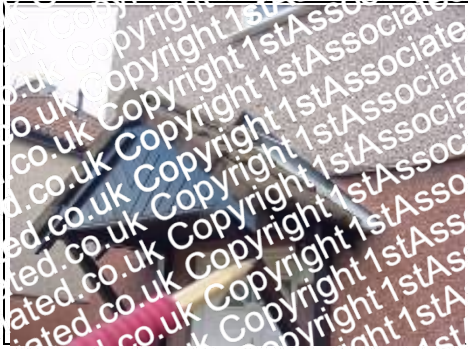
The roof is pitched and clad with concrete tiles and, from ground level, this looks in average condition considering the roof's age, type and style. There is no gutter to this roof which is often the case with smaller roofs. We were pleased to see there was a lead flashing where the roof meets the building although these can come away on external wall cladding insulation panels.

No gutter to front entrance

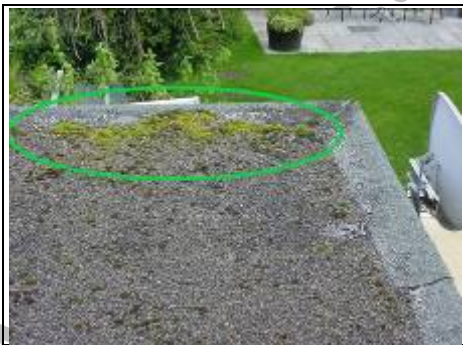
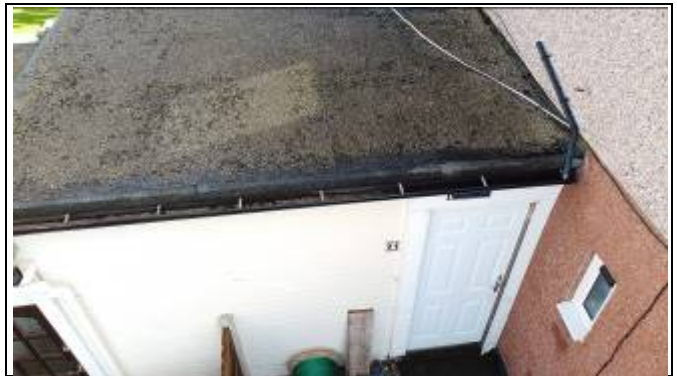
This is a flat roof covered in felt with chippings. There is a moss covering to this roof.

Moss

Flat roof
~ Aerial View - 360 Photo ~

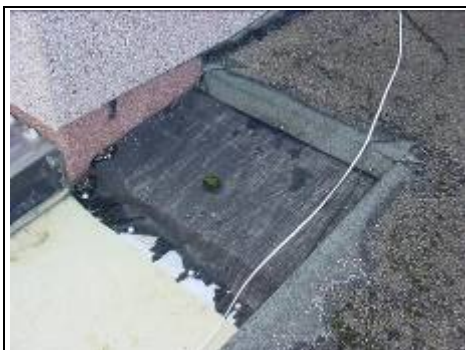
This roof is deteriorating and in need of replacement.

Roof needs replacing

ACTION REQUIRED: Replace link corridor area. Please see our comments in the Executive Summary.

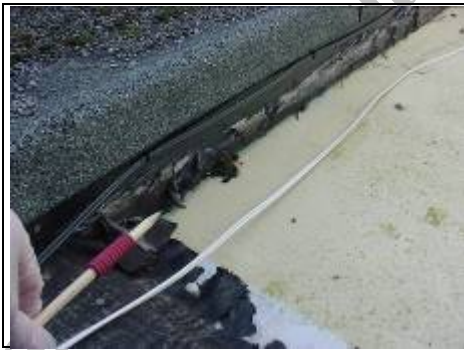
Side detailing where we assume water getting through

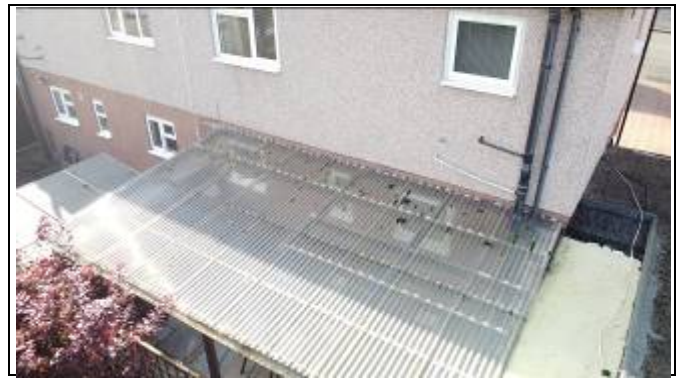
This is a large shallow pitched corrugated plastic roof. From ground level, this looks in average condition considering the roof's age, type and style. With shallow pitched roofs you do tend to get leaks and we can see some moss is sitting on the roof which may be difficult to clear.

Corrugated plastic roof
~ Aerial View - 360 Photo ~

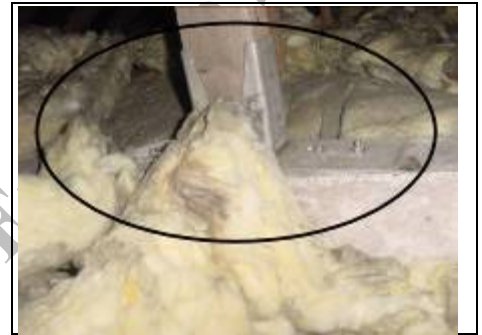
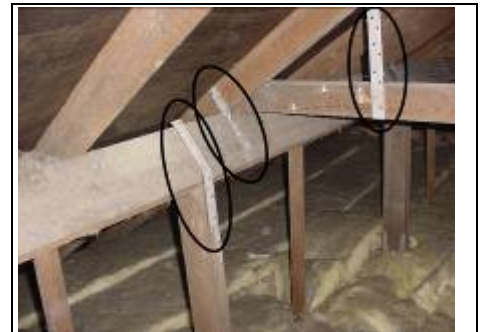
Metal bracket fixing timber to concrete frame

Brackets

ACTION REQUIRED: Your legal Advisor needs to check and confirm if the local authority/owner have carried out repairs retro-fits to the roofs. We would add that the only way to be one hundred percent certain is to have the roof cleared of all insulation, stored items, etc and checked.

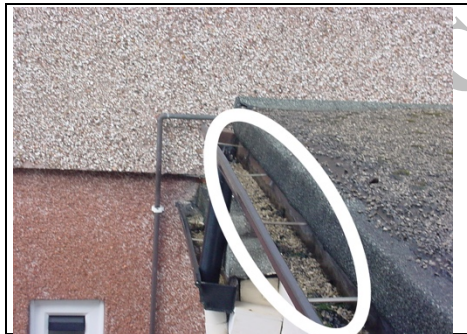
To the outbuilding we could see metal gutters and there looks to be the same to the main building. As with most gutters we could see that they would benefit from a clean.

Debris to gutter on outbuilding roof

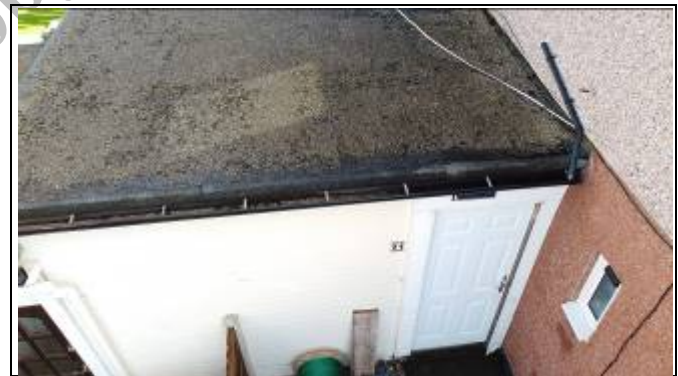
Wastepipe into metal gutter
~ Aerial View - 360 Photo ~

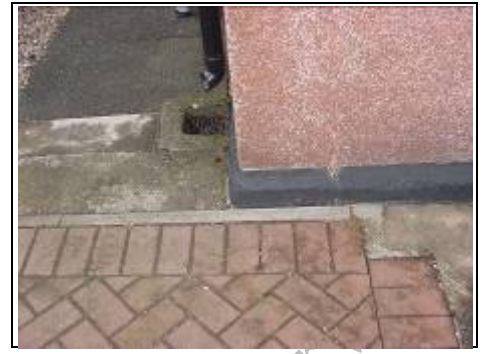
Downpipe and no wall around gully

ACTION REQUIRED: We would always recommend you stand outside the property next time it rains heavily and see how well the drains cope with the rainwater particularly looking at the guttering and the joints.

We also recommend that the gutters and downpipes are cleaned out, the joints are checked and the alignment checked to ensure that the gutters fall towards the downpipes.

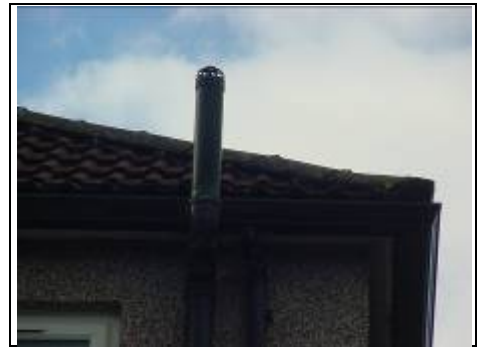
Plastic soil and vent pipe to rear

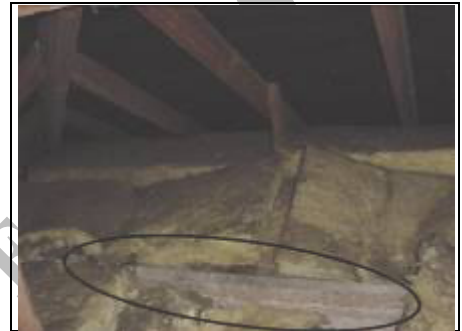
In this case we believe it to be a pre-cast concrete construction and from our searches via various data bases we believe it to be a Dyke non-traditional building. All we can see of it is a concrete frame within the roof (see adjoining photographs).

Concrete frame visible within roof

ACTION REQUIRED: Please see our comments in the Executive Summary and articles in the Appendices.

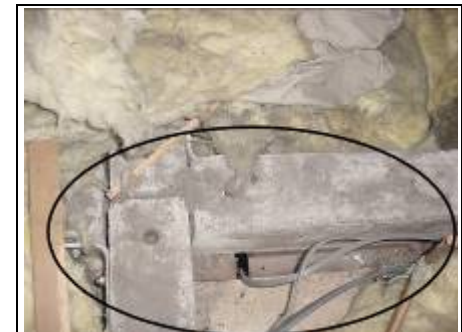
Close up of concrete frame

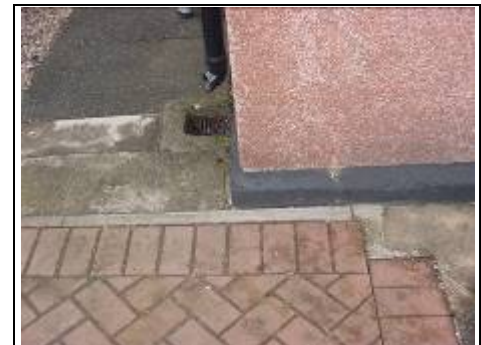
The external walls are finished in a thin render which has been applied to the insulation board. It has a reinforcement beneath it which can be seen (see photo below – render starting to deteriorate). We would comment that there is not a long term history in England of the use of this type of finish and the jury is still out with regard to how it will perform.

Pea shingle render

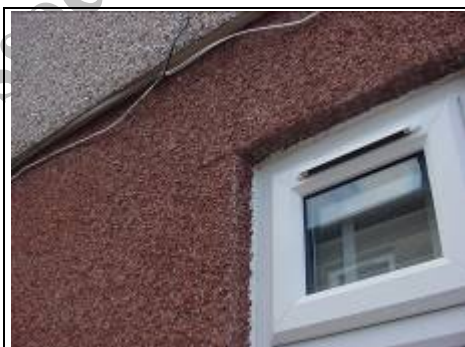
Reveals around window

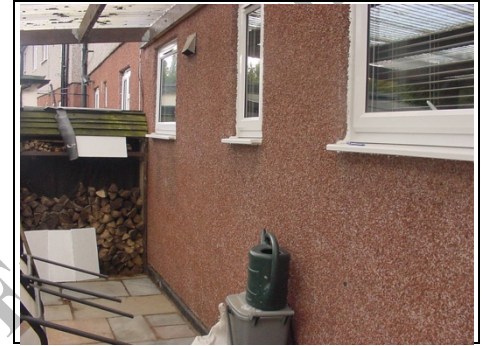
All modern properties should incorporate a damp proof course (DPC) and good building practice dictates that a differential of 150mm (6 inches) should be maintained between the damp proof course and ground levels. In this case we cannot see a DPC due to the render and plinth.

The Dyke data sheet advises the property has a DPC and a pre-cast plinth unit, it does not advise what the DPC is made out of.

Plinth to base

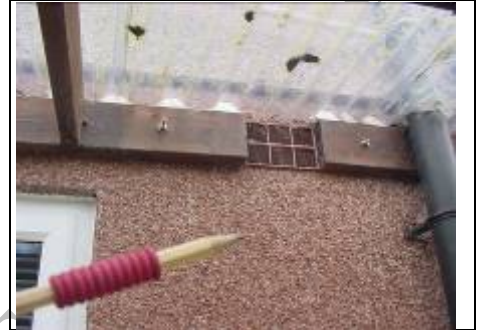
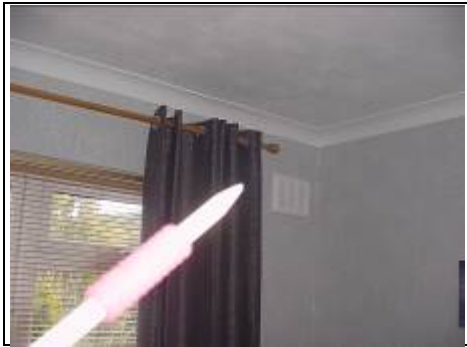
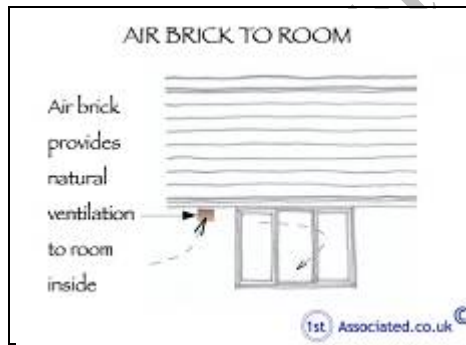
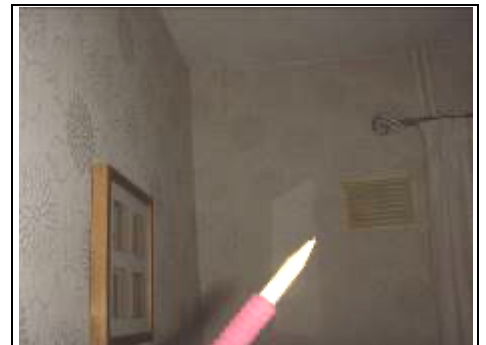
High level air vent

High level airbrick in rear right bedroom

High level airbrick

Air brick

ACTION REQUIRED: Ensure the airbricks are clear.

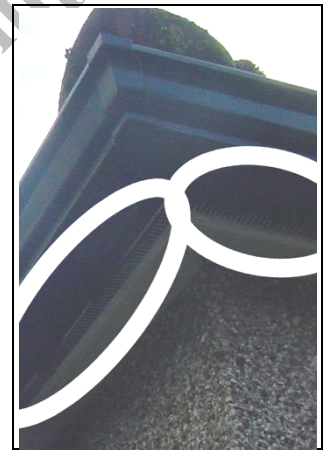
The fascias and soffits are difficult to see however they look to be plastic and have a vent.

Vent to soffit

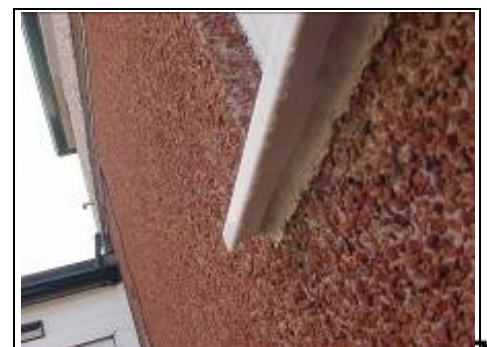
Thin window sill

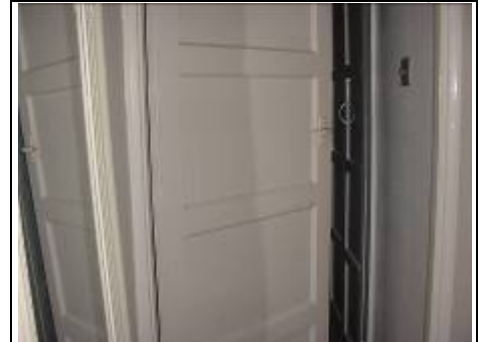
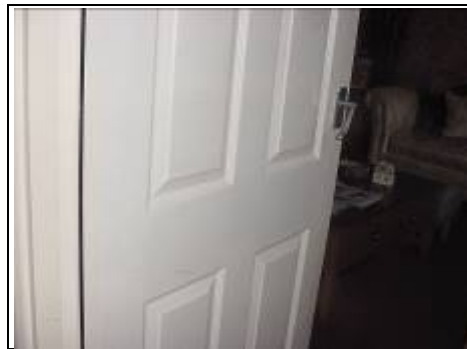
The property has a mixture of the original doors and hollow core doors (sometimes referred to as egg box doors, as this is what the internal of them looks like when they are opened up). Hollow core doors can damage very easily.

Original door upstirs

Hollow core door

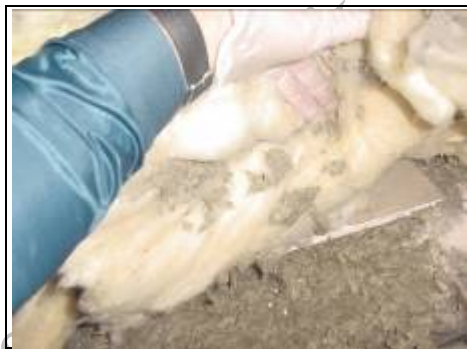
Some roof insulation was present although not to current Building Regulations requirements of 300mm. In this case there is 200-300mm.

Layers of insulation

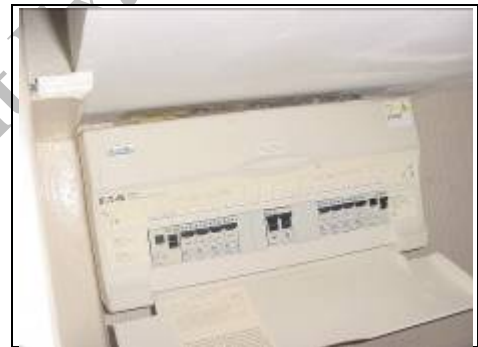
Fuse Board

The electric fuses and consumer units were located in the hallway above the entrance door to the kitchen. The fuse board looked 1980s/1990s and better are now available.

ACTION REQUIRED: We recommend a new fuse board with a fire resistant metal case. An Institution of Engineering and Technology (IET) test and report and any recommendations should be carried out by a NICEIC registered, or equivalent, approved electrical contractor or similarly approved.

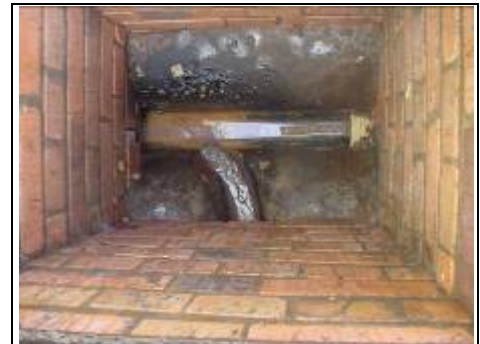
We duly lifted the cover and found it to be free flowing at the time of our inspection.

From what we could see it is brick built.

Rear manhole

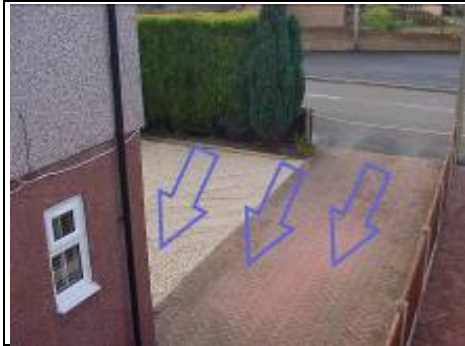
There looks to be a relatively new parking area. Water has been discharging towards the front of the building.

Sloping site

ACTION REQUIRED: Please see our comments in the Executive Summary.

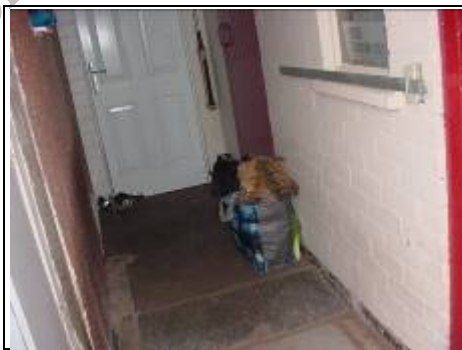
Alleyway between house and outbuilding

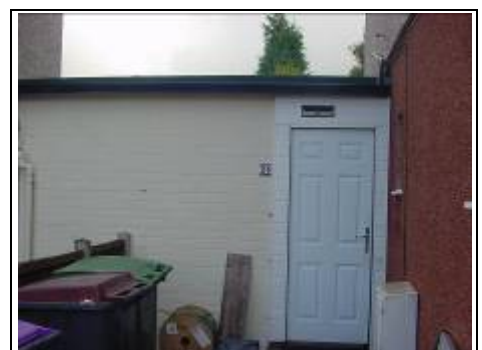
Access to outbuilding

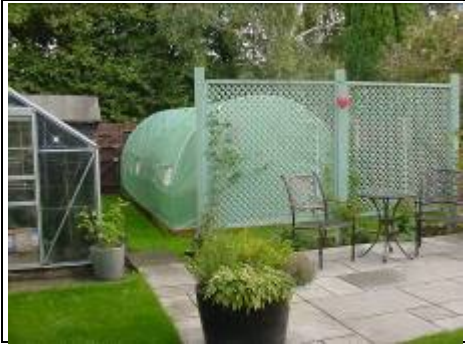
Greenhouse and shed to rear

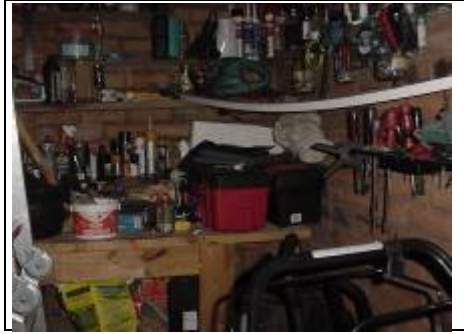
Tool shed to rear left

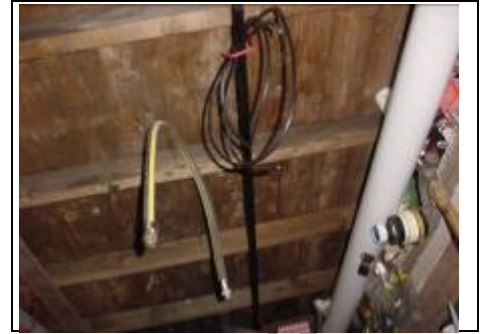
Shed has original boarded roof

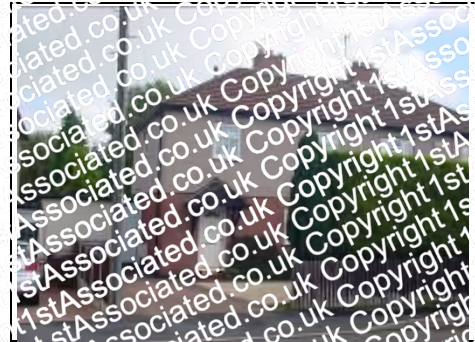
Front garden with hedge

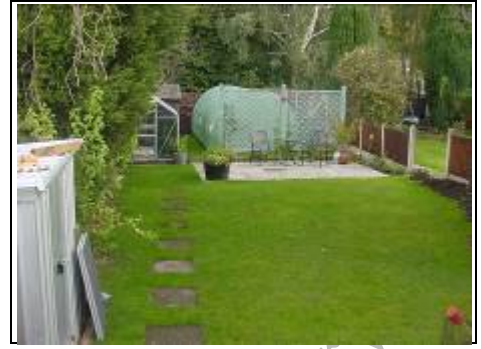
Rear Garden

To the rear is a good sized garden that has a patio area adjacent to the house which then drops away as the garden slopes away from the building.

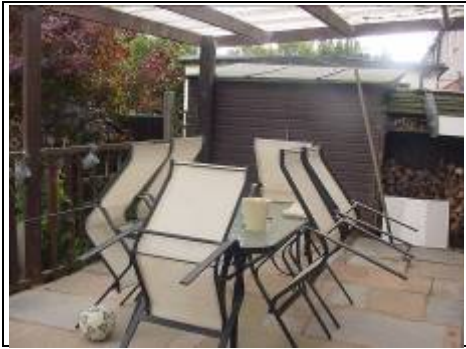
Covered sitting out area

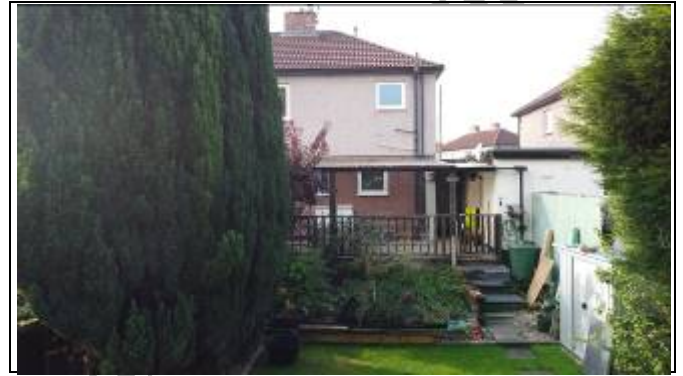
Rear garden
~ Aerial View - 360 Photo ~

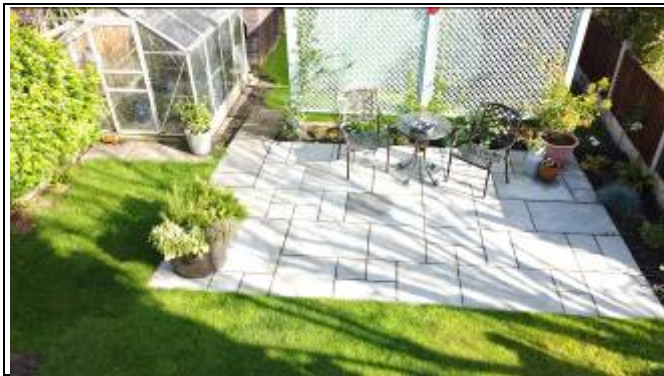
Rear sitting out area
~ Aerial View - 360 Photo ~

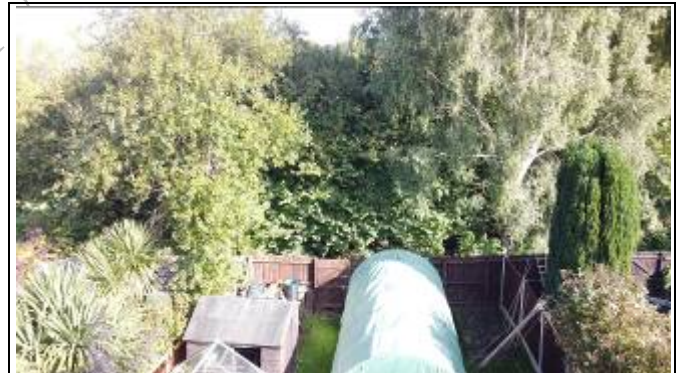
End of garden
~ Aerial View - 360 Photo ~

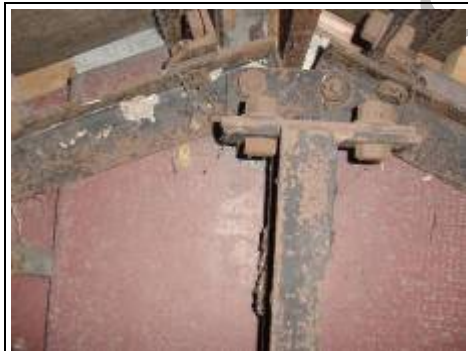
Rusting to a lightweight metal frame or damage or deterioration to the metal frame of a non-traditional house

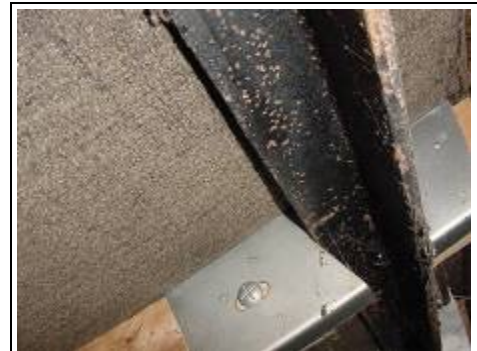
Some fixings replacements/repairs to a non-traditional house
