RESIDENTIAL BUILDING SURVEY

Non-Traditional Pre-Cast Concrete House

South West England

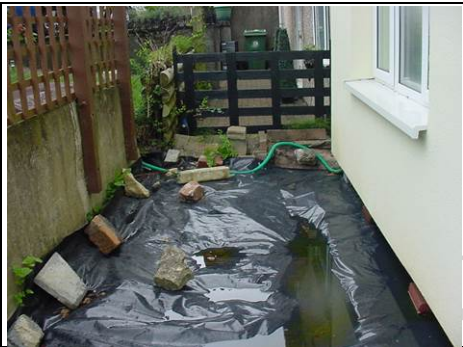
Front garden covered with tarpaulin

ACTION REQUIRED: We recommend the tarpaulin is removed immediately.

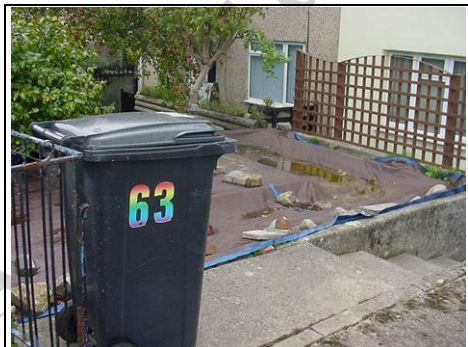
Front garden at high level,
covered with tarpaulin

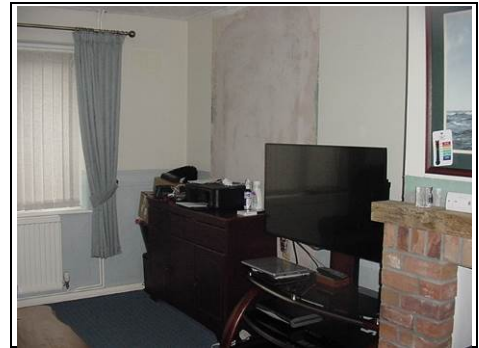
Lounge (where door has been blocked up)

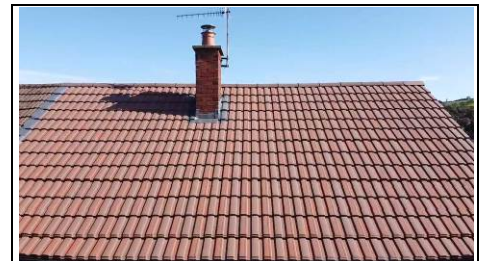
The roof has a dry ridge, often used for venting. The problems with this type of roof is that it can get condensation and as such it needs suitable ventilated.

We understand you had problems having the roof covering installed.

Main roof
Aerial view – 360 photo

ACTION REQUIRED: Your Solicitor needs to speak to the Local Authority to see if there is any form of Warranty/Guarantee with regard to the roof.

Also you need to get information with regard from the Local Authority with regard to how these roofs should be appropriately ventilated to help reduce/stop condensation.

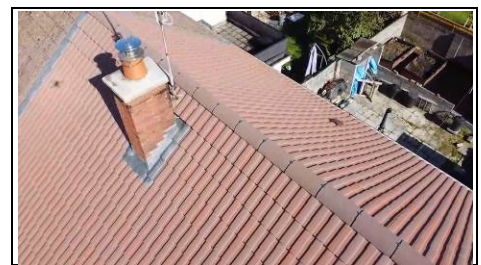
Dry ridge on roof
Aerial view – 360- photo

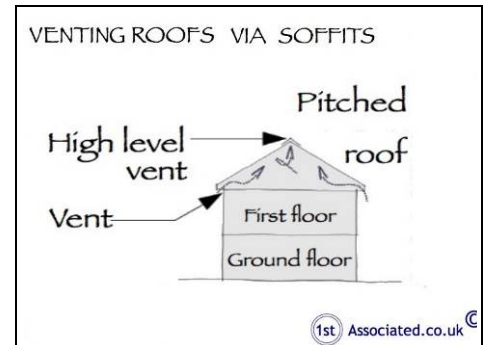
Vents into roof via fascias and soffits

The Local Authority have replaced the original fascias and soffits with a system that has a running trickle vent into the soffit boards to the roof space, allowing air movement. In our experience with retro-fits they tend to get blocked by the insulation already in the roof unless pre-formed plastic vents are used between the soffit vents and the roof void.

ACTION REQUIRED: Ask the Local Authority whether pre-formed vents have been used to ensure that air goes from the running vent in the soffit boards to the roof space.

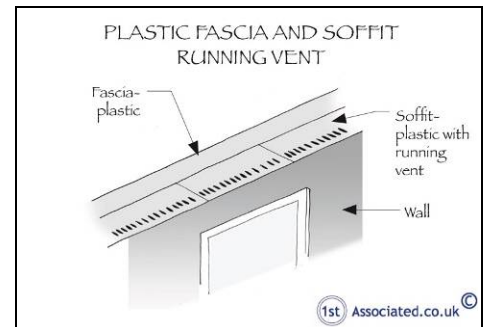
Vent in soffit

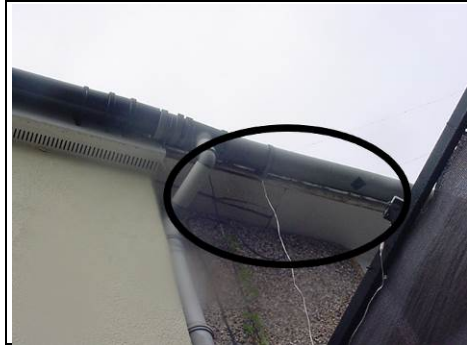
We understand this is the third time the plastic fascias and soffits have been fitted. They were original fitted over the original ones, which had deteriorated from what we understand. They have been replaced but are in small sections.

Timber to next door

ACTION REQUIRED: The Local Authority to provide details of how they fixed the fascias and soffit boards.

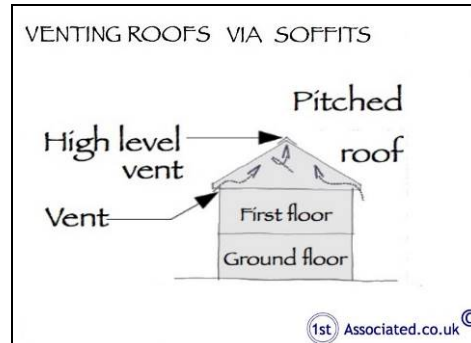
Roof vented through soffits

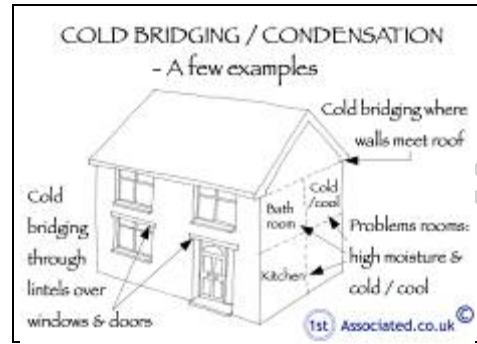
Cold bridging is caused by a colder element in the structure allowing coldness to pass through the structure much quicker when warm moist air is present in the property, often caused by things like having a shower or a bath, cooking or washing, particularly if you are drying washing on the radiators. This is also caused by the general climate which results in condensation on the element.

Cold bridging / thermal bridging

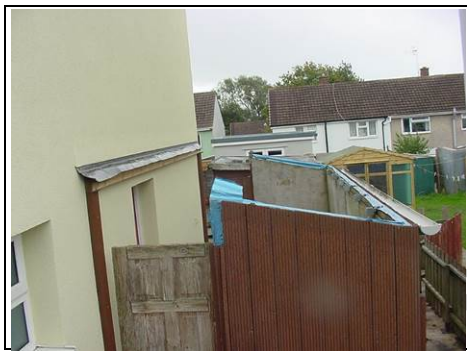
Half-built lean-to to right side of property

To complete the lean-to as we see it, you will need to either to build a completely self-supporting separate structure, that is then abutted to the main building, and the insulation be replaced, subject to the manufacturer's agreement, or have a manufacturer approved detail that allows you go fix through the insulation.

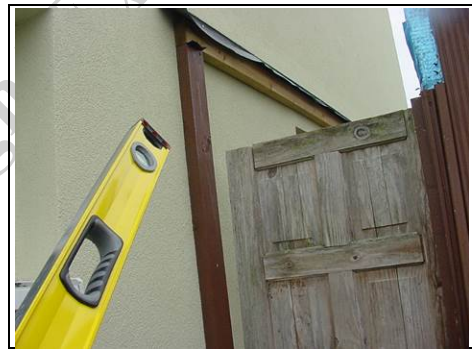
Where the lean-to should be

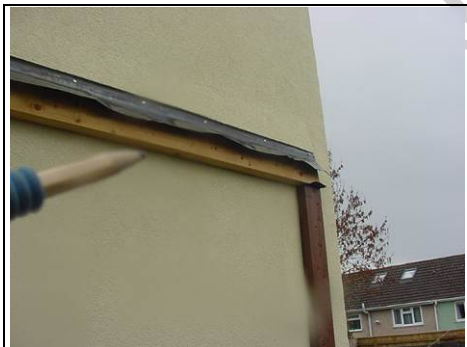
Wall posts for lean-to

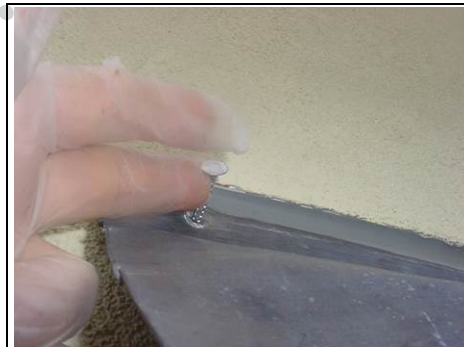
Flashing nailed into the external wall insulation (EWI)

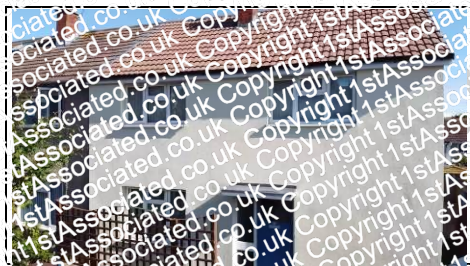
Front with a mineral fibre finish
Aerial view – 360 photo

ACTION REQUIRED: We recommend you ask for a written report with regard to the External Wall Insulation (EWI) manufacturer's findings, together with them advising what they think is the best way forward, so they can give you a Guarantee and what they feel is the best way forward if they are not prepared to give you a Guarantee.

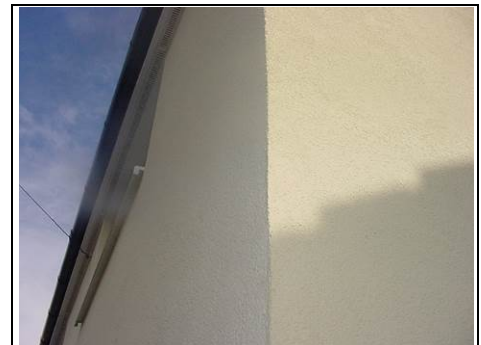
Difference between the two materials, with the mineral fibre finish to front and silicone finish to gable end

We understand the manufacturer of the External Wall Insulation (EWI) system is in the process of inspecting this property.

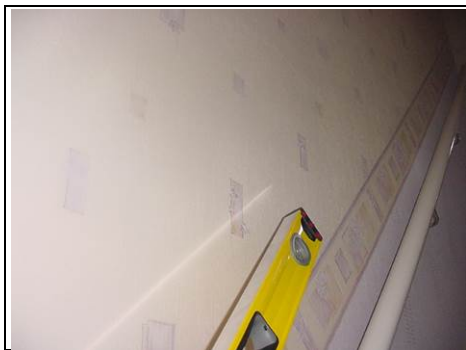
You advised that there has been some movement to the staircase wall and also the wall to the left hand bedroom (adjacent to the semi-detached property) has dropped.

Staircase wall

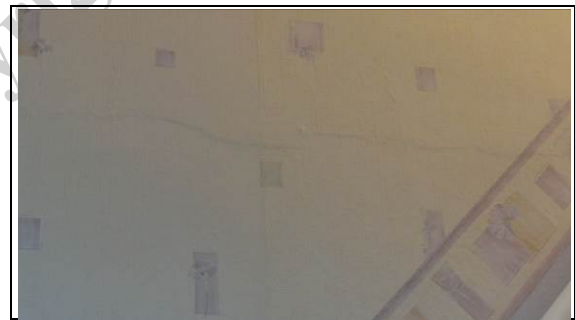
Movement seen through marks on wallpaper to staircase area (client's photo)

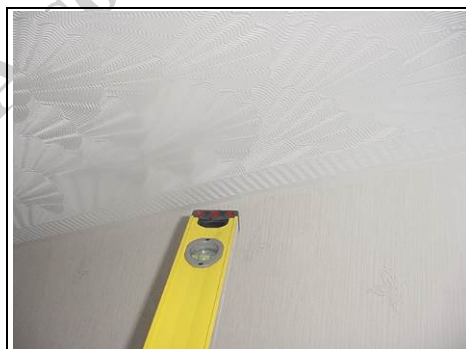
Movement in front left bedroom

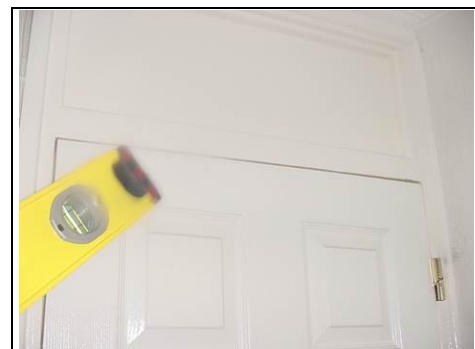
Checking for alignment on door in front left bedroom

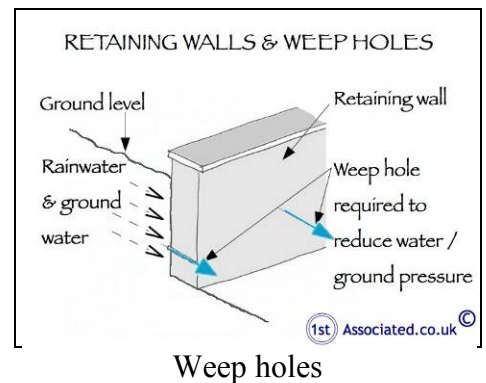
There is also a retaining wall to the left side, which is the garden side. It is built in a similar manner and we also noted a crack in this wall.

Crack in left side retaining wall

ACTION REQUIRED: We recommend adding weep holes to the retaining wall. This will then relieve the pressure behind the walls and in due course repair the walls.

ANTICIPATED COST: A few hundred pounds to add weep holes. Then it will depend upon what you want to do. Please obtain quotations.

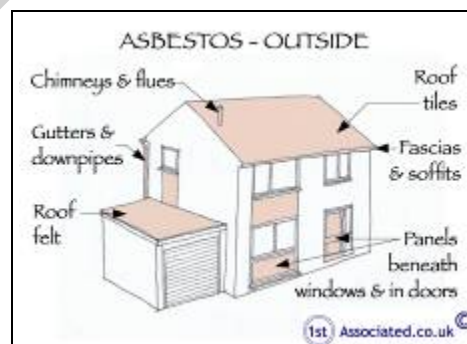
Asbestos - outside

ACTION REQUIRED: Your legal advisor to specifically ask in writing if all asbestos has been removed and for the Local Authority/present owners to provide Asbestos Reports. If not you will need to carry out your own Asbestos Survey.

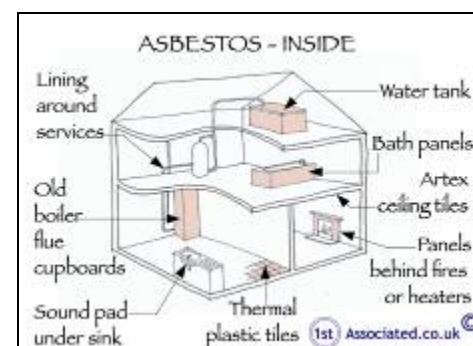
Asbestos - inside

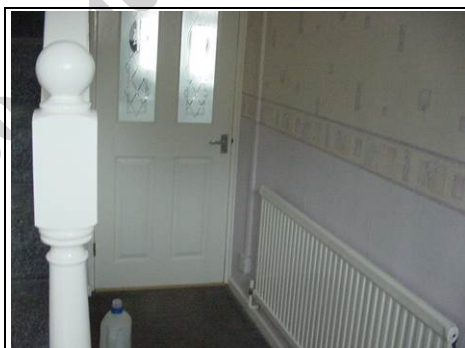
The radiators are single panel radiators. You may wish to upgrade these to double panel convection radiators, ideally positioned under windows which would also allow better air circulation around the property.

Single panel radiator in hallway

ACTION REQUIRED: We recommend you replace the radiators with double panel convection radiators as we feel this would improve air circulation, particularly with the number of people living in the property, to help towards reducing the chance of black mould.

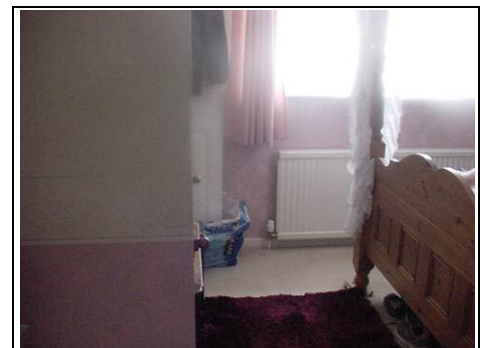
Single panel radiator in front left bedroom

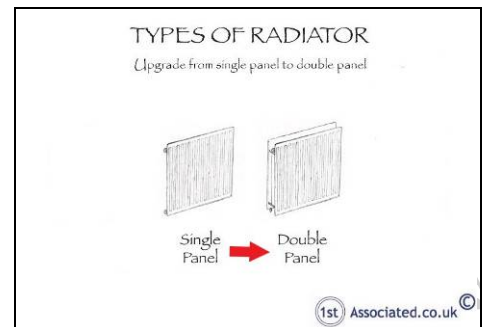
Replace single panel radiators with double panel convection radiators

ANTICIPATED COST: A few hundred pounds per radiator; please obtain quotations.

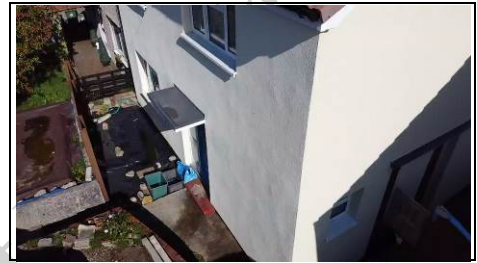
Undulations in front render
~ Aerial View - 360 Photo ~

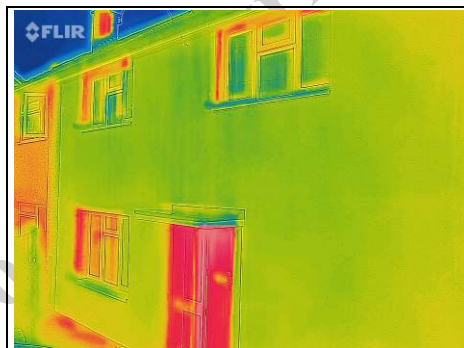
Close up of heat coming through windows and open front door

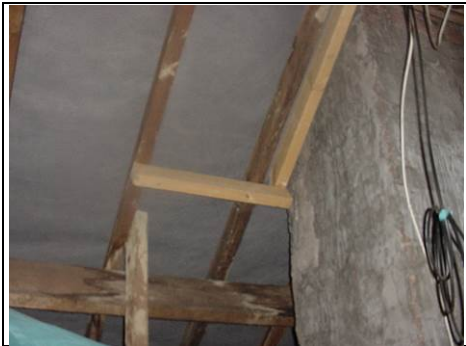
Within the roof we can see there has been water damage around the chimney. We understand this is historic, based upon our discussions with yourself about how you had problems getting the roof renewed. We would nevertheless monitor this area.

Water damage around chimney

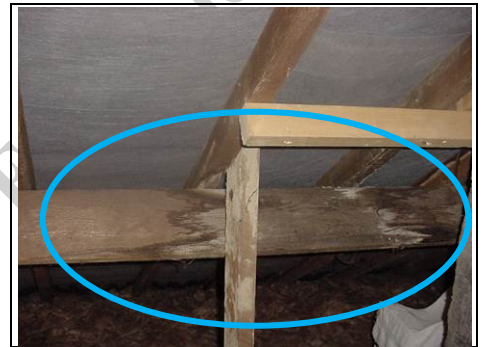
Our examination was limited by the general configuration of the roof, the insulation and stored items. What we could see was generally found to be in average condition for its age, type and style, with the exception of the staining on the timber which we believe relates to roof problems.

Dampness to timbers

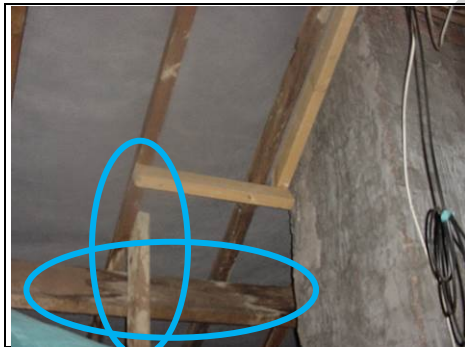
New timber visible and dampness to timbers around chimney

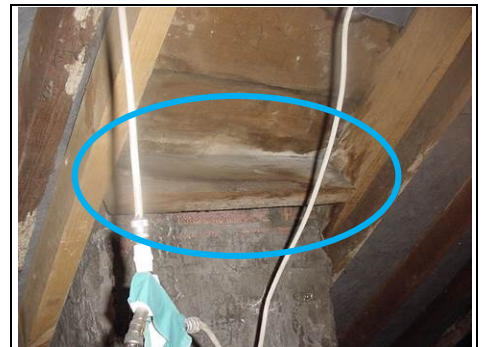
Dampness on timbers around chimney

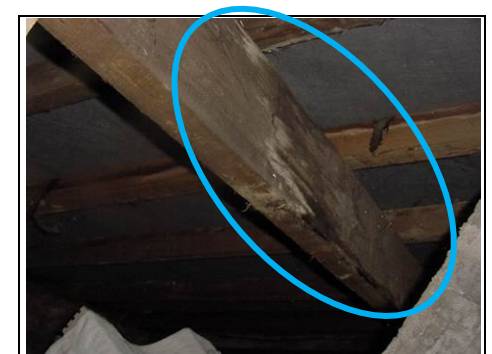
Dampness to is the purlin and common rafters, we believe from the chimney

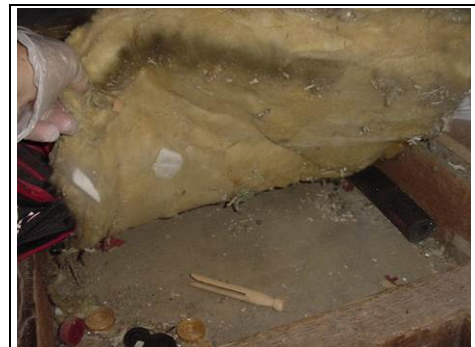
Please note that too much insulation can also lead to condensation in this type of building, which can be problematic.

Lifting insulation

ACTION REQUIRED: Use a pre-formed plastic vent to the edge of the roof, or whatever the manufacturer recommends, to allow a through flow of trickle air via the soffits. This will involve adjusting the fibreglass in the roof.

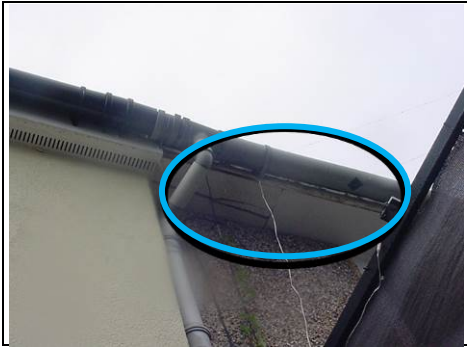
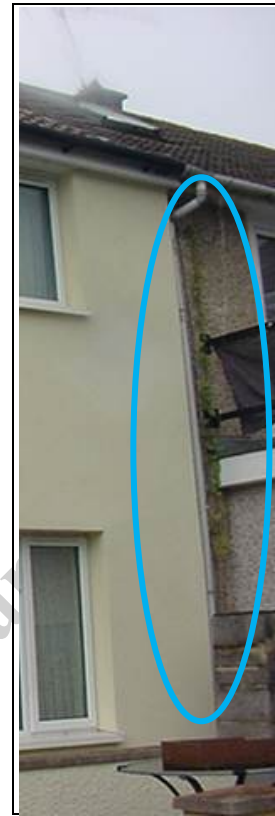
Rear downpipe on next door's property with long run of gutter

ACTION REQUIRED: We would always recommend you stand outside the property next time it rains heavily and see how well the drains cope with the rainwater particularly looking at the guttering and the joints.

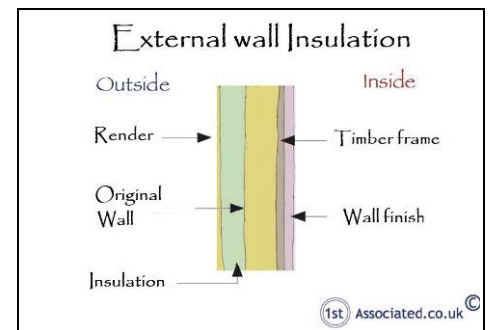
Concrete structure with EWI
(external wall insulation)

ACTION REQUIRED: Your solicitor needs to specifically ask the owners what system was used and explain your concerns with regard to the quality of work and the different materials used.

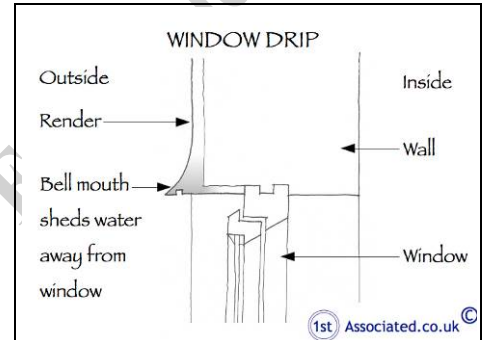
Traditional render would usually have a drip detail. Generally we are finding there is no drip detail on modern thin rendered systems.

Window drip

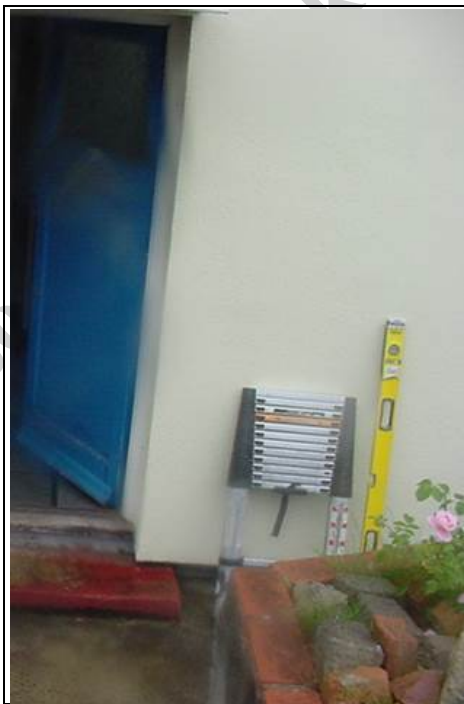
Equally a traditional render would usually have a bell mouth to the base of the render and we are finding no drip detail.

No bell mouth to base of render

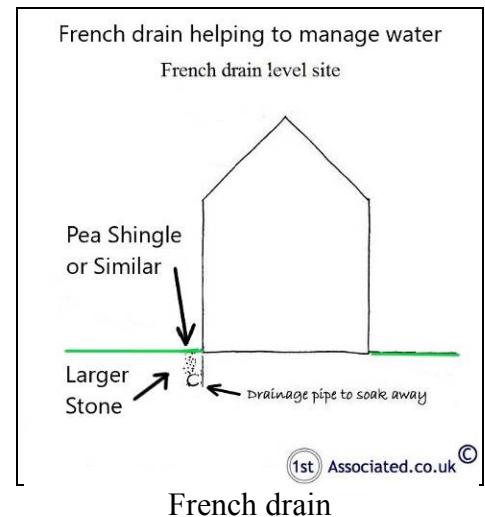
Our concern is that the polythene sheet/tarpaulin to the front will cause dampness under the property.

ACTION REQUIRED: We recommend it is removed immediately. If water is not draining away from this area then we would recommend a French drain is added, which is taken to the manhole to the right hand side of the property.

ANTICIPATED COST: In the region of £1,500 to £3,000 for a French drain; please obtain quotes.

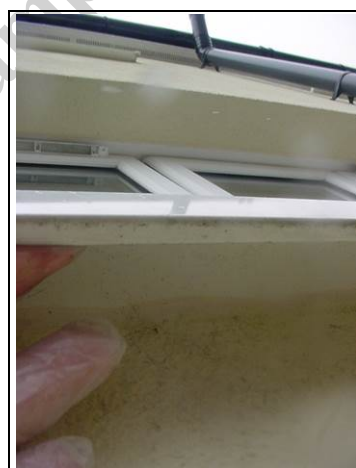
The underside of the sill detail is relatively thin and therefore you need to take care not to damage it.

Thin sill detail door

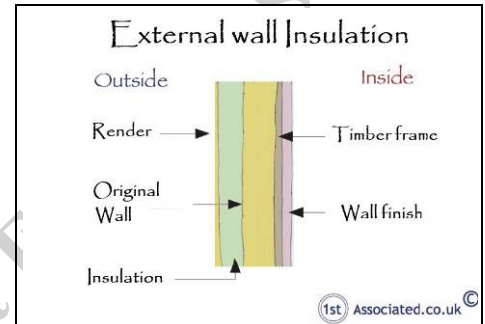
The original perimeter wall are concrete, which have now had an insulation covering with a render finish.

Concrete structure with EWI
(external wall insulation)

ACTION REQUIRED: If you wish us to comment further we recommend the wall is opened up in three areas, approximately one metre square. If you contact us we will identify exactly where we would recommend opening up in this particular case.

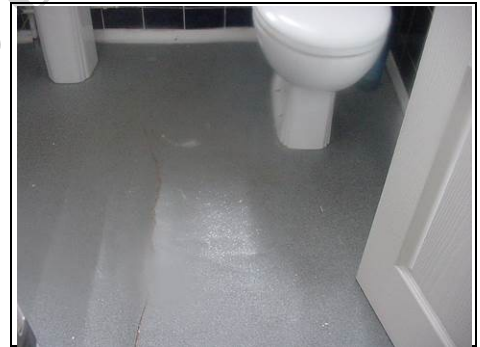
You advised us of bathroom floor problems.

Bathroom floor

ACTION REQUIRED: Please see our comments in the Executive Summary.

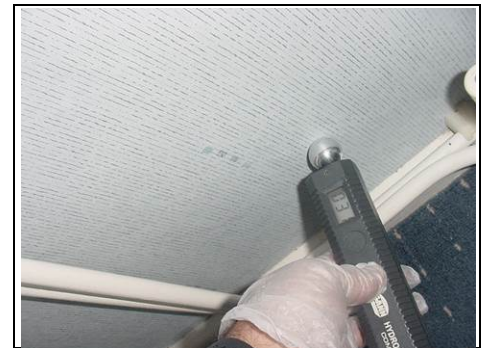
A visual inspection and tests with a moisture meter have been taken to the perimeter walls. In this particular case the walls are dry lined so we were unable to get damp readings, although dampness may be occurring in the property. We have not way of checking it without opening up the walls.

Testing for rising damp

ACTION REQUIRED: If you wish to be 100% certain that the property is in good condition you will need to open up the walls. We normally recommend three areas of approximately one metre squared.

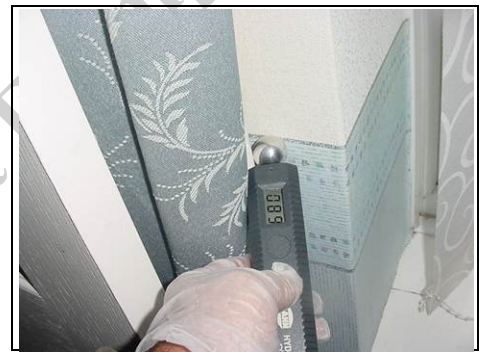
We used a resistance meter on the external walls. Again the walls are dry lined so we were unable to get readings.

Testing for lateral dampness

ACTION REQUIRED: See our comments in the earlier dampness section about opening up the walls.

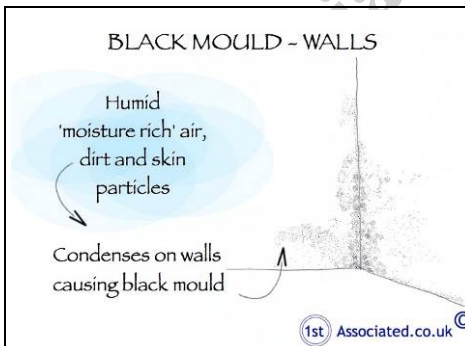
At the time of the inspection there were signs of condensation in the form of black mould in the rear right bedroom and bathroom.

Black mould

ACTION REQUIRED: If these extract fans are not suitable we would recommend large humidity controlled extract fans are added to the bathroom, kitchen and any rooms used as drying areas.

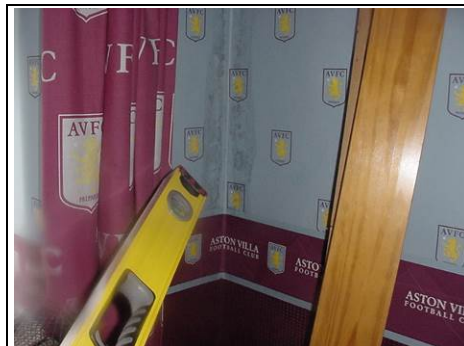
Black mould to corner of rear right bedroom

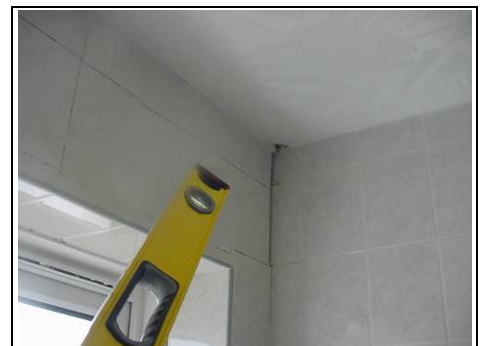
Black mould in bathroom

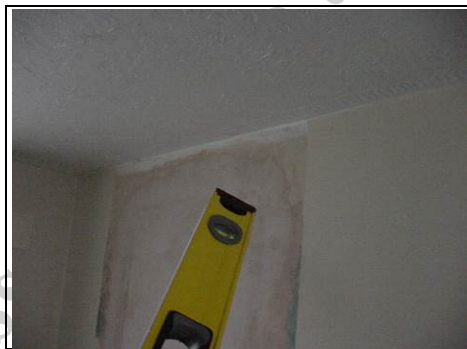
There is a blocked up door to the rear of the lounge, which used to access the kitchen and we assume an opening up of the door to the end of the hallway. The plan below shows door blocked up (black oval) and wall removed (white oval).

Blocked up door

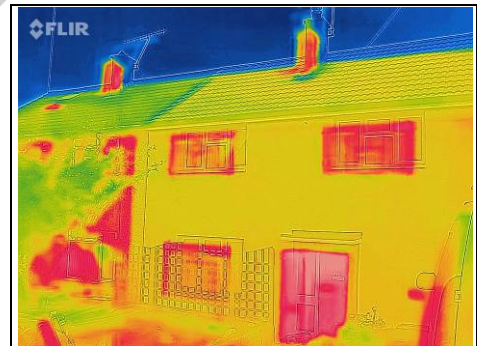
We would comment that the adjacent photo shows the heat loss is through the window and open door.

Thermal imaging of front of property

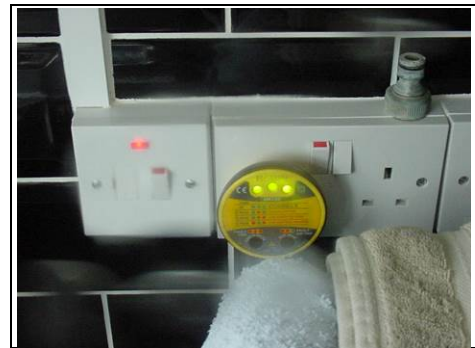
We carried out an earth test in the kitchen area to the socket point that is normally used for the kettle, this proved satisfactory.

Earth test

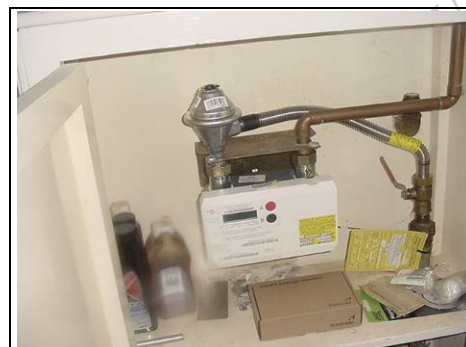
Gas meter in kitchen

ACTION REQUIRED: As a matter of course it is recommended that the entire gas installation is inspected and made good, as necessary, by a Gas Safe registered contractor. Thereafter the installation should be serviced annually.

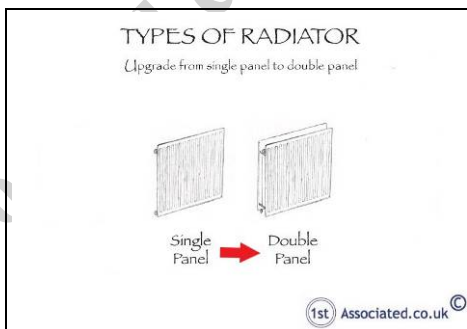
We did note some single panel radiators and you may wish to upgrade to double panel convection radiators.

Replace single panel radiators with double panel convection radiators

ACTION REQUIRED: We recommend you upgrade to double panel convection radiators, preferably positioned under windows for good air movement.

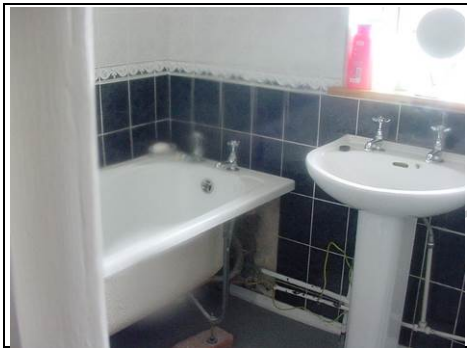
At the time of our inspection the bath panel was removed and there was damage to the floor and black mould to the wall.

General view of bathroom

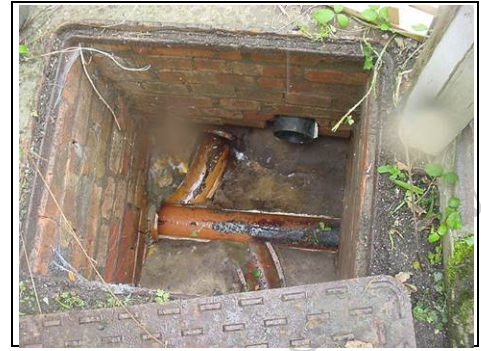
We duly lifted the cover and found it to be clear at the time of our inspection.

From what we could see it is brick built.

Manhole to right corner of property

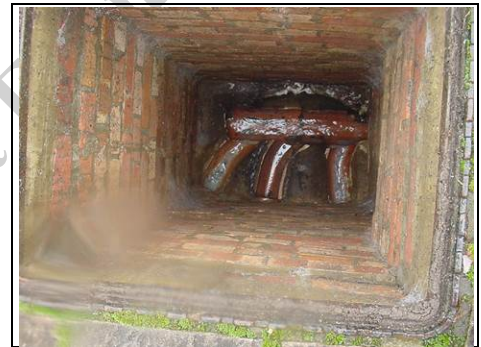
We duly lifted the cover and found it to be clear at the time of our inspection.

Again, from what we could see it is brick built.

Rear manhole

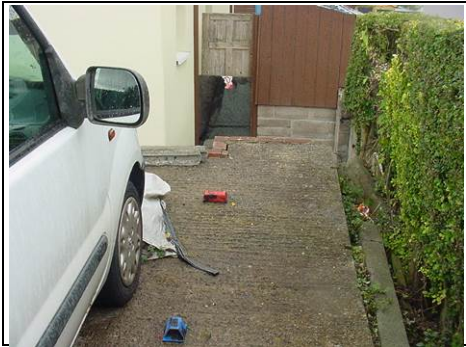
There is parking to the front right side of the property. It is on built up ground, as the property sits on a sloping site.

There are retaining walls, which we noted cracking to both sides.

Driveway drops away top right hand side

ACTION REQUIRED: Add weep holes to the retaining walls and repair cracks to all retaining walls.

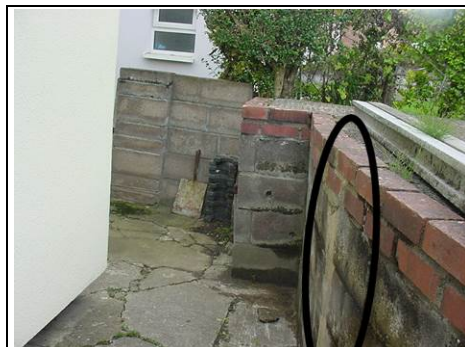
Retaining wall around drop from front driveway

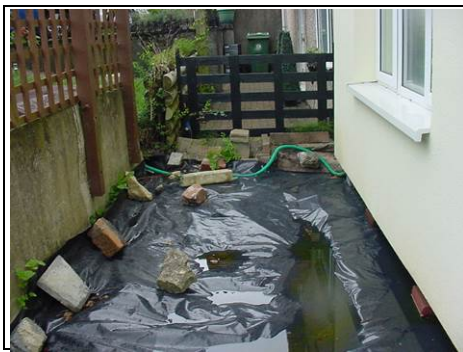
The front is paved and on a sloping site. There was tarpaulin to the front garden at the time of the survey.

Tarpaulin to front left

Remove all the tarpaulin immediately as we feel it will cause dampness to get into the building.

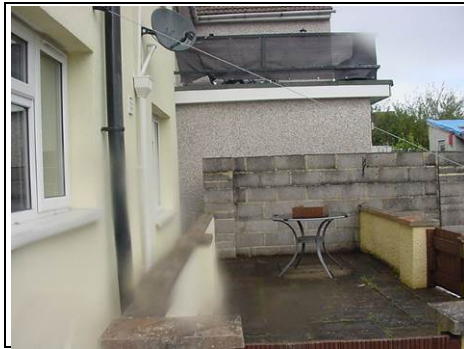
This is not a traditional lawned garden and the concrete may hold water which could add to dampness in the property.

Rear Garden

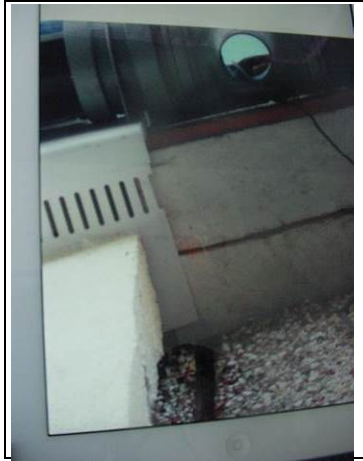
Trickle vent from fascias and soffit not allowing air movement into roof

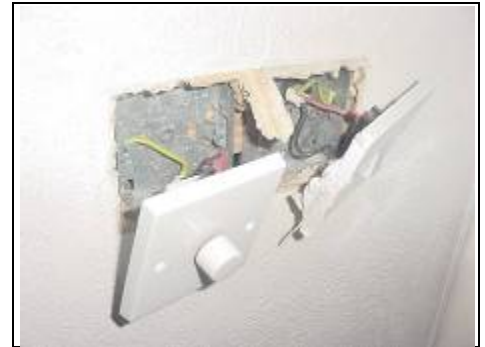
Removing electric points to view construction
