RESIDENTIAL BUILDING SURVEY

Non-Traditional BISF House Lincolnshire

Mr X

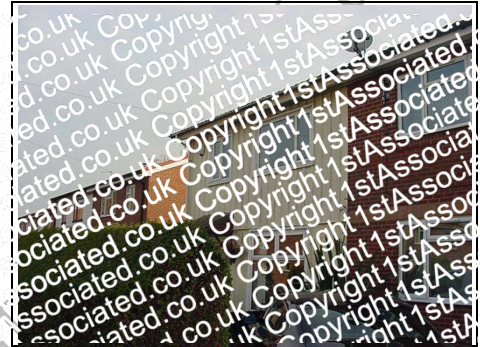
Both neighbours have brick frontages

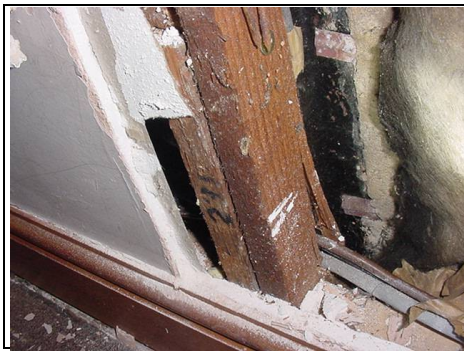
The risk with buying any steel framed property is if the structural frame is sound or not. We have opened up the building in two areas on the ground floor under the front window in the lounge to the left and right. In this case we can see the metal frame which has had treatment post its original construction. In the areas we could see it was in average condition.

Front left opening up black area

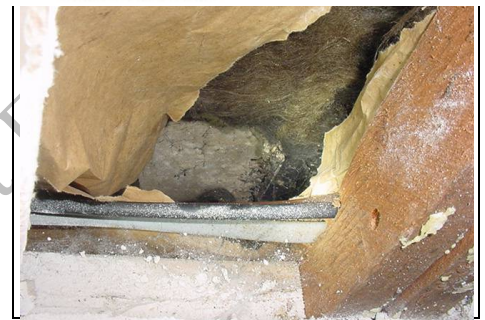
Front right opening

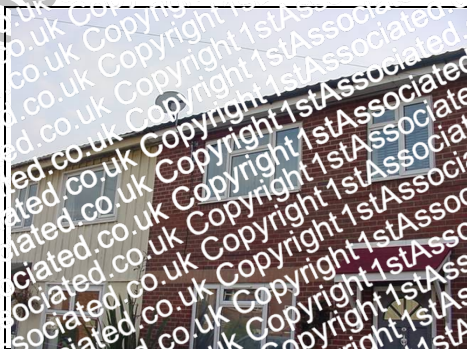
As the property is a non-traditional construction this raises the question can it be made into a more mortgageable house? Many houses in the area have been upgraded and now have a brick exterior. The jury is still out with regards to how good these upgrades are. In some cases, we believe there is a possibility of interstitial condensation.

Upgrade with brickwork to right neighbour

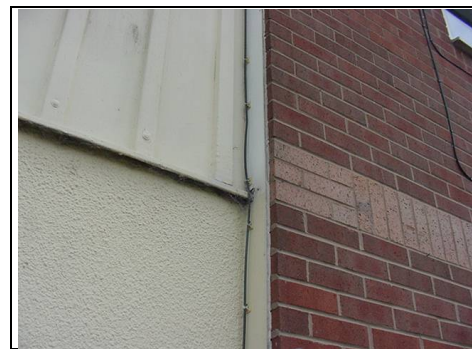
Difference in thickness of insulation to neighbour's brick finish

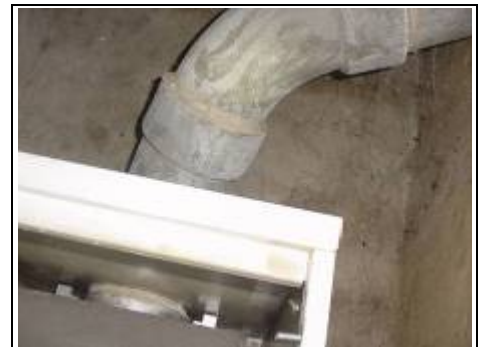
Example of Asbestos flue on similar metal frame non traditional property (Not your property)

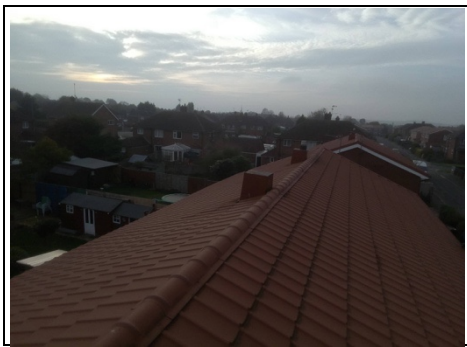
The main roof would have originally been asbestos and has now been removed and replaced with a pressed metal roof which looks like tiles.

Pressed metal roof

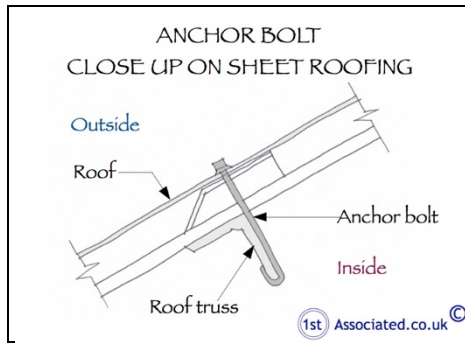
The anchor bolts are rusting to the pressed metal sheets. This type of problem is fairly common on commercial properties which use a similar detail however we have not come across it on this type of BISF house.

Anchor bolt

A close inspection needs to be carried out of the rusting anchor bolts and replace as necessary.

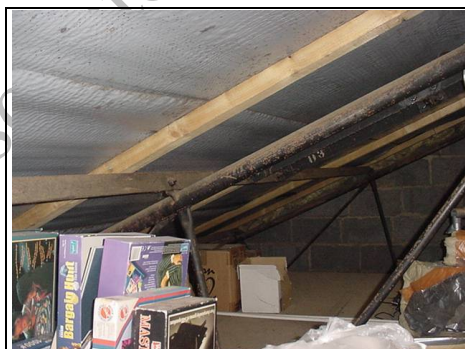
Within the roof we found a plastic based membrane. This type of membrane was used in the 1970's and tends to suffer from condensation. Today protective underlayers are a breathable membrane. Unfortunately having condensation in a house such as this means that the metal frame rusts.

Rust to metal roof structure

Within the roof where we could see the metal frame we could see that the rusting is above average.

Rust to metal frame

ACTION REQUIRED: We would recommend the roof is vented and that air movement is introduced. Unfortunately this is a difficult and awkward task as it will involve emptying the roof of stored items, removing the boarding that has been added, removing the insulation and rubbing back the metalwork, preparing it and applying a protective paint.

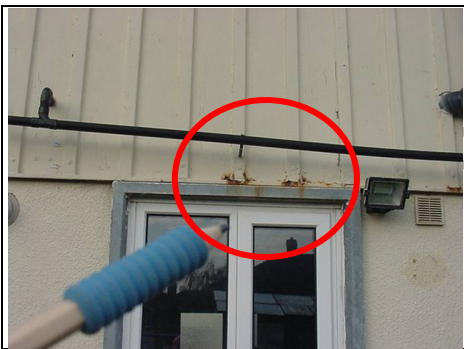
The profile metal sheeting is showing signs of deterioration. There is rusting occurring at the drip detail where the frame meets the main building. This can be for many reasons, for example leaking gutters and it can also be due to lack of maintenance and the paint being allowed to weather in these areas. We anticipate some deterioration for its age, type and style however this is above average.

Rusting to drip detail where profile metal sheet meets render and window surround

ACTION REQUIRED: Repair, prepare and redecorate.

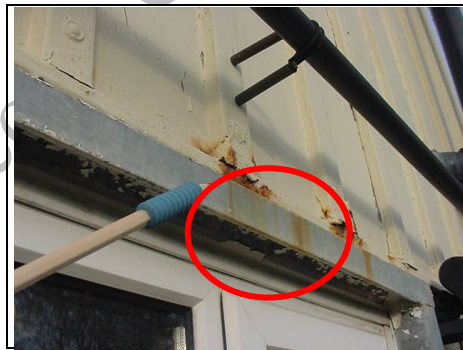
Close up of detail where profile metal sheet meets the lower part of the building

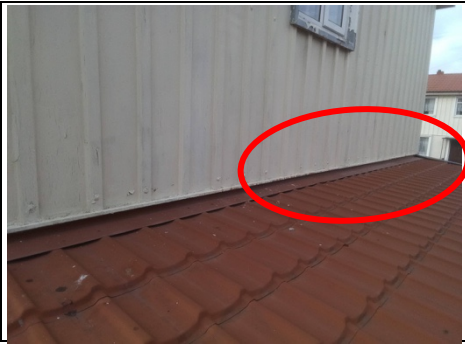
Rusting to rear left

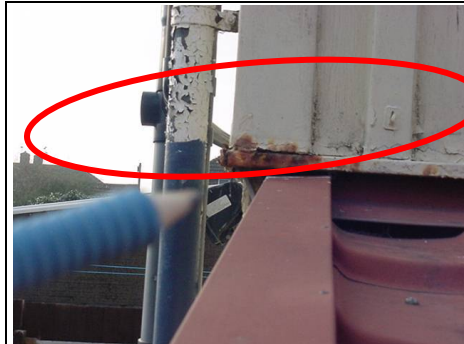
Rust to rear left corner

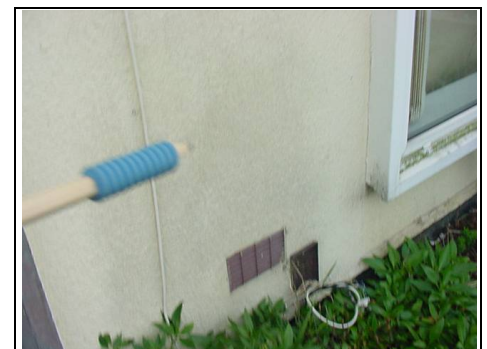
Blackening of render

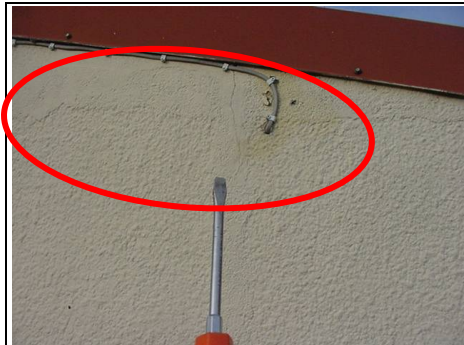
There are cracks to the front, side and rear of the property. We feel that all of these need sealing and monitoring. They need to be sealed using a flexible mastic to enable movement to occur.

Signs of cracking covered up to rear left

ACTION REQUIRED: Ideally we would recommend that you place an insurance claim, advising that the cracking has been noted by a structural surveyor. This usually means that the insurance company will carry out a monitoring exercise (the Building Research Establishment recommend monitoring any cracks for a minimum of one year) to establish if there is any progressive movement. Your future liability should be limited to the cost of the excess on the insurance.

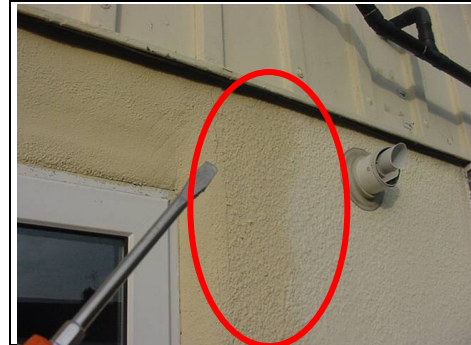
Vertical crack to rear

We believe the cracks are historic from our one-off inspection however given the condition of the metal cladding and sill detail we feel that dampness could get into the building. Some of the cracks are difficult to age, particularly the vertical cracks which may be from expanding and corroding metalwork or may be from differential movement between the main building and the adjoining single storey structure such as for example the vertical crack on the lean-to.

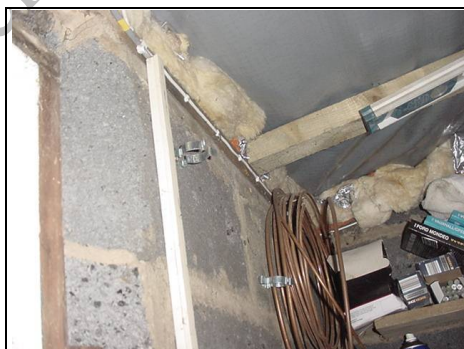
The cracks to the lean-to we are not overly concerned about as we believe this to be a traditional construction. We noted blockwork when we went into the store area.

Blockwork to left lean-to

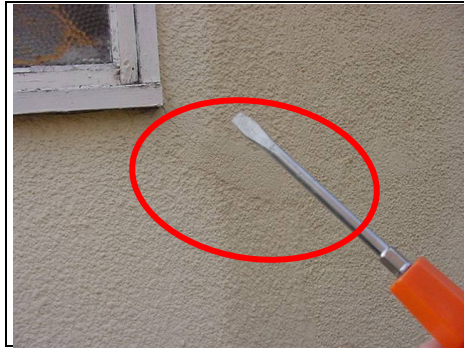
Repaired cracks on left side

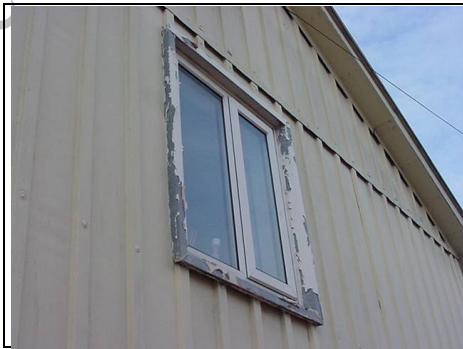
The property has older style plastic windows set within a metal frame. The paint to the metal frame is deteriorating. There is a timber window to the lean-to which is in need of repair and redecoration.

Deterioration to left window

ACTION REQUIRED: Repair, prepare and redecorate. We would also add that the windows do not have trickle vents; it is good to have air movement in the property so either add trickle vents to the windows or replace them and/or add ventilation to the rooms.

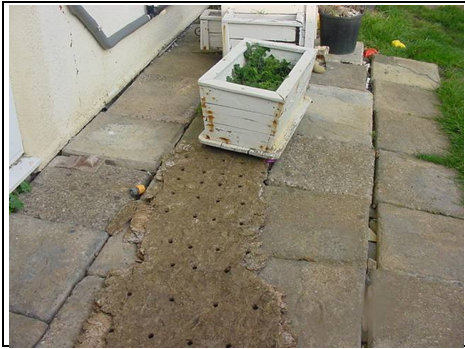
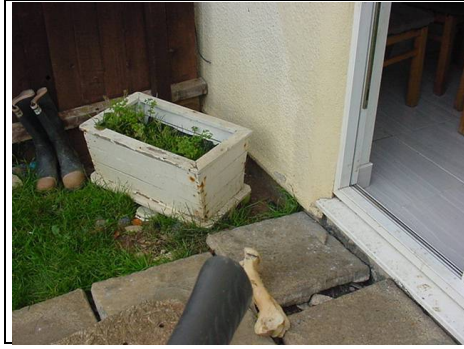
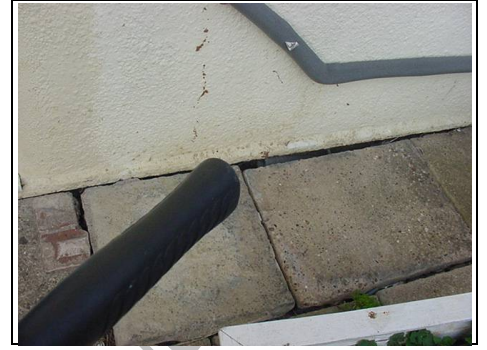
The paving slabs to the rear are uneven.

Uneven paving slabs

Rear paving slabs uneven

ACTION REQUIRED: Re-bed and level.

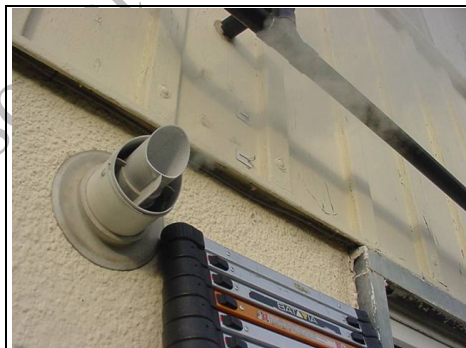
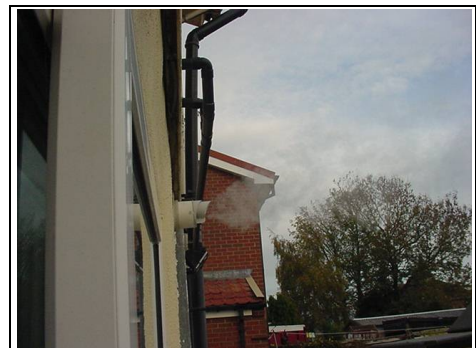
The modern boiler is discharging steam onto the rear of the property. This needs a cover to divert steam away from the property particularly as it is going onto the metal frame and will accelerate deterioration in this area.

Boiler flue

Steam from boiler

ACTION REQUIRED: Extend flue and add deflector to keep condensation away from the building.

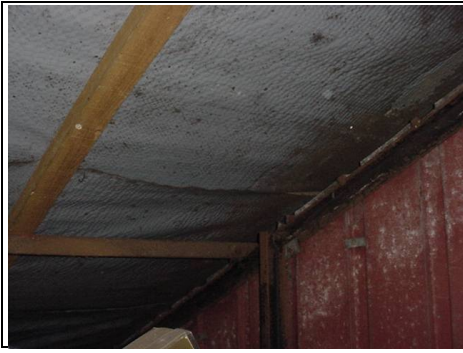
Plastic underlayer to main roof

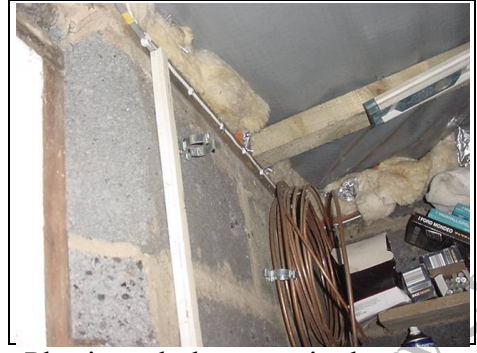
Plastic underlayer to single storey extension roof

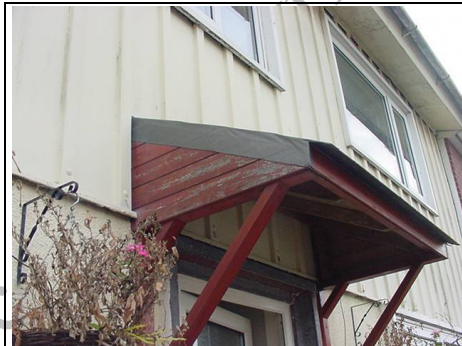
Flashband is a sticky backed felt which is best used for temporary repairs only.

Canopy gallow brackets with flashband on side and timber needs redecoration

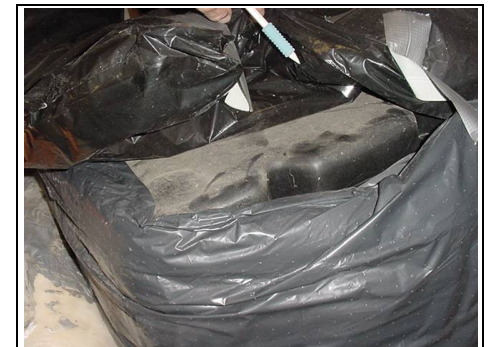
There are water tanks within the roof which sometimes can add to the condensation occurring. This should be checked periodically.

Water tank

We would always recommend that water tanks be drained down and cleared of any debris etc. (we have seen dead birds and other unmentionable things in these tanks). As you are often cleaning your teeth with this water it is best that it is as clean as possible!

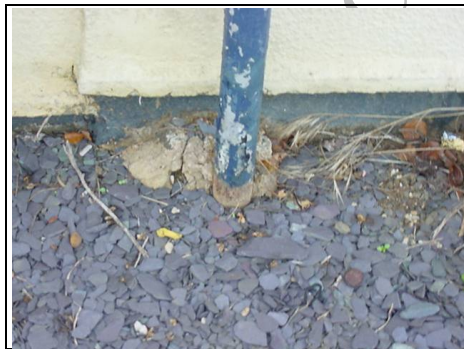
The downpipes feed directly into the ground so if there is a blockage then the drain would have to be opened up. This is a practice we are not particularly keen on; we would much prefer a gully.

Downpipes feed directly into ground

ACTION REQUIRED: We would always recommend you stand outside the property next time it rains heavily and see how well the drains cope with the rainwater particularly looking at the guttering and the joints.

We also recommend that the gutters and downpipes are cleaned out, the joints are checked and the alignment checked to ensure that the gutters fall towards the downpipes.

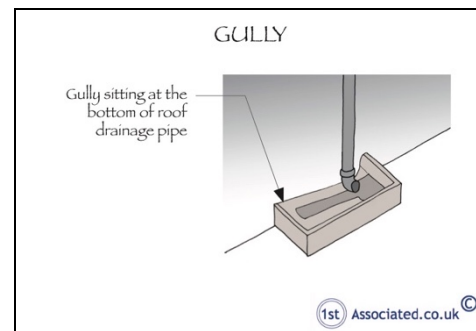
Downpipes should feed to gully

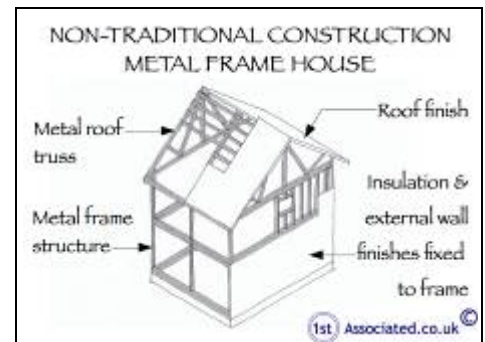
Sorry to repeat ourselves but this really is so important, this house is of a non traditional construction commonly known as a BISF house which stands for British Iron and Steel Federation who manufactured this type of house system. It was one of the more popular types. This type of system build house effectively means the building is built on a foundation with a structural frame and then cladding added to the roof and to the walls.

Non traditional construction

ACTION REQUIRED: Please see our comments in the Executive Summary and our articles in the Appendices.

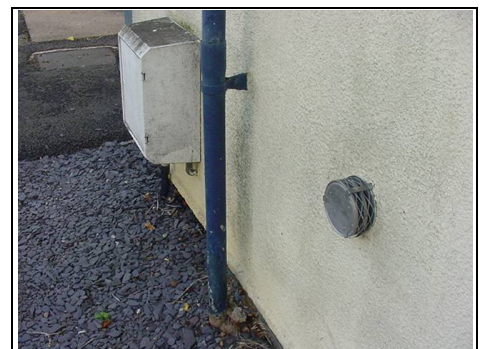
Painted render

To the base of the render there was a bell mouth detail. This should in theory be 100mm to 200mm above ground level. We recommend the ground around the property is reduced to do this.

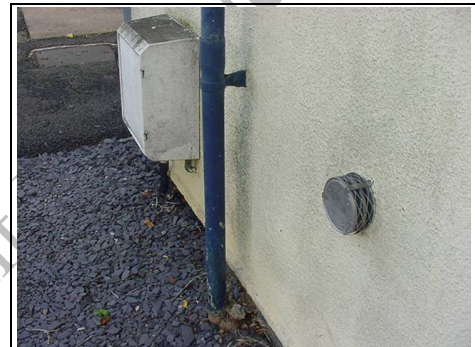
All modern properties should incorporate a damp proof course (DPC) and good building practice dictates that a differential of 150mm (6 inches) should be maintained between the damp proof course and ground levels. In this case we cannot see a DPC due to the render.

Render to base

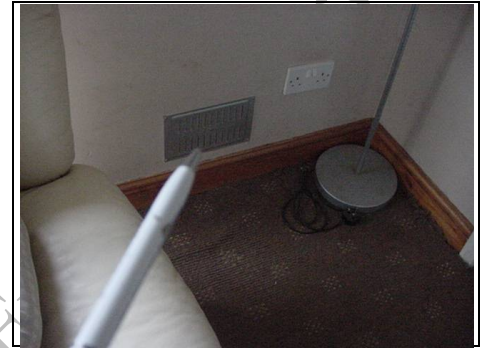
There were low level air bricks to the render. It is important these are added to allow air circulation and to ensure they are not blocked and are kept clear.

Air vent to front

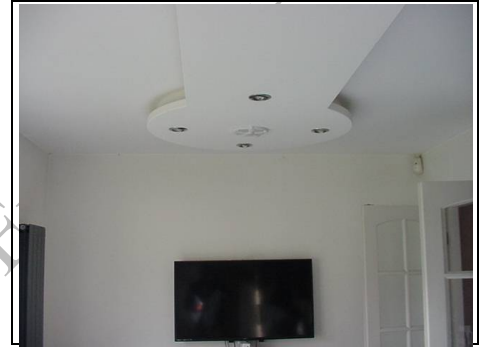
Ceiling amendments

In this case the owner has added new ceilings as far as we can understand, some of them are quite decorative such as the ceiling within the kitchen dining/breakfast area. This type of alteration will appeal to some people but not all.

We noted popping to some of the plaster. This is where the nail heads have not been put into the plaster correctly and the plaster over the top pops which leads us to believe that probably the plaster has been tacked onto the original ceiling. We have not been able to check what this is.

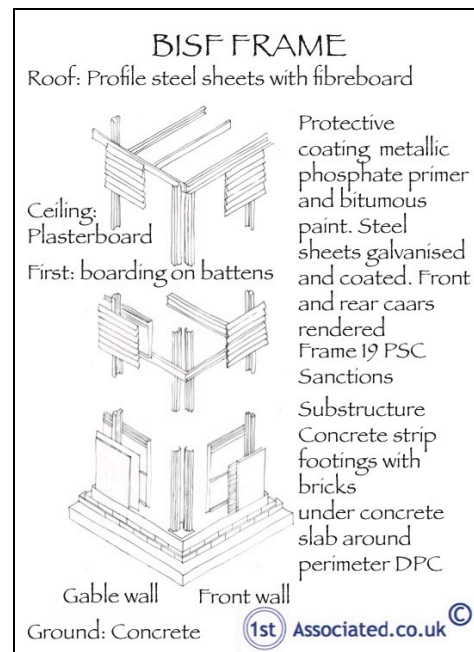
A random visual inspection and tests with a moisture meter have been taken to the perimeter walls. In this particular case we were unable to obtain readings due to the lining.

Dry lining

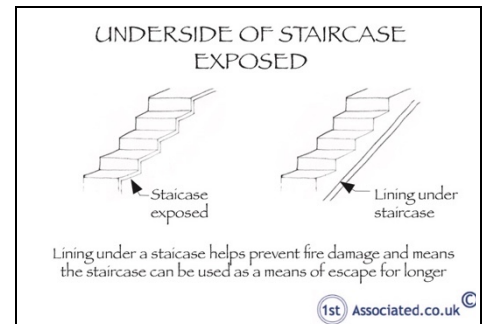
We were unable to examine the underside of the stair timbers due to it being lined where we could see it, which precluded our inspection, so we cannot comment further upon the stair structure. We can, however, say that the lining gives a resistance to the spread of fire if such circumstances were to occur.

Under stairs lined

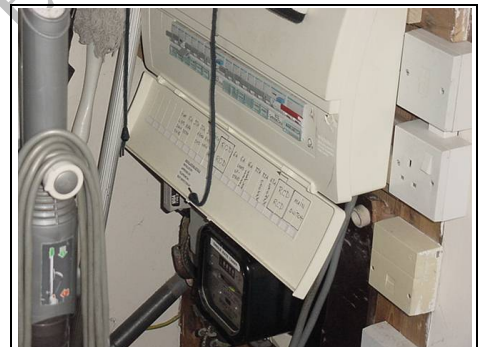
The electric fuses and consumer units were located under the stairs. The fuse board looked 1990's/2000's and better are now available.

Fuse Board

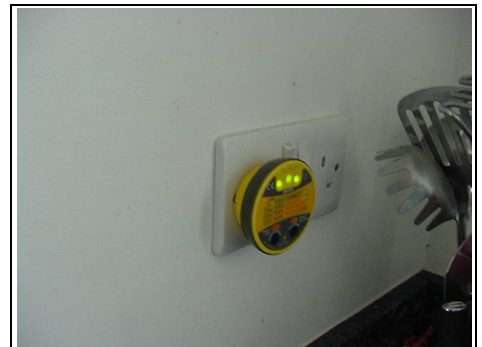
We carried out an earth test in the kitchen area to the socket point that is normally used for the kettle, this proved satisfactory.

Earth test

ACTION REQUIRED: All work carried out since 2005 should have suitable certification which will be required if/when the property is sold.

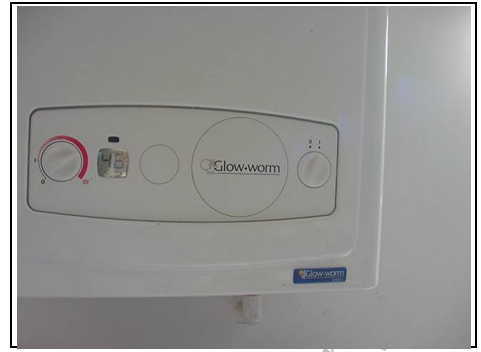
Our limited inspection of the hot water and central heating system revealed no evidence to suggest any serious defects but we would nevertheless recommend that the system be tested and overhauled and that a regular maintenance contract be placed with an approved heating engineer.

Boiler

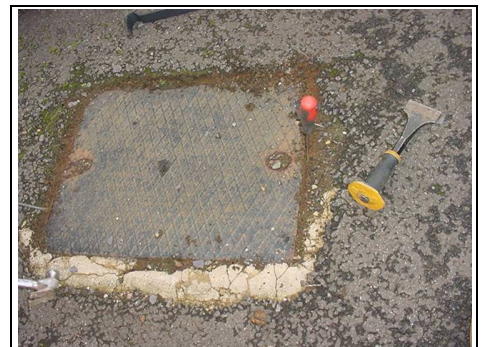
Front left manhole

We were unable to lift the manhole therefore are unable to comment.

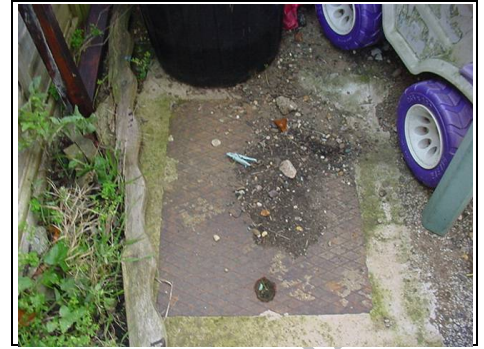
Rear left manhole

We were unable to lift the manhole therefore are unable to comment.

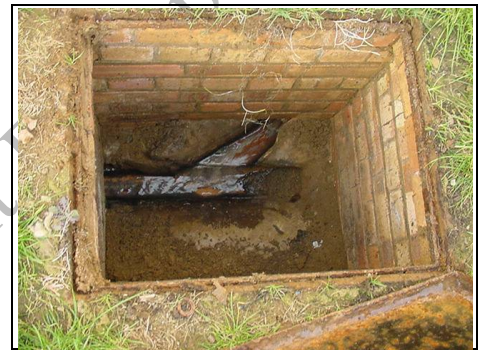
Rear right manhole

We duly lifted the cover and found it to be free flowing at the time of our inspection.

From what we could see it is brick built.

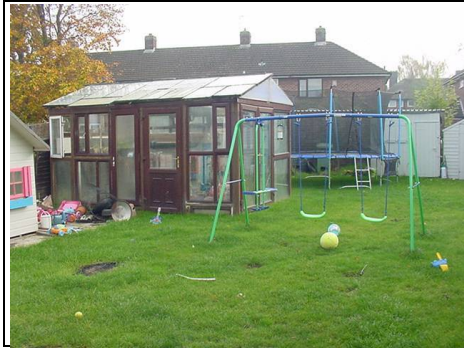
Rear Garden

There is a good sized garden with various outbuildings to the rear and also a trampoline to the rear of the garden. The paving slabs are uneven and need re-bedding and levelling.

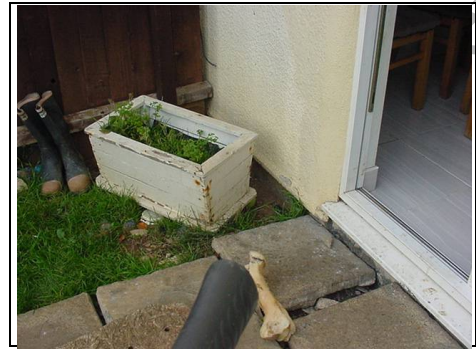
Uneven paving slabs

ACTION REQUIRED: Please see our comments in the Executive Summary.

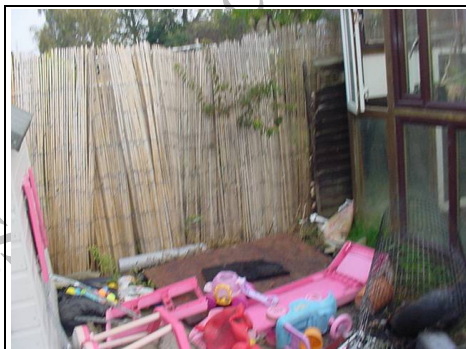
The left fence is in need of repair.

Left fence in need of repair

ACTION REQUIRED: Please see our comments in the Executive Summary.

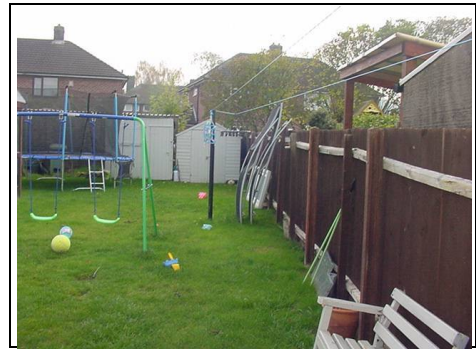
Right fence

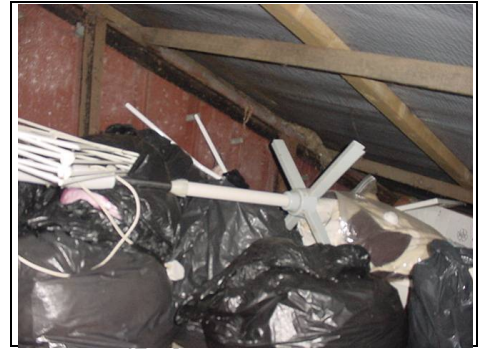
- 1) We did not have a full view of the roof due to the insulation and boarding covering the ceiling joists, general configuration of the roof and stored items.
- 2) We only opened up the walls in two areas.
- 3) We did not open up the ground floor or the first floor as we could not see a way to do it without causing damage.
- 4) We thank you for taking the time to meet us during the survey.

Stored items limited view

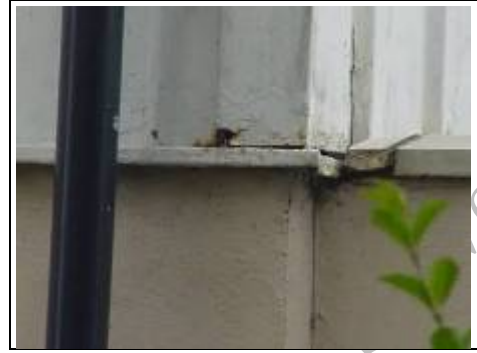
Rusting to profile metal cladding

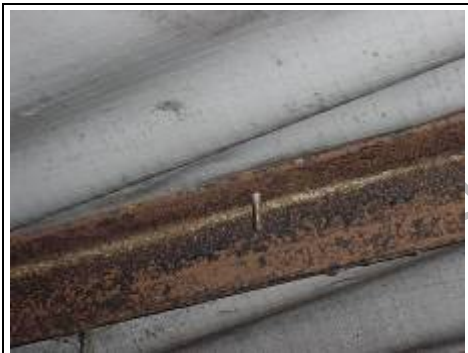
Example of rusting that we have seen in the roof of a metal framed building

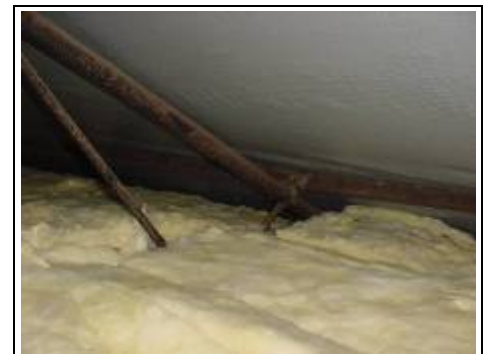
Example of over insulation of a metal framed property which causes condensation

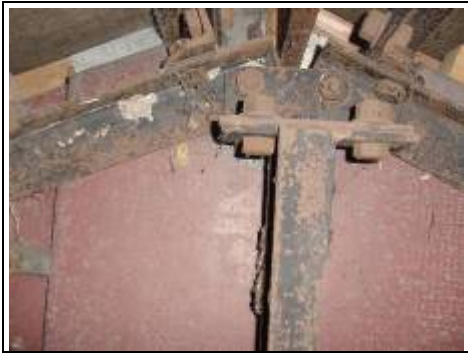
Rusting to a lightweight metal frame or damage or deterioration to the metal frame of a non-traditional house

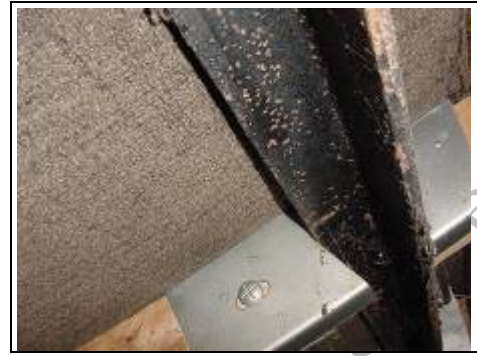
Some fixings replacements/repairs to a non-traditional house

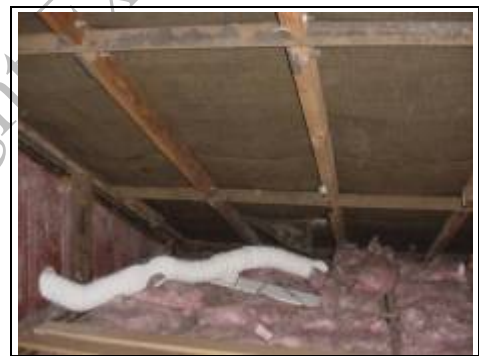
It is very common these days to have a shower/bathroom with an extract system. Does that extract system discharge into the roof or does it discharge out of the building? If it discharges into the roof then there can be problems with rusting and corroding of metal and dampness to timber.

Extract vent to outside often discharges into roof which is essential that they do not in this type of roof

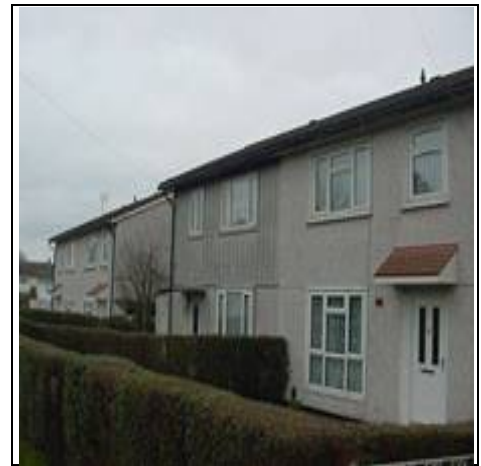
Non-traditional house looks like any other house to the average person

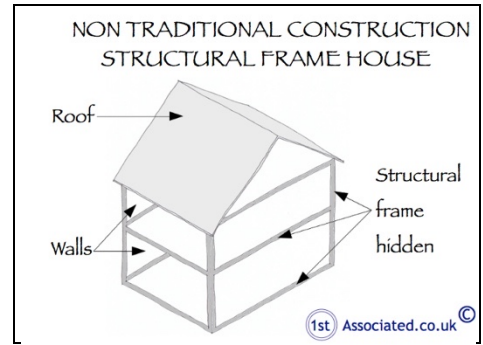
Non-traditional frame construction

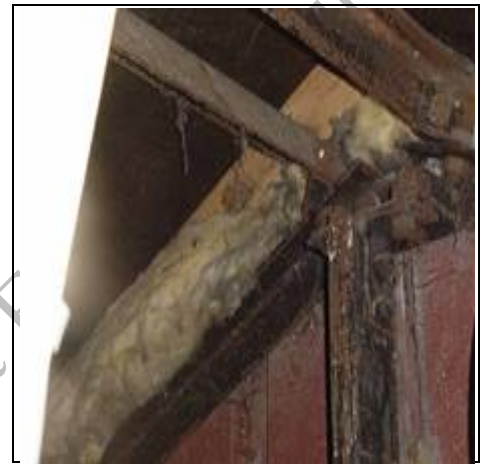
Steel frame visible on a close inspection to the property which is why this is a BISF or non-traditional property
