Victorian Example Residential Building Survey

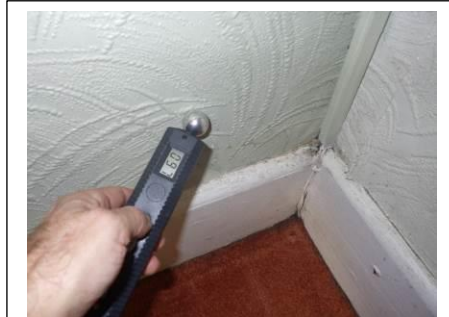
We found dampness in the property and in many areas obtained high damp meter readings (by high we mean approx. 25% plus more than we would normally expect). Dampness occurs for a combination of reasons, we think the most likely reasons in this particular instance are:

High damp meter reading of 97

ACTION REQUIRED: We think moving into the building and generally heating it and adding full heating at some point (central gas heating or electric heating) will help the building considerably and also managing humidity created. Also see our section on removing the cement mortar and getting the building to breathe.

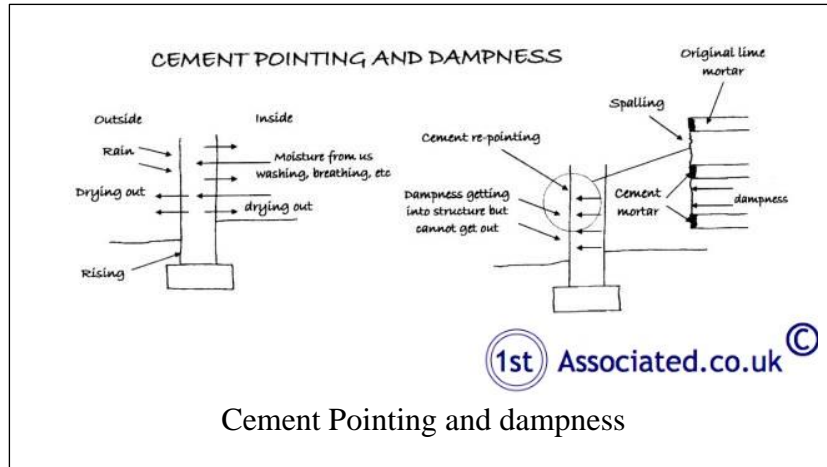
Re-pointing is required in a lime based mortar and this is what should be used for any re-pointing in the future as this allows the property to 'breathe' and dissipate dampness.

The use of cement mortar causes deterioration to brickwork and does lead to the face of the bricks deteriorating and also leads to dampness and cracking.

ACTION REQUIRED: We would recommend repointing with a lime mortar. If you recall, the cement mortar was falling out in many areas and we think a stiff brush would remove a fair amount of it. We would initially concentrate on the base of the property which should help considerably. Care needs to be taken as we feel some of the bricks are starting to deteriorate/shale.

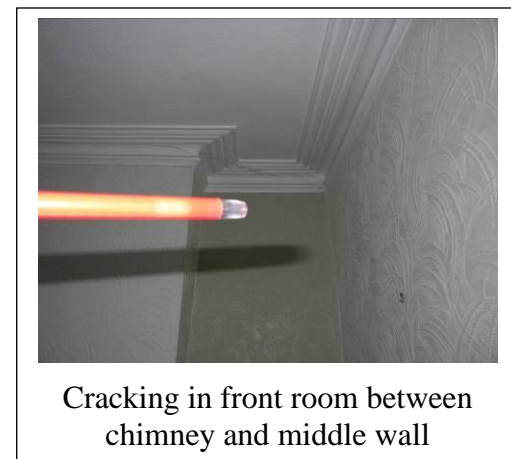
2) Internal

Gable end wall internally to the plaster

ACTION REQUIRED: Ideally, we would recommend the existing owners take out an insurance claim, advising that the cracking has been noted by a structural surveyor (this should cost them nothing other than time to write the letter/email). This usually means that the insurance company will carry out a monitoring exercise (the Building Research Establishment recommend monitoring any cracks for a minimum of one year) to establish if there is any progressive movement. Your future liability should be limited to the cost of the excess on the insurance providing the insurance company is happy for you to take over the insurance claim.

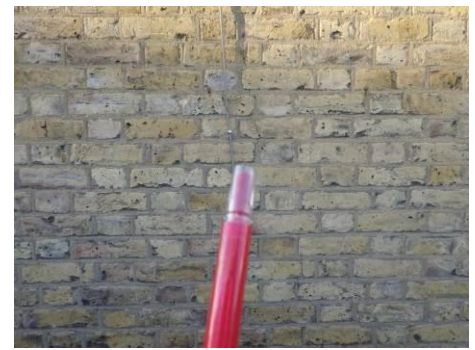
Cracking to the gable end brickwork

Crack to gable end

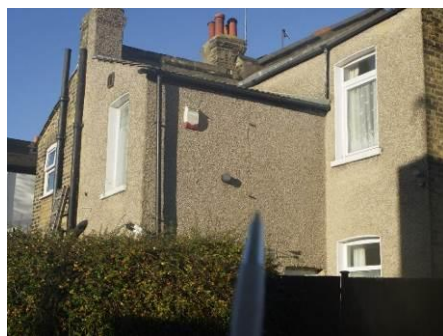
Cracking to render. We would comment generally that the render and the stonework to the front of the property could be hiding cracks.

Crack to rear render

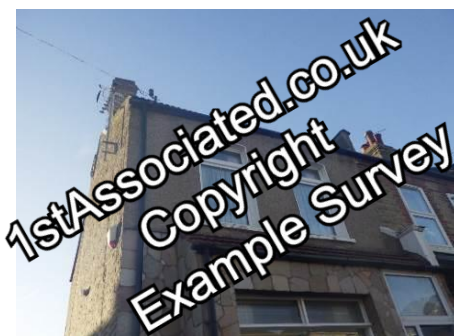
Render and stonework could be hiding cracking

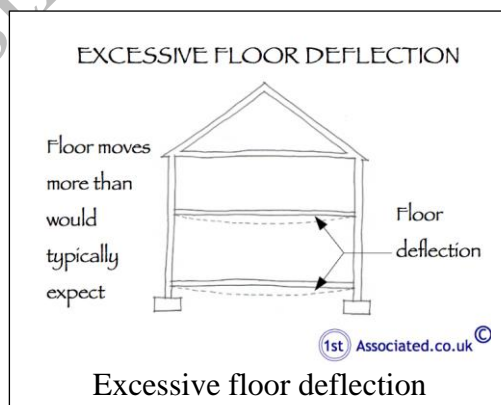
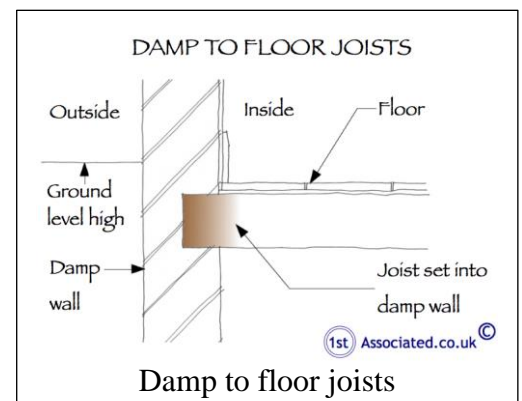
As mentioned, the property has deflection. This may indicate that the timber joist ends have deteriorated often due to dampness as this is a solid wall construction building and the cement mortar that has been added to it has stopped it from dissipating the dampness which in turn can lead to deterioration of the joists. Equally, it could be that the joists are undersized and there may be some repair needed or strengthening of the joists using herringbone strutting.

ACTION REQUIRED: Open up the floor and check the joist ends and the joist sizes. If you forward us photographs we would be more than happy to comment

ANTICIPATED COST: You may decide that you can live with the deflection, alternatively you may put in strengthening of the timbers (we call back to backing) or herringbone strutting. Budget £1,000 - £3,000; please obtain quotations before you legally commit to purchase the property.

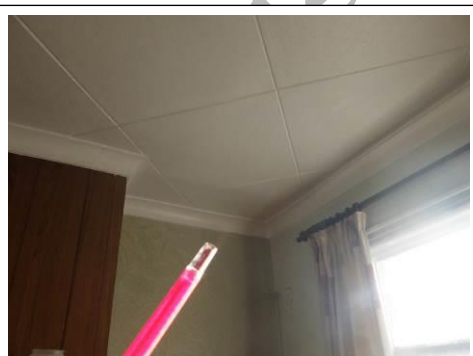
There are polystyrene tiles throughout the property which were once popular and are now generally considered a fire hazard. We would also advise that many mortgage companies require them to be removed from what we understand to meet their mortgage requirements. Polystyrene tiles are often added as:

Polystyrene ceiling tiles

ACTION REQUIRED: Remove the tiles and repair the ceilings as necessary. You do have to be careful when removing the tiles as it can bring parts of the ceiling down.

ANTICIPATED COST: A few hundred pounds to perhaps a thousand pounds per ceiling. This could add up to a fair amount of money in a worst case scenario when you are taking the ceiling tiles down and the ceiling is in a poor condition. Budget £4,000 - £8,000; please obtain quotations before legally committing to purchase the property.

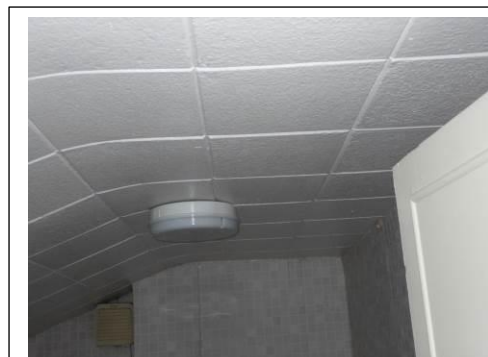
Polystyrene ceiling tiles in bathroom

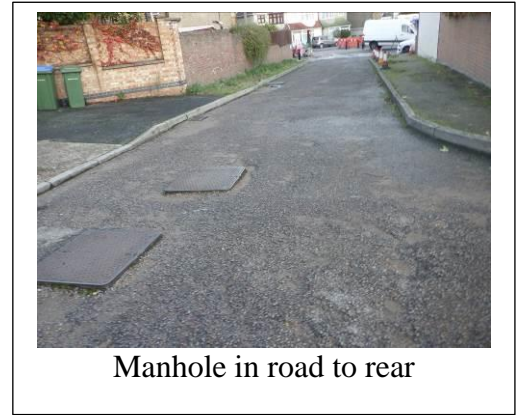
Manhole in road to rear

As we discussed, there is not a manhole within the curtilage of the property. The only manhole we have seen is in the rear private road, which we have not had access to. In years gone by, in older properties such as this, drainage was often push fitted together rather than bonded together and they can leak.

ACTION REQUIRED: Your legal advisor to check and confirm who would have responsibility if there are blockages in the drains. When this occurs we would then recommend you have a manhole added.

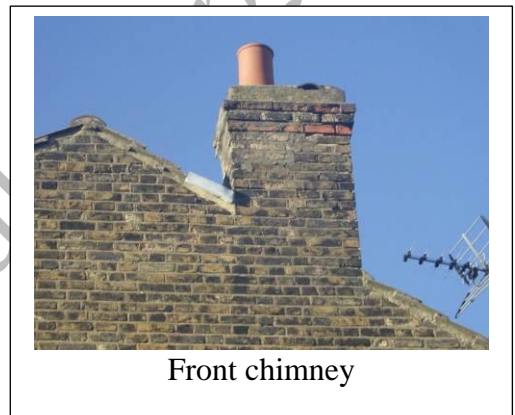
Front chimney

This chimney is brick finished with a lead flashing and one chimney pot. Our view was limited of the chimneys. From what we could see from ground level it looked in slightly below average condition considering its age, type and style which typically relates to problems with the flashing.

ACTION REQUIRED: Periodically inspect the chimney.

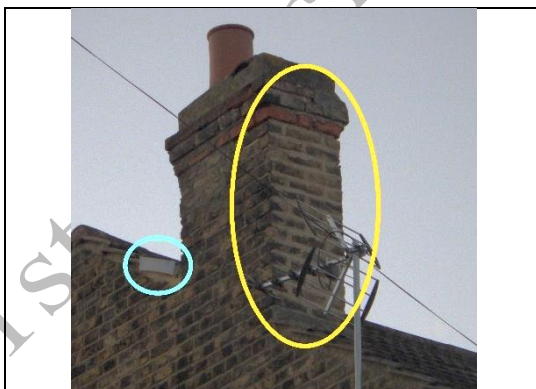
We could see dampness to this chimney within the roof space which may be due to a problem flashing.

Front chimney poorly repointed and problem flashing allowing dampness in

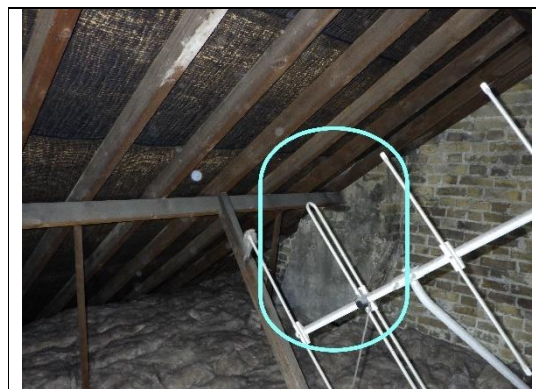
Dampness to front chimney

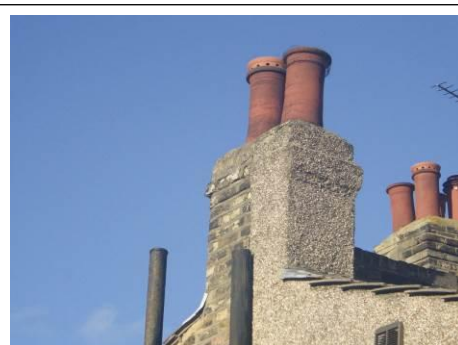
Rear chimney

This chimney is brick finished with a lead flashing and two chimney pots. From what we could see from ground level it looked in average condition considering its age, type and style although having seen the dampness problems to the other two chimneys we suspect there may be problems with this flashing as well. We could not physically see this chimney within the roof.

ACTION REQUIRED: Periodically inspect the chimney.

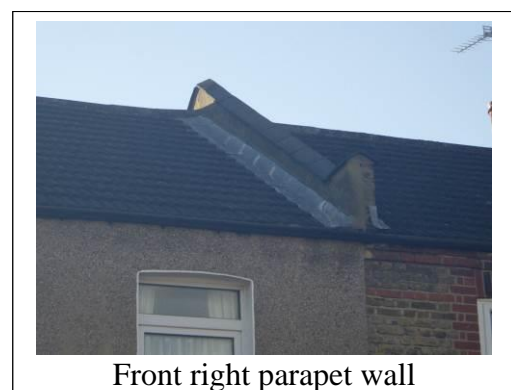
We would comment the flashing has a poor quality straight cut rather than being stepped. It was either not originally laid very well or there has been some movement. Please see our comments with regards to the existing owners taking out an insurance claim that you then take over with regard to possible movement in the property.

Movement?

ACTION REQUIRED: Please see our comments in the Executive Summary.

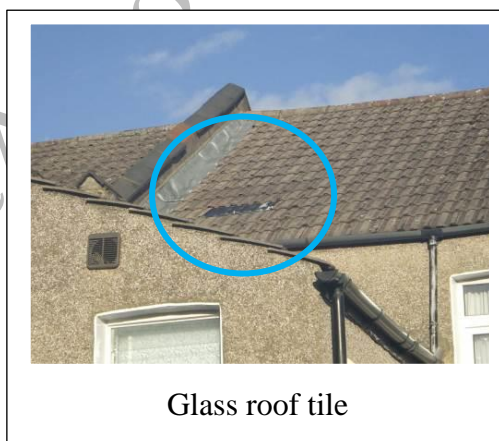
There are glass roof tiles. Early glass tiles are prone to leaking and are not as good as a modern day roof window.

Glass roof tile

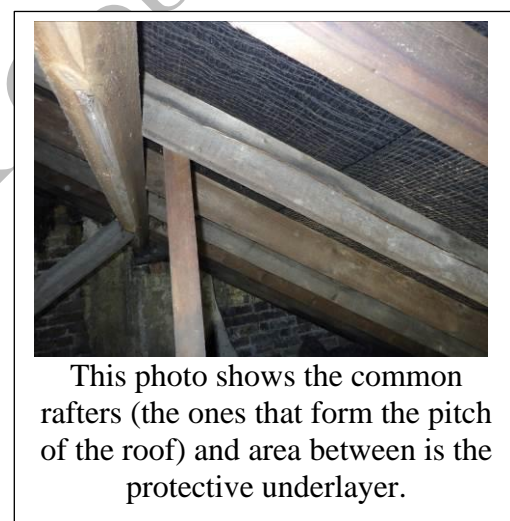
When we inspected the loft space, we found a Hessian based bitumen membrane. This type of membrane has been used since the 1960s. We generally found it to be in average condition with damage in some areas which is what we typically find.

This photo shows the common rafters (the ones that form the pitch of the roof) and area between is the protective underlayer.

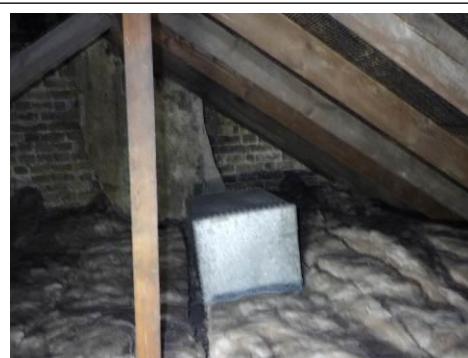
There is an old cast iron water tank.

Old cast iron water tank

We would always recommend that the water tanks are drained down and cleared of any debris, etc.

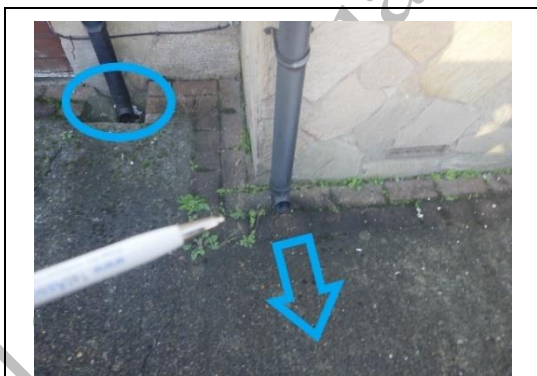
The downpipes discharge directly onto the ground; we would much prefer a gully.

Gutter discharging directly onto the ground and also into a gully

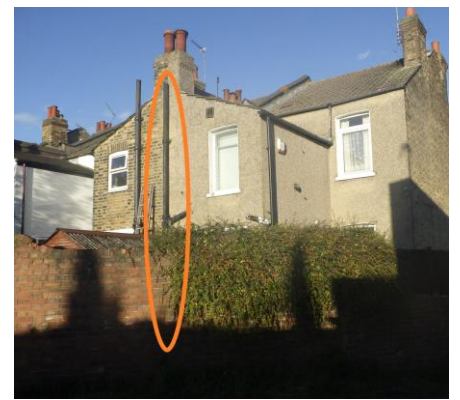
Soil and Vent Pipe

The property has cast iron soil and vent pipes. It would benefit from redecoration.

Cast iron of this age can crack and rust and needs regular maintenance; if regularly maintained it lasts longer than plastic, in our experience.

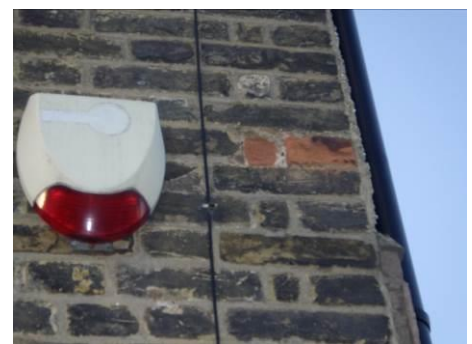
The property is finished in a brick originally in a lime mortar in what is known as Flemish bond brickwork which has now been wrongly repointed in cement mortar.

Spalling red brick

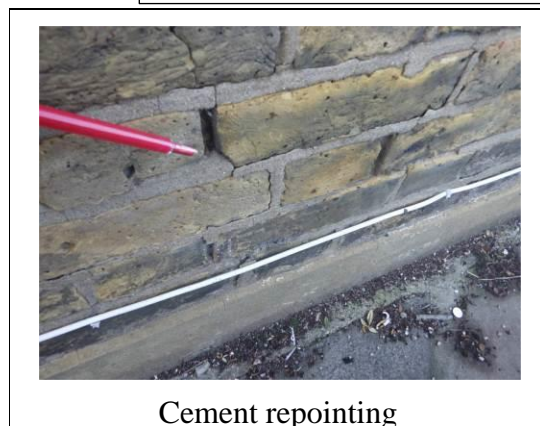
Cement repointing

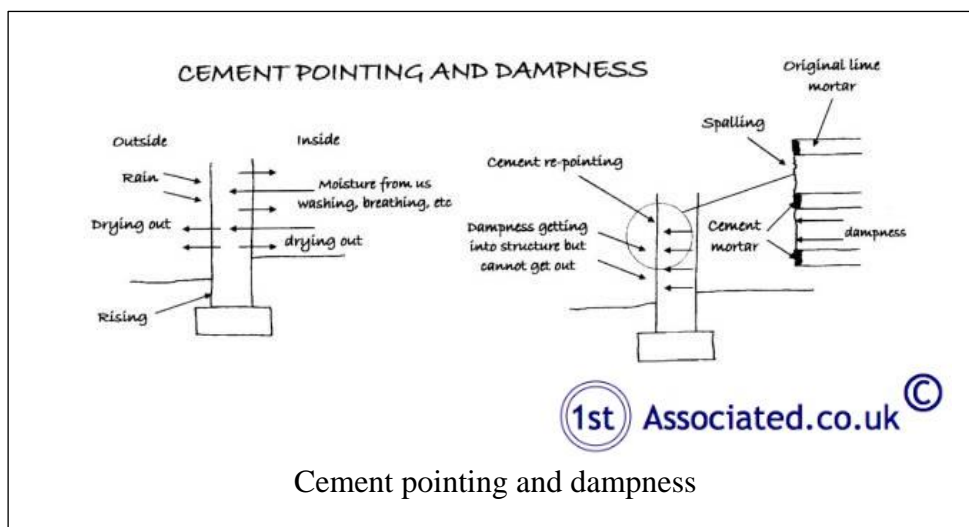
Lime every time and lime takes time

We would draw your attention to the cement mortar re-pointing that has been carried out on the exterior of the property that we feel is not appropriate to this building. Originally it will have been built with a lime-based mortar and this is what should be used for any re-pointing in the future.

The original lime mortar is a softer material which allows dampness to dissipate, whereas cement mortar is a harder material that does not allow the walls to 'breathe' and in turn causes dampness to come into the walls. The use of cement mortar causes deterioration to brickwork and does lead to the face of the bricks deteriorating, which in turn leads to dampness. This is a very important point.

ACTION REQUIRED: We would replace the cement mortar with lime mortar gradually and carefully over a long period of time, using the oldest/most experienced builder you can find who is experienced with lime work.

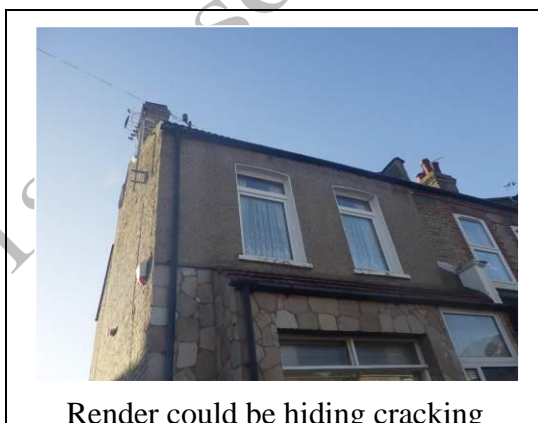
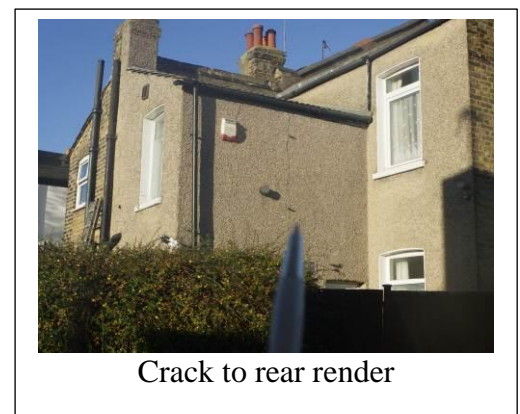
Cracking

We would remind you that any hairline cracks that appear need to be sealed as soon as possible to stop dampness and water getting in.

ACTION REQUIRED: Please see our comments in the Executive Summary.

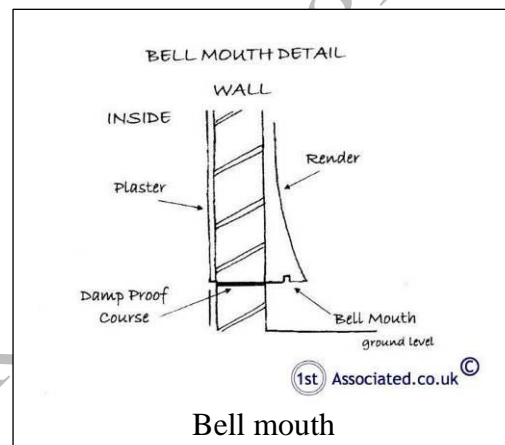
Bell mouth to base of render

To the base of the render there was no bell mouth detail. We would much prefer to see one, which would also help with dampness in the building.

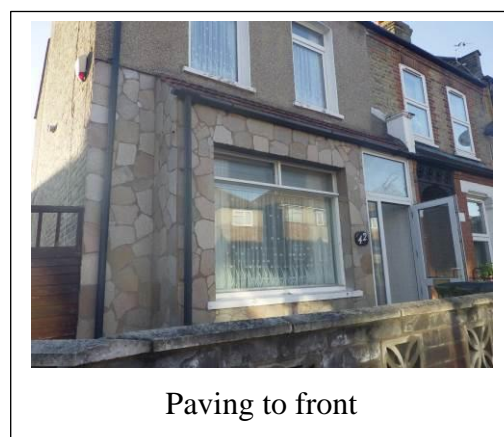
CLADDING

There is a crazy paving type cladding to the front of the property. The difficulty is what to do with it. We assume it was added as a feature.

ACTION REQUIRED: We recommend that you test to see how removable it is as removing it may cause damage to the front of the property and you would then have to think about whether you would want to render the front of the property or not. Often, if you walk up and down a road you will see examples of what other people have done and you will be able to pick one of those that you like if you dislike the crazy paving type finish.

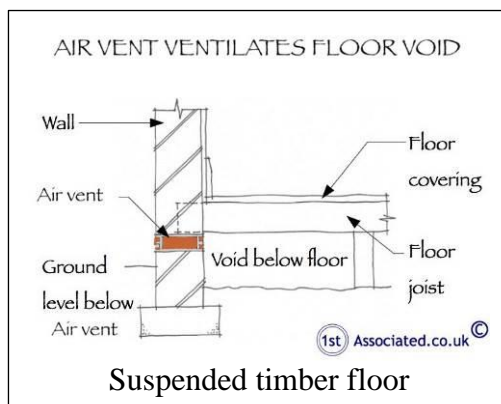
Low Level Air Vents

Air vents are essential to have a through flow of air as this helps to reduce the chances of wet rot, dry rot and woodworm. In this case, we noted air vents to the front of the property but no air vents to the rear.

ACTION REQUIRED: We would recommend further vents are added and we would also open up the floor to check its condition.

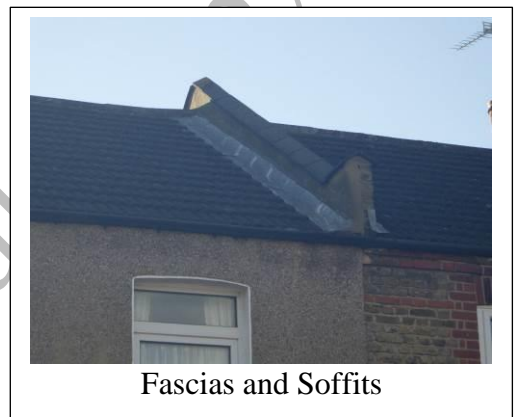
Fascias and Soffits

The fascias and soffits are decorated timber and we would comment we had a limited view as they are hidden by the gutters. They are in average condition for their age, type and style from what we could see.

ACTION Periodically repair, prepare and redecorate.

Make sure gutters and downpipes are watertight before carrying out any work on fascias and soffits.

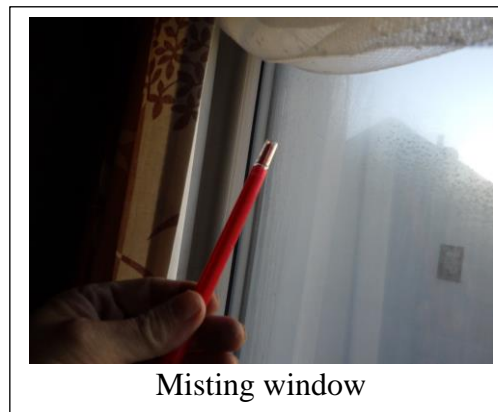
Knife Test

We would draw your attention to the fact that sealed double glazed units can fail, particularly as a result of poor workmanship during installation. Failure of the seal leads to condensation between the two panes of glass and simply replacing the affected units may not provide a satisfactory long-term solution. We would also advise that some of the seals on the plastic windows are starting to go and we can see them misting over for example the rear left window.

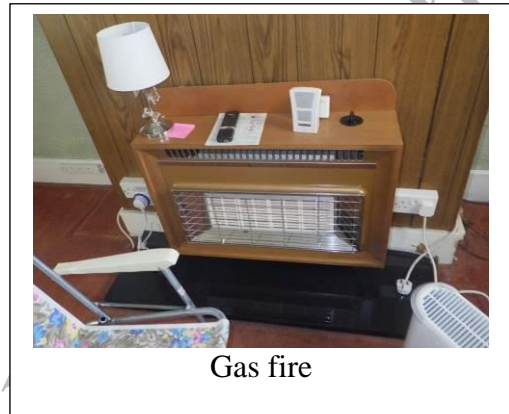
Gas fire

At the time of the survey the chimneys look to be being used partly as a ventilation system for the gas fires. We think if the gas fires are checked they may be condemned and not usable.

ACTION REQUIRED: Have the gas fires checked if you intend to use them and removed if you don't intend to use them.

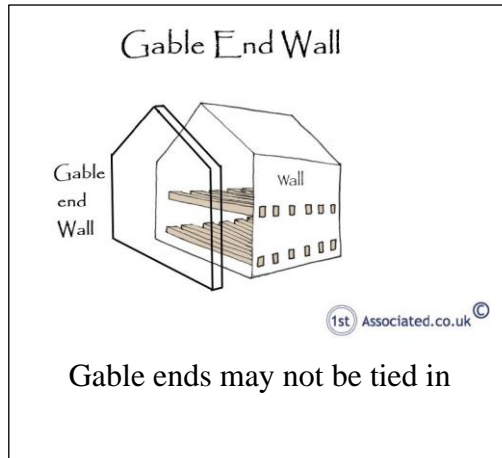
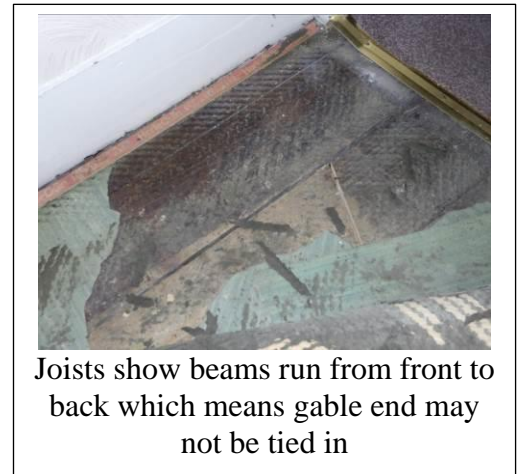
We noted the joists show beams run from front to back which means the gable end may not be tied in.

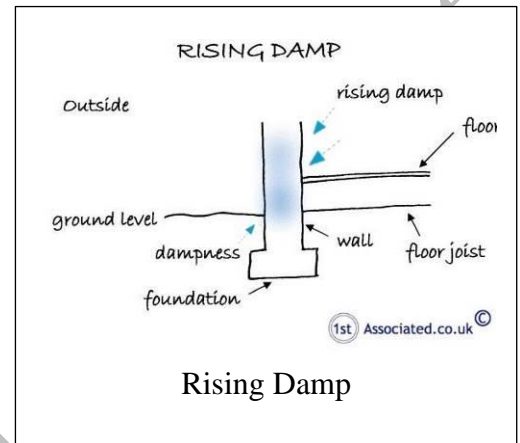
A visual inspection and tests with a moisture meter have been taken to the perimeter walls. In this particular case, we have found significant rising damp.

This is based on our damp meter readings, as well as our knowledge and skill in identifying dampness in this age, type and style of property.

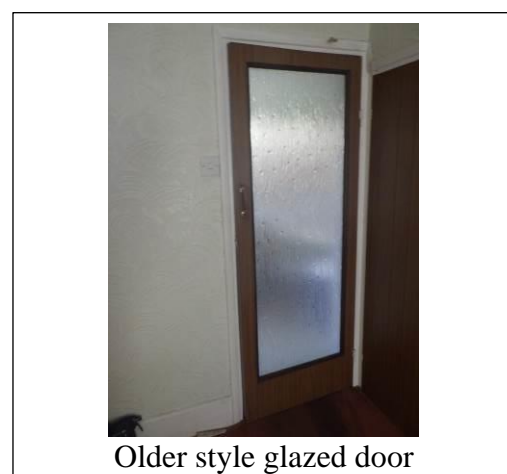
Older style glazed door

No safety glass to glazed doors

We cannot see a British Standard Institution safety kitemark on the glazed doors and we therefore assume that this glass is not safety glass therefore it can shatter. We would recommend changing the glass to safety glass.

ACTION REQUIRED: Replace glass with safety glass.

ANTICIPATED COST: Set aside the sum of £75 to £200 per door depending upon the quality of door you want; please obtain quotations before legally committing to purchase the property.

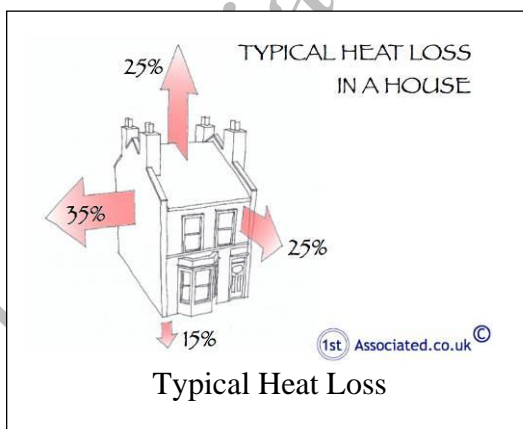
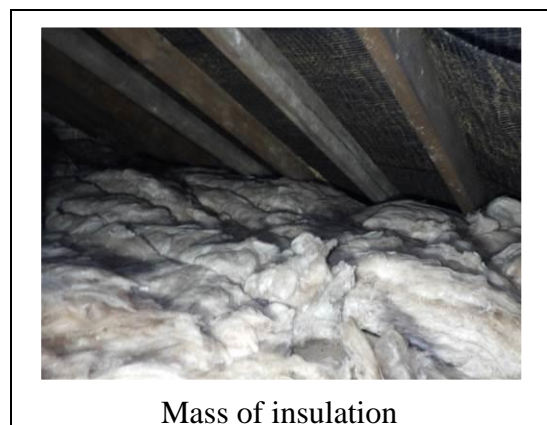
Some roof insulation was present although not to current Building Regulations requirements of 300mm. In this instance there is 200-300mm; if anything without ventilation it may cause some condensation.

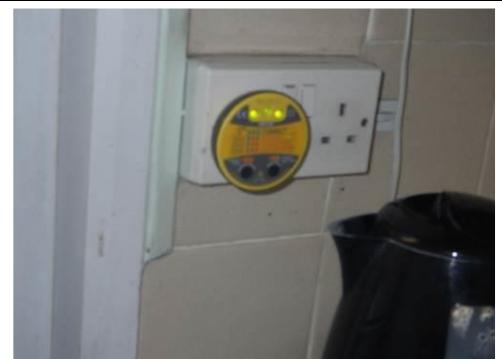
Earth test

We carried out an earth test in the kitchen area to the socket point that is normally used for the kettle; this proved satisfactory.

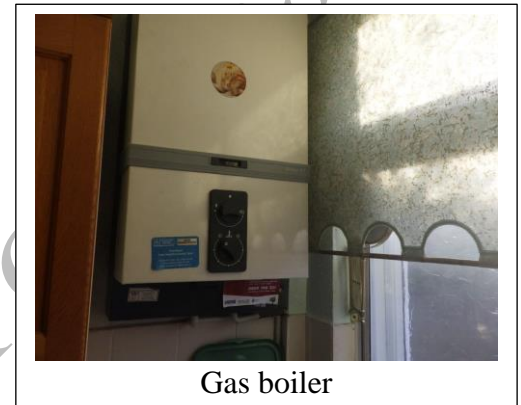
Gas boiler

We believe that the property has mains gas.
There is a dated gas boiler.

ACTION REQUIRED: As a matter of course, it is recommended that the entire gas installation is inspected and made good, as necessary, by a Gas Safe registered contractor. Thereafter the installation should be serviced annually.

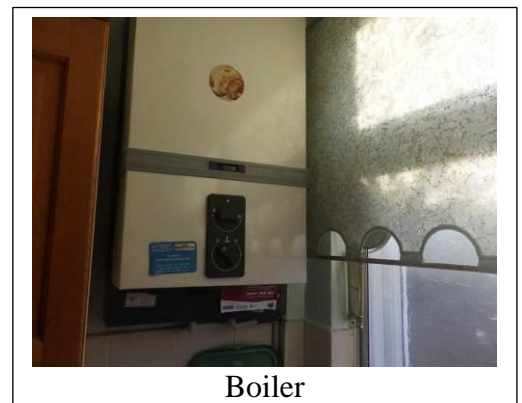
Boiler

There is a wall mounted Britony boiler located in the kitchen. The boiler is a make that we rarely come across therefore it may be difficult to obtain spare parts.

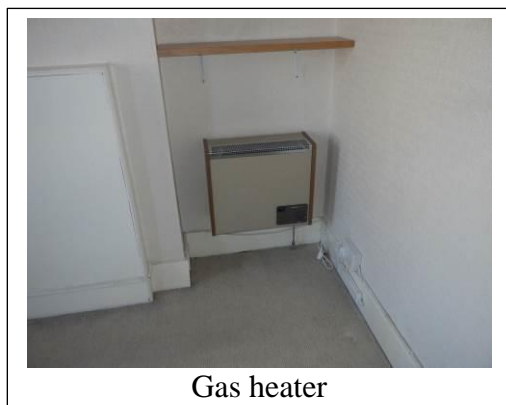
Gas heater

Heating is via gas heaters. The owner advised that they were not condemned when we spoke about them but we do not know whether this is simply because they have not been tested for some time.

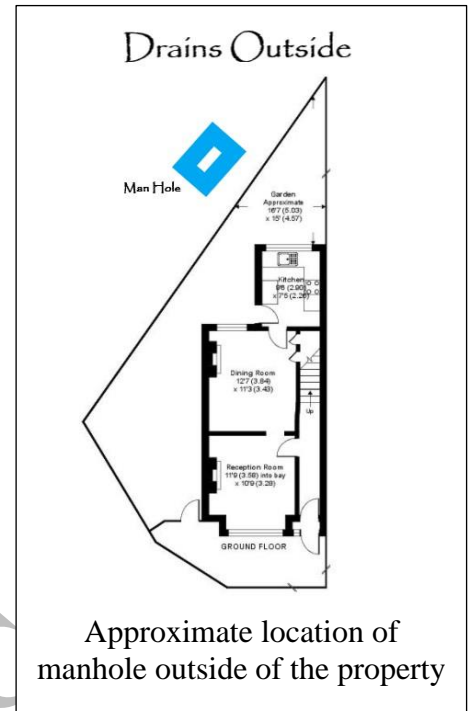
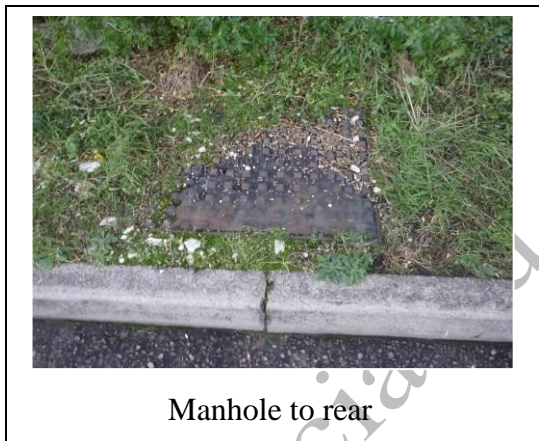
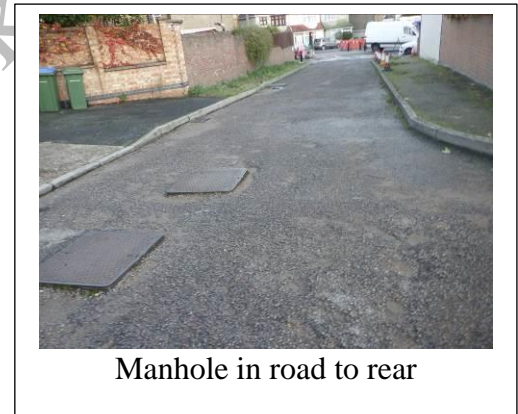
We have not lifted the manhole therefore are unable to comment.

Thank you for forwarding the drainage report.

Finally, it must be emphasised that the condition of the property's foul drains can only be ascertained by the carrying out of a test; such a test has not been undertaken. Should there be leaks in the vicinity of the building then problems could occur, particularly with respect to the stability of the building's foundations. Drainage repairs are inevitably costly and may result in damage being caused to those areas of the property beneath, or adjacent to, which the drains have been run.

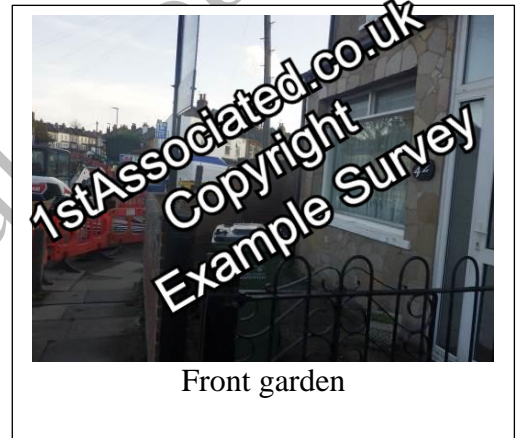
Front garden

There is a small garden to the front of the property.

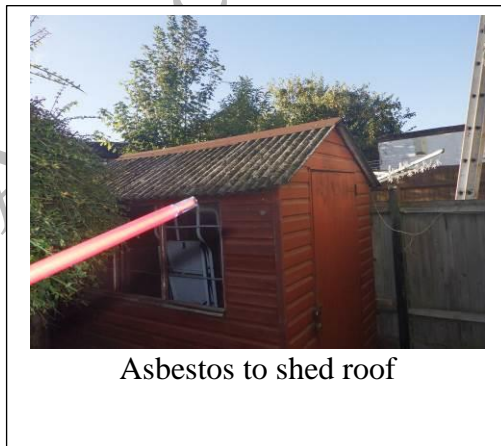
There is a reasonable size rear and side garden. The shed has an asbestos roof.

Asbestos to shed roof

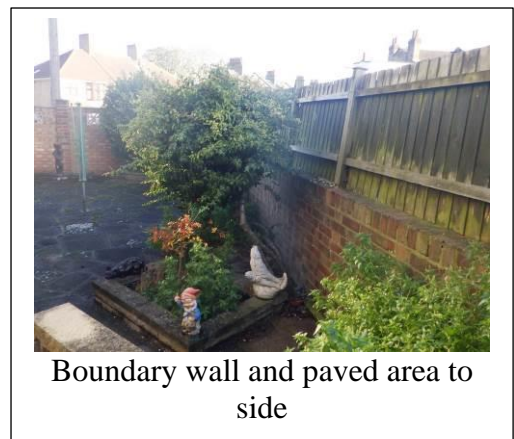
Boundary wall and paved area to side

There is cracking to the boundary wall. In this case, we assume that the wall is the boundary wall but you should not assume anything; your legal advisor to check and confirm.

ACTION REQUIRED: Please see our comments in the Executive Summary.

ACTION REQUIRED: We recommend you chat to the neighbours before you legally commit to purchase the property.
