Georgian/Regency Example Residential Building Survey

LATE 18TH CENTURY SASH WINDOW

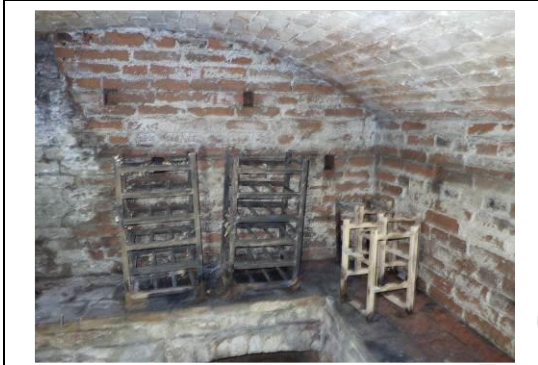
Off ground storage, indicating cellar possibly gets damp

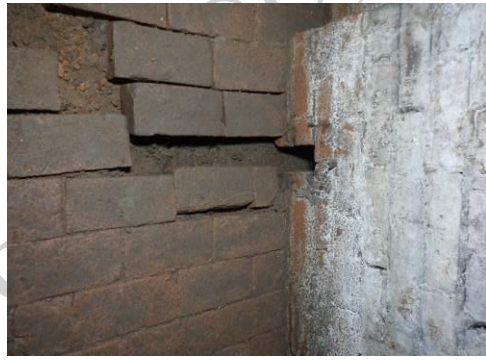
Openings in brickwork which may have been some kind of timber frame (conjecture)

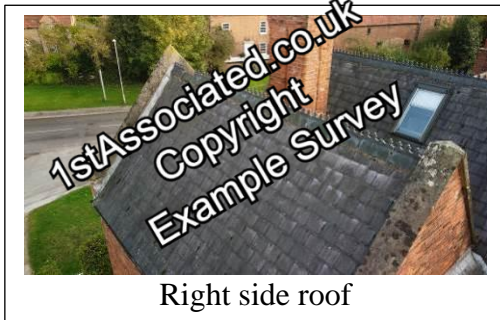
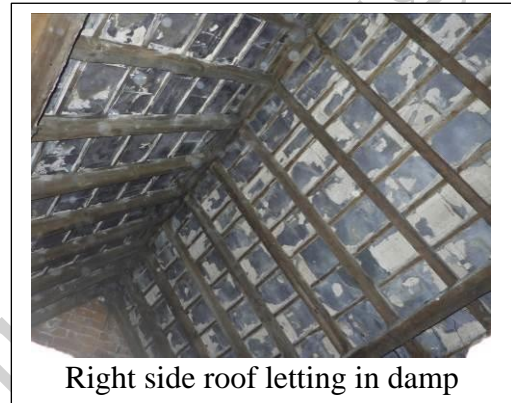
We believe the roofs are allowing some dampness in. This is a Catch-22 situation, we think in this case the insulation is approximately which is 300mm deep is hiding much of the dampness. Also it looks like it has been recently repainted. If you recall, it took some time and effort to open the loft hatch.

Right side roof

Right side roof letting in damp

The best way forward is to re-roof, however boarding out of the roof with insulated boarding throughout will help the situation (although not solve it in the long-term) and will give you four benefits:

If you carry out this work in conjunction with having a roofer for a day or two to repair the roof slates (you need to have a supply of slates ready for when the roof problem occurs) this should see you through this winter and then you can make further investigations in the summer of xxxx.

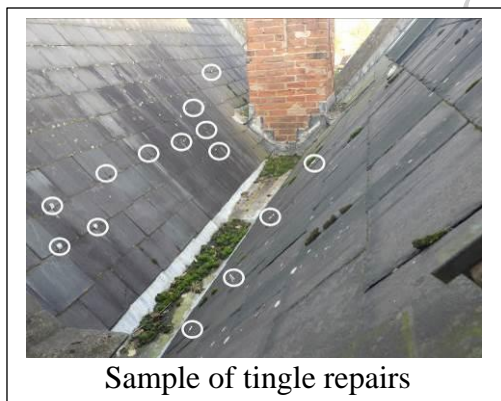
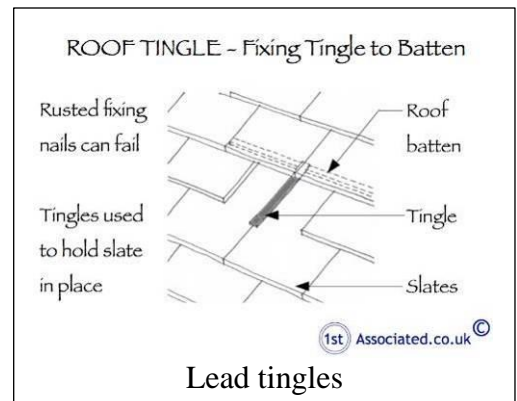
We noted some tingle repairs to the slates to both the left and right side of the roof.

Sample of tingle repairs

Lead tingles

We believe water is getting into the roof and think this has been a long term problem which have been repaired many times with a number of styles of different tingles, from wire tingles, to lead tingles, with different thickness of lead from what we can see used on all the different tingles.

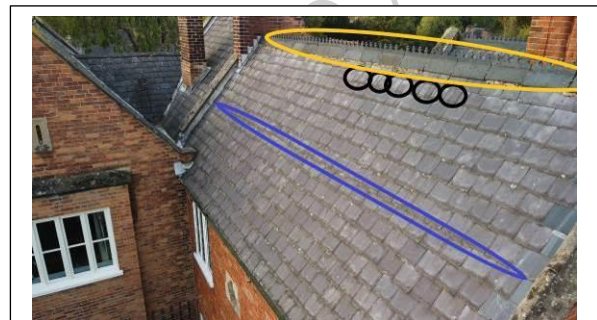
On the left side of the roof we can see a darker horizontal line on the tiles which is where we think they are susceptible to wind driven rain. We have also seen a number of slates split to the top part of the roof and the ridge tiles look like they need re-bedding.

We are not 100% sure how bad the problem is but we certainly think it needs investigation.

Problems to left roof

Key for above photo – sample of problems	
Orange oval	Ridge of roof needs re-bedding
Black circles	Split slates to top of roof
Purple oval	Example of one of the darker horizontal line of tiles

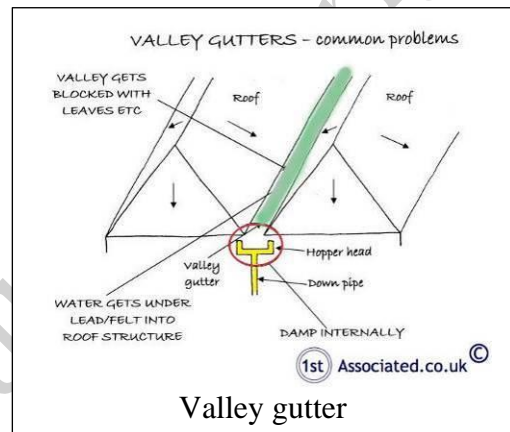
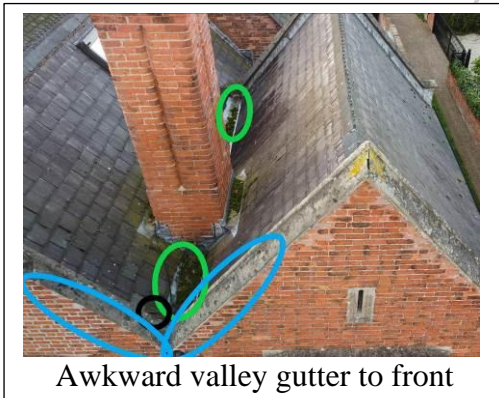
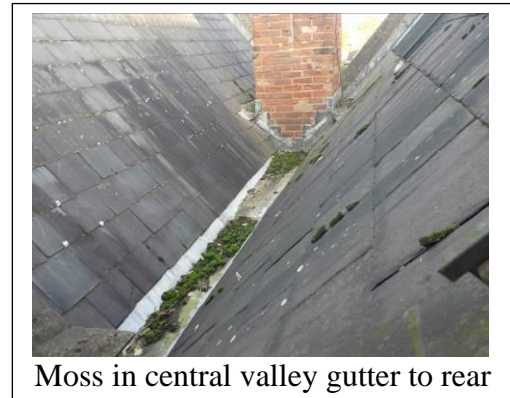
Main roof awkward valley gutters

Where the two roofs meet there is an awkward valley gutter around the central chimney. These can often be problematic areas. You do have the benefit of being able to view the area via the roof windows. We can see in the rooms in the roof that the roof windows are letting in water.

Key for above photo, showing a sample of the problems	
Green ovals	Moss in valley gutter
Black circle	Where a slate has come loose into the valley
Blue ovals	Area where we think water is getting in

ACTION REQUIRED: As already mentioned, we recommend some form of eye-bolt is fitted that allows harnessing to be carried out so these areas can be looked at properly, also using ladders and crawler boards, etc.

We recommend starting off with basic cleaning of these areas and repairing of any damaged areas, such as putting the gutter end on.

We always think that lead is the best way forward for repairing valley gutters. We would take as many pictures as possible and speak to someone who is good with lead work.

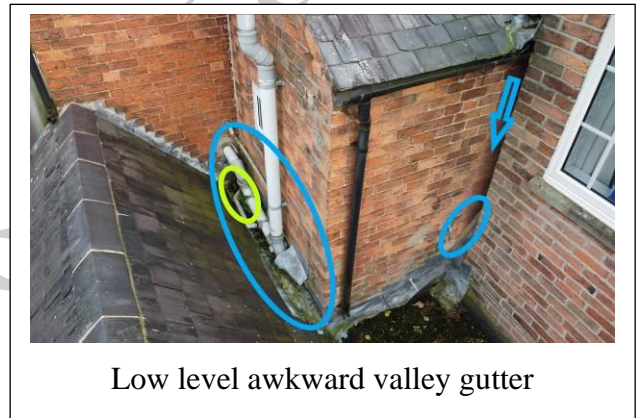
We think water will be getting in around this valley both to your property and the neighbouring property.

Key for above photo, showing a sample of the problems	
Light green oval	Looks like a fern or similar growing
Blue ovals and arrow	Area where we think both your property and your neighbour's property could be getting wet

It possibly needs a hopper head adding. We like the ones that have an overflow pipe on them, sometimes seen on churches.

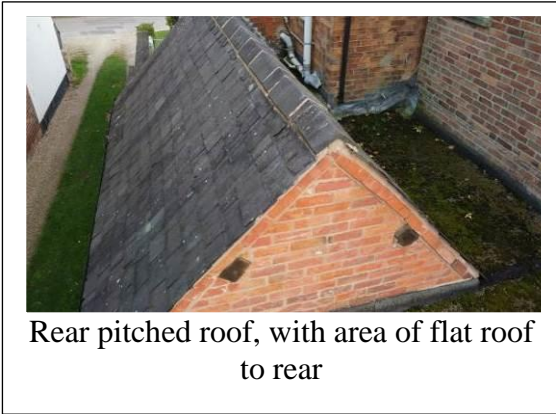
There are also a number of tingles to the rear pitched roof and as mentioned we think there will be problems where the awkward valley gutter is. We think it very likely there will be some rot to the rafter feet in this area.

Rear pitched roof, with area of flat roof to rear

ANTICIPATED COST: In the region of £2,500 to £5,000 to repair/replace slates. Please obtain quotes before you legally commit to purchase the property.

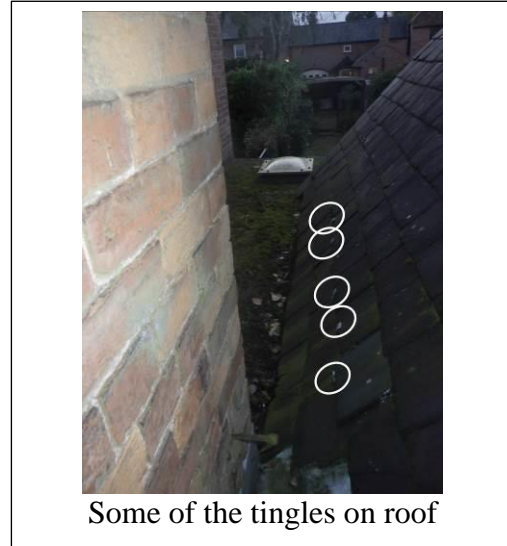
Some of the tingles on roof

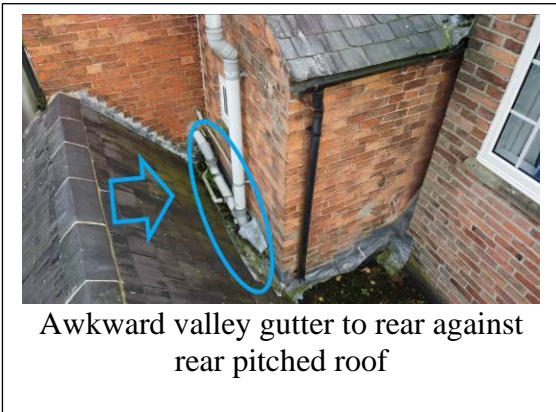
Awkward valley gutter to rear against rear pitched roof

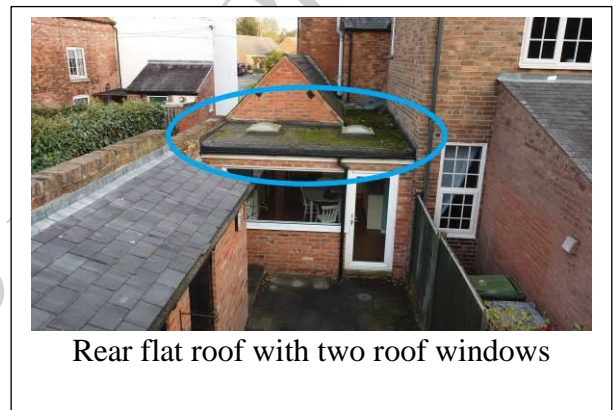
There is a flat, flat roof to the rear, by this we mean the green moss you can see water is likely to be sitting in these areas as there is no true fall on the roof, we like to see flat roofs with a fall of approximately 22 degrees.

Rear flat roof with two roof windows

Awkward detail behind pitched roof

ACTION REQUIRED: You could, as with many roofs, patch repair this for many years to come, however ultimately it will need to be re-roofed, we believe with a high performance felt roof, ideally cut to falls with insulation.

ANTICIPATED COST: It really depends on whether you are repairing the flat roof, replacing it or having a new roof. We would expect the patching of the roof to be a relatively small cost, although it would be a frequent cost, and the re-roofing with a good quality flat roofing material with insulation to be in the region of £7,500 to £10,000 depending upon the awkwardness of the detail. Costs for a new pitched roof to be in the region of £15,000 to £25,000 depending on what you are having done.

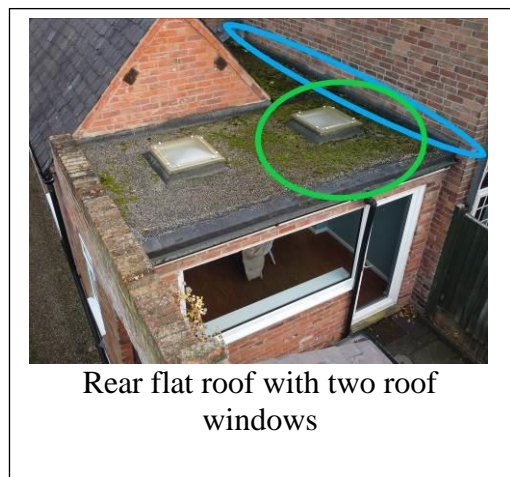
There are felt flashings, we much prefer to see lead flashings, particularly where there is likely to be a build up of water, as there is in this case.

Rear flat roof with two roof windows

Key for above photo, sample of problems areas	
Blue oval	Example of one of the felt flashings, which we recommend is replaced with lead
Green oval	Moss which indicates it is a flat, flat roof without any fall

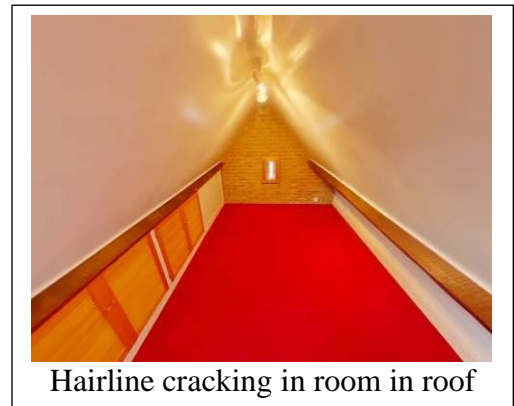
We do think some dampness will be getting in from the room from time to time. As mentioned, we noted that some of the ceilings look to have been painted. We also noticed some cracking in the plaster.

ACTION REQUIRED: Unfortunately the only way to truly understand how much water is coming through is to actually occupy the property.

We would, however recommend that you redecorate all the ceilings in the rooms in the roof as soon as possible, as this will then give a good indication of what water is coming through, as well as being a good thing to do to make the house your home.

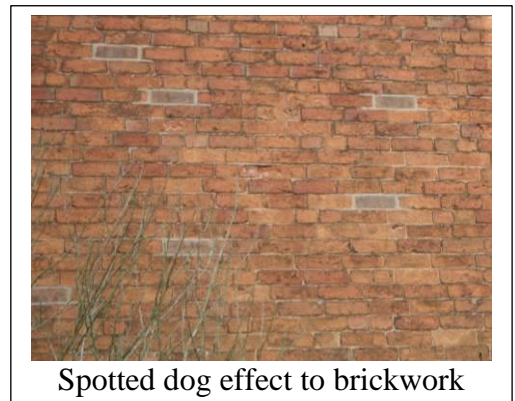
Spotted dog effect and deteriorating brickwork

You need to be so careful with carrying out repairs to the deteriorating brickwork. If not carried out correctly it can stand out considerably with the wrong colour bricks, causing what we term as a 'spotted dog' effect.

The other thing that causes a spotted dog effect is where cement mortar is used to cover up deteriorating brickwork. Unfortunately there are examples of both on this property.

ACTION REQUIRED: Find the oldest/most experienced bricklayer/mason you can who is skilled in using lime mortar to replace cement mortar with lime, ideally during warmer/summer months, known as the lime season.

ANTICIPATED COSTS: Budget £5,000
£10,000 over the next few years to do the worst of the work. Please obtain quotations before legally committing to purchase the property.

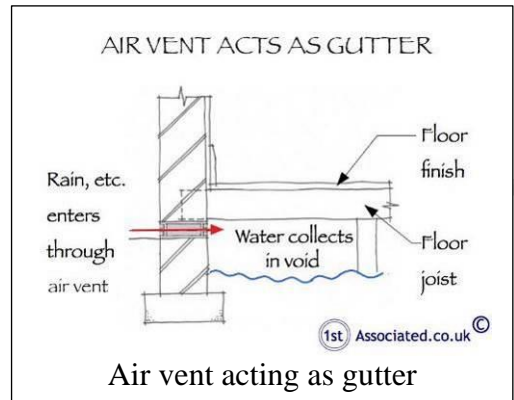
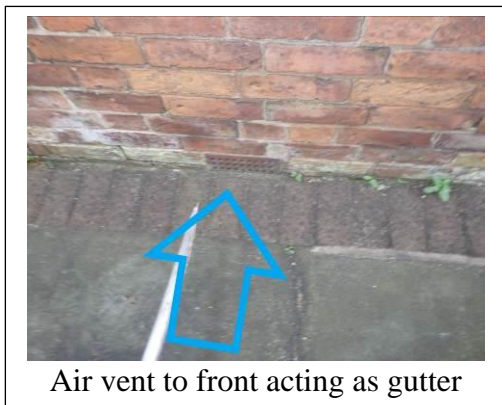
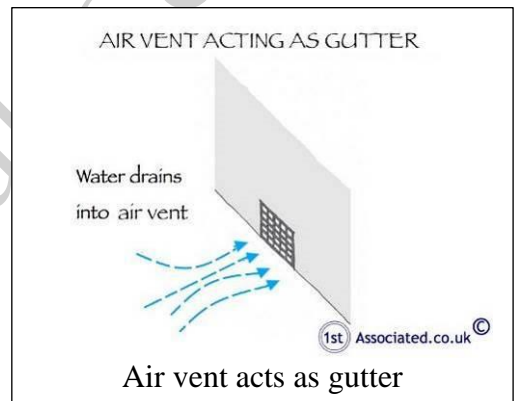
Air vents acting as gutters

We can see a number of the air vents are acting as gutters, allowing water to get underneath the timber floor, which will cause dampness and deterioration.

ACTION REQUIRED: We recommend you add a land drain/French drain around the front and side of the property and also to the rear (see our comments specifically on this). It should have a perforated pipe which discharges into the drains in the road area (subject to permission) and/or a soak-away.

ANTICIPATED COST: Between £2,500 to £5,000 for a French drain type solution. Ensure air vents are cleared and protected.

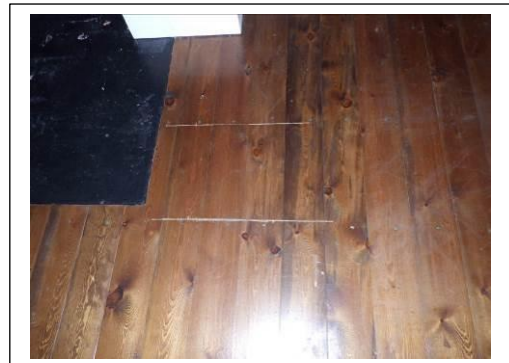
Ideally open up the floor and check its condition. There was an area of the floor to the front right dining room which looked like it had been opened up. We would recommend this is re-opened before you commit to purchase the property and we would be more than happy to comment on any photos taken, also any comments as to whether there is a damp smell when the floor is opened up.

Area of floor in dining room which looks as though it has been opened up before

Costs could be many thousands of pounds if some timber in the floor has to be replaced, although, we would say that in older properties such as this the quality of timber used under the flooring tends to be far better than you would find today.

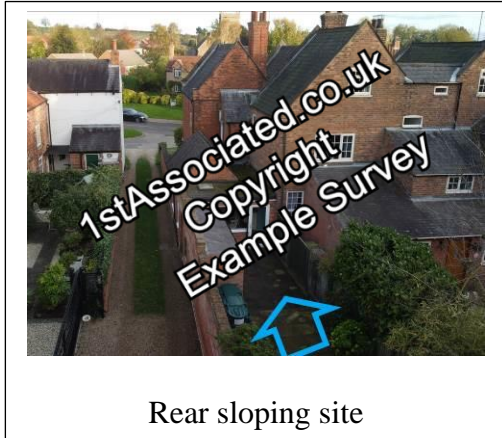
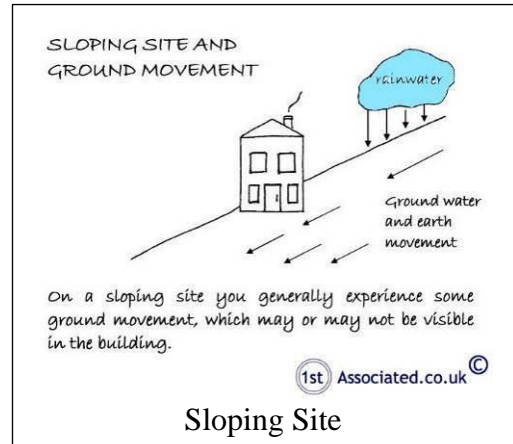
Rear sloping site

Sloping Site

The rear floors are solid under foot, assumed to be concrete and we think they may be acting like blotting paper, drawing dampness in.

ACTION REQUIRED: There are two gullies in this area, however we would recommend a French drain/land drain is added which will help reduce some of the effects of the sloping site and water discharging against the property. If you can have two of these it will be even better.

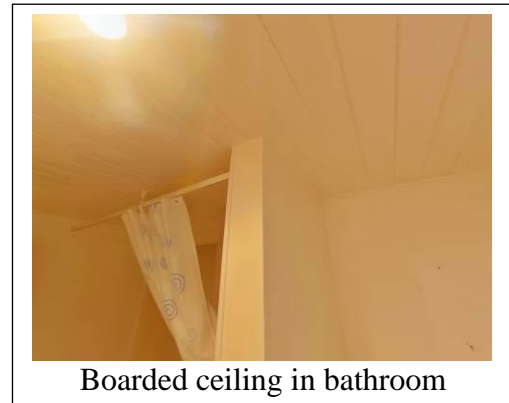
The bathroom has a boarded ceiling and we wondered whether this was due to there having been a leak in this area?

Boarded ceiling in bathroom

ACTION REQUIRED:
Further investigation needed.
Please see our earlier comments regarding the roofs.

ANTICIPATED COST: We think we have identified the problem areas with the roof, it may be worth having an additional £1,000 to £2,000 contingency in case there are problems in this area.

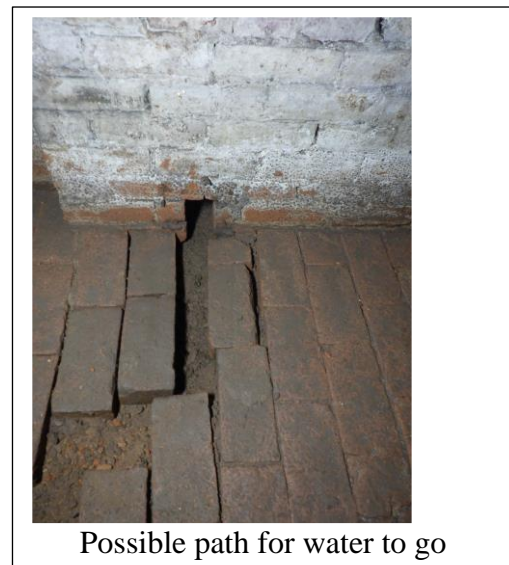
There did look to be an area where it looked like a path of water would be travelling through the cellar.

Possible path for water to go

ACTION REQUIRED: We would recommend a sump pump is added for removing water away from the cellar, although we cannot quite see how this would work. You may have to consider flooding of the cellar as a characteristic of this property.

ANTICIPATED COST: Few hundred pounds; please obtain quotations before legally committing to purchase the property.

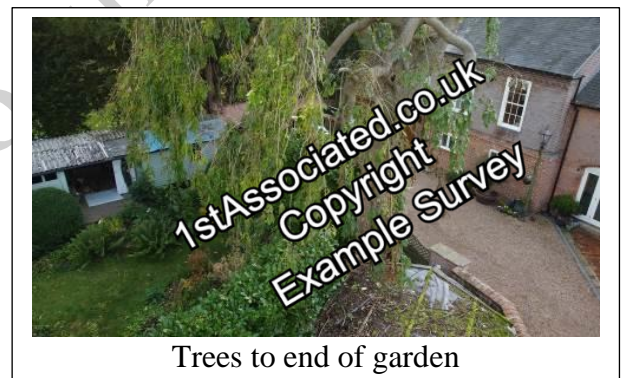
There is a fairly large tree at the bottom of the garden, which does look like it needs maintenance, as does the covered garage area to the rear, which we think is your tree, although it may possibly belong to the neighbour and this need confirming.

ACTION REQUIRED: We would recommend an arboriculturalist (not a tree surgeon) is asked to view the trees and give a ten year plan of maintenance. This tree is taking water away from the property.

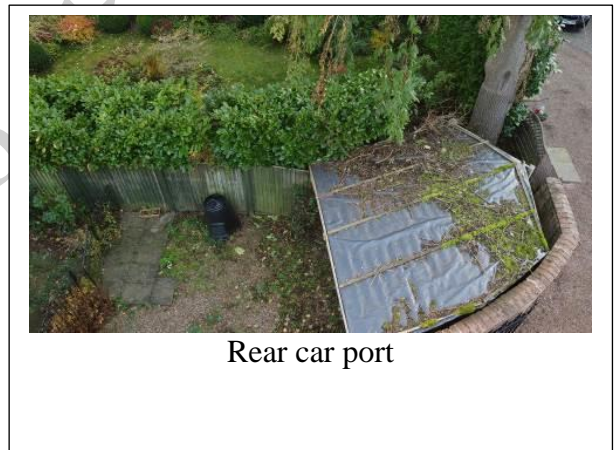
The rear covered car port roof is a fairly basic plastic sheet battened down from what we can see.

Rear car port

ACTION REQUIRED: Really depends upon what you intend to use the car port for. If you have a prestigious car or something you want to make sure is safe/dry then we would be looking to generally improve and re-roof.

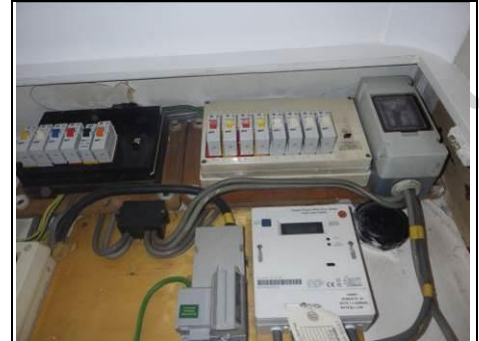
The electrics are located above the entrance door. They are 1980's-2000's and far better are available.

Dated fuse board

ACTION REQUIRED: As the property is changing occupancy we recommend a test and report, as do The Institution of Engineering and Technology (IET). The test and any recommendations should be carried out by an NICEIC registered and approved electrical contractor or equivalent.

1. £250 - £500 for test and report
2. £250 - £500 for a new fuse board
3. In the region of £100 - £200 per additional socket point
4. Plus any further work recommended

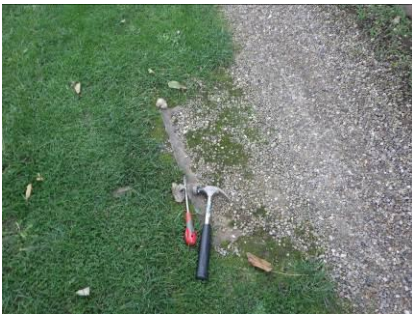
Manhole One to front of driveway has been bent so we were unable to open

ACTION REQUIRED: As we are recommending adding French drains/ land drains in it is good if they can discharge into the main drains, although often it is not allowed and you will have to make your own soak-away, however if you are able go into the main drains we would recommend a closed circuit TV camera report of the drains to check their condition.

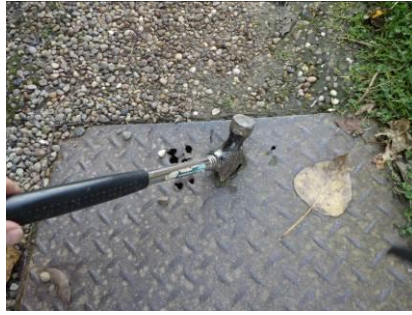
Manhole Two to middle, again we were unable to open

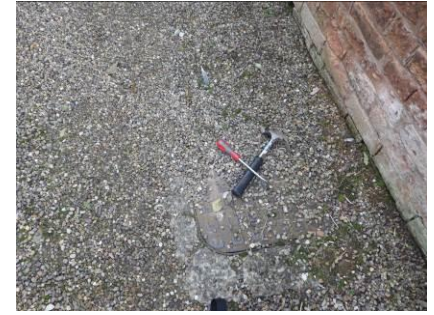
Unable to lift Manhole Three

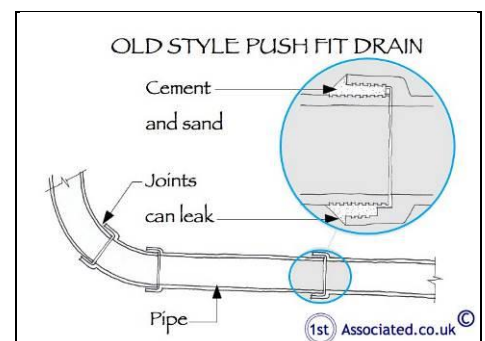
In older properties, such as this, drainage was often push fitted together rather than bonded together which means that they may leak over the years.

Push fit drain

ACTION REQUIRED: You need find out how this is maintained.

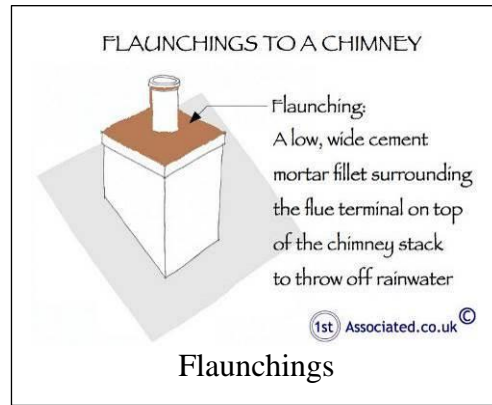
Chimney Two – Rear Right

This chimney is brick finished with a lead flashing and two chimney pots. We believe the flaunching (top) is allowing water in, as we could see dampness internally. We had a very limited view as we could only see one side of the chimney.

ACTION REQUIRED: Ad hoc repointing and repair of flaunching.

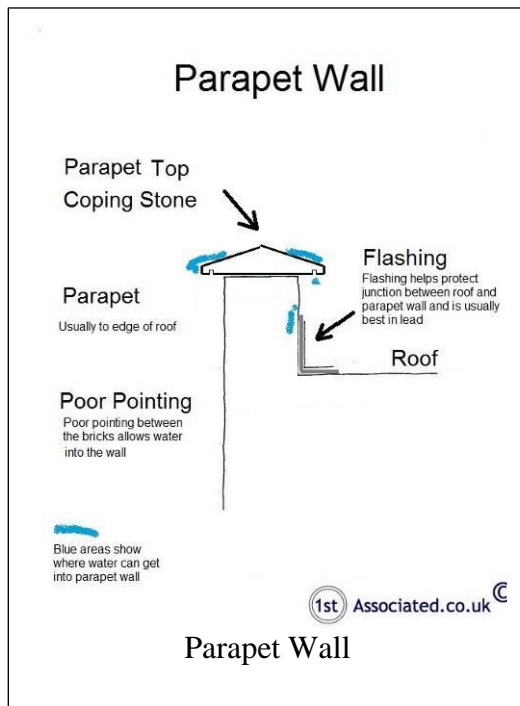
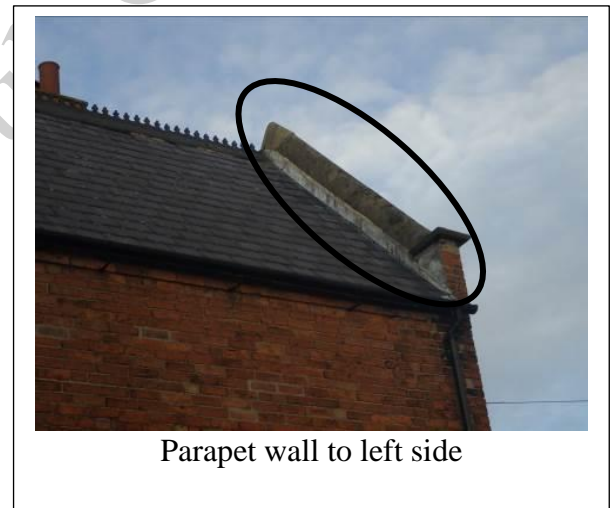
The parapet walls are brick with a coping stone of stone and lead flashing. From what we could see from ground level they look in average condition considering its age, type and style, although having said that we can see there have been cement repairs to the brickwork and we can also see that there is deteriorating plaster within rooms on the gable ends of the property around the parapet walls. Therefore we think there may be a combination of some dampness getting in, perhaps on the joints of the coping stones and through the walls, with problems themselves identified in the Executive Summary.

ACTION REQUIRED: It could be down to the drip detail on the coping stones, which could be a historic defect which you just need to consider part of the characteristic of the property. This is another detail we would like to see how it performs when it is raining heavily.

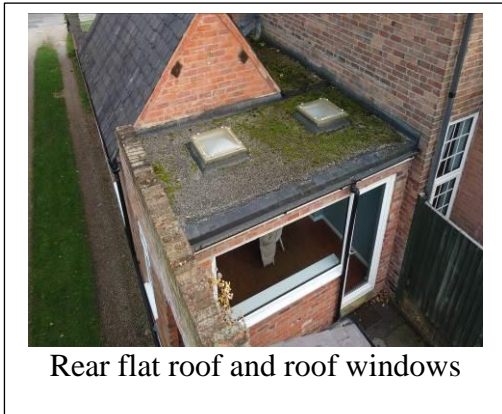
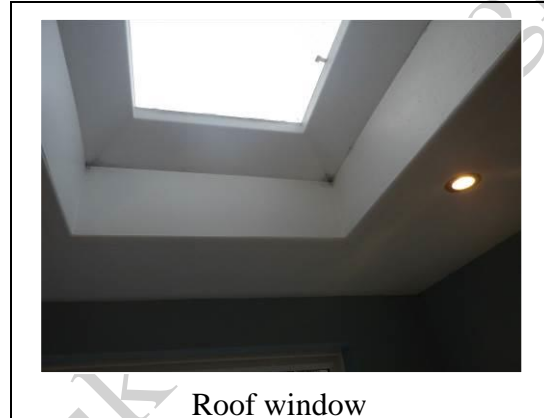
Low level Kitchen roof windows

There are also two purpose made roof windows to the rear single storey flat roof kitchen extension. We would comment they are domed roof windows, which is probably our preferred style on flat roofs, however this is a flat, flat roof and we can see the greening of the roof from build up of moss from where water has been sitting on the roof, which we believe will sooner or later mean rainwater will get through.

ACTION REQUIRED: Check the flashings around the roof windows.

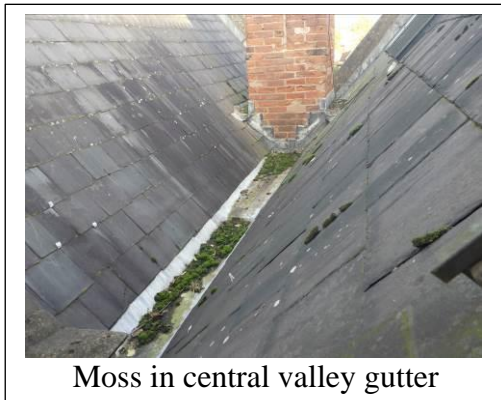
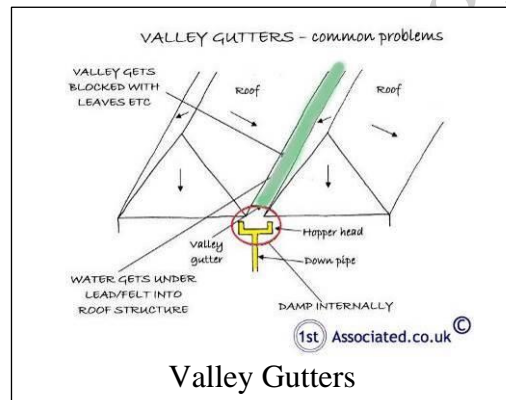
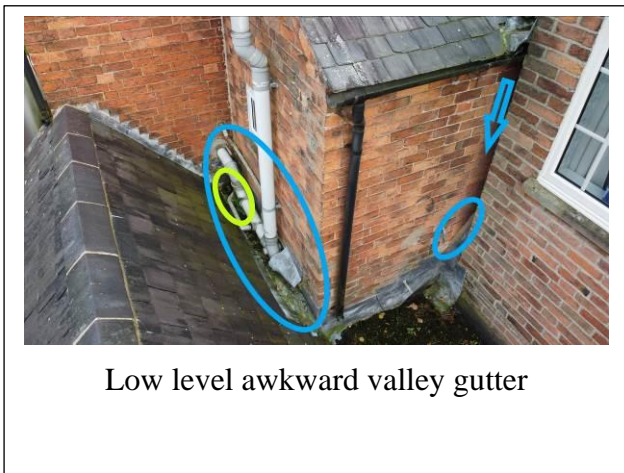
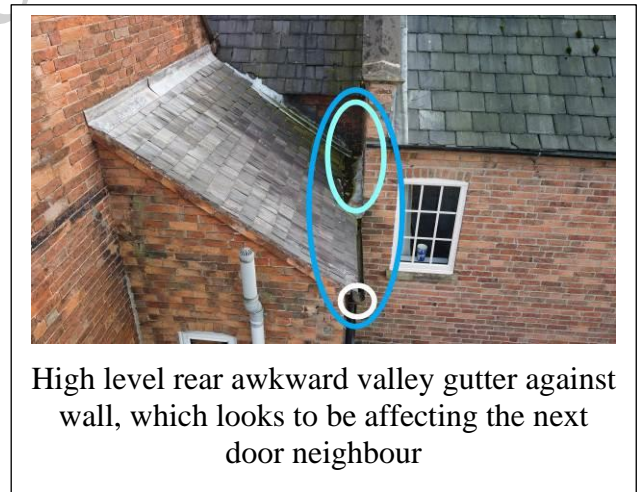
Awkward valley gutters

There are three awkward valley gutters.

As well as allowing dampness into your property we believe they are causing problems on the neighbouring property so we recommend you go and chat to the neighbours.

ACTION REQUIRED: Please see our comments in the Executive Summary.

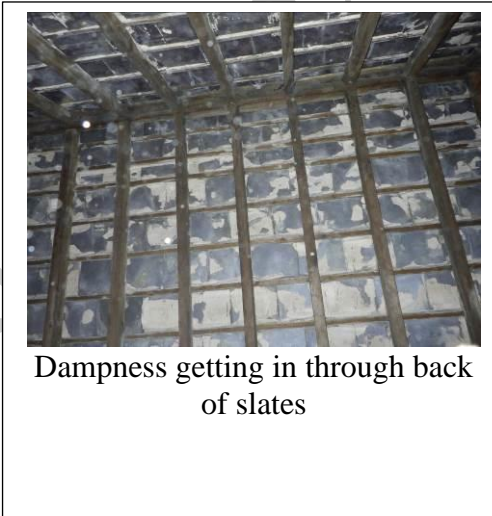
In this case, the roof does not have a protective underlayer. It is bedded on mortar, known as torching, originally it would have been lime, however often, as in this case, it is replaced with cement. In this particular case a lot of the mortar is no longer there.

Most importantly we can see that dampness is getting in.

ACTION REQUIRED: Please see our comments in the Executive Summary.

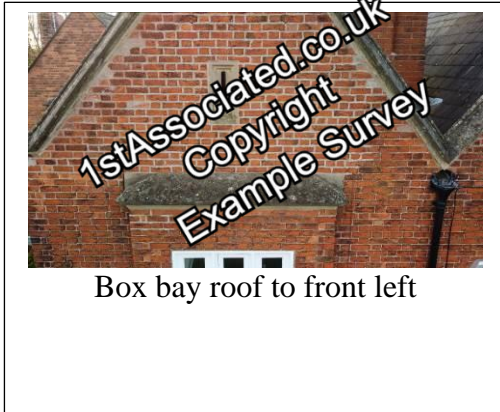
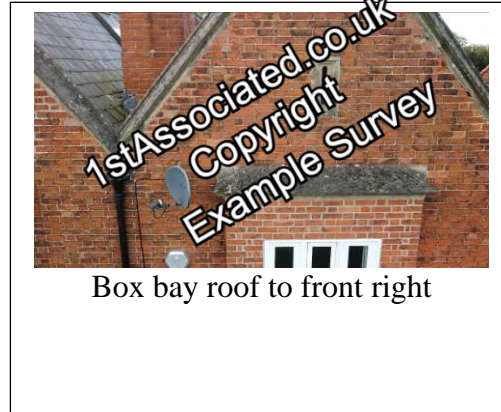
BAY WINDOW ROOFS

These are flat roofs covered with what looks to be stone. They looked in average condition, with some moss build up, from our view, which was limited.

ACTION REQUIRED: Periodic inspection.

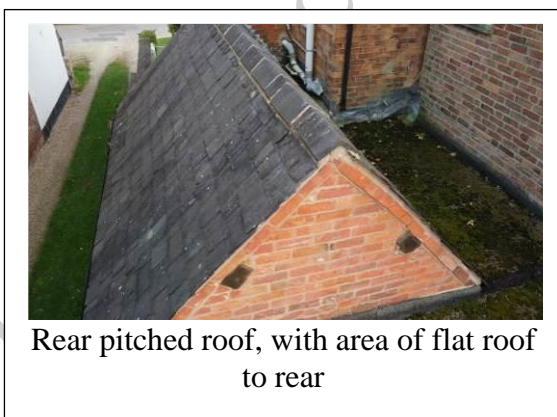
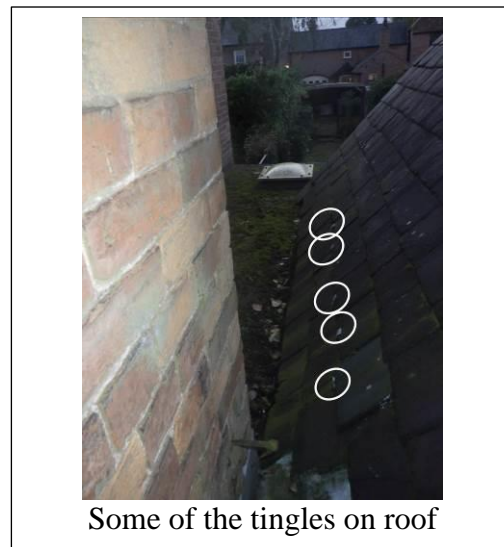
REAR LOW LEVEL PITCHED ROOF

This roof is pitched and clad with slate. We had a limited view of this roof, we think there could be problems where the awkward valley gutter is. We think it very likely there will be some rot to the rafter feet in this area.

We can see that slates are uneven and there are quite a number of tingles.

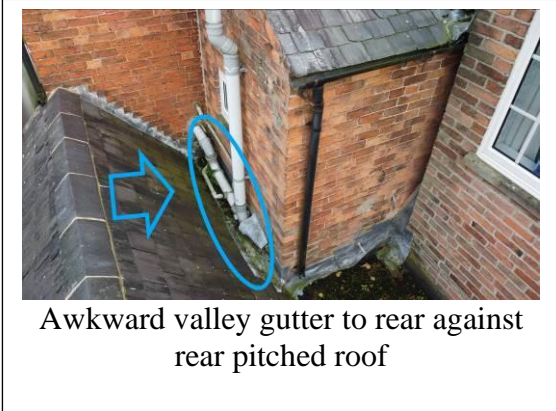
Key for above photo, showing sample of problems	
White circles	Sample of the tingle repairs
Black circles	Slipped or damaged slates
Blue oval and arrow	Awkward valley gutter

ACTION REQUIRED: We did not gain access into this roof during the survey and we would be more than happy to comment upon any photos taken before you legally commit to purchase the property.

ANTICIPATED COST: In the region of £2,500 to £5,000 to repair/replace slates. Please obtain quotes before you legally commit to purchase the property.

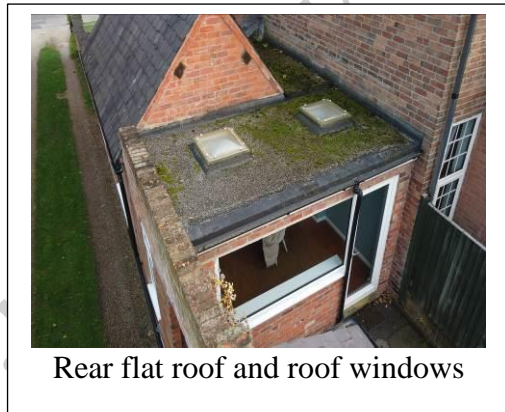
Rear Flat Flat Roof

The flat roof over the kitchen is located to the rear and is covered with mineral felt and two roof windows. It is a flat, flat roof with a covering of moss, indicating water has been sitting upon the roof, which will cause accelerated deterioration of the roof.

ACTION REQUIRED: Please see our comments in the Executive Summary.

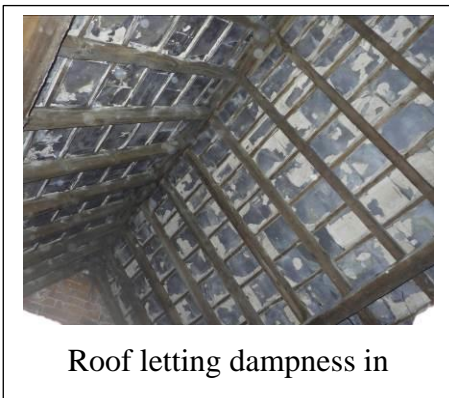
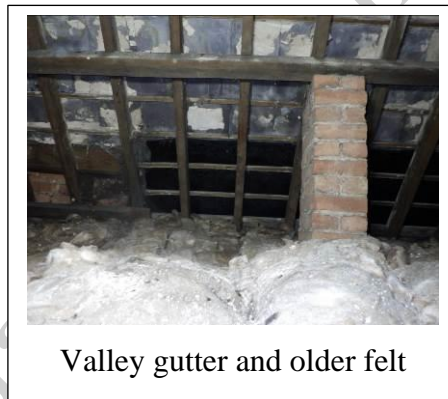
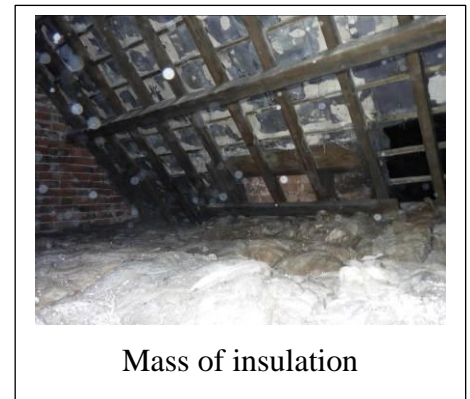
Our examination was limited by the general configuration of the roof, the insulation and stored items. What we could see was generally found to be in below average condition for its age, type and style due to the dampness getting in. It is, however, feasible that there are problems in the roof that are hidden.

It is a relatively large span which means that the dampness getting into the structure is not ideal and we believe it needs work on it sooner rather than later to make it watertight. Do note, this is an important point.

ACTION REQUIRED: Please see our comments in the Executive Summary.

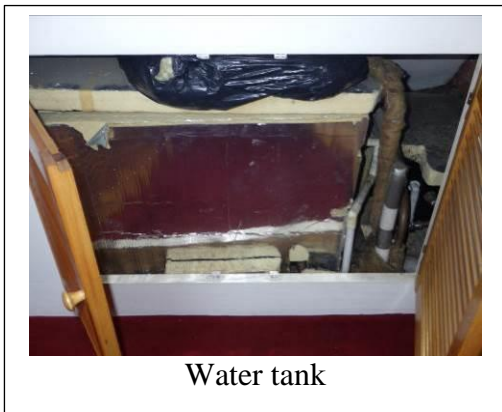
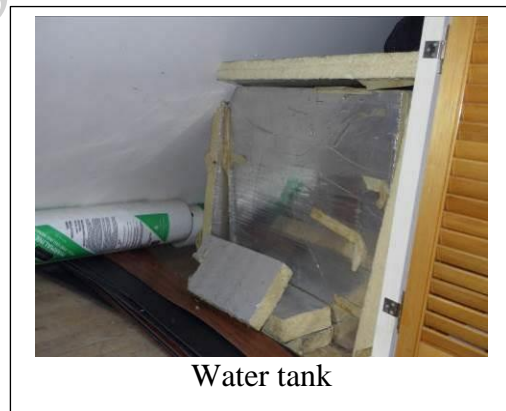
There are plastic water tanks with lids in the room in the roof. Water tanks can be very good at giving a head of water pressure in a building such as this.

ACTION REQUIRED: We would always recommend that the water tanks are drained down and cleared of any debris, etc. As you are often cleaning your teeth with this water it is best that it is as clean as possible! We would generally recommend you may want to change the water tanks.

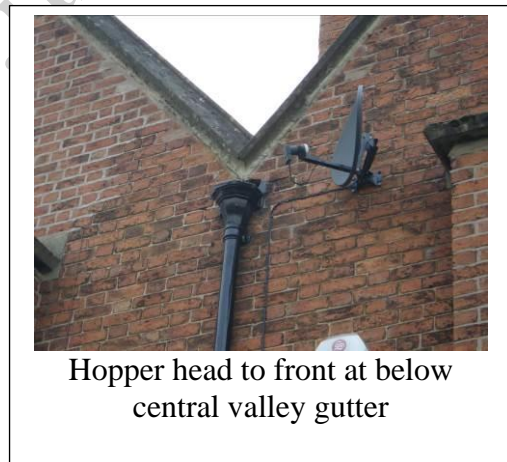
Hopper head to front at below central valley gutter

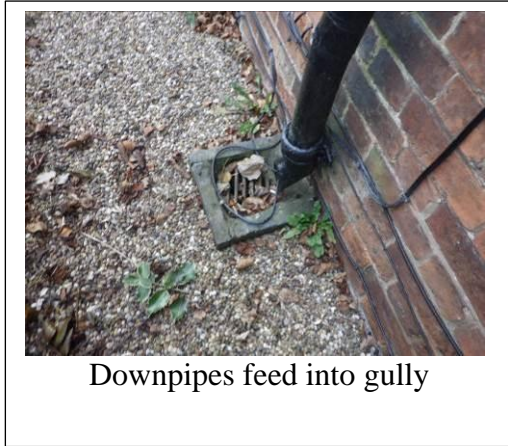
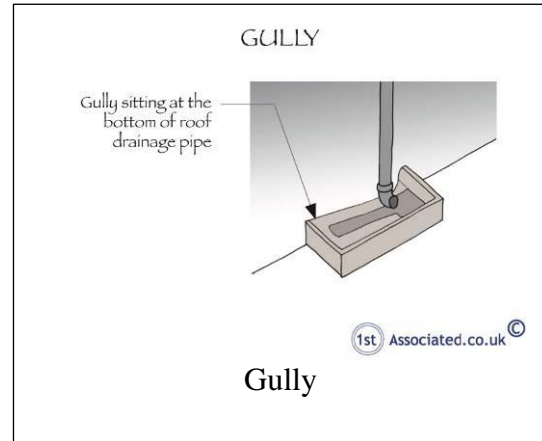
Downpipes feed into gullies

We were pleased to see the downpipes feed into gullies. We would ideally like to see them bigger but at least there are gullies and can clear the leaves from these.

ACTION REQUIRED: As mentioned elsewhere within this report, next time it rains heavily you need to stand outside the property and see how well the hopper heads, gutters and downpipes and drains cope with the rainwater particularly looking at the guttering and the joints.

However, the first thing you need to do is clear all the gutters, particularly the blocked valley gutters as soon as possible and check the joints and the alignments to ensure that the gutters fall towards the downpipes.

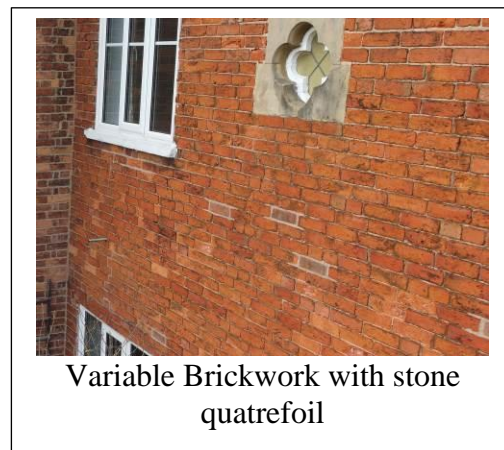
Variable, or local, bond brickwork

We did note a vertical joint crack to the left side.

ACTION REQUIRED: Find the oldest/most experienced bricklayer you can to repoint/repair the brickwork with lime mortar.

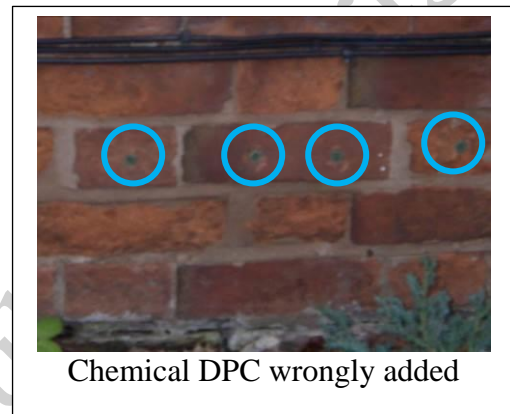
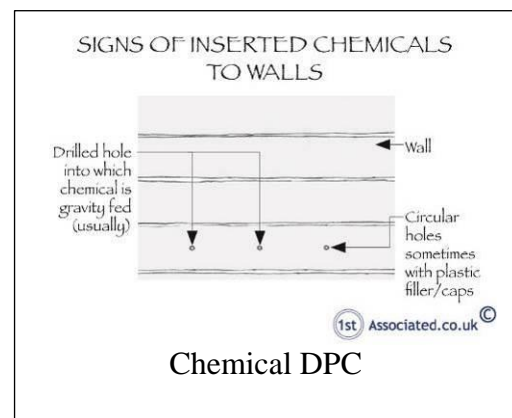
In properties of this age, it is unlikely that a damp proof course (DPC) would have been built in originally however often they have had damp proof courses added at a later date. In this case, we can see what looks like a chemical DPC has been added, which is inappropriate for this era of property.

We would like to mention that chemical damp proof courses can sometimes cause more problems than they solve. From the research we have read generally in older properties it is considered that they do not work. We do believe that they can cause problems, particularly where things such as waterproof renders and waterproof plasters have been used on older construction, where the construction is meant to 'breathe'/dissipate dampness, like an overcoat rather a plastic raincoat!

ACTION REQUIRED: We would ask the owners if they have any information with regard to the chemical damp proof course. Then look to remove any chemical waterproof renders or plasters that may have been added. We would move in this era of building to one that 'breathes'.

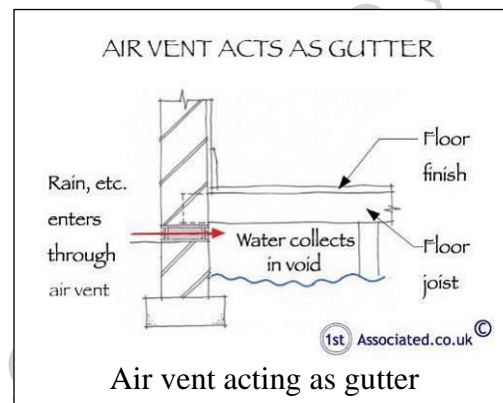
Low Level Air Vents

Air vents are essential to have a through flow of air as this helps to reduce the chances of wet rot, dry rot and woodworm. In this case, the air vents are acting as gutters.

ACTION REQUIRED: Please see our comments in the Executive Summary.

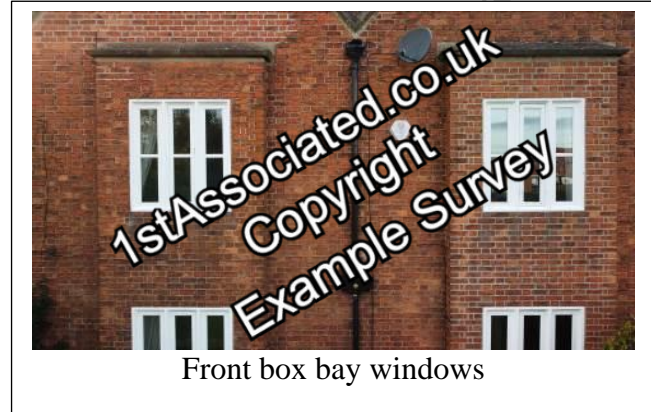
Front box bay windows

Generally we would comment they are slightly below average quality for their age, type and style with flaking paint.

ACTION REQUIRED: Repair, prepare and redecorate.

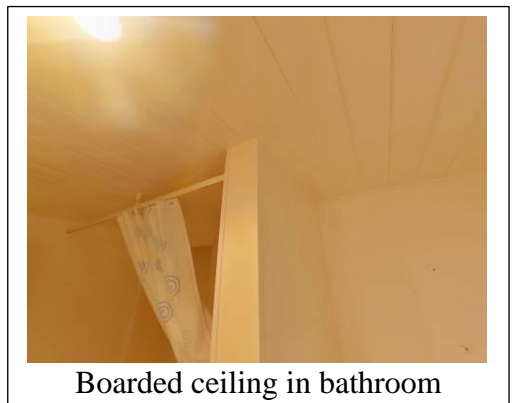
The ceiling in the family bathroom is boarded, we wonder whether there has been a leak from the roof above this area, although we do come across boarded ceilings sometimes in older properties.

Boarded ceiling in bathroom

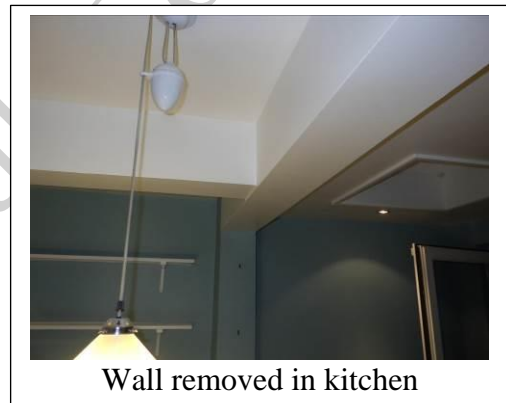
A wall has been removed to form the rear kitchen/diner extension. We think this wall is likely to partly be supporting the roof above which is pitched.

ACTION REQUIRED: Further investigation required.

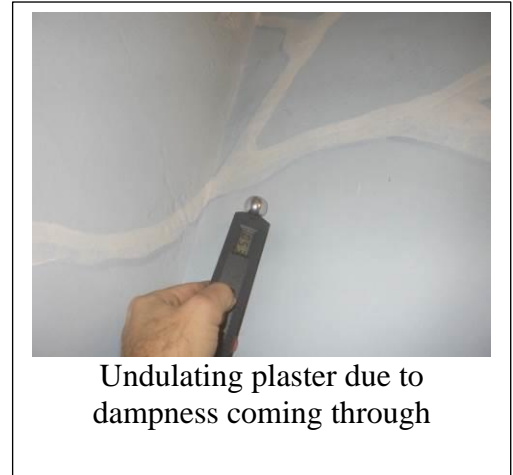
We noted some undulating plaster in the front bedroom on the exterior wall caused we believe by dampness coming through the walls.

In some ways it is not surprising there is dampness in the property when it has not been occupied for some time, particularly when there are areas where repointing is needed externally and also areas where there has been cement repointing.

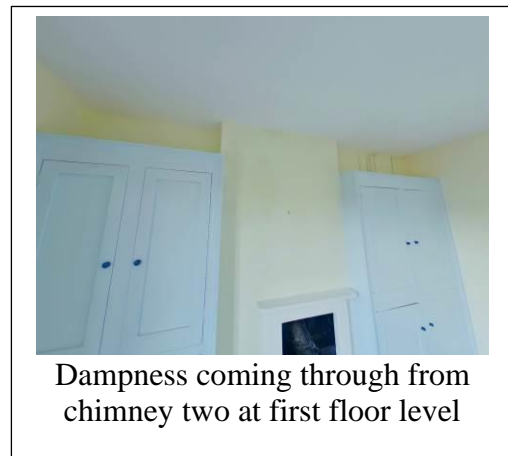
We noted dampness coming in the around the chimney breast of rear chimney number two both at ground and first floor level.

Dampness coming through from chimney two at first floor level

We think the dampness at ground floor level could be due to the flue condensing from the boiler.

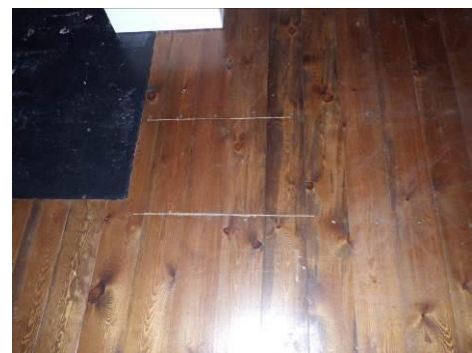
Are of floor in dining room which looks as though it has been opened up before

ACTION REQUIRED: Please see our comments in the Executive Summary about the air vents acting as gutters. For this reason we feel the floor should be opened up. There does look to be a section that has been opened up previously and you/your legal adviser should specifically ask the owner about this. We would be happy to comment on any photos taken once the floor is opened up and/or re-visit prior to you legally committing to purchase the property.

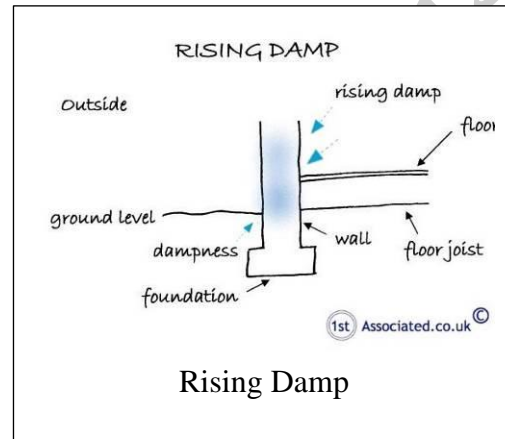
A visual inspection and tests with a moisture meter have been taken to the perimeter walls. In this particular case, we have found some rising damp, however as the property has been unoccupied to some extent this is not surprising.

This is based on our damp meter readings, as well as our knowledge and skill in identifying dampness in this age, type and style of property.

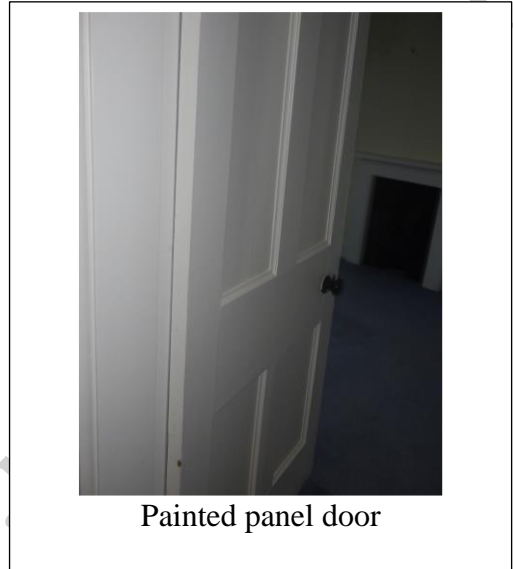
Painted panel door

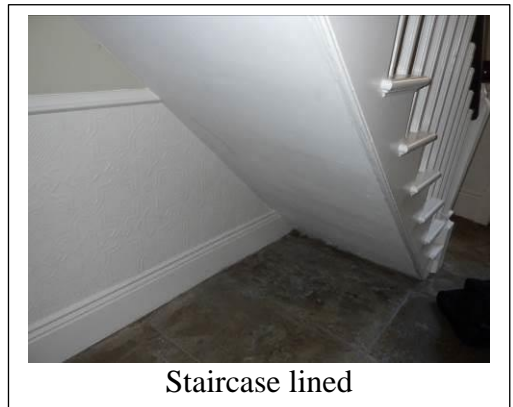
We were unable to examine the underside of the stair timbers due to it being lined where we could see it, which precluded our inspection, so we cannot comment further upon the stair structure. We can, however, say that the lining gives a resistance to the spread of fire if such circumstances were to occur.

Staircase lined

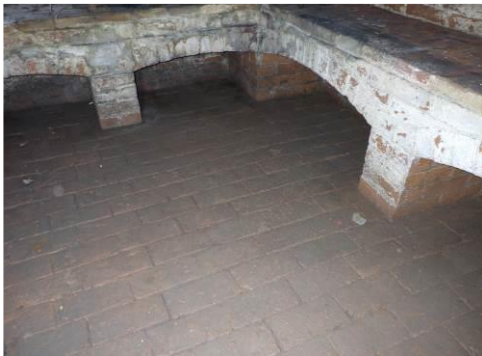
Cellar

The property has a cellar, which are usually damp areas. We do find cellars are flooding more and more, which may relate to our changing climate, having more intense rain.

We do like to have a sump pump in a cellar so you can remove any water that does get into it.

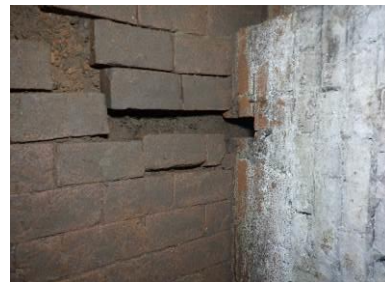
Openings in brickwork which may have been some kind of timber frame (conjecture)

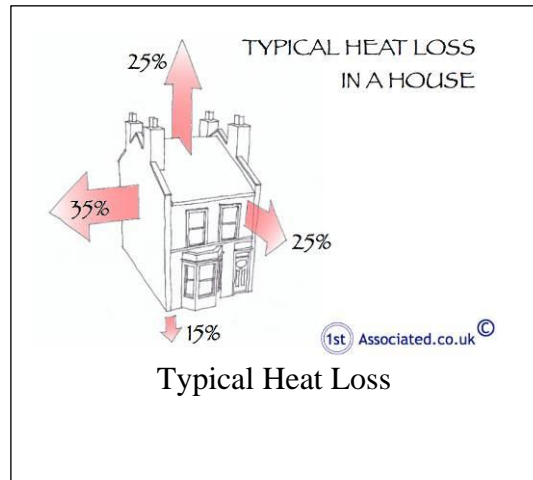
Flat Roof

We think it is unlikely there will much insulation here. It is above the kitchen so there will be a fair amount of heat loss in this area.

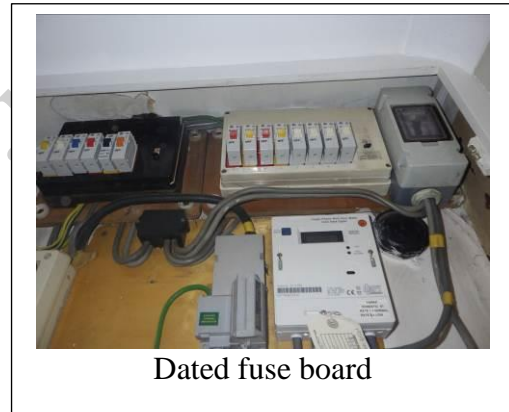
Earth Test

We carried out an earth test in the kitchen area to the socket point that is normally used for the kettle; this failed.

ACTION REQUIRED: Please see our comments in the Executive Summary.

We recommend a test and report of the electrics as soon as possible. The Institution of Engineering and Technology (IET) also recommend a test and report when properties are changing occupancy, as in this case. This should be carried out by an NICEIC registered, or equivalent, approved electrical contractor or similarly approved and gives a quotation with regard to repair work.

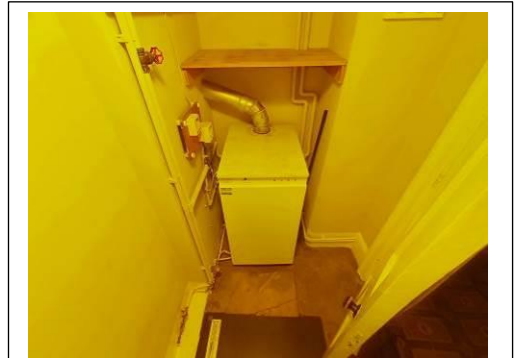
Oil Boiler

We are not sure whether the oil boiler would meet current regulations as we think the flue will need to have an inspection hatch. There was also a stain on the chimney near where the flue is, which could be due to condensation.

Our limited inspection of the hot water and central heating system revealed no evidence to suggest any serious defects but we would nevertheless recommend that the system be tested and overhauled before exchange of contracts and that a regular maintenance contract be placed with an approved heating engineer.
