Georgian/Regency Example Residential Building Survey

LATE 18TH CENTURY SASH WINDOW

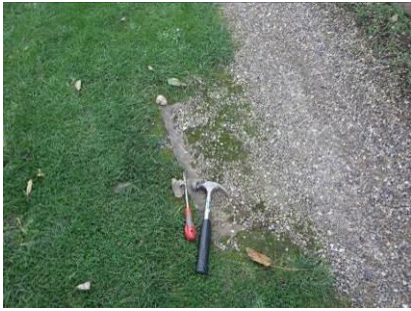
Manhole one to front of right side drive, with bent cover

ACTION REQUIRED: We would recommend a closed circuit TV camera report of the drains to check their condition and your legal adviser needs to check if they are your responsibility.

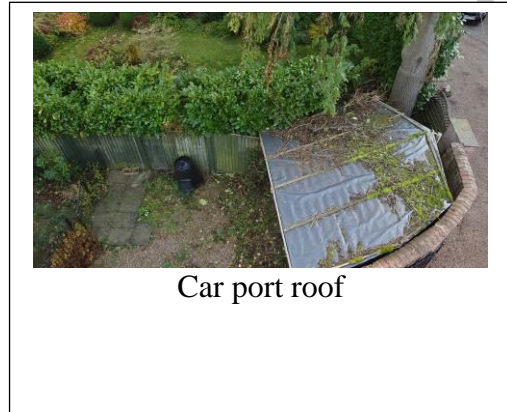
Car port roof

The property has a covered car port to the rear. We would comment that the roof is in need of maintenance.

ACTION REQUIRED: Really depends upon what you intend to use the car port for. If you have a prestigious car or something you want to make sure is safe/dry then we would be looking to generally improve and re-roof.

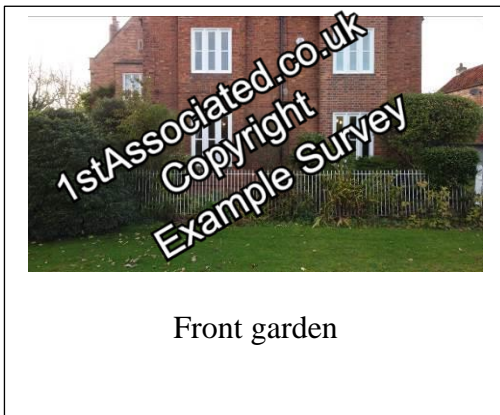
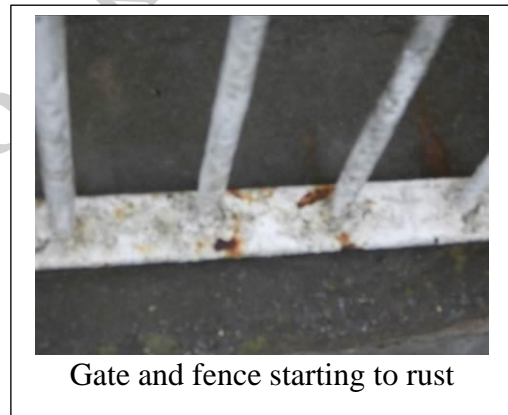
There is a reasonable size front garden. The gate and fence are starting to rust.

ACTION REQUIRED: Add the maintenance of the gate and fence to the list of things that need painting.

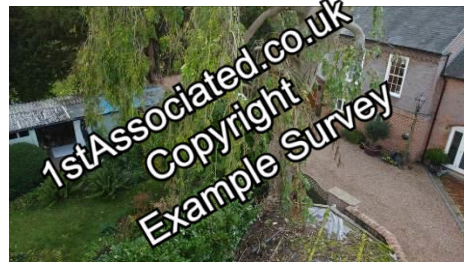
There is a paved area to the rear, with lawn and large tree to the end. The garden is on a slope which is discharging water towards the rear of the property.

Large tree to end of rear garden needs regular maintenance

ACTION REQUIRED: Please see our comments on the sloping site in the Executive Summary.

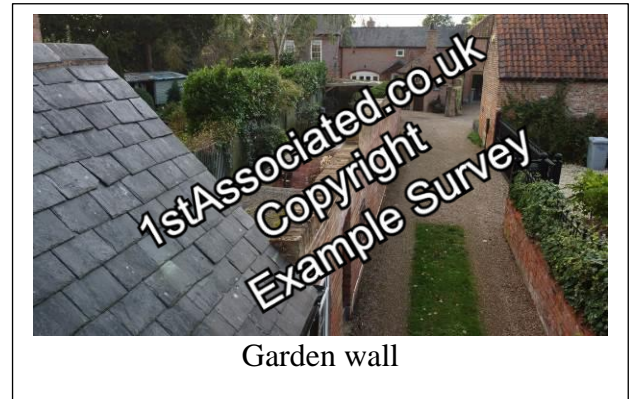
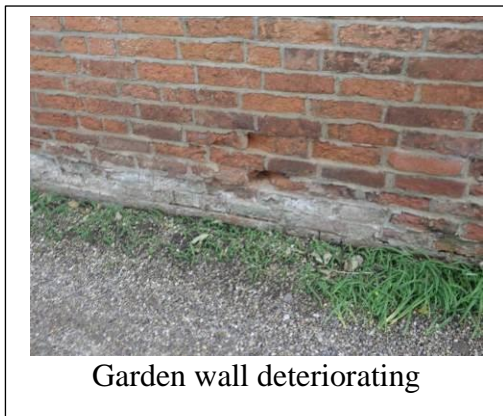
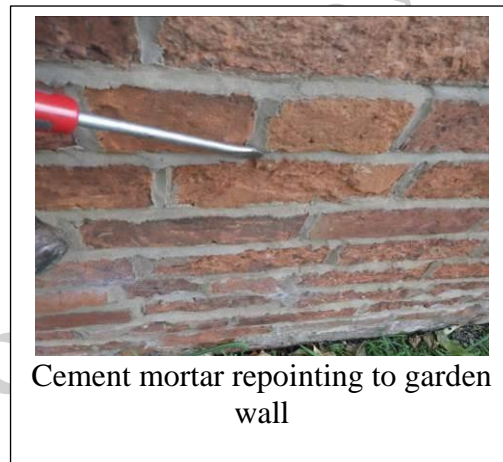
Garden wall to right side

The garden wall is deteriorating. They do not have very deep foundations.

ACTION REQUIRED:
Repair/repoint in lime mortar to make the wall stable, once of course you have checked that it is your boundary.
